ASBESTOS, LIMITED LEAD BASED PAINT AND MISCELLANEOUS HAZARDOUS MATERIALS SURVEY

SEVERAL LOCATIONS INCLUDING SEVERAL DEBRIS
PILES, BLOCK AND METAL BUILDINGS, COOLING TOWER,
ASPHALT, BLAST WALLS, PIPE RACKS AND PIPE RUNS

TRONOX 8000 WEST LAKE MEAD PARKWAY, GATE 2 HENDERSON, NEVADA

Converse Project No. 10-43153-01

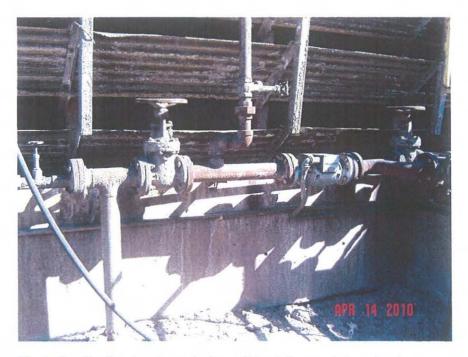
Photo 1 – Cooling tower gaskets on this piping contain asbestos, south side of cooling tower.

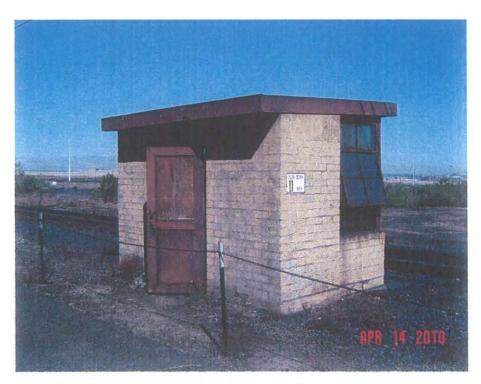
Photo 2 - Window putty on five windows contain asbestos.

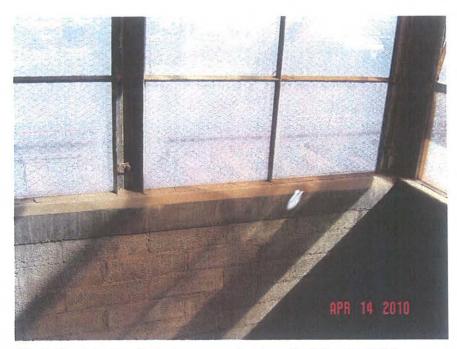
Photo 3 – Interior of windows seen in above building contains asbestos window putty.

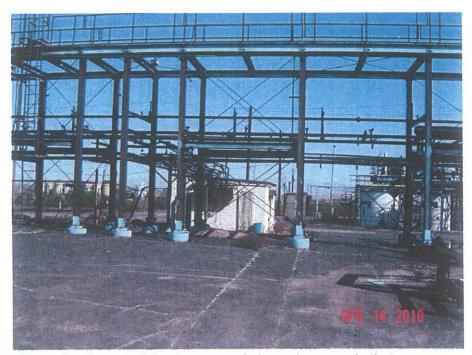
Photo 4 – Small building in center of picture has panels that are non-asbestos on north side of building

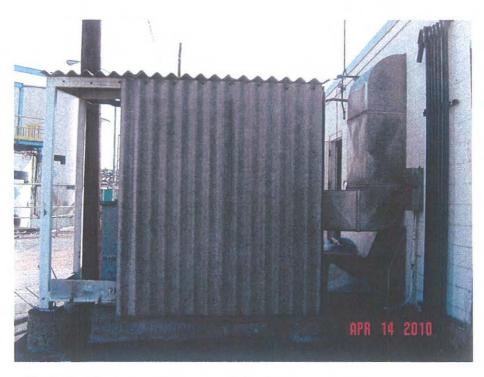
Photo 5 - These panels are non-Asbestos.

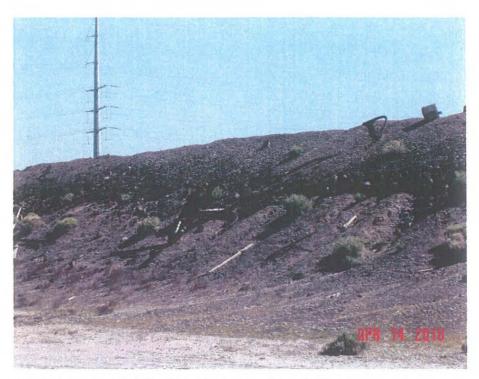
Photo 7 – West debris pile with pipe on side of hill. Pipe contains asbestos pipe wrap.

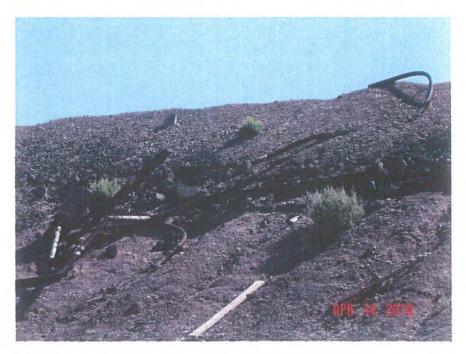
Photo 8 – West debris pile with pipe on side of hill. Pipe contains asbestos pipe wrap.

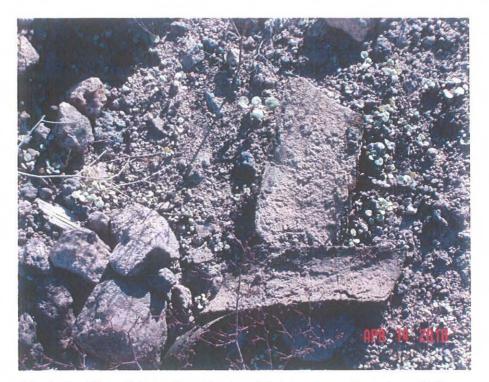
Photo 9 - West debris pile with pipe debris on ground on slop of hill.

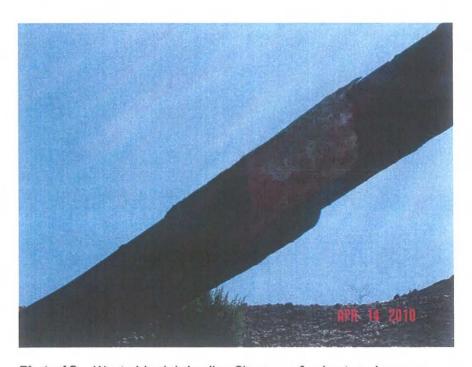
Photo 10 - West side debris pile. Close-up of asbestos pipe wrap.

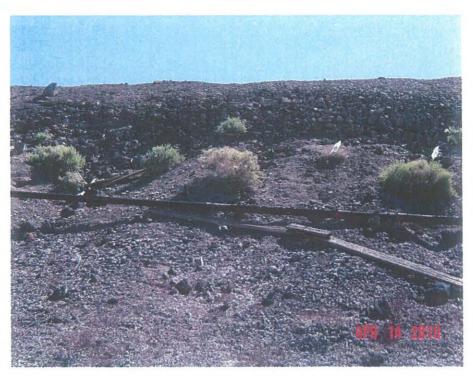
Photo 11 – West debris pile with pipe on side of hill. Pipe contains asbestos pipe wrap.

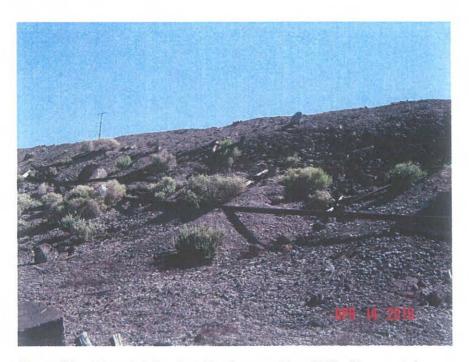
Photo 12 – West debris pile with pipe on side of hill. Pipe contains asbestos pipe wrap.

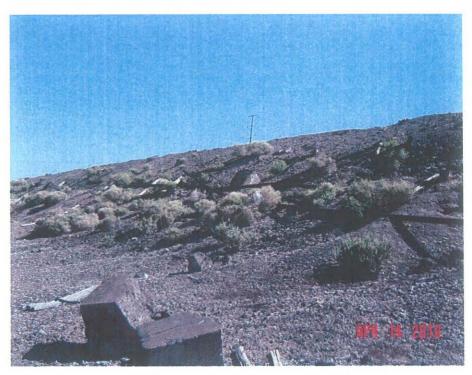
Photo 13 – West debris pile with pipe on side of hill. Pipe contains asbestos pipe wrap.

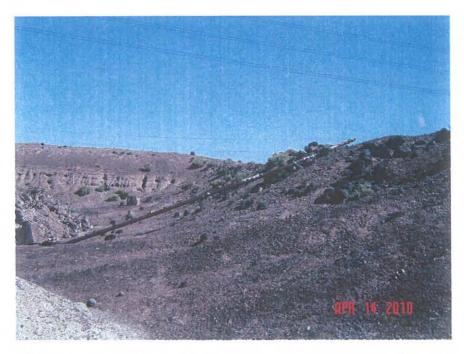
Photo 14 – West debris pile with pipe on side of hill. Pipe contains asbestos pipe wrap.

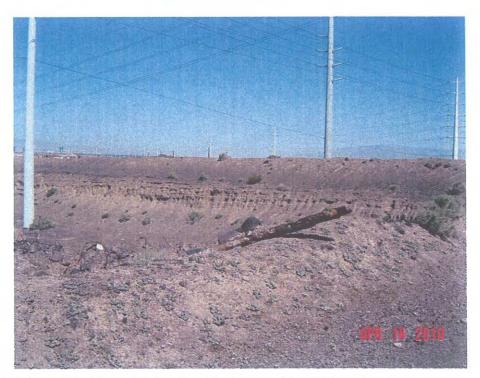
Photo 15 – West debris pile with pipe on side of hill protruding over hill. Pipe contains asbestos pipe wrap.

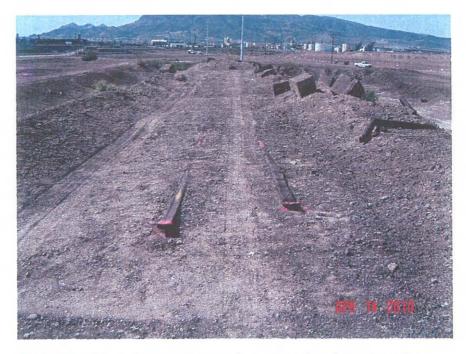
Photo 18 – West side debris pile. Pipe protruding from ground on top of hill. Buried pipe may contain asbestos pipe wrap.

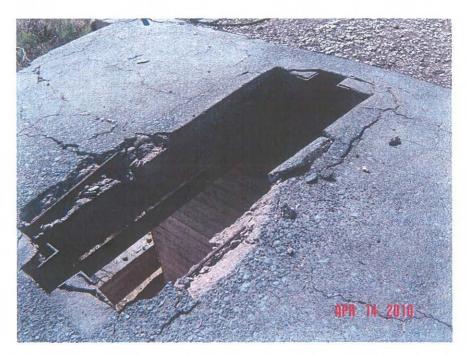
Photo 20 – West side debris pile. Pipe under concrete at far south of hill.

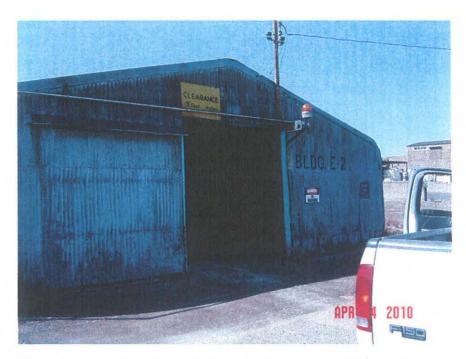
Photo 1 – Example of metal building with loose and flaking paint on the interior beams. Four Buildings such as this one are located on the north side of the facility.

The structures sampled may be demolished without lead containing paint removal provided the paint is in good condition. Because the lead containing paint identified in Table 1 was damaged, it must be stabilized by removal or encapsulation before demolition of the structures may occur. The demolition debris must be tested using the Toxicity Characteristic Leaching Procedure (TCLP) for lead to determine if it is hazardous waste before disposal. In Nevada, this must be conducted by or under the supervision of a Nevada Certified Environmental Manager (CEM).

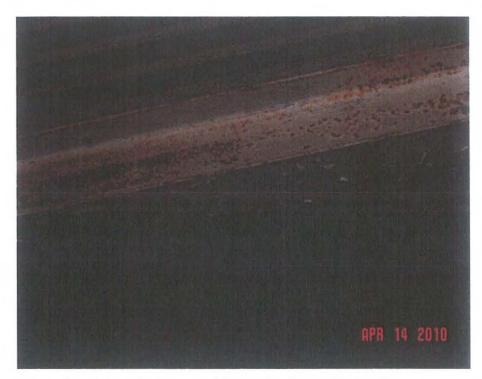
Photo 2 – Beam with loose and flaking lead containing paint on beam inside metal building(s) as seen in previous photo.

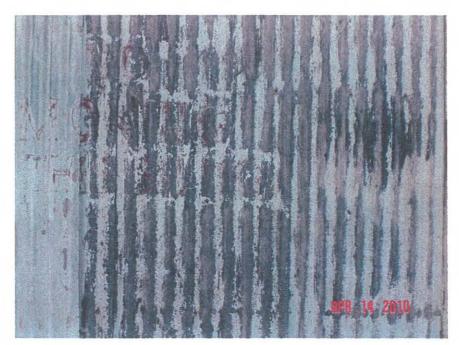
Photo 3 – Door with blue/greenish paint on door of metal building as seen in photo 1.

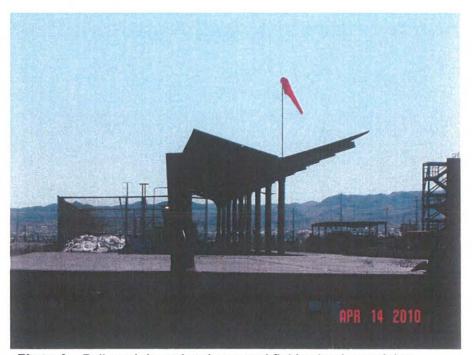
Photo 4 – Rail road depot has loose and flaking lead containing paint.

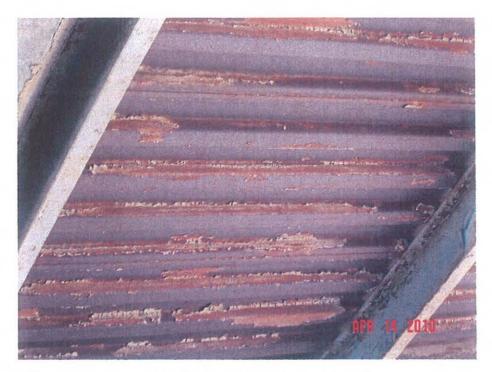
Photo 5 – Loose and flaking lead containing paint on the underside of the roof deck.

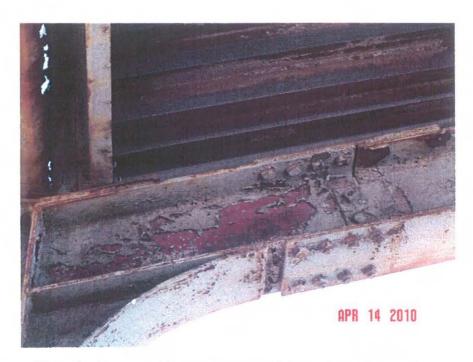
Photo 6 – Loose and flaking lead containing paint on beam of railroad depot.

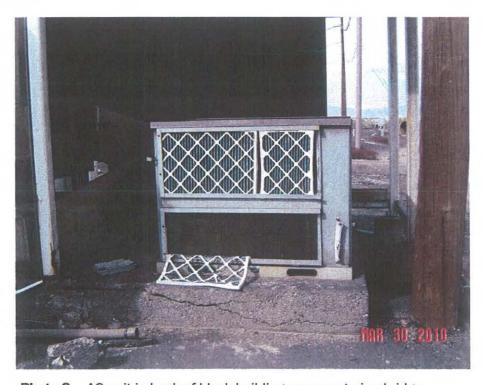
Photo 2 - AC unit in back of block building near west pipe bridge.

Before disposing of refrigeration or air-conditioning units that may contain chlorofluorocarbon (CFC) or hydro-CFC (HCFC) refrigerants, the refrigerant should be removed by a properly certified technician. The technician should be certified to service and dispose of small appliances such as the subject air conditioning units under the EPA Section 608 Technician Certification Program. The refrigerant should be reclaimed by sending it to an EPA Certified Refrigerant Reclaimer.

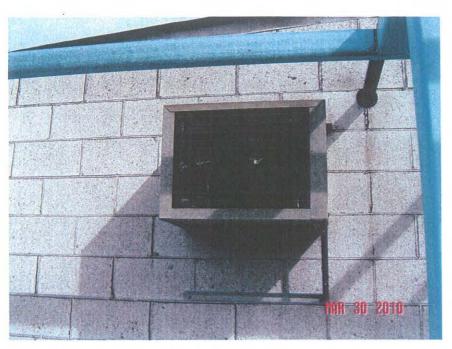
Photo 3 - AC unit on calciner building.

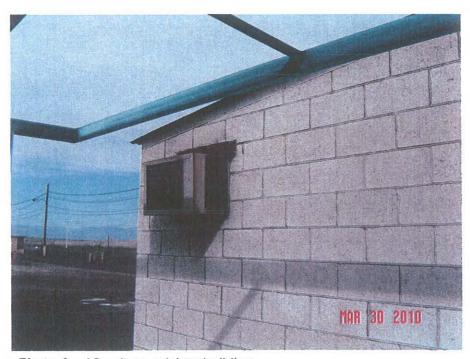
Photo 4 – AC unit on calciner building

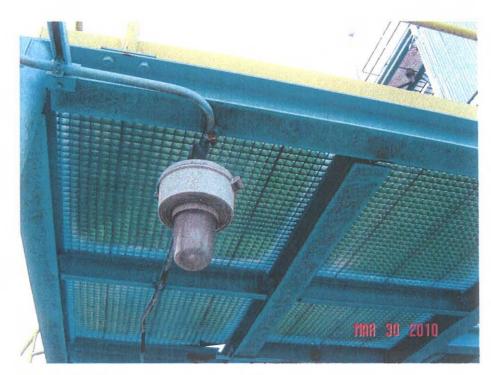
Photo 5 – Mercury containing light, these lights can be found throughout the AP area.

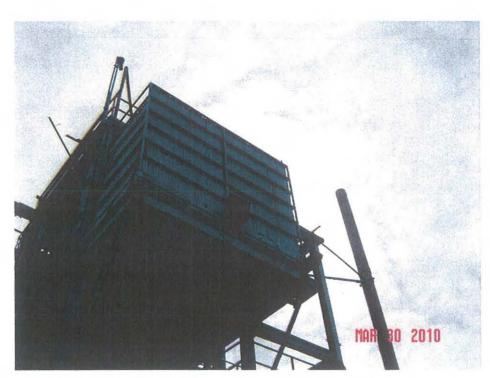
Photo 6 – Mercury containing light, these lights can be found throughout the AP area

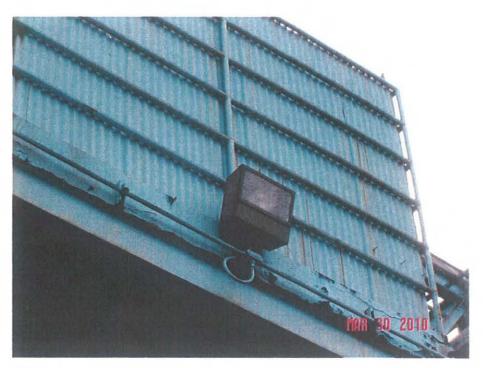
Photo 7 - Mercury containing light, close up view
