Re: Dive Report for Third Dive

Summary Report on Third Dive into GW-11

The Following are the results from the Dive inspection done on Sept 24th 2013, at the Envirogen GW11 Pond in Henderson NV.

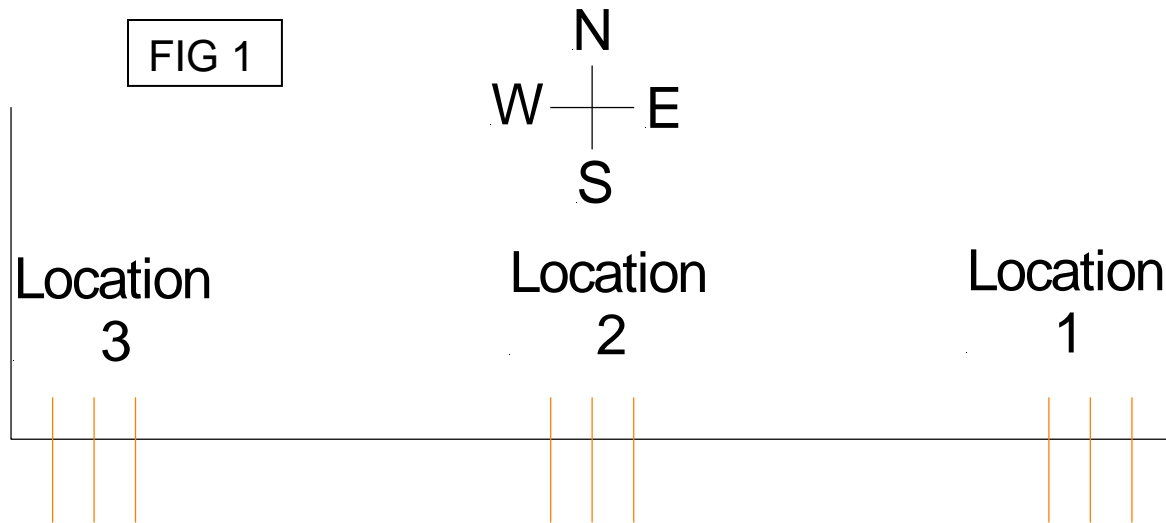
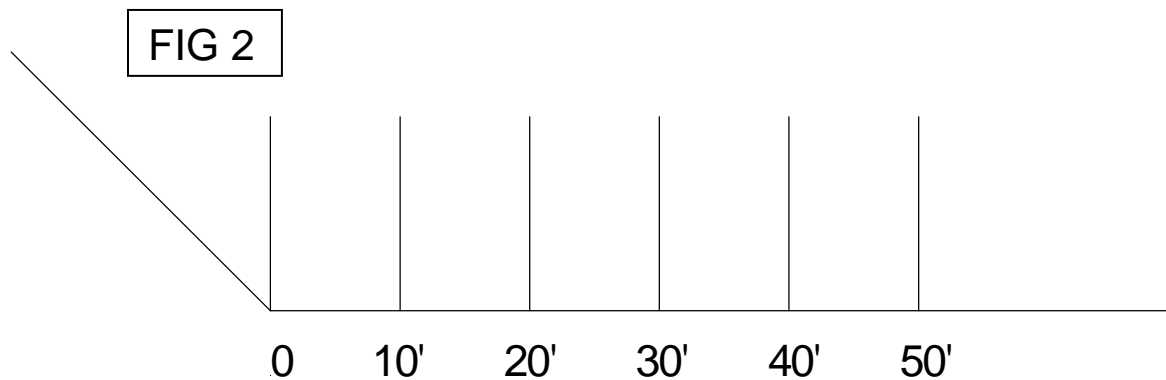
We were asked to inspect 3 locations on the GW11 pond. 1/4, 1/2 and 3/4 the way down the South side of the pond. At each location (see below), we also inspected 20' East of the location as well as 20' West of the location, totaling 9 points of inspection. We marked each inspection point with orange marking paint as shown below (see Fig 1). at each location we started the inspection at the Invert of the pond, and in 10' increments out to the 50' mark (see Fig 2) Each location we inspected:

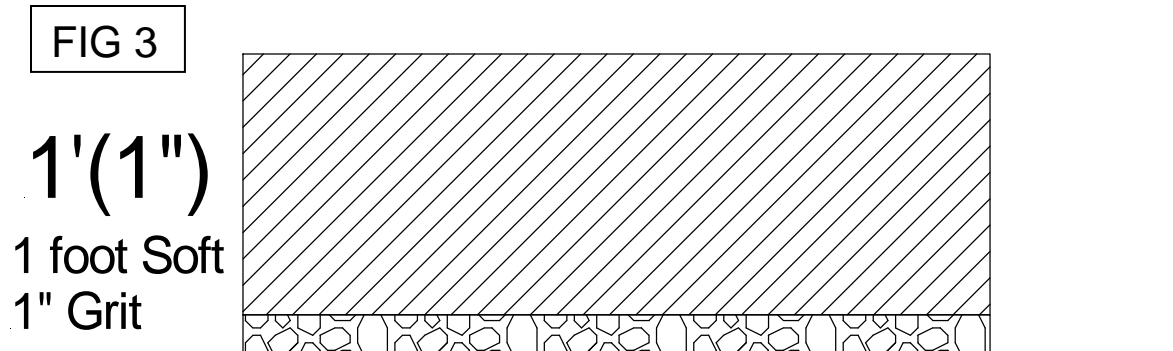
All grit or gravel was located under the soft Bio Media. No crusty top layer was found.

The first number on the inspection result = Soft Bio Media

The second number in Parentheses, on the inspection result = Grit or Gravel (see Fig 3)
