## MEMORANDUM

To: Shannon Harbour, NDEP  
From: Jim Hutchens, ENVIRON International  
Subject: Proposed Erosion Control Measures – NERT Henderson

Subject: Data Summary for Soil Sampling and Moisture Content Test Results  
NERT/Tronox Site  
Henderson, Nevada  
Project No. 11.1049

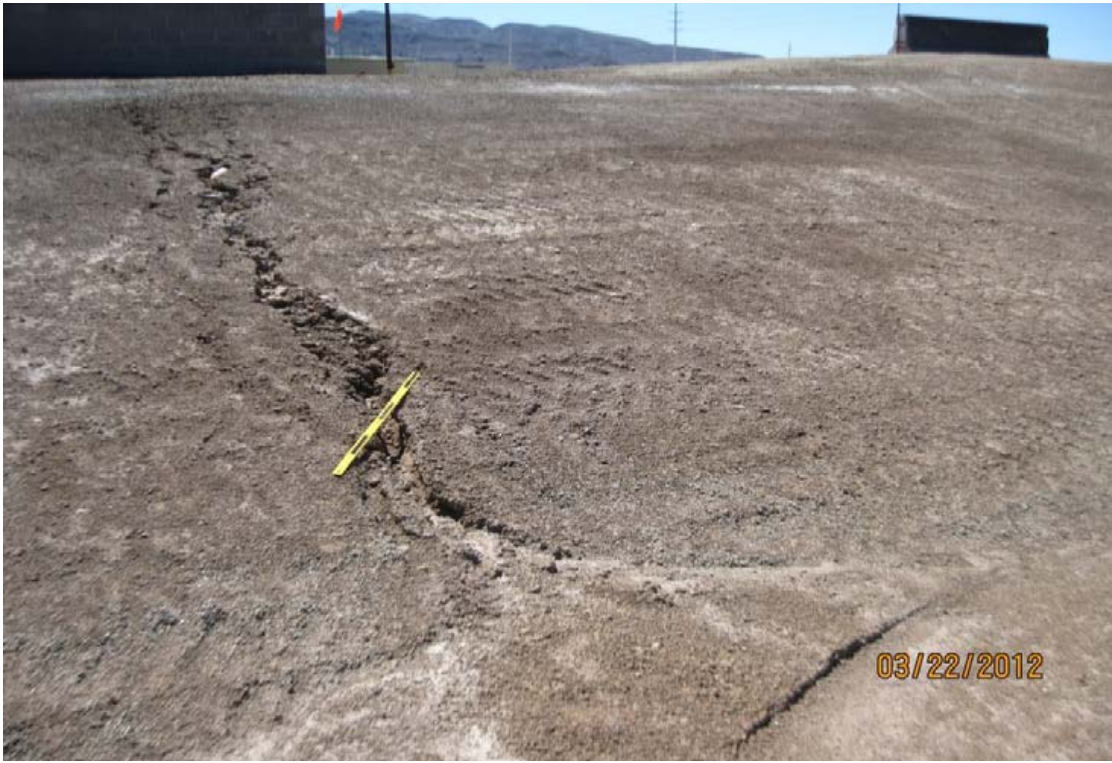
**Photo 1:** Looking south-southwest rill in southern slope of Beta Ditch just east of 5th Street.

Figure 1 identifies the areas which will require repair and additional grading work. The damaged areas will be re-graded to previously designed grades. Directional berms will then be installed to move the water to a designated energy dissipating channel into the respective basin. The flow channel will consist of a geotextile fabric covered by approximately 8 inches of 3" to 6" angular stone. Photographs of the typical flow channels previously constructed on the site are attached.

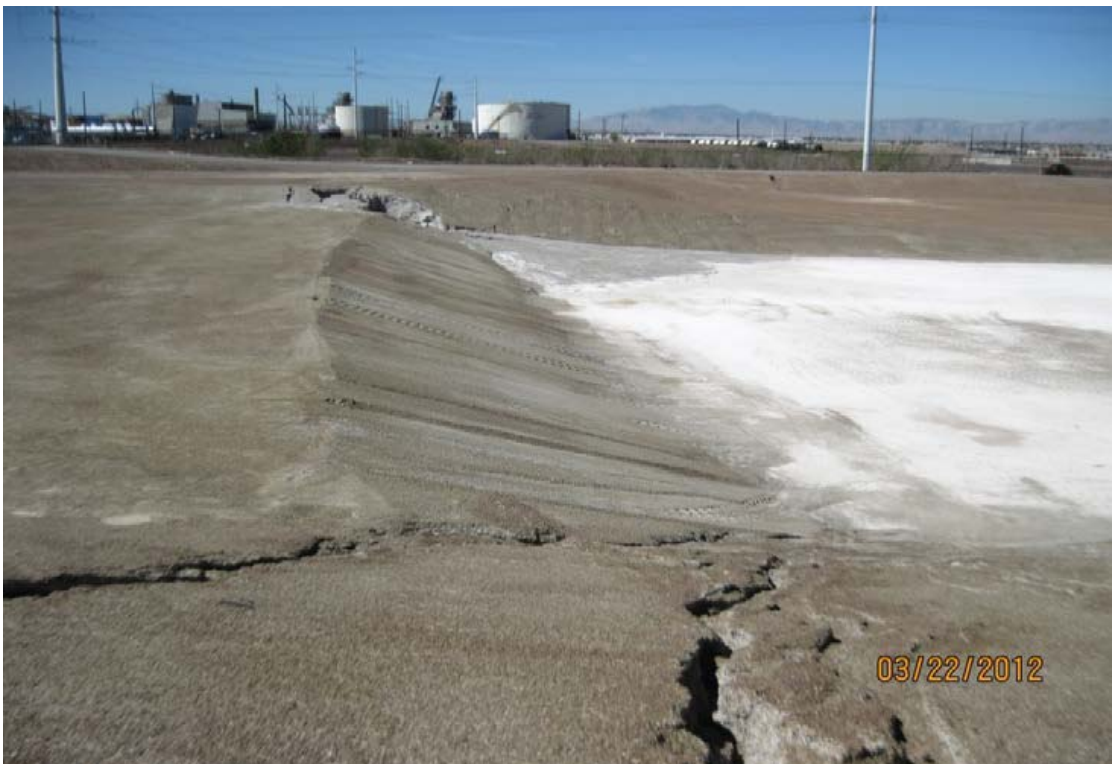
**Photo 2:** Looking west from 4th Street.

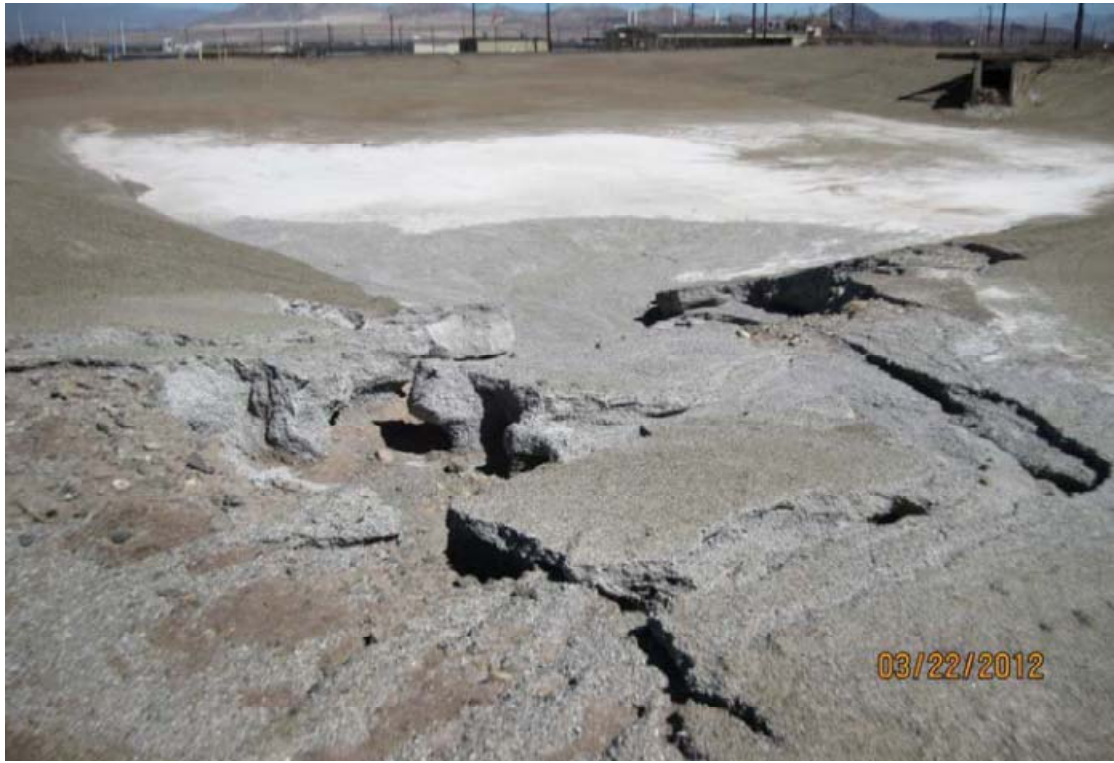
**Photo 3:** Large washout area looking northeast.

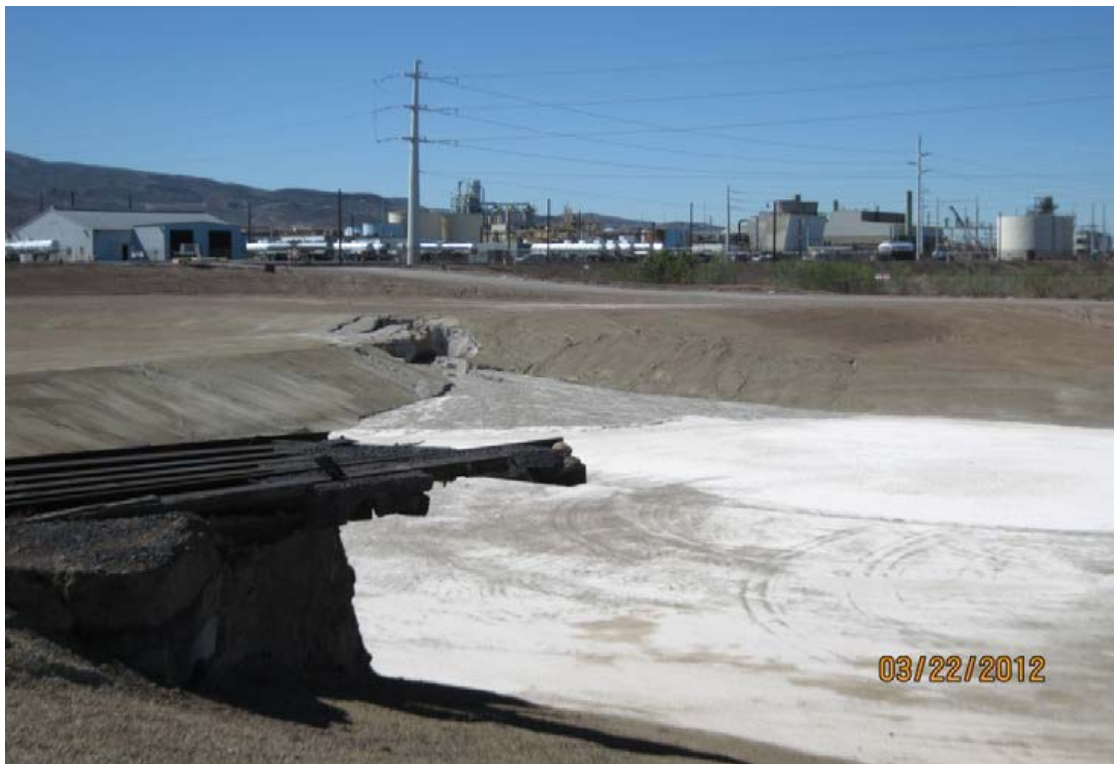
**Photo 4:** Looking southwest over rail crossing at large wash out.

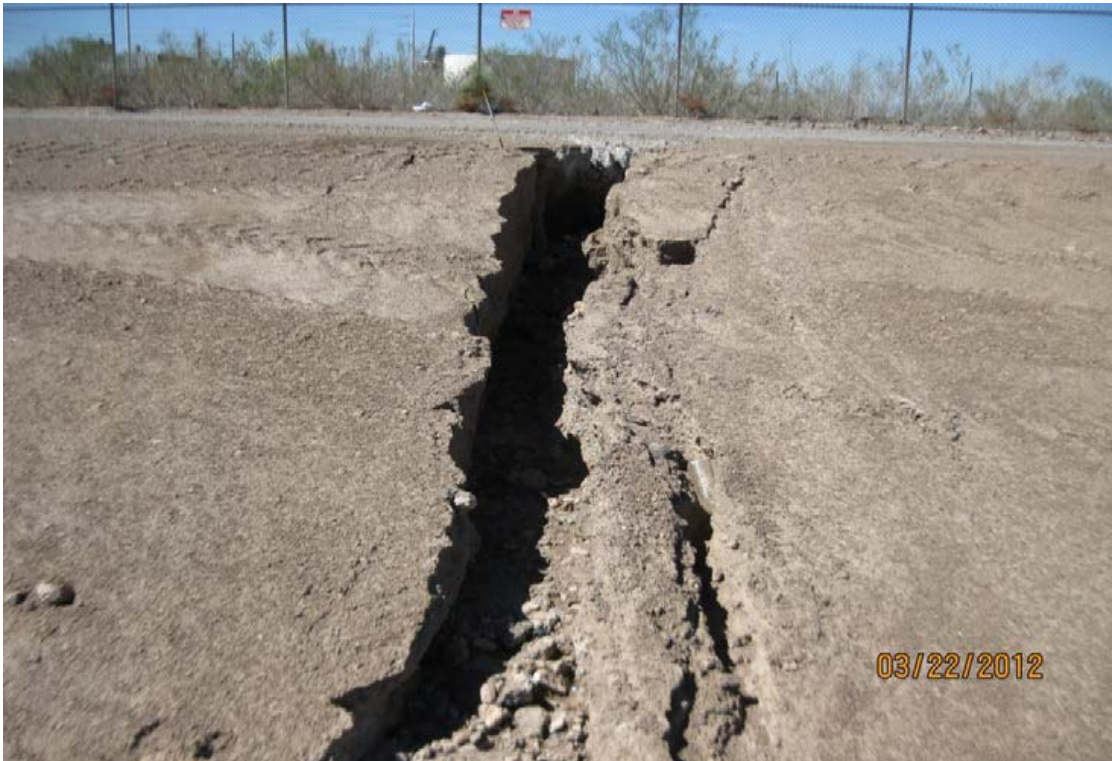
**Photo 5:** Looking west at a wash out off of 5th Street.

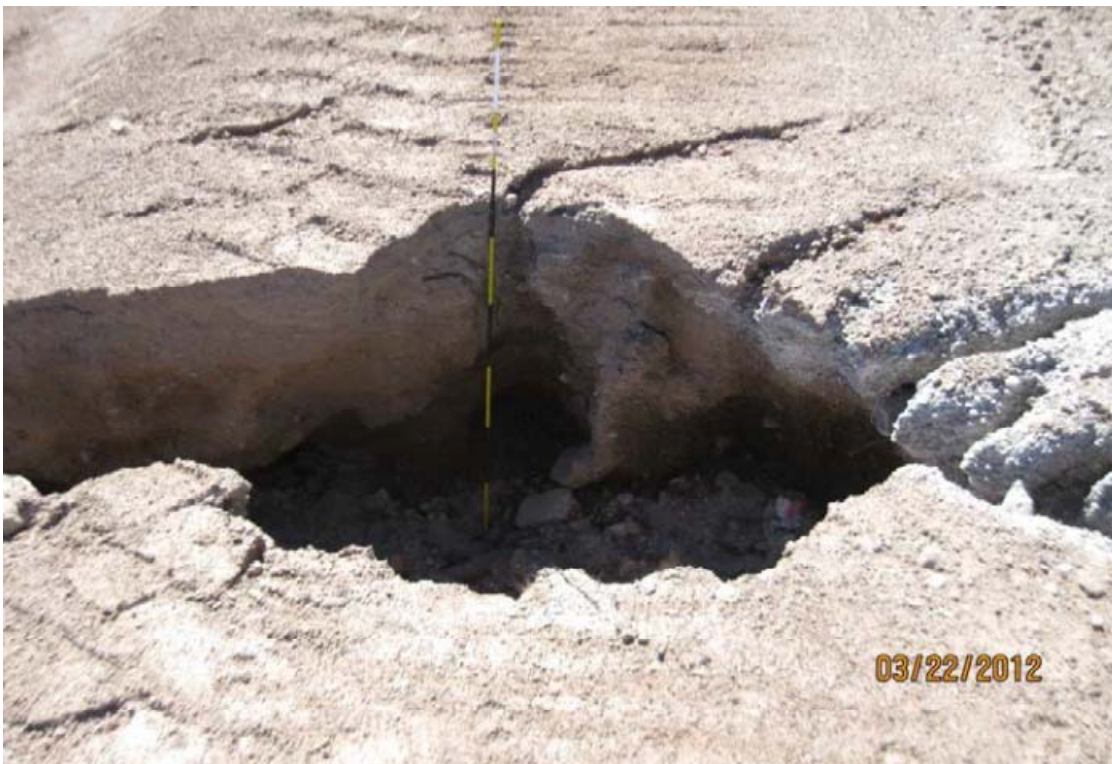
**Photo 6:** Looking south at same area, approximately 34 inches deep.

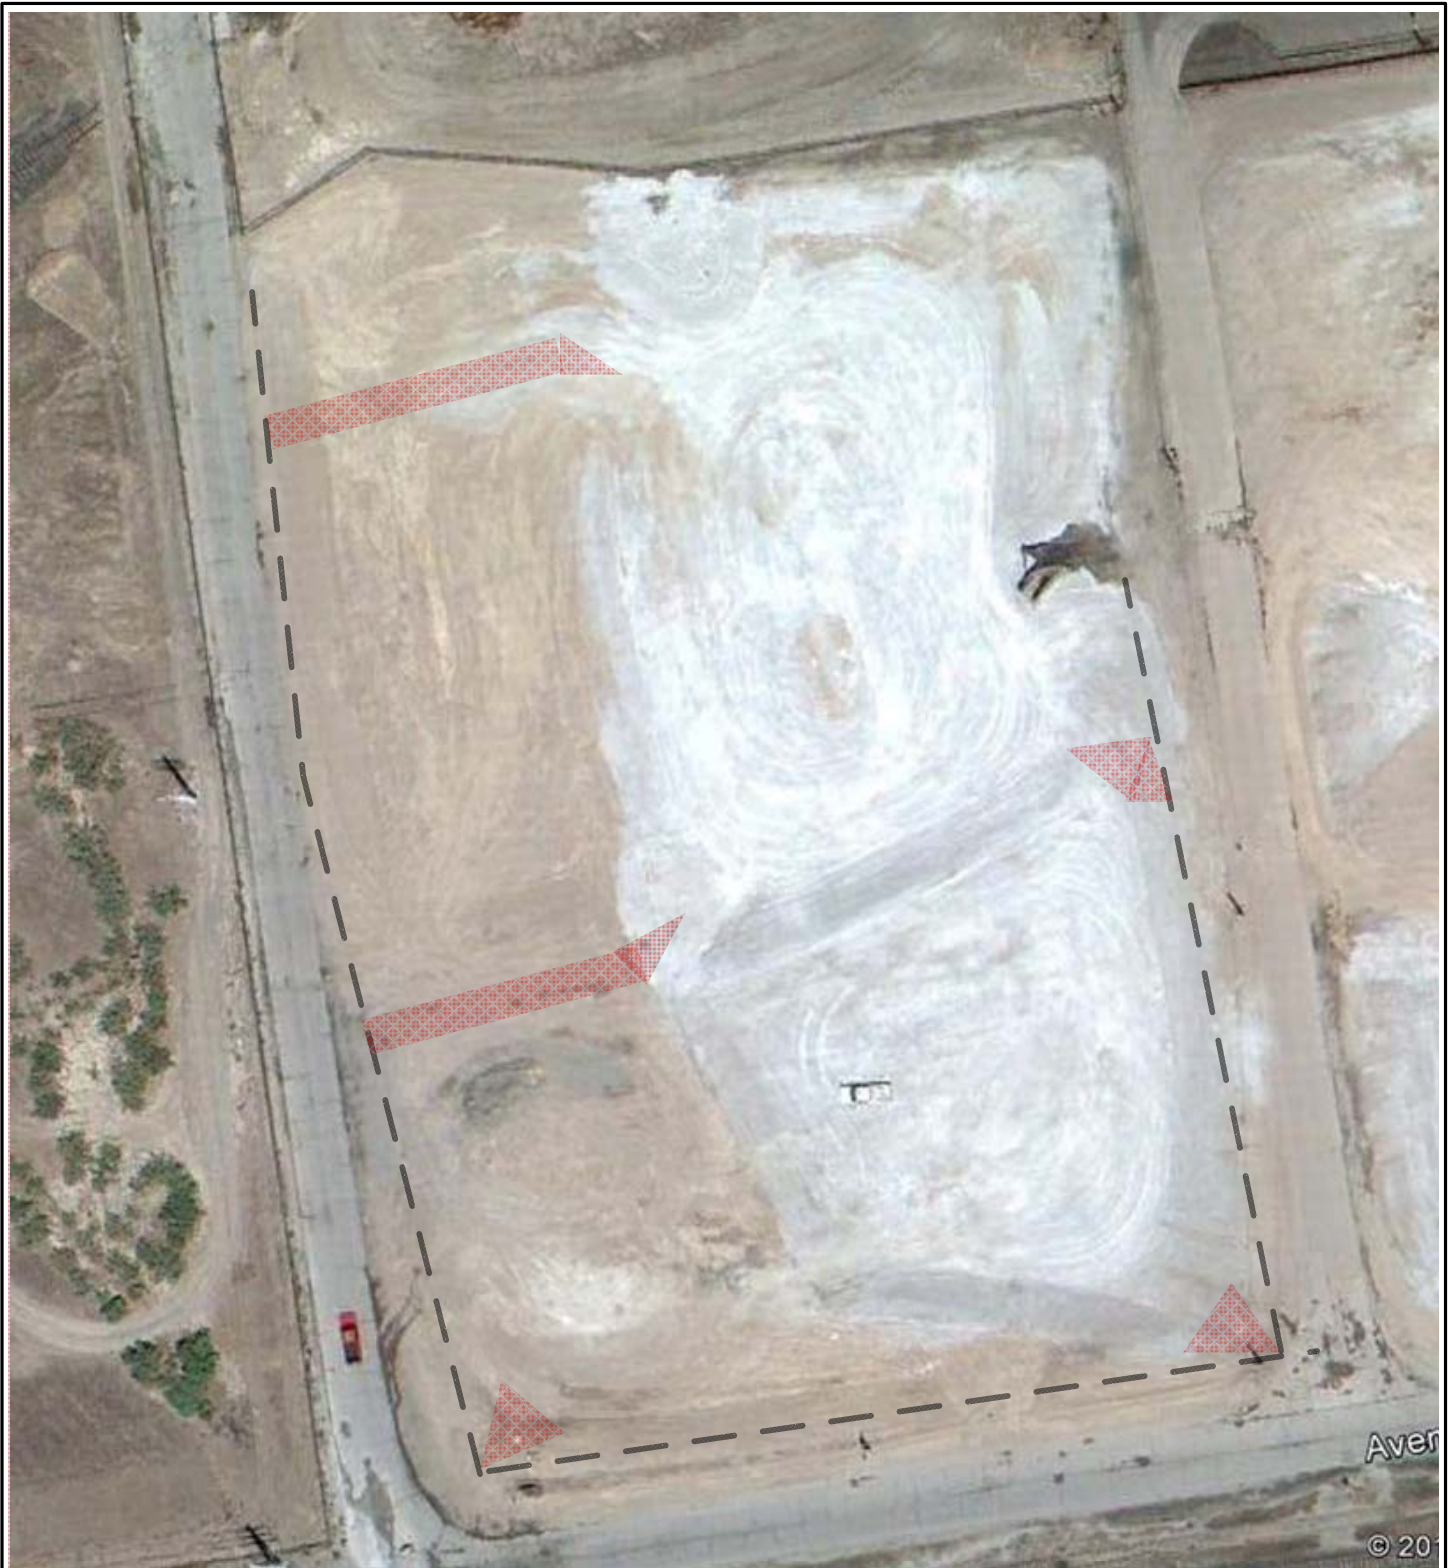
PROJECT: NERT Henderson, Nevada		SHEET TITLE: Erosion Control Plan

Proposed Energy Dissipation Channels

Proposed Directional Berm

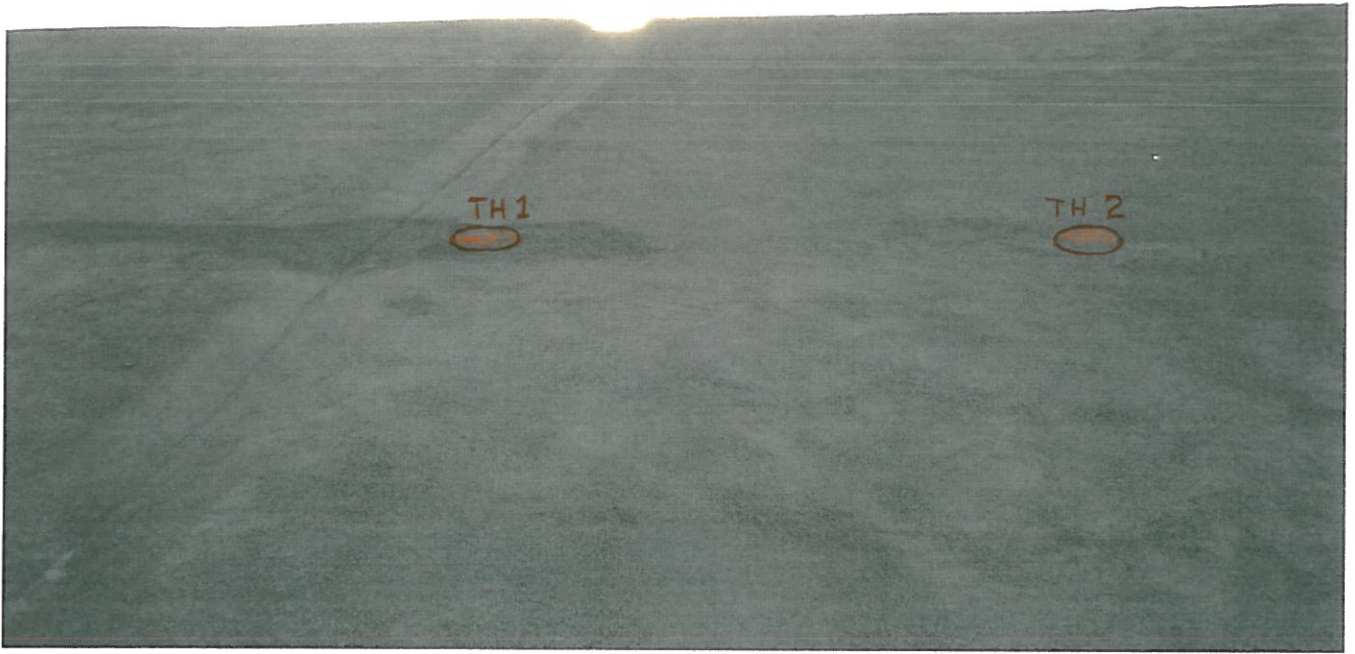
Results of the moisture tests indicate the discolored soils on the surface, that appear wet, do not necessarily contain higher moisture contents as indicated by test holes 5, 6, 8 and 10. Conversely, the dry appearance of some surface soils may contain relatively high moisture contents as indicated in test holes 2 and 4. Photographs of test holes 1 through 8 and the appearance of the soils encountered are shown in Photo Plate 3.

The locations with the highest moisture contents were found to be at higher elevations on the slope. Test holes 1, 2 and 4 are 12 to 34 feet above the toe of slope and contained moisture contents ranging from 16.5% to 32.3%. Samples obtained at lower elevations on the slope and areas in front of the slope ranged between 4.1% and 6.9% moisture content. Further investigation would need to be performed to determine possible reasons for these moisture conditions.

Photo 1: West pond slope discolored area and location of Test Holes 1 and 2 .

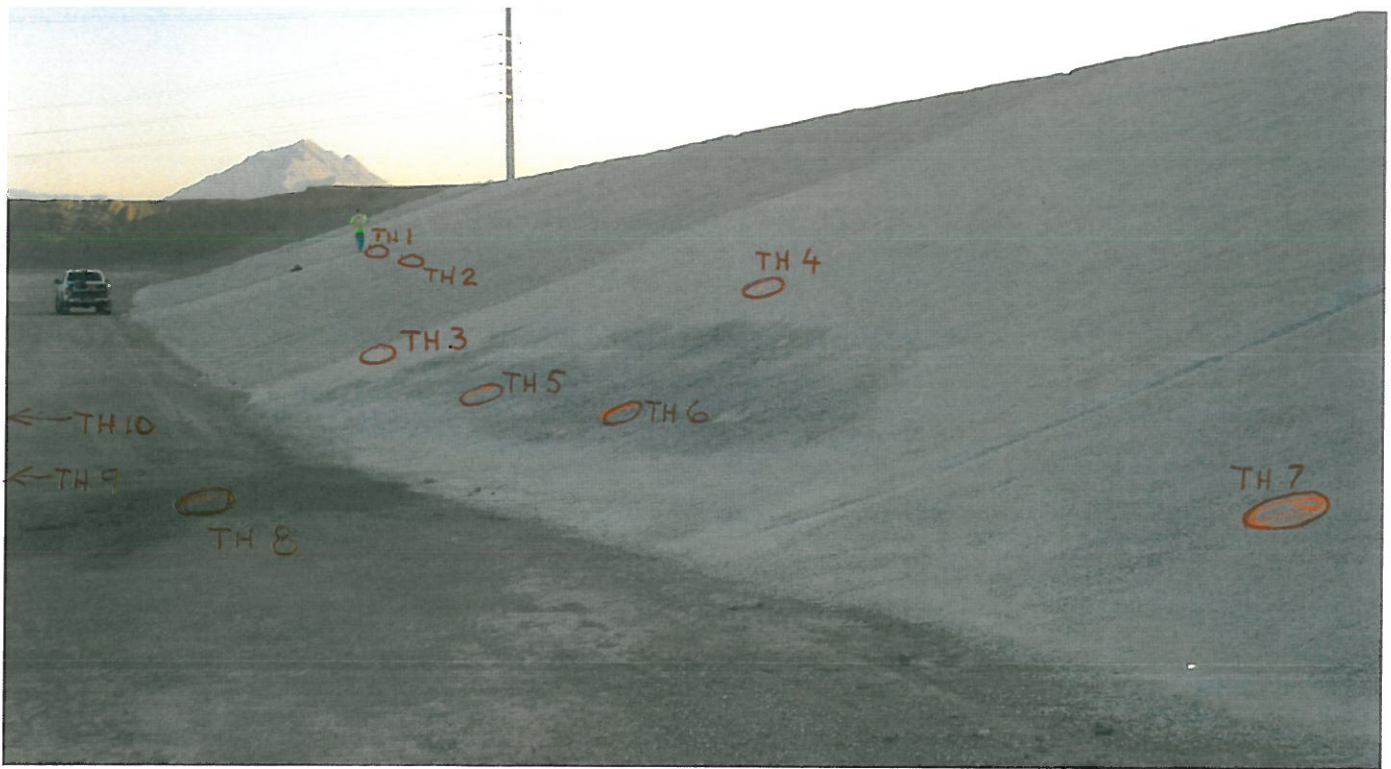
Photo 2: West pond slope discolored area and location of Test Holes 3, 4, 5, 6, 7 and 8.

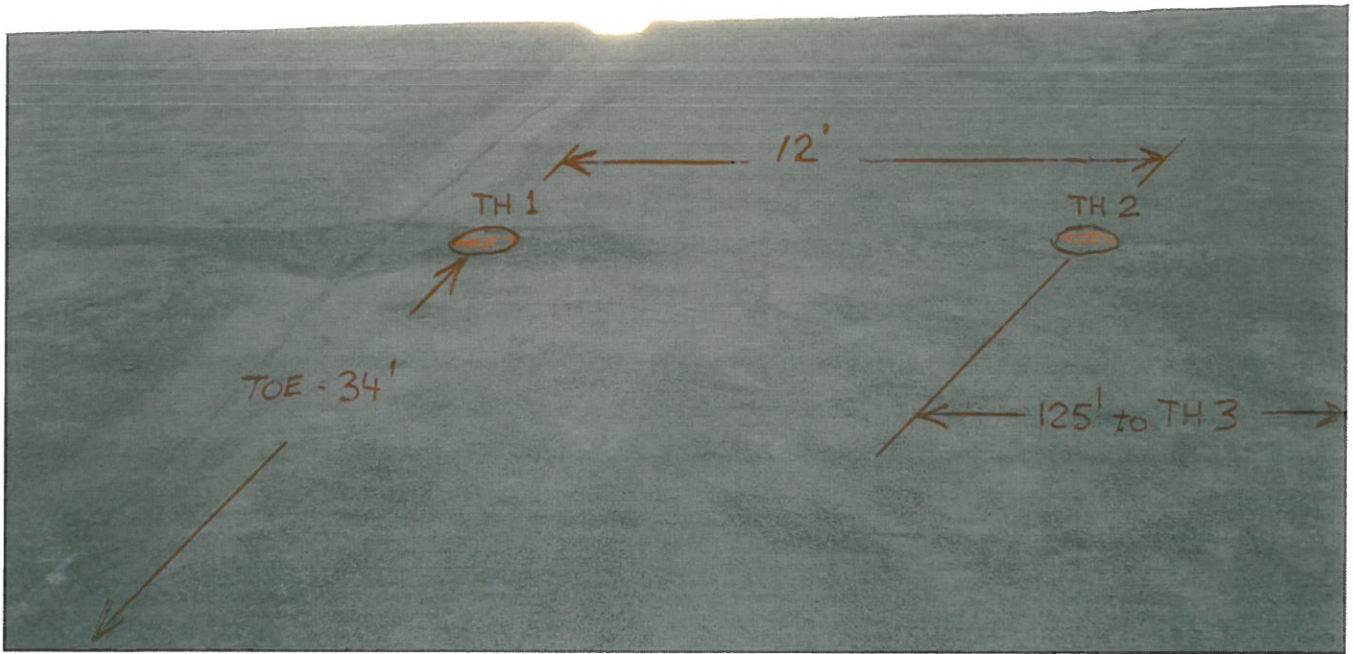
Photo 3: West pond slope, Test Holes 1 and 2, dimensions.

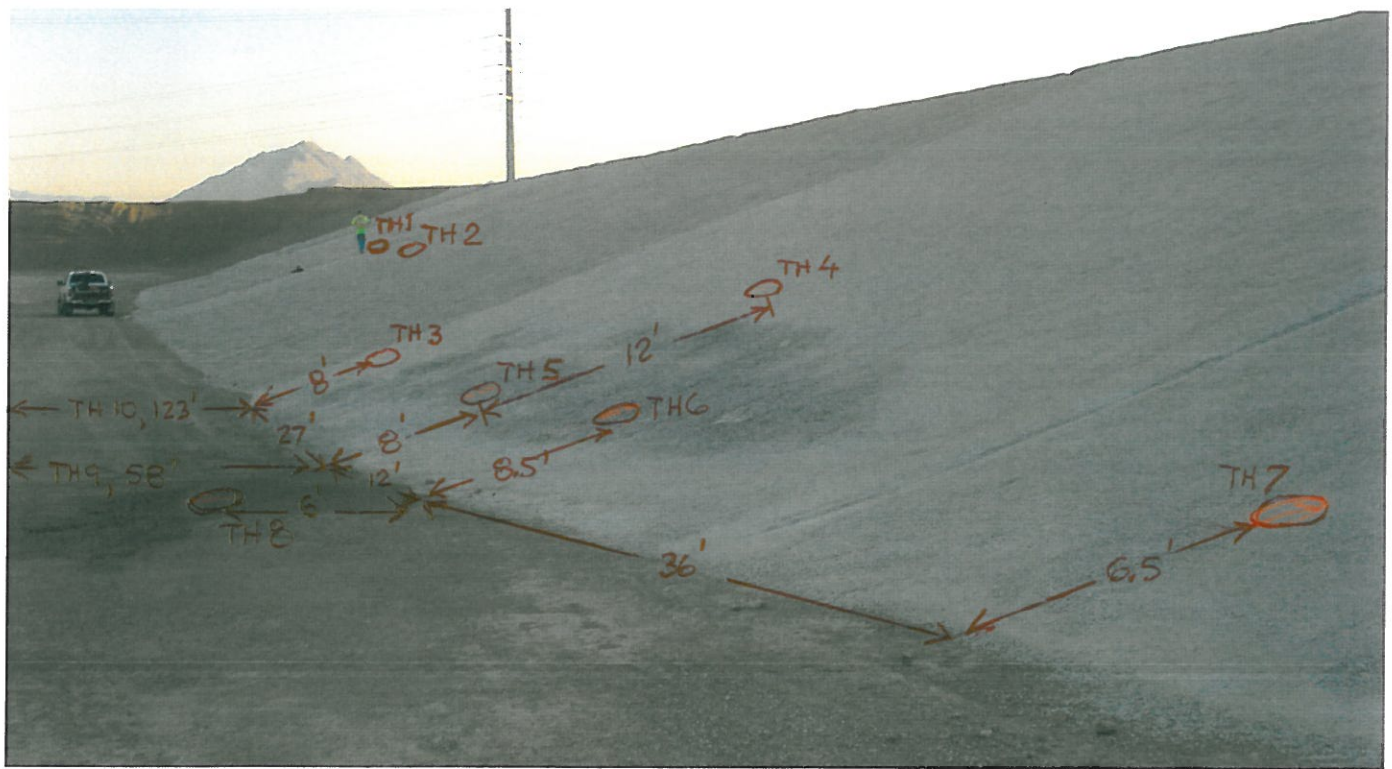
Photo 4: West pond slope, Test Holes 3, 4, 5, 6, 7, 8, 9 and 10, dimensions.
