October 24, 2011

Regarding: *Final Visual Inspection – Pipe Abatement RZ-D-16A*
Nevada Environmental Response Trust
560 West Lake Mead Parkway
Henderson, Nevada 89015
Project No. CON111106

SITE PHOTOGRAPHS	
Nevada Environmental Response Trust Within or Adjacent RZ-D-16A	
Project Number CON111106

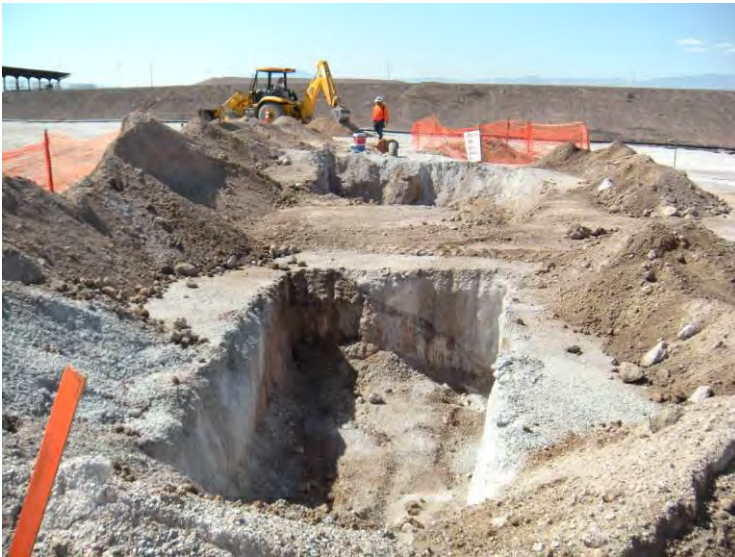
1. General area of the soil excavation activities being conducted at the location where the transite pipe was located.

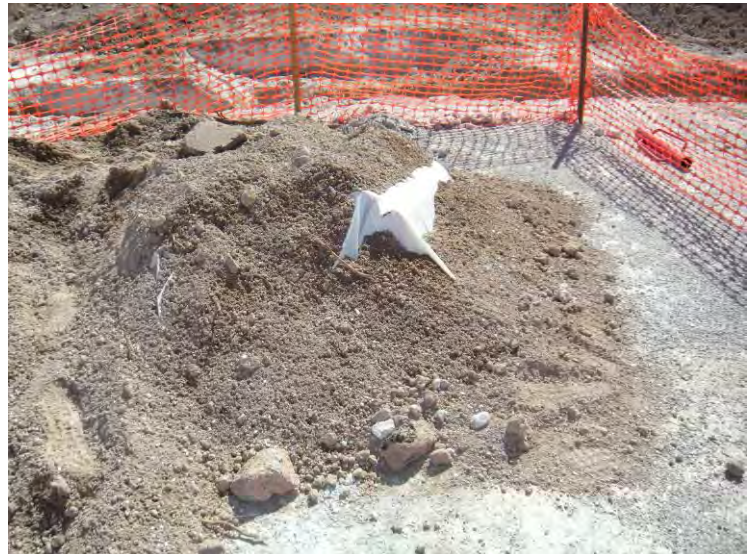
2. View of transite pipe and soil removed from the excavation. The transite pipe was wrapped in polyethylene sheeting.

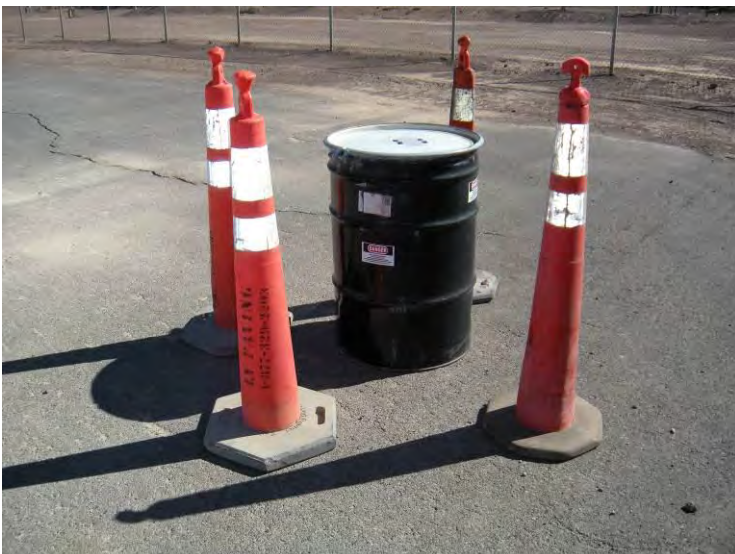
3. View of the 55-gallon drum containing the piece of transite pipe.
