Purpose: CERCLA Screening Site Inspection

Site: Kerr-McGee Chemical Corporation
Lake Mead Drive
Henderson, Nevada
Clark County

Date of Inspection: September 14, 1989

Report Date: March 15, 1990

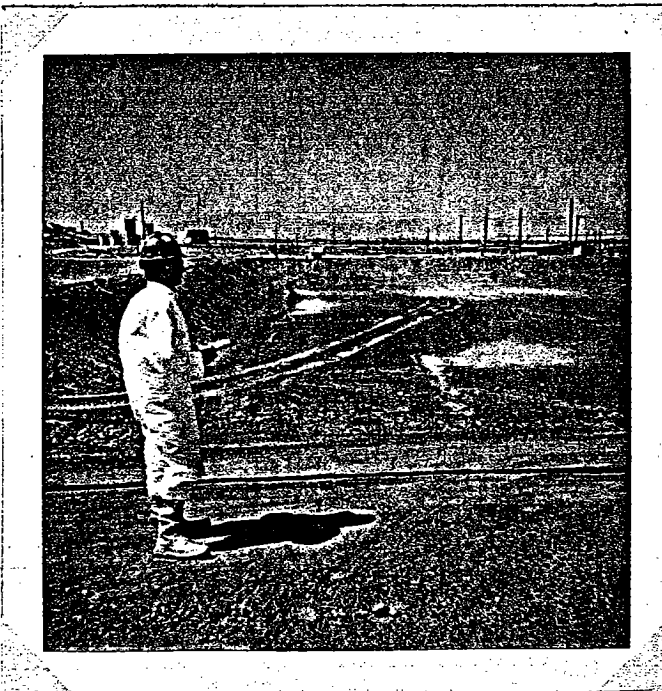
Closed surface impoundment P-1.

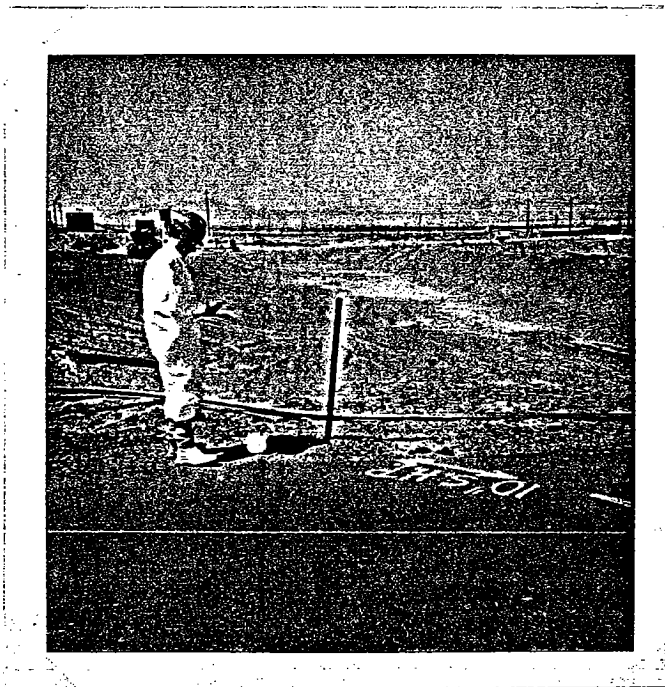
Closed surface impoundment S-1.
