*Prepared For:*  
**Kerr-McGee  
Chemical L.L.C.**

# **Dye Injection Study of the Las Vegas Wash, Nevada**

March, 2002  
Document No. 4020-011-100

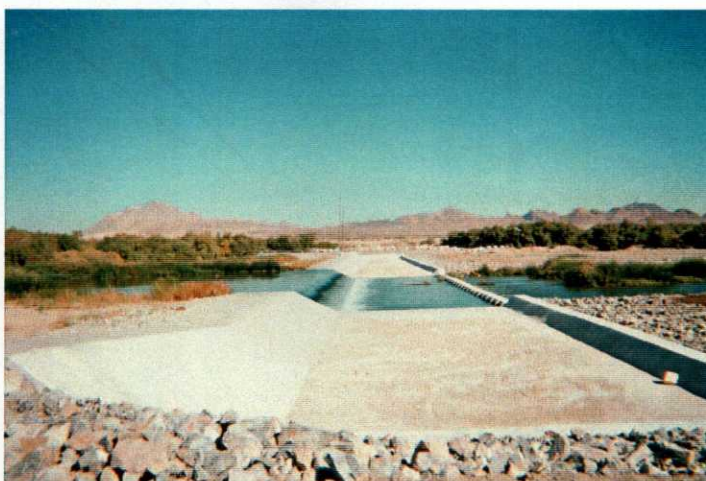
**Figure 3: Las Vegas Wash at the Pabco Road erosion control structure.**

Results of this dye study show that the discharge enters the Las Vegas Wash and remains unmixed and localized to the right bank of the channel until it flows past the Pabco Road structure (Figures 3, Figure 9). Upon flowing through the Pabco Road structure, the plume partially disperses laterally. Complete lateral mixing of the plume occurs 2,400 feet downstream. Therefore the discharge fully mixes in with the waters of the Las Vegas Wash prior to LW 5.5, which is approximately 3,000 feet downstream of the Henderson discharge (Figure 1, Figure 2). Flows in the Las Vegas Wash as measured by the USGS and ENSR at the time of this study indicate that the dye injection study was conducted during a typical daily average flow rate. Furthermore, the difference between the upstream and downstream flow measurements of 220 cfs and 236 cfs, respectively may be the result of groundwater seepage between the two transects along the Las Vegas Wash; however, this difference is within the expected error associated with a single instream flow measurement.

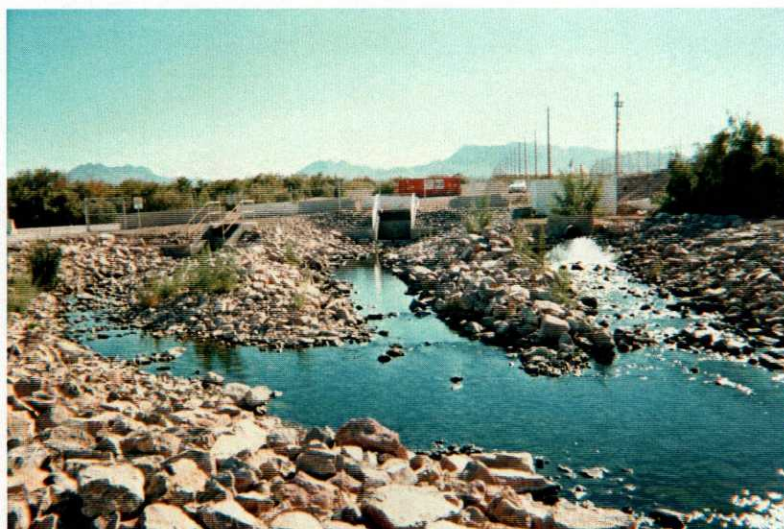
**Figure 5: Henderson discharge channel showing the three main discharge streams upstream of the Kerr-McGee discharge water inflow point; the primary and secondary Henderson wastewater discharges (left and middle) and the BMI discharge (right).**

The City of Las Vegas and Clark County discharge to the Las Vegas Wash a considerable distance upstream of the upstream boundary of the study area at Pabco Road. The City of Henderson and BMI discharge into a small channel that enters the Las Vegas Wash upstream of Pabco Road (Figure 1). The discharge from the City of Henderson and BMI enter the Las Vegas Wash by first passing through a small rock-lined channel as shown in Figure 5. This channel is approximately 735 feet long and discharges to the Las Vegas Wash approximately 160 feet upstream of the Pabco Road structure. The Kerr-McGee effluent enters this channel approximately 300 feet upstream of its discharge to the Las Vegas Wash (435 feet downstream of Figure 5).

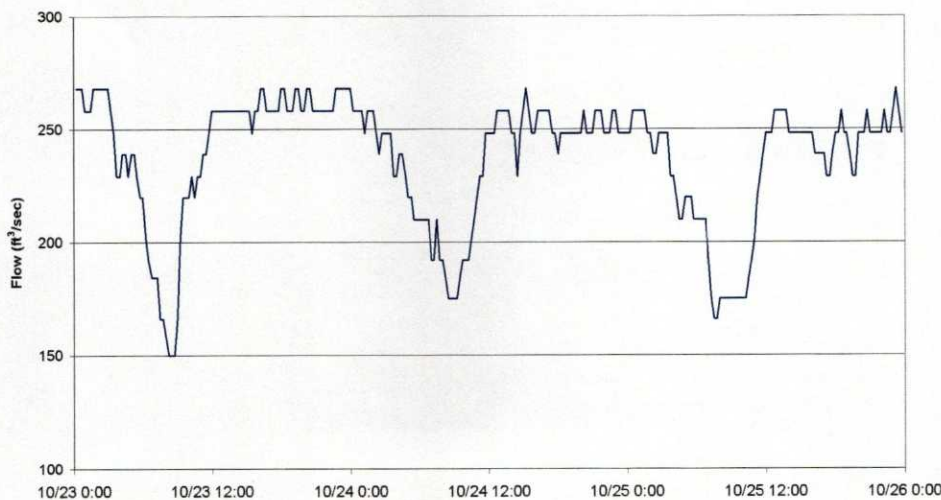
**Figure 7: Recent hydrograph from Pabco Road gage (#09419700) on Las Vegas Wash.**

Daily dry weather flows in the Las Vegas Wash consist primarily of municipal wastewater and vary with changes in discharge from the three municipal wastewater treatment plants. The average annual flow measured at the USGS gage at Pabco Road (#09419700) during the year prior to this investigation was 262 cfs. A summary of the monthly average flows measured at the Pabco Road gage indicate that flows are slightly lower during the summer months and can be high during the winter but do not generally vary much throughout the year (Figure 6). Additionally, daily variations in flow can be as much as 100 cfs as indicated in a recent hydrograph from the USGS gage (Figure 7).

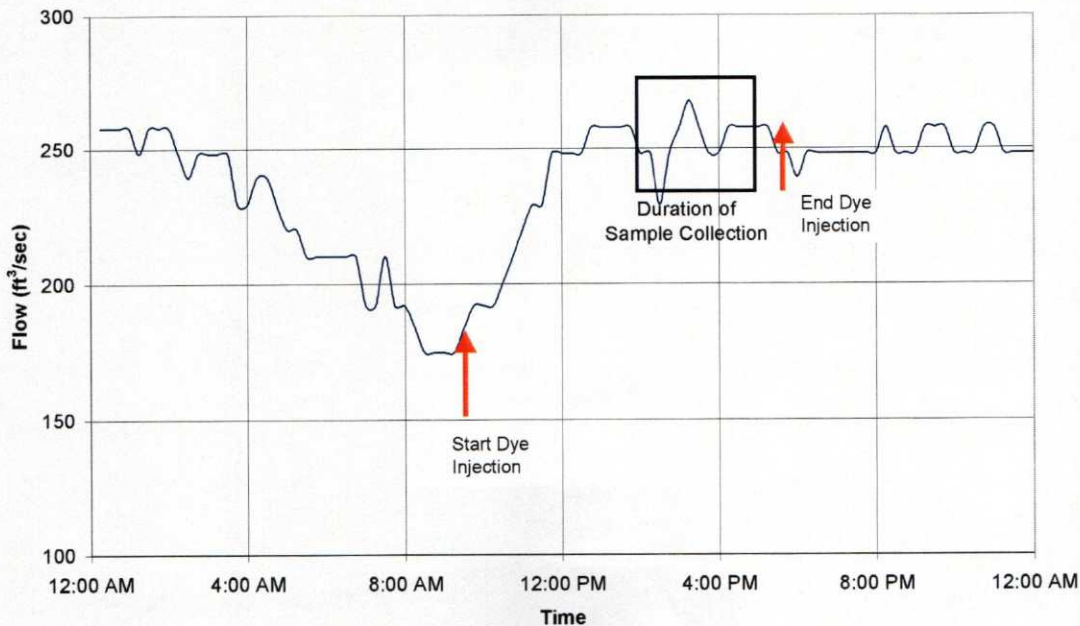
**Figure 10: Hydrograph at the USGS gage (#09149700) Pabco Road indicating dye injection including a window representing the time period when transect samples were collected.**

To obtain a quasi-steady state dye concentration in the Las Vegas Wash, the dye was injected for a period of four hours before collection of samples for fluorescence measurement at downstream transects. Overall, the dye was injected for a period of approximately seven hours, from 10:00 a.m. to 5:00 p.m. (Figure 10).

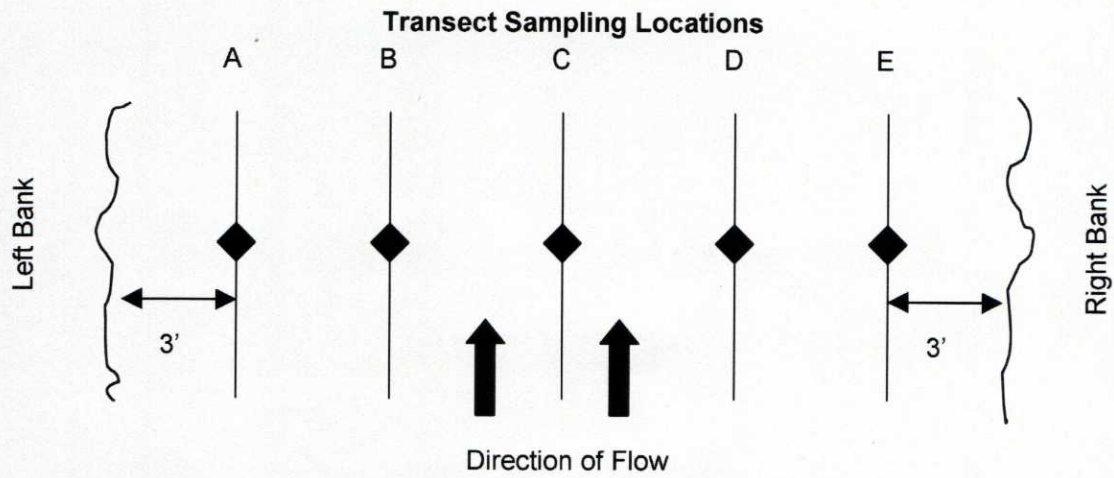
**Figure 11: Illustration of lateral fluorescence sample locations at each transect.**

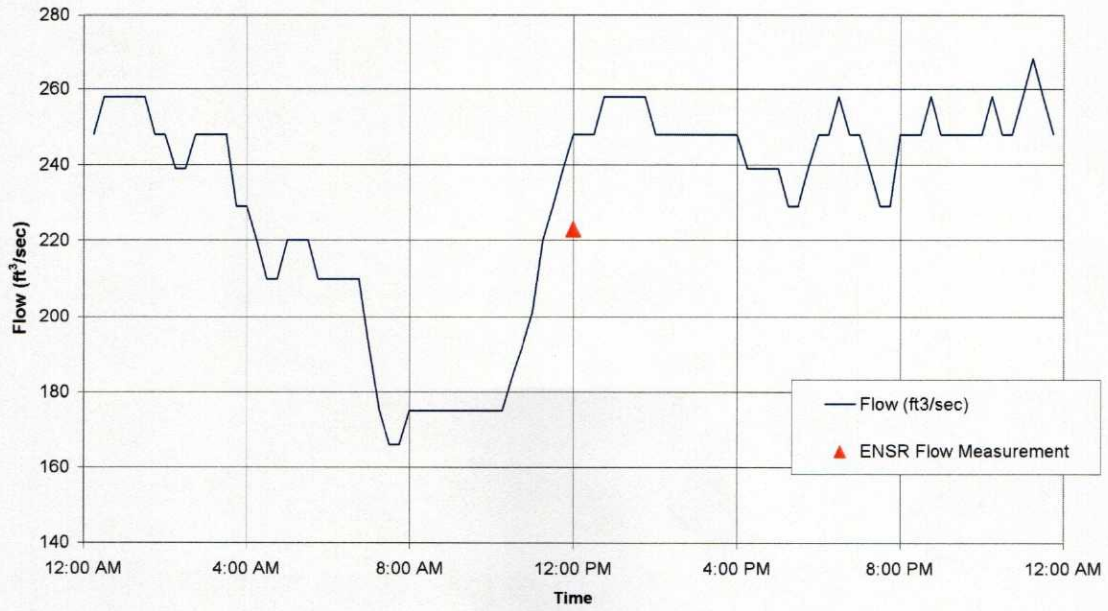
**Figure 13: Comparison of ENSR Flow with USGS Flow at Pabco Road gage.**

Streamflow was measured at the Pabco Road structure for comparison with the USGS flow measured at that site; this measurement was made to verify the accuracy of the USGS gage. Streamflow was also measured at the downstream transect. This downstream streamflow measurement was made to indicate whether any additional water was entering the Las Vegas Wash between the upstream and downstream transects. The streamflow measured during the investigation at Pabco Road is shown below in Figure 13 as a red triangle over the hydrograph from the USGS gage (#9419700) at Pabco Road. The ENSR measured streamflow of 220 cfs is 14.7% less than the USGS gage measurement of 258 cfs. Downstream at Transect #5 streamflow was measured at 236 cfs, which is 7.3% more than the flow measured at Pabco Road. In each case, the difference in flow rates is within the range of error associated a single streamflow measurement. Furthermore, on walking the river course from the Henderson discharge channel downstream to Transect #5 there was no evidence of any additional surface water entering the Las Vegas Wash.
