Location:	Nevada Facility, Henderson, NV	Position:		Ground level:	Test No.:
Project ID:		Client:	NORTHGATE	Date:	PSS-3
Project:	TRONOX REMEDIATION			Page:	Scale:
				1/1	1 : 55
				File:	Fig.:
				CA04O1003C.csv

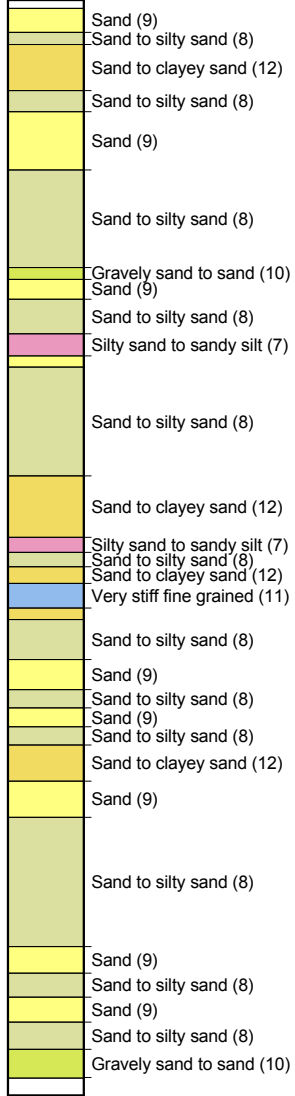
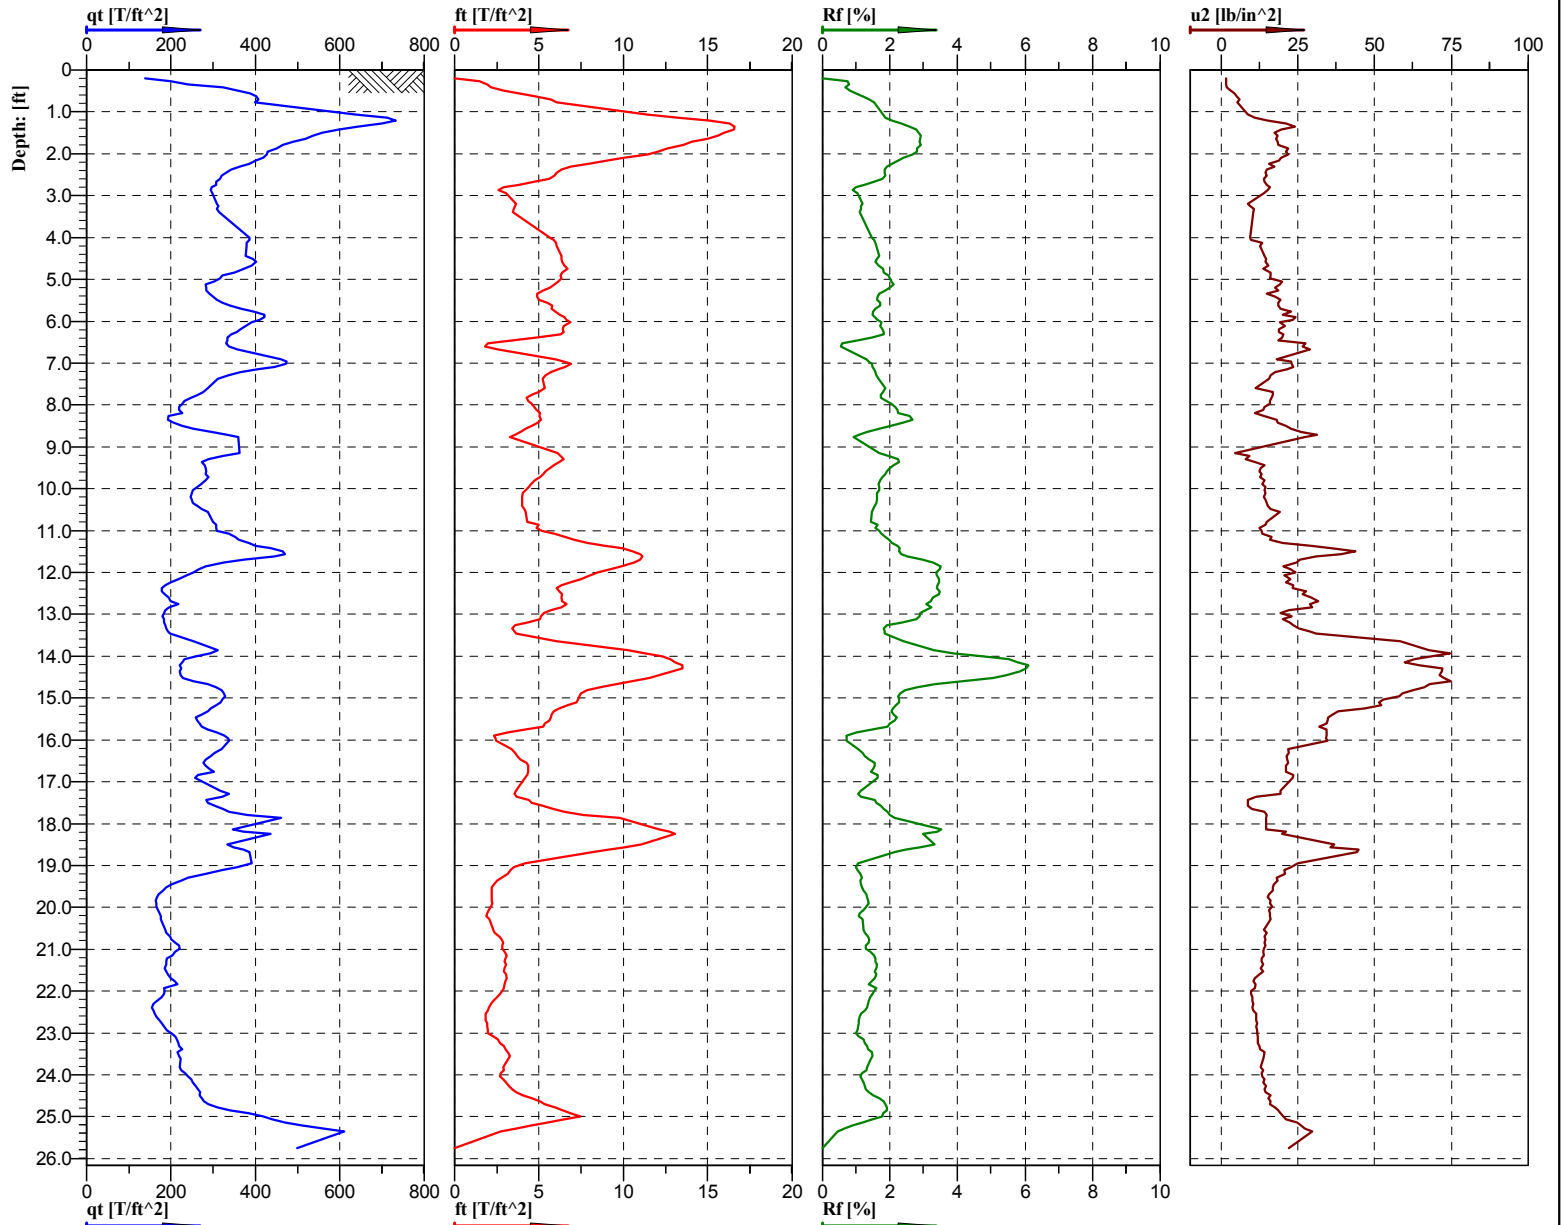
Classification by Robertson 1986
