Supplemental Surface Water Investigation Technical Memorandum

NERT Remedial Investigation – Downgradient Study Area
Nevada Environmental Response Trust Site
Henderson, Nevada

Final Draft

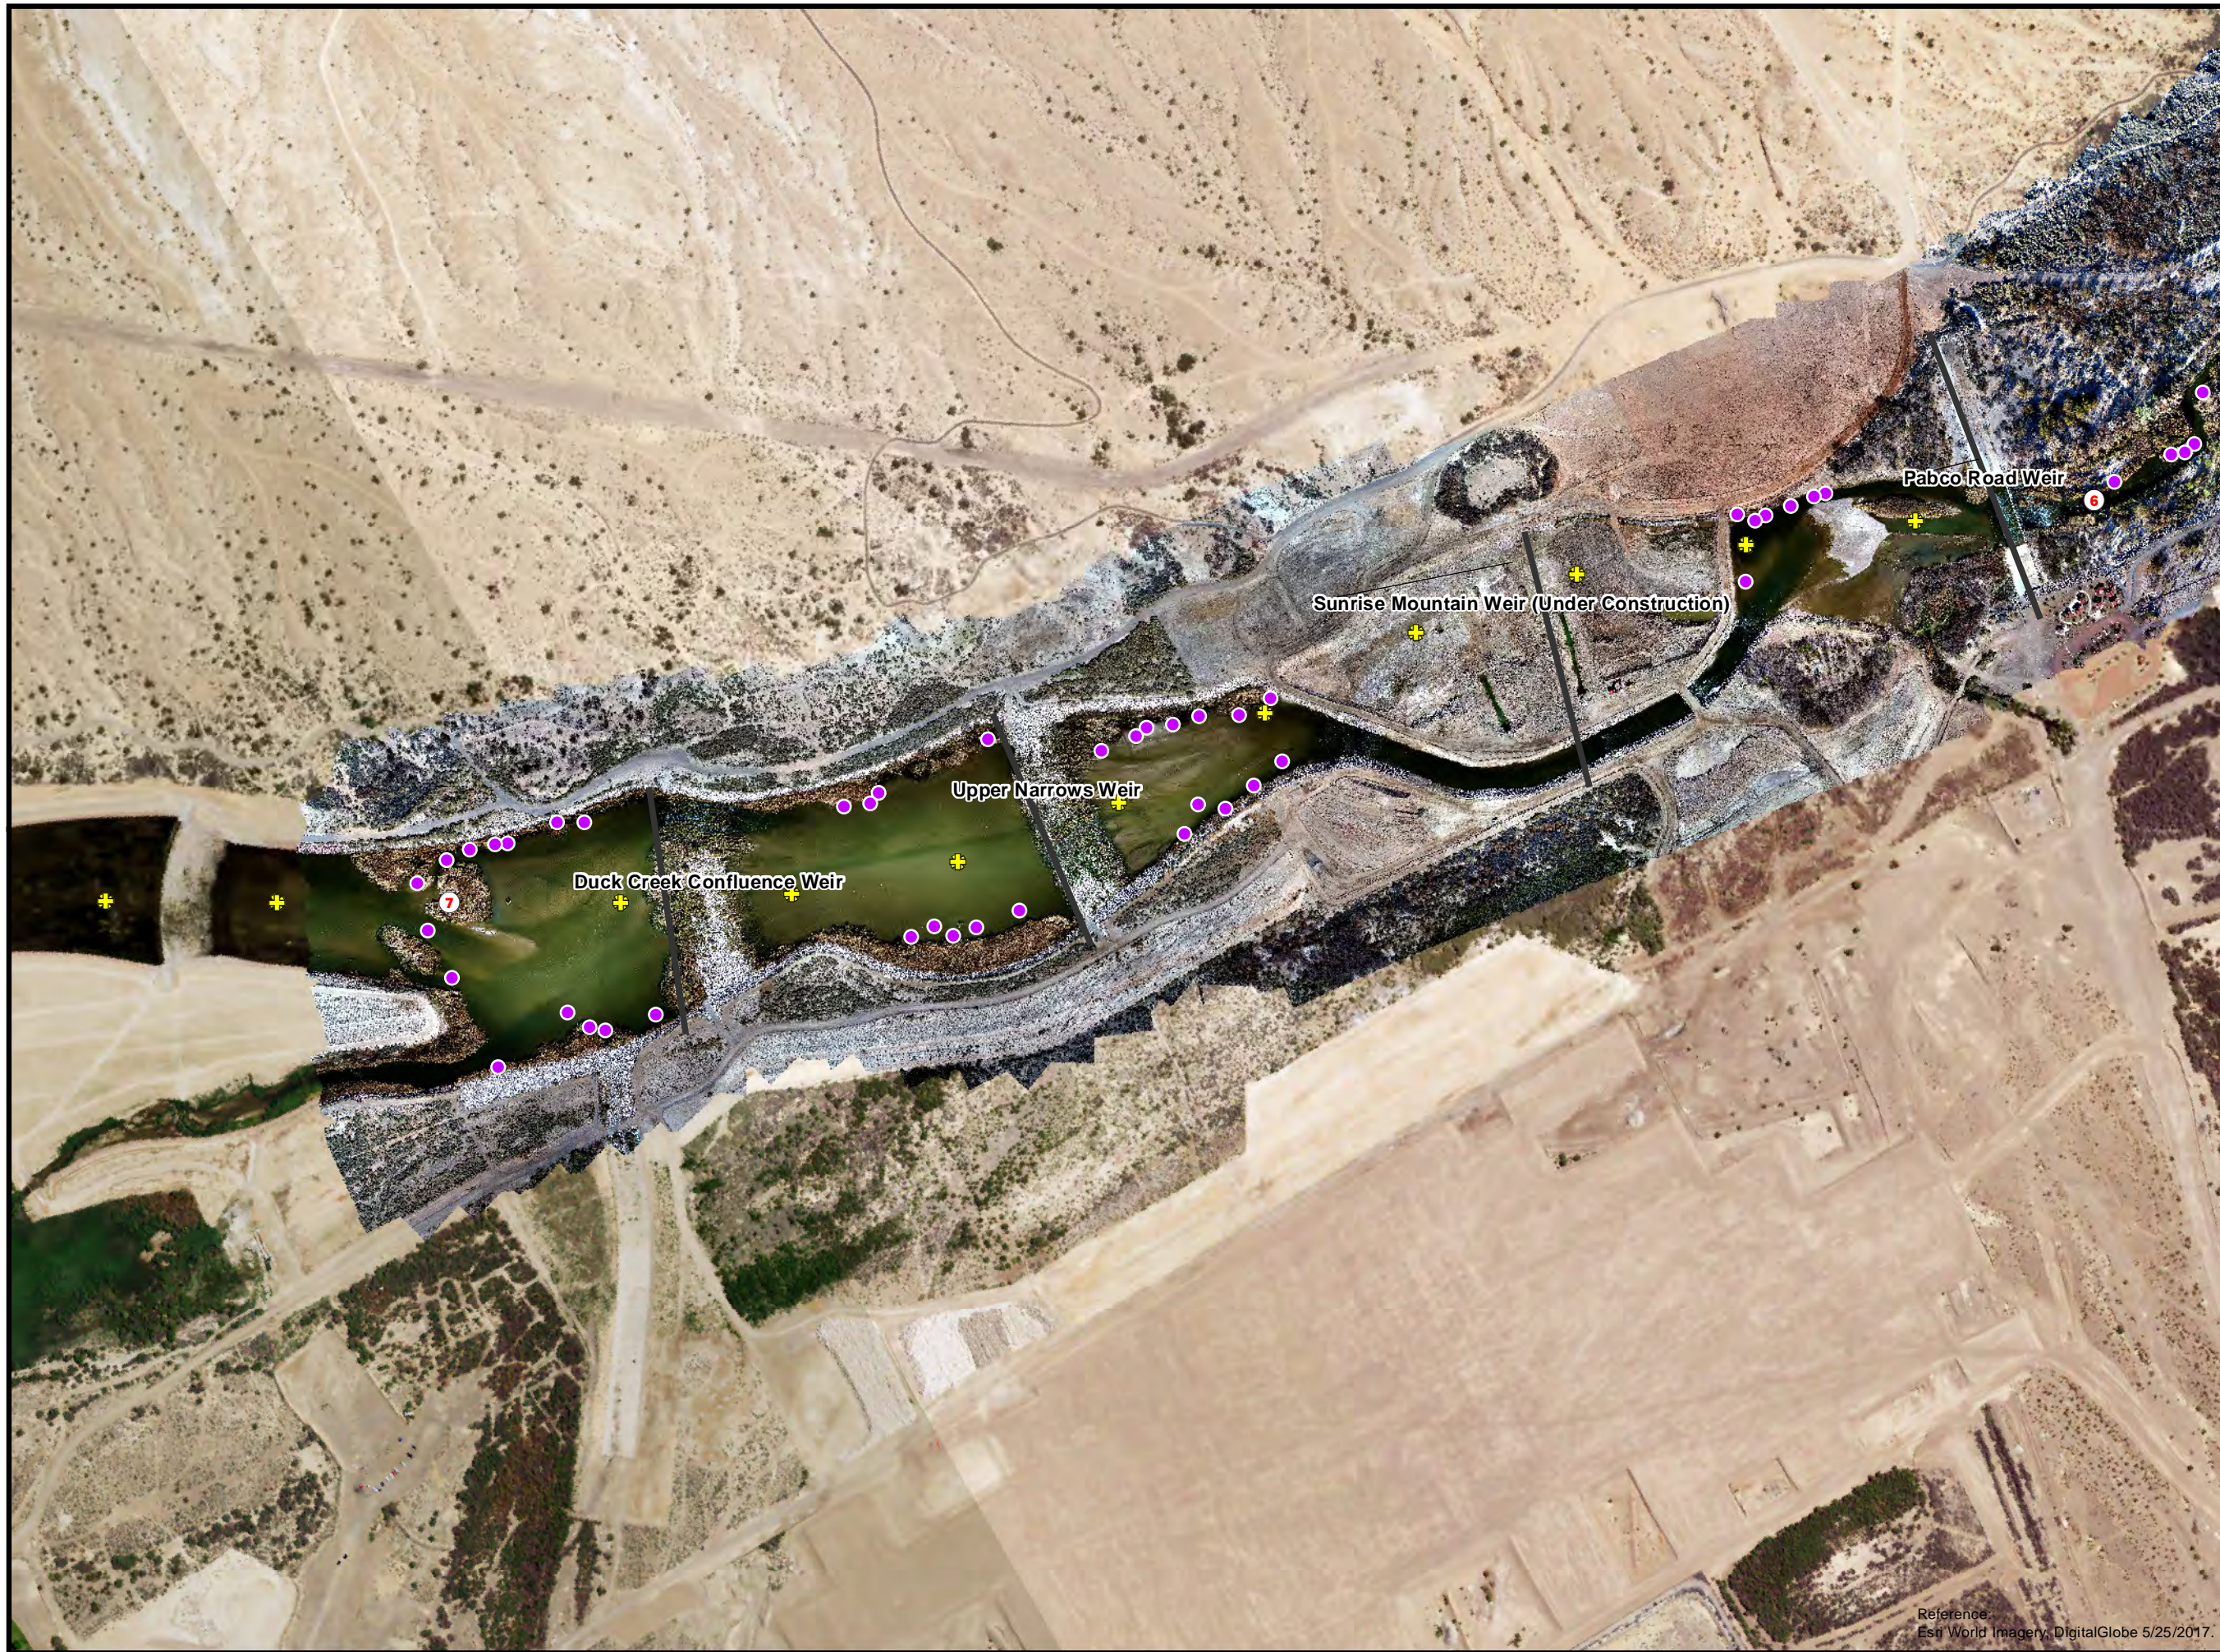
AECOM Figure 3

A general overview of thermal anomalies observed during manual TIR image processing is depicted on **Figure 3**. More detailed TIR results are presented in **Figures 4 through 7**, which are arranged from upstream to downstream along the investigated reaches of the LVW. TIR imagery is included as a digital appendix (**Appendix F**).

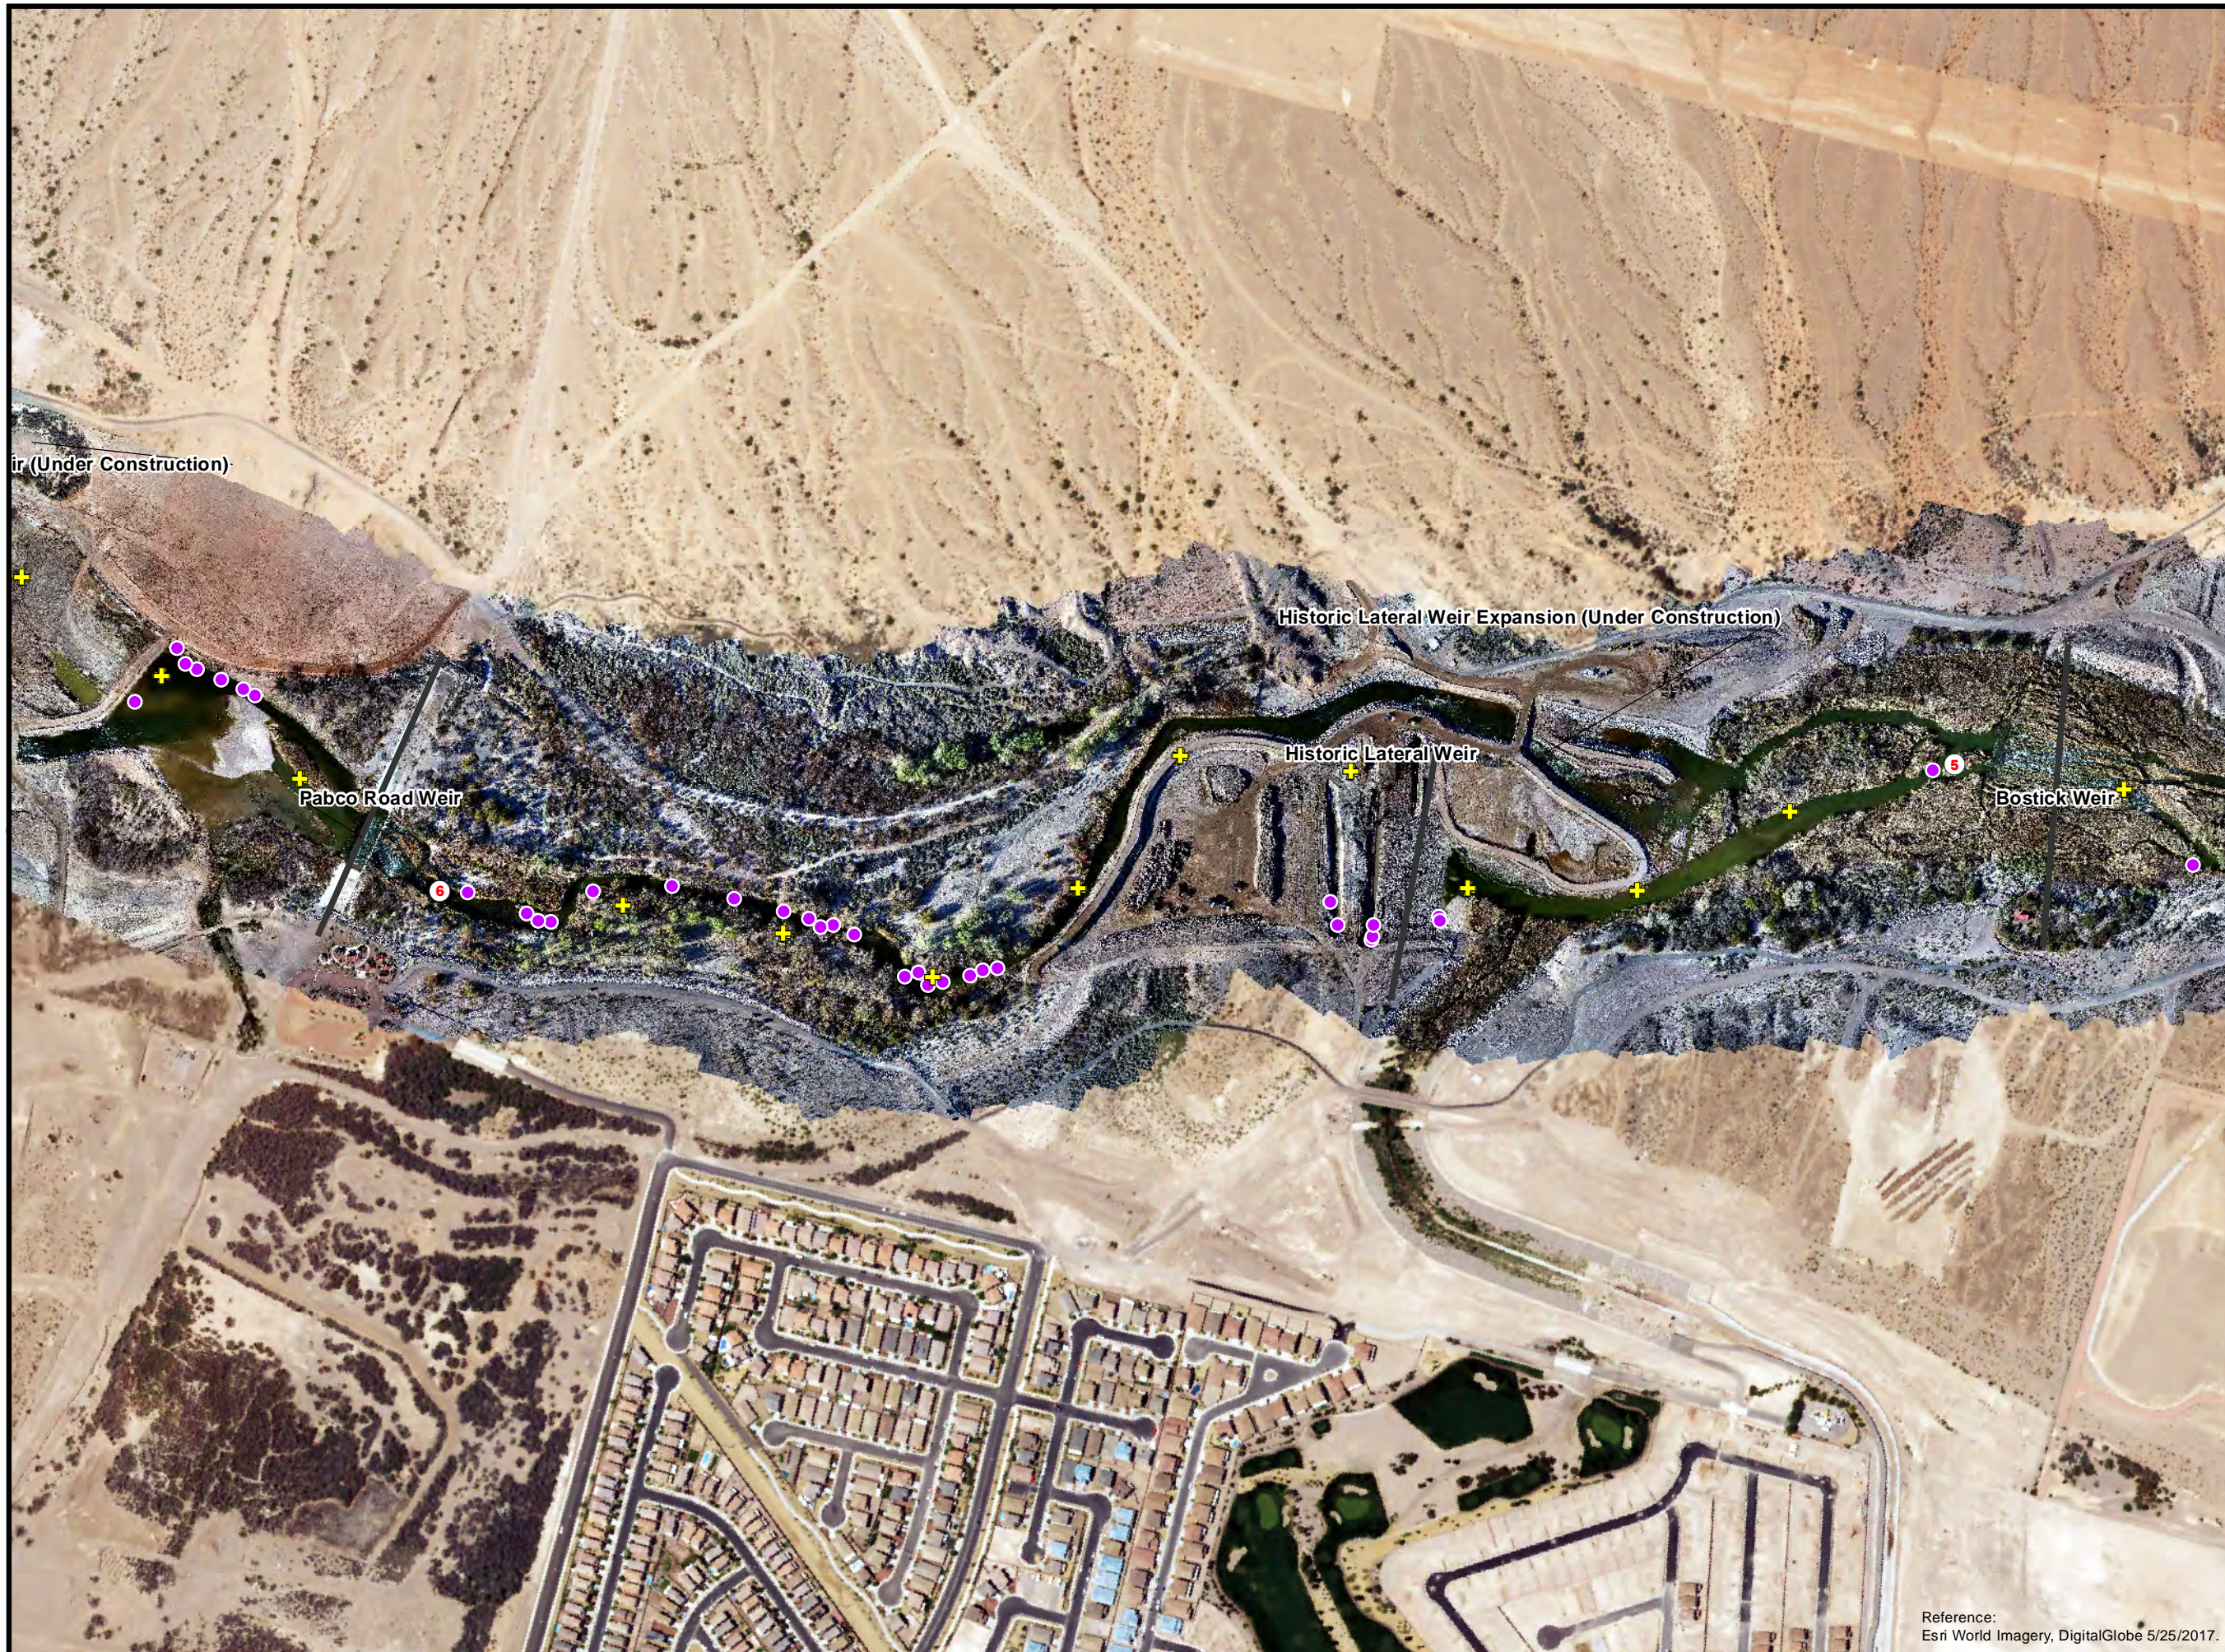
AECOM Figure 4

Upstream of Duck Creek Confluence Weir – Figure 4

Several thermal anomalies were identified along the south and north banks of this reach, along with one mid-channel anomaly. Additional investigations (FODTS and sampling) were not planned for this area due to the historically low concentrations of perchlorate noted here.

Duck Creek Confluence Weir to Upper Narrows Weir – Figure 4

Nine thermal anomalies were identified in the reach between Duck Creek Confluence Weir and the Upper Narrows Weir. Low perchlorate concentrations were noted in this reach historically; therefore, subsequent investigations (FODTS and sampling) were not planned.

Upper Narrows Weir to Sunrise Mountain Weir – Figure 4

A large portion of this reach is currently undergoing construction. The stream channel has been reworked substantially to allow rehabilitation/reconstruction of the Sunrise Mountain Weir. Thermal anomalies were observed on both north and south banks upstream of the construction area, proximal to Upper Narrows Weir. With a small increase in historic perchlorate concentrations in this location, additional high-resolution temperature surveys (FODTS) were planned for a portion of this reach from Upper Narrows Weir to the start of construction activities along the south and north banks. High-resolution temperature survey methods and results are discussed in Section 3. Seven thermal anomalies were also observed downstream of the construction zone on the north bank, proximal to the Pabco Road Weir.

Sunrise Mountain Weir to Pabco Road Weir – Figure 4

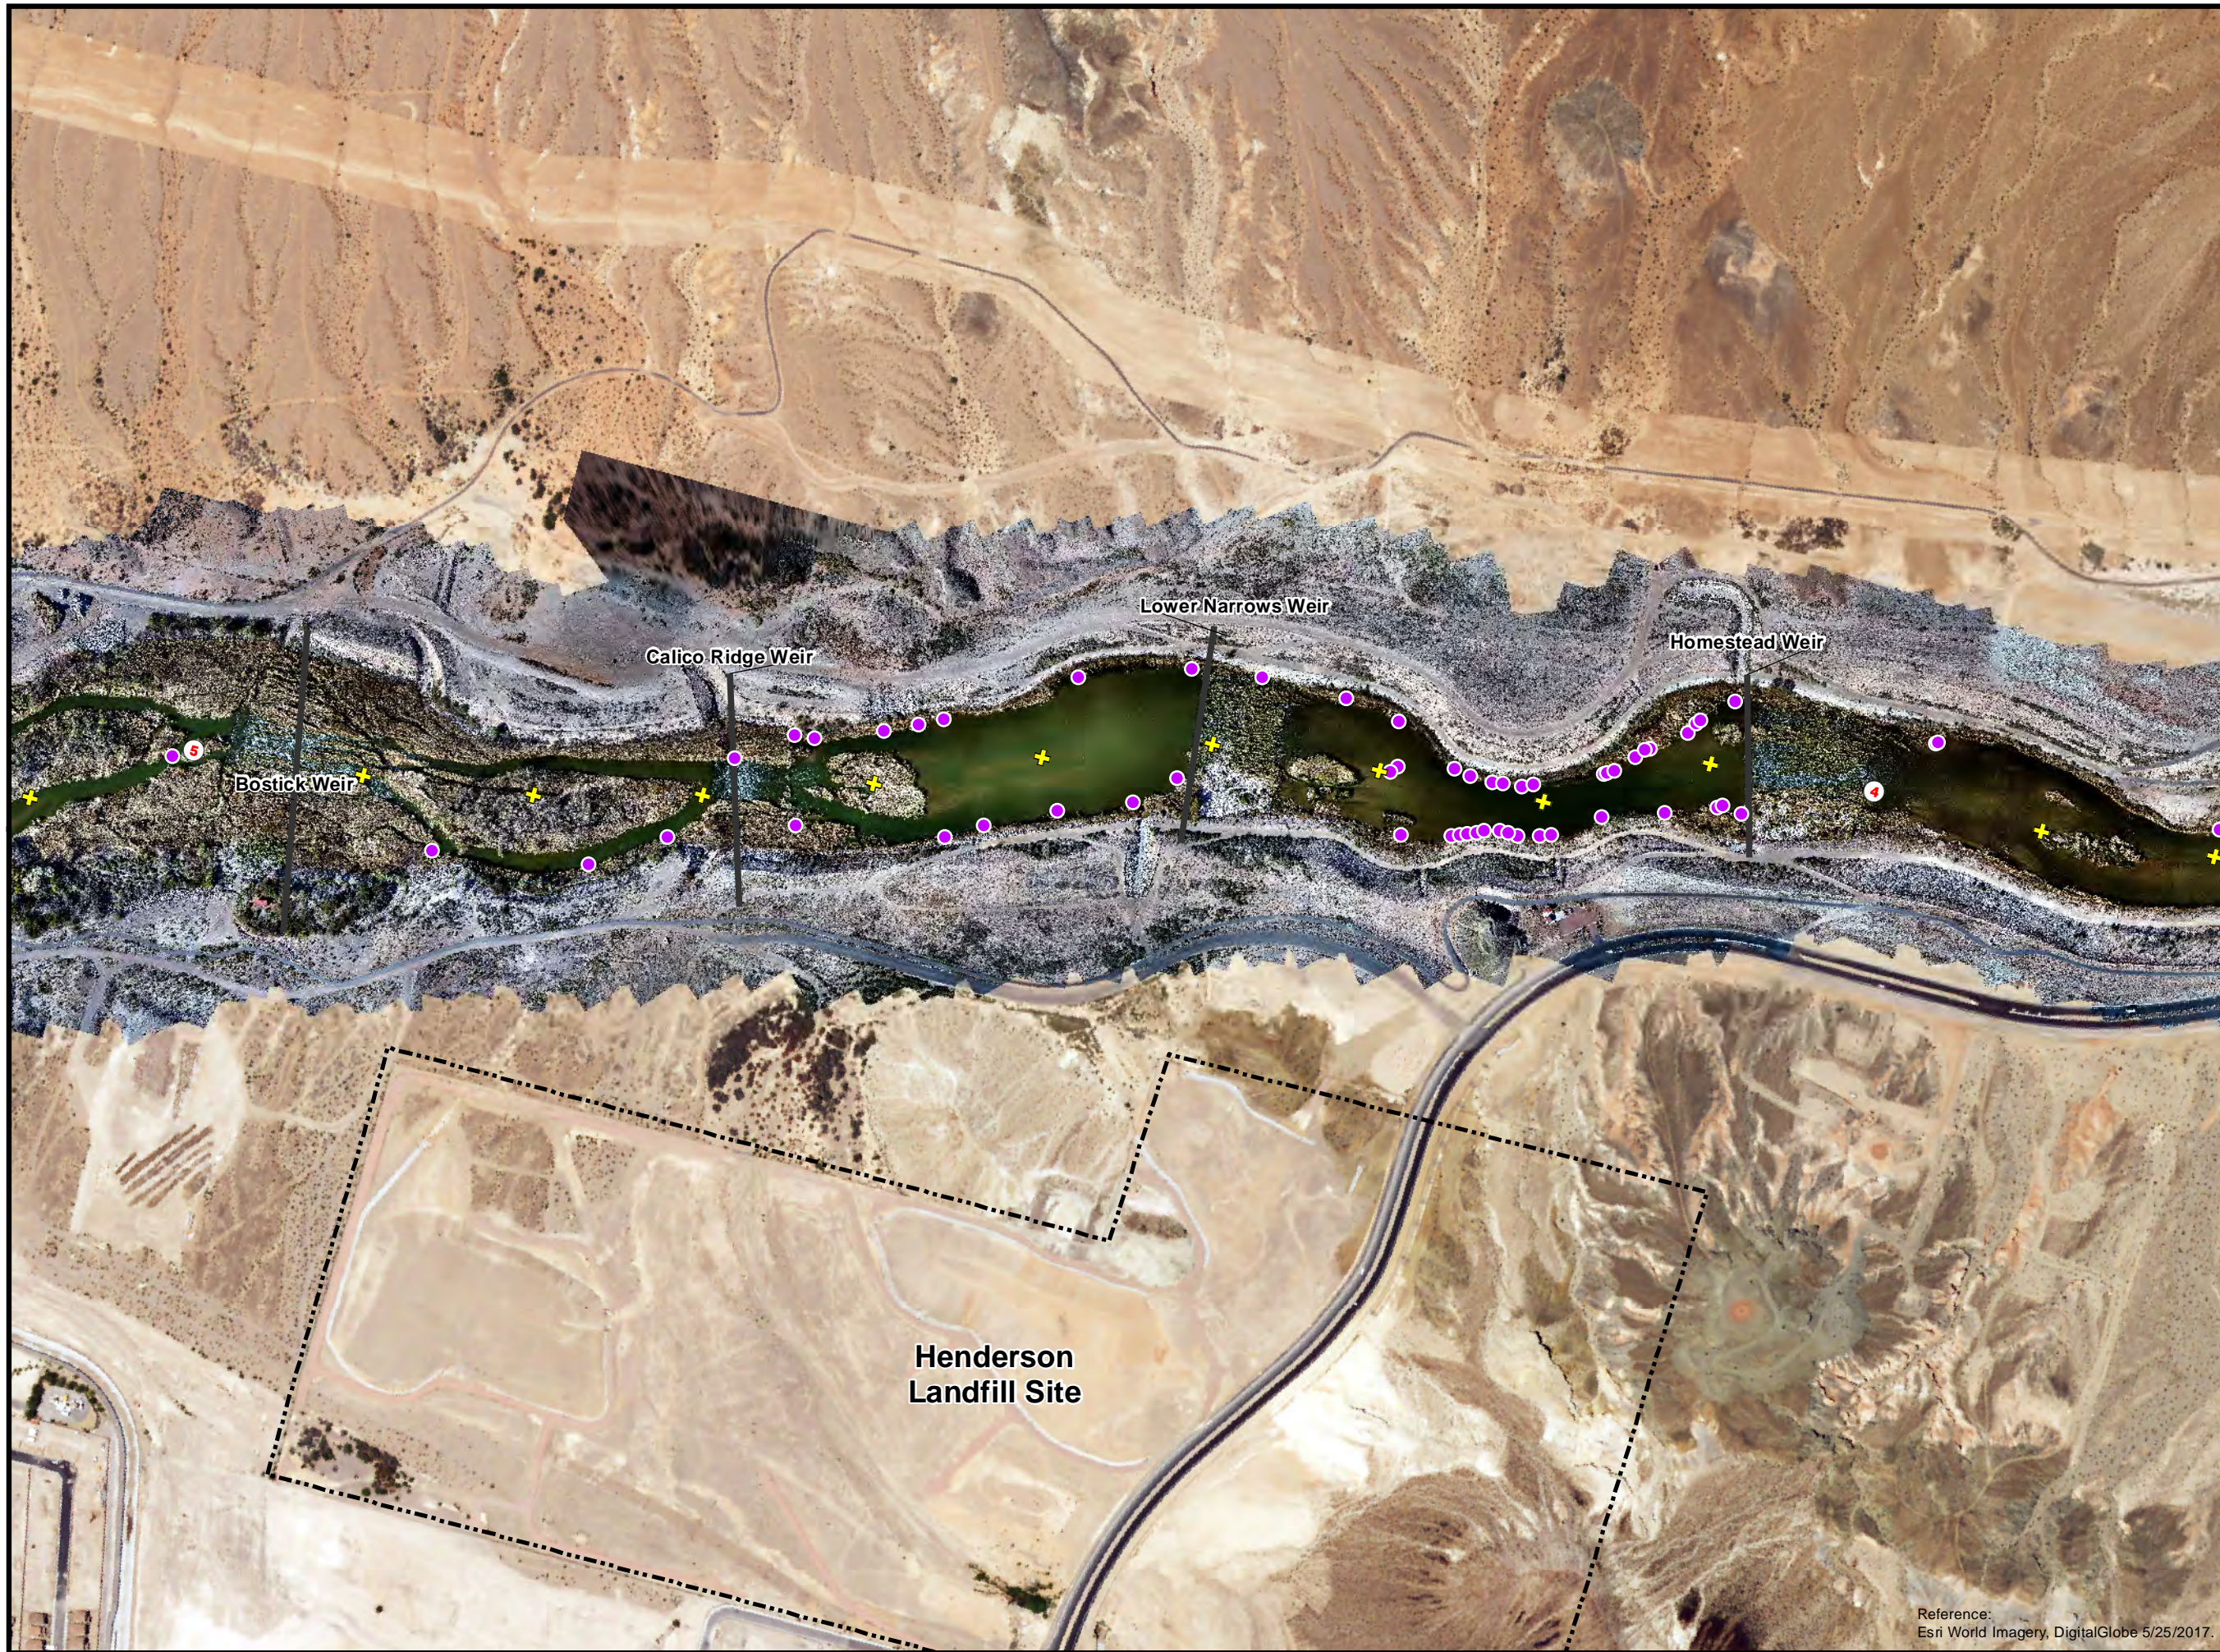
The channel becomes very narrow along this reach. Several thermal anomalies were observed in the narrow channel downstream from Pabco Road Weir to the construction zone in the vicinity of the Historic Lateral Weir and the Historic Lateral Weir Expansion. Additional high-resolution temperature surveys were not planned for this reach due to the ongoing/active construction.

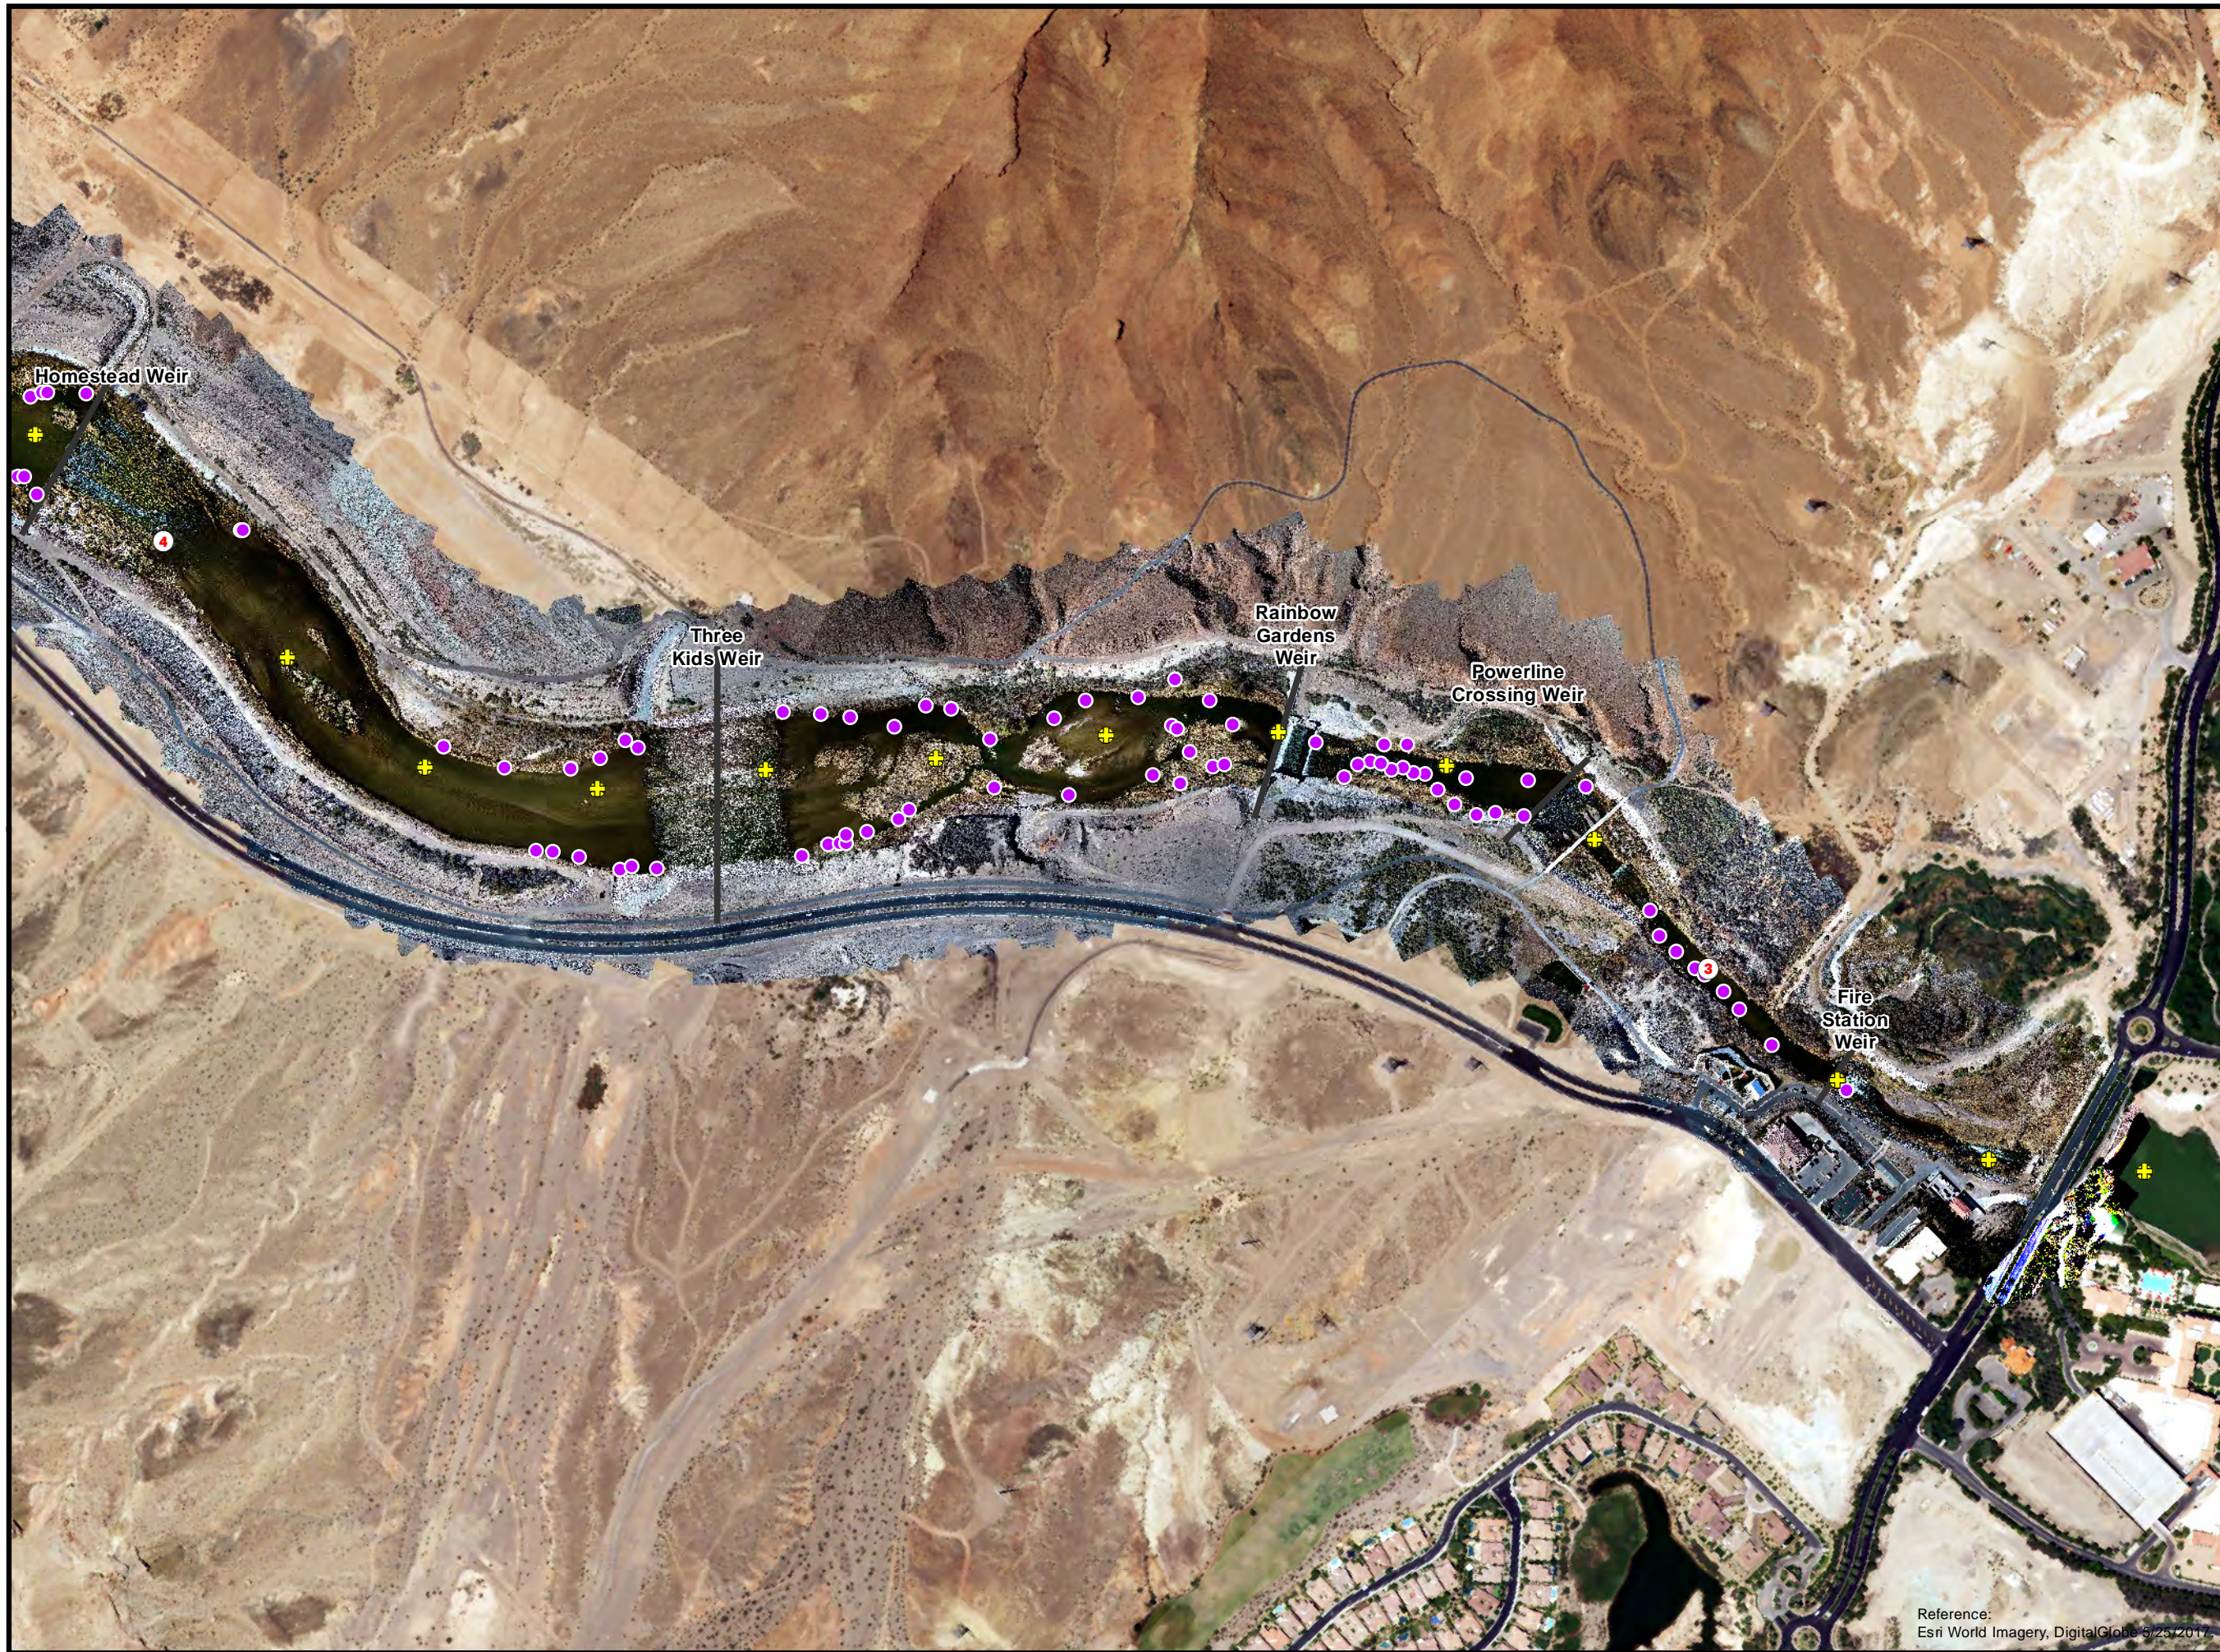
AECOM Figure 6

Bostick Weir to Calico Ridge Weir – Figure 6

Calico Ridge Weir to Lower Narrows Weir – Figure 6

Lower Narrows Weir to Homestead Weir – Figure 6

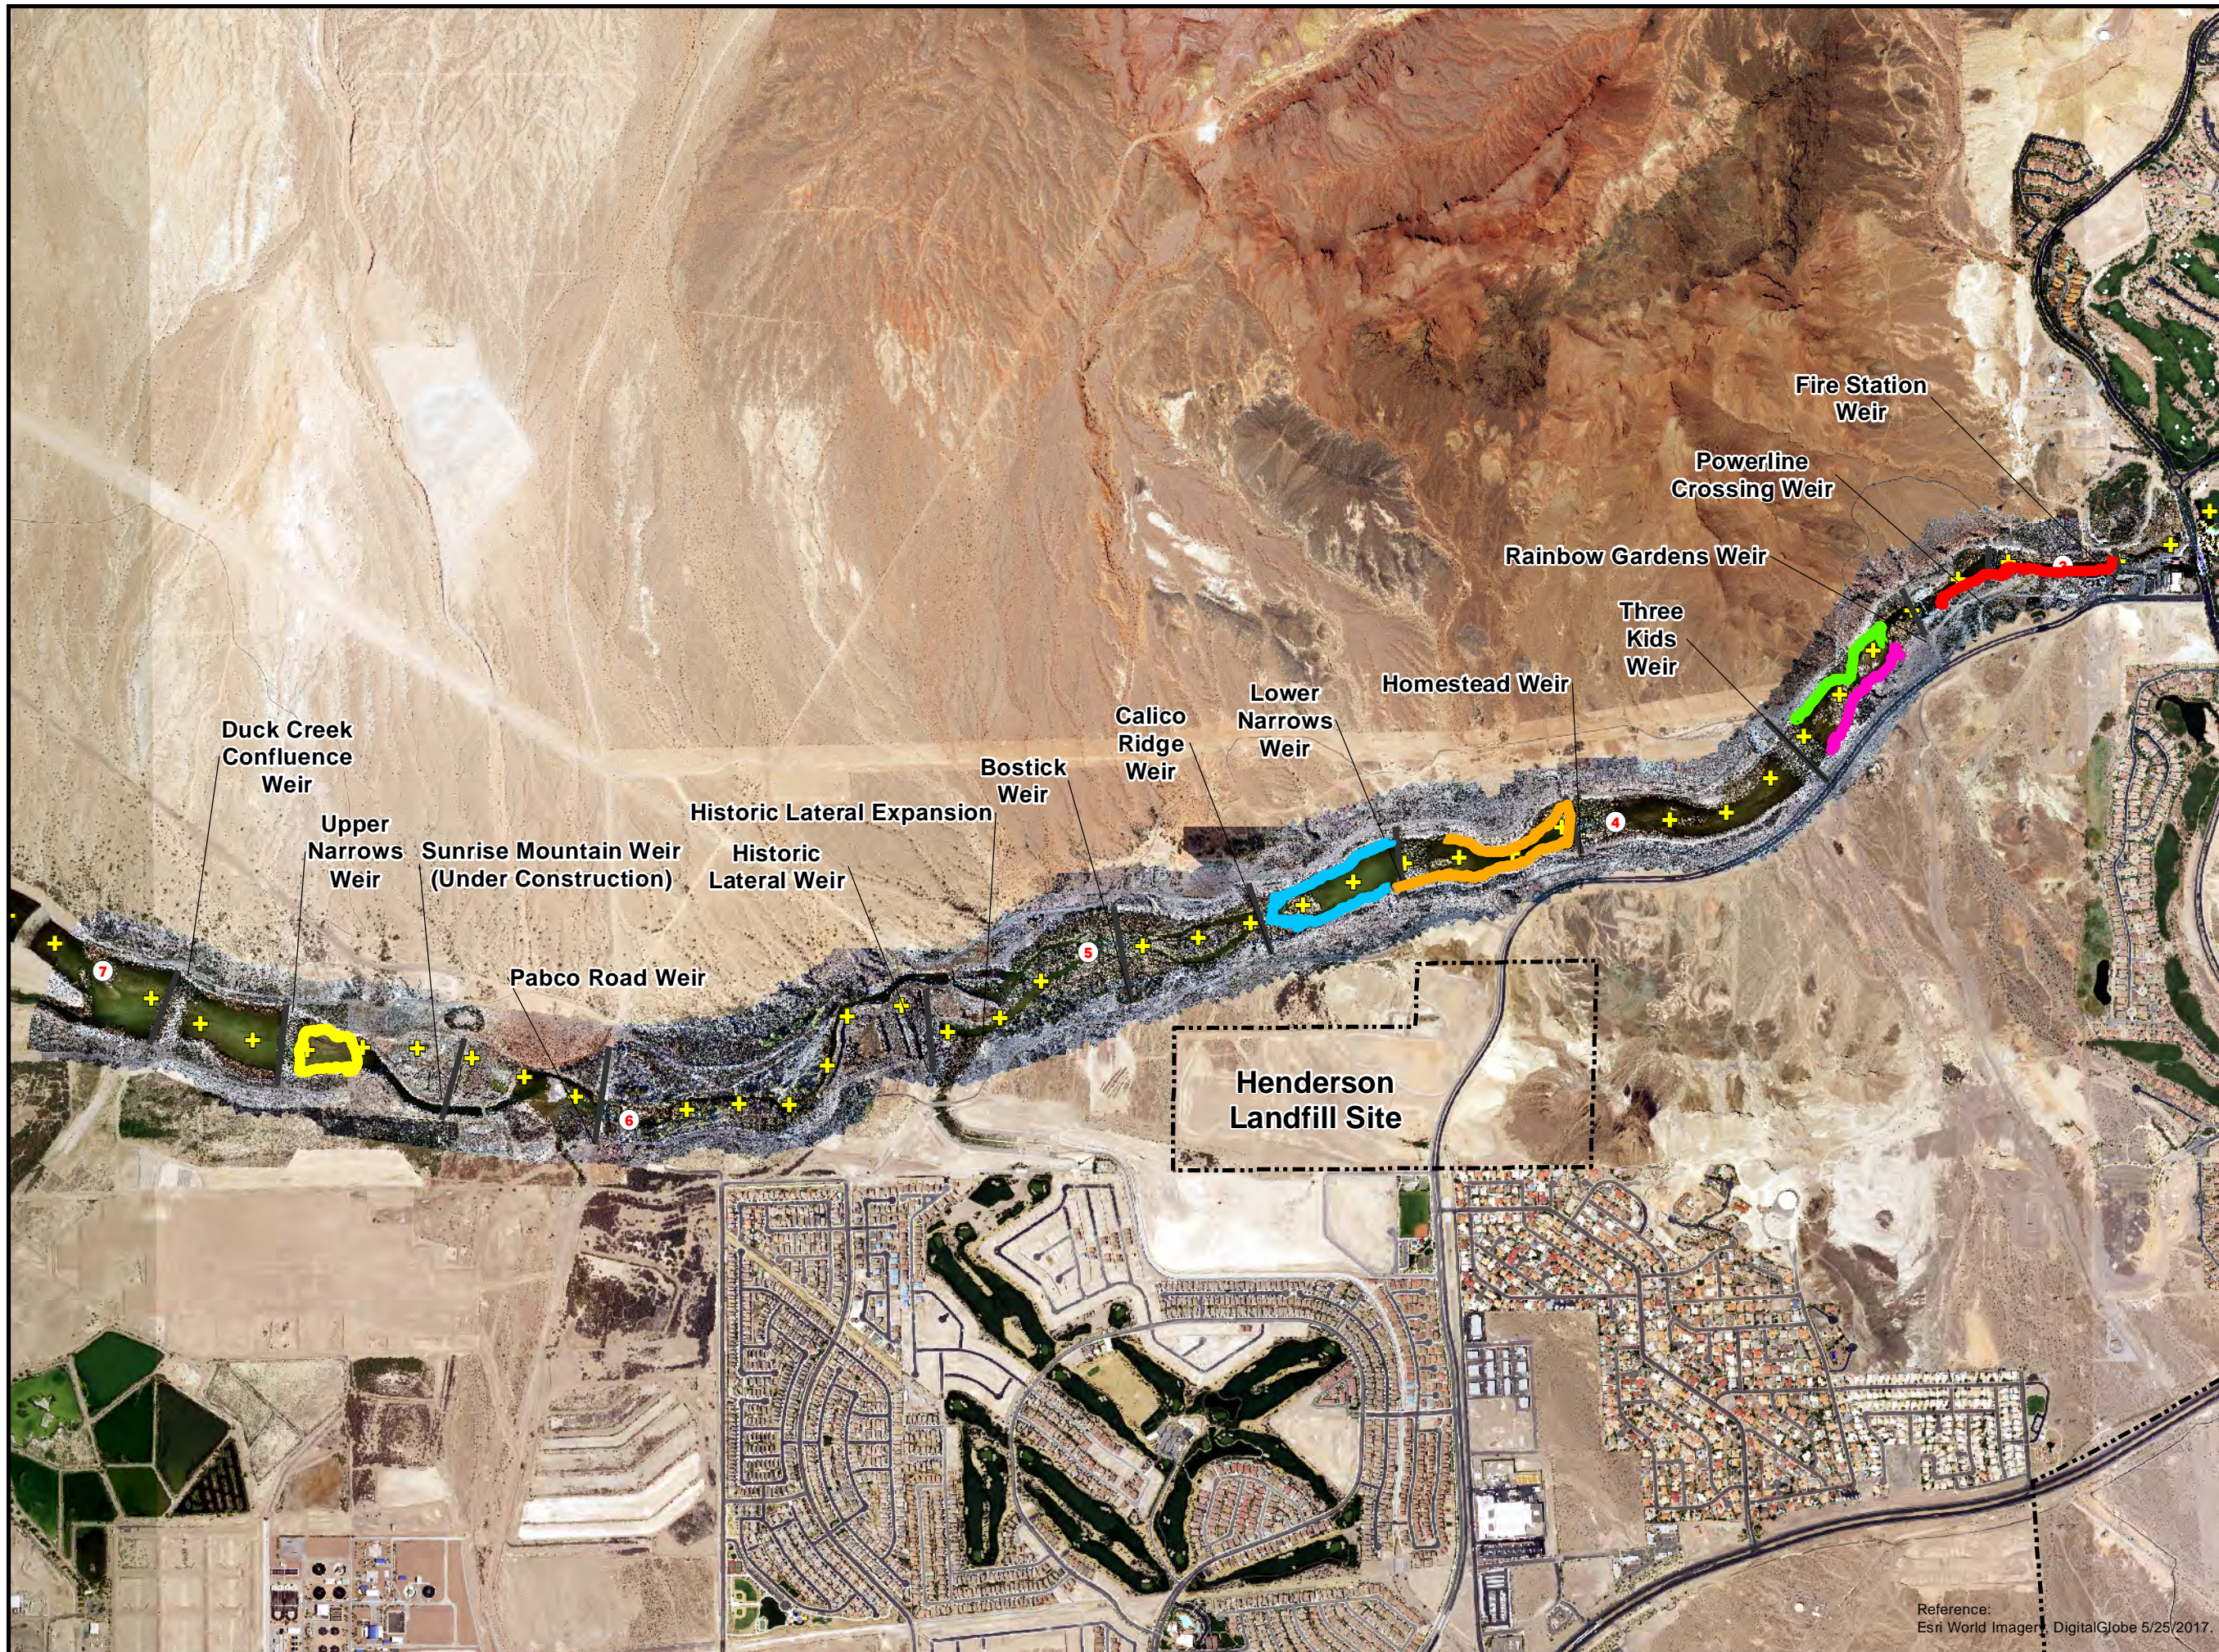
AECOM **Figure 7**

Homestead Weir to Three Kids Weir – Figure 7

Three Kids Weir to Rainbow Gardens Weir – Figure 7

Rainbow Gardens Weir to Powerline Crossing Weir – Figure 7

Powerline Crossing Weir to Fire Station Weir – Figure 7

Fire Station Weir to Lake Las Vegas Inlet – Figure 7

**TIR ANOMALIES
HOMESTEAD WEIR
TO LAKE LAS VEGAS INLET**

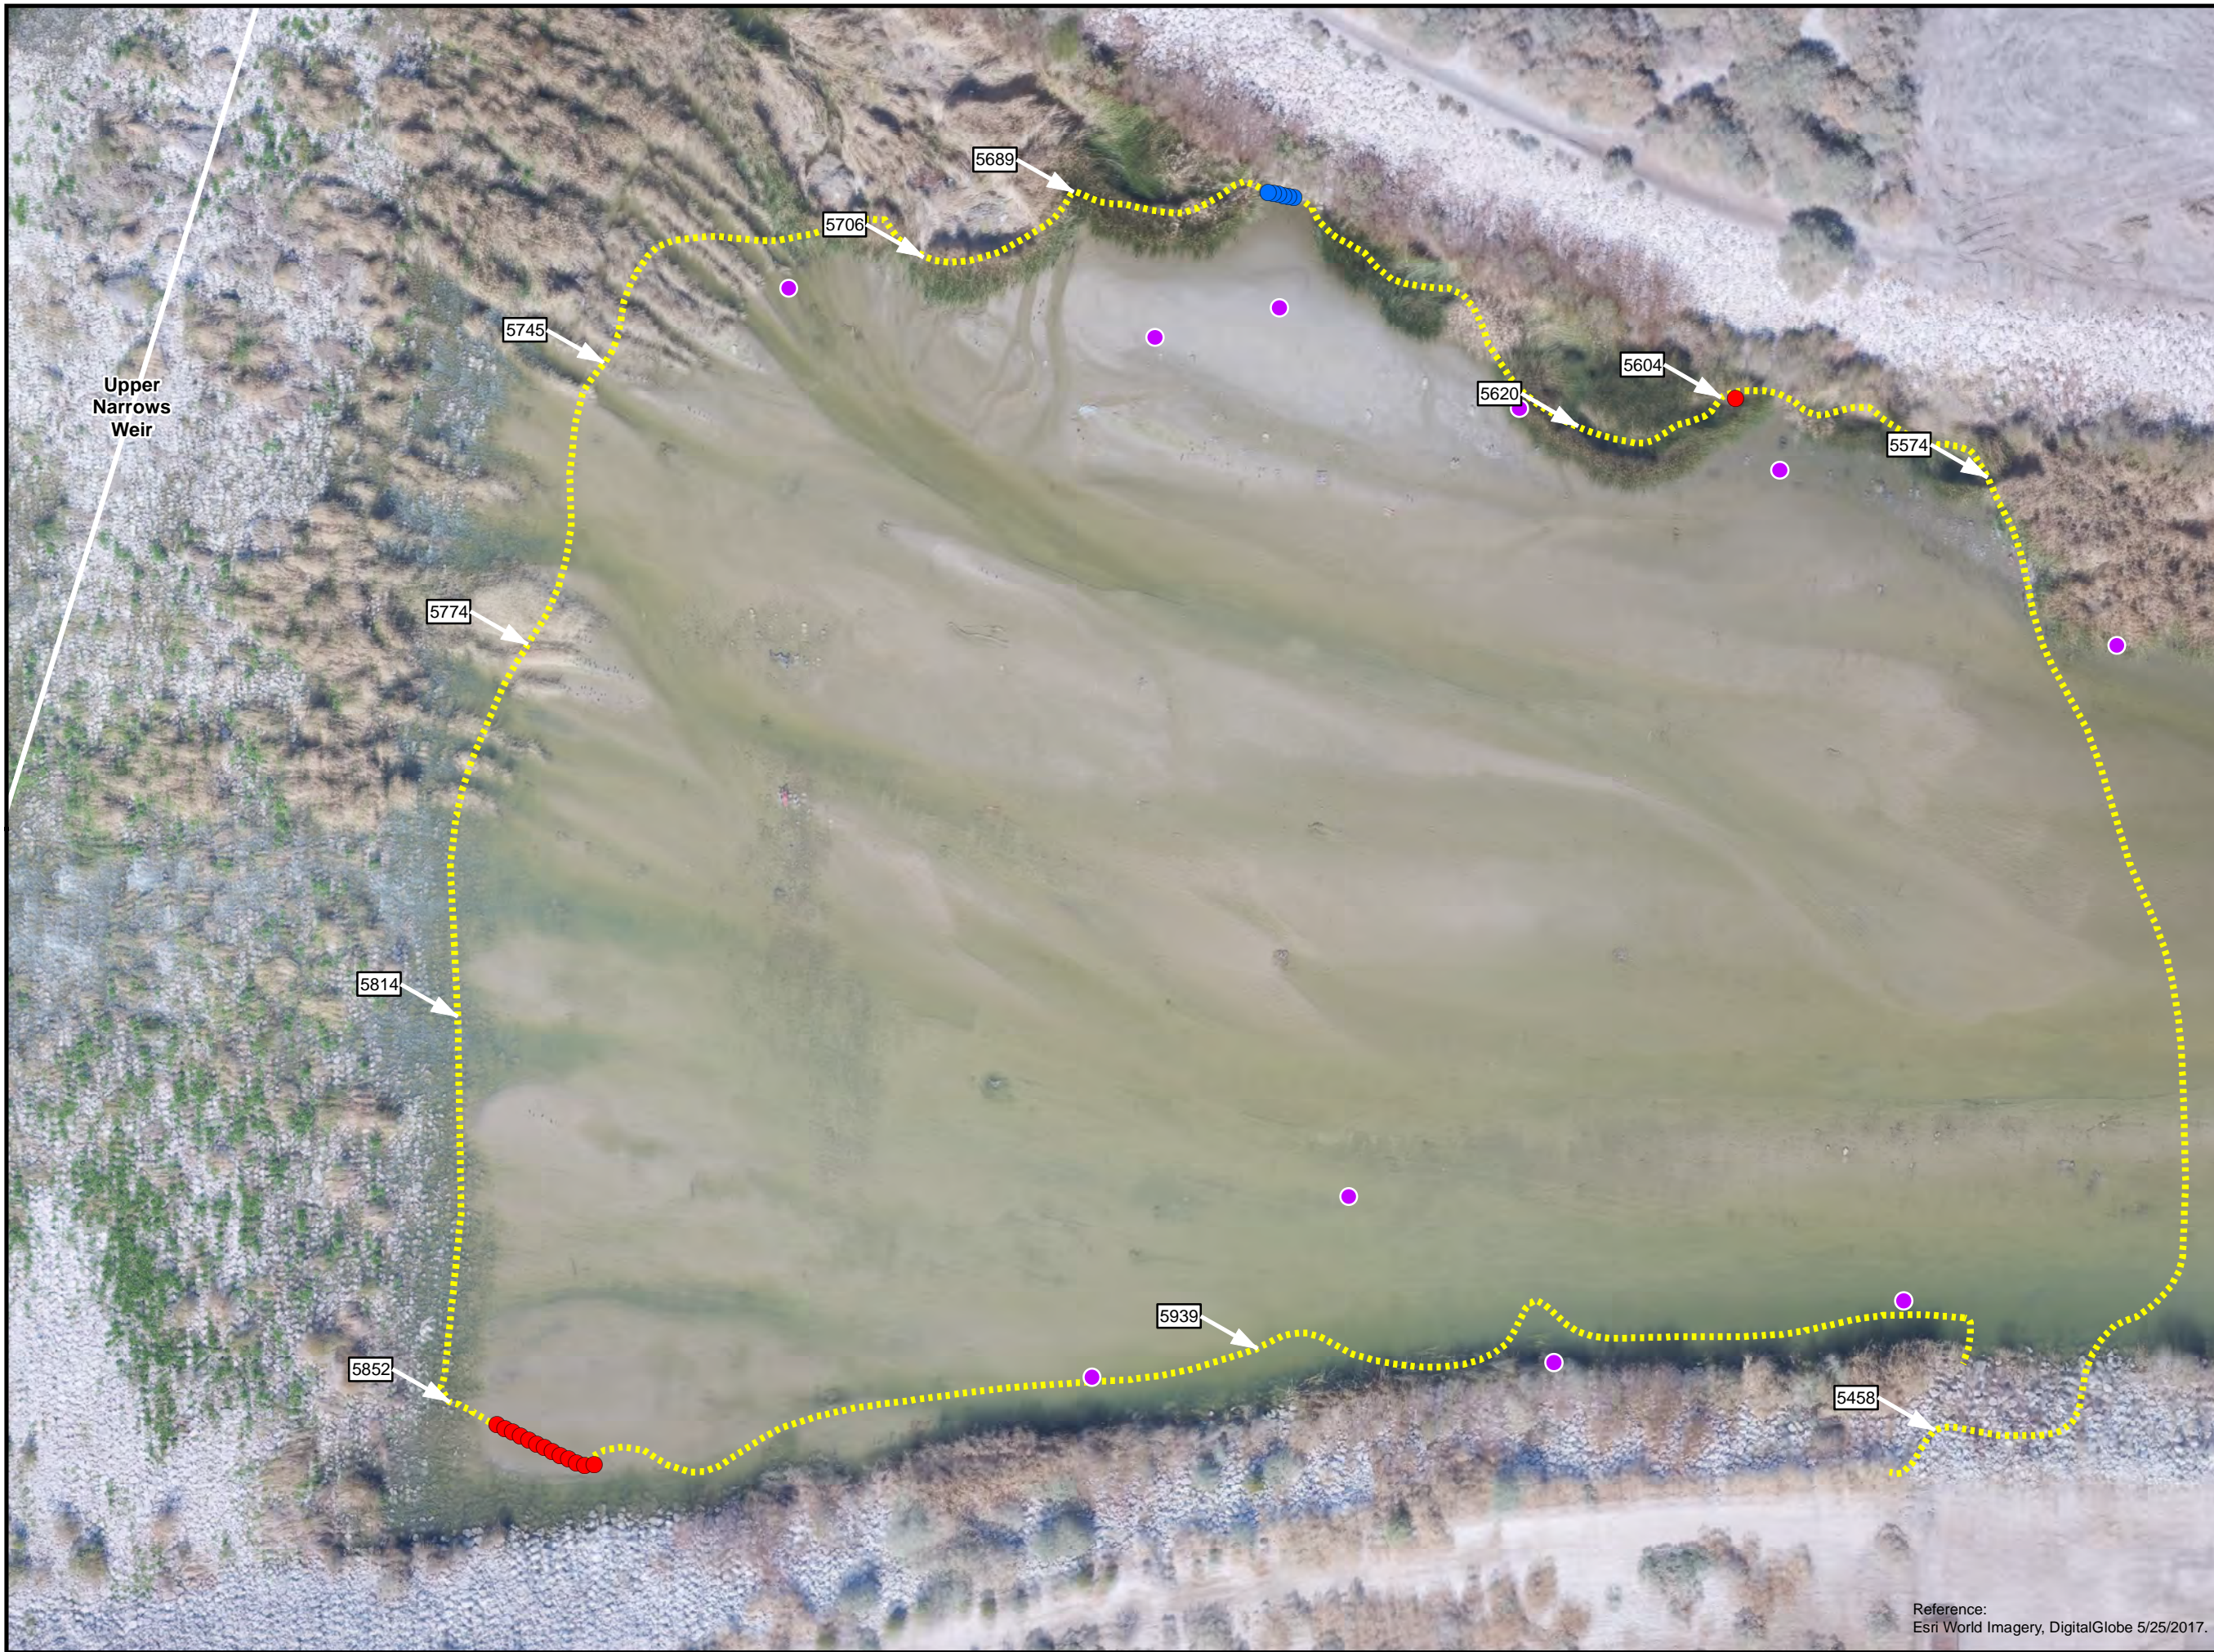
AECOM Figure 9

**FODTS DEPLOYMENT AND
THERMAL ANOMALIES
UPPER NARROWS WEIR**
