Supplemental Surface Water Investigation Technical Memorandum

NERT Remedial Investigation – Downgradient Study Area
Nevada Environmental Response Trust Site
Henderson, Nevada

Final Draft

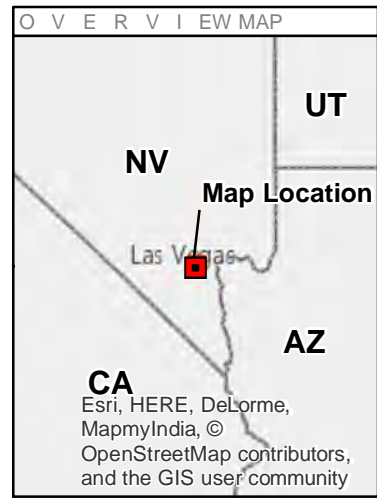
AECOM Figure 8

Based on the recent TIR survey and perchlorate concentration data obtained during 2017 sampling event (AECOM 2017a), it was determined that locations of high-resolution temperature surveys would be completed at Upper Narrows Weir, Calico Ridge Weir to Lower Narrows Weir, Lower Narrows Weir to Homestead Weir, Three Kids Weir to Rainbow Gardens Weir, and Rainbow Gardens Weir to Fire Station Weir. **Figure 8** identifies the locations of the FODTS deployments relative to the entire study area.

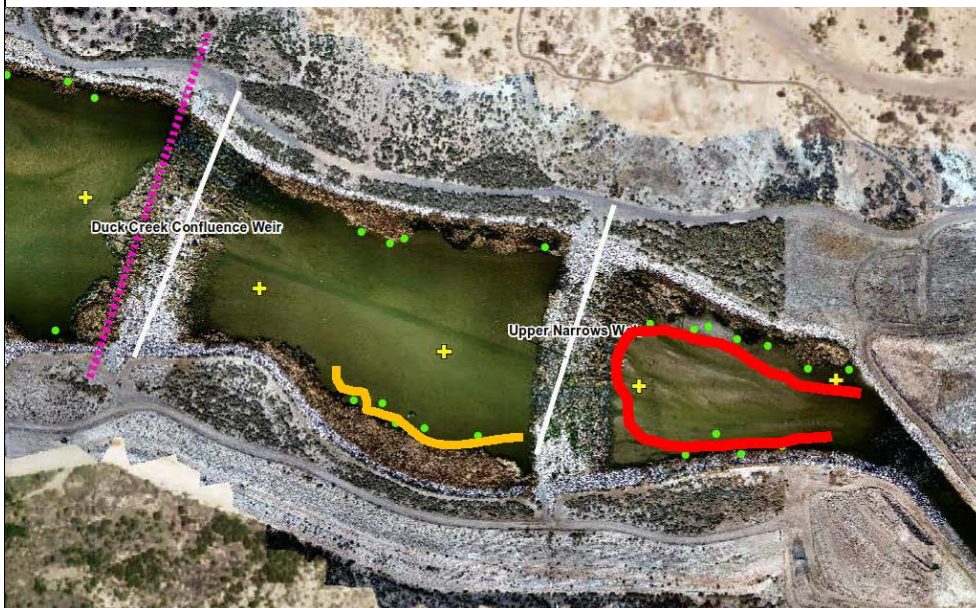
The DTS and calibration baths were set up on the South Bank near the edge of the construction zone (located to the east.) The red annotation on the below figure indicates the approximate layout of the fiber optic cable for DTS data collection.

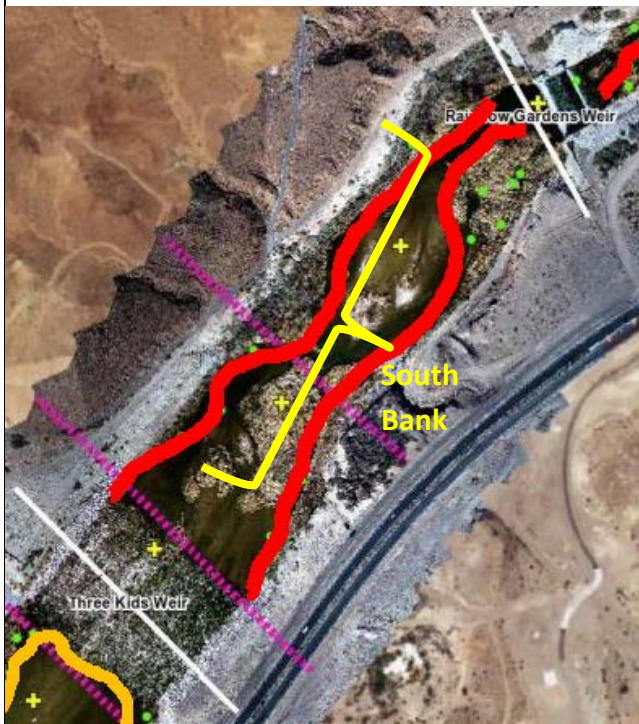
The red annotation along the South bank on the below figure indicates the targeted approximate layout of the fiber optic cable for DTS data collection between Three Kids and Rainbow Garden Weirs.

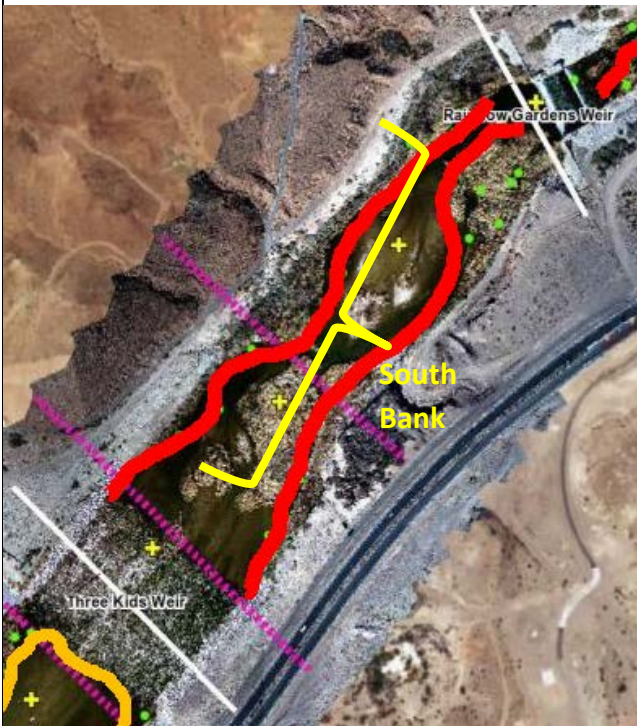
The red annotation along the South bank on the below figure indicates the targeted approximate layout of the fiber optic cable for DTS data collection between Three Kids and Rainbow Garden Weirs.

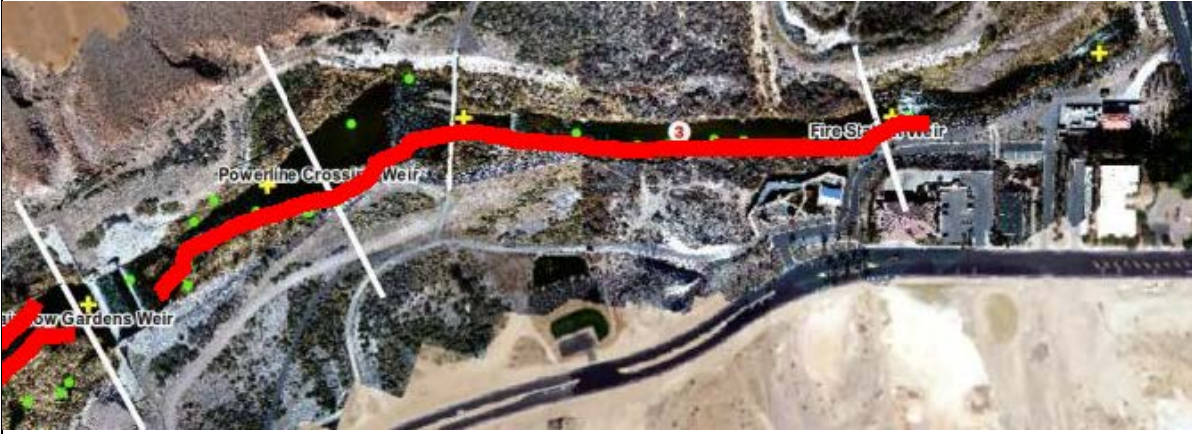
The red annotation on the below figure indicates the targeted approximate layout of the fiber optic cable for DTS data collection.

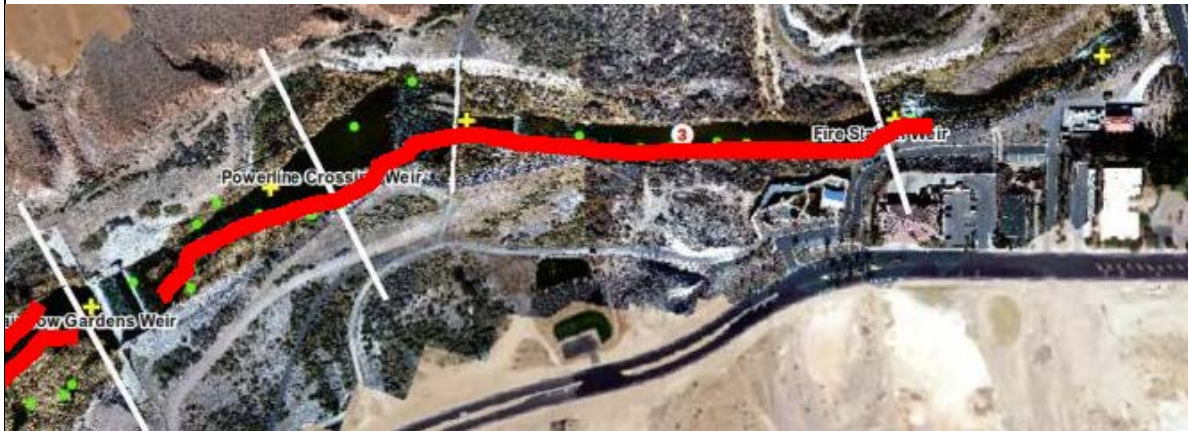
The red annotation on the below figure indicates the targeted approximate layout of the fiber optic cable for DTS data collection.

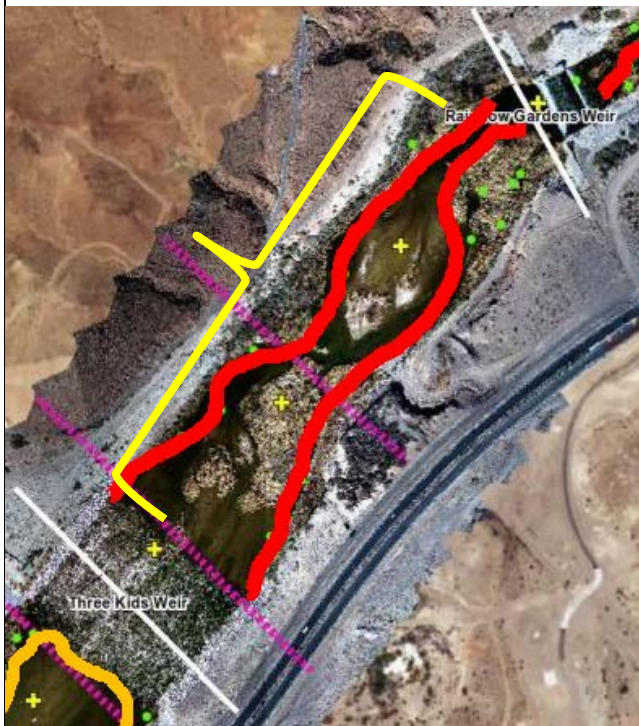
The red annotation along the North bank on the below figure indicates the targeted approximate layout of the fiber optic cable for DTS data collection between Three Kids and Rainbow Garden Weirs.

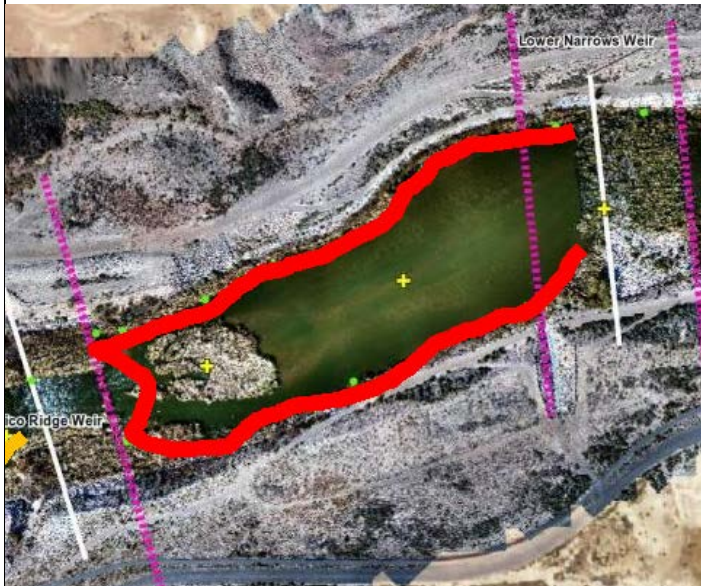
The red annotation on the below figure indicates the targeted approximate layout of the fiber optic cable for DTS data collection between Lower Narrows and Calico Weirs.

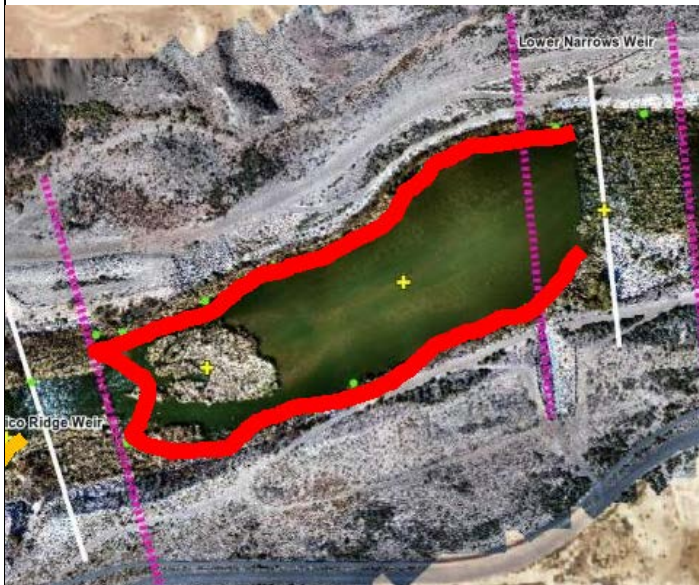
The red annotation on the below figure indicates the targeted approximate layout of the fiber optic cable for DTS data collection between Lower Narrows and Calico Weirs.

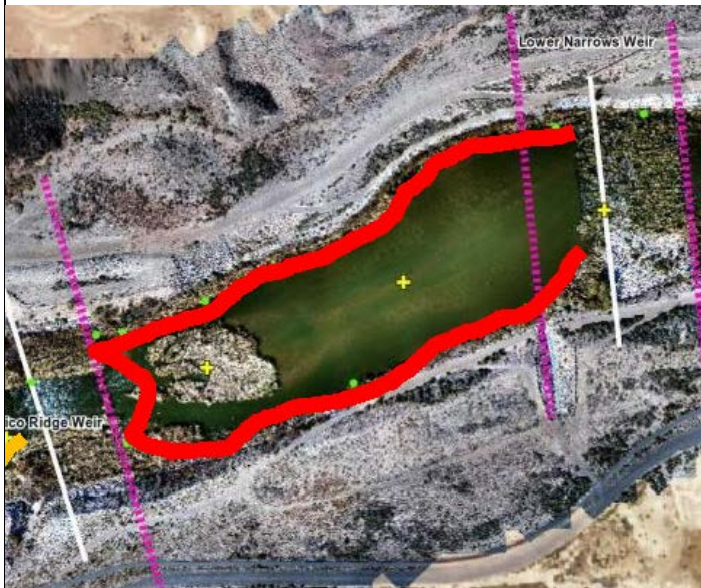
The red annotation on the below figure indicates the targeted approximate layout of the fiber optic cable for DTS data collection between Lower Narrows and Calico Weirs.

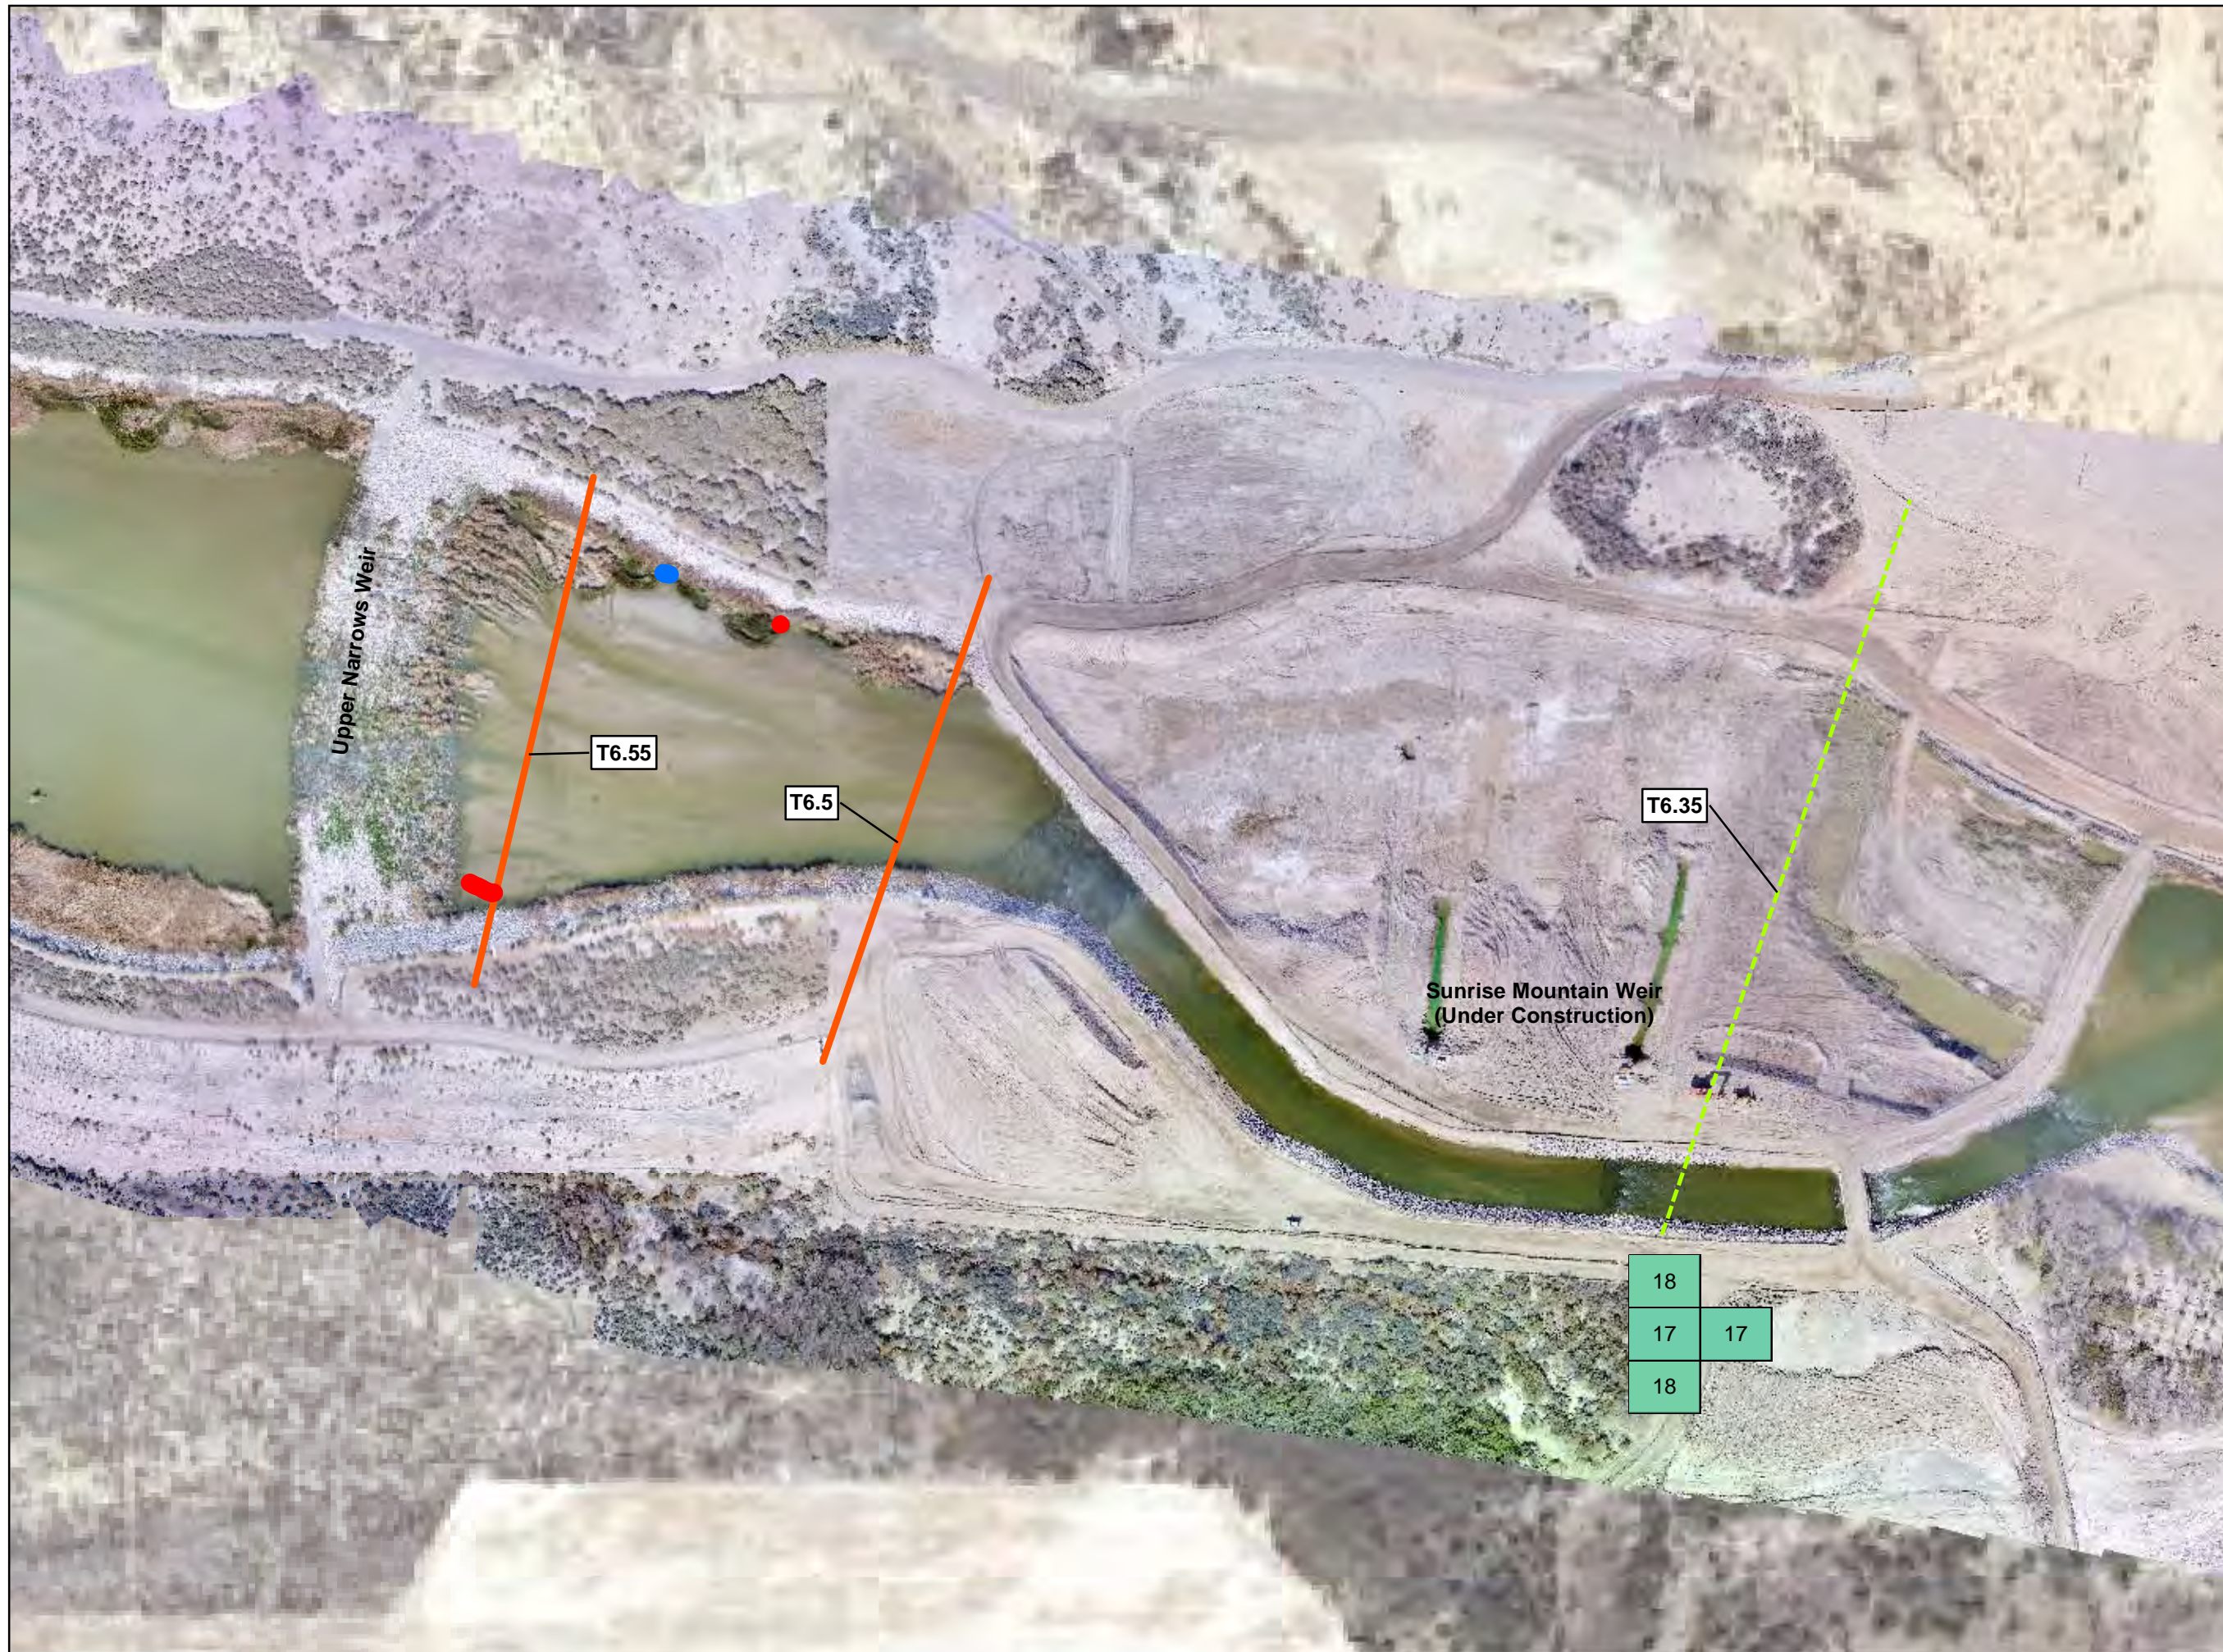
AECOM **Figure 3**

Upper Narrows Weir to Sunrise Mountain Weir - **Figure 3** shows the proposed revised sample locations from Upper Narrows Weir to Sunrise Mountain Weir construction zone.

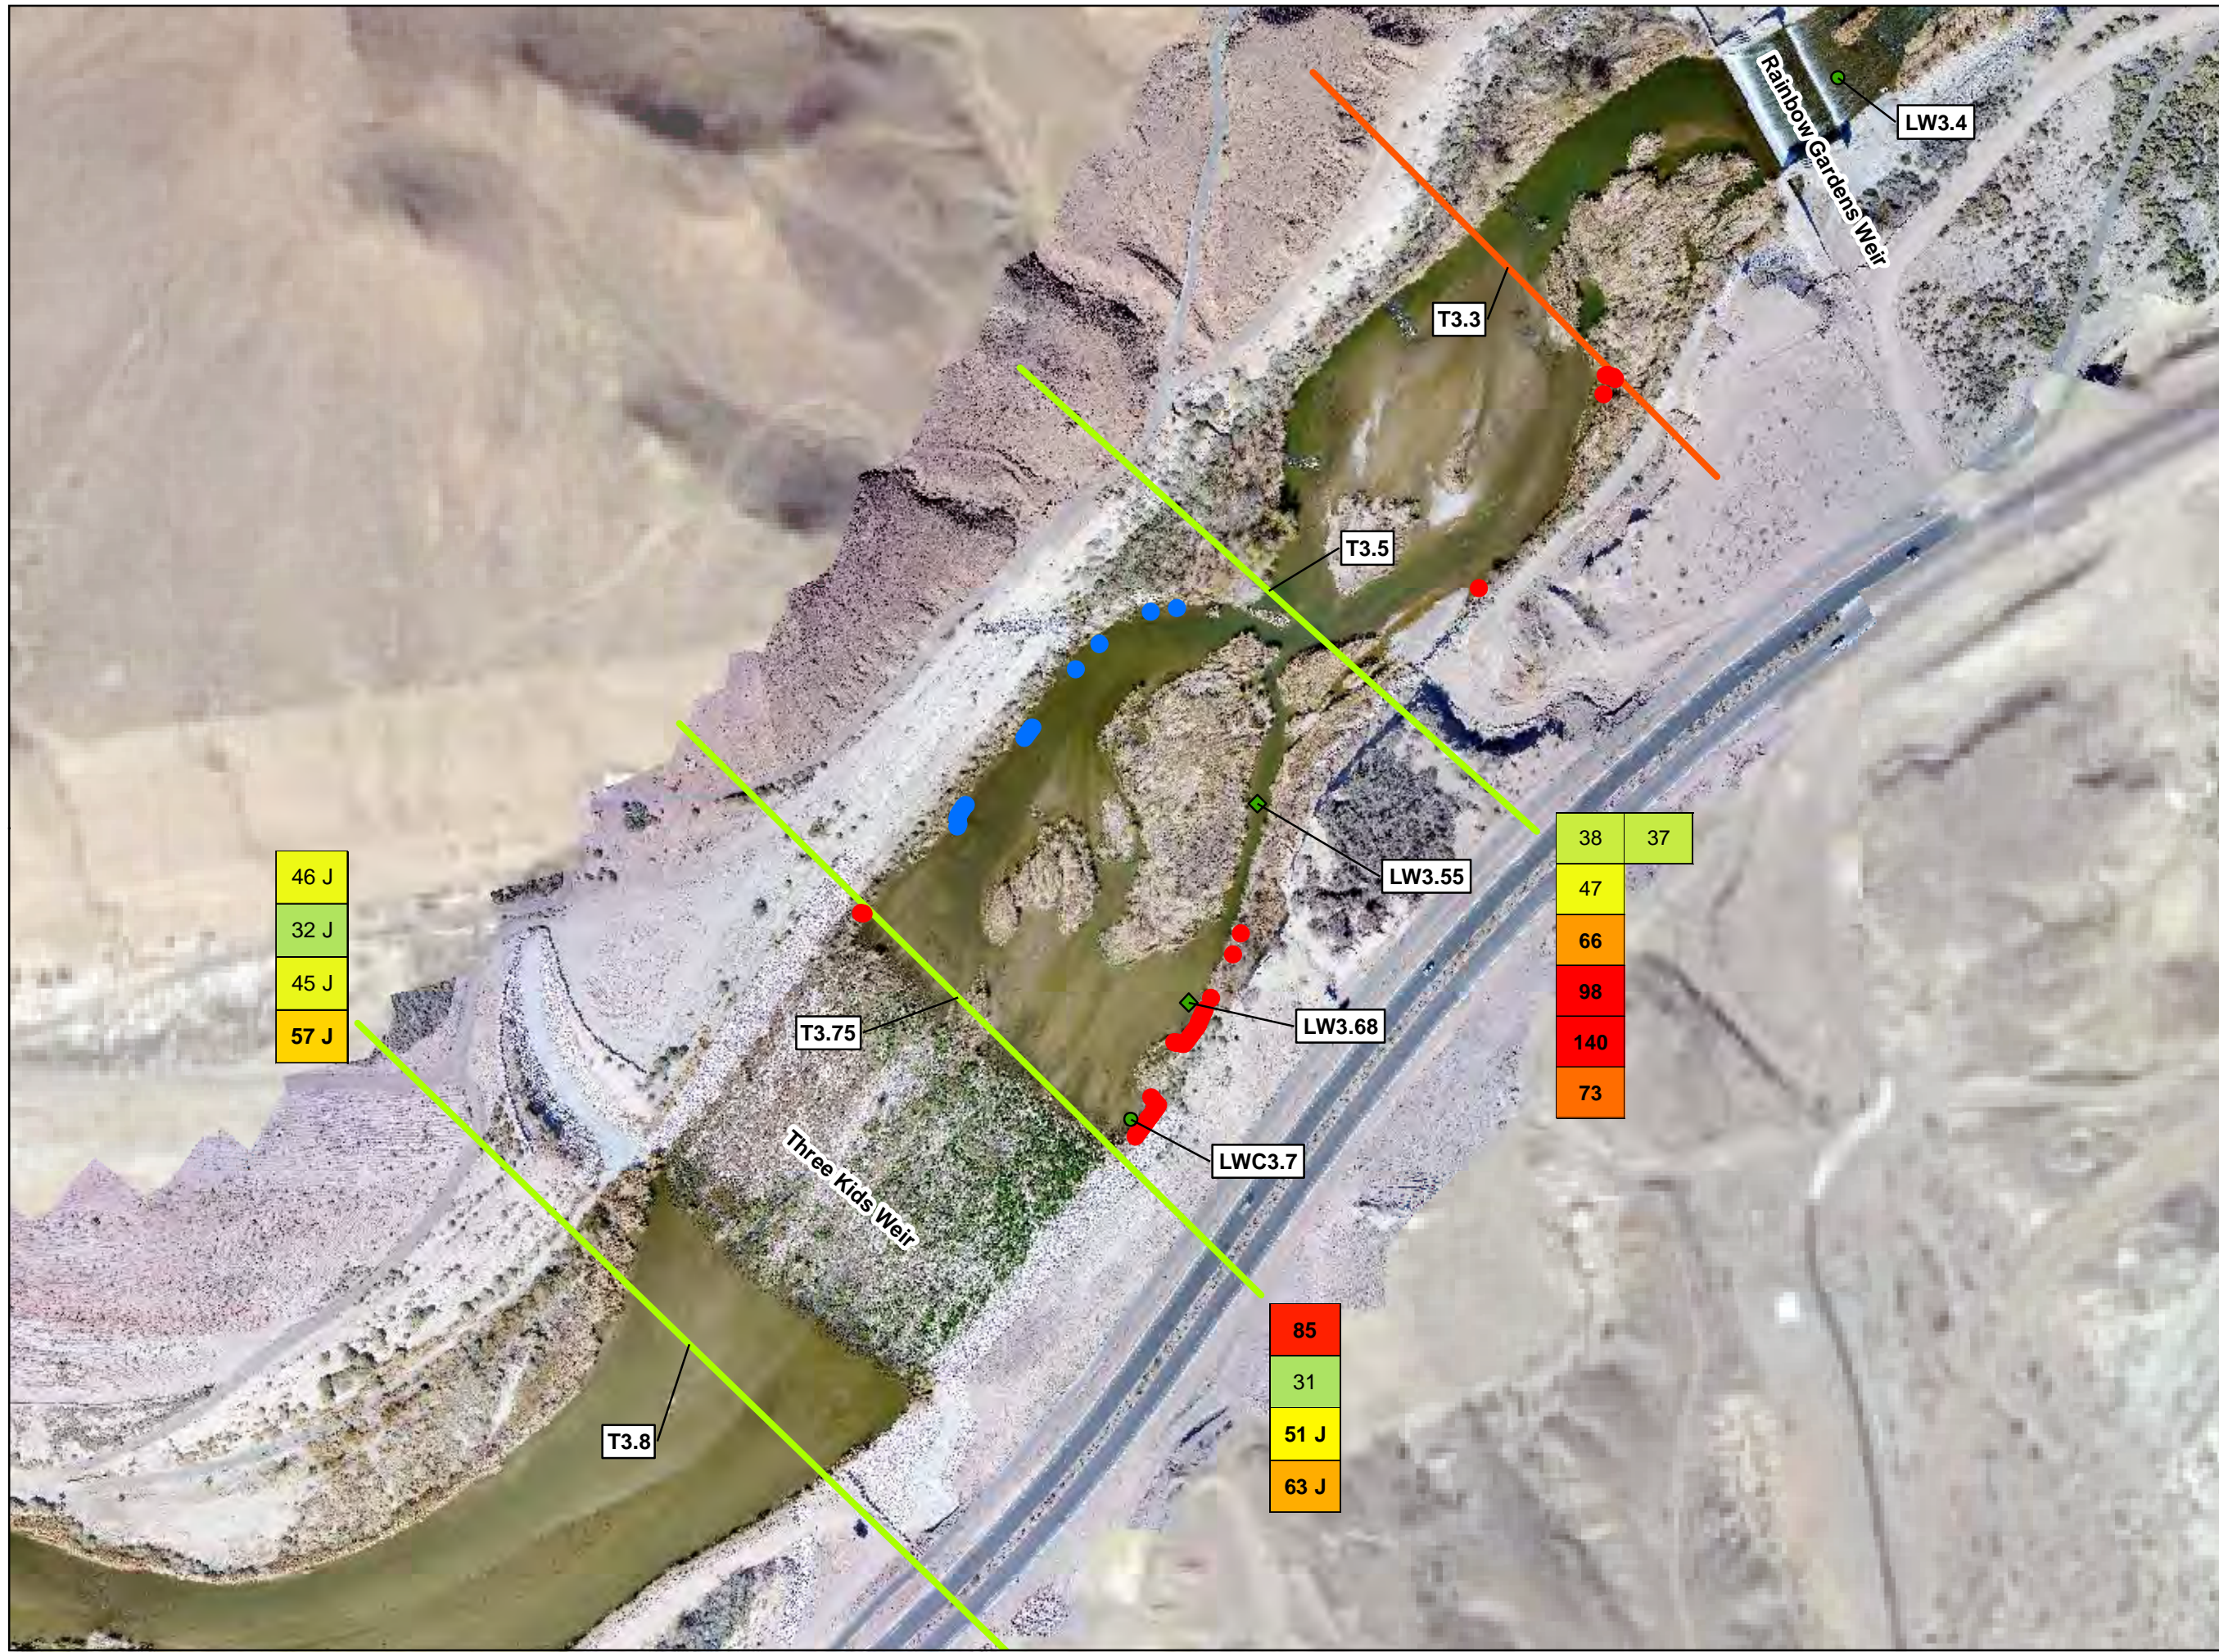
AECOM Figure 4

Calico Ridge Weir to Homestead Weir - **Figure 4** shows the proposed revised sample locations from Calico Ridge Weir to Homestead Weir.

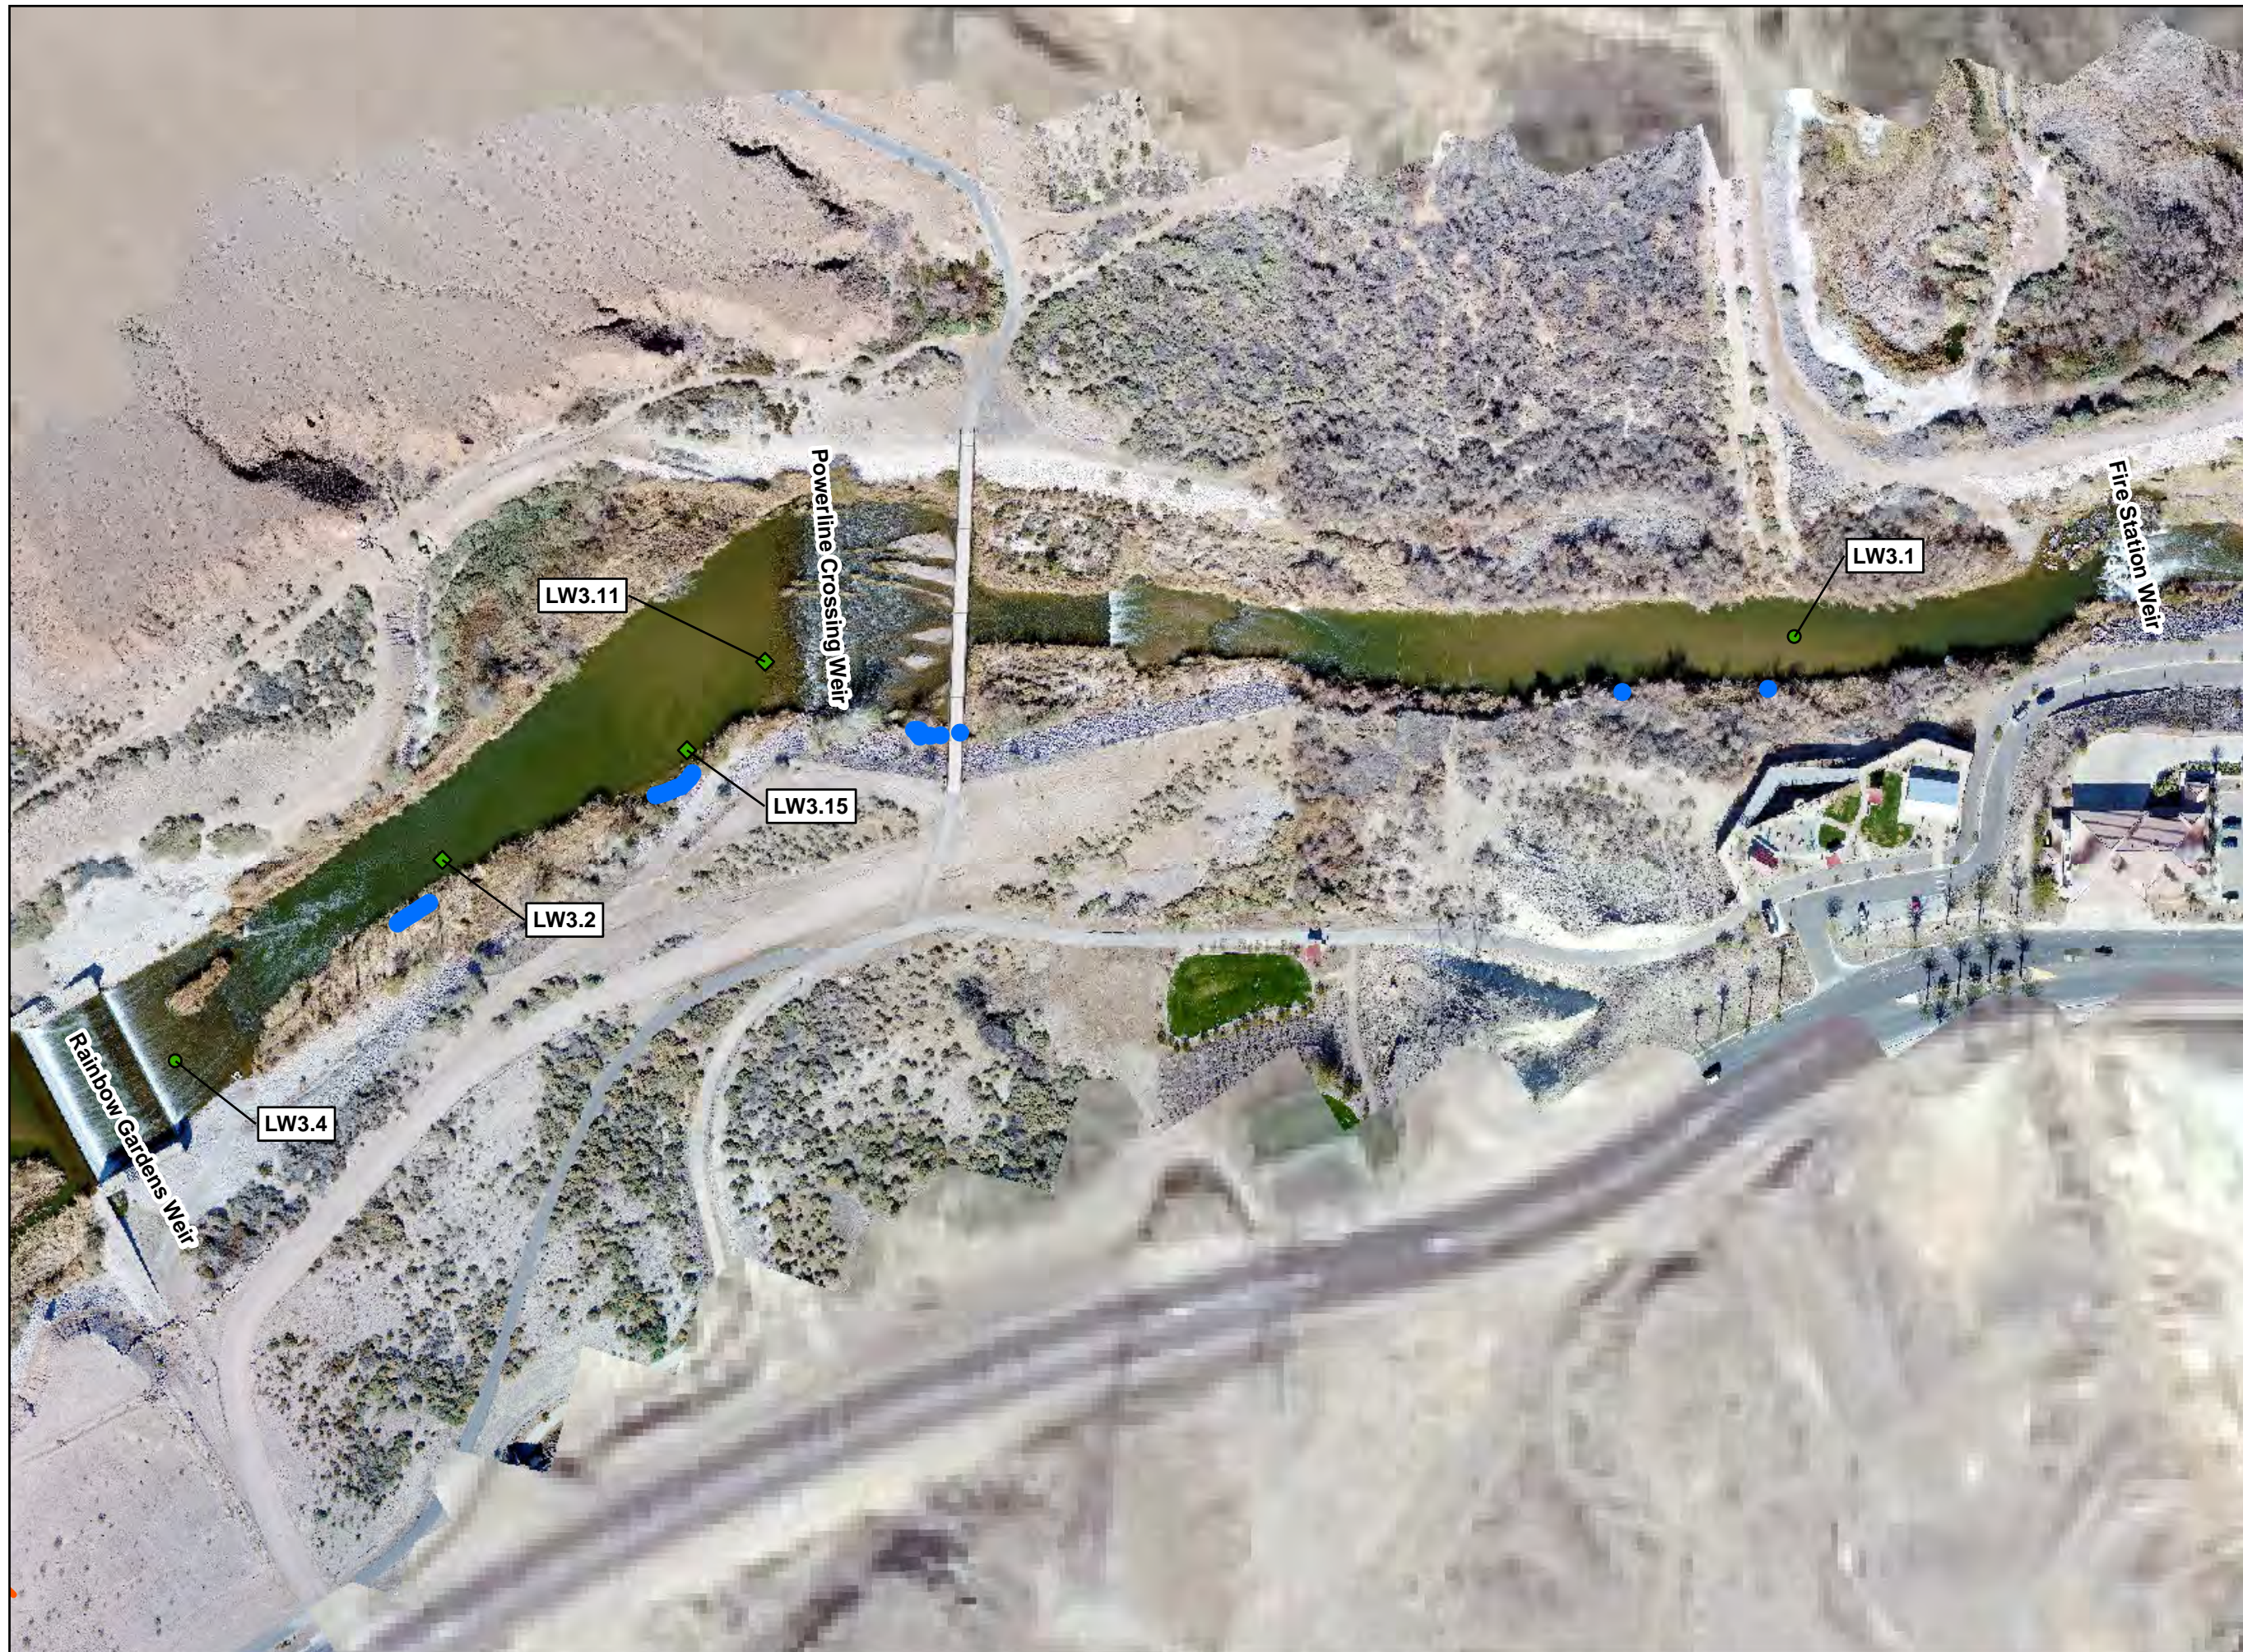
- Legend**
- Cool DTS Anomaly
 - Proposed Grab Sample (Previously Sampled in 2016)
 - ◆ Proposed Additional Grab Sample
