Interim Soil Removal Action
Completion Report
Nevada Environmental Response
Trust Site, Henderson, Nevada
August 2010 – November 2011

Prepared for:
Nevada Environmental Response Trust

Prepared by:
ENVIRON International Corporation
Emeryville, California
Chicago, Illinois

Date:
January 2012

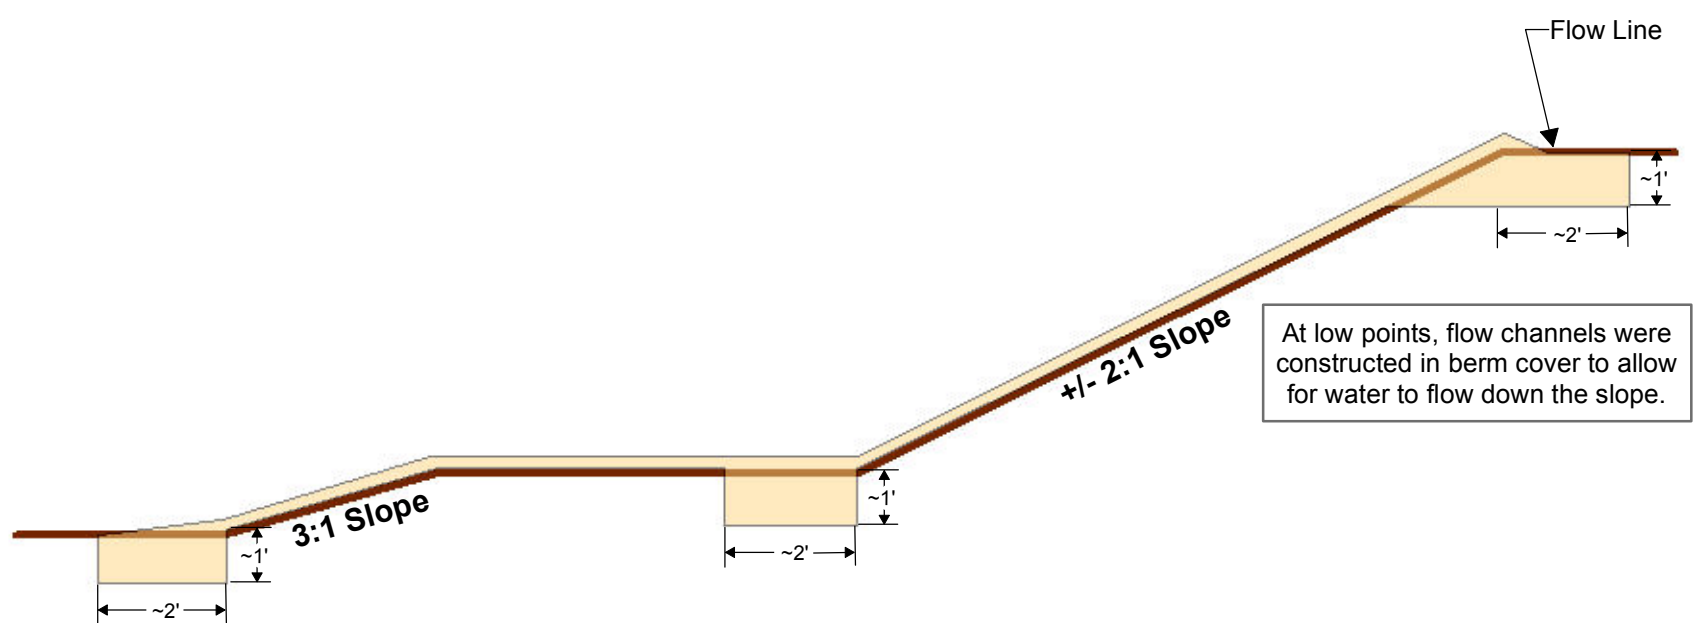
Typical Cross Section for 2:1 Slopes Cement Treated Aggregate Cover for Berms
