Interim Soil Removal Action
Completion Report
Nevada Environmental Response
Trust Site, Henderson, Nevada
August 2010 – November 2011

Prepared for:
Nevada Environmental Response Trust
Henderson, Nevada

Prepared by:
ENVIRON International Corporation
Emeryville, California

Date:
January 2012
Revised September 2012

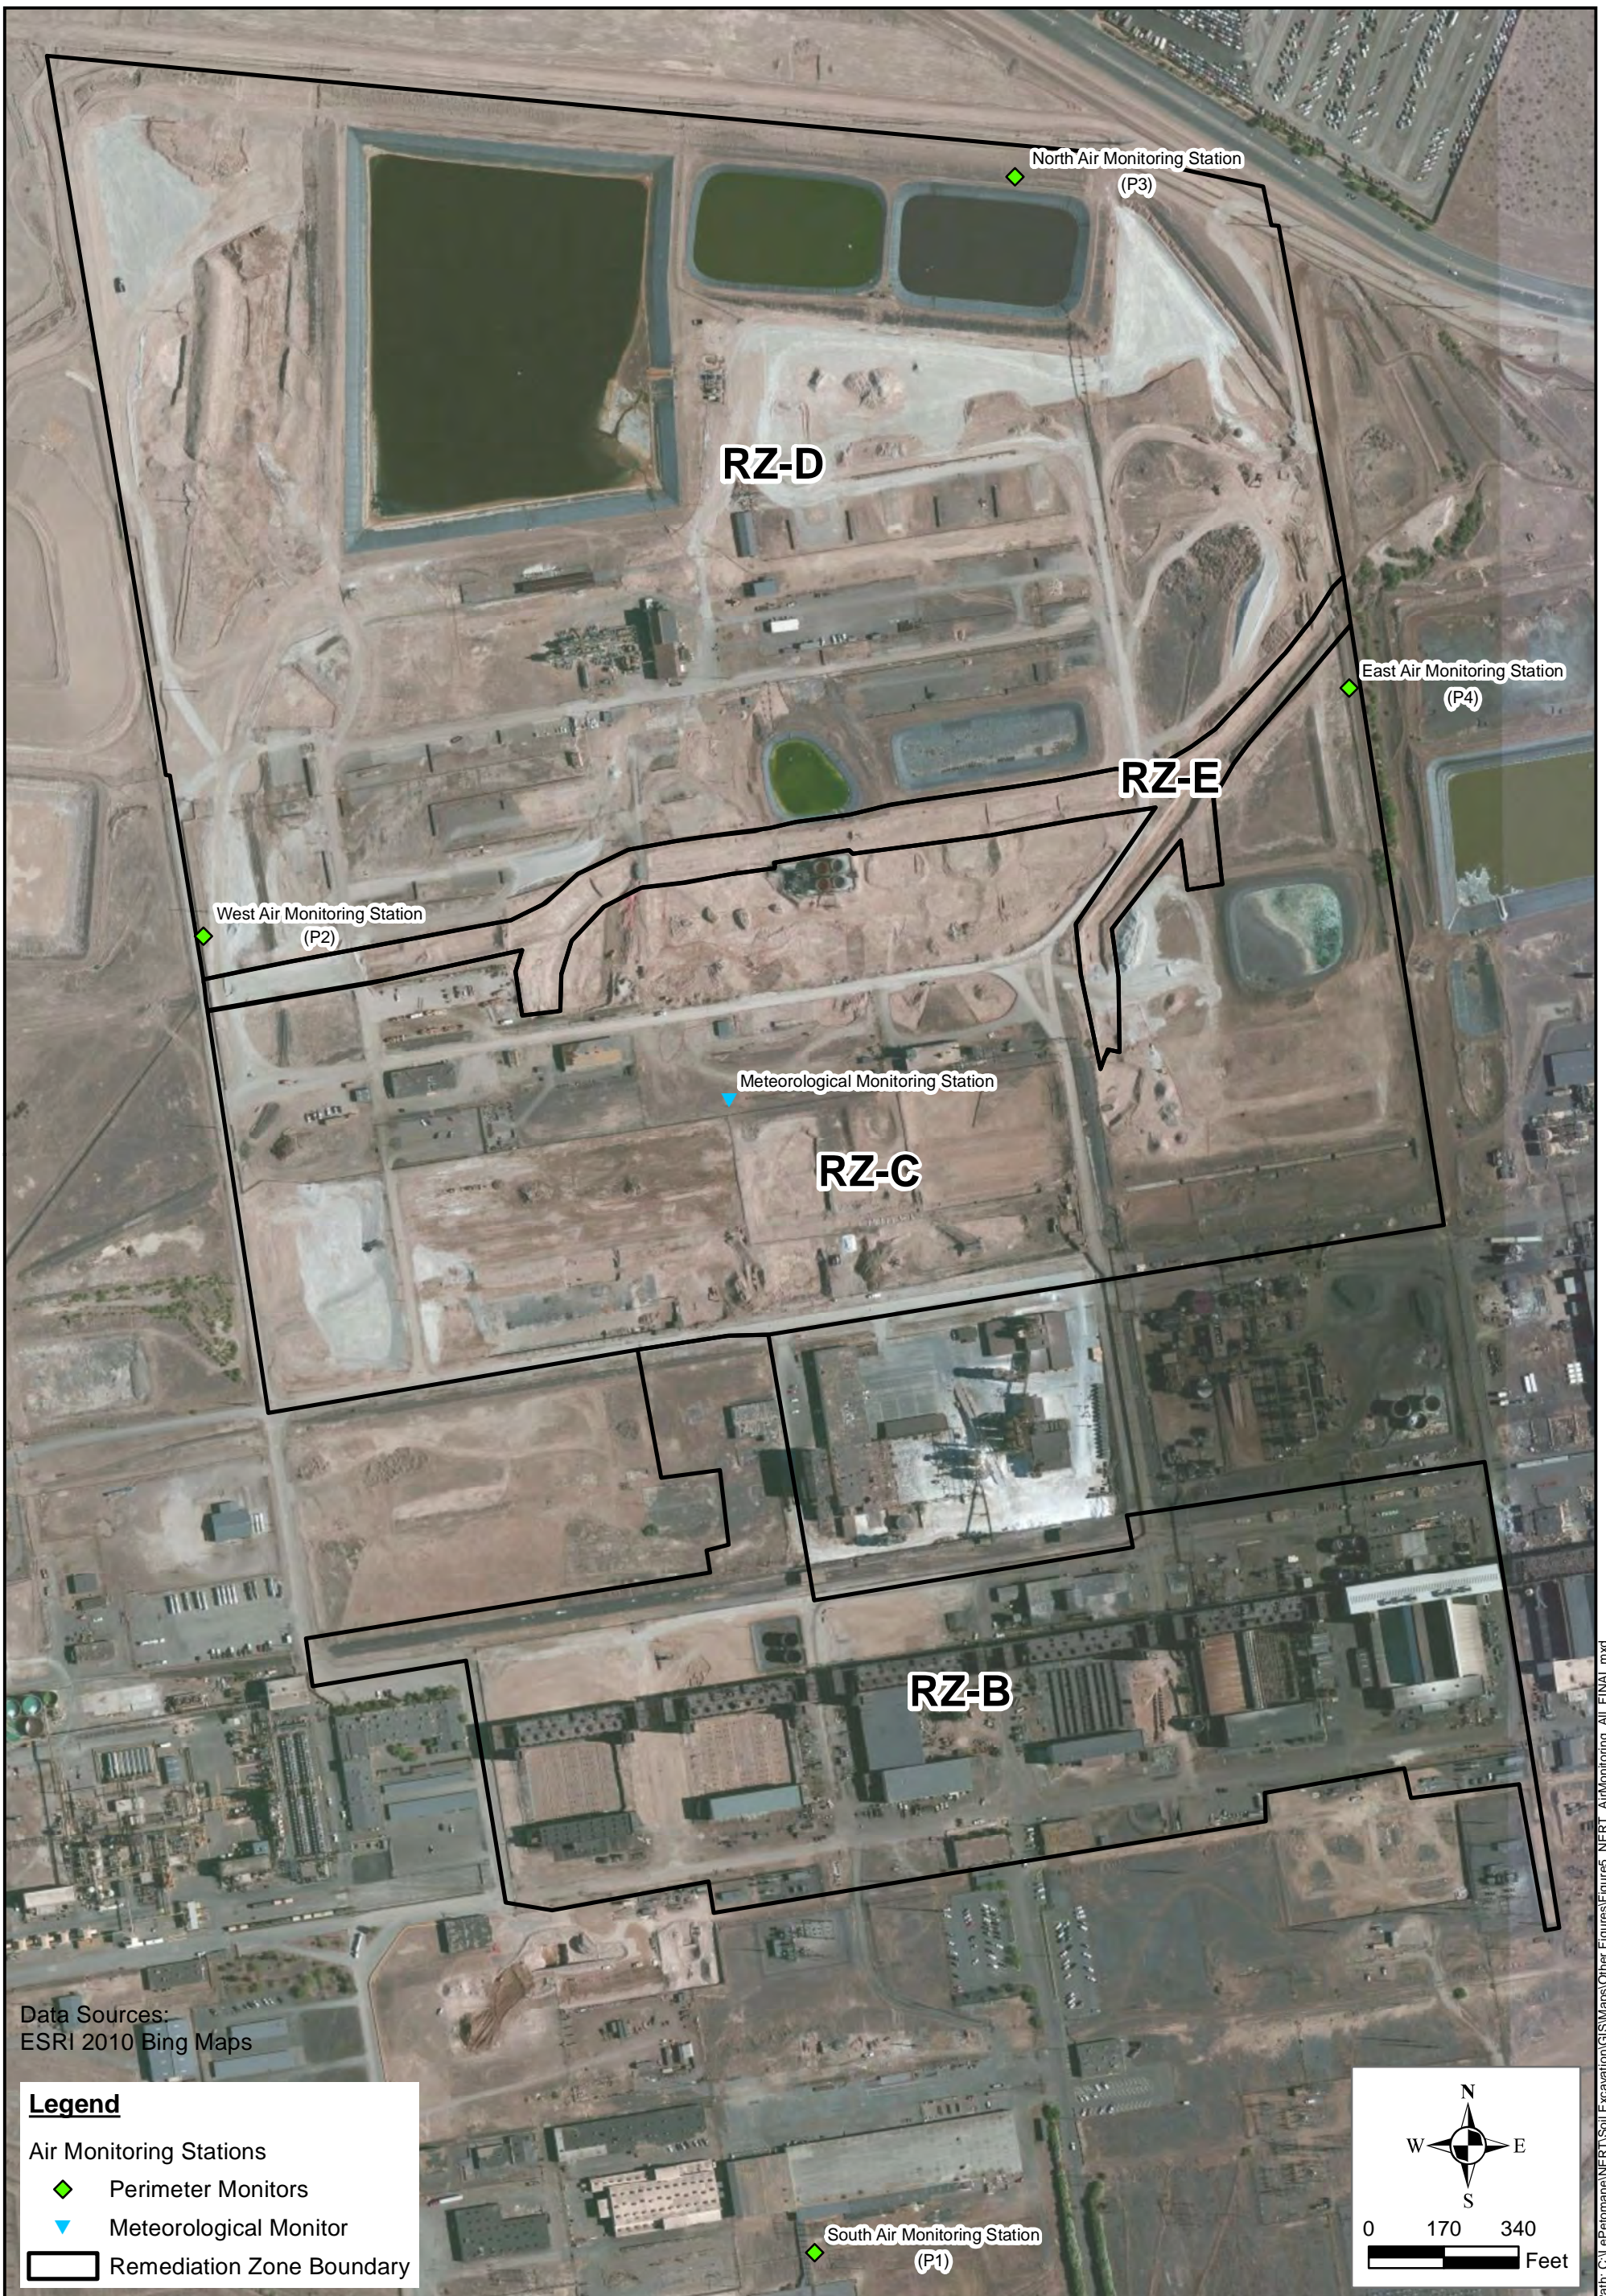
Figure
5

Site-specific meteorological conditions were measured using a Davis Instruments Vantage Pro2™ wireless weather station located southeast of the LVP field trailer (Figure 5). The station measured several meteorological conditions, including wind speed and direction, and reported real-time data to a remote console located onsite. Data gathered from August 2010 to March 2011 were logged in ten-minute intervals, and were provided to ENVIRON in spreadsheet form. Data gathered from March to November 2011 were logged in fifteen-minute intervals and were downloaded regularly to a computer in the ENVIRON field trailer. Onsite personnel used the real-time data to determine the appropriate locations for upwind and downwind dust monitoring at active excavation sites. Wind data collected during the duration of the project showed that the prevailing wind came from the south to southwest.

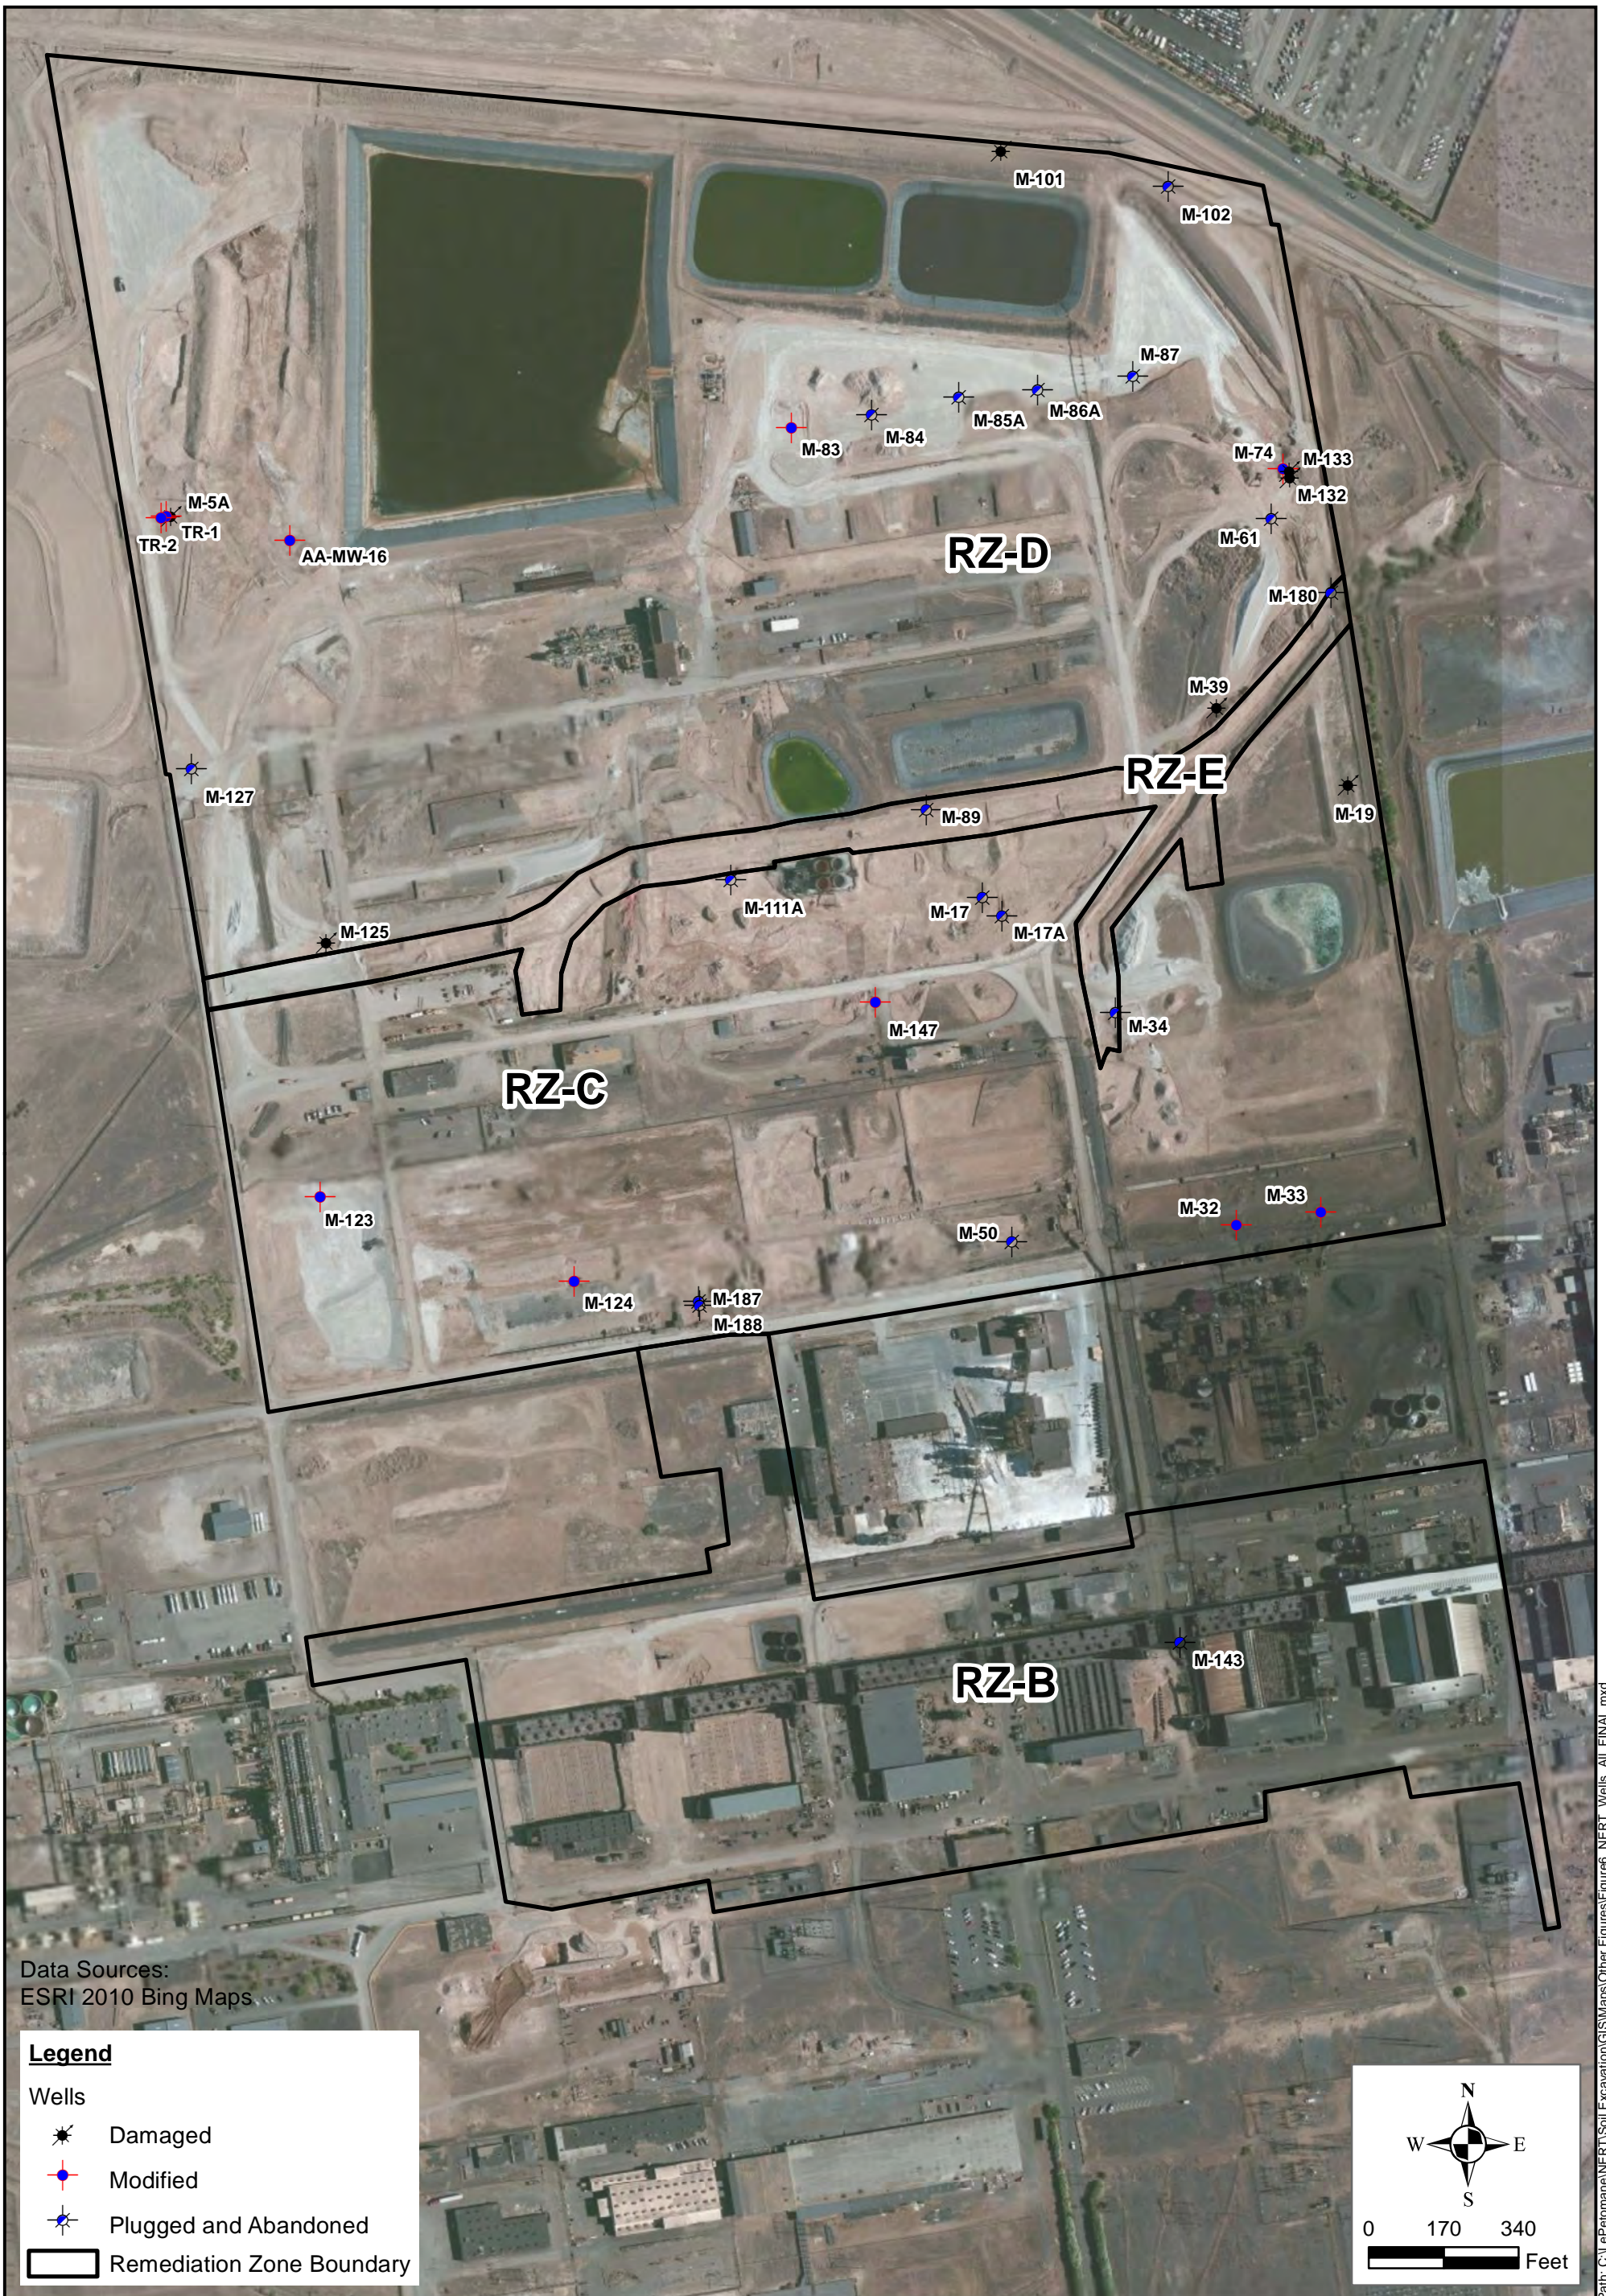
Figure
6

A number of monitoring wells were previously installed in the remediation areas as part of historical field investigations. Locations of existing monitoring wells are depicted in Figure 6. Prior to excavation which would potentially damage the monitoring wells, Northgate and ENVIRON evaluated whether protection of the existing monitoring wells in planned excavation areas and access routes was feasible. Concrete barriers were placed around wells requiring protection from construction traffic. Some of the wells were previously plugged and/or removed prior to the Trust oversight. The following table identifies the wells which were modified during excavation activities:

Monitoring Well Abandonment and Repair
Nevada Environmental Response Trust Site, Henderson, Nevada

Monitoring Well Modifications – Excavation Activities	
Well ID	Comments
M-5A	Ground elevation changed; concrete pad destroyed
M-17	Plugged prior to Trust; found during excavation; to be overdrilled
M-17A	Plugged prior to Trust; found during excavation; to be overdrilled
M-18	Plugged and Abandoned prior to Trust
M-19	Concrete pad damaged
M-32	Removed as Part of Manganese Tails Removal Work
M-33	Removed as Part of Manganese Tails Removal Work
M-34	Ground elevation significantly changed, 3.5 ft of casing cut
M-35	Ground elevation significantly changed, 3.2 ft of casing cut
M-39	Damaged during excavation activities; repair or removal anticipated
M-50	Overdrilled and Removed 6/16/11 by Eagle Drilling
M-61	Damaged during excavation; overdrilled and removed 6/16/11
M-74	Damaged during excavation activities; repair or removal anticipated
M-83	Ground elevation changed
M-84	Removed prior to Trust oversight
M-85	Grouted and removed prior to Trust

M-85A	Removed prior to Trust oversight
M-86A	Removed prior to Trust oversight
M-87	Removed prior to Trust oversight
M-88	Removed prior to Trust oversight
M-89	Plugged prior to Trust oversight; need to overdrill
M-101	Damaged - Concrete pad broken
M-102	Removed prior to Trust oversight
M-111A	Overdrilled and removed 6/16/11 by Eagle Drilling
M-123	Ground elevation and access changed due to excavation
M-125	Ground elevation changed due to excavation; concrete pad broken
M-127	Damaged and removed during soil remediation
M-132	Damaged during excavation activities; repair or removal anticipated
M-133	Ground elevation changed due to excavation
M-143	Removed prior to Trust oversight
M-147	Damaged and removed during soil remediation
M-148	Abandoned and replaced by M-148A prior to Trust
M-180	Plugged and Abandoned prior to Trust oversight; need to overdrill
M-187	Overdrilled 6/16/11 by Eagle Drilling
M-188	Overdrilled 6/16/11 by Eagle Drilling

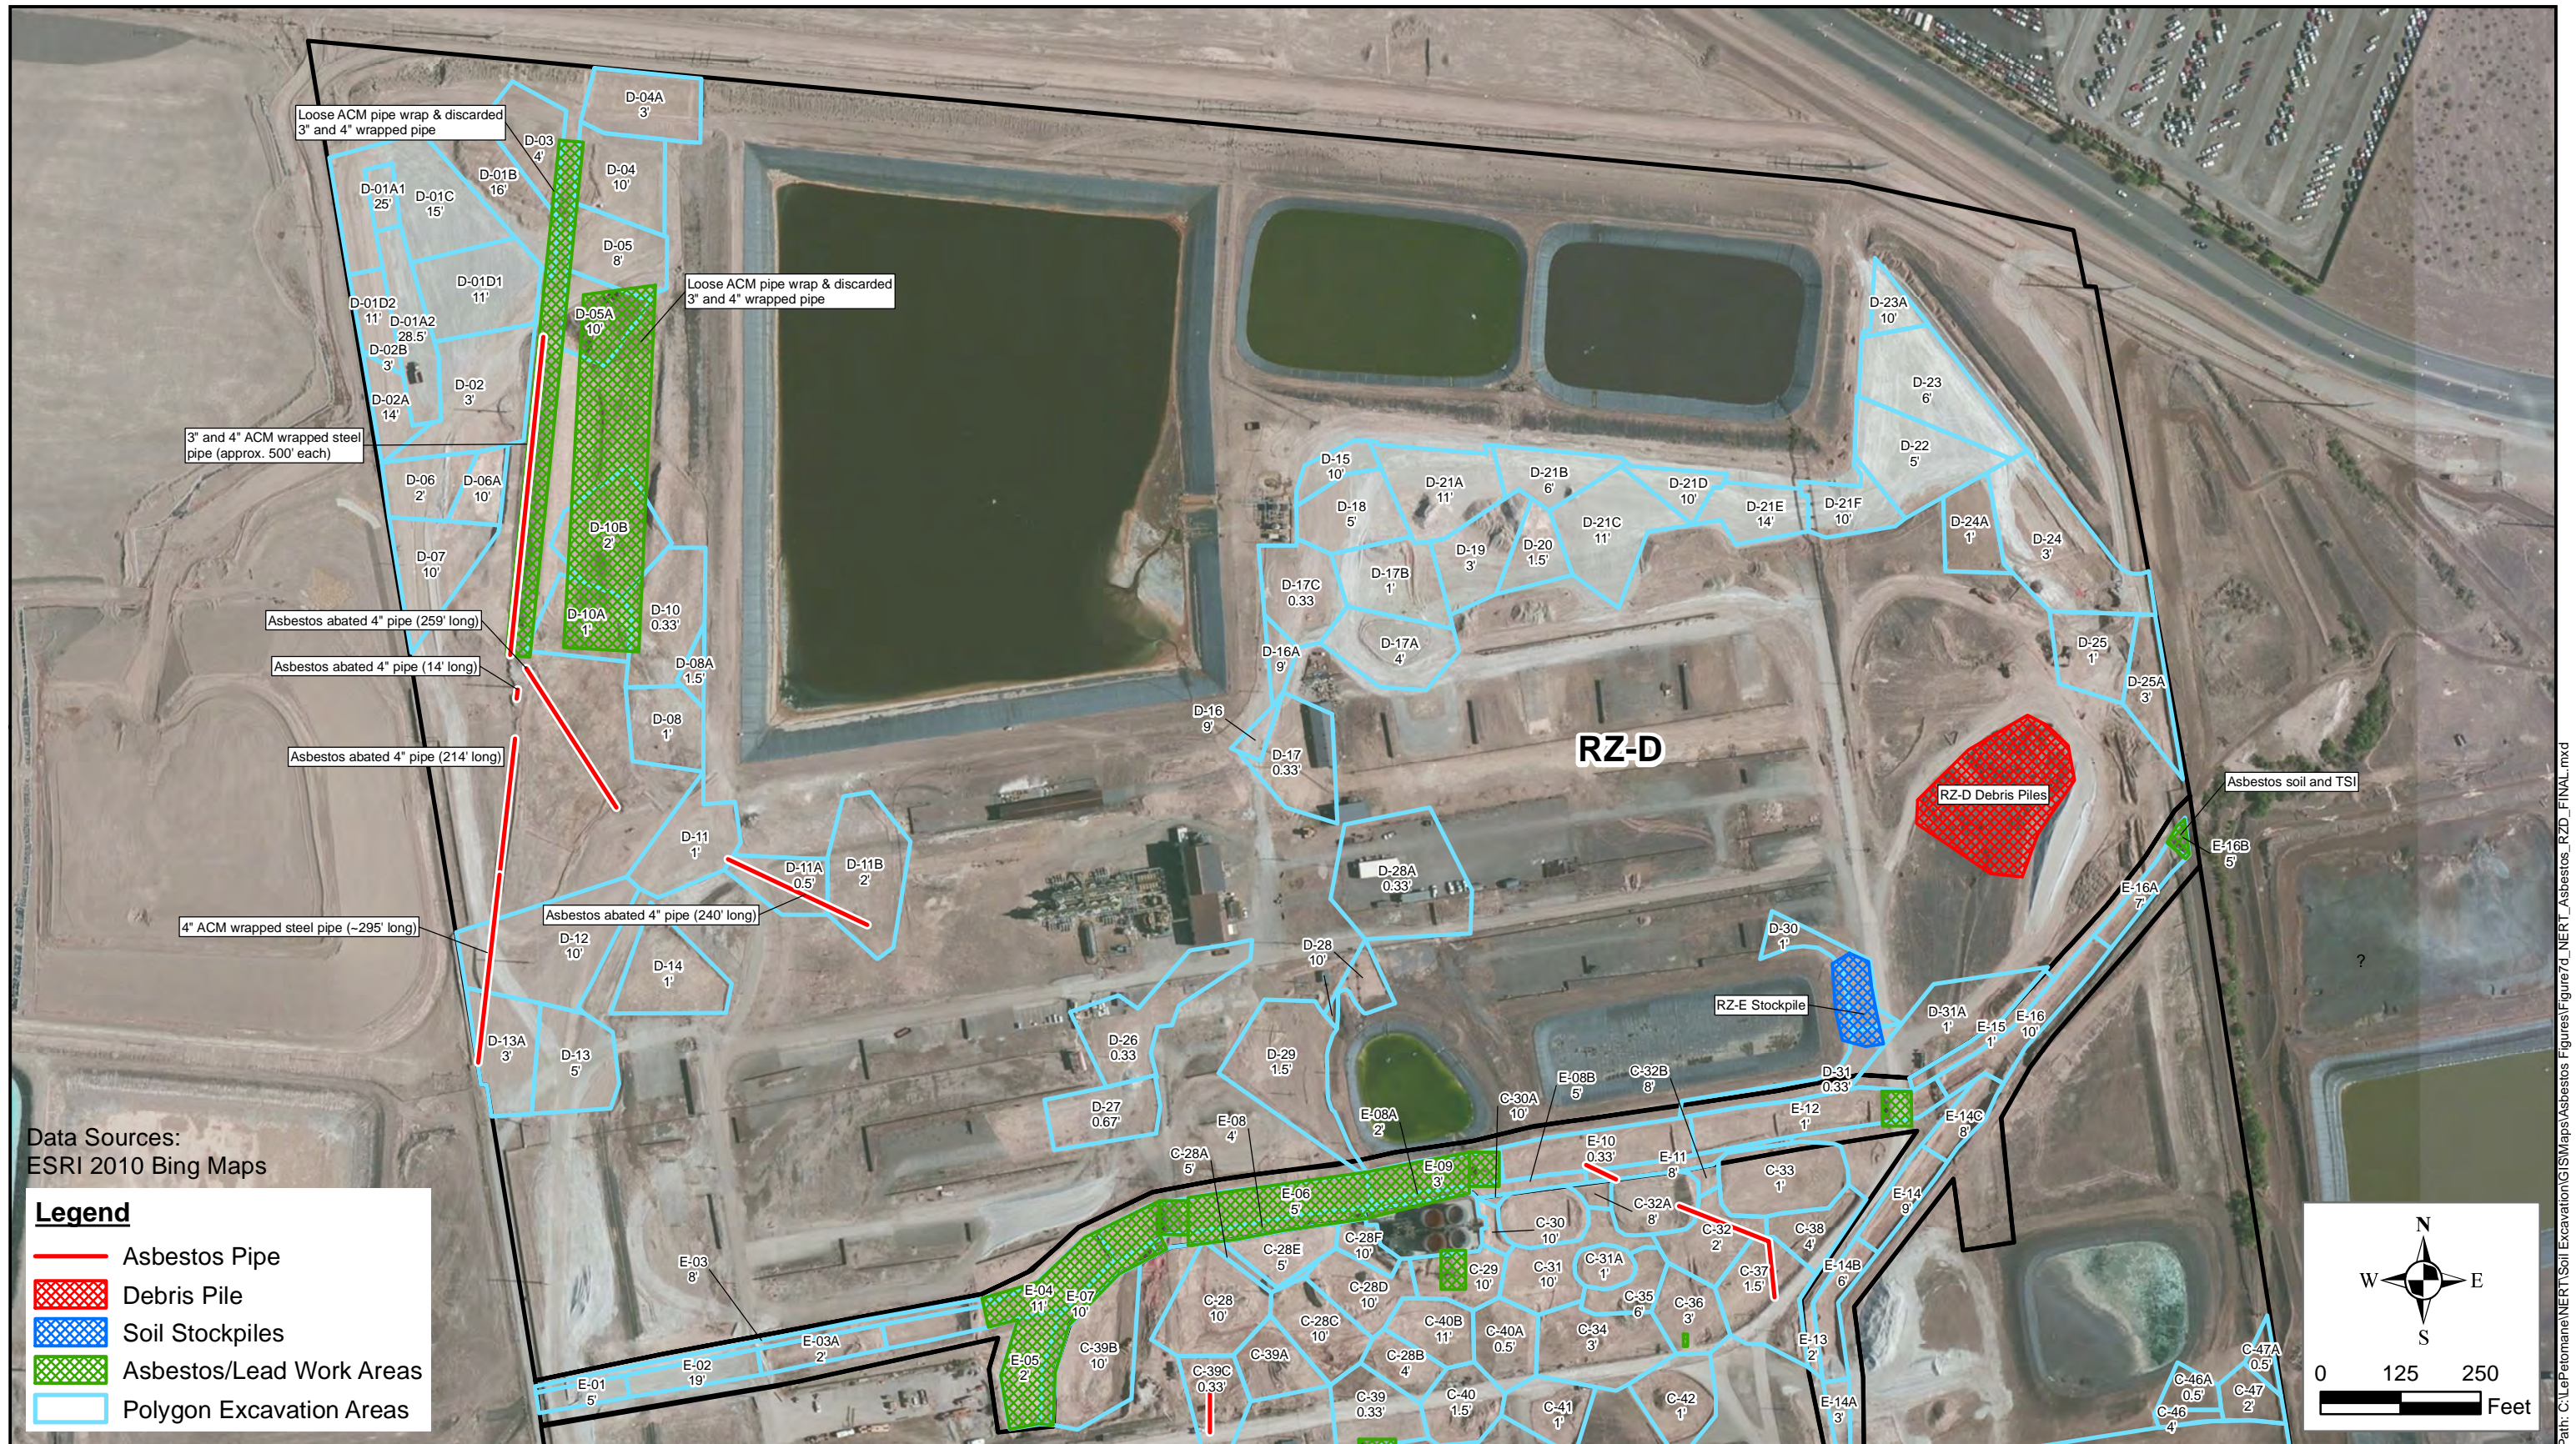
On April 28, 2011, various sizes of suspect ACM pipes were found while excavating discolored soil along the western and northern edges of polygon RZ-C-24. Wood debris and suspect ACM pipes were also found along Avenue F in that same area (Figure 7c). Upon discovery, ENVIRON and LVP stopped work in the area and marked off the area with caution tape. LoSo performed a limited asbestos survey on May 3-4, 2011 and collected a total of 24 bulk material samples. The suspect ACM initially identified included one 1-inch diameter wrapped pipe, three 4-inch diameter wrapped pipes, two 2-inch diameter wrapped pipes, and two 6-inch diameter wrapped pipes. Three samples collected from the one-inch diameter beige wrapped pipe and from both two-inch diameter brown/black wrapped pipes had detected concentrations of asbestos of 35%, 3%, and 2%, respectively.

On April 28, 2011, various sizes of suspect ACM pipes were found while excavating discolored soil along Avenue F in polygons RZ-C-14 and RZ-C-15 (Figure 7c). The pipes were found with wood and insulation-type material, which looked similar to shoring within a pipe trench. Upon discovery of the pipes, ENVIRON and LVP stopped work in the area until the pipes could be sampled for asbestos. On May 12 and 19, 2011, LoSo collected seven bulk material samples from suspect ACM, including black pipe wrap, beige thermal system insulation (TSI), wood, gray grout material, and soil. Three samples from the black and beige TSI, were found to have asbestos concentrations of 15% and are classified as ACM. From May 18-19, 2011, Greenway performed asbestos abatement on the area and removed one 1-inch diameter pipe that was approximately ten ft in length with about 3.5-inch thick TSI wrapping. They also removed one 1.5-inch steel pipe, one 2-inch steel pipe, and one 5-inch steel pipe that were all approximately 120 ft in length, and some soil. A total of approximately 480 linear ft of ACM and non-ACM pipes were removed from the area. Both ACM and non-ACM pipes were removed due to the close proximity and similarity of the pipes.⁵ The area was visually cleared of ACM on May 19, 2011 by LoSo.

On April 28, 2011, the transite pipe on the berm south of RZ-C-18 was cracked, exposing ACM, by an excavator that had driven over the pipe (Figure 7c). Upon discovery of the pipe, ENVIRON and LVP stopped work, LVP marked the pipe with paint, and LVP placed steel plates over the pipe to keep it from being further damaged. On May 12, 2011, LoSo collected one bulk sample from the transite pipe, which was found to have an asbestos concentration of 22%. The 18-inch diameter pipe was considered non-friable ACM, with the potential to become friable if damaged by excavation traffic and/or other disturbance in the area. From May 13-16, 2011, Greenway abated approximately 130 ft of the 18-inch diameter pipe. The area was cleared of ACM material by LoSo on May 16, 2011.

In November 2010, a 3-inch ACM-wrapped steel pipe was found in the northeastern portion of RZ-C within remediation polygons RZ-C-32 and -37 (Figure 7c). The pipe wrap was assumed to be asbestos since it was determined that this was a continuation of ACM-wrapped pipe previously found in the northwest corner of RZ-D. Greenway removed approximately 200 ft of

During excavations of the pipes in RZ-C-24, soil was also removed and considered to contain ACM. The soil was stockpiled to the northwest of polygon RZ-C-14 in the former pump house yard area. The stockpile was covered with a plastic tarp and the area was marked with asbestos caution tape. The pile was also frequently watered to maintain the soil in a moist condition. Removal of the stockpile occurred on July 30, 2011 by Greenway. LoSo visually cleared the area of ACM the same day.

On August 29, 2011, an additional 16 inches of pipe was found within the southwest portion of RZ-C-36 during grading and backfilling activities. The pipe was abated by LVP on August 30, 2011. LoSo visually cleared the area of ACM on August 30, 2011.
