Figure 1
LOCATION MAP
 Semi-Annual Remedial Performance Report
 Nevada Environmental Response Trust Site
 Henderson, Nevada

Hydrograph Pair Across the Barrier Wall - M-69 and I-Y
 Nevada Environmental Response Trust Site
 Henderson, Nevada

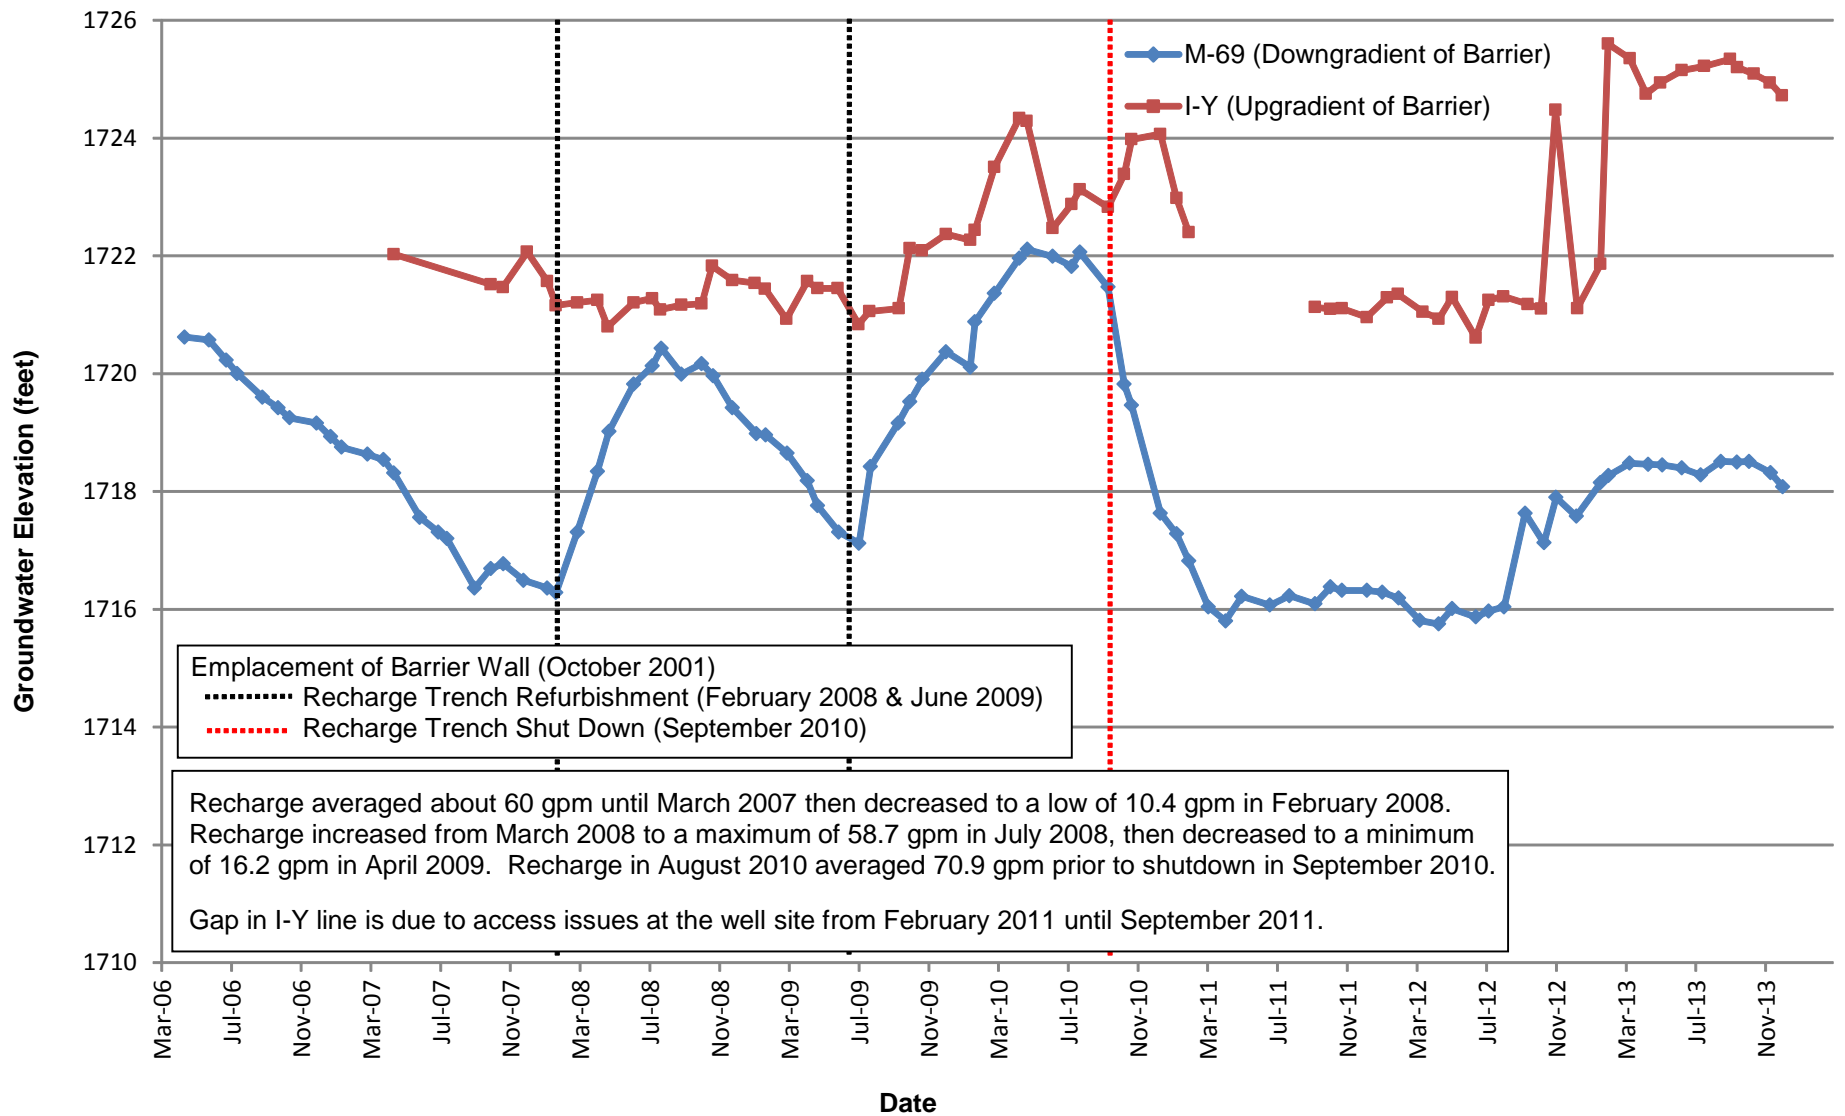
2a

Emplacement of Barrier Wall (October 2001)
 - - - - - Recharge Trench Refurbishment (February 2008 & June 2009)
 Recharge Trench Shut Down (September 2010)

Recharge averaged about 60 gpm until March 2007 then decreased to a low of 10.4 gpm in February 2008. Recharge increased from March 2008 to a maximum of 58.7 gpm in July 2008, then decreased to a minimum of 16.2 gpm in April 2009. Recharge in August 2010 averaged 70.9 gpm prior to shutdown in September 2010. Gap in I-Y line is due to access issues at the well site from February 2011 until September 2011.

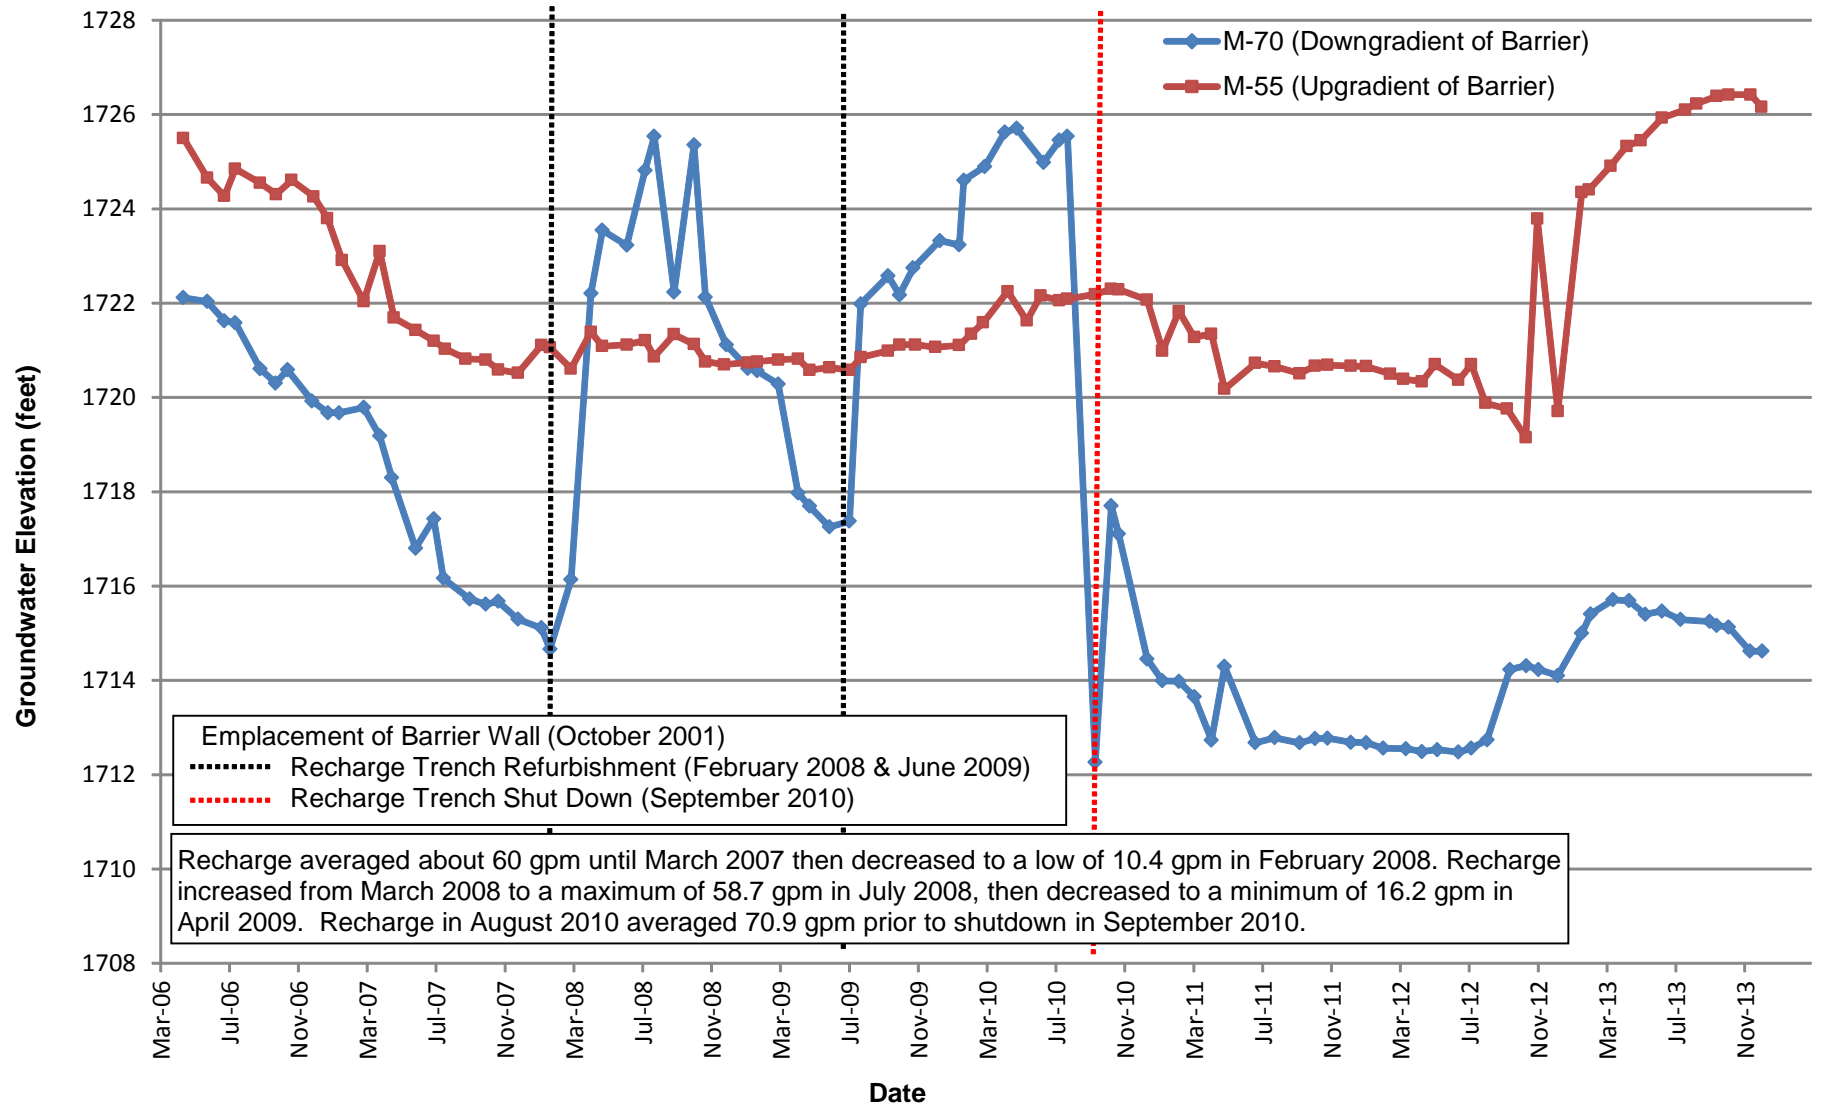
2b

Emplacement of Barrier Wall (October 2001)
 Recharge Trench Refurbishment (February 2008 & June 2009)
 Recharge Trench Shut Down (September 2010)

Recharge averaged about 60 gpm until March 2007 then decreased to a low of 10.4 gpm in February 2008. Recharge increased from March 2008 to a maximum of 58.7 gpm in July 2008, then decreased to a minimum of 16.2 gpm in April 2009. Recharge in August 2010 averaged 70.9 gpm prior to shutdown in September 2010.

Hydrograph Pair Across the Barrier Wall - M-70 and M-55
 Nevada Environmental Response Trust Site
 Henderson, Nevada

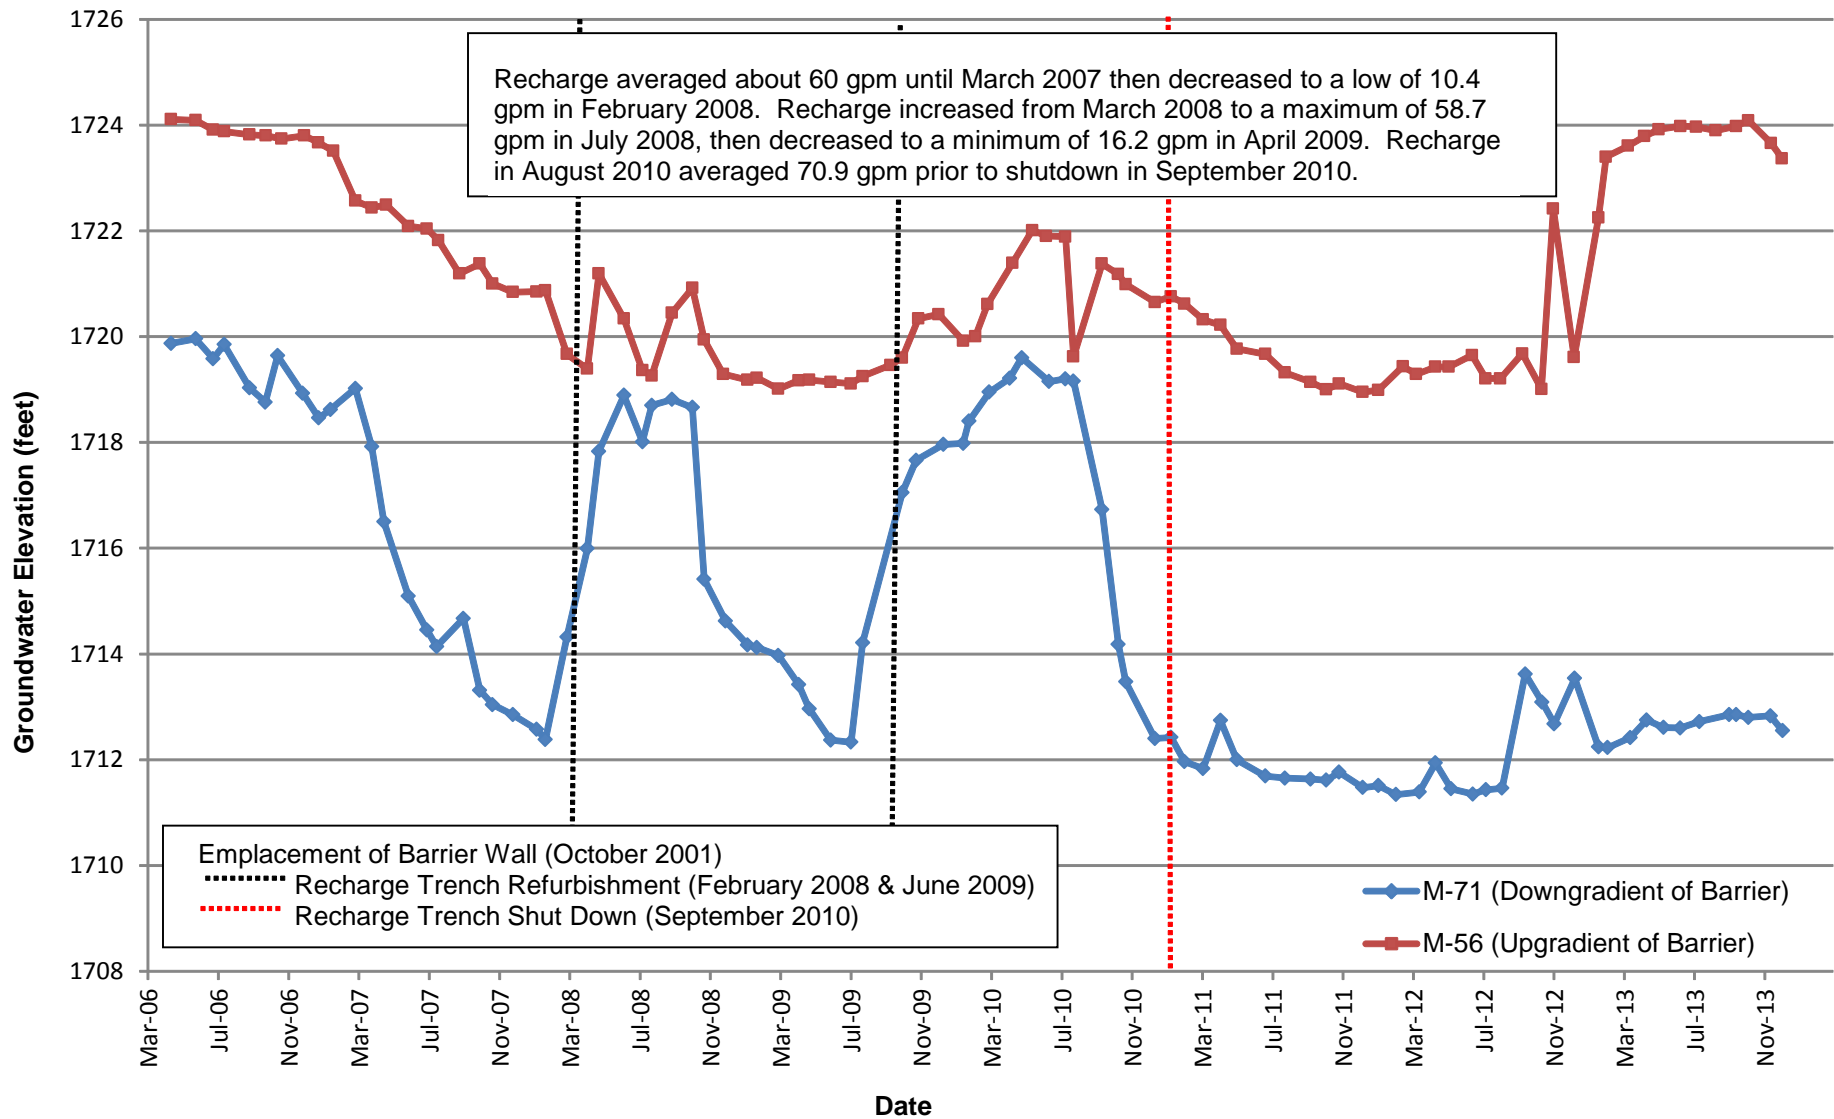
2c

Hydrograph Pair Across the Barrier Wall - M-71 and M-56
 Nevada Environmental Response Trust Site
 Henderson, Nevada

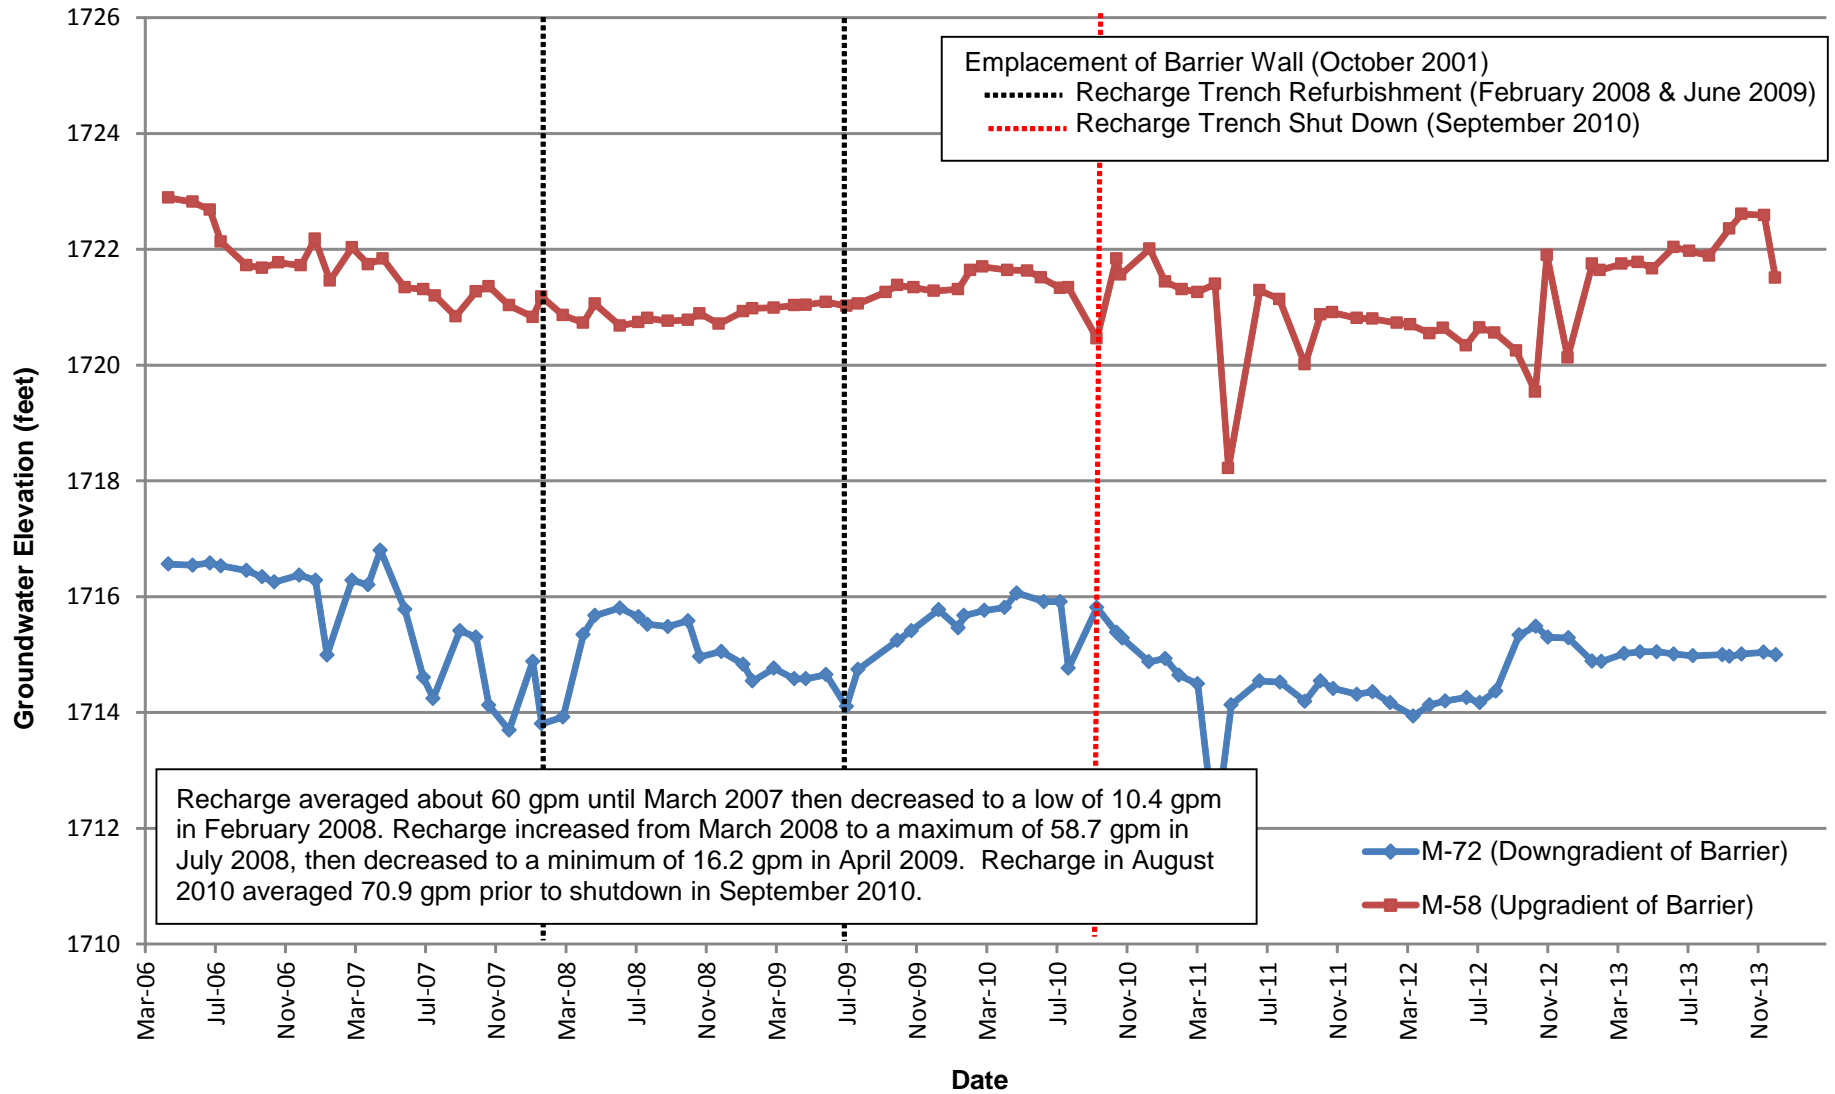
Figure
2d

Hydrograph Pair Across the Barrier Wall - M-72 and M-58
 Nevada Environmental Response Trust Site
 Henderson, Nevada

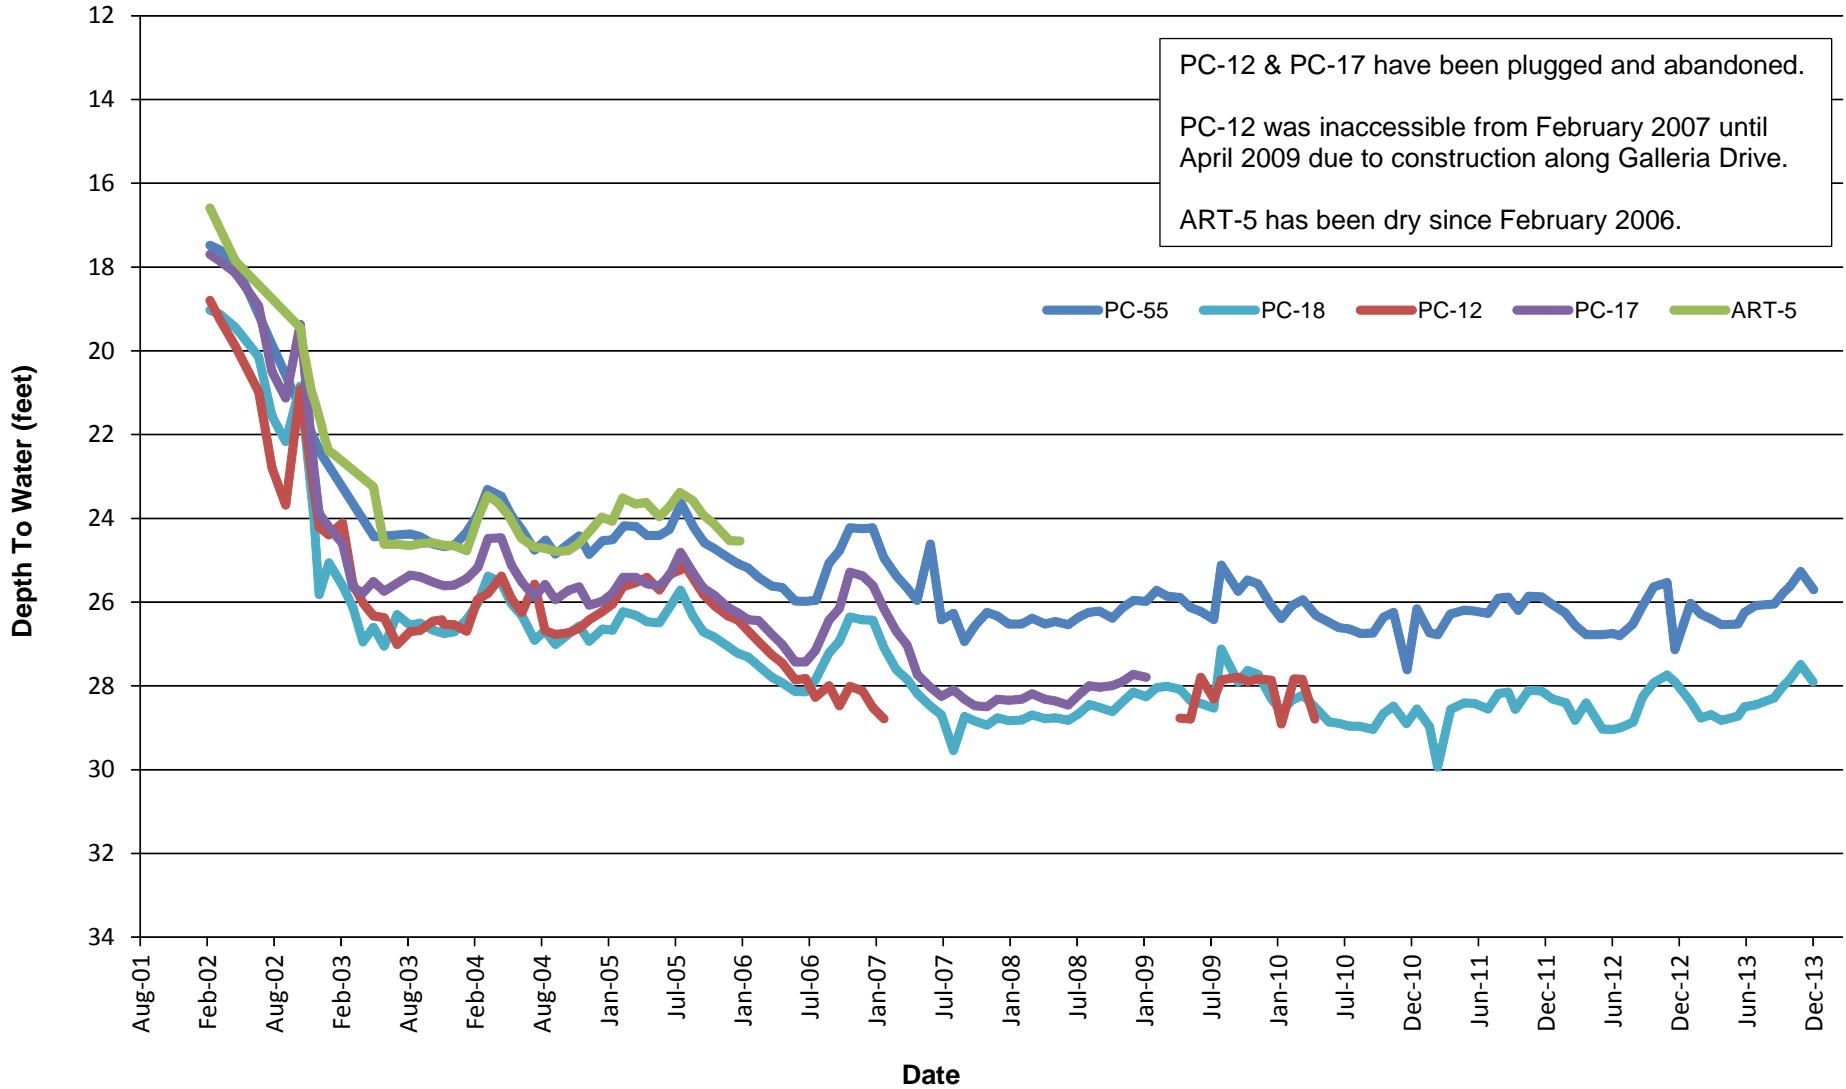
3

Athens Road Well Field Drawdown
 Nevada Environmental Response Trust Site
 Henderson, Nevada

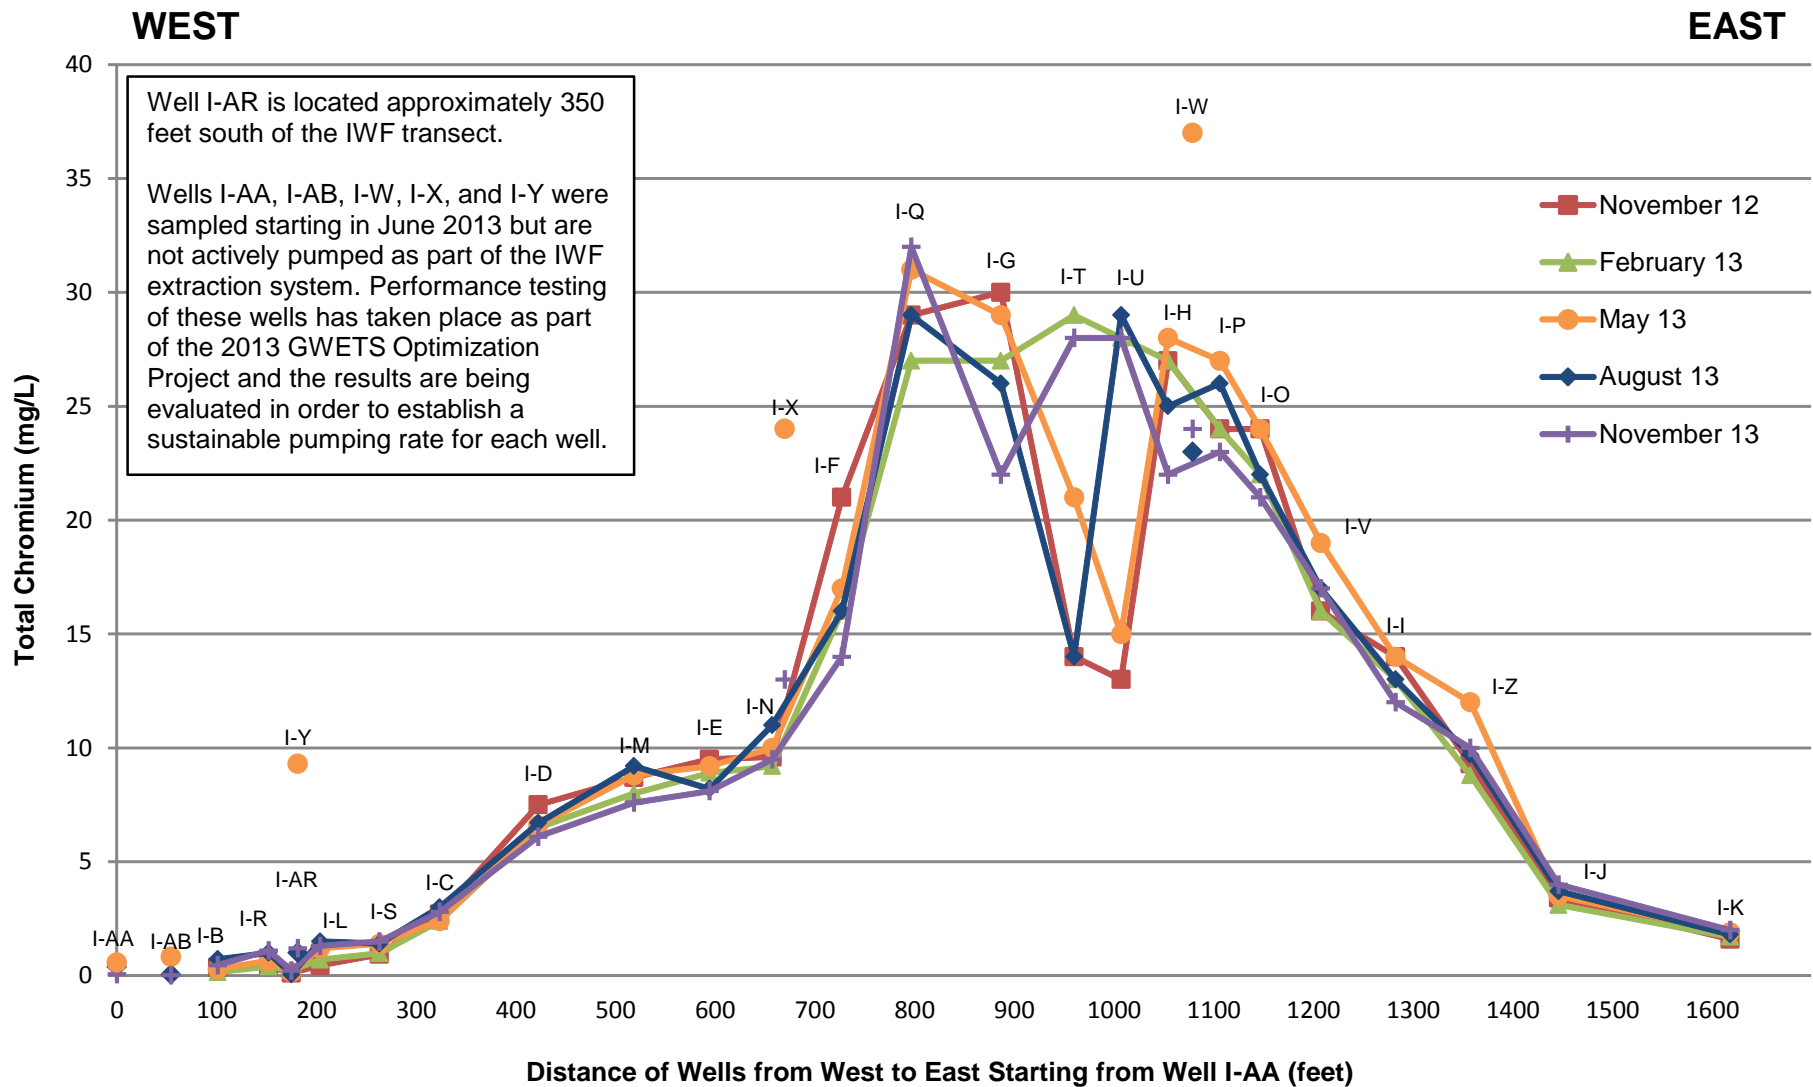
5

Interceptor Well Field Total Chromium Concentrations
 Nevada Environmental Response Trust Site
 Henderson, Nevada

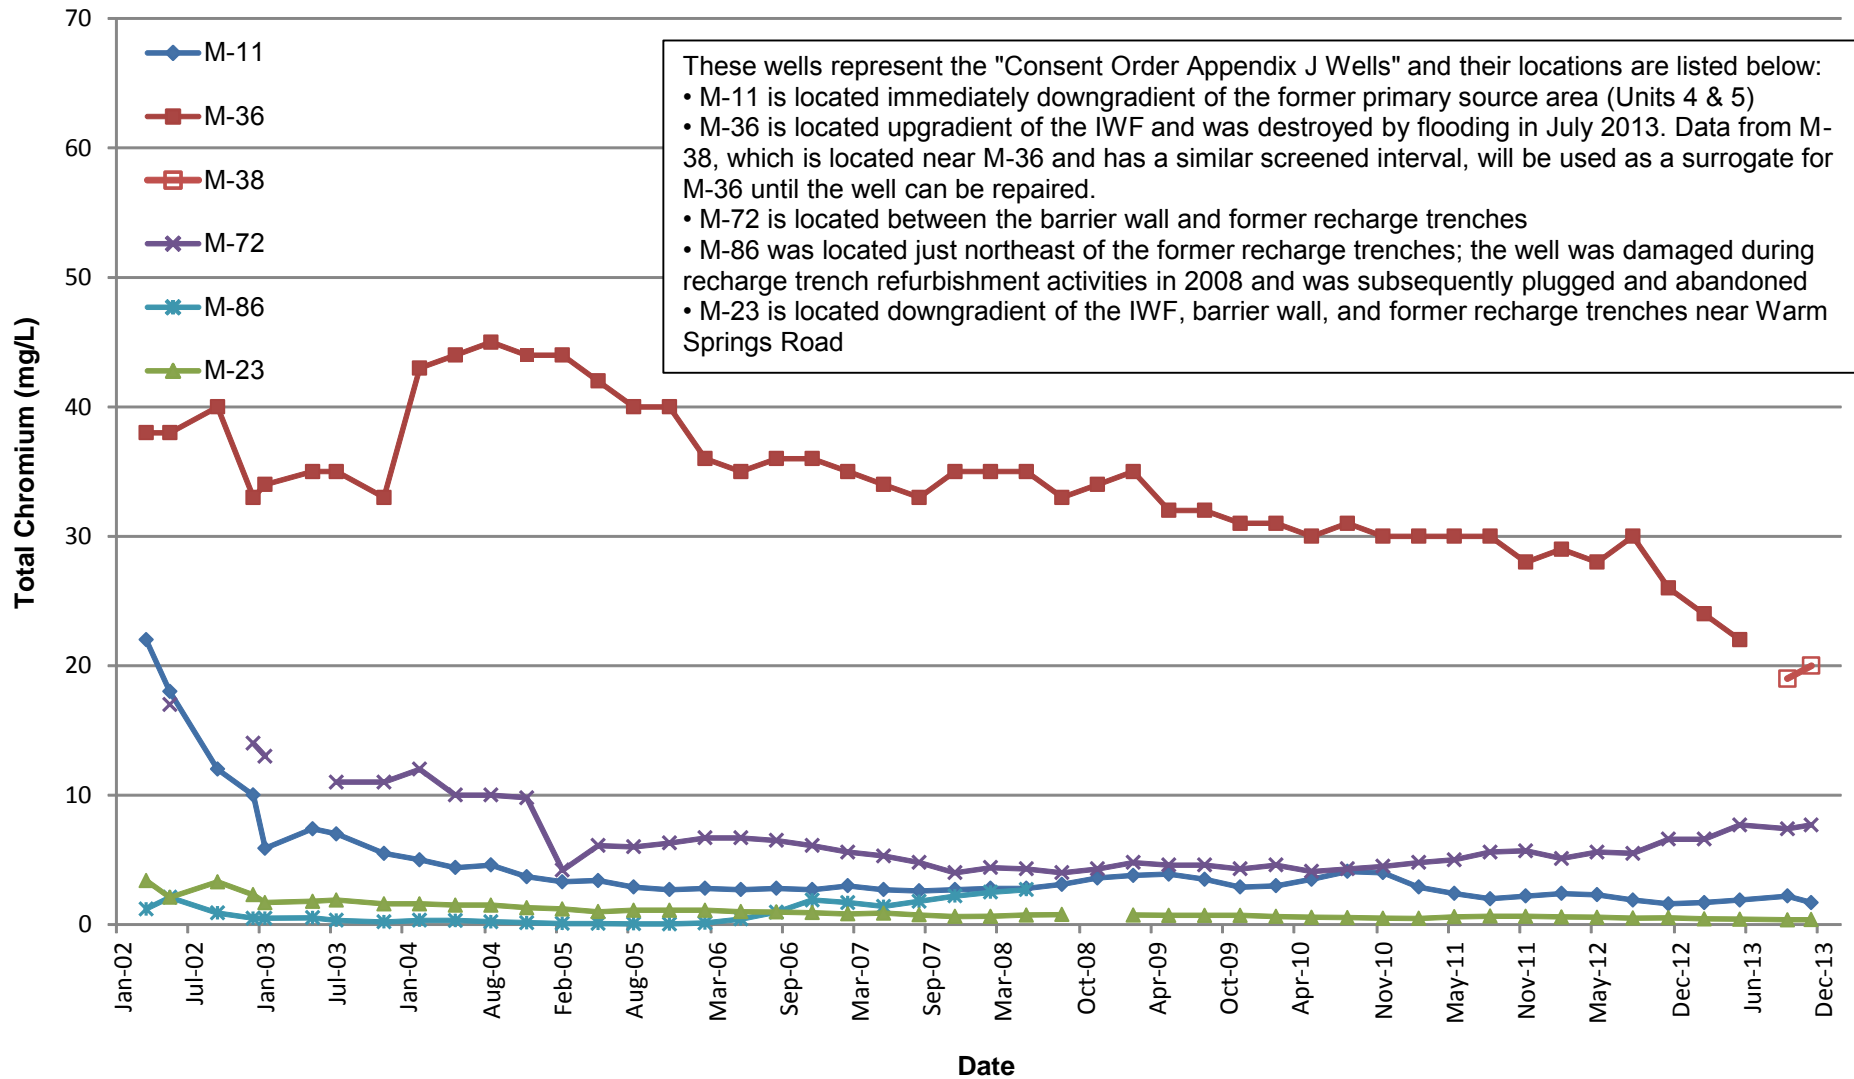
6

Total Chromium Concentration Trends in Select Wells
 Nevada Environmental Response Trust Site
 Henderson, Nevada

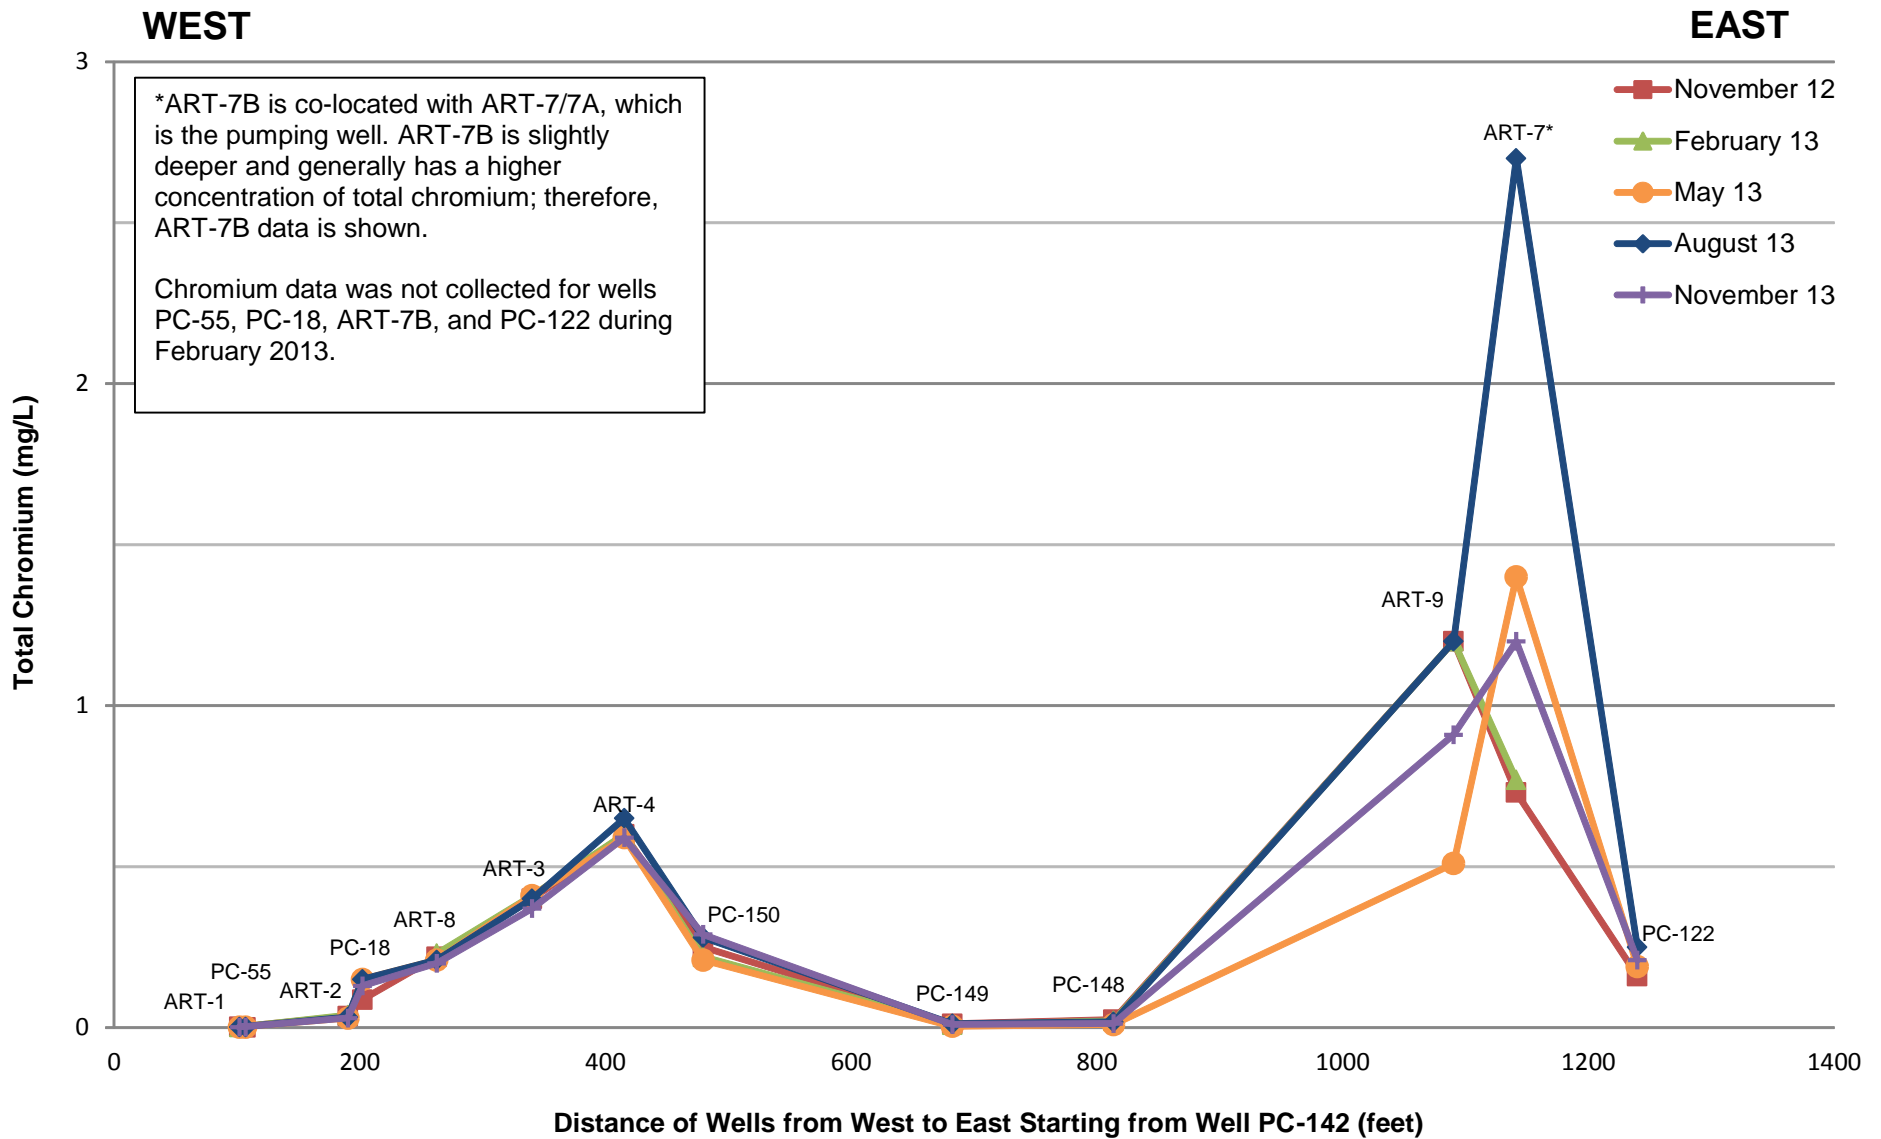
7

Athens Road Well Field Total Chromium Concentrations
 Nevada Environmental Response Trust Site
 Henderson, Nevada

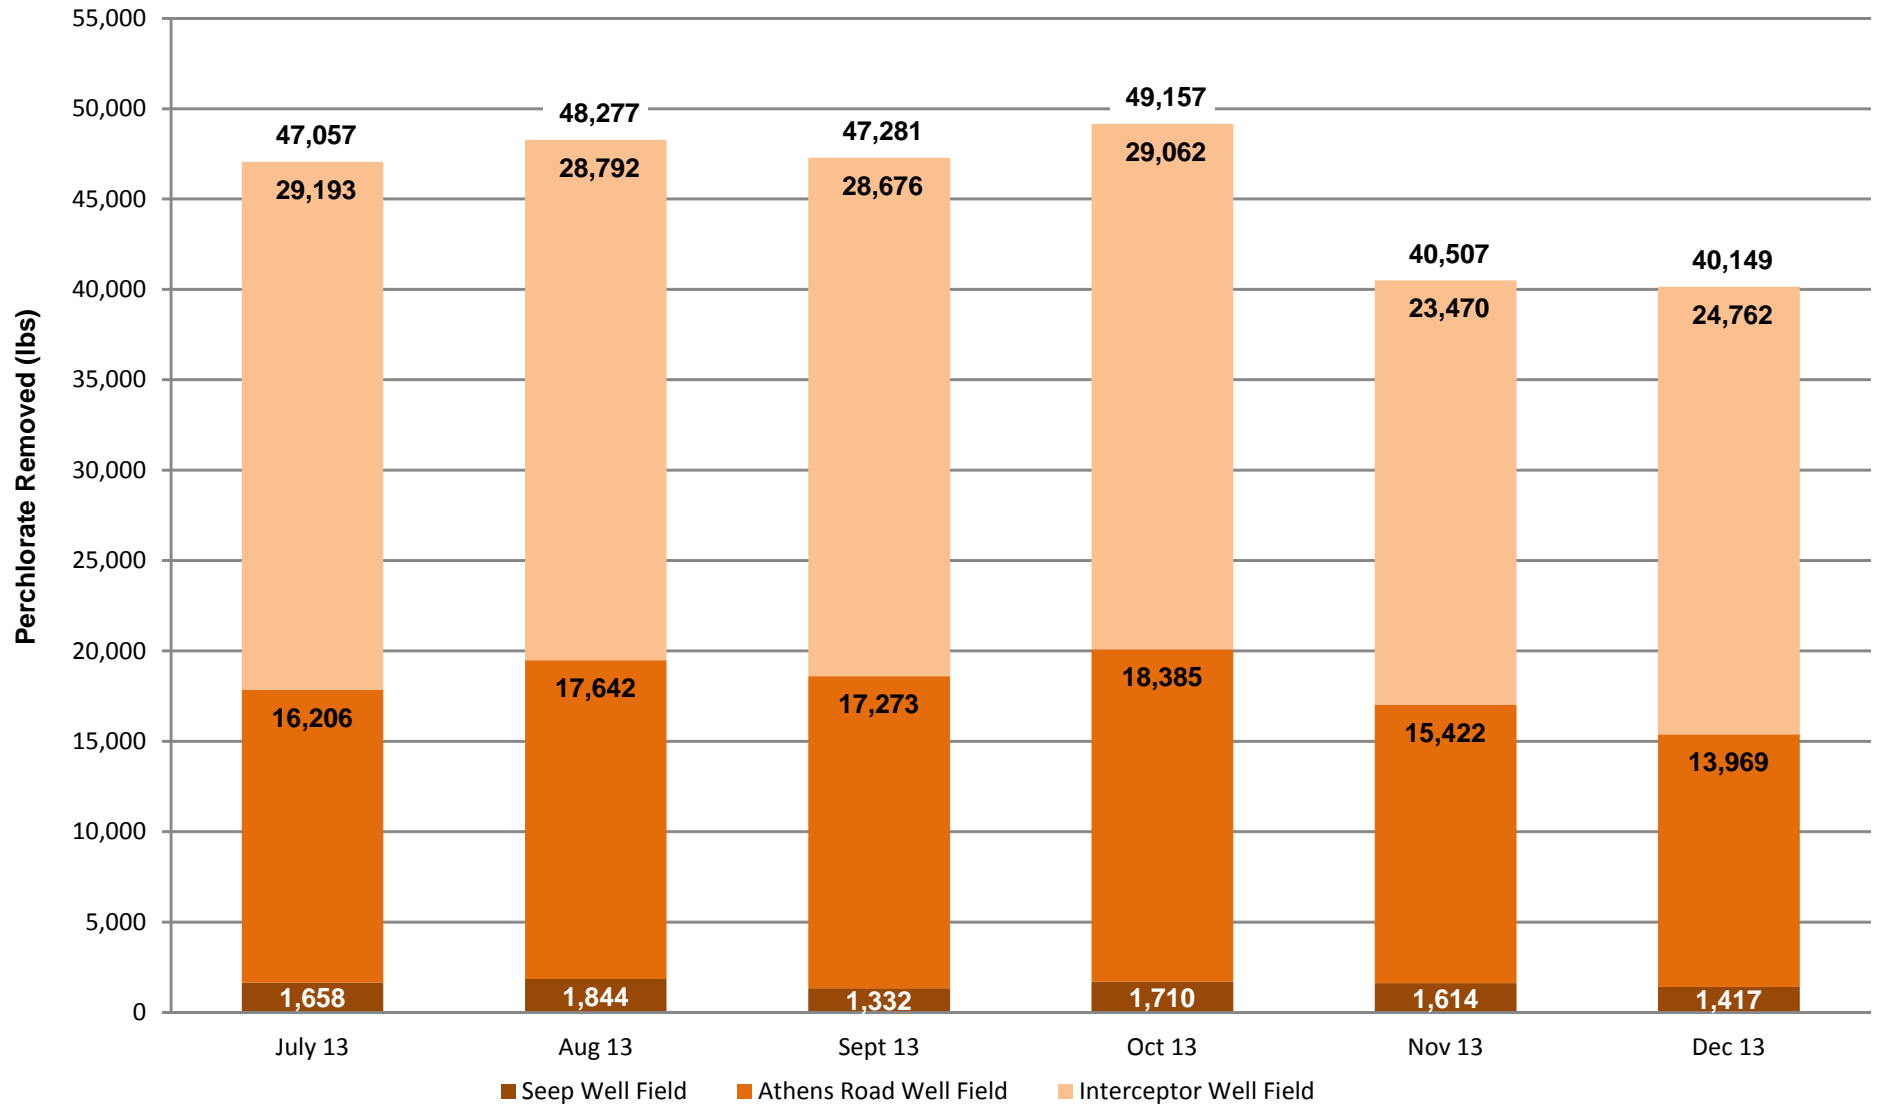
8

Perchlorate Removed from the Environment July - December 2013
 Nevada Environmental Response Trust Site
 Henderson, Nevada

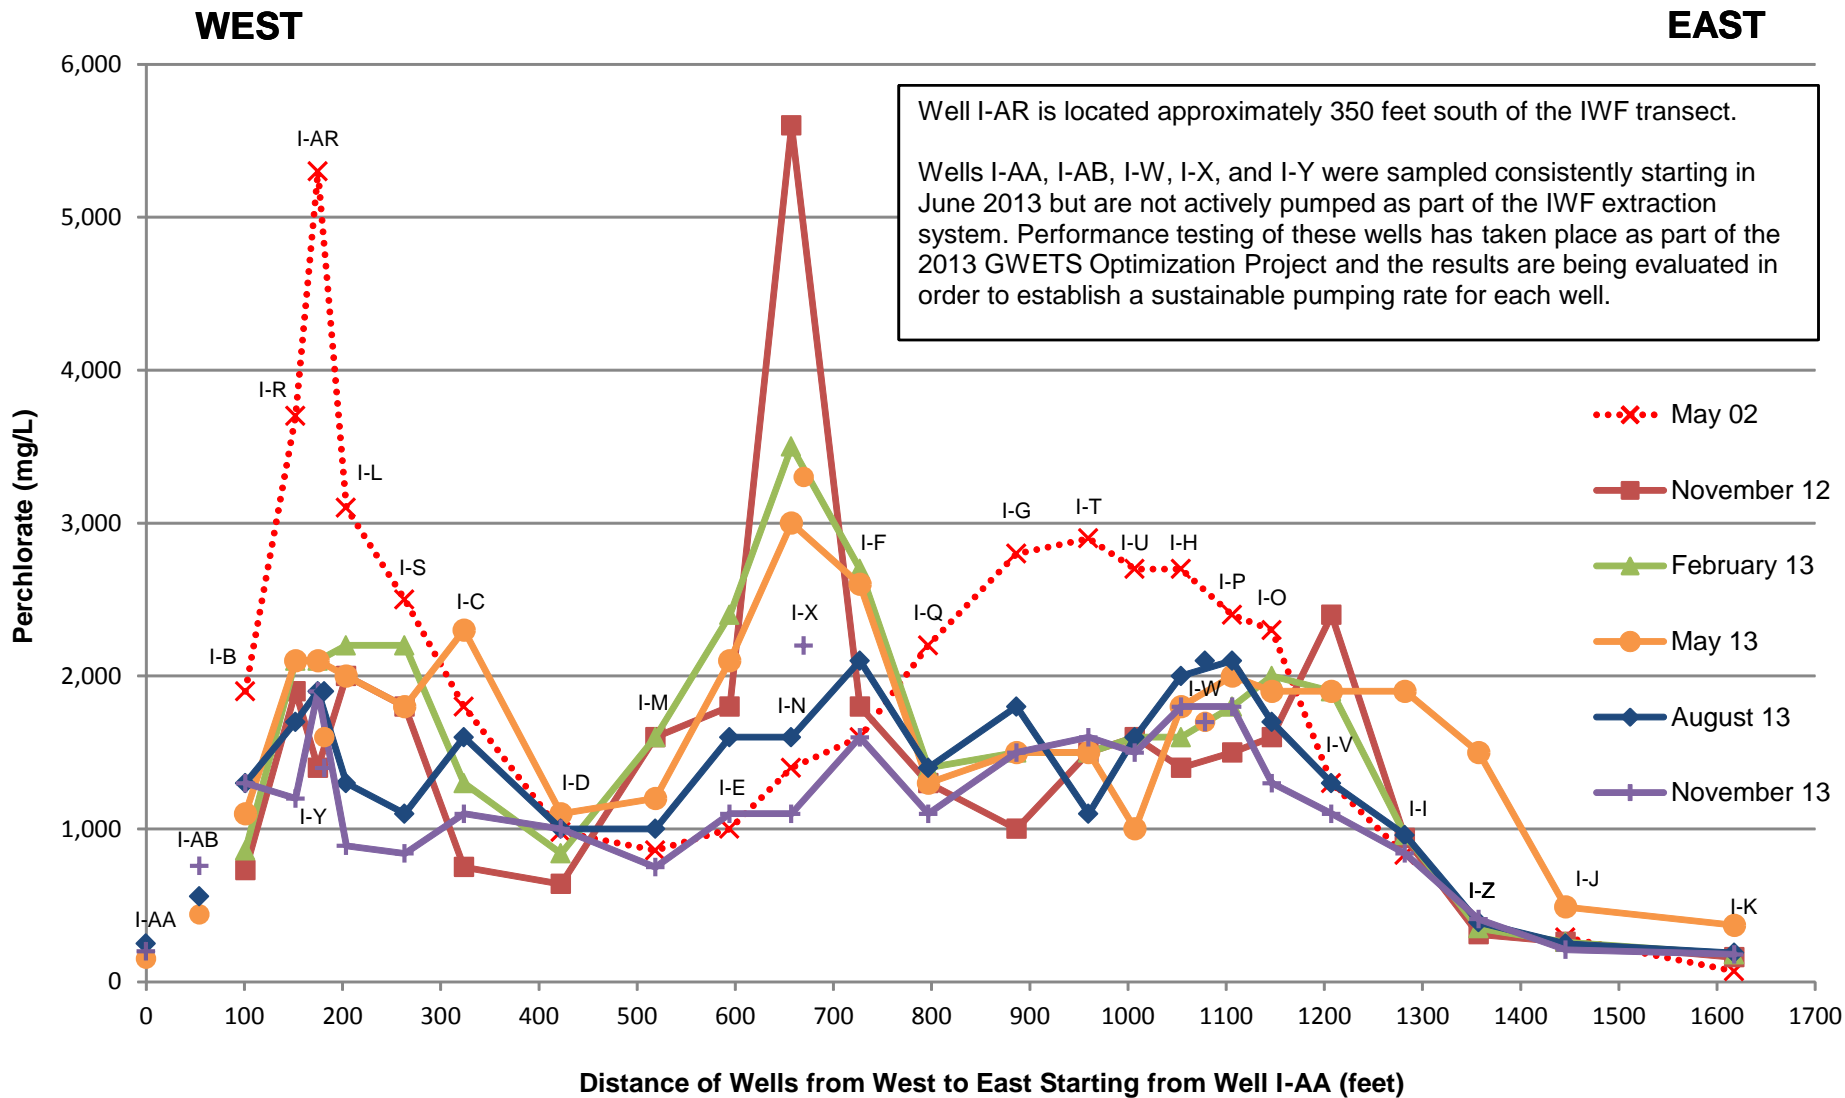
9

Interceptor Well Field Perchlorate Concentrations
 Nevada Environmental Response Trust Site
 Henderson, Nevada

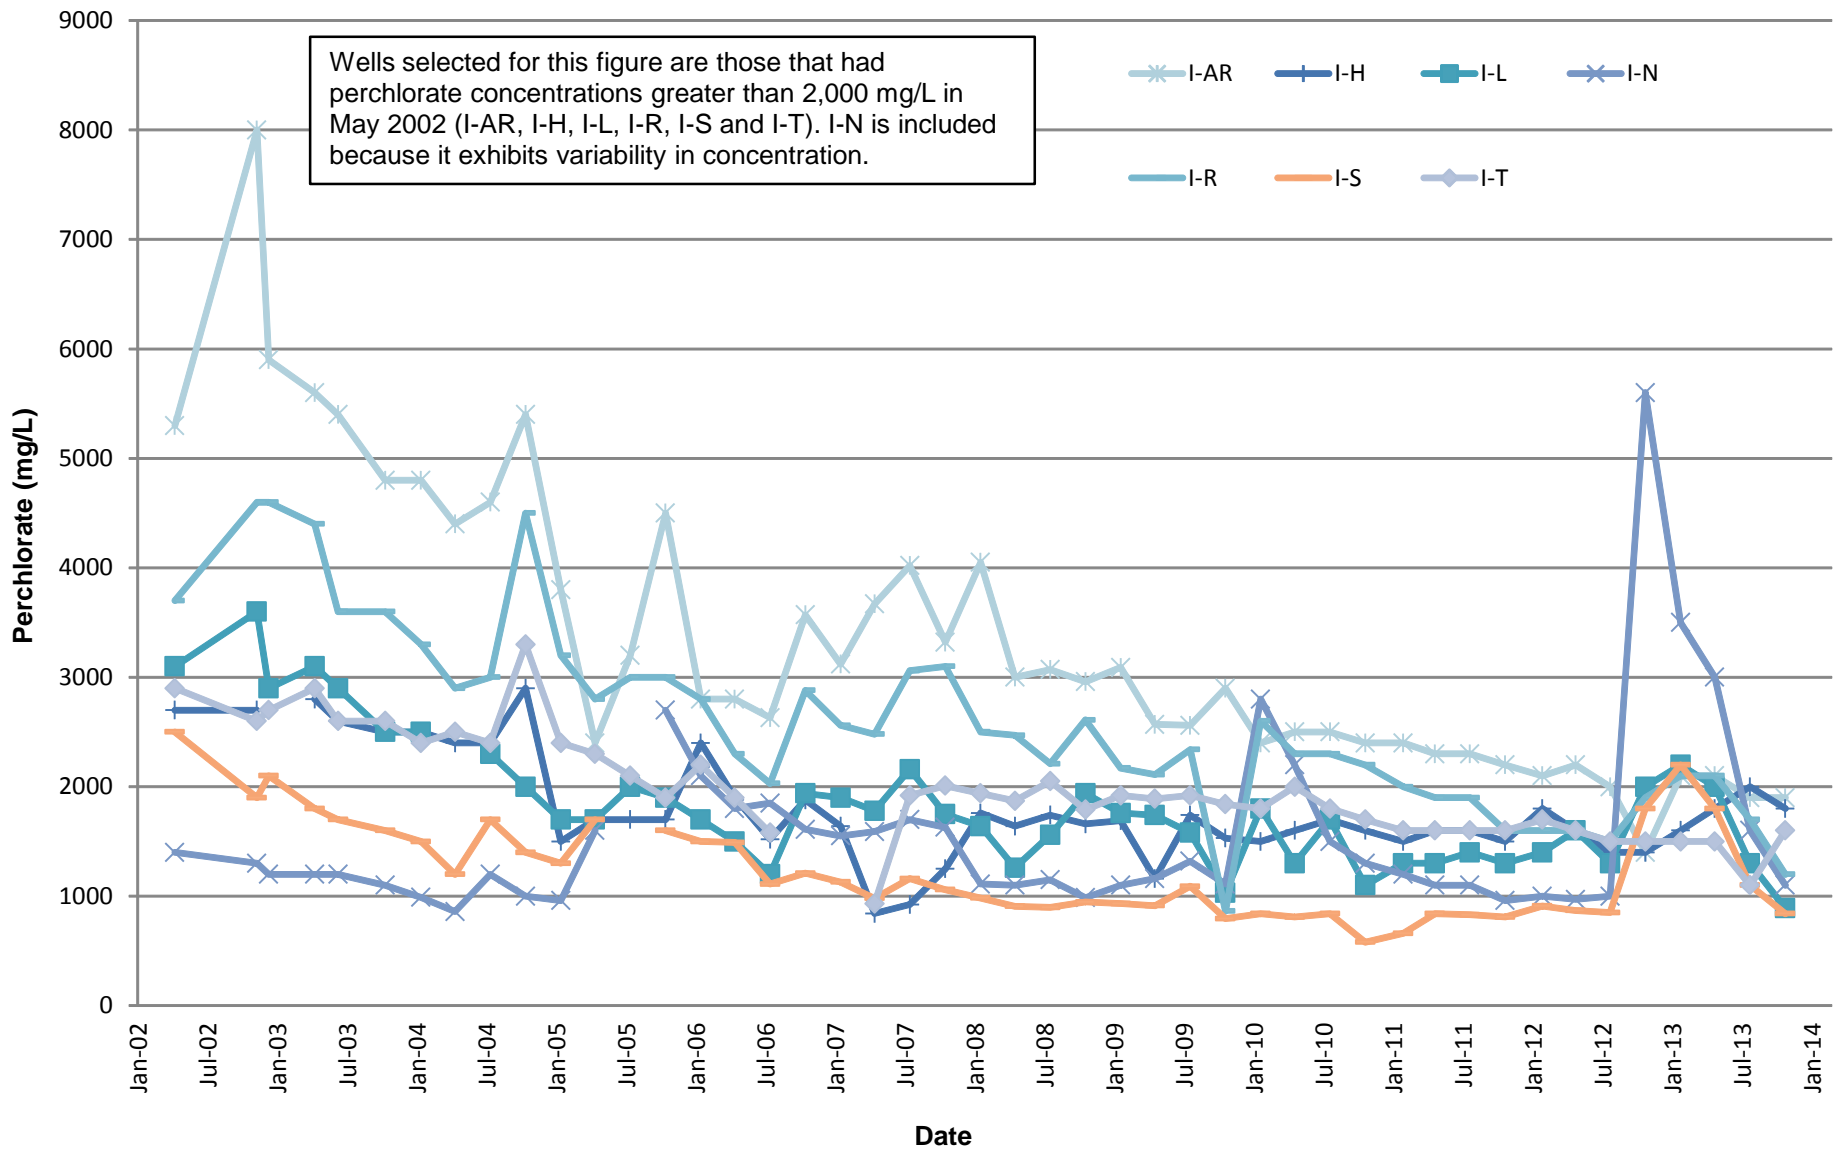
Figure
10

Interceptor Well Field Perchlorate Concentration Trends for Select Wells
 Nevada Environmental Response Trust Site
 Henderson, Nevada
