Figure 1
LOCATION MAP
 Semi-Annual Remedial Performance Report
 Nevada Environmental Response Trust Site
 Henderson, Nevada

Hydrograph Pair Across the Barrier Wall - M-69 and I-Y
 Nevada Environmental Response Trust Site
 Henderson, Nevada

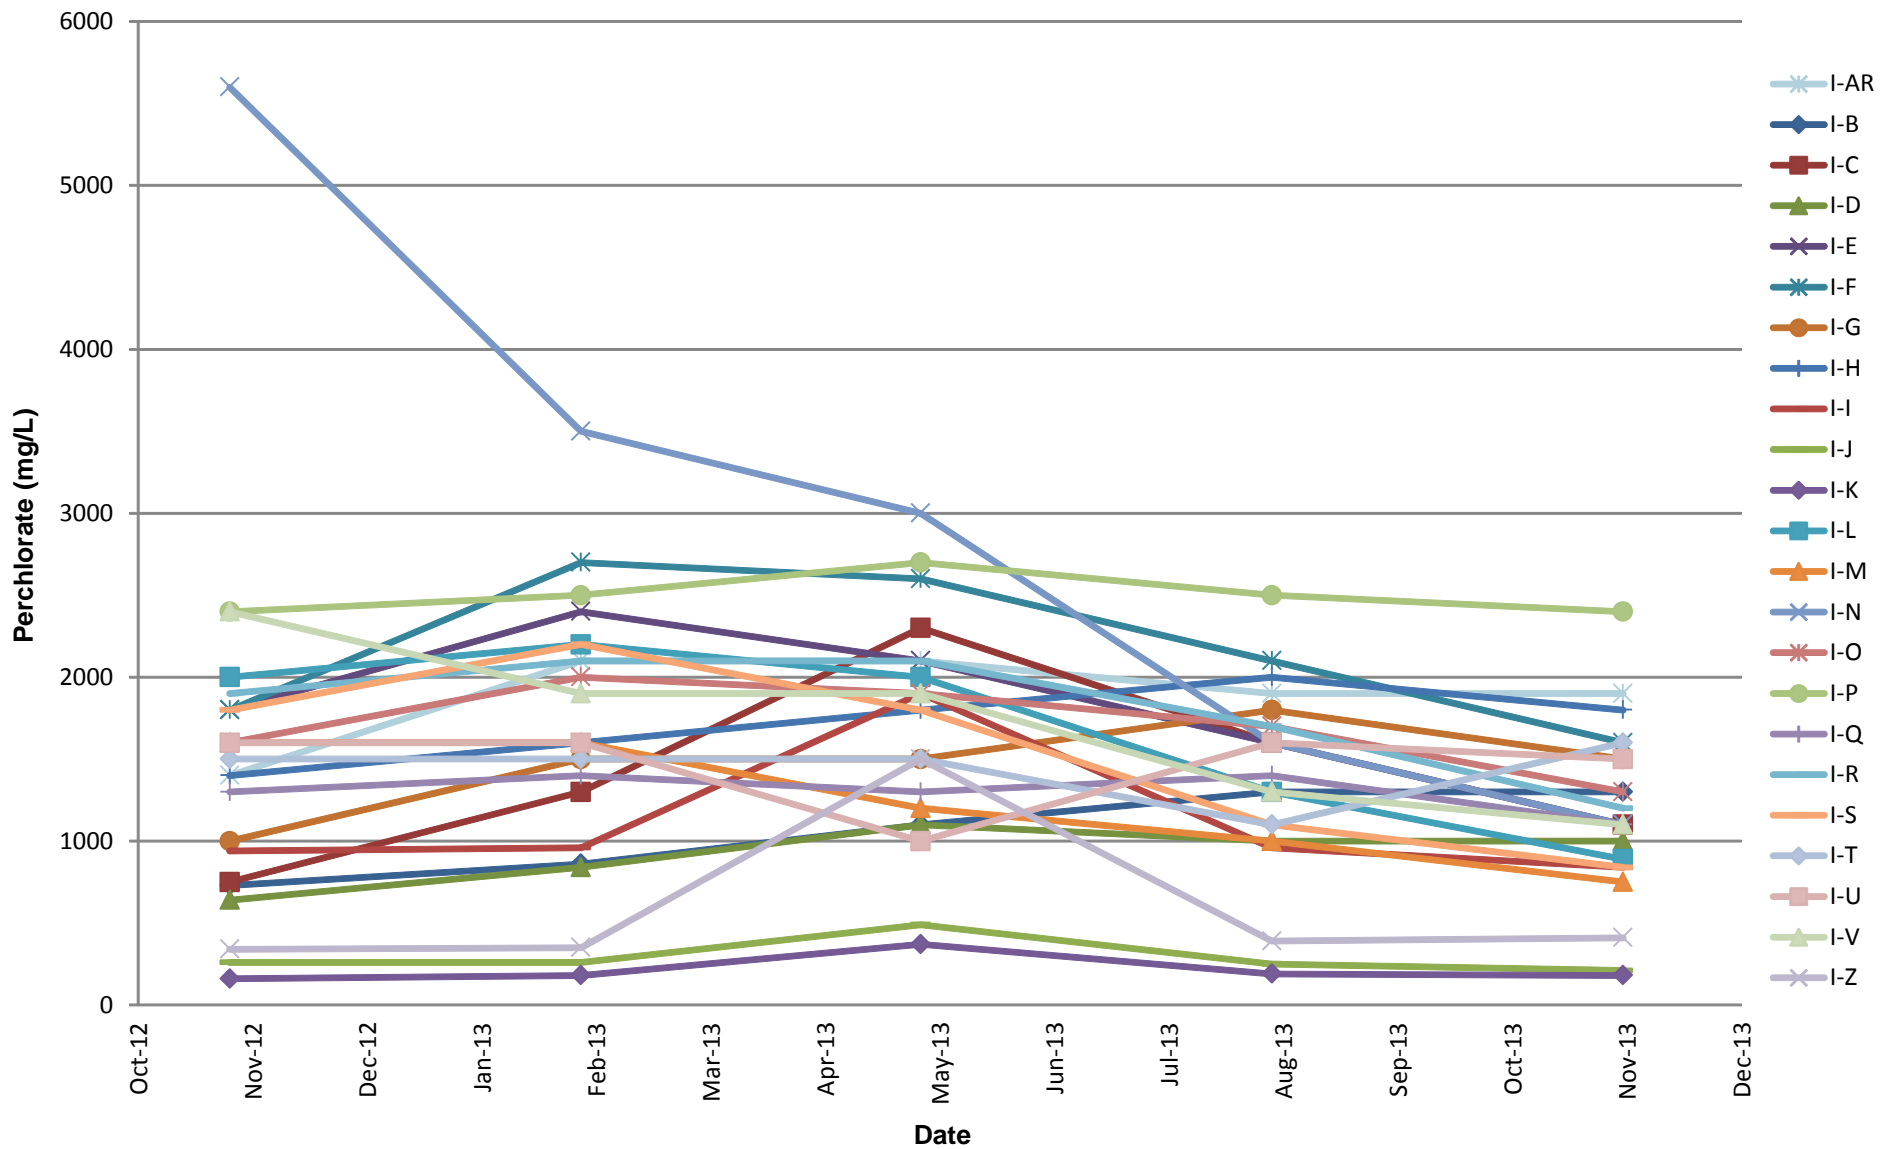
Figure
10a

Interceptor Well Field Perchlorate Concentration Trends, November 2012 - November 2013
 Nevada Environmental Response Trust Site
 Henderson, Nevada

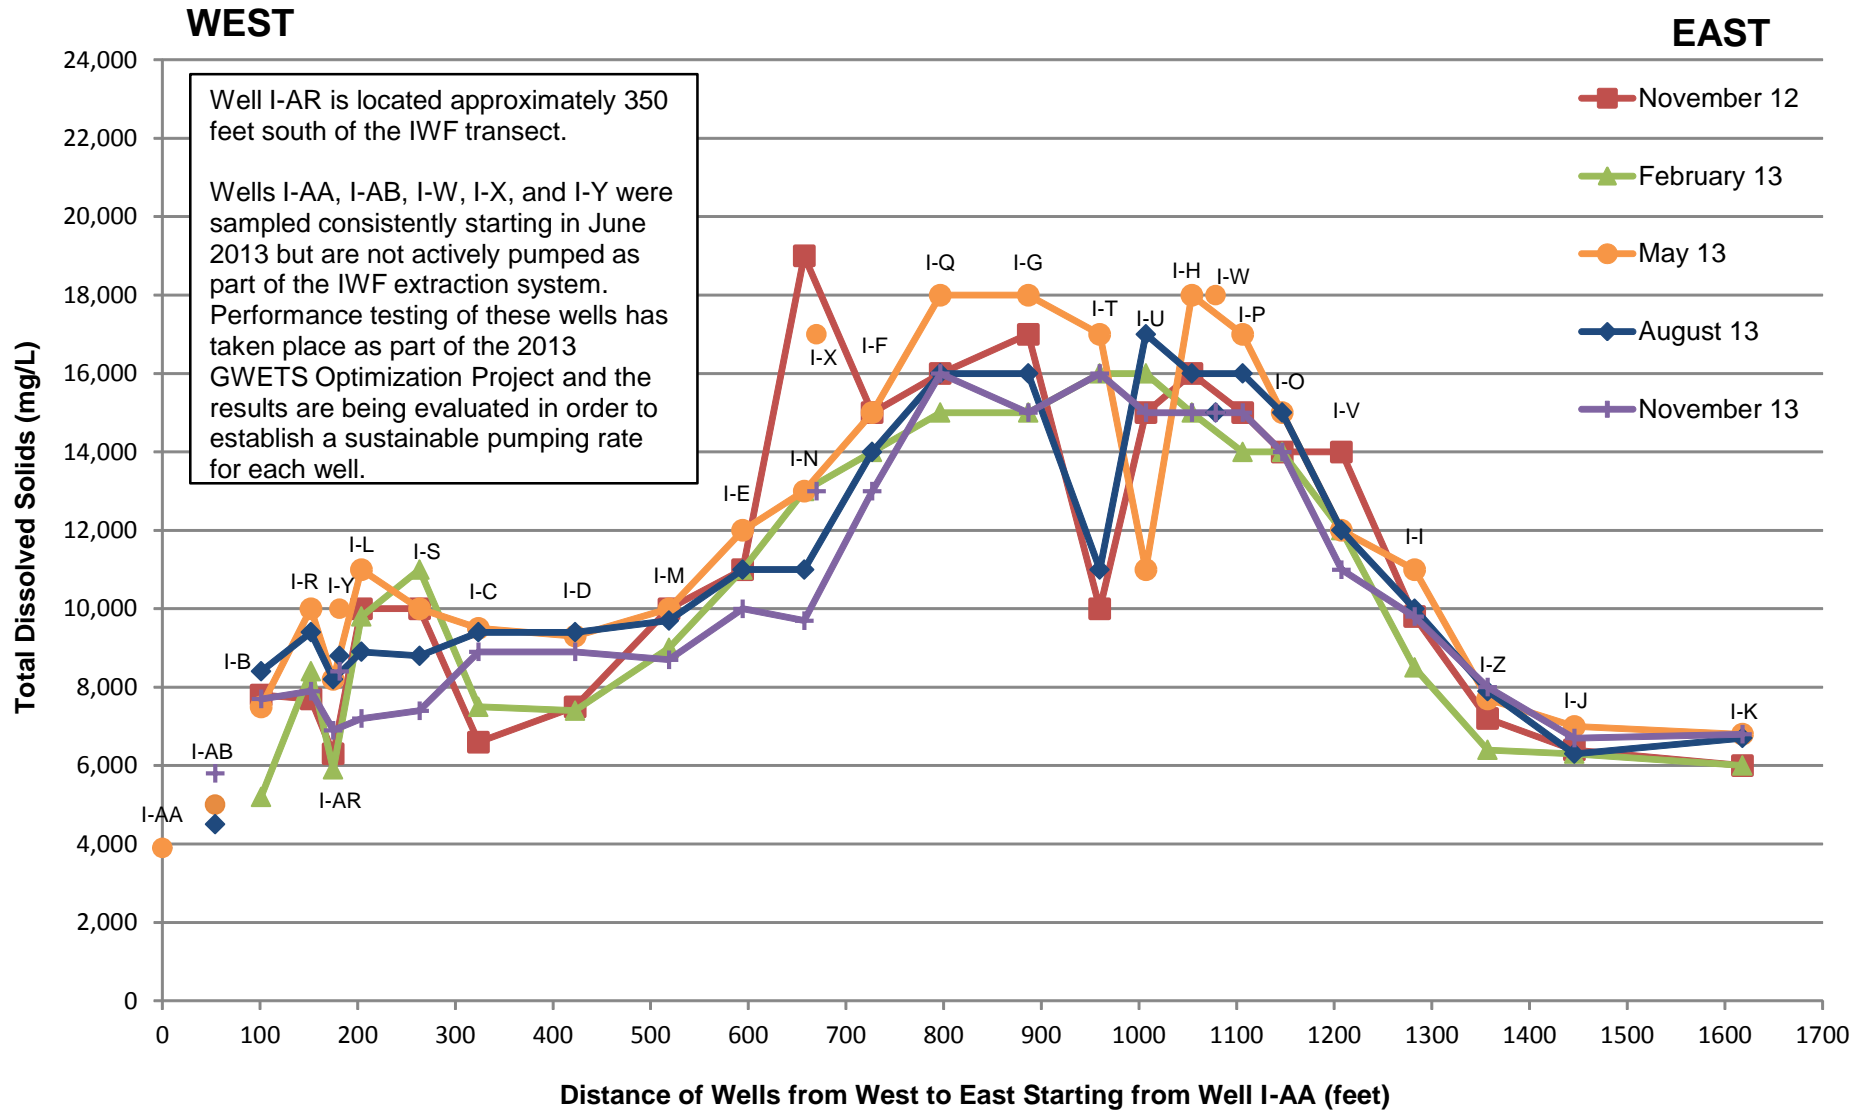
11

Interceptor Well Field Total Dissolved Solids Concentrations
 Nevada Environmental Response Trust Site
 Henderson, Nevada

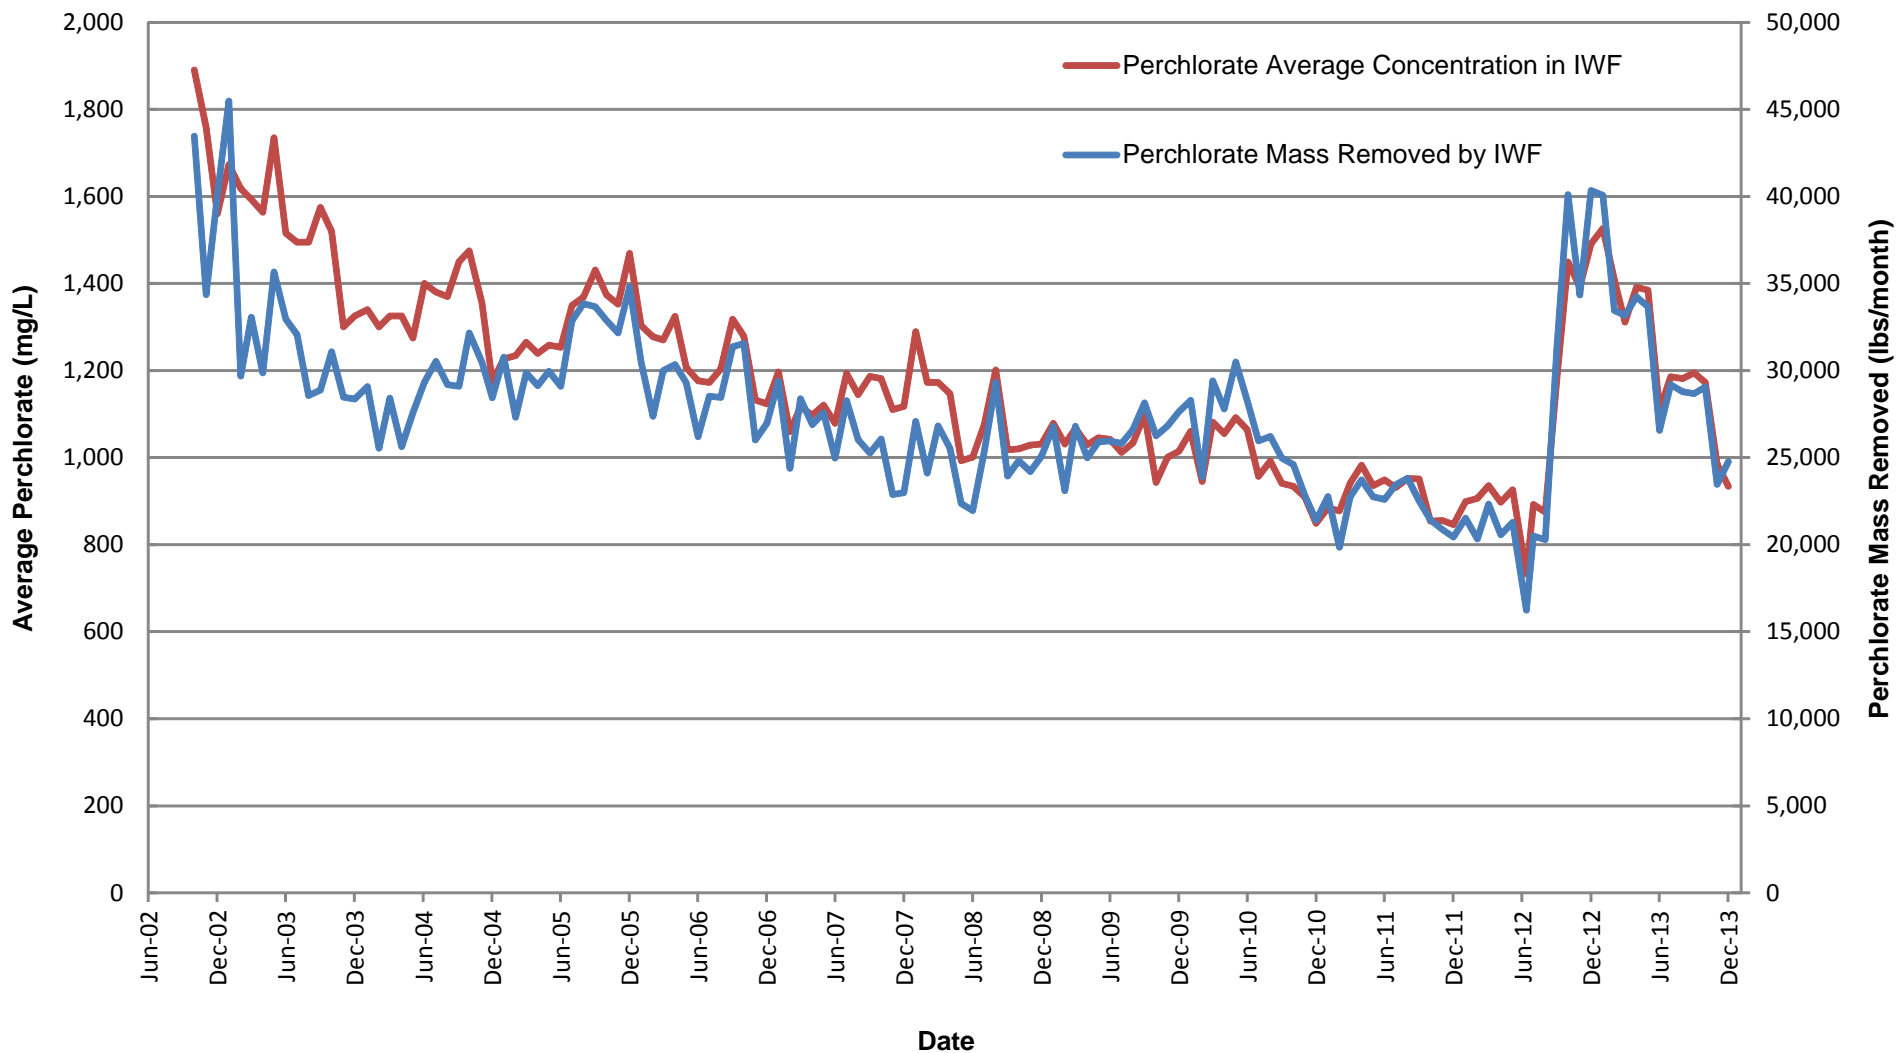
12

Interceptor Well Field Average Perchlorate Concentration and Mass Removed
 Nevada Environmental Response Trust Site
 Henderson, Nevada

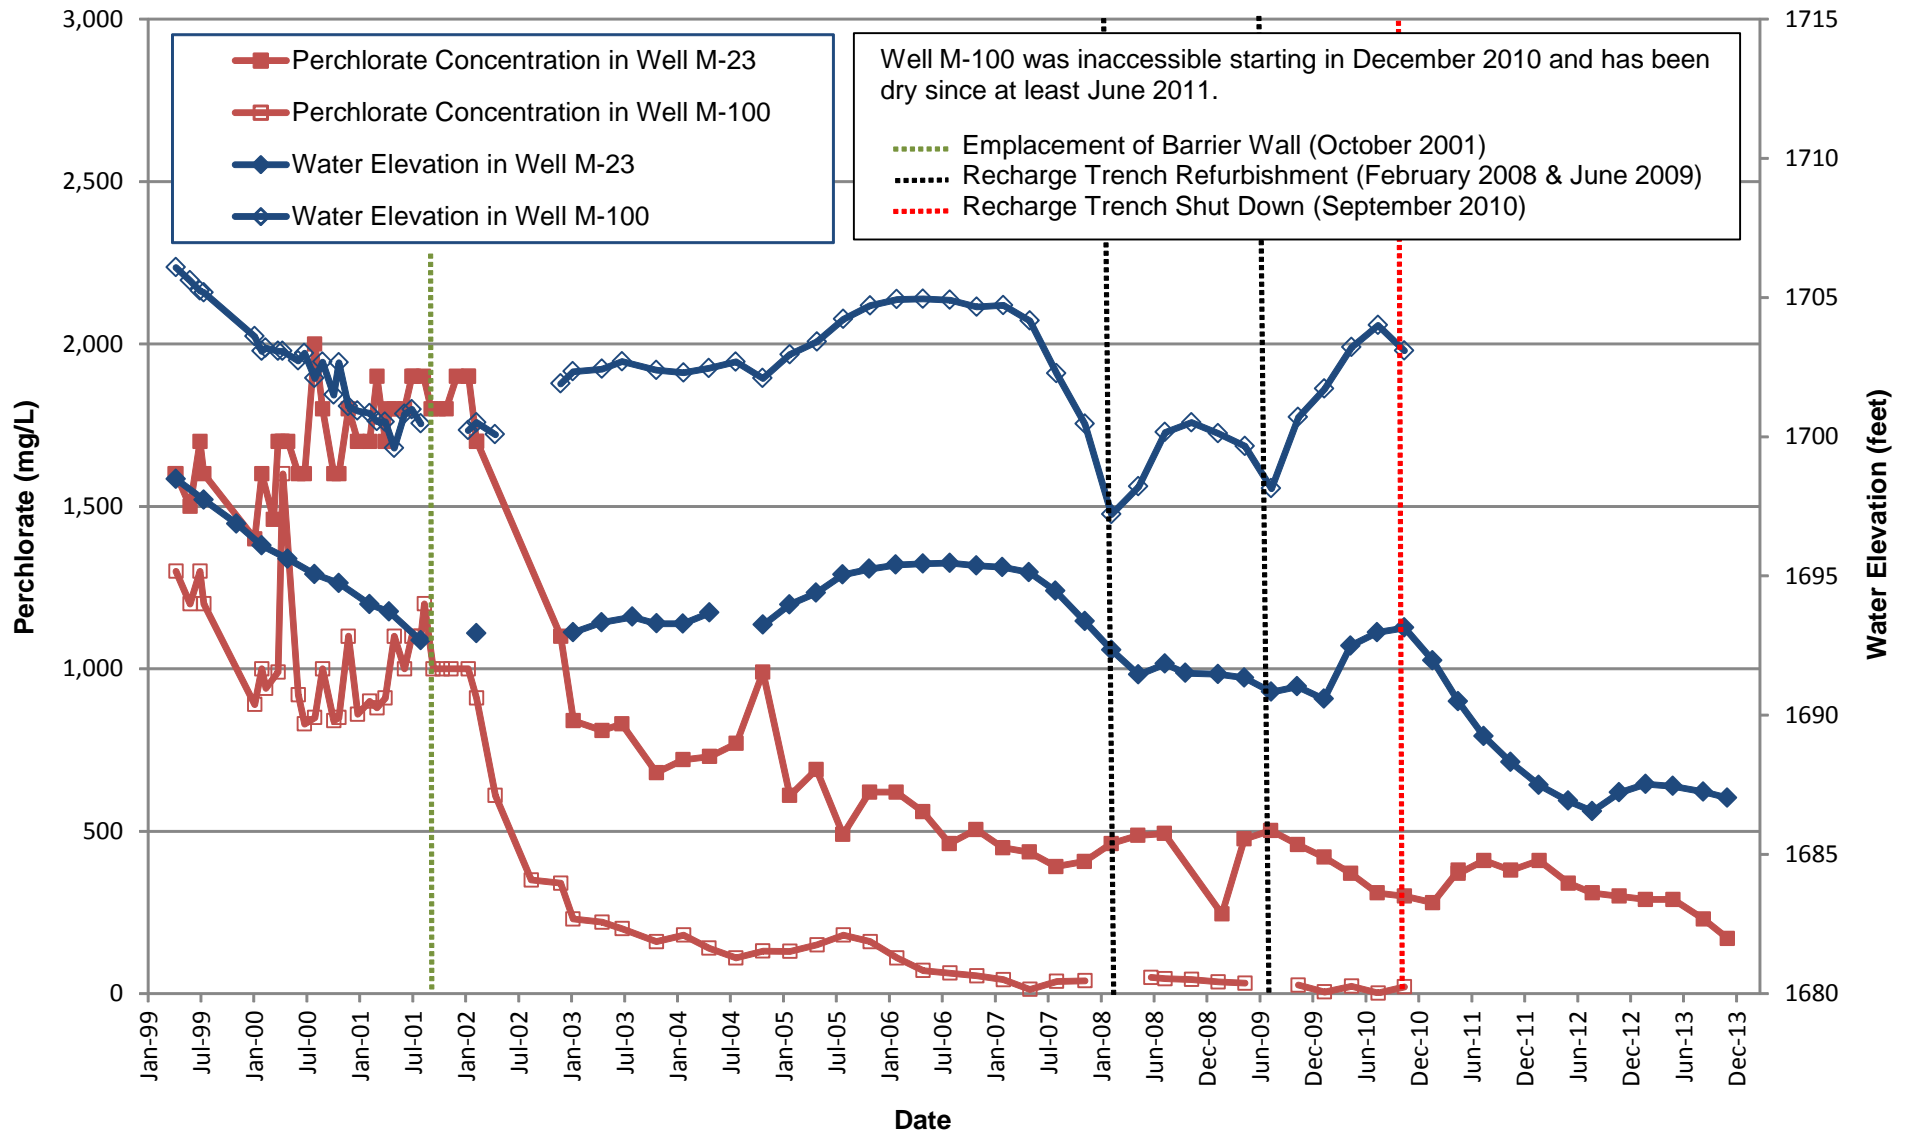
13

Wells M-23 and M-100 Perchlorate Concentration vs. Water Elevation Trends
 Nevada Environmental Response Trust Site
 Henderson, Nevada

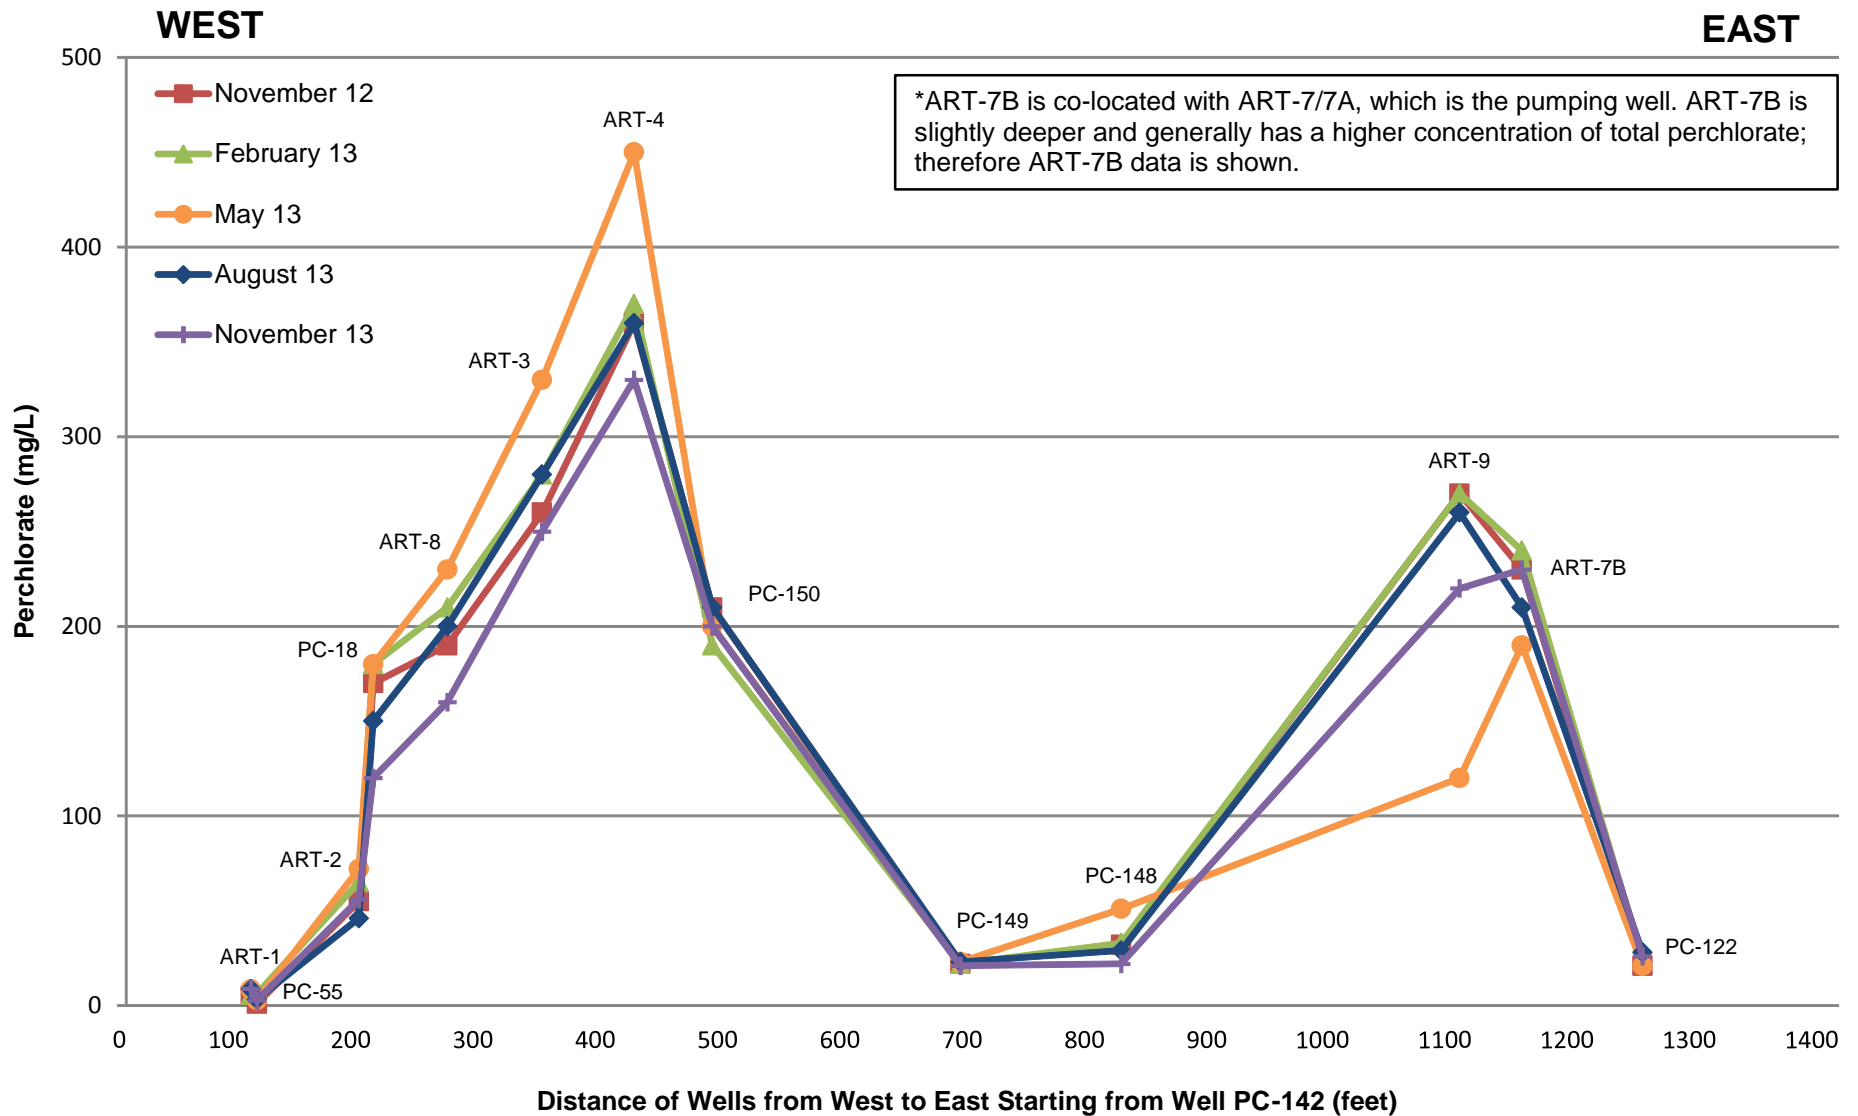
14

Athens Road Well Field Perchlorate Concentrations
 Nevada Environmental Response Trust Site
 Henderson, Nevada

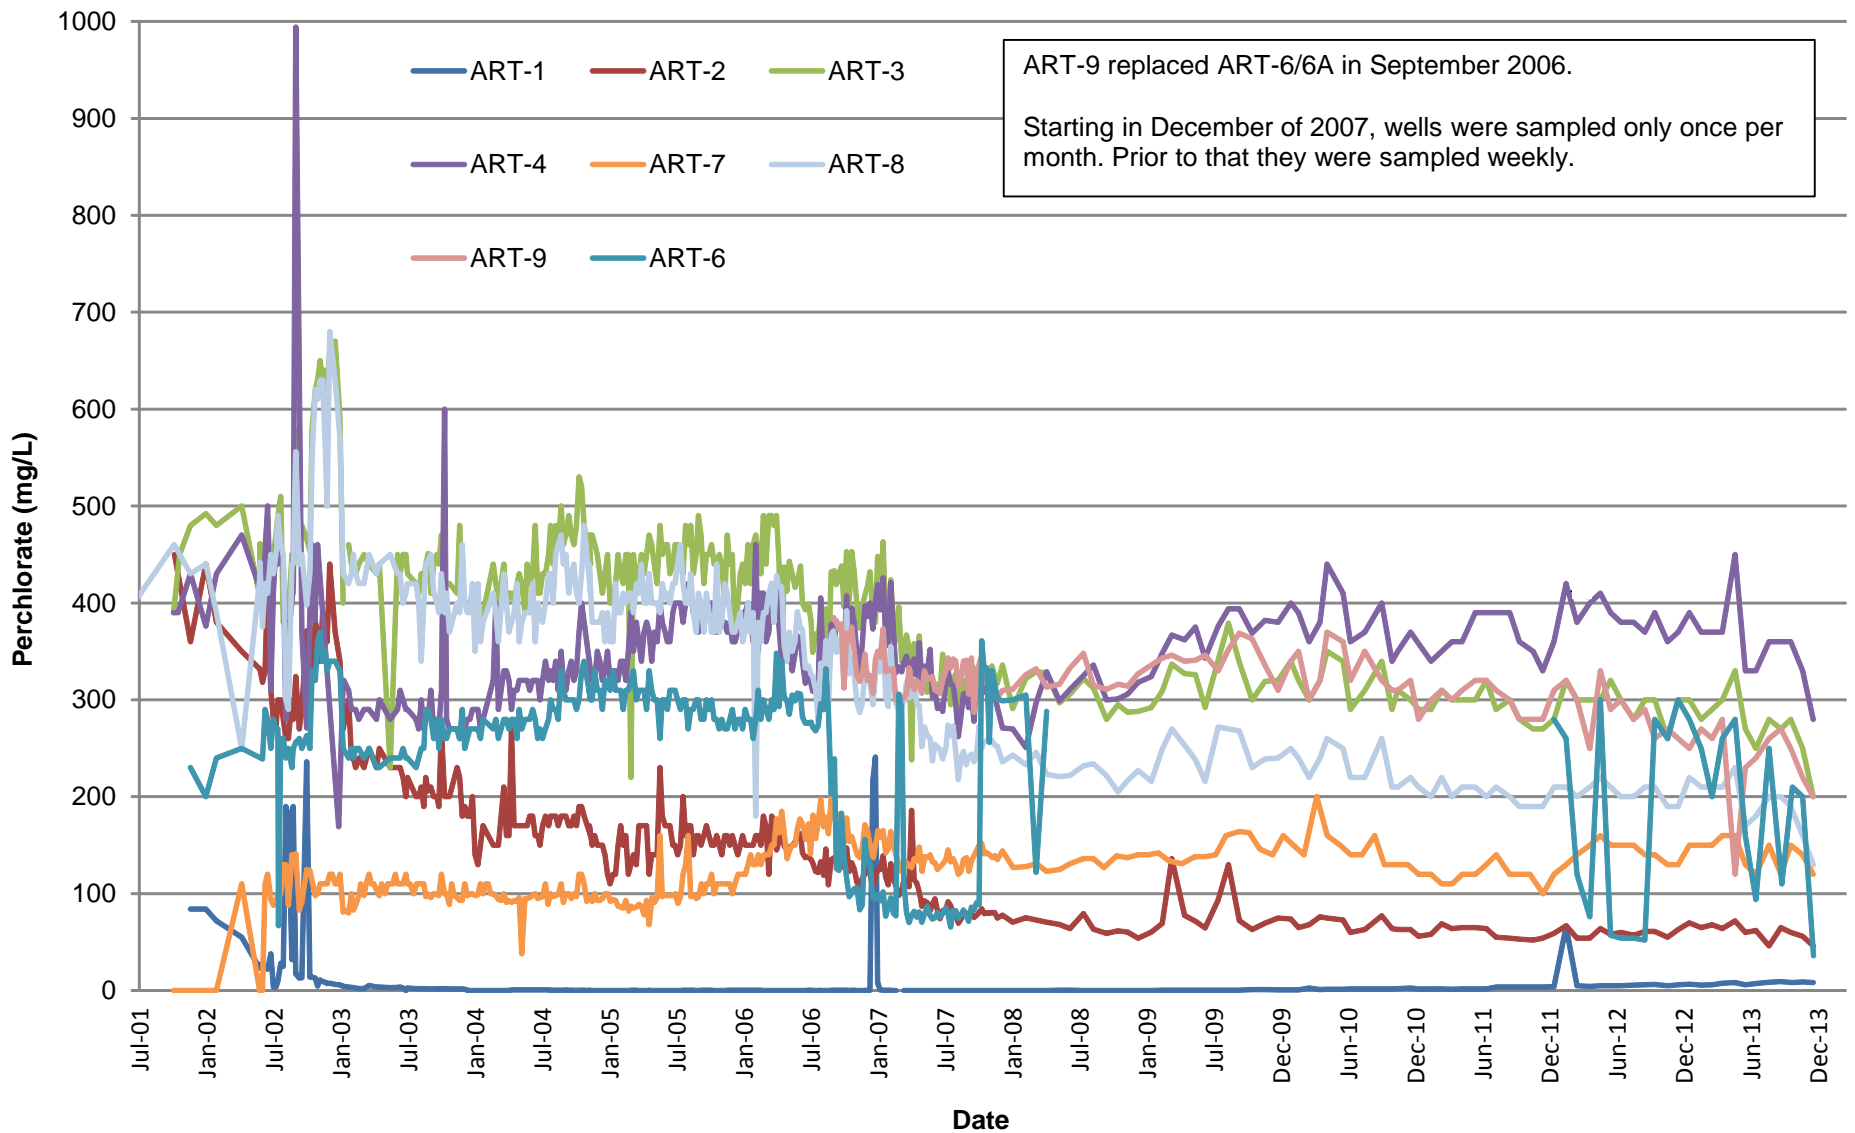
Athens Road Well Field Perchlorate Concentration Trends
 Nevada Environmental Response Trust Site
 Henderson, Nevada

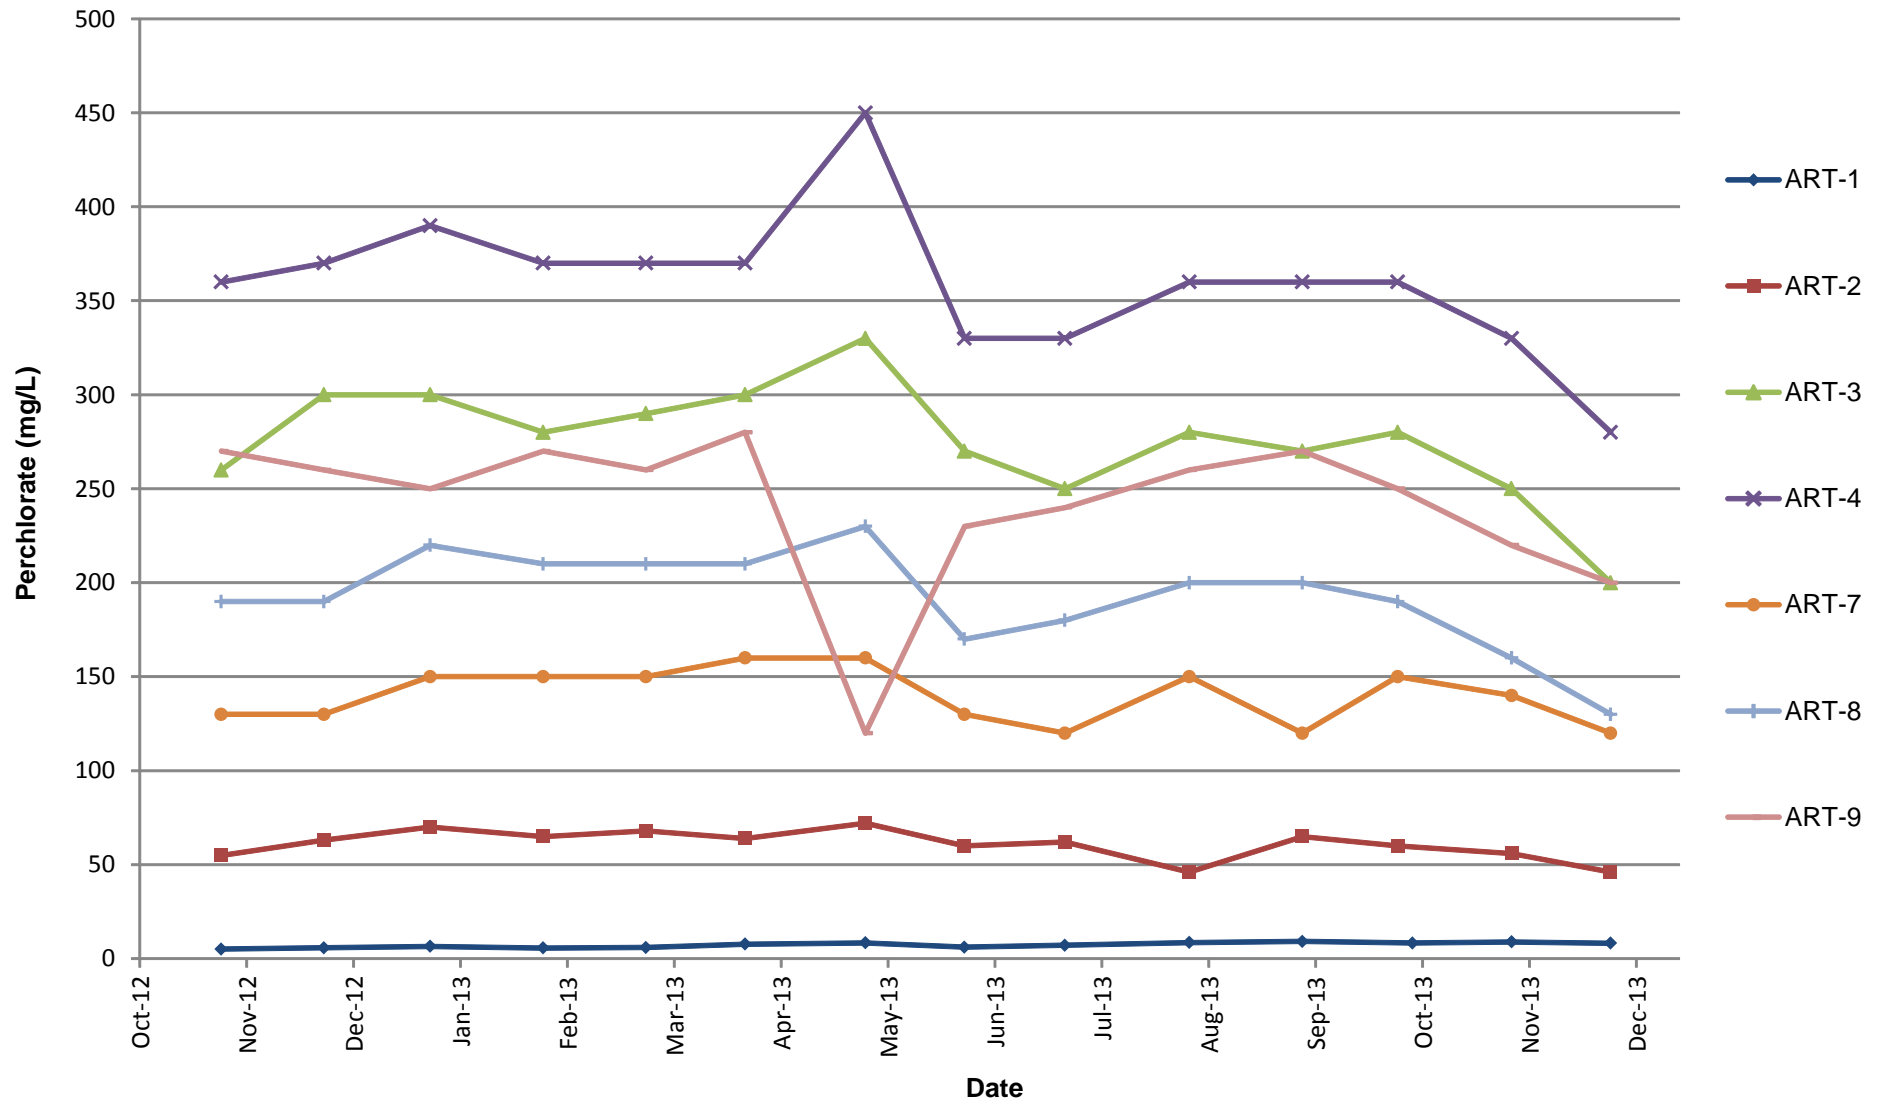
15a

Athens Road Well Field Perchlorate Concentration Trends, November 2012 - December 2013
 Nevada Environmental Response Trust Site
 Henderson, Nevada

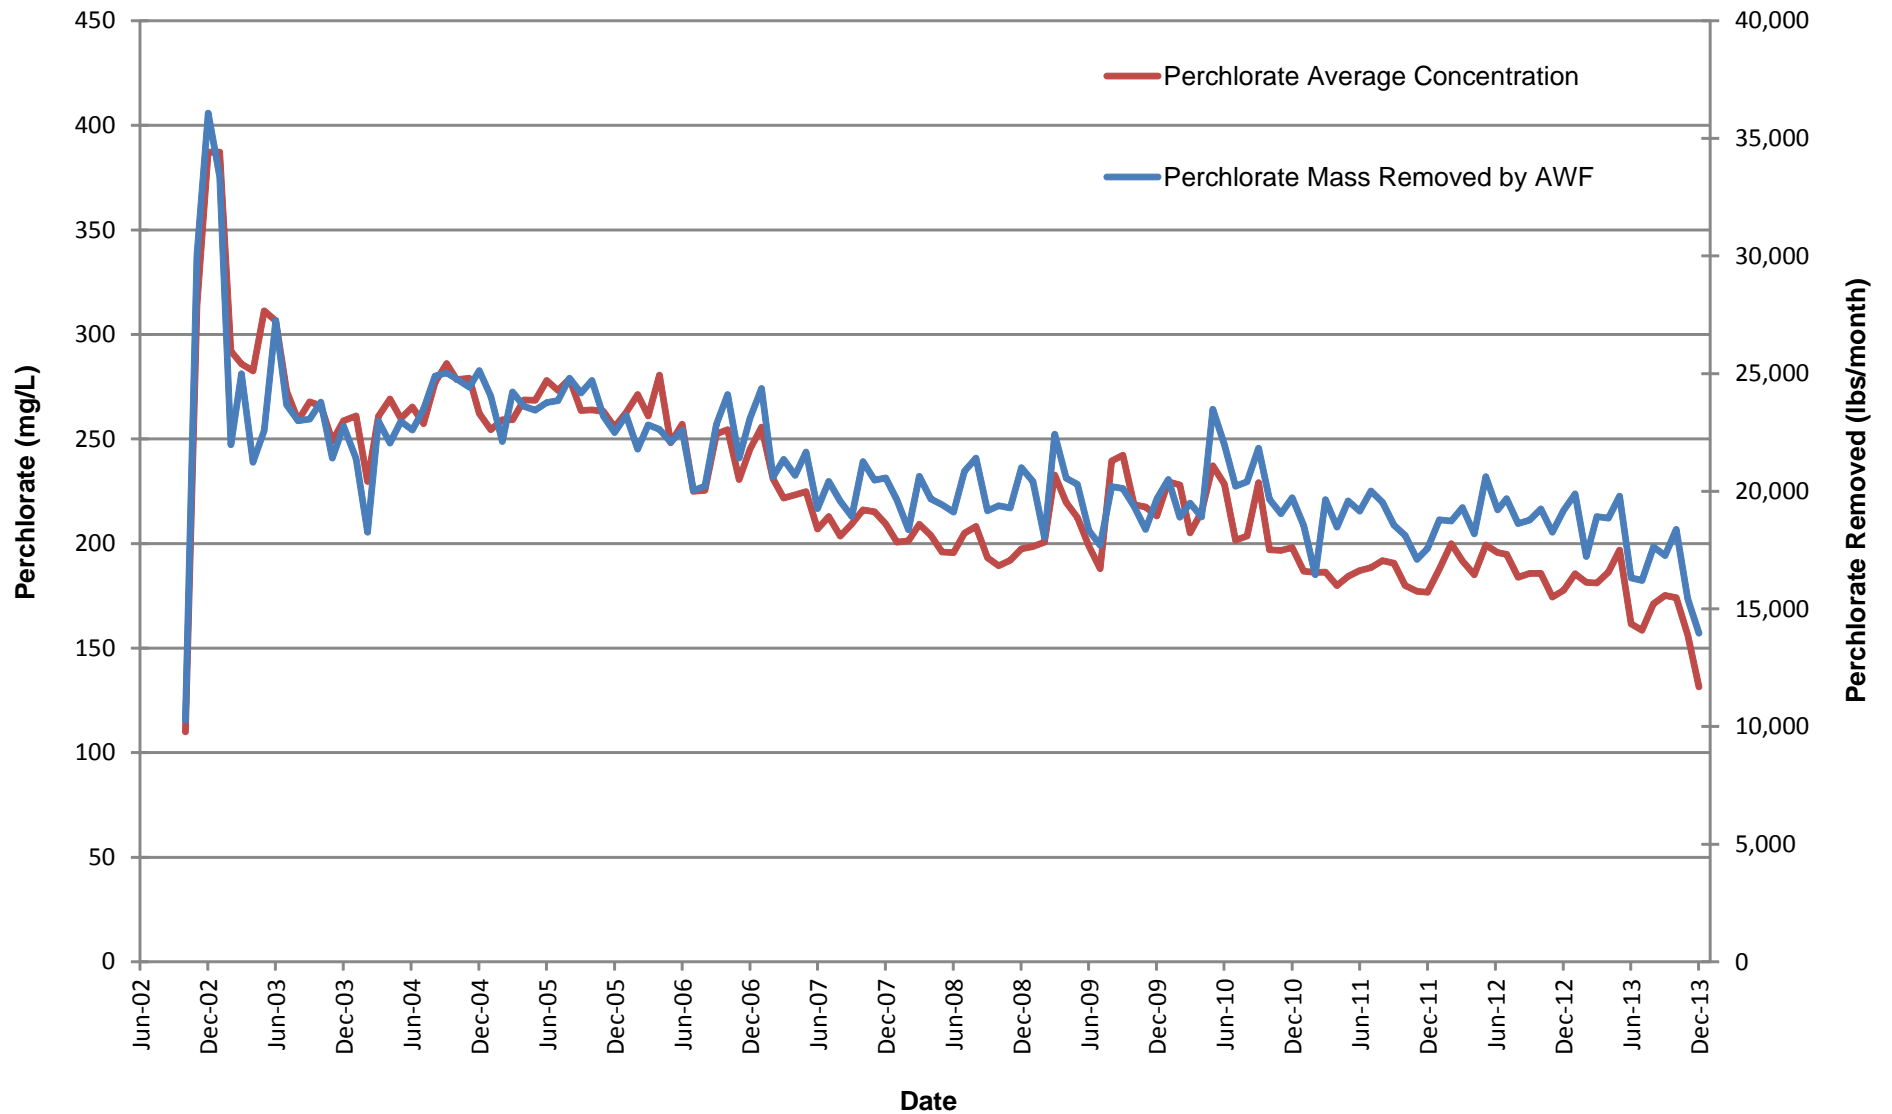
16

Athens Road Well Field Average Perchlorate Concentration and Mass Removed
 Nevada Environmental Response Trust Site
 Henderson, Nevada

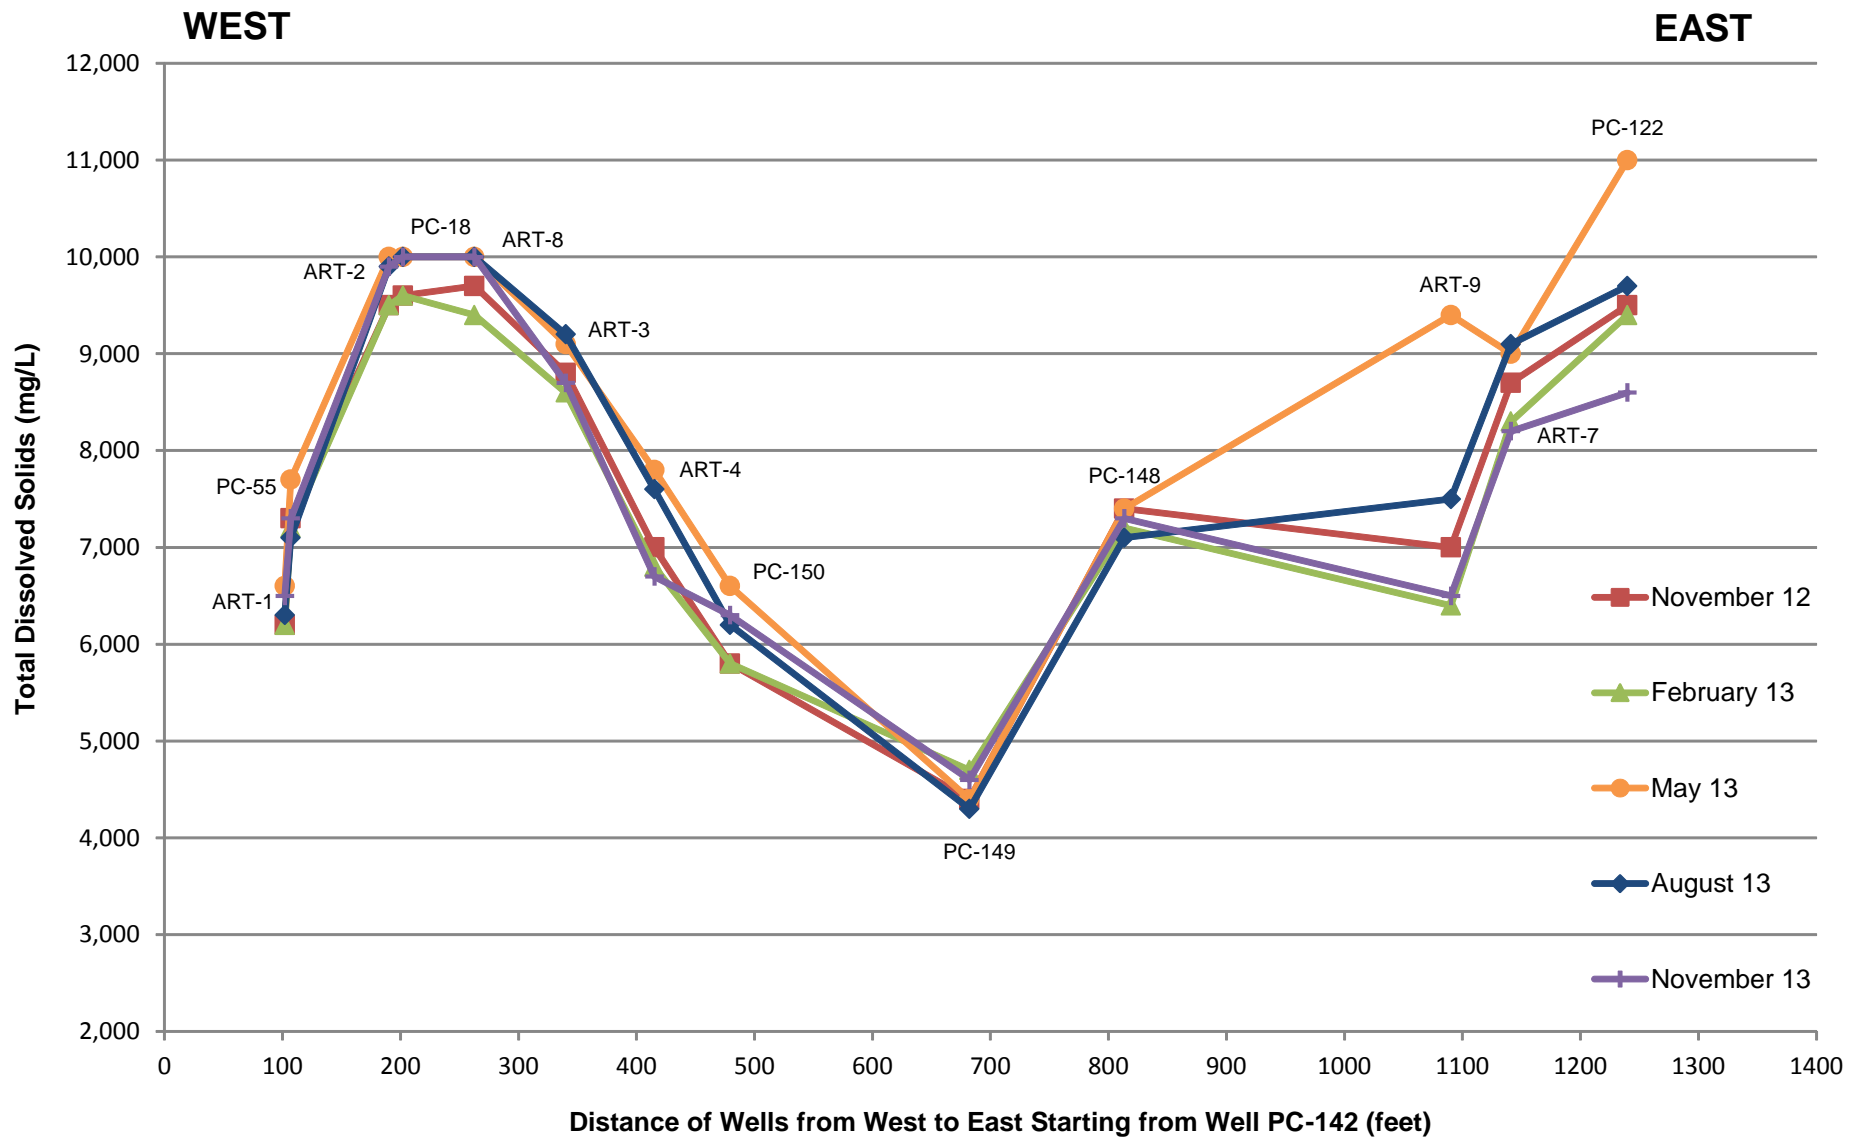
17

Athens Road Well Field Total Dissolved Solids Concentrations
 Nevada Environmental Response Trust Site
 Henderson, Nevada

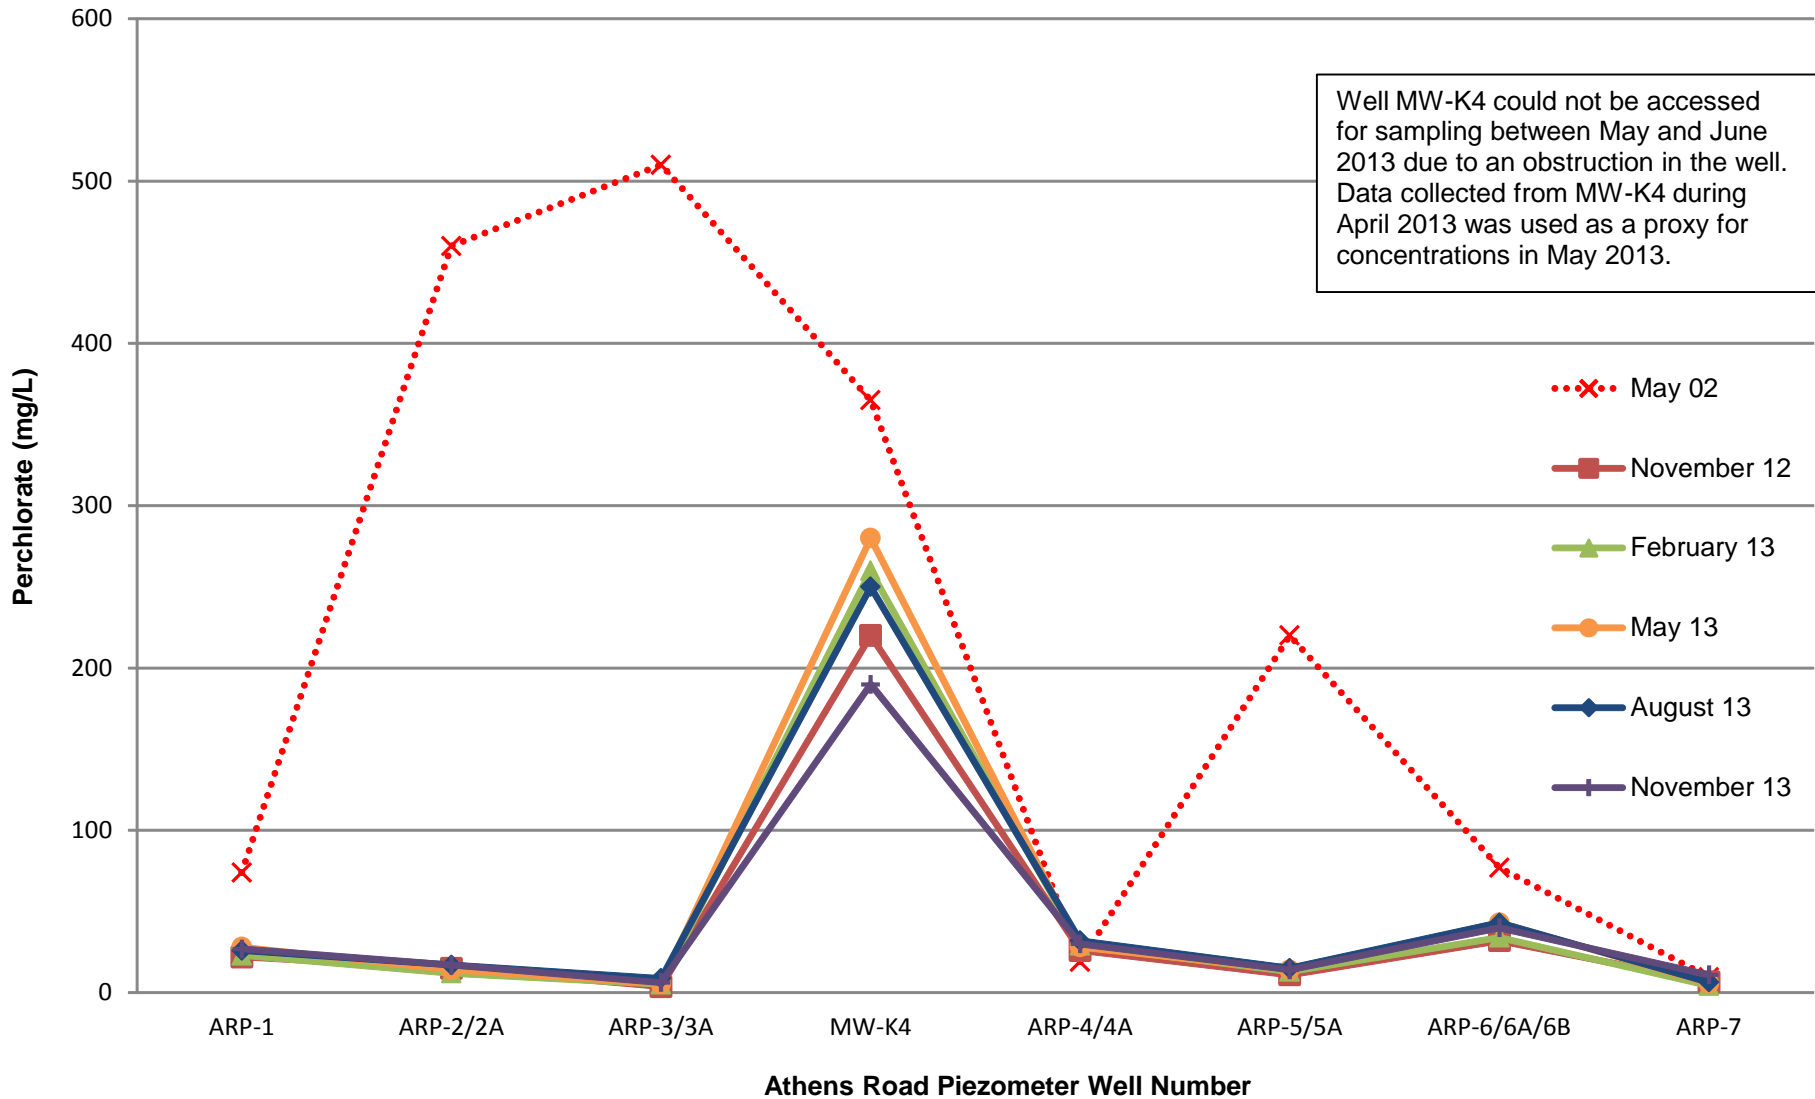
18

Athens Road Piezometer Well Line Perchlorate Concentrations
 Nevada Environmental Response Trust Site
 Henderson, Nevada

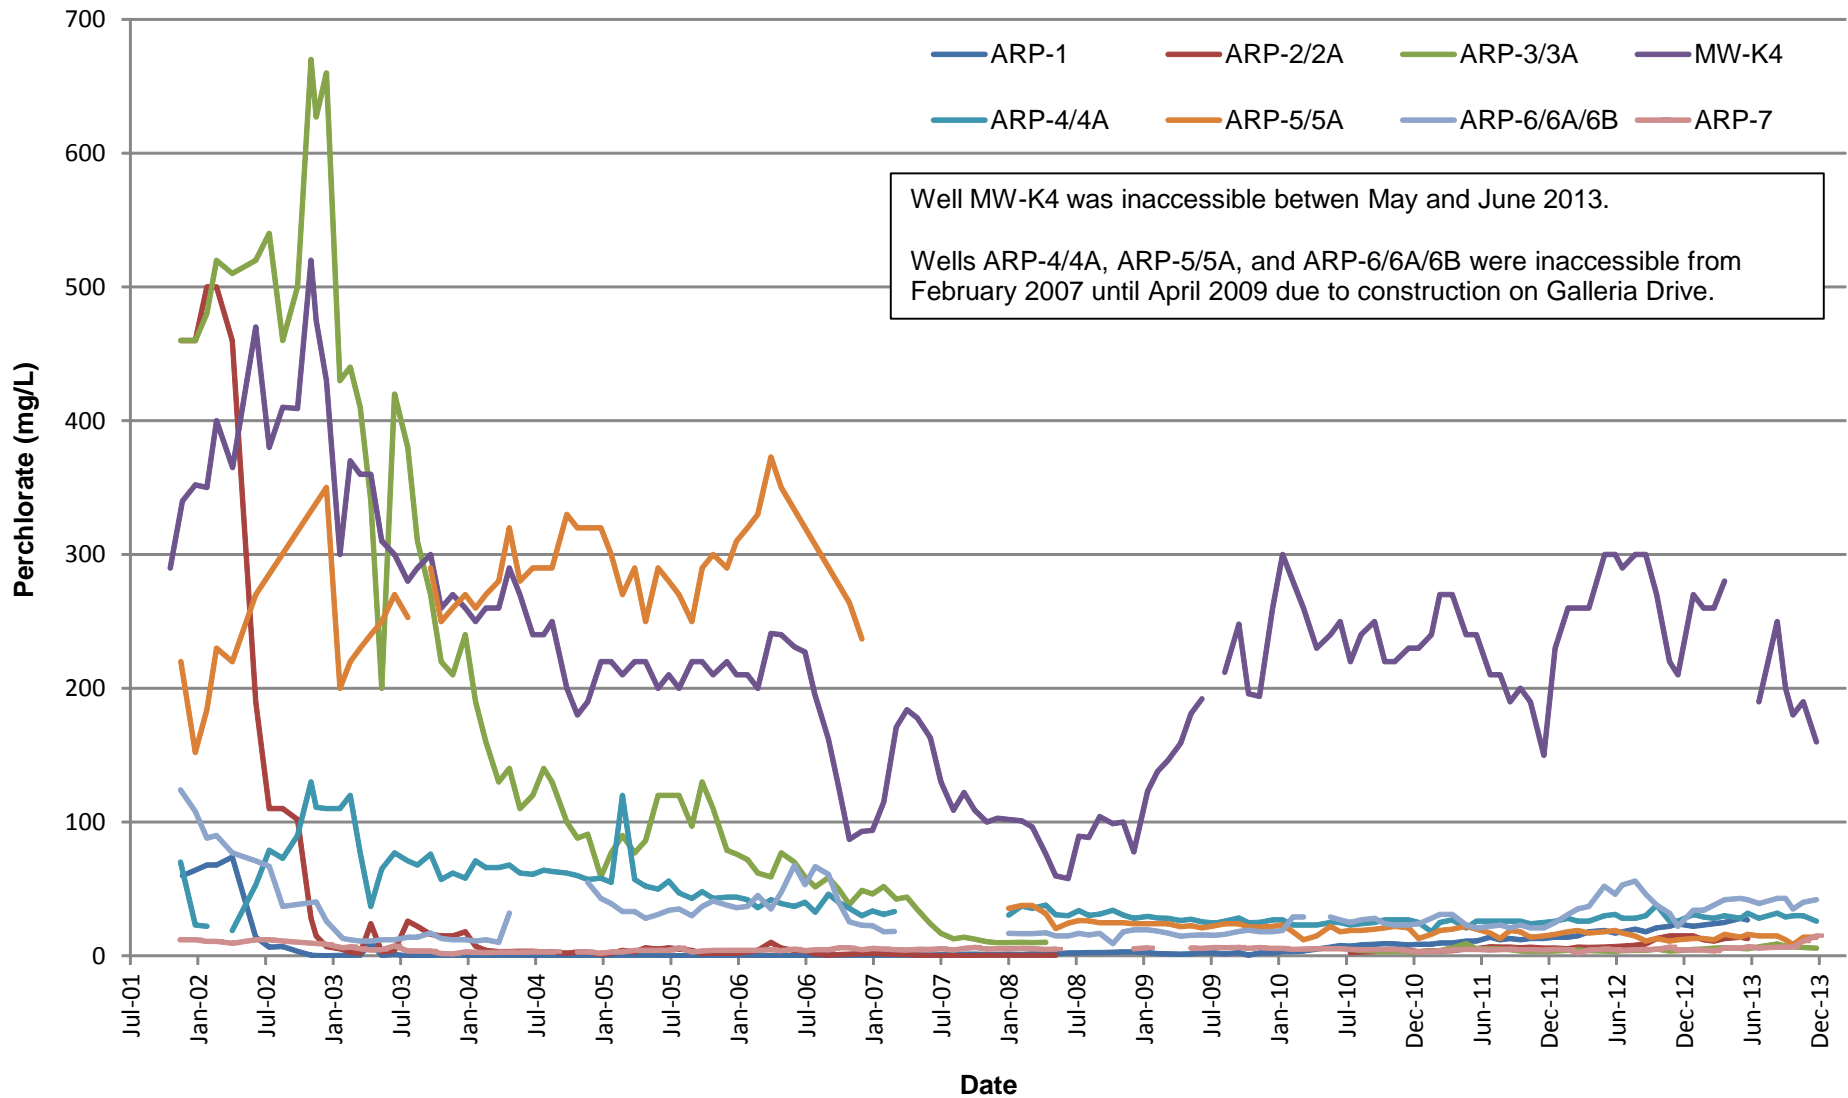
19

Athens Road Piezometer Well Line Perchlorate Concentration Trends
 Nevada Environmental Response Trust Site
 Henderson, Nevada
