Figure 1
LOCATION MAP
 Semi-Annual Remedial Performance Report
 Nevada Environmental Response Trust Site
 Henderson, Nevada

Hydrograph Pair Across the Barrier Wall - M-69 and I-Y
 Nevada Environmental Response Trust Site
 Henderson, Nevada

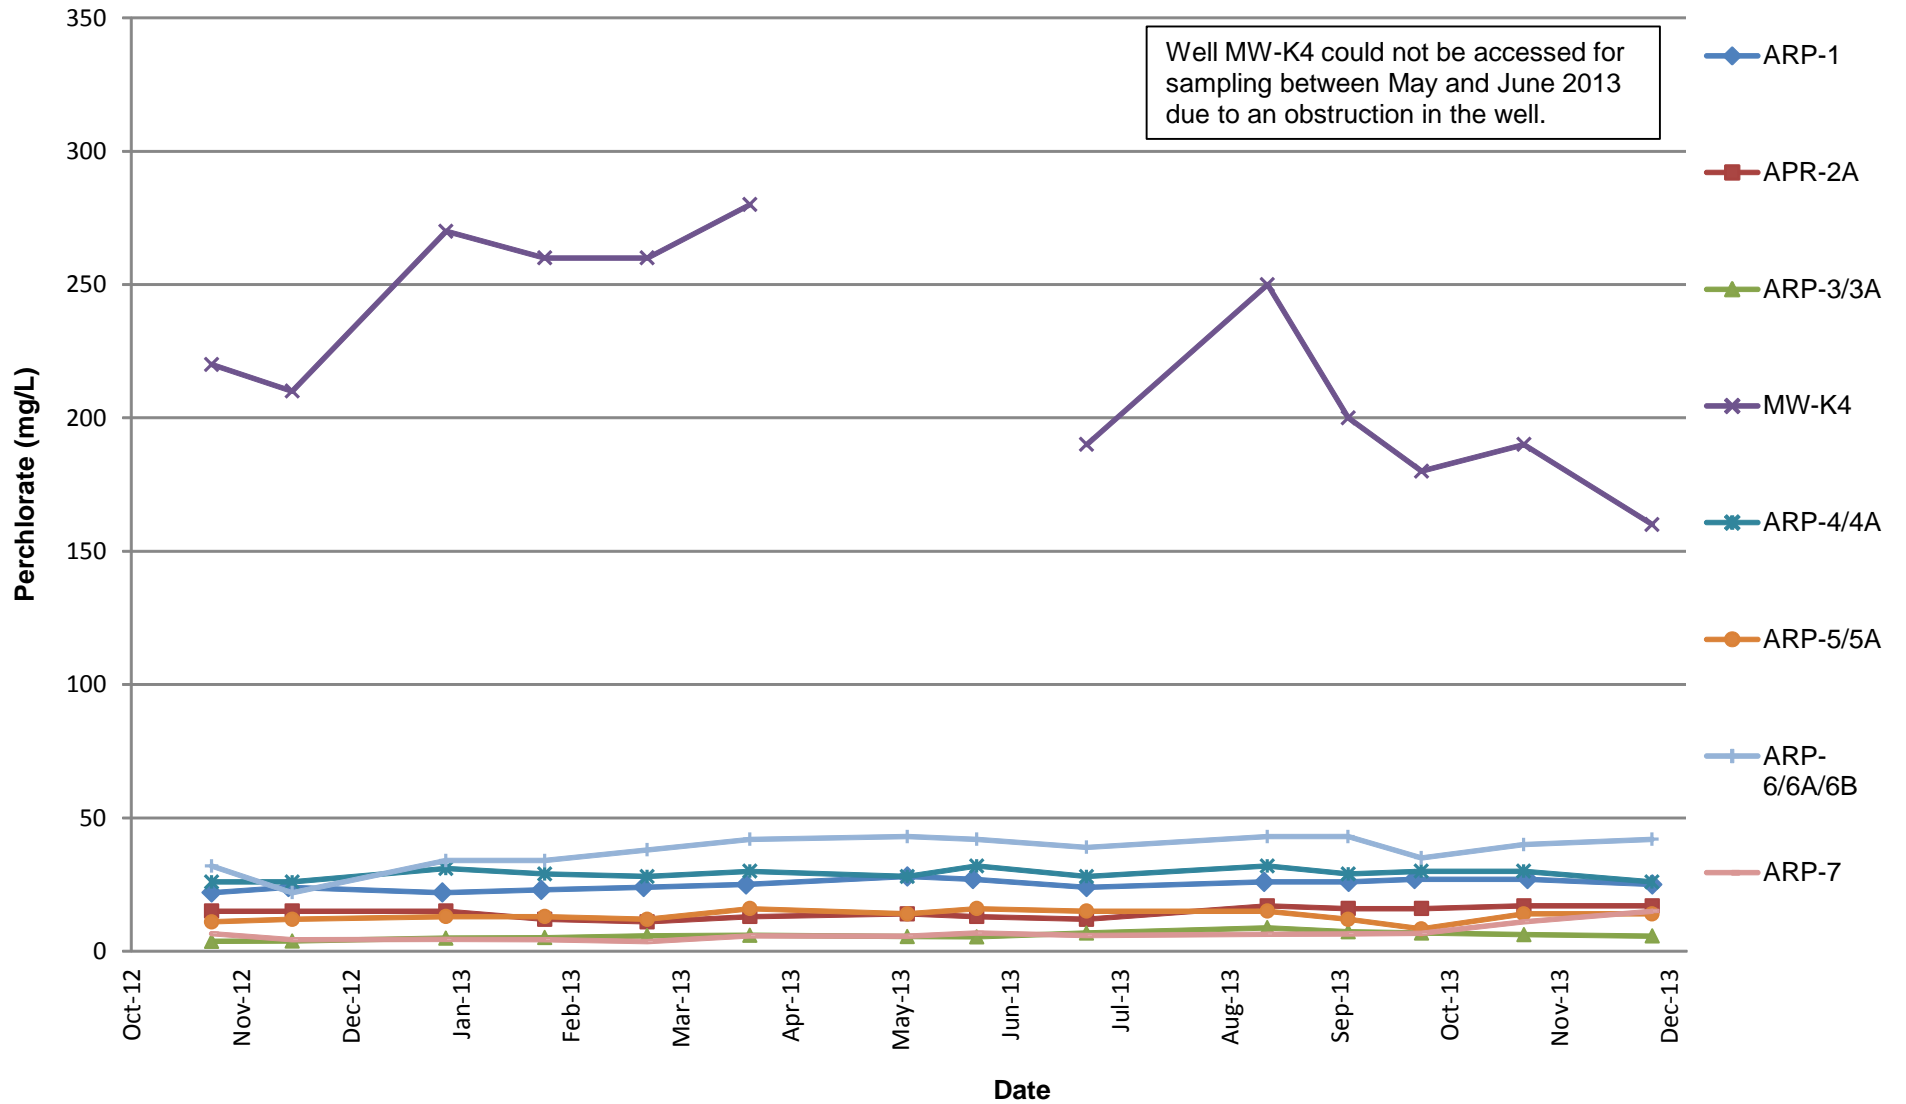
19a

Athens Road Piezometer Well Line Perchlorate Concentration Trends, Nov 2012 - Dec 2013
 Nevada Environmental Response Trust Site
 Henderson, Nevada

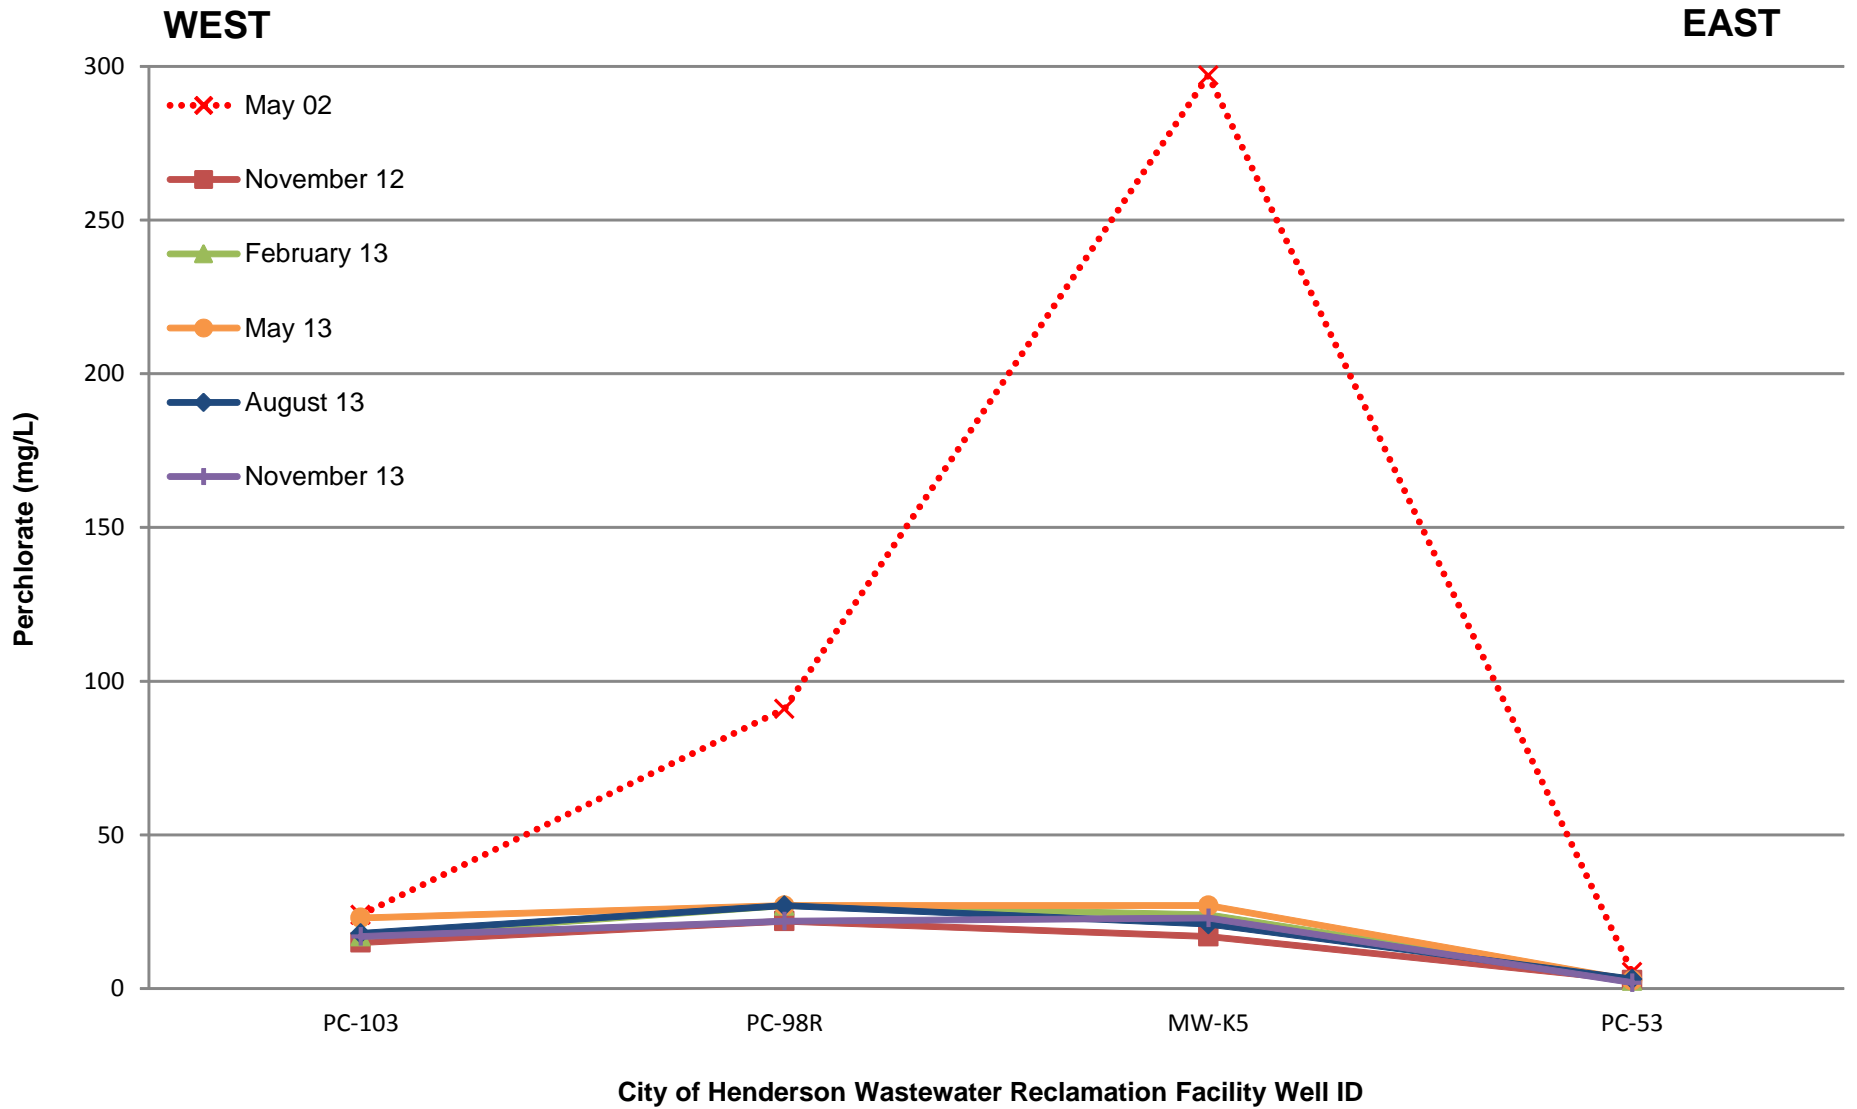
20

City of Henderson WRF Well Line Perchlorate Concentrations
 Nevada Environmental Response Trust Site
 Henderson, Nevada

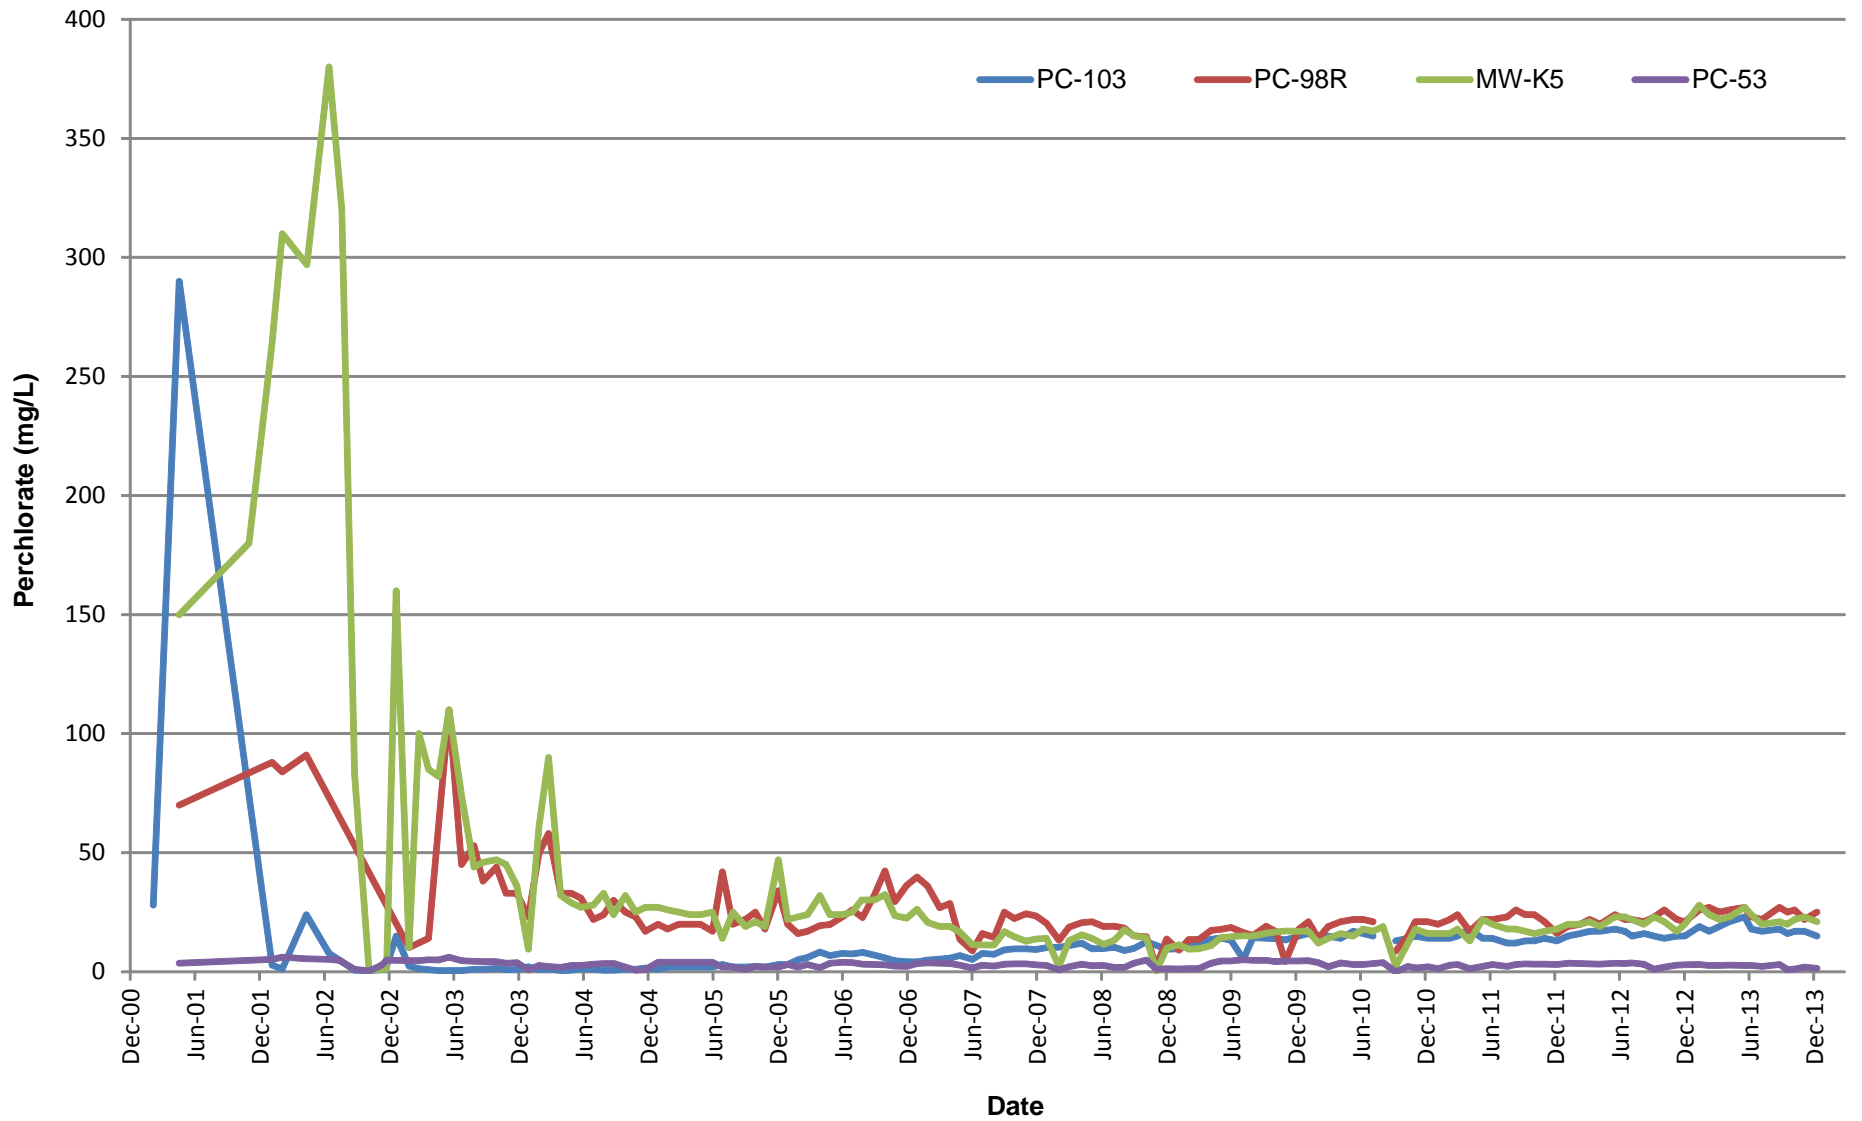
21

City of Henderson WRF Well Line Perchlorate Concentration Trends
 Nevada Environmental Response Trust Site
 Henderson, Nevada

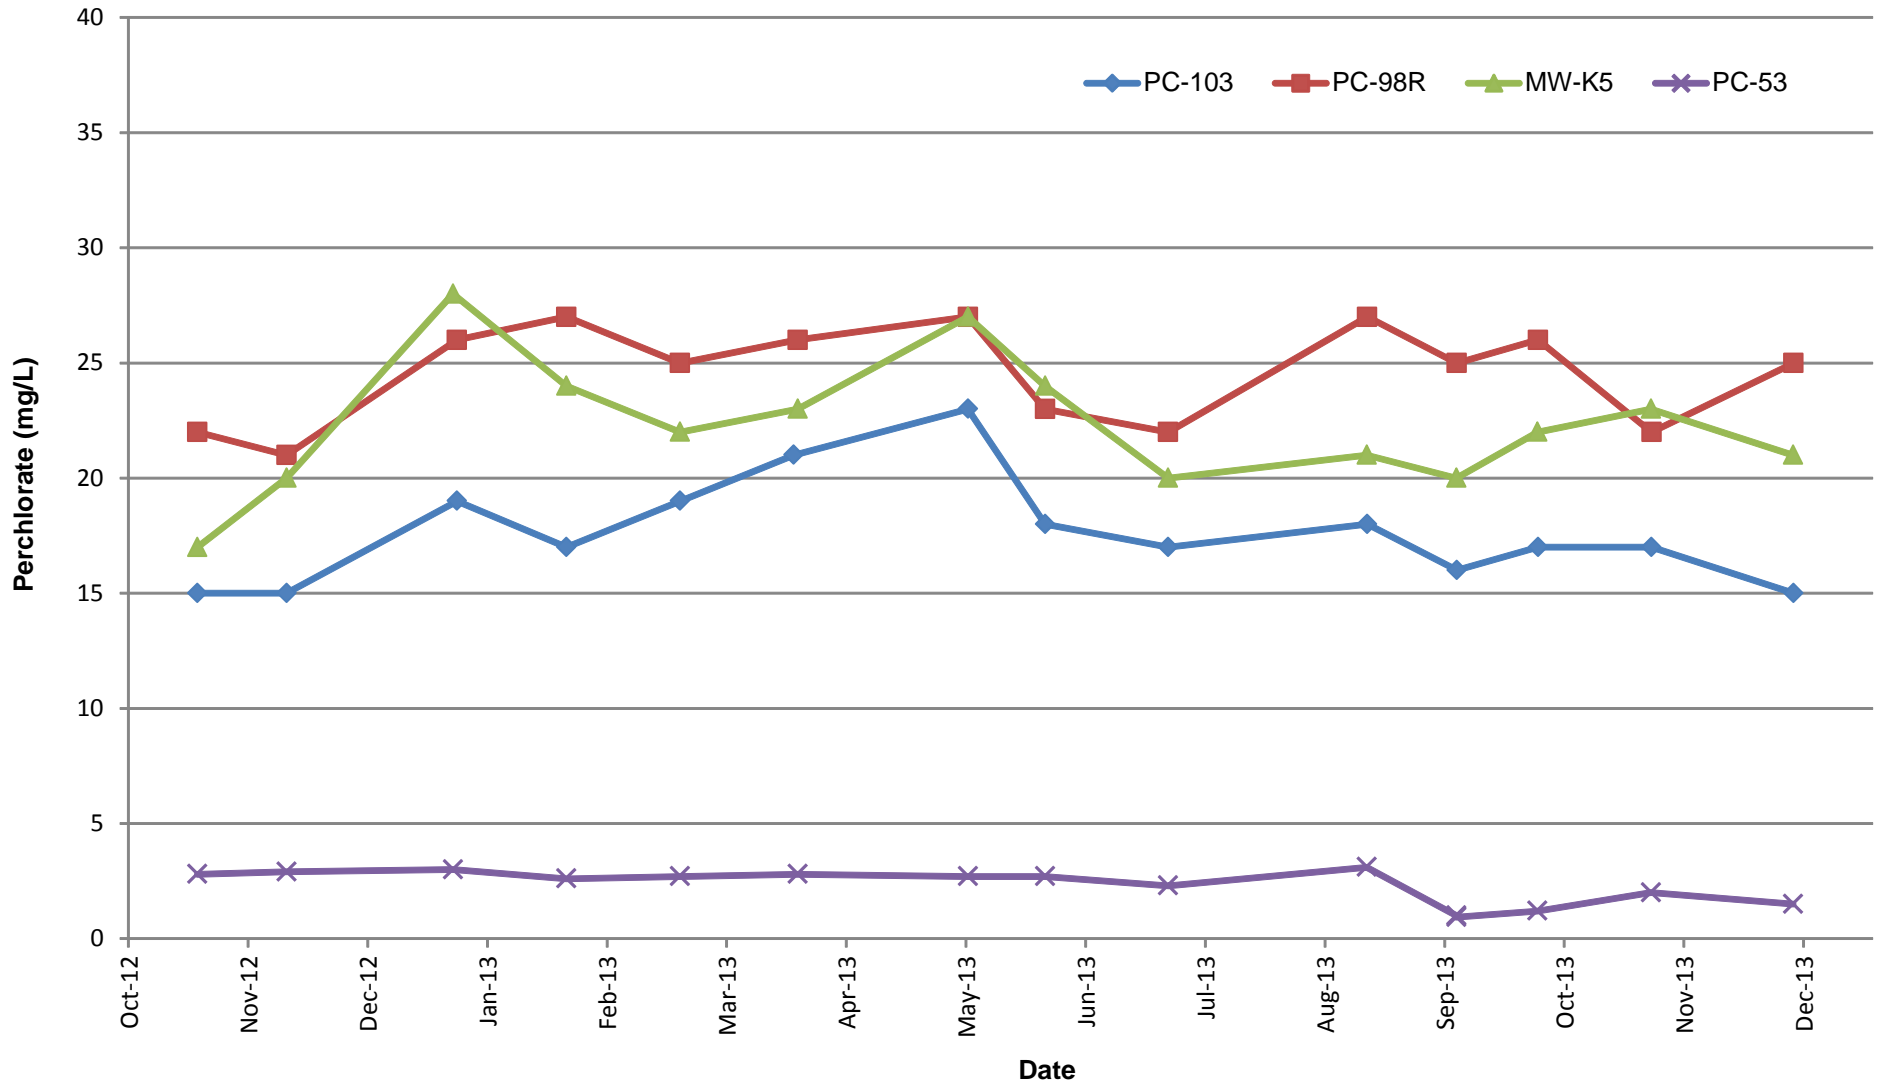
21a

City of Henderson WRF Well Line Perchlorate Concentration Trends, Nov 2012 - Dec 2013
 Nevada Environmental Response Trust Site
 Henderson, Nevada

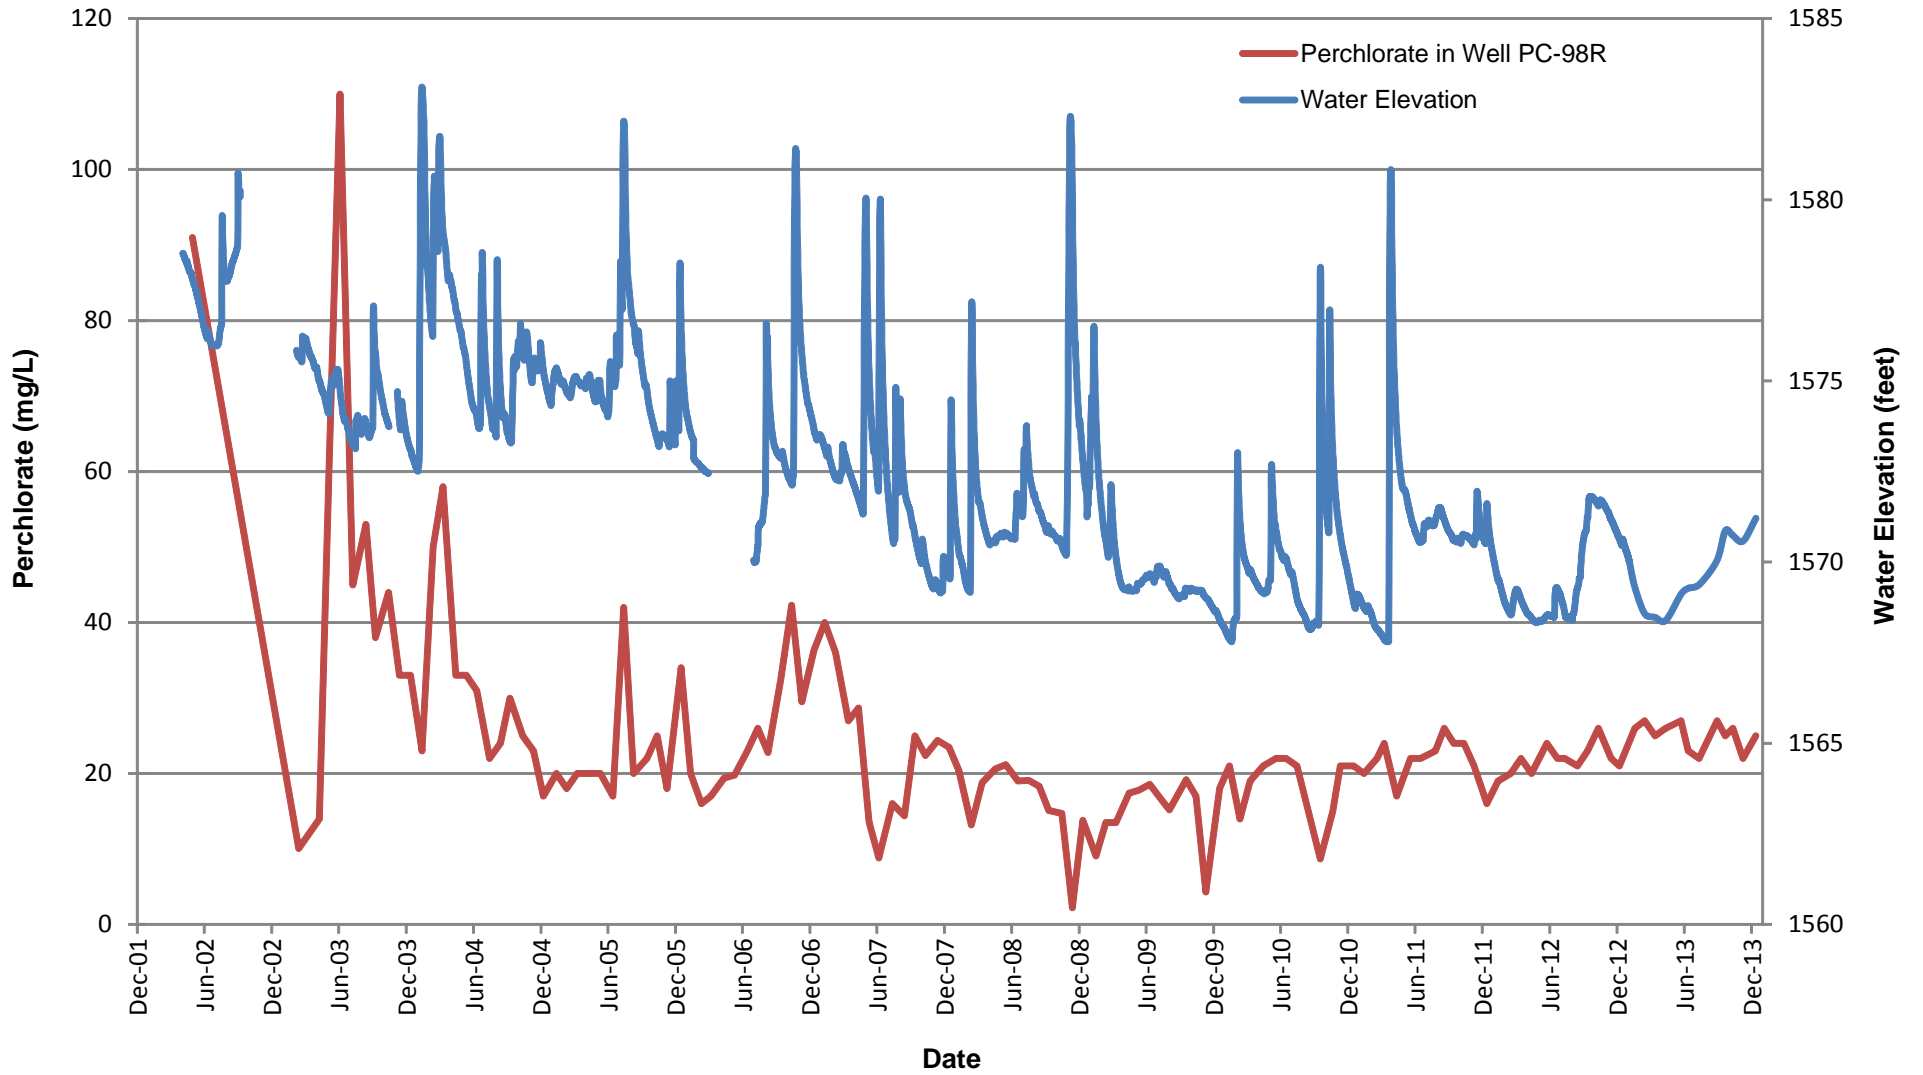
22

Well PC-98R Perchlorate Concentration vs. Water Elevation Trends
 Nevada Environmental Response Trust Site
 Henderson, Nevada

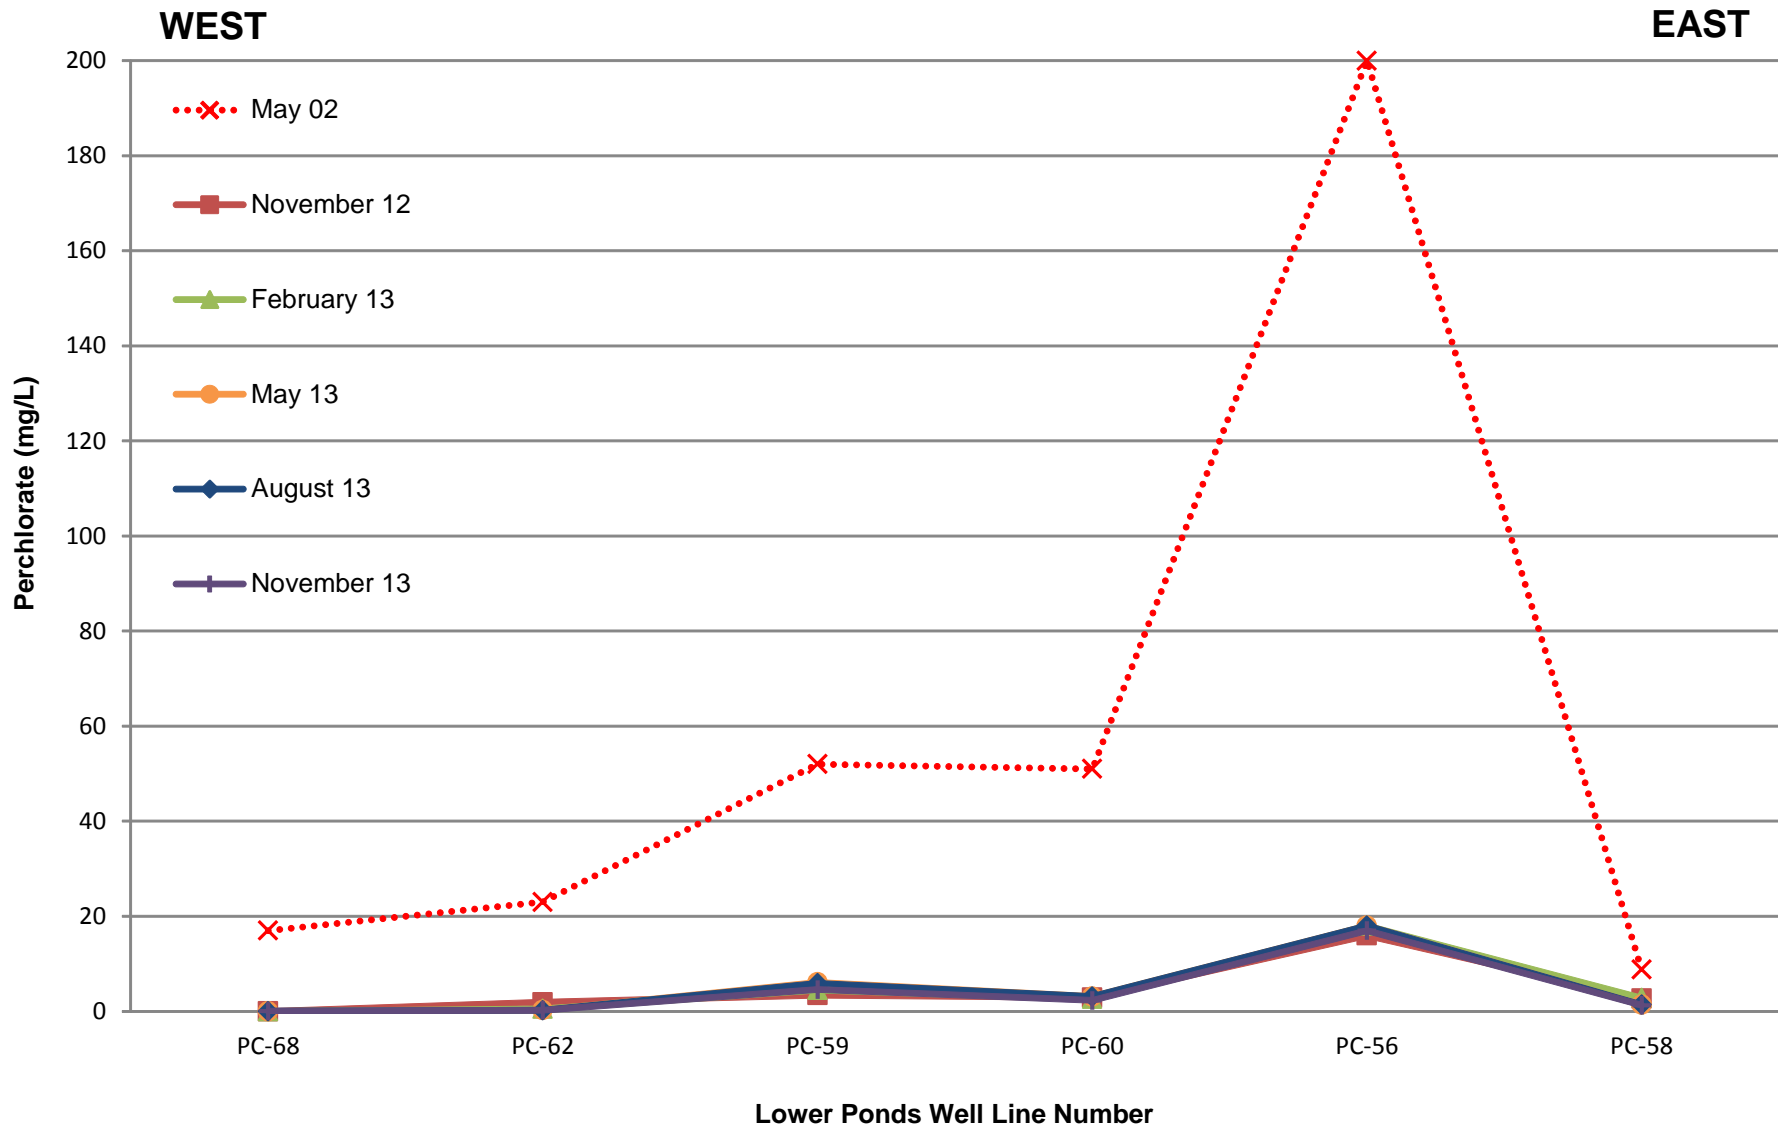
23

Lower Ponds Well Line Perchlorate Concentrations
 Nevada Environmental Response Trust Site
 Henderson, Nevada

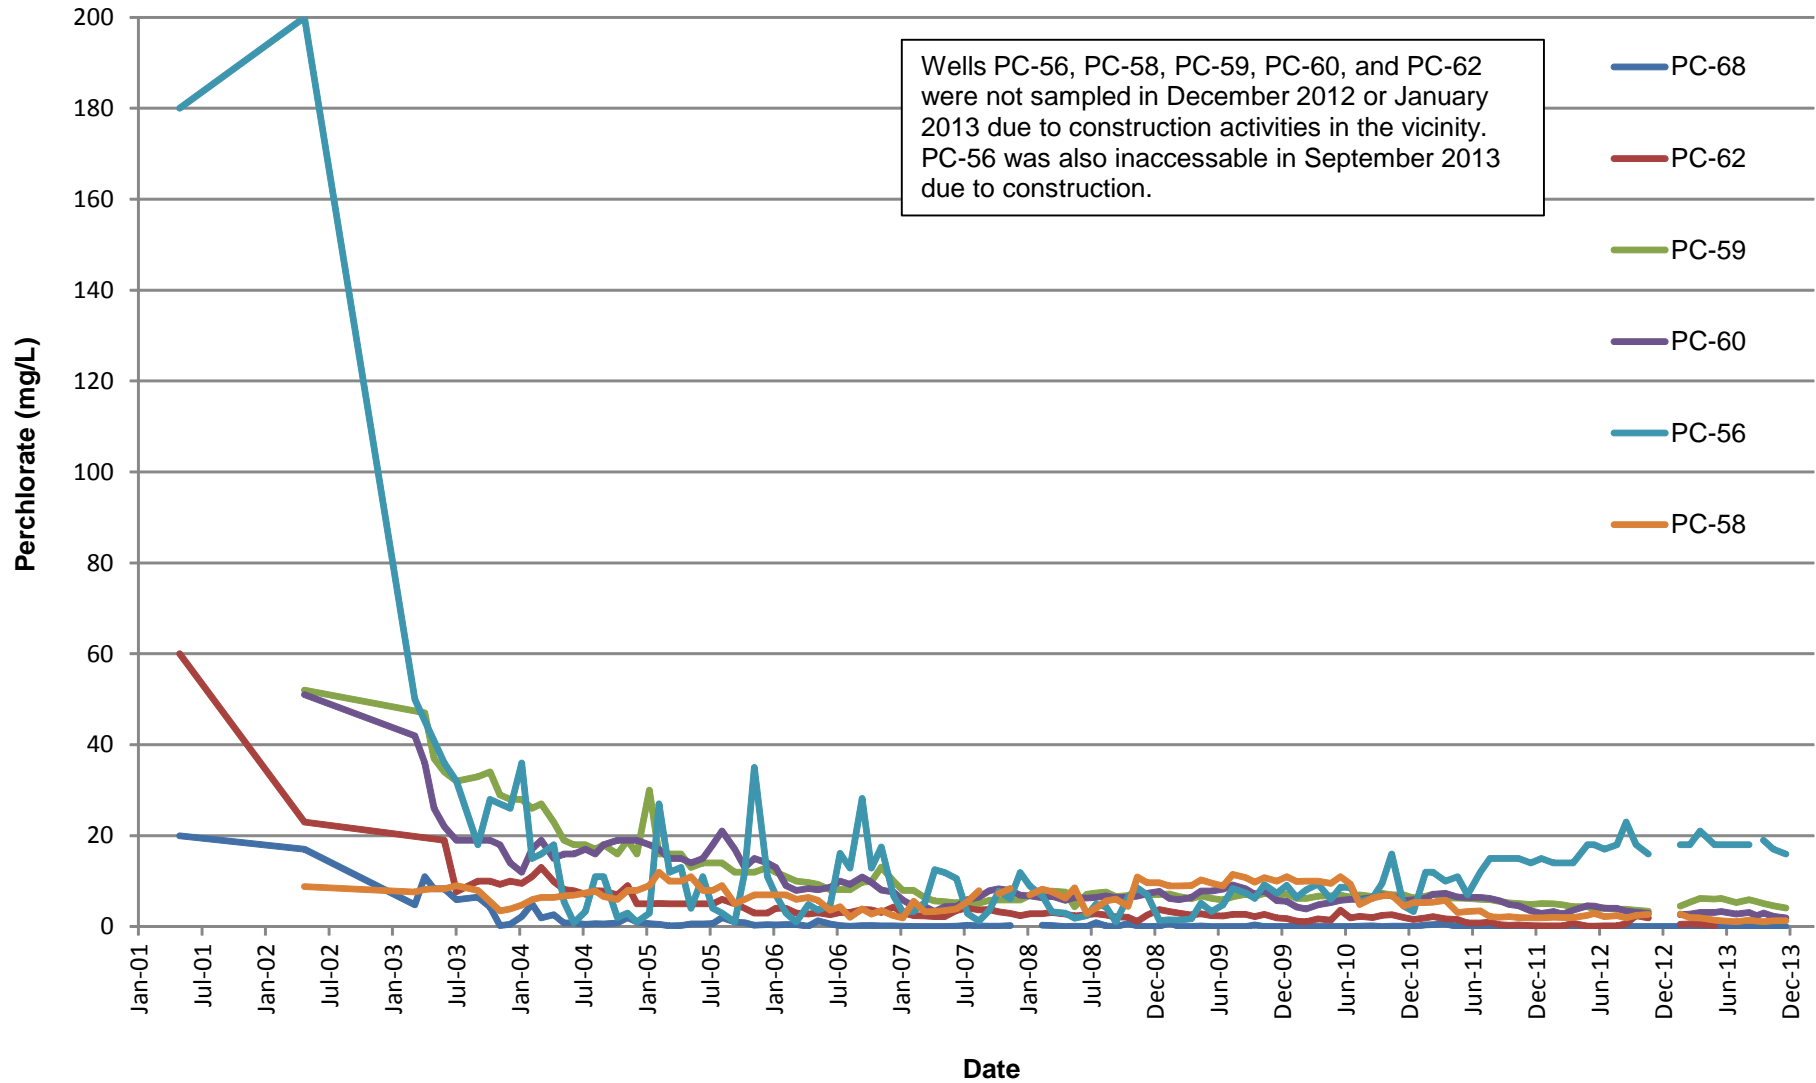
24

Lower Ponds Well Line Perchlorate Concentration Trends
 Nevada Environmental Response Trust Site
 Henderson, Nevada

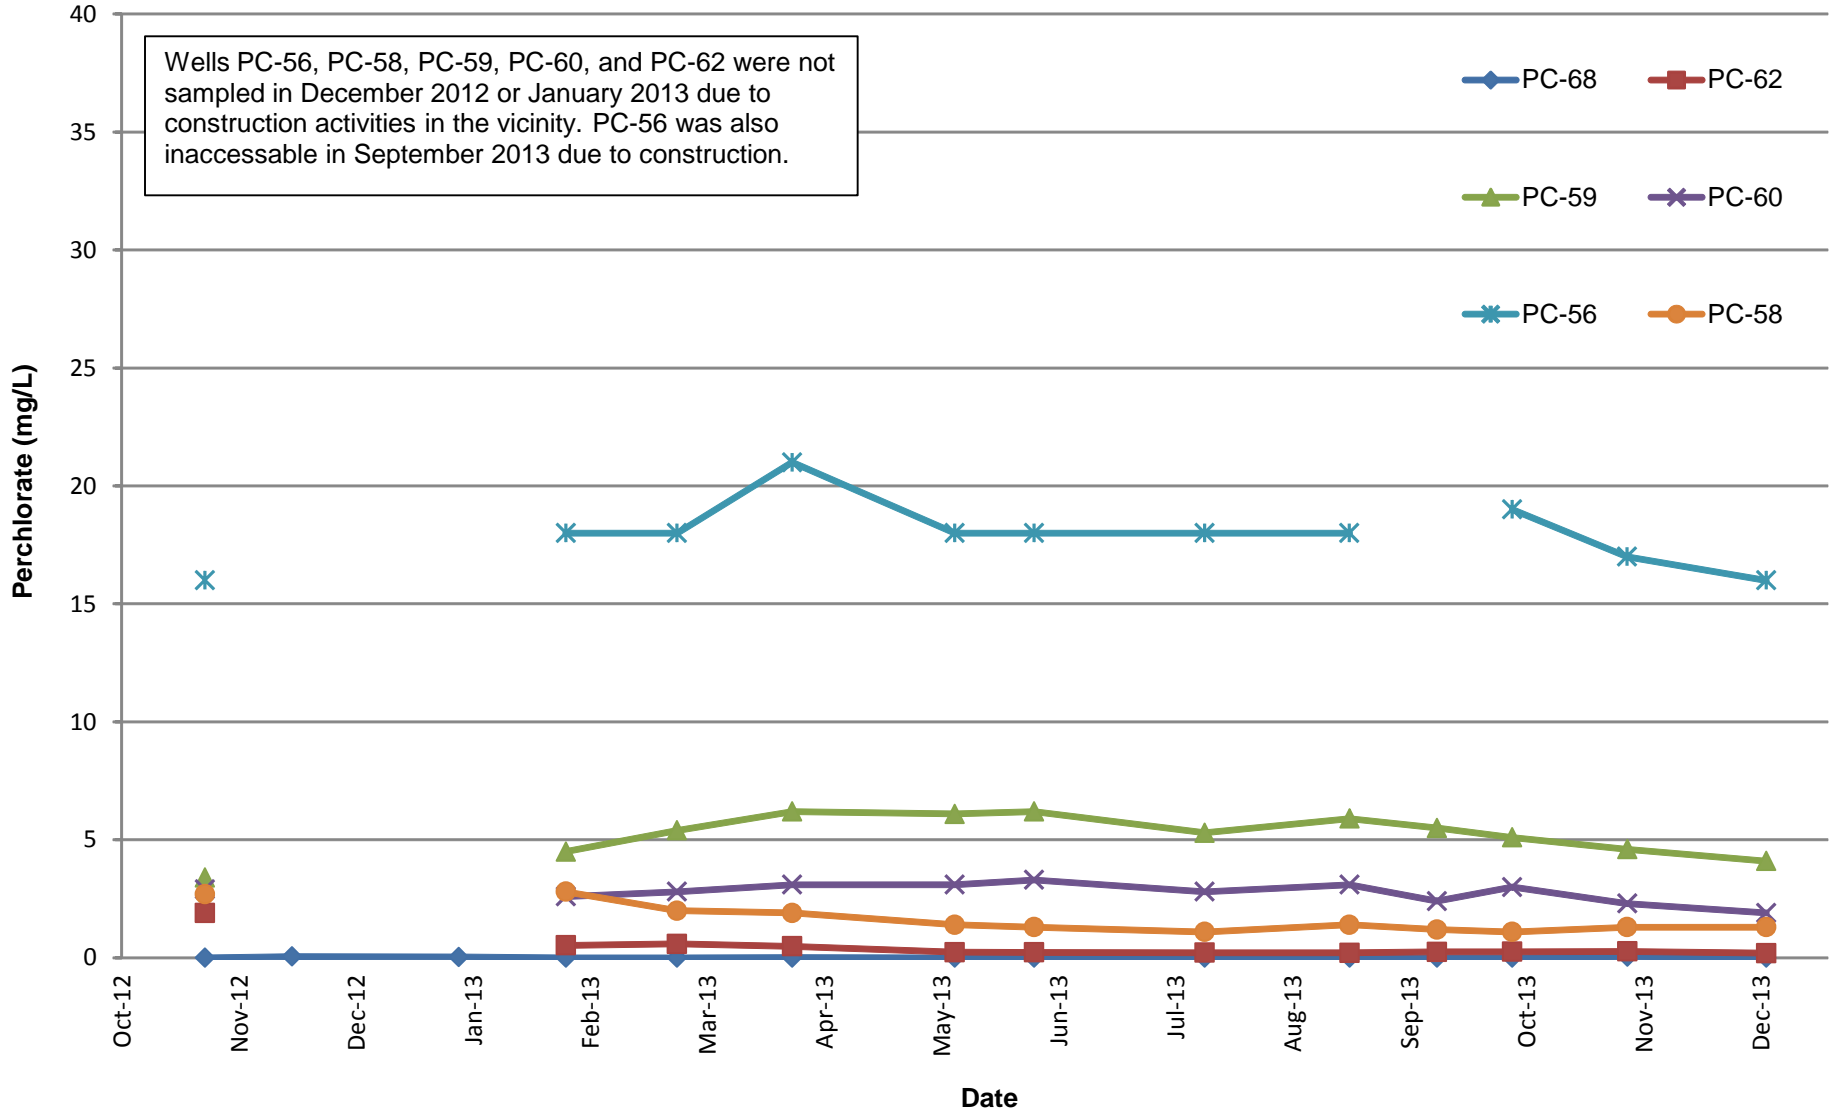
24a

Lower Ponds Well Line Perchlorate Concentration Trends, Nov 2012 - Dec 2013
 Nevada Environmental Response Trust Site
 Henderson, Nevada

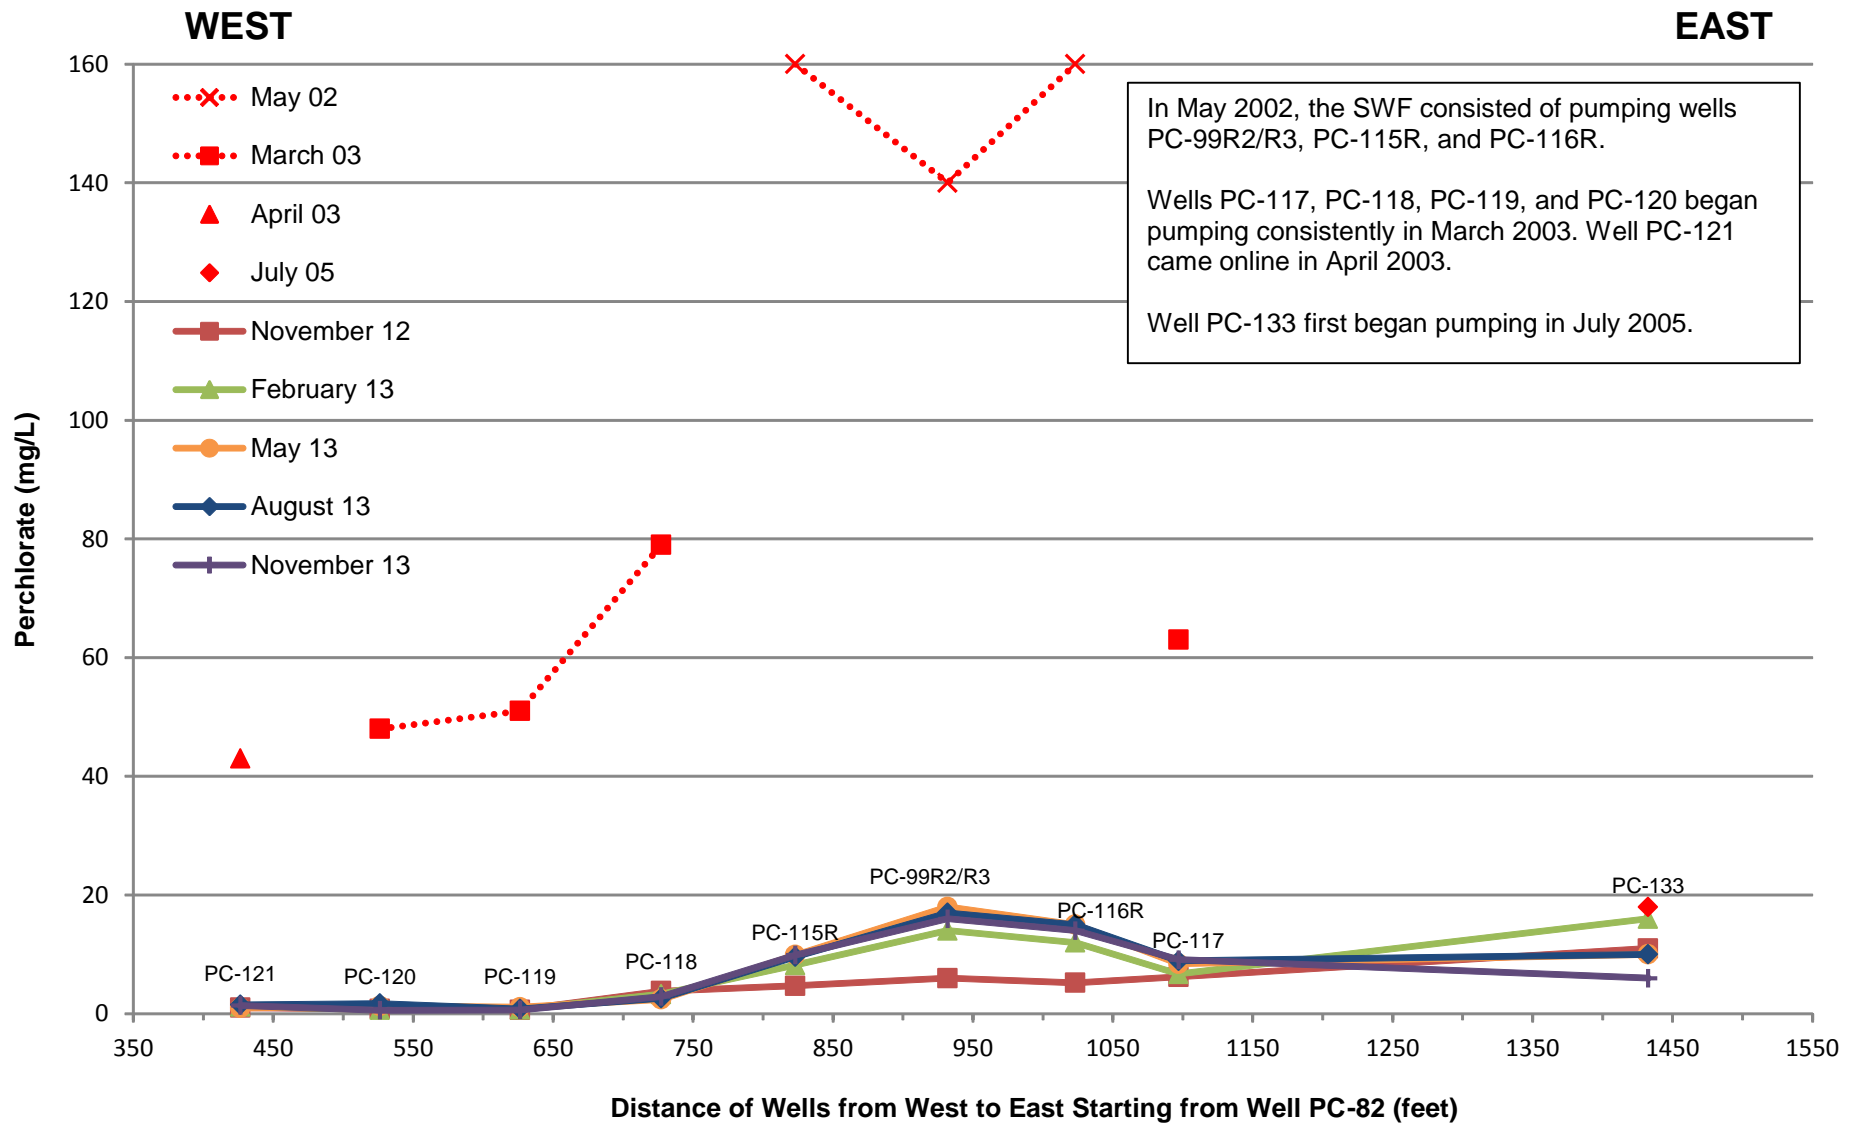
25

Seep Well Field Perchlorate Concentrations
 Nevada Environmental Response Trust Site
 Henderson, Nevada

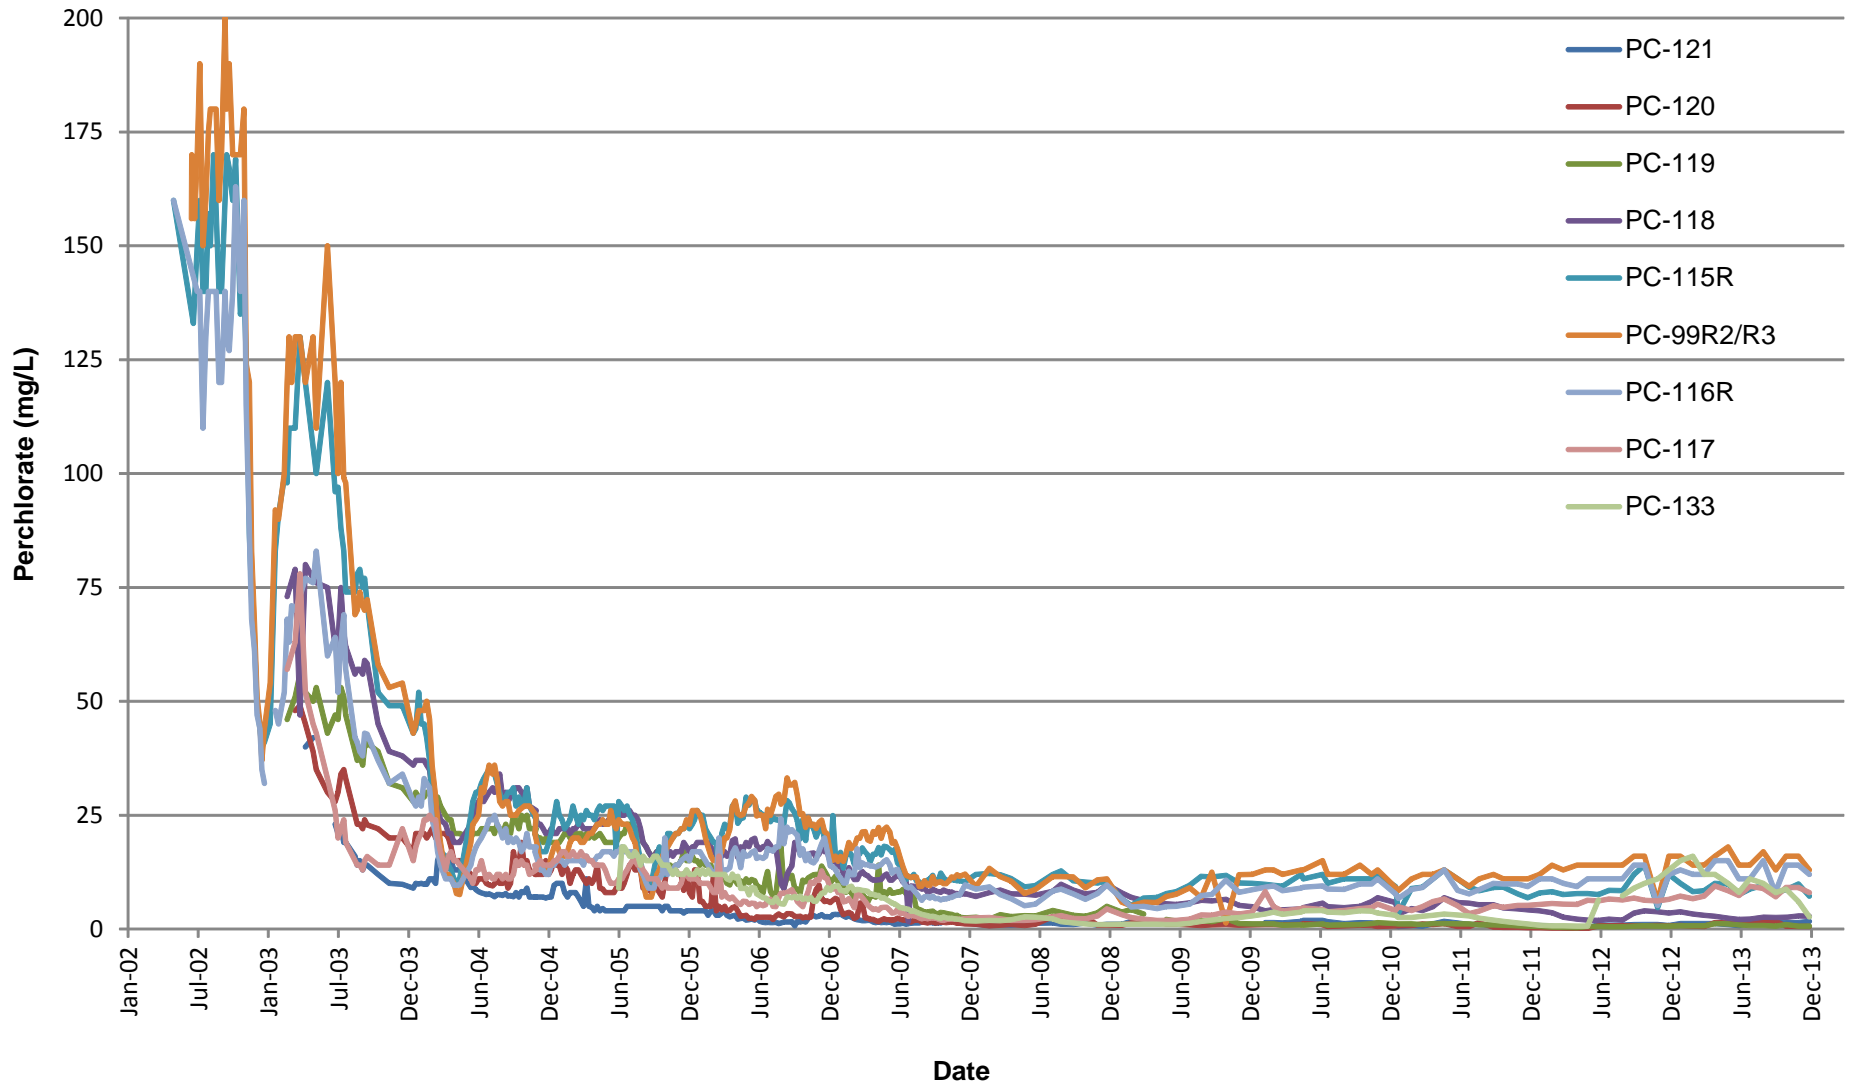
26

Seep Well Field Perchlorate Concentration Trends
Nevada Environmental Response Trust Site
Henderson, Nevada

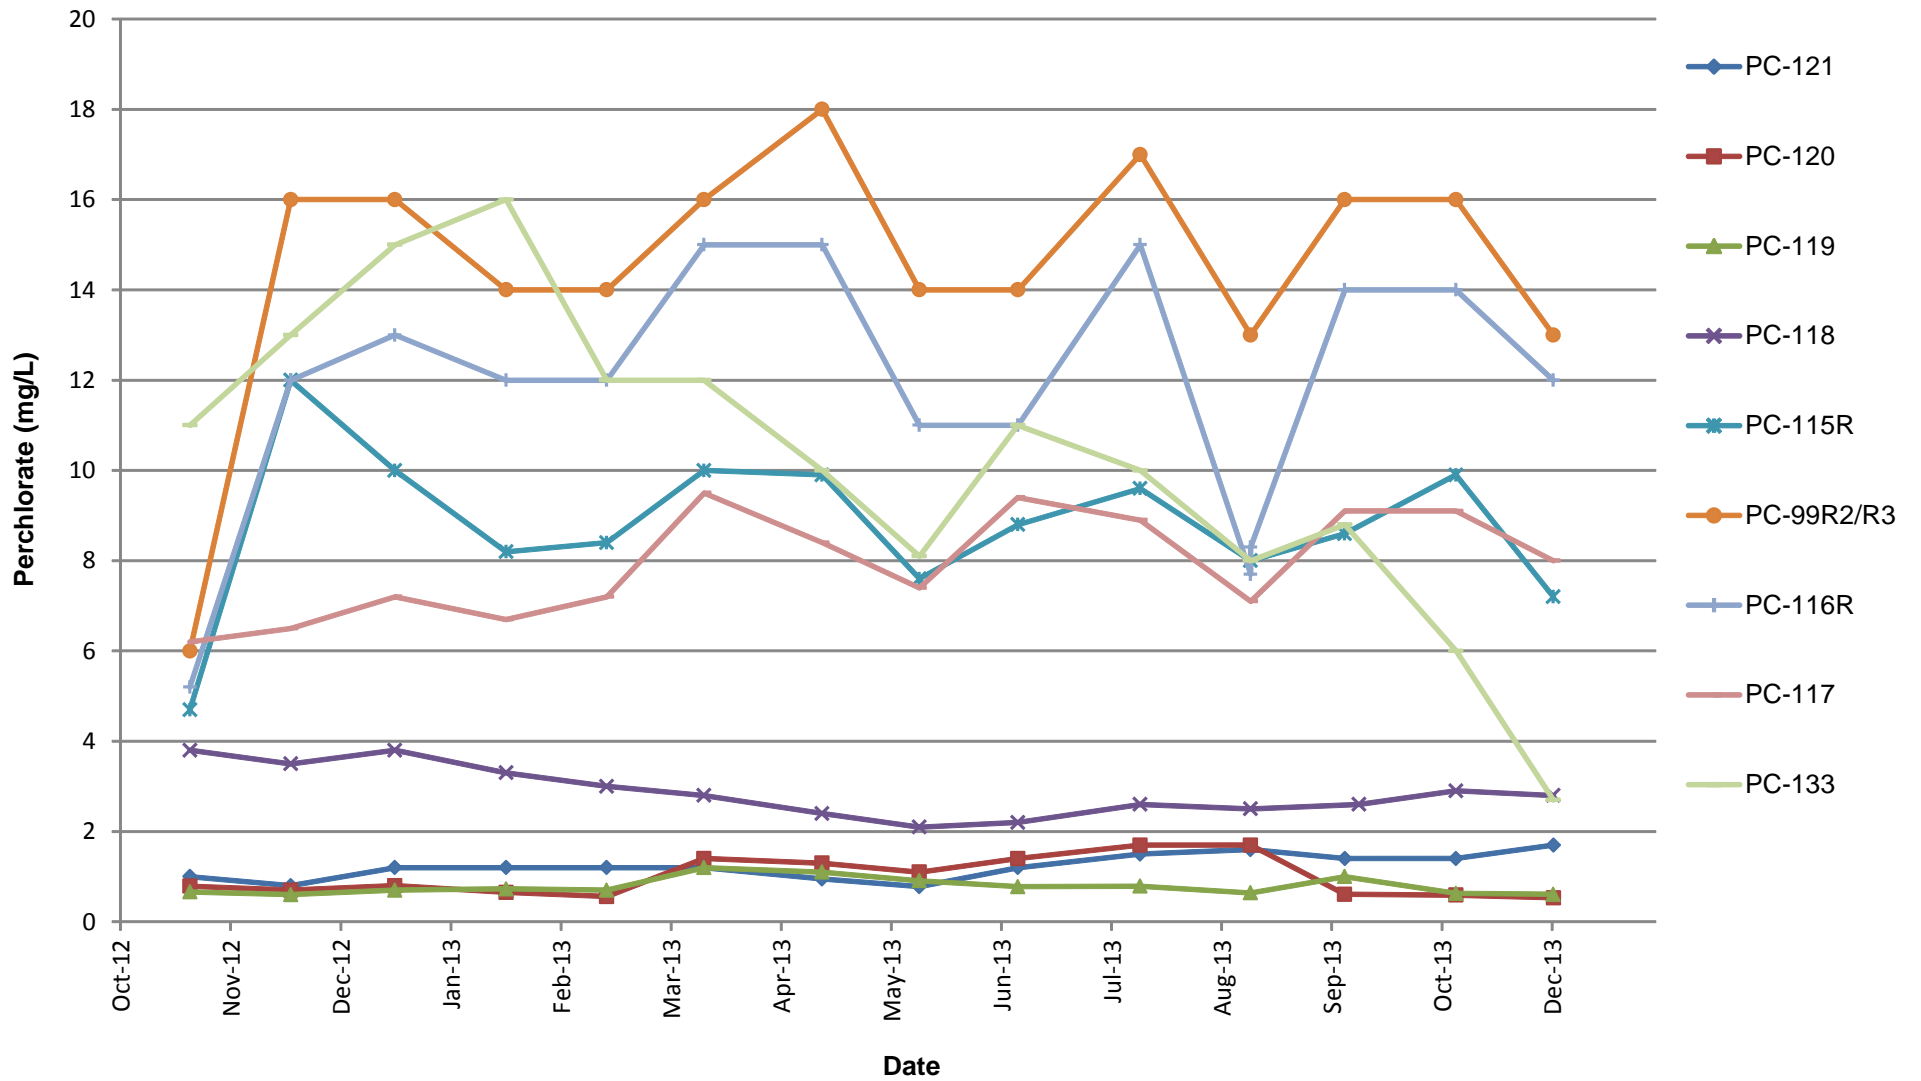
26a

Seep Well Field Perchlorate Concentration Trends, November 2012- December 2013
 Nevada Environmental Response Trust Site
 Henderson, Nevada
