Figure 1
LOCATION MAP
 Semi-Annual Remedial Performance Report
 Nevada Environmental Response Trust Site
 Henderson, Nevada

Hydrograph Pair Across the Barrier Wall - M-69 and I-Y
 Nevada Environmental Response Trust Site
 Henderson, Nevada

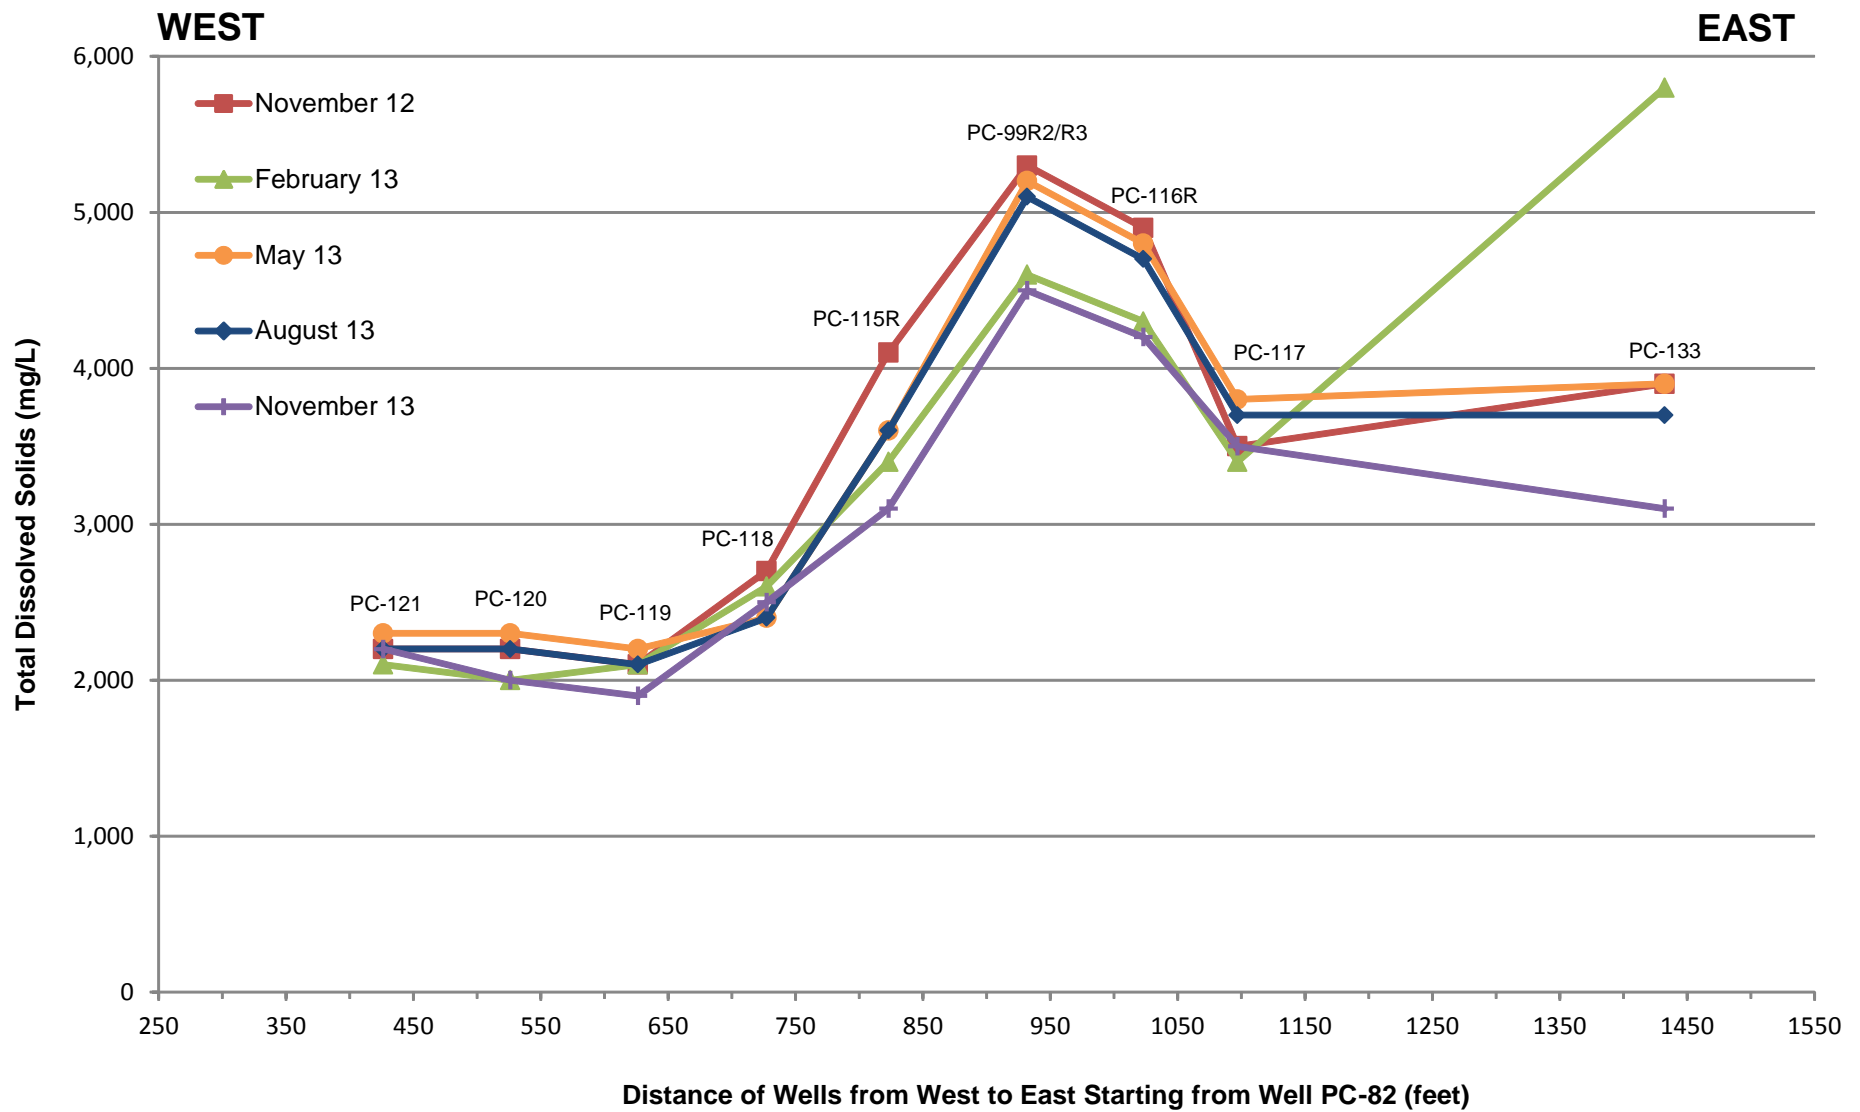
27

Seep Well Field Total Dissolved Solids Concentrations
 Nevada Environmental Response Trust Site
 Henderson, Nevada

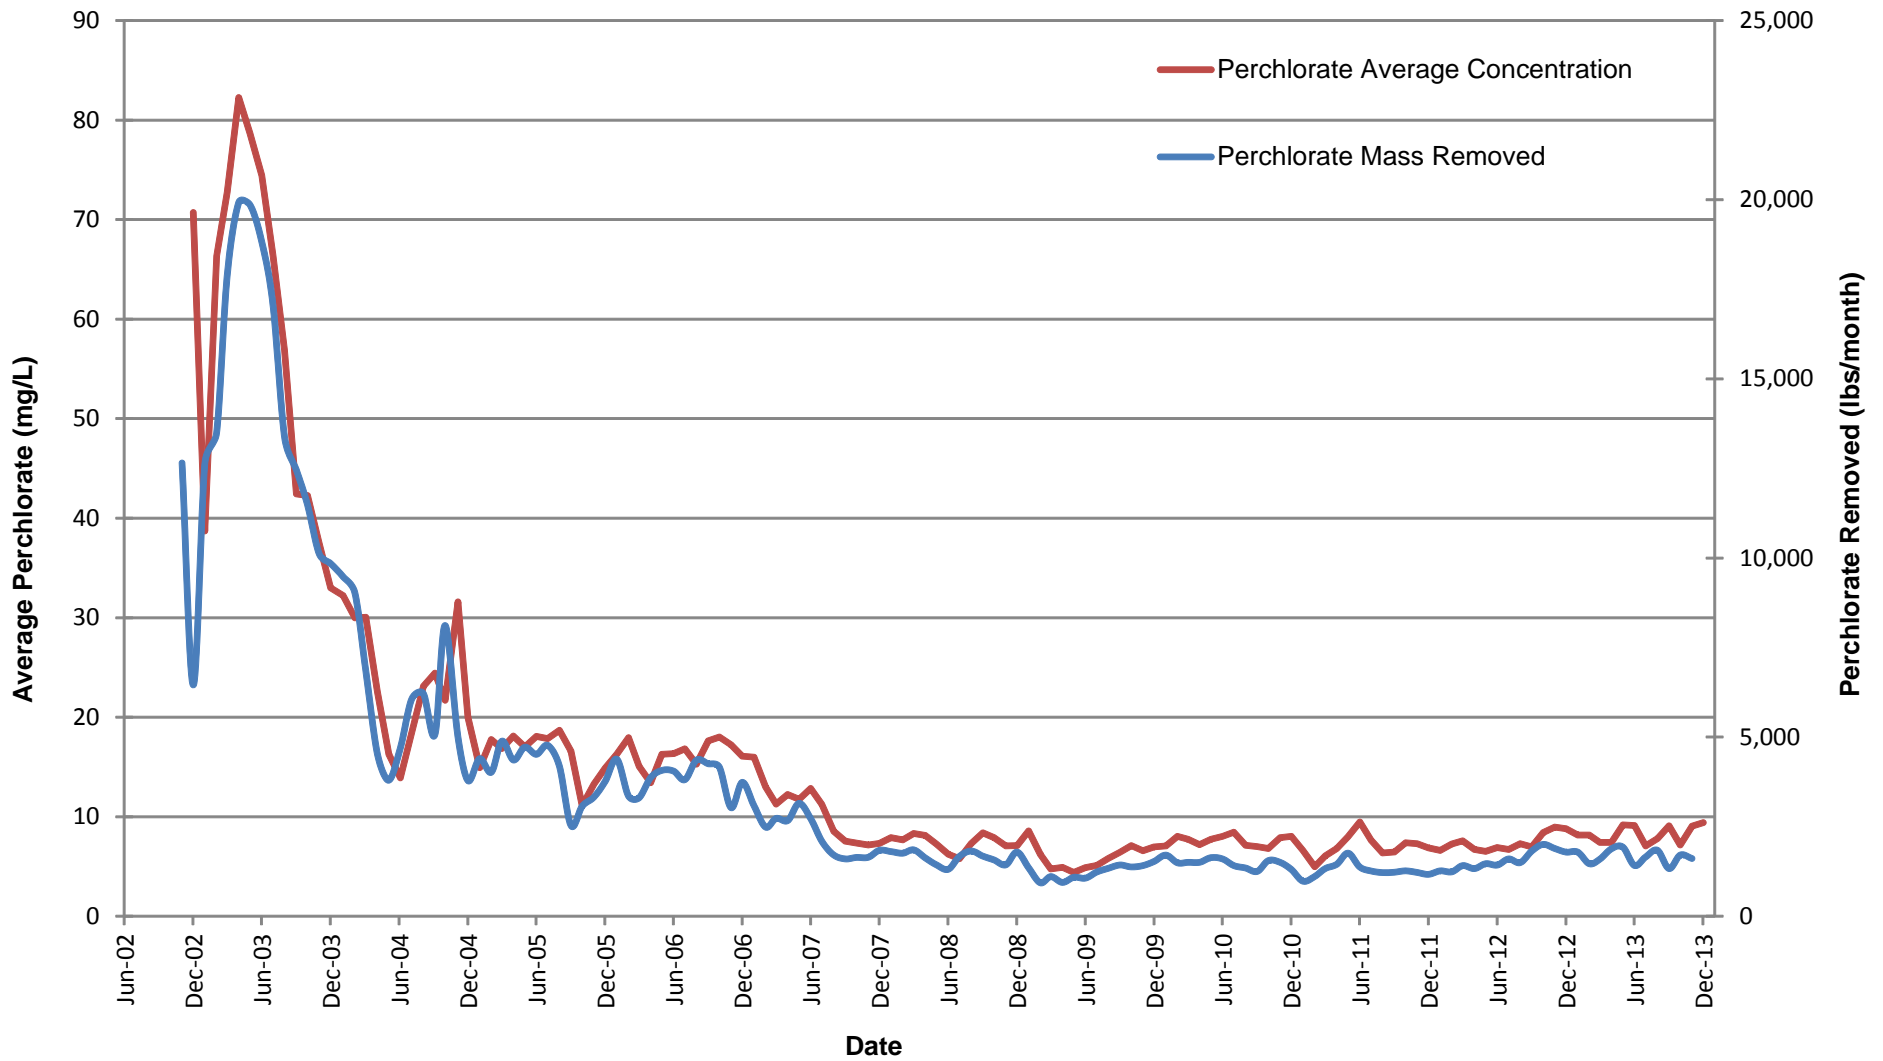
Figure
28

Seep Well Field Average Perchlorate Concentration and Mass Removed
 Nevada Environmental Response Trust Site
 Henderson, Nevada

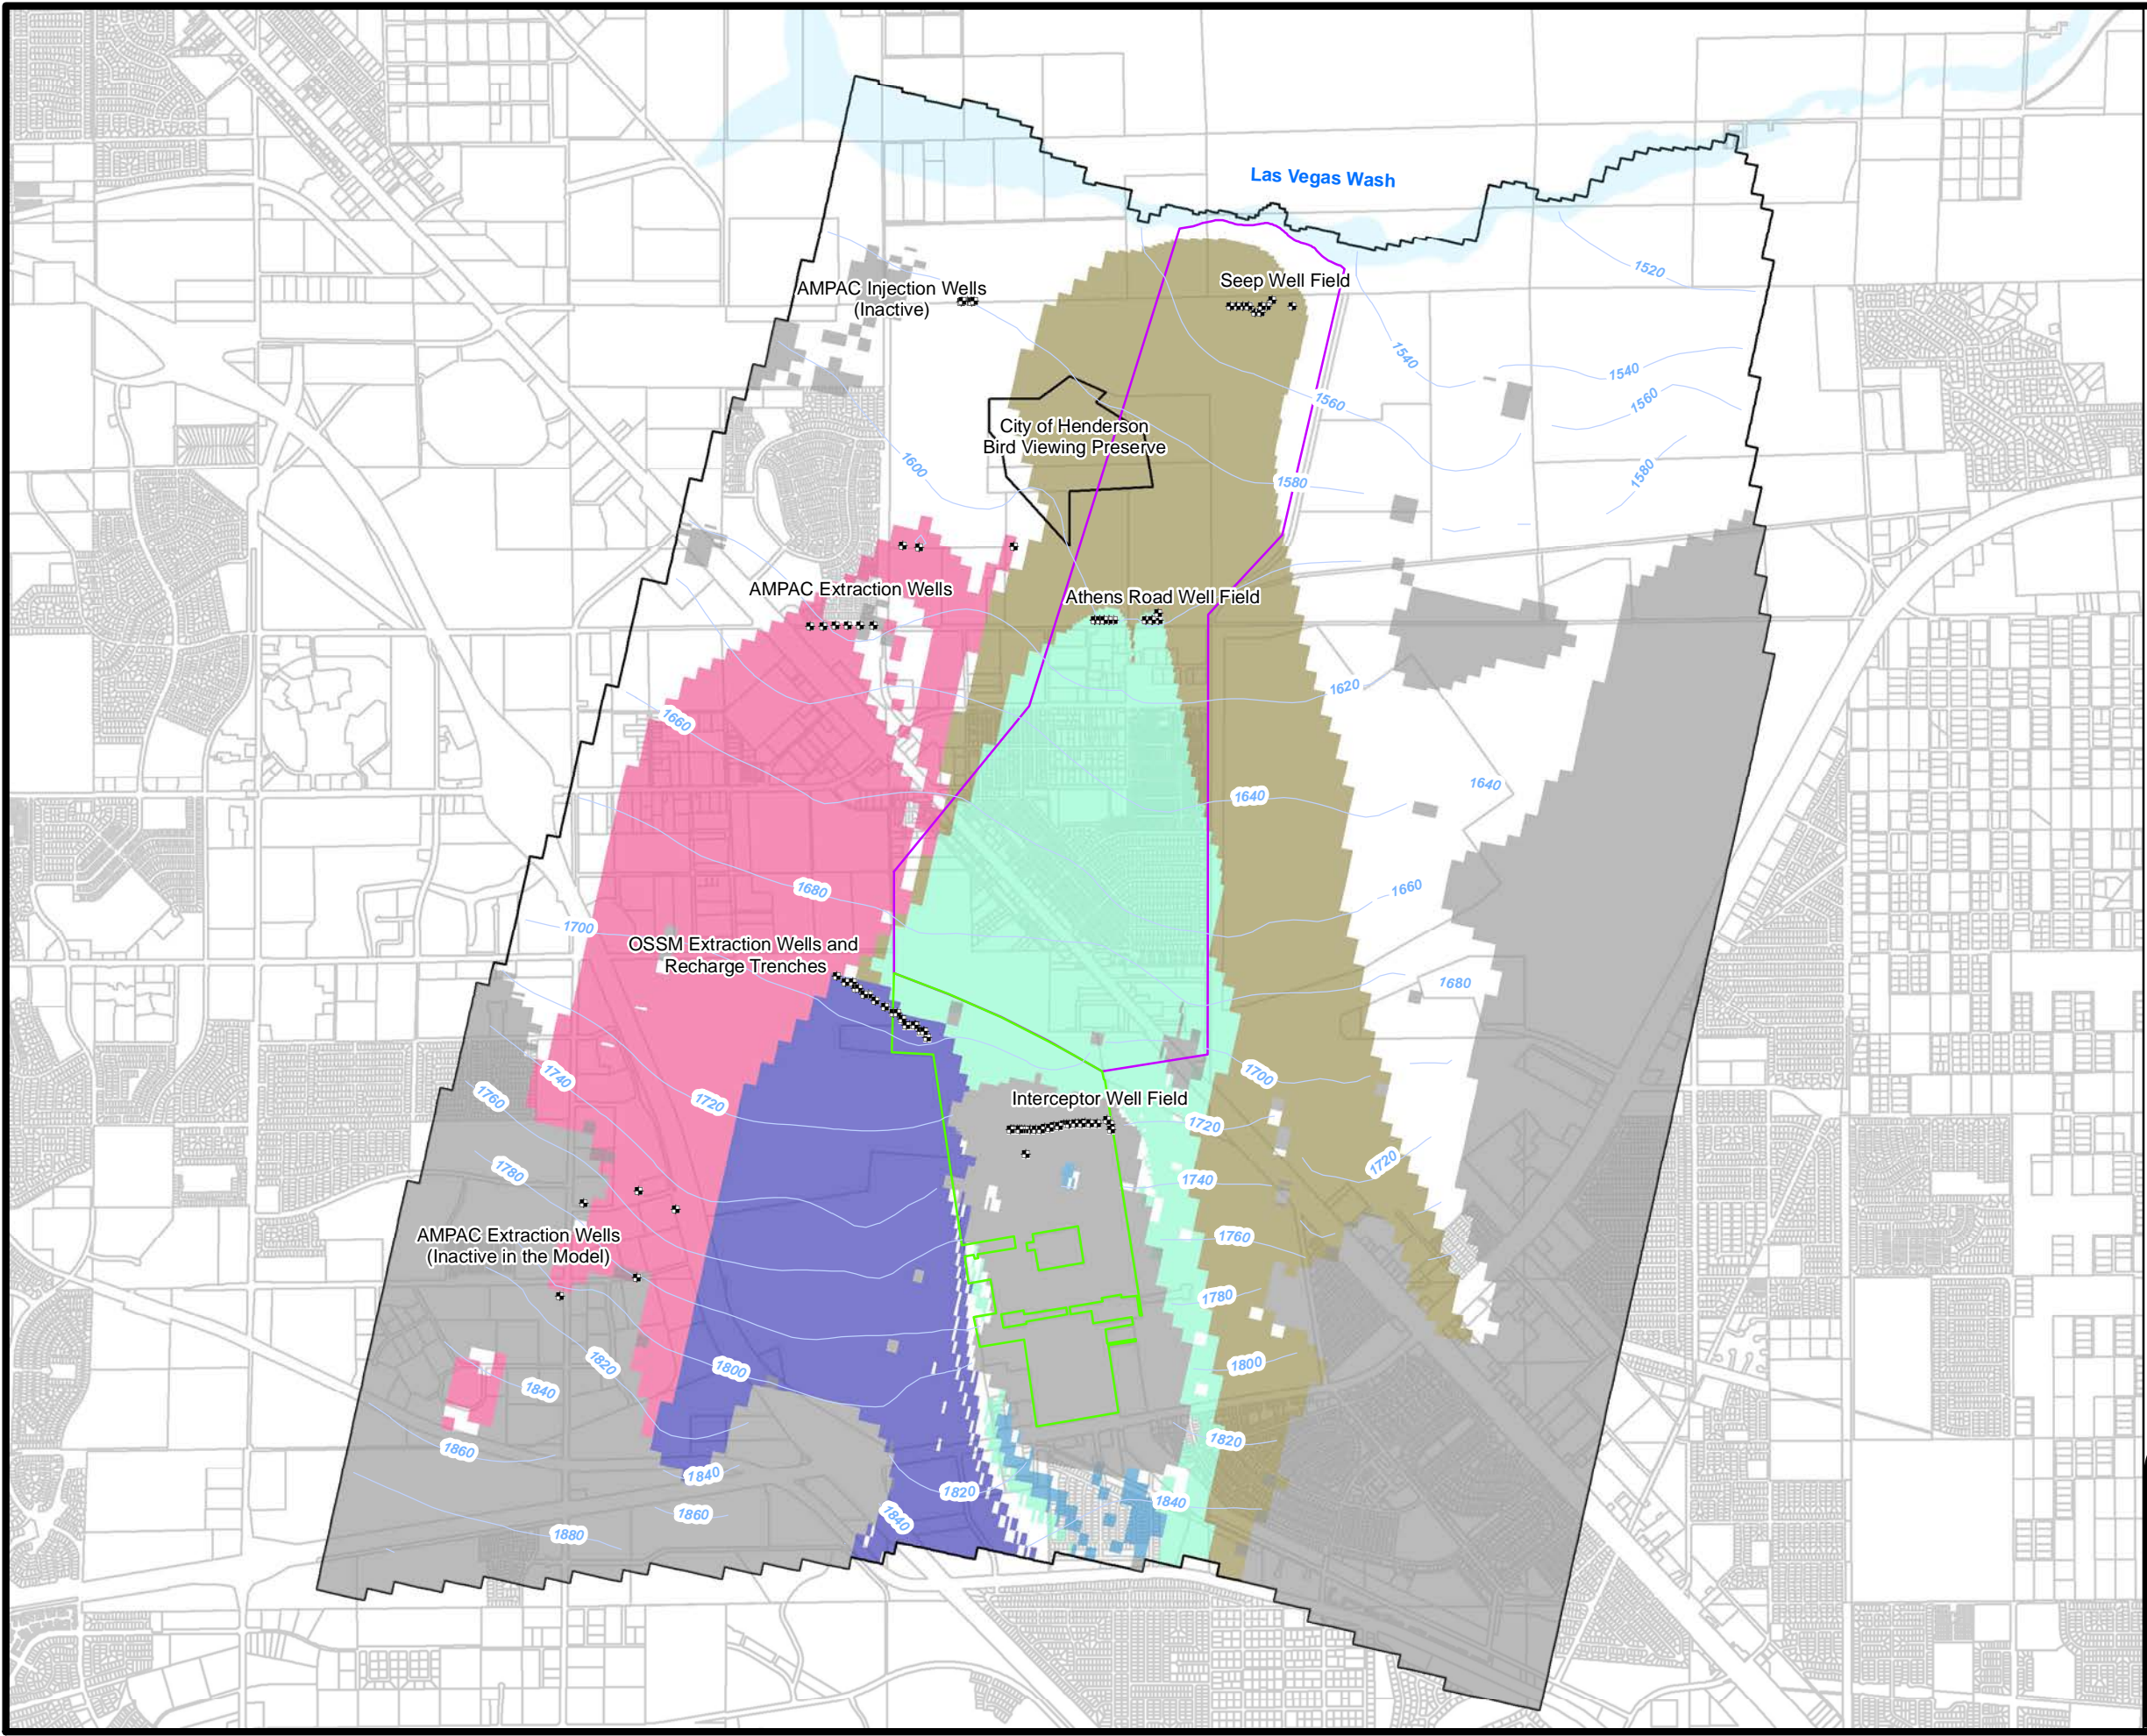
Capture Zones - Alluvium
 Nevada Environmental Response Trust Site
 Henderson, Nevada

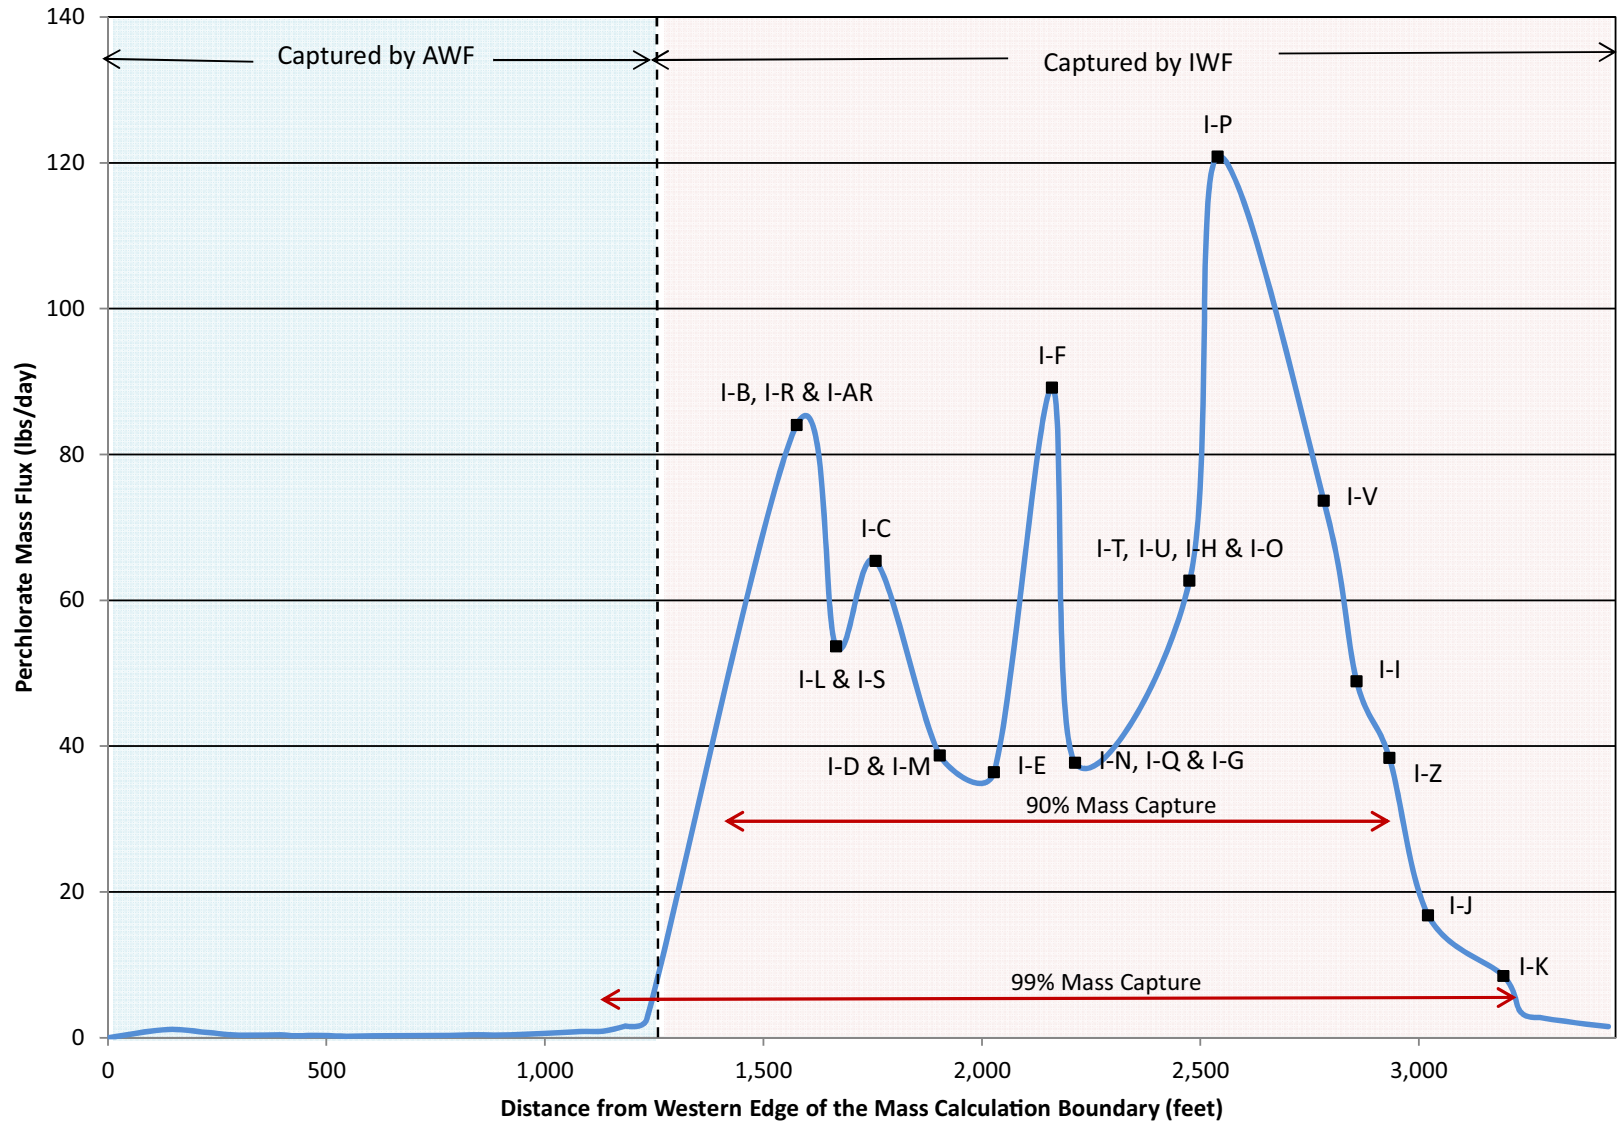
30b

Perchlorate Mass Flux at Interceptor Well Field
 Nevada Environmental Response Trust (NERT) Site
 Henderson, Nevada

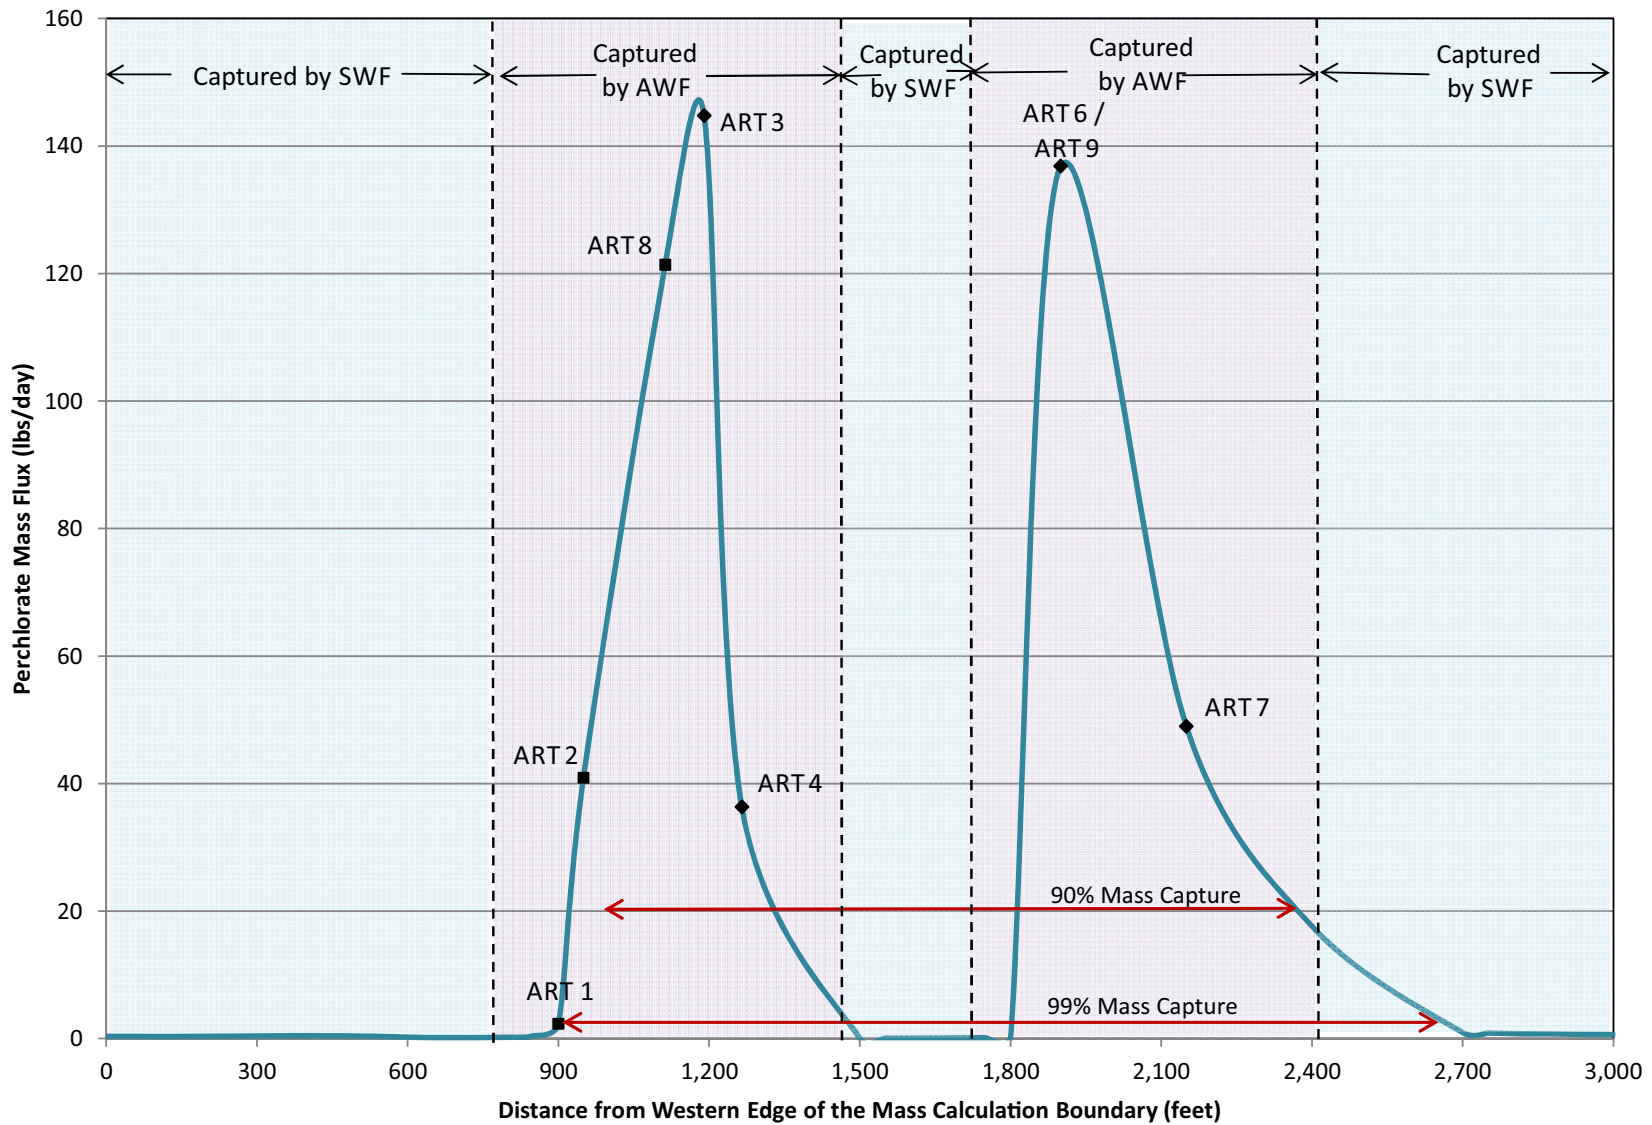
30c

Perchlorate Mass Flux at Athens Well Field
 Nevada Environmental Response Trust (NERT) Site
 Henderson, Nevada

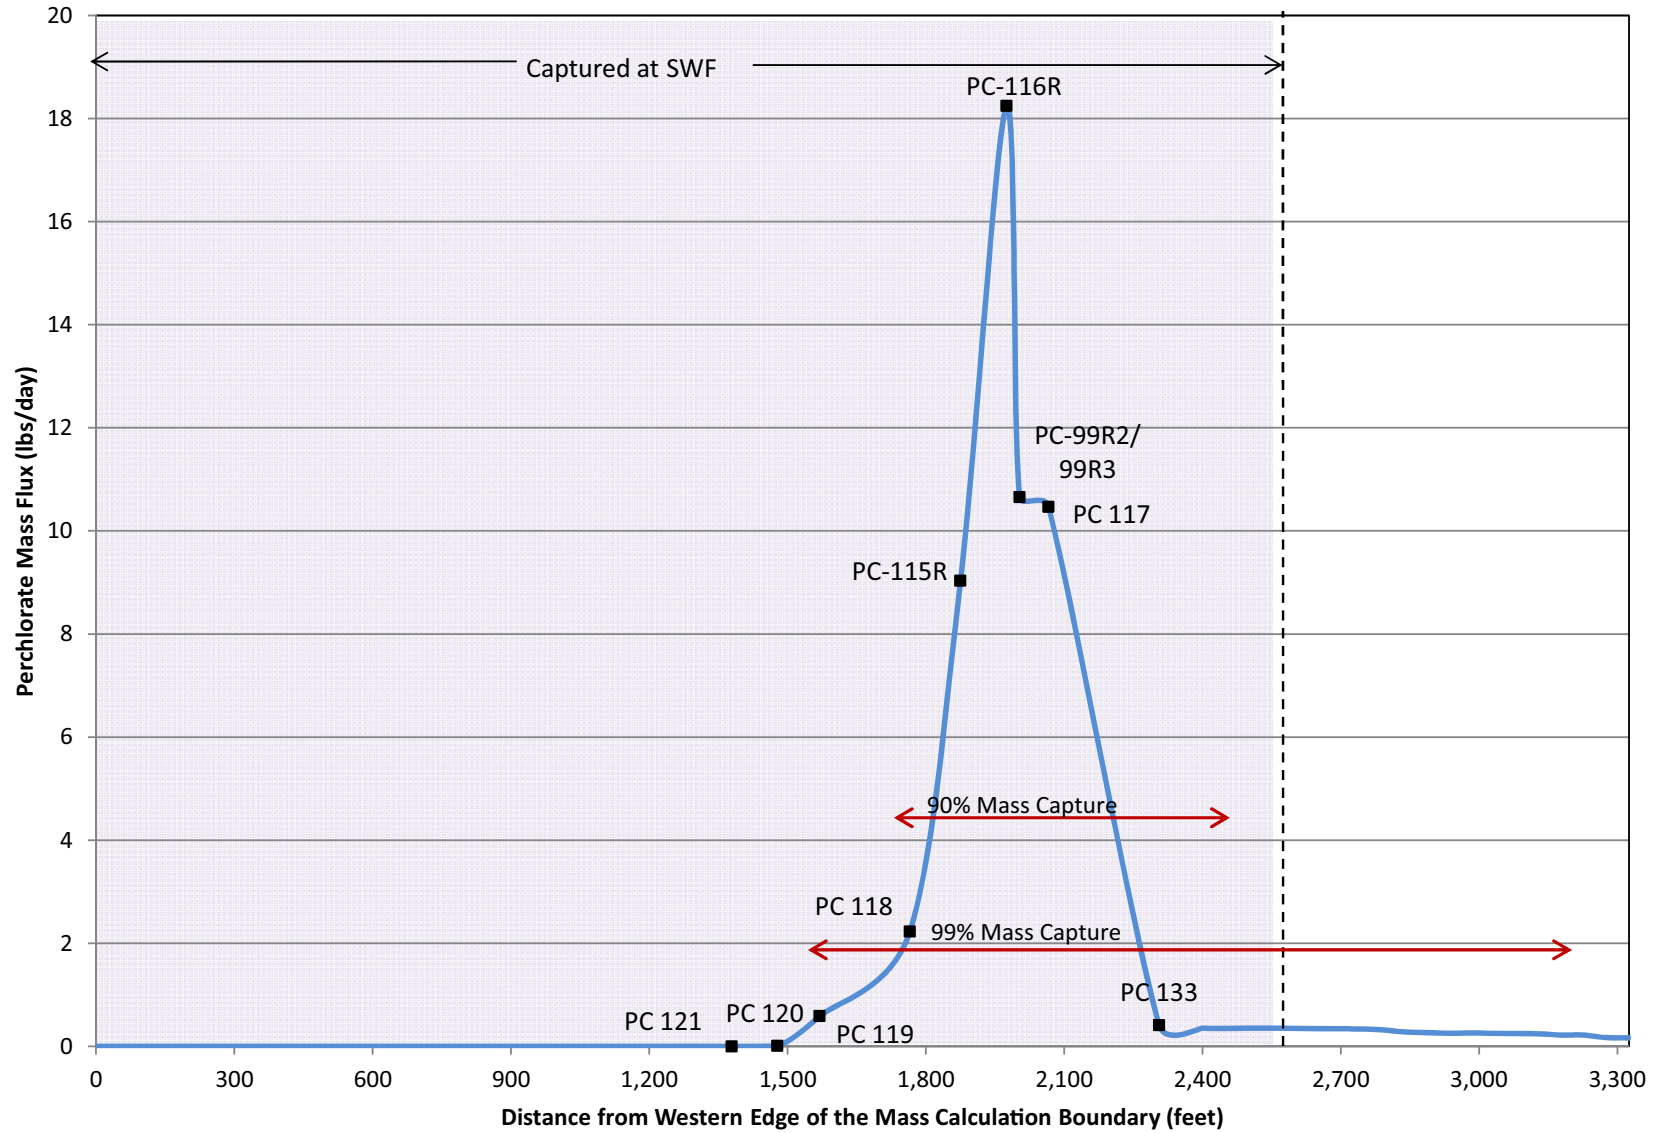
30d

Perchlorate Mass Flux at Seep Well Field
 Nevada Environmental Response Trust (NERT) Site
 Henderson, Nevada

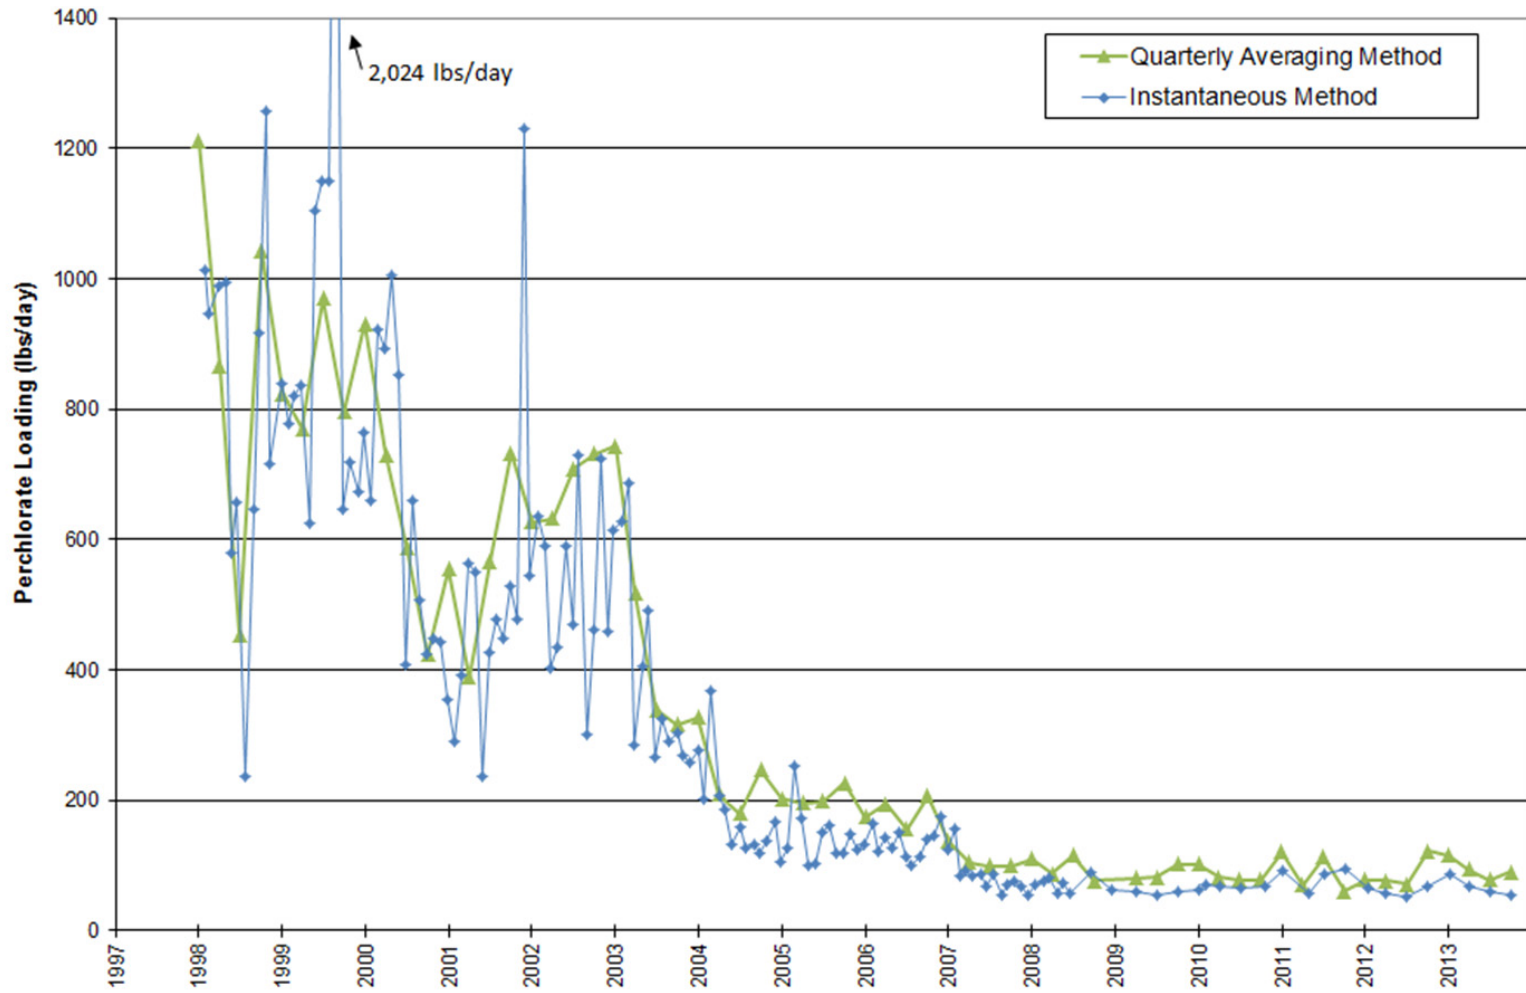
31b

Historical Perchlorate Loading in the Las Vegas Wash at Northshore Road
Nevada Environmental Response Trust (NERT) Site
Henderson, Nevada

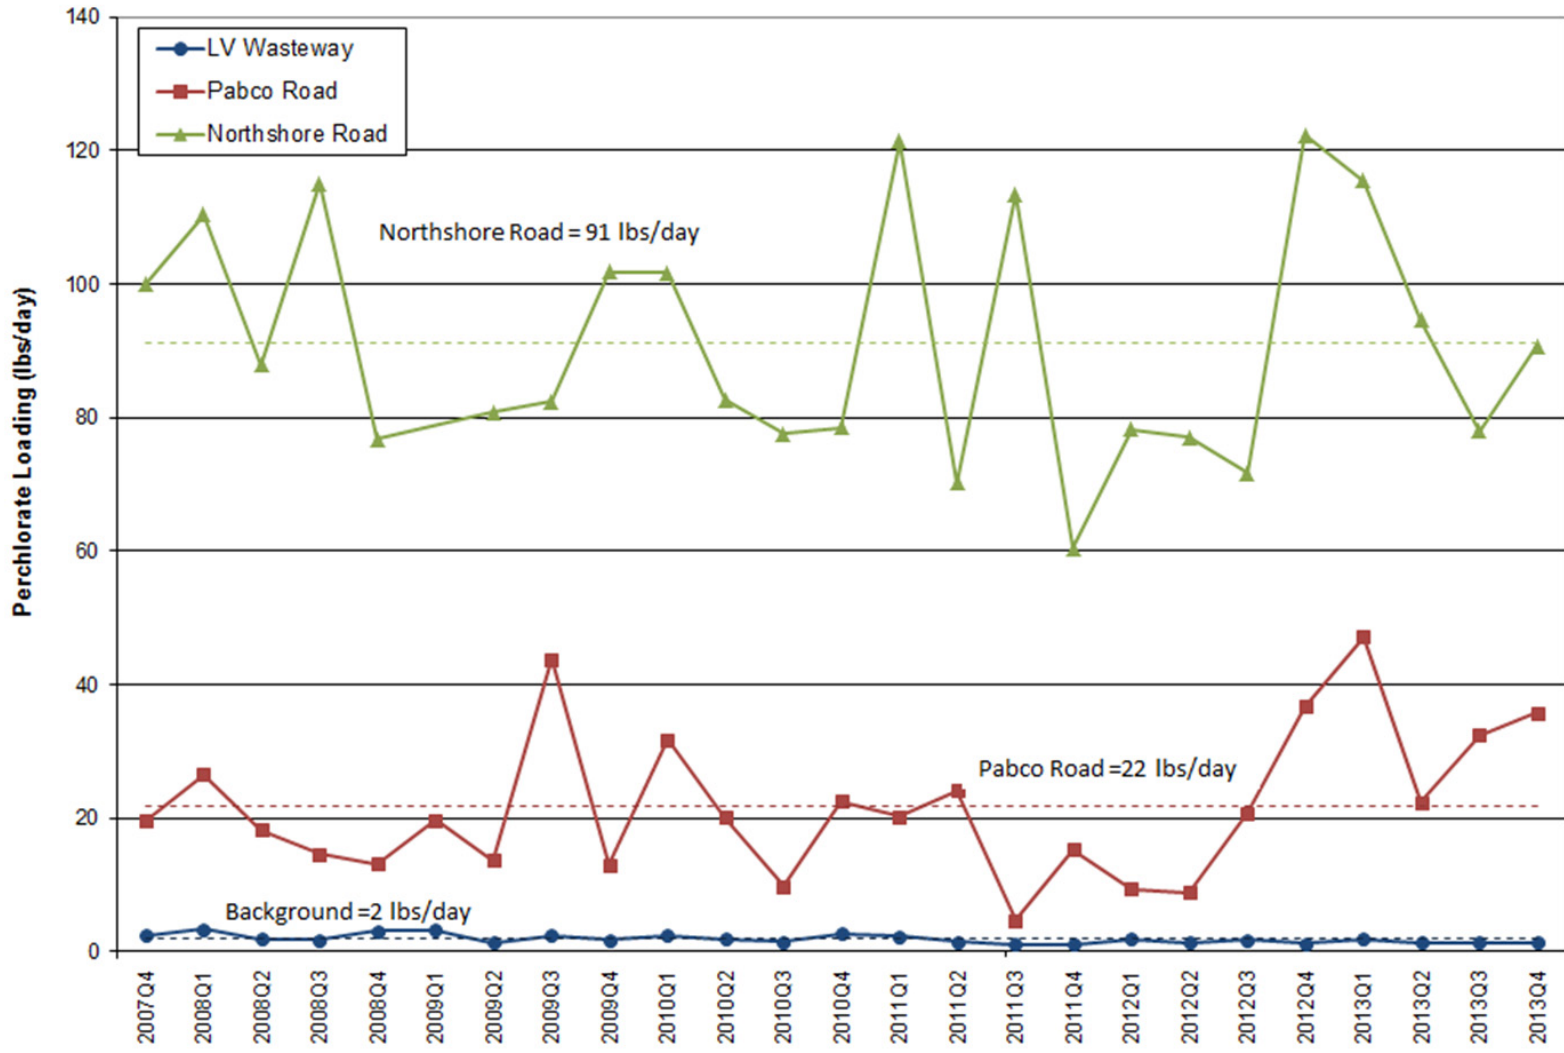
Figure
31c

Recent Quarterly Average Perchlorate Loading in the Las Vegas Wash
 Nevada Environmental Response Trust (NERT) Site
 Henderson, Nevada
