Final Demolition Work Plan

Unit 4 Cell Building

Nevada Environmental Response Trust Site

February 9, 2016

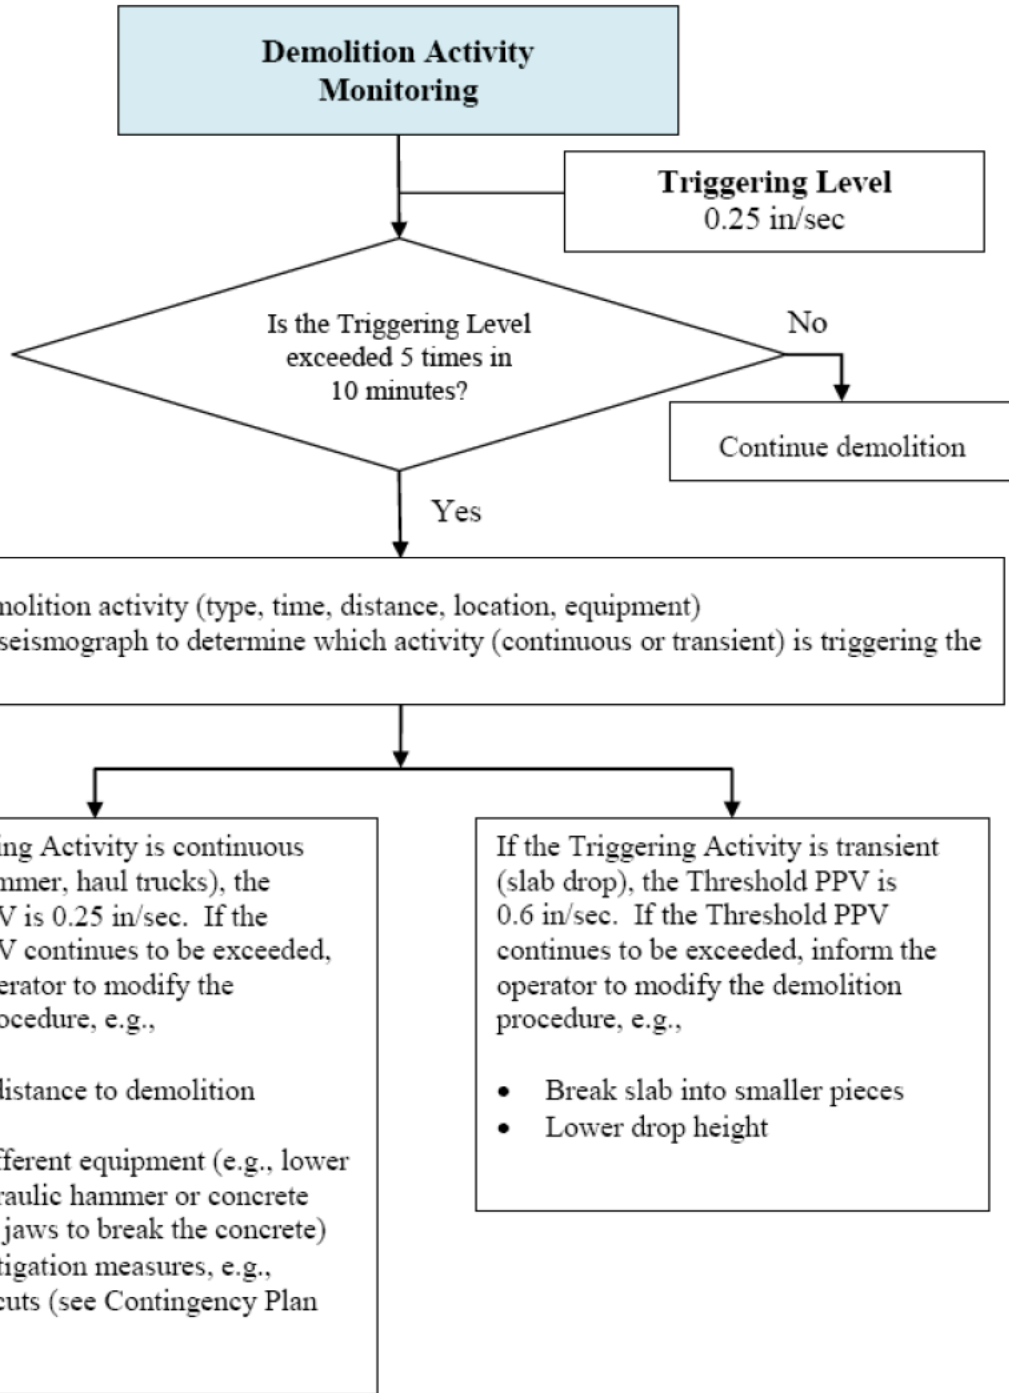
JAN 25, 2016 U:\BOULDER\INERT\MXD\UNIT_4\2016 UPDATE\FIG03_DEMOLITIONMONITORING.MXD

Figure 3 provides a logic flow diagram that describes how the vibration monitoring results will be used to guide the demolition activities and what actions will be taken if the threshold values are exceeded. Figure 3 references a Contingency Plan section. That reference is to the Contingency Plan section of the Demolition Vibration Impact Study. The Contingency Plan sections recommends the following actions if the vibrations are exceeding the acceptable PPV thresholds, or if better control and/or dampening of the vibrations is desired:

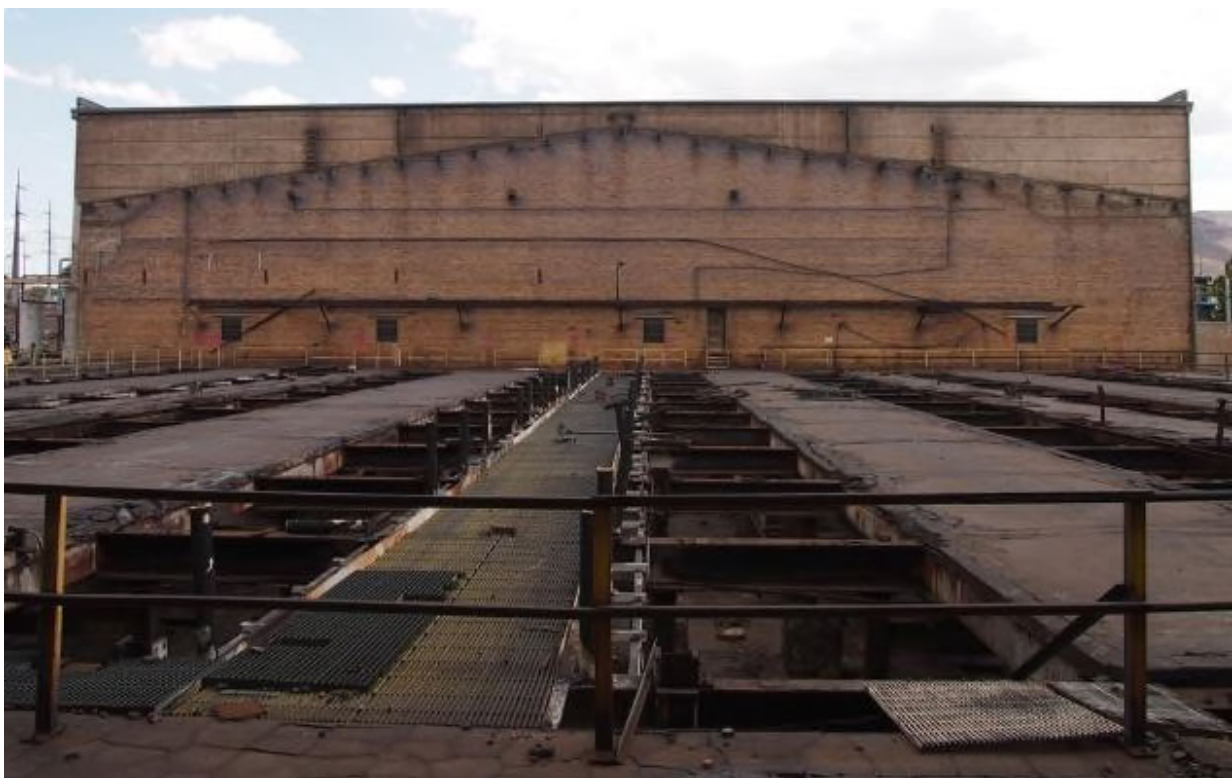
Figure 3: Unit 4 Substation Building brick wall, looking south

The Unit 4 Substation Building has been affected by the removal of the roof structure over the Cell Floor Area, as shown in Figure 3. The north wall has a partial brick façade with visibly loose bricks along the upper portions, as shown in Figure 6. There are also visible horizontal ties to the CMU walls behind the brick; it is assumed that this construction method is typical and the brick is tied to the CMU wall throughout.

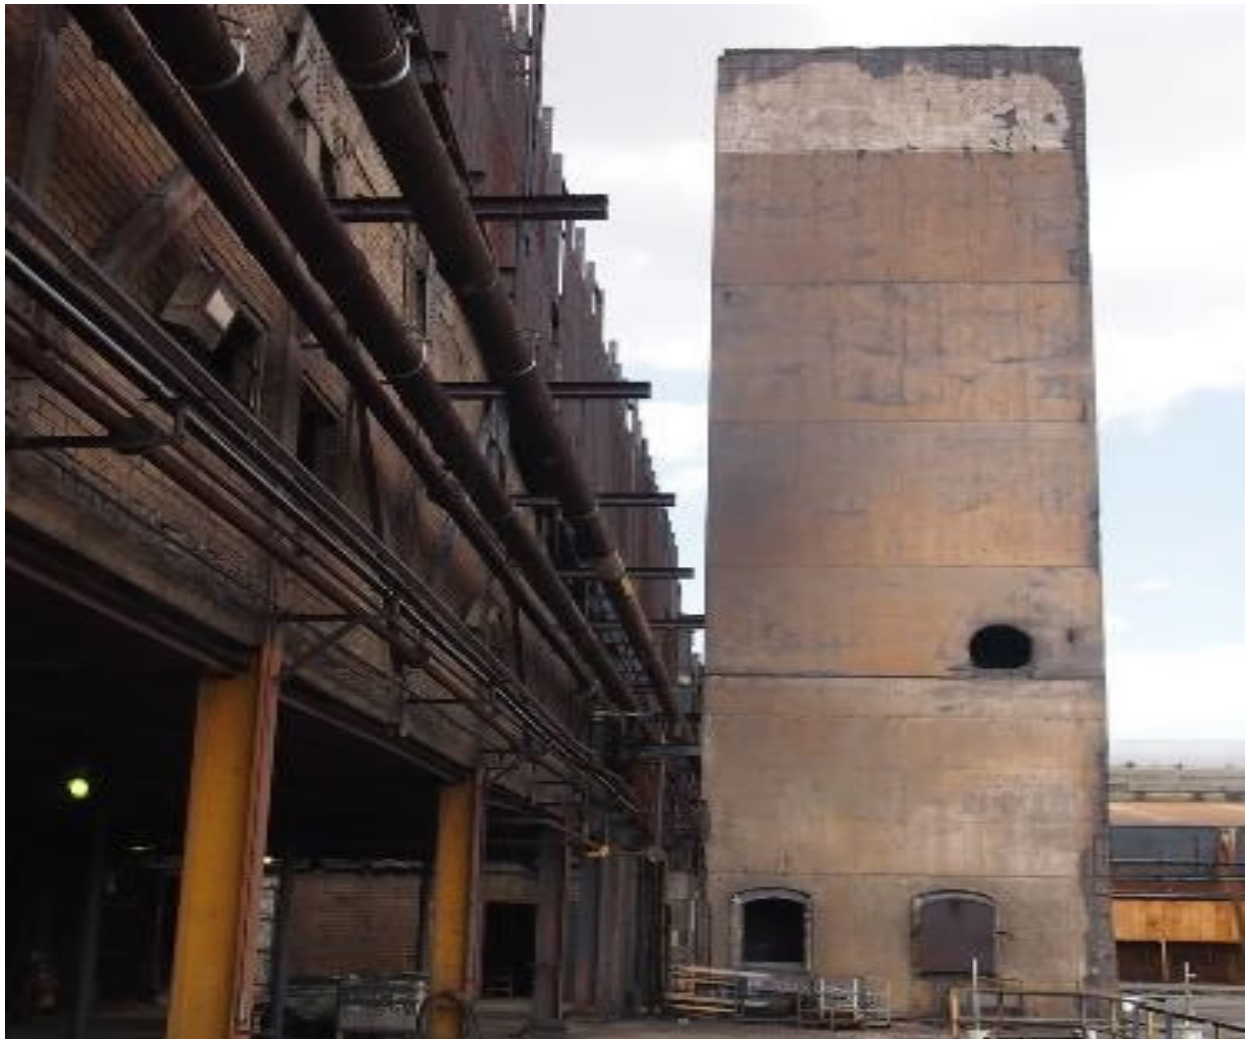
A Wash Down Tower is located east of the Unit 4 Cell Floor Area and south of the Unit 4 Chlorinator Building, as shown in Figure 5. The Wash Down Tower is constructed of concrete and has brick lining. The Wash Down Tower is not currently in operation, and a few ground level openings have been infilled with brick.

Figure 5: Unit 4 Wash Down Tower, looking east

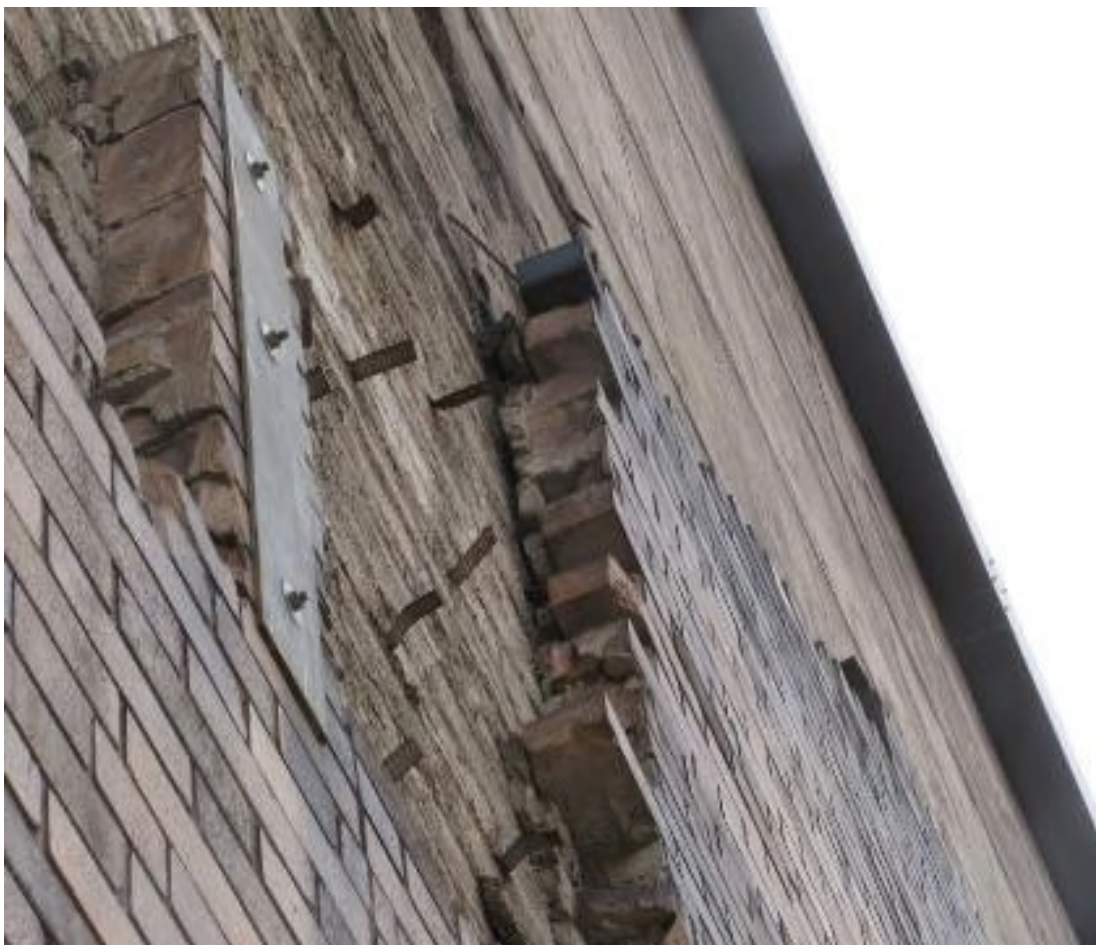
Figure 6: Loose façade bricks on the north wall of Unit 4 Substation Building

The north side of the Substation Building includes a brick façade from which bricks have reportedly periodically fallen in the past. While the falling bricks do not hamper the structural integrity of the wall, they could cause injury

to workers if they were to be struck by the falling bricks. To address that concern, the area below that wall will be cordoned off from all pedestrian access prior to and during the demolition activities. At the start of the demolition activities the visibly loose bricks on this wall will be carefully removed to minimize bricks that may fall. In the event that other façade bricks become loose, they will fall harmlessly to the ground within the cordoned off area.

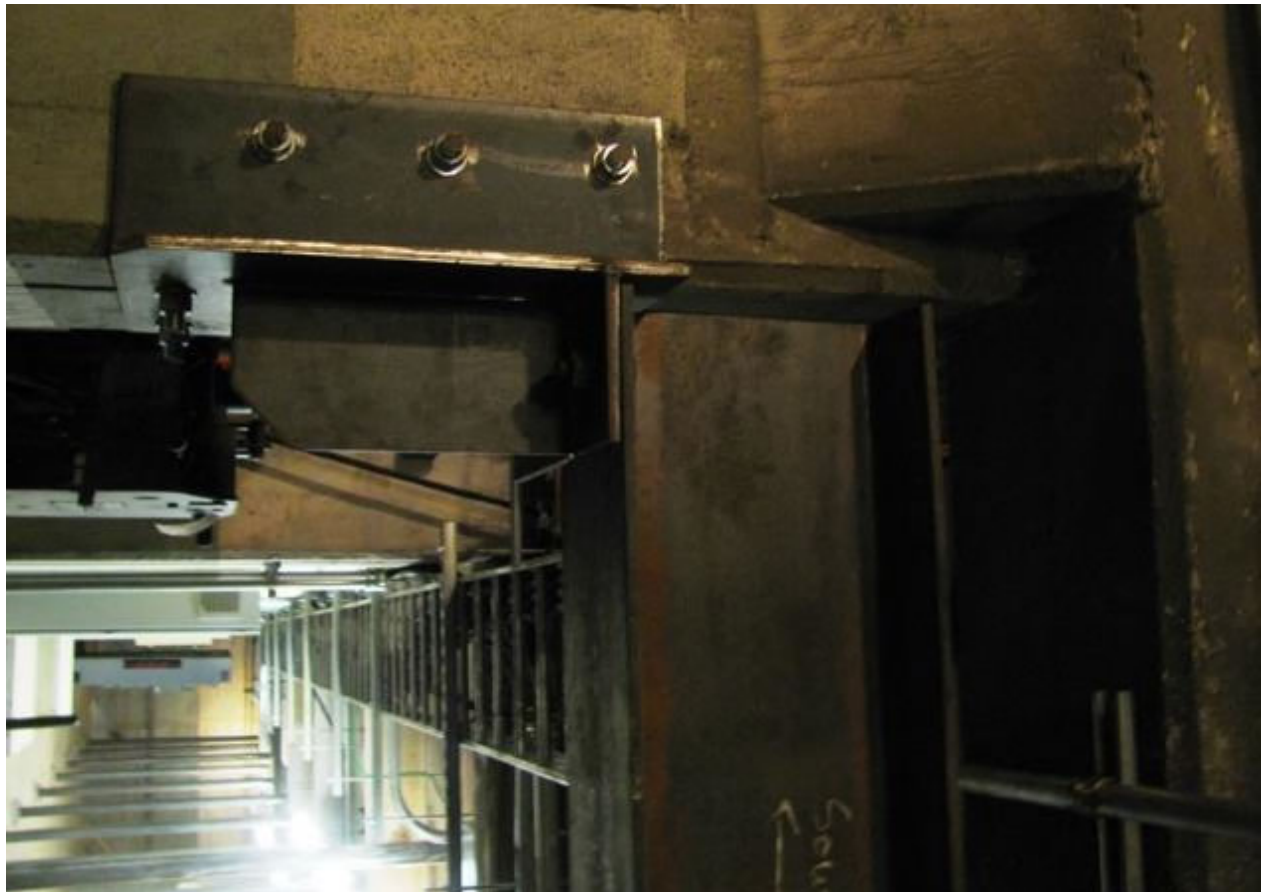
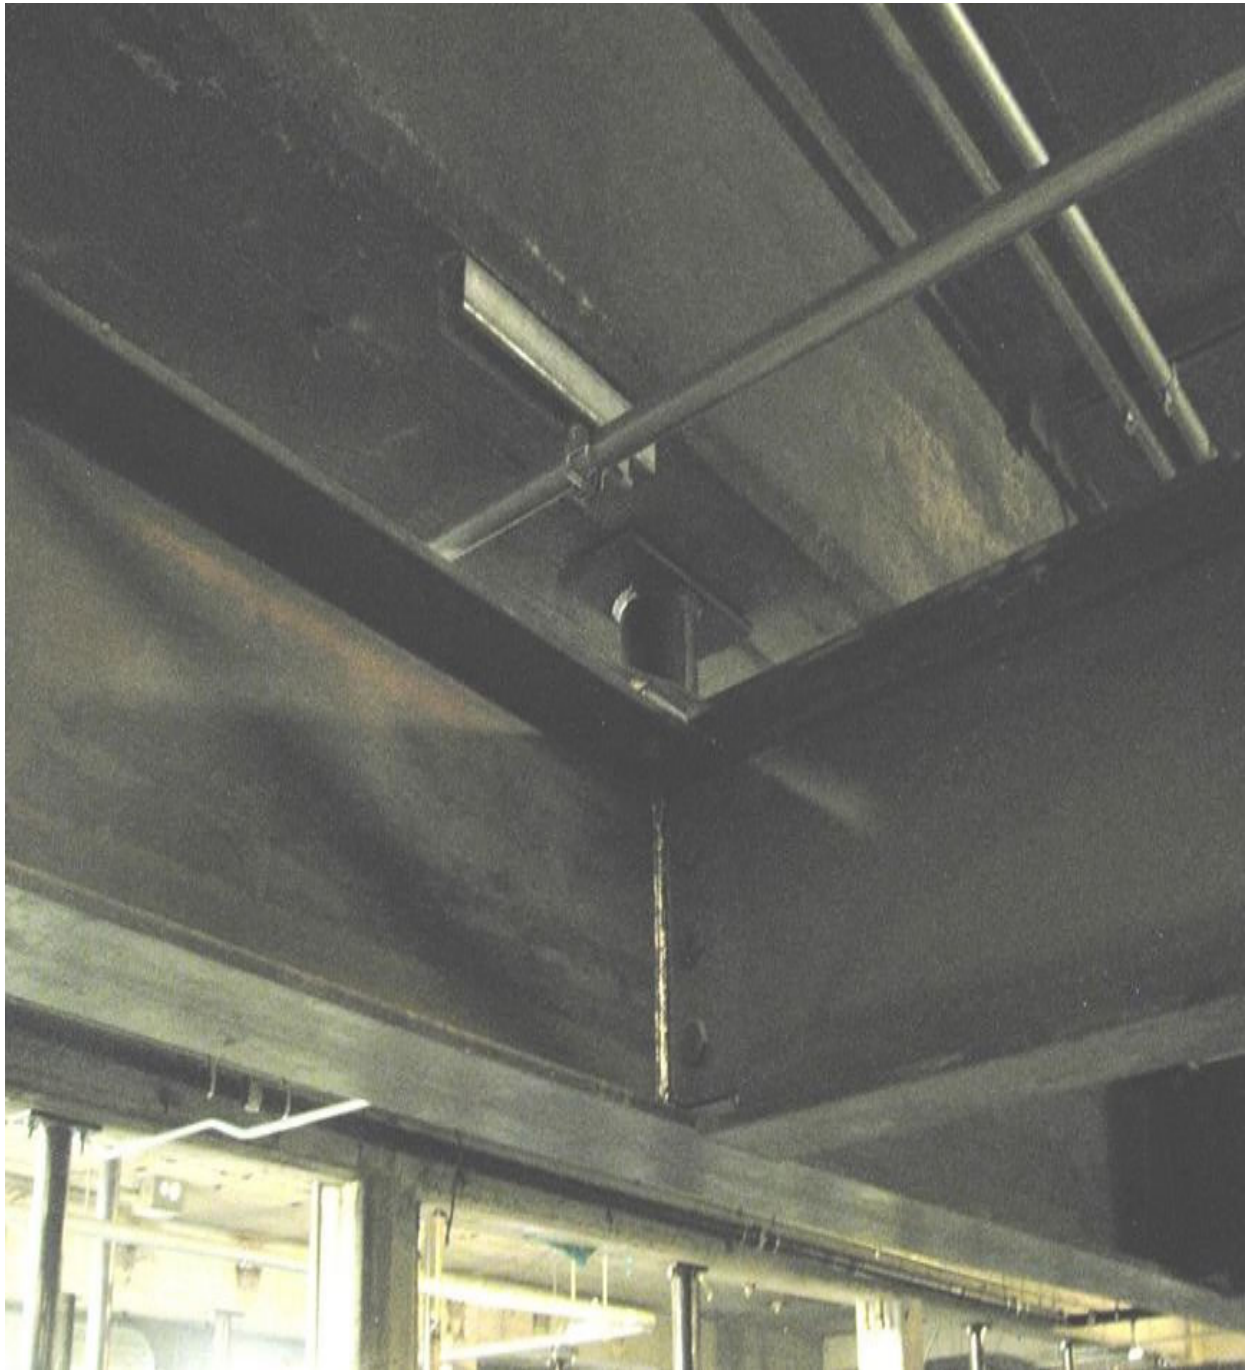
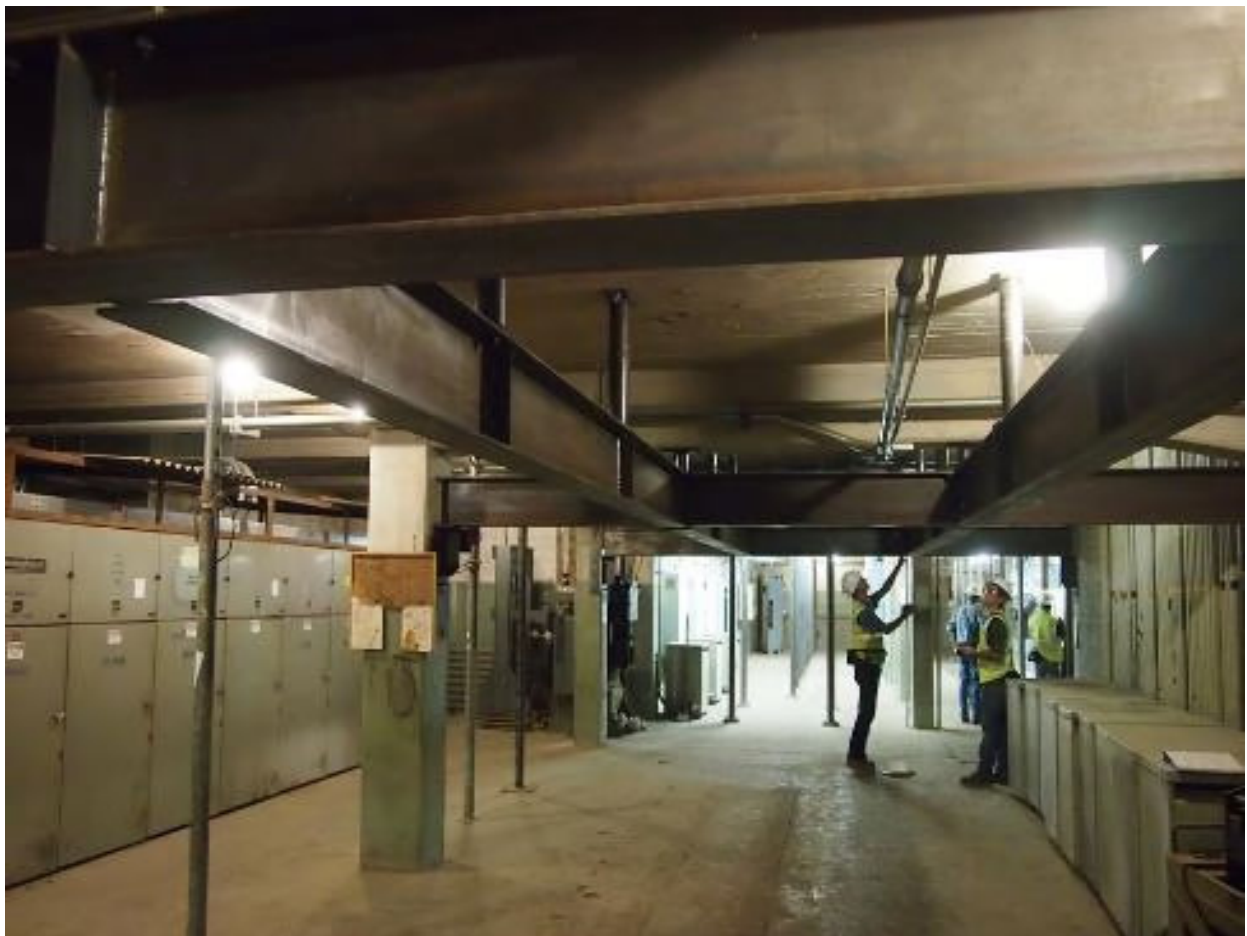
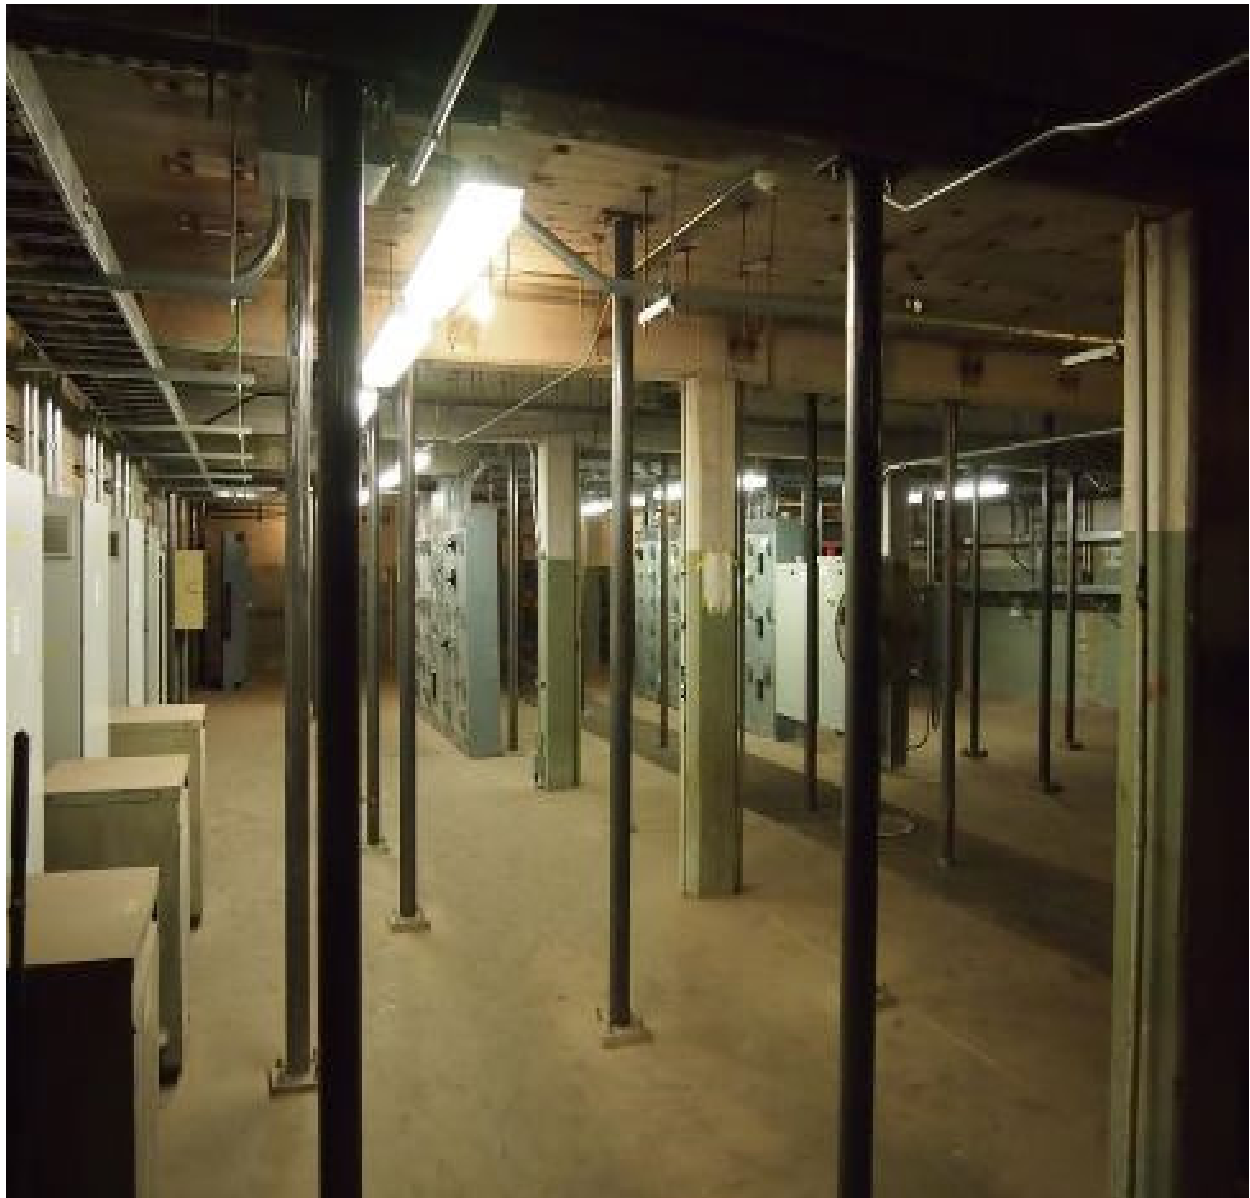
The ground level floor was substantially reinforced with steel beams and columns. Our Tronox escort indicated that this reinforcing was done to allow fork lift access on the ground level floor. See Figures 8, 9, 10 and 11 for illustration of this reinforcing.

Figure 8: Floor reinforcing bracket, Unit 4 Substation Building

Figure 9: Floor reinforcing beams, Unit 4 Substation Building

Figure 10: Floor reinforcing beams, Unit 4 Substation Building

Figure 11: Floor reinforcing columns, Unit 4 Substation Building

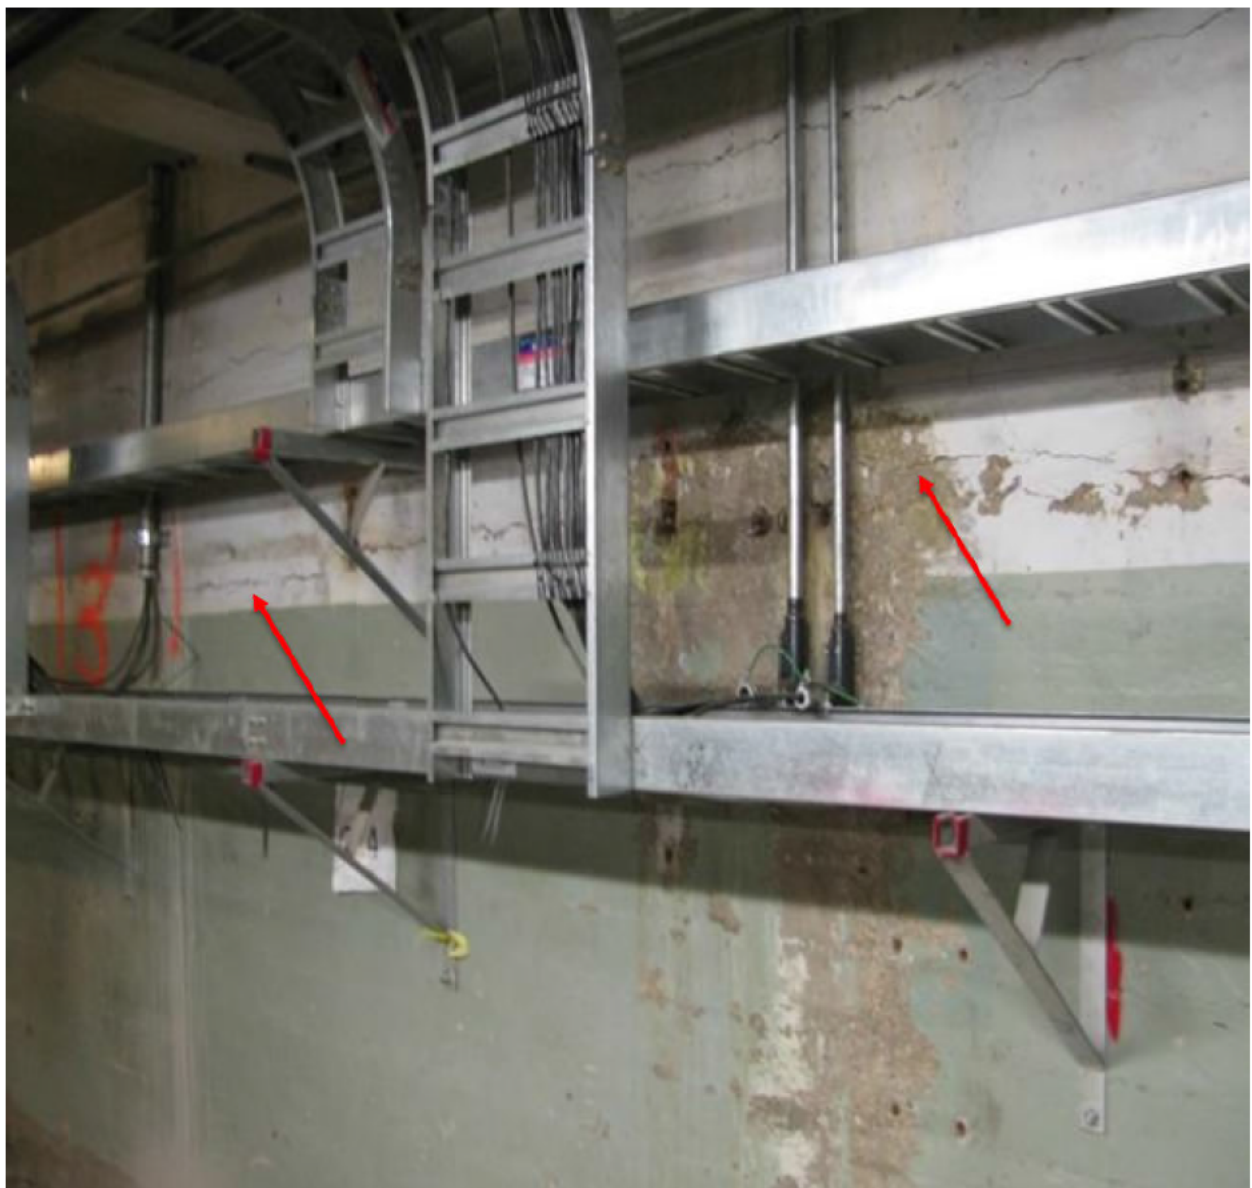
The north basement wall has significant horizontal cracking that appears to align with the bottom of the curtain slab in the Unit 4 Cell Floor Area. Figure 12 shows the cracks along a portion of that wall. The basement wall has also been modified with two gated doorways to provide personnel access to the adjacent Unit 4 Cell Area basement. There is one doorway on the west end and one on the east end of the Unit 4 Substation Building. Our escort indicated that these doorways were cut into the wall utilizing existing penetrations in the wall. It was also indicated that the horizontal cracking had already occurred at that time, and each doorway was reinforced with a steel channel header. A

Figure 12: Horizontal cracks in basement north wall

Cracks are present in the basement wall that separates the Cell Building from the Substation Building. The basement wall will be reinforced to restore the strength of the wall. Epoxy and grout injection technology will be utilized to provide the necessary reinforcing.

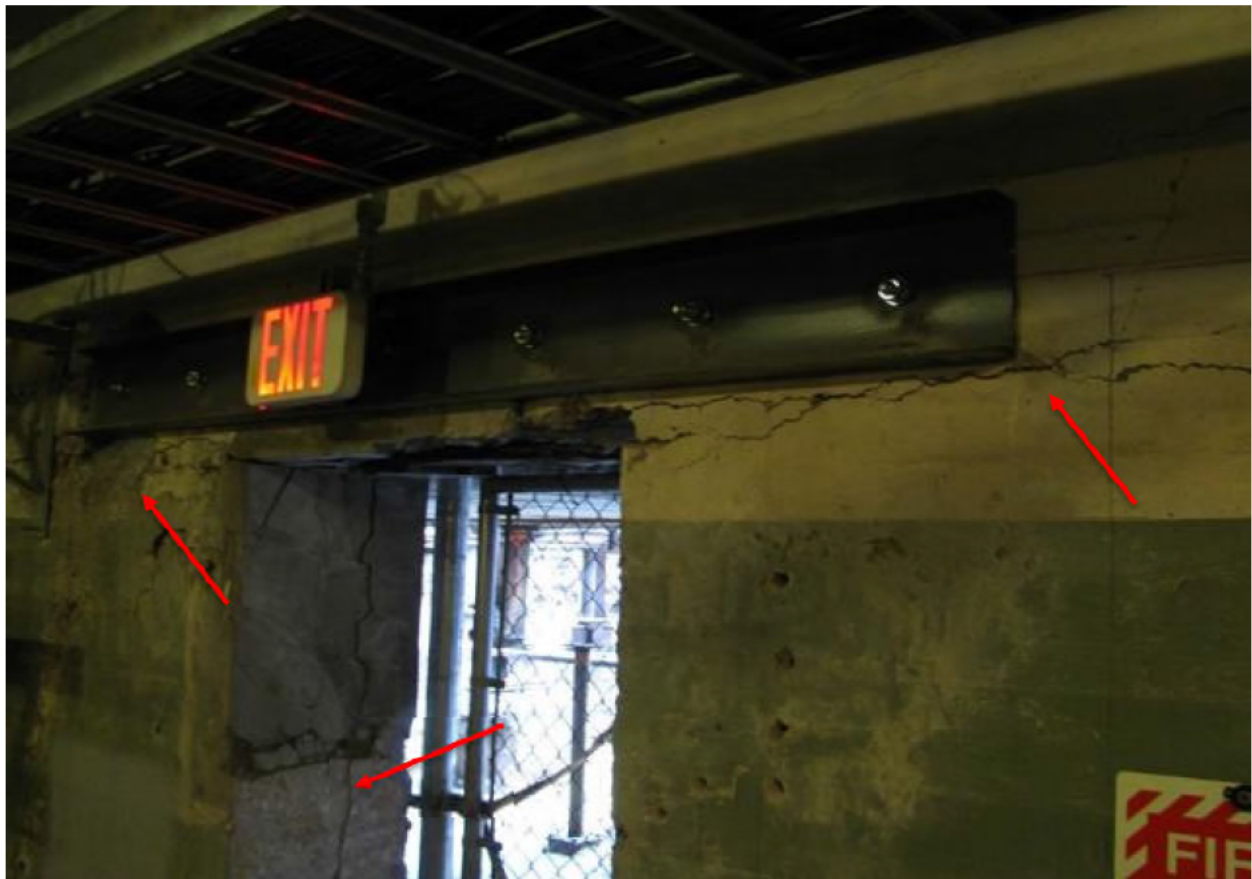
significant vertical crack was observed and can be seen in Figure 13 in the exterior wall at the outside middle third of the wall section. Both doorways are in similar condition.

Figure 13: Horizontal cracks in Unit 4 Substation Building basement wall near eastern door, and vertical crack in the wall section at the door opening

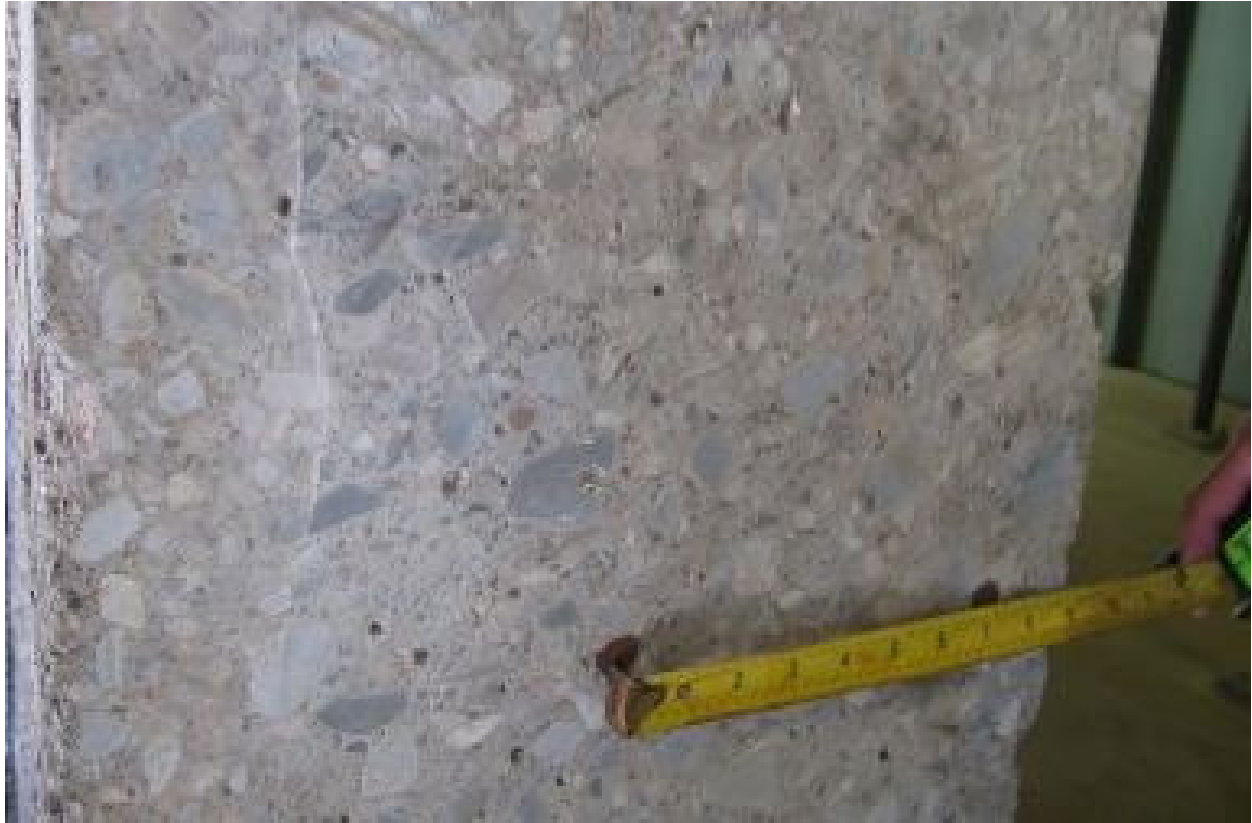
The basement wall was measured to be 16 inches thick with two layers of reinforcing, as shown in Figure 14. The wall has reinforcing at the center and the inside face, leaving an approximately 8 inch thick concrete cover adjacent to the Cell Floor Area, rather than reinforcing near both the inner and outer faces. It is suspected that this was done to provide a corrosion or thermal barrier.

Figure 14: Basement wall section at doorway to Cell Floor

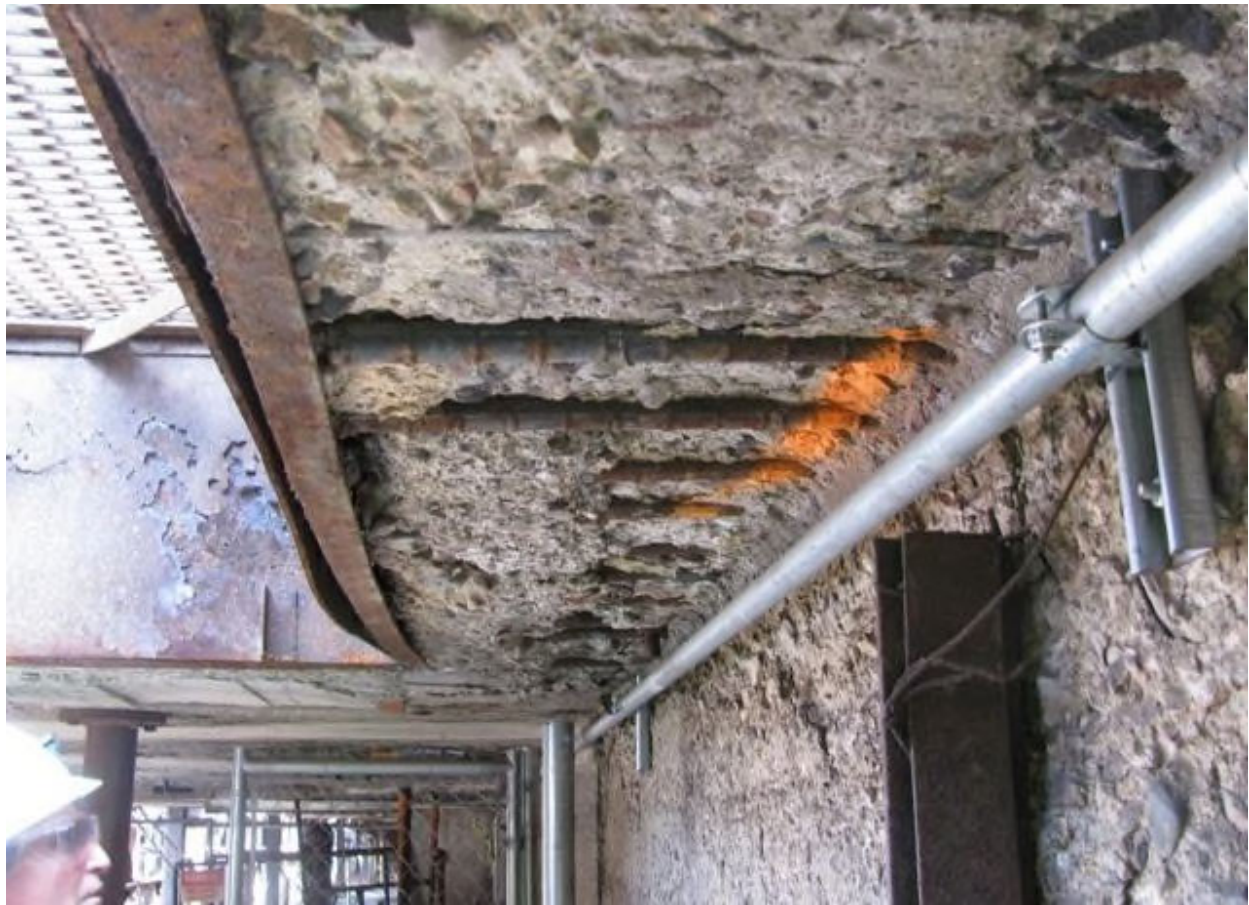
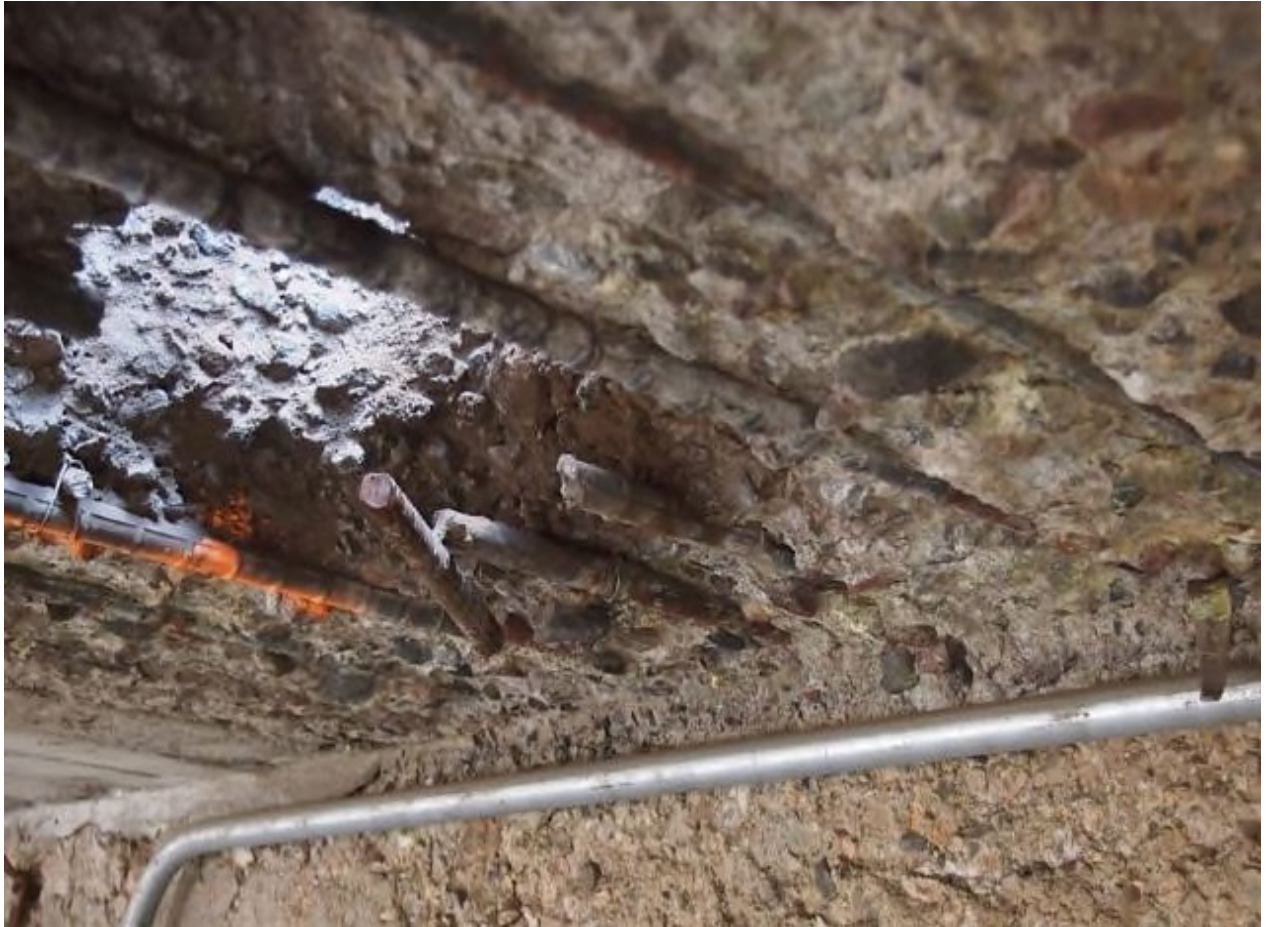
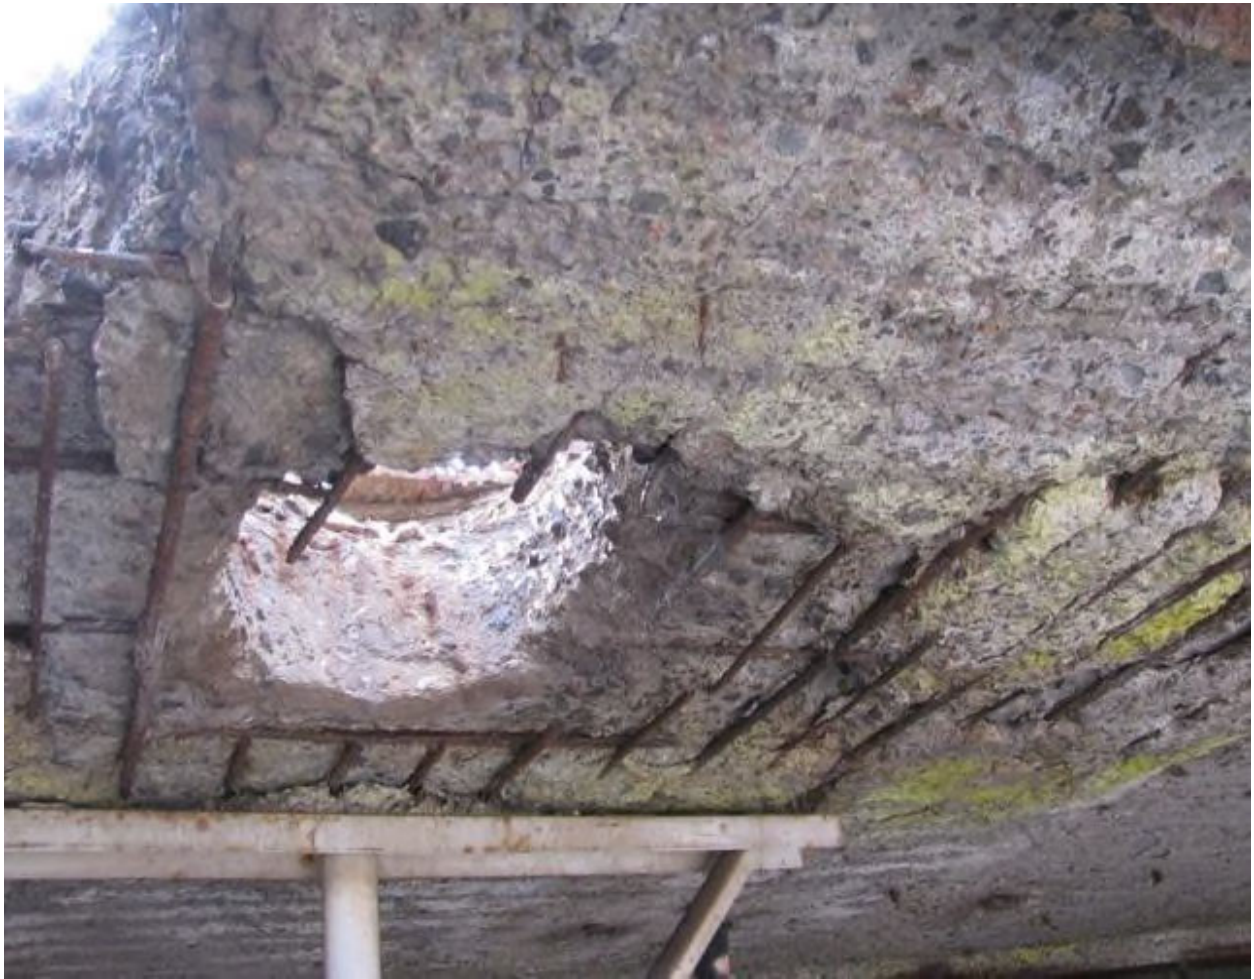
The curtain slab of the on the south side of the Unit 4 Cell Floor Area has structural support for the southern edge provided by the Unit 4 Substation Building foundation wall. The north side of this slab is supported by steel columns that bear on concrete pedestals in the basement area. The underside of the curtain slab shows severe concrete degradation and reinforcing bars are exposed and rusted. Figures 15, 16, and 17 illustrate the typical condition of the underside of the curtain slab.

Figure 15: Curtain slab of Unit 4 Cell Floor near Substation Building foundation wall

Figure 16: Curtain slab of Cell Floor near Unit 4 Substation Building foundation wall

Figure 17: Curtain slab of Unit 4 Cell Floor showing typical spalling

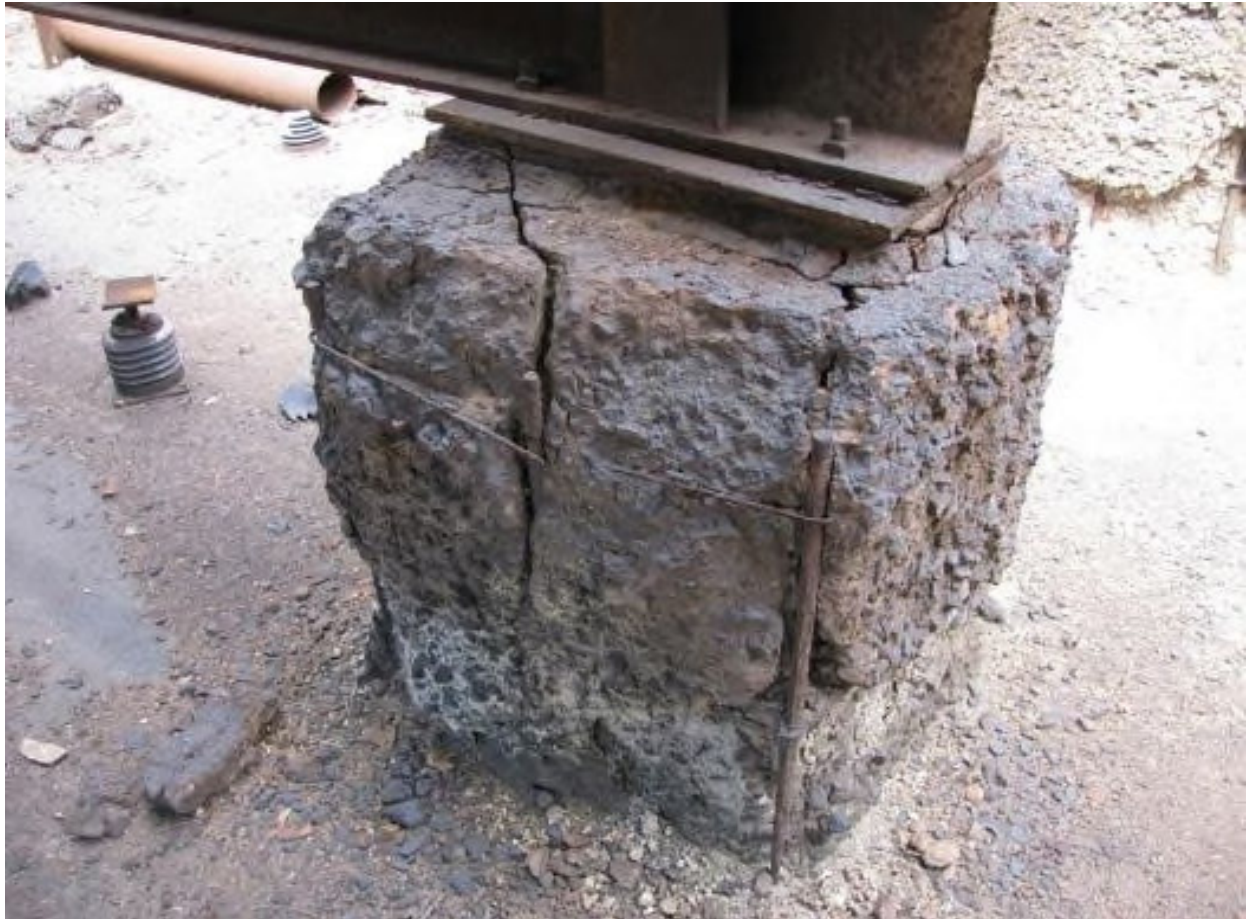
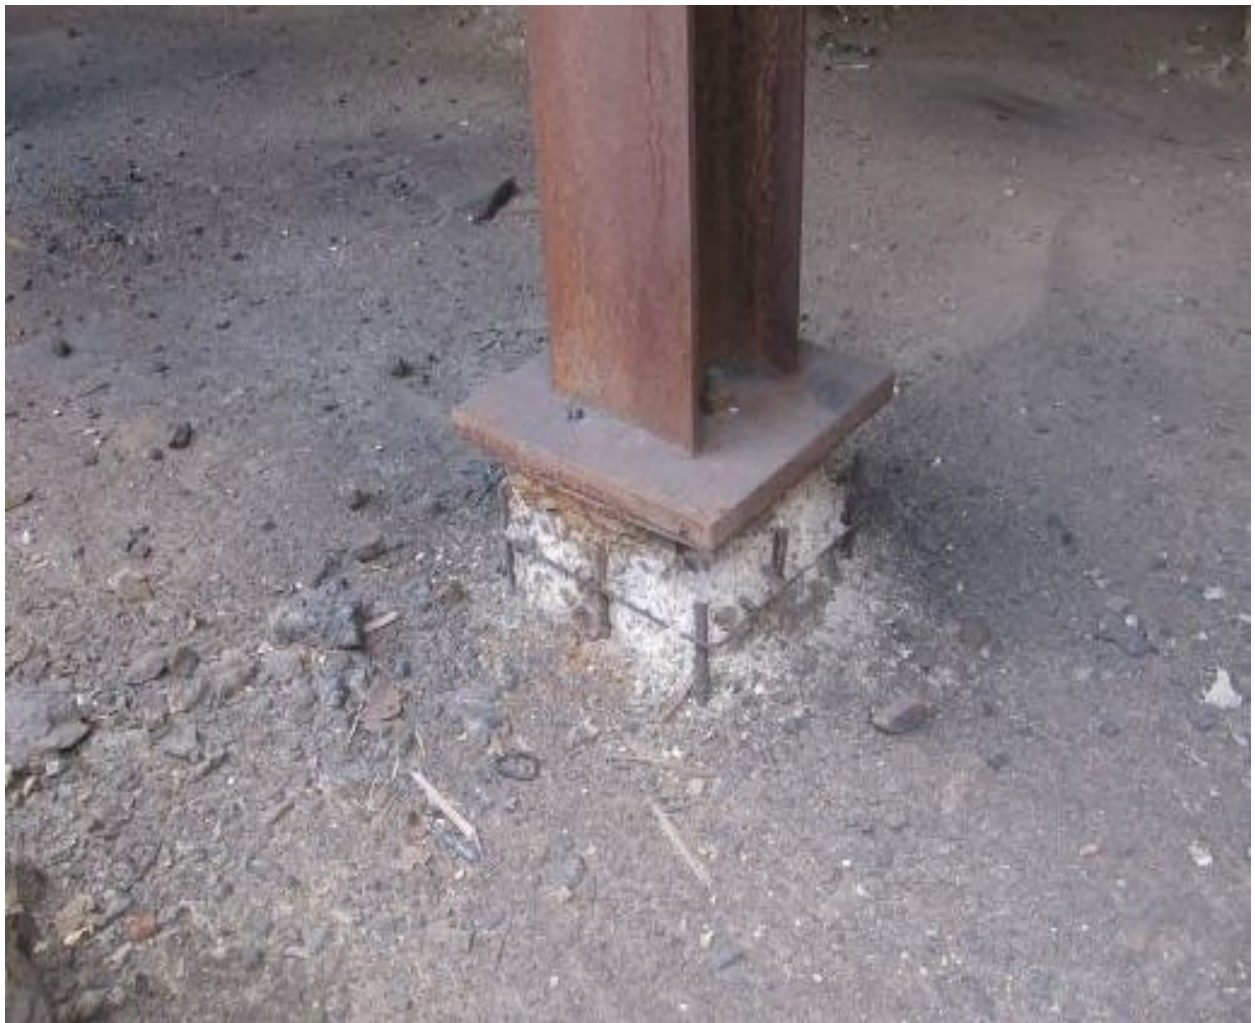
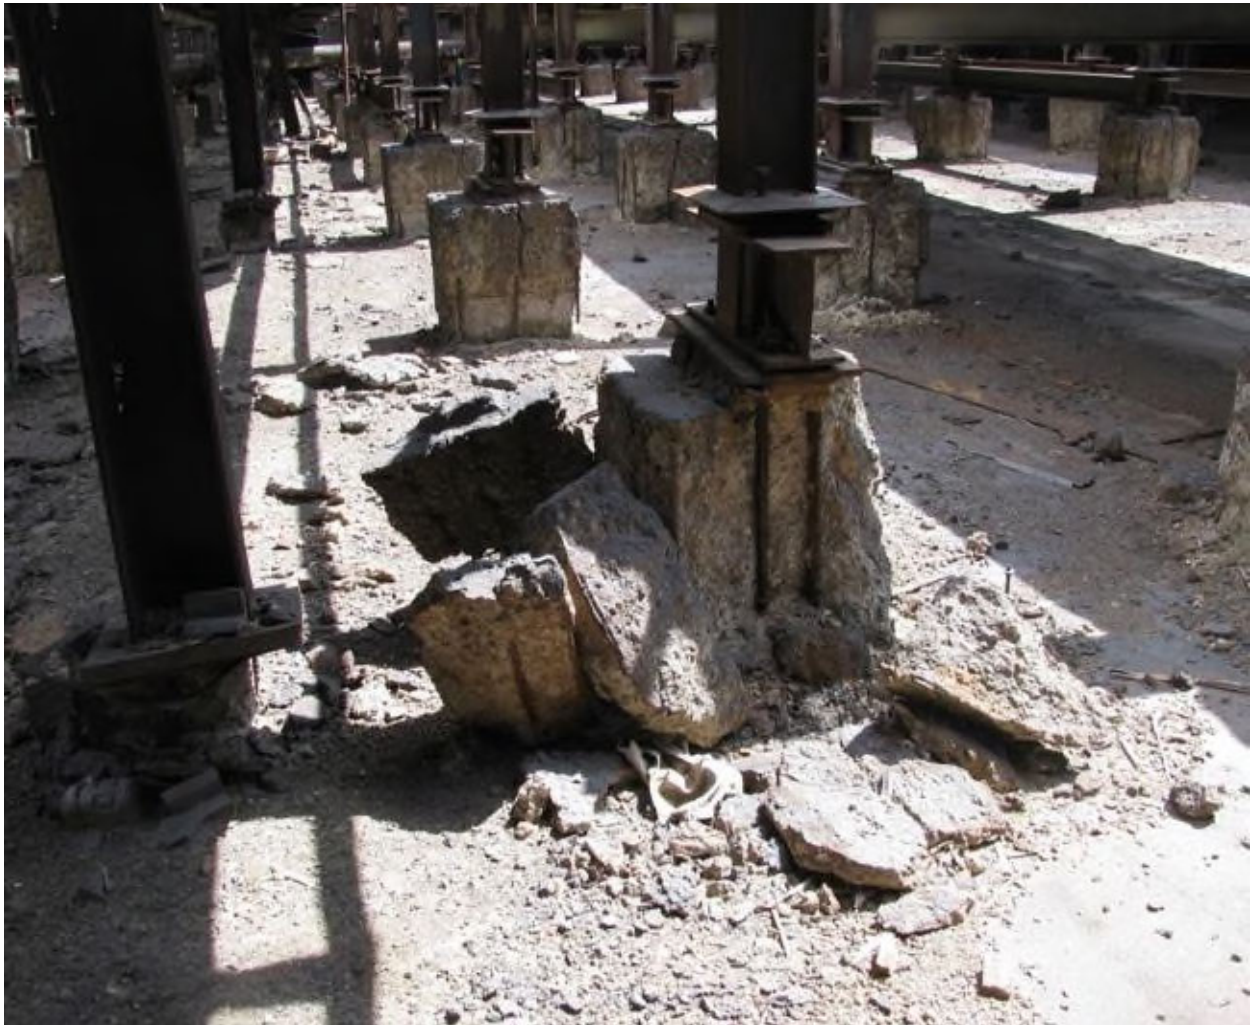
The support columns for the curtain slab and the Unit 4 Cell Island are supported by concrete pedestals in the basement area. All of these pedestals were observed to be severely corroded; many have catastrophic cracks and have partially crumbled. Figure 18, 19 and 20 illustrate the typical condition of the column pedestals observed in the Unit 4 Cell Floor basement area.

Figure 18: Unit 4 Cell Floor column pedestal, exposed rebar and severe rust and cracking

Figure 19: Unit 4 Cell Floor column pedestal, exposed rebar, severe spalling

Figure 20: A crumbling Unit 4 Cell Floor column pedestal
