Final Demolition Work Plan

Unit 4 Cell Building

Nevada Environmental Response Trust Site

February 9, 2016

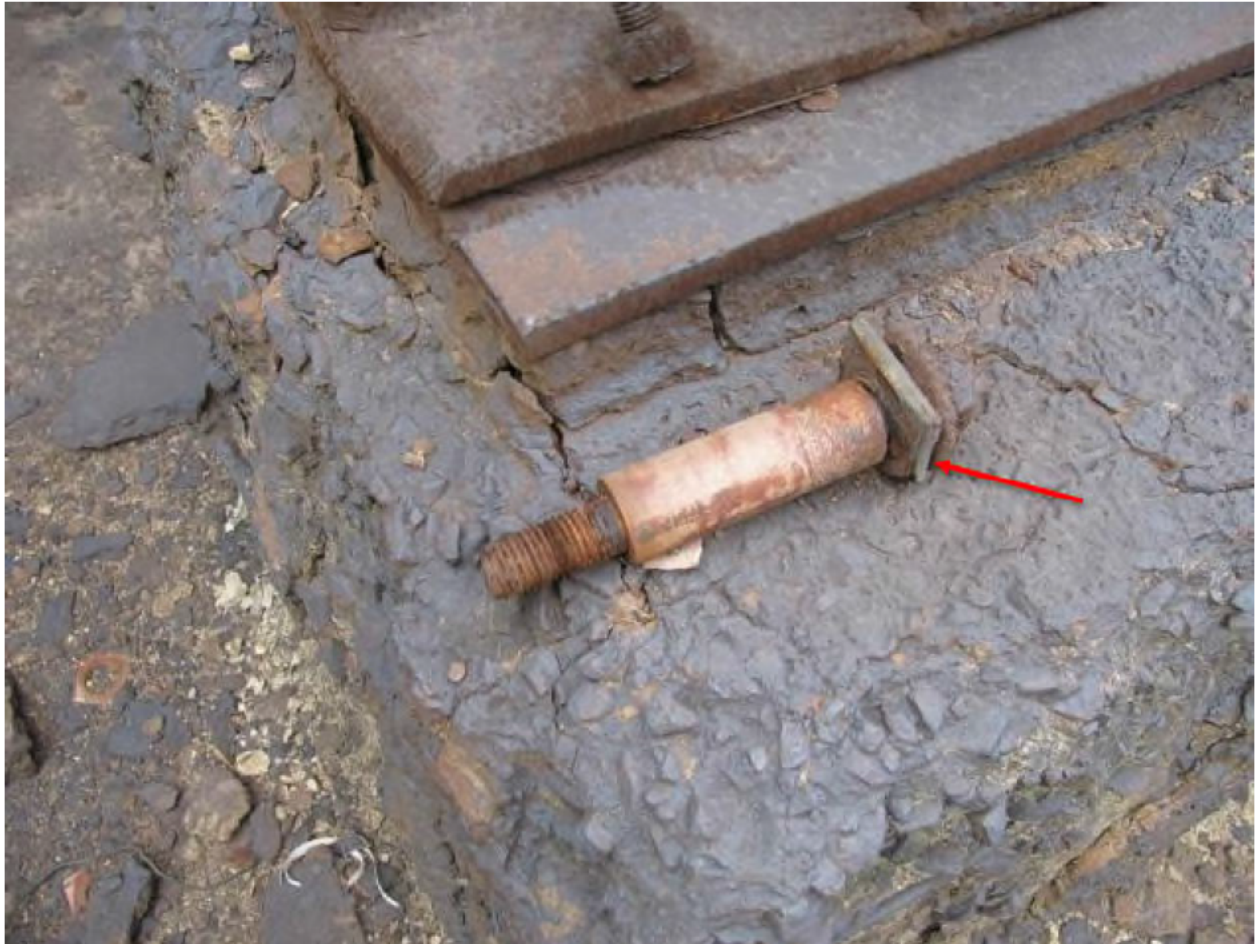
In the Unit 4 Cell Building basement area, many anchor bolts were observed, both in use and discarded. The bolts have a square washer that may contain asbestos, per our Tronox escort. One typical bolt is shown in Figure 21.

Figure 21: Anchor bolt with square washer suspected of containing asbestos

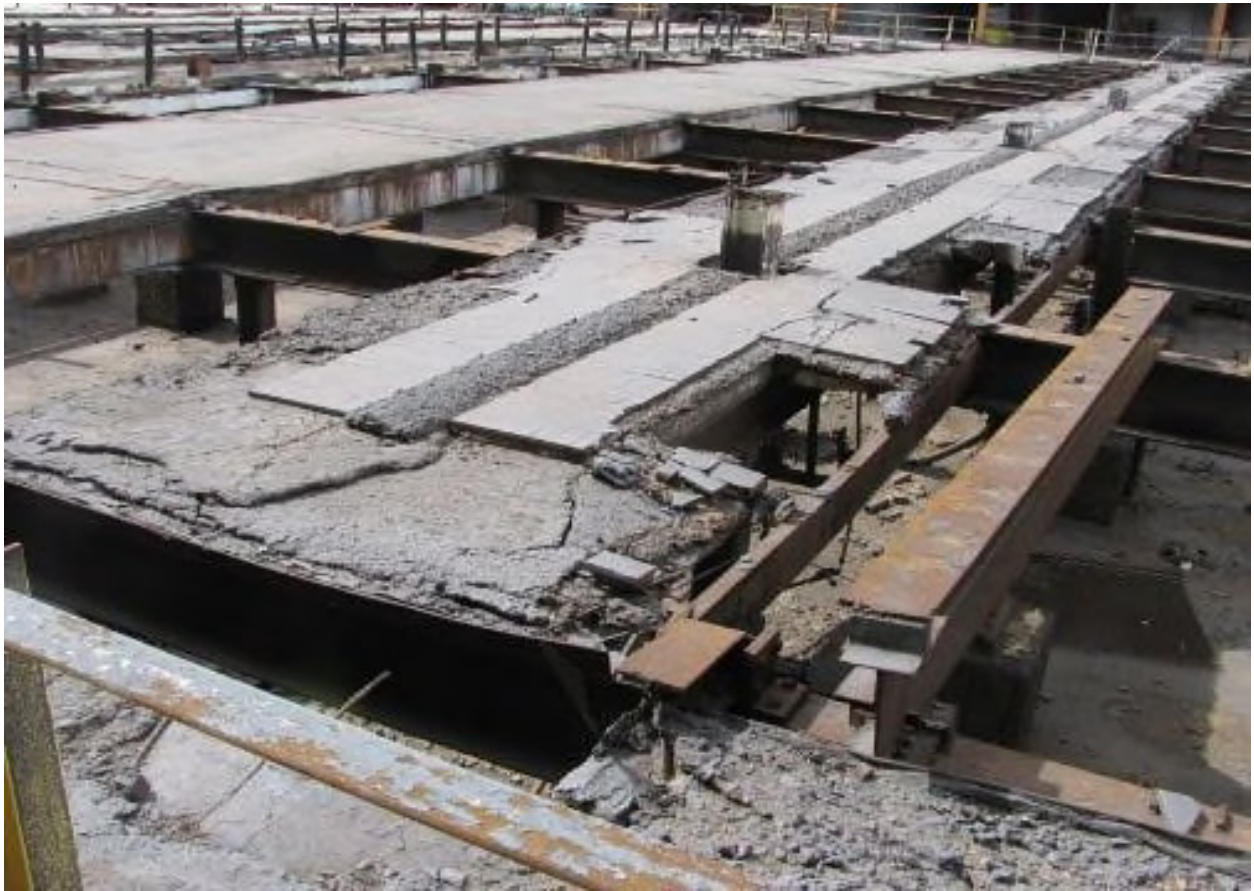
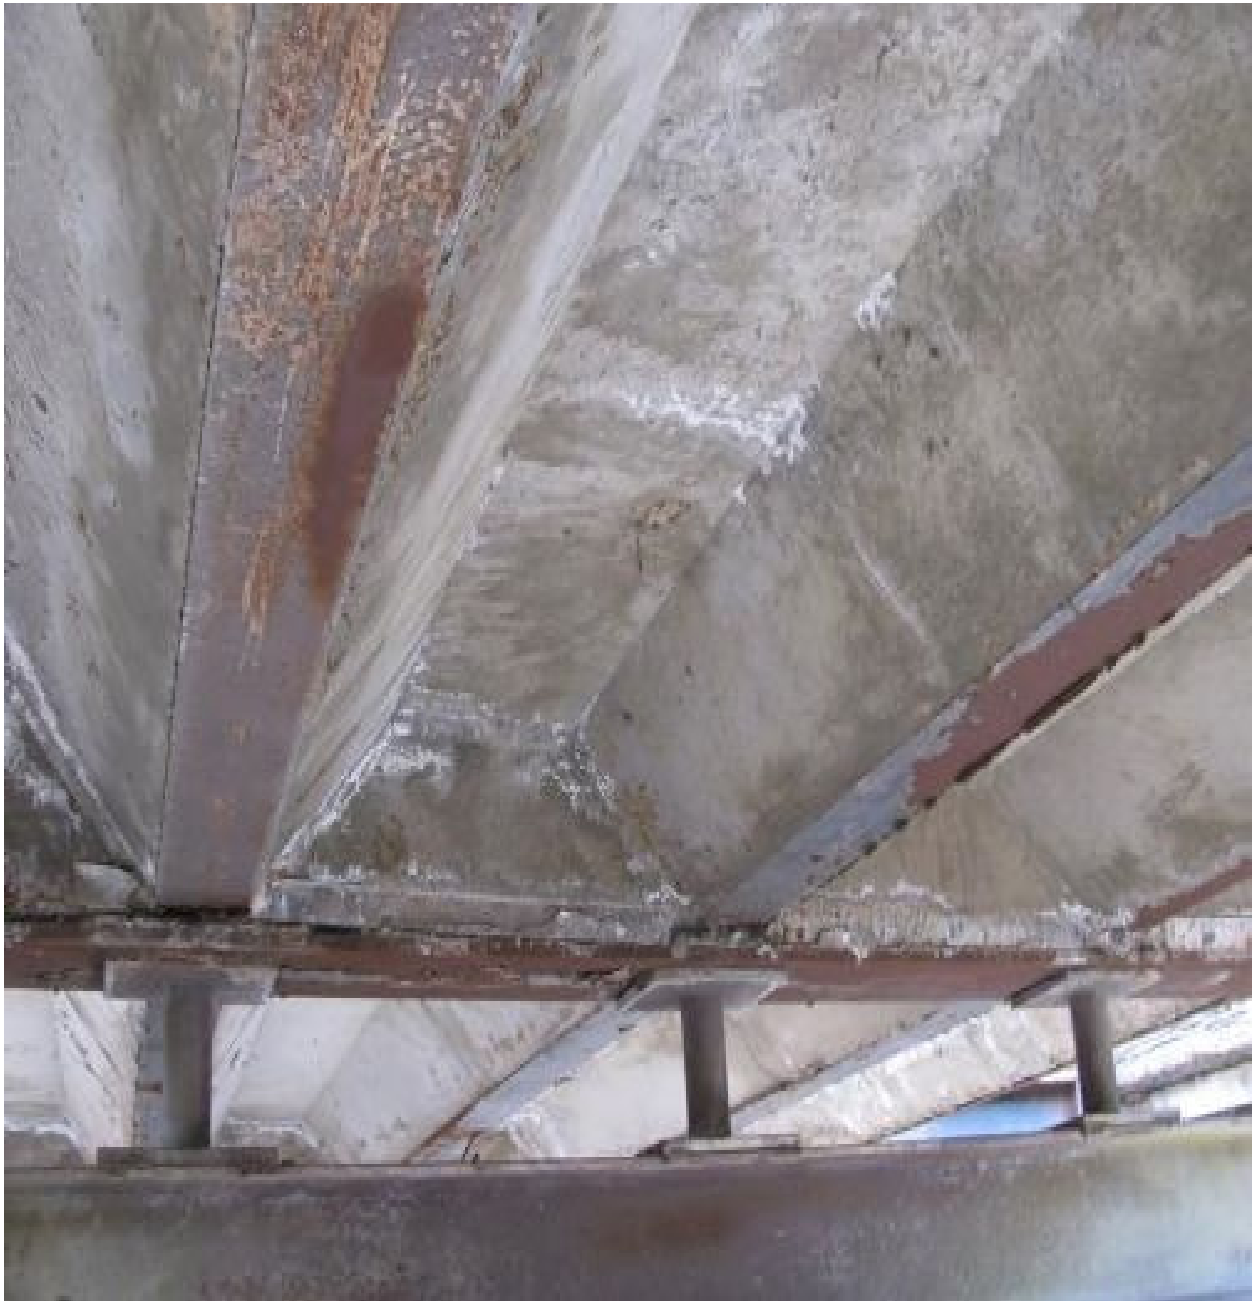
The Unit 4 Cell Floor Island consists of reinforced concrete slabs supported by steel beams and columns, as can be seen in the foreground of Figure 3 and in Figure 22. The concrete slab has spalling and exposed reinforcing bar similar to what was observed in the adjacent curtain slab. Portions of the Cell Island have been retrofitted with additional concrete encasement. Our Tronox escort indicated this was done by Tronox to allow for light vehicle use of the Unit 4 Cell Floor; however, this use has been discontinued. Typical encasing of the Unit 4 Cell Floor slab is shown in Figure 23. This encasement was not observed to be corroded or have areas of spalling concrete. The condition of the steel and original concrete slab are unknown, but are assumed to resemble the observed conditions of the unreinforced areas of the Cell Floor.

Figure 22: Cell Island slab

Figure 23: Typical cell floor concrete encasement

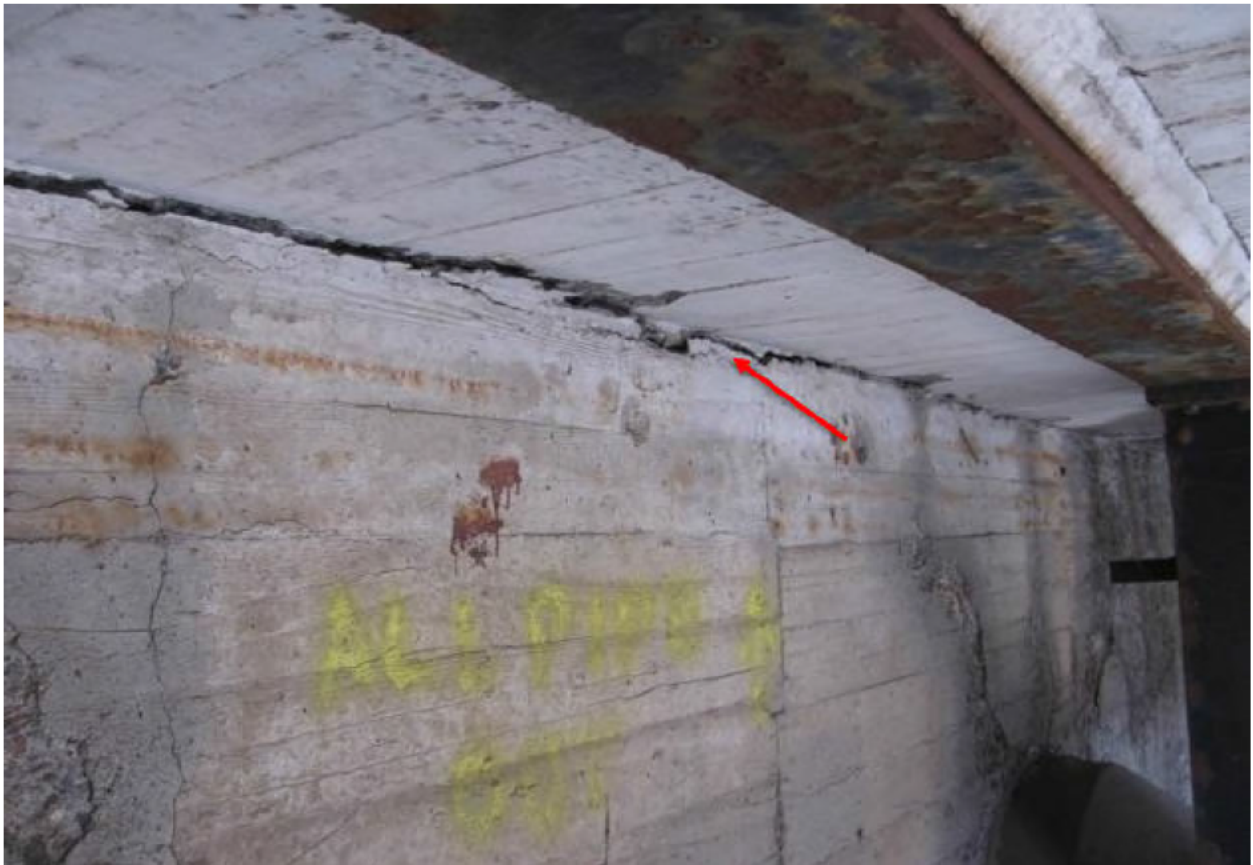
air passageway. This passageway is inaccessible by design, its presence was indicated by our Tronox representative but not observable from the Unit 4 Cell Floor. The partition wall was observed to have extremely severe cracking along the top, between the wall and the curtain slab. It appears as though the curtain slab is no longer structurally connected to the partition wall, but simply bearing on top of it. This cracking is shown in Figure 24.

Figure 24: Cracking between the Unit 4 Cell Building north curtain slab and supporting partition wall

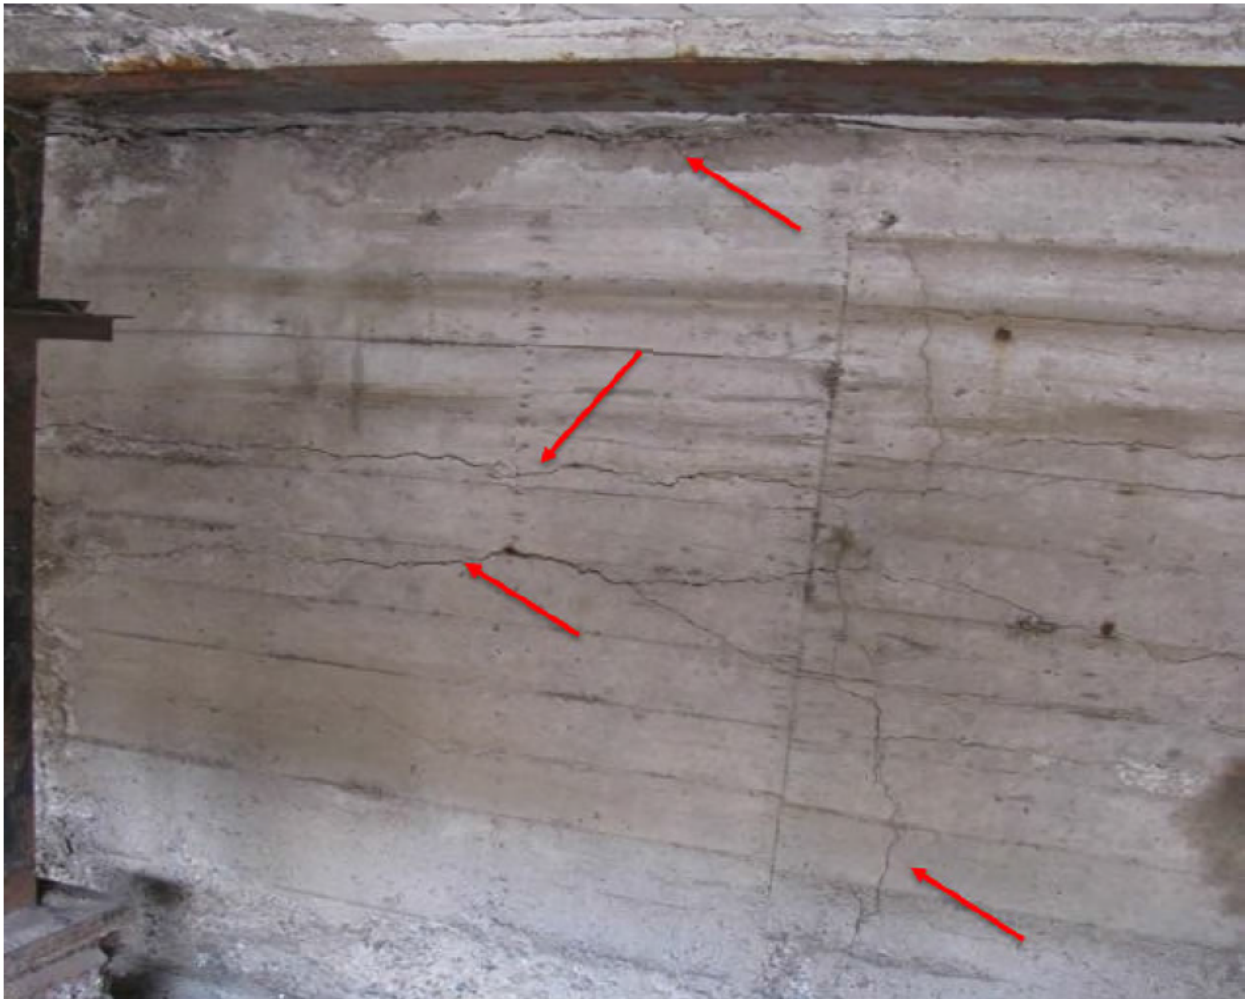
Furthermore, the partition wall was observed to have bowed inward to the south with significant horizontal cracking along the entire height and length of the wall. Typical cracking is shown in Figure 25.

Figure 25: Horizontal cracking in the partition wall separating the Unit 4 Cell Floor Area from an air passageway

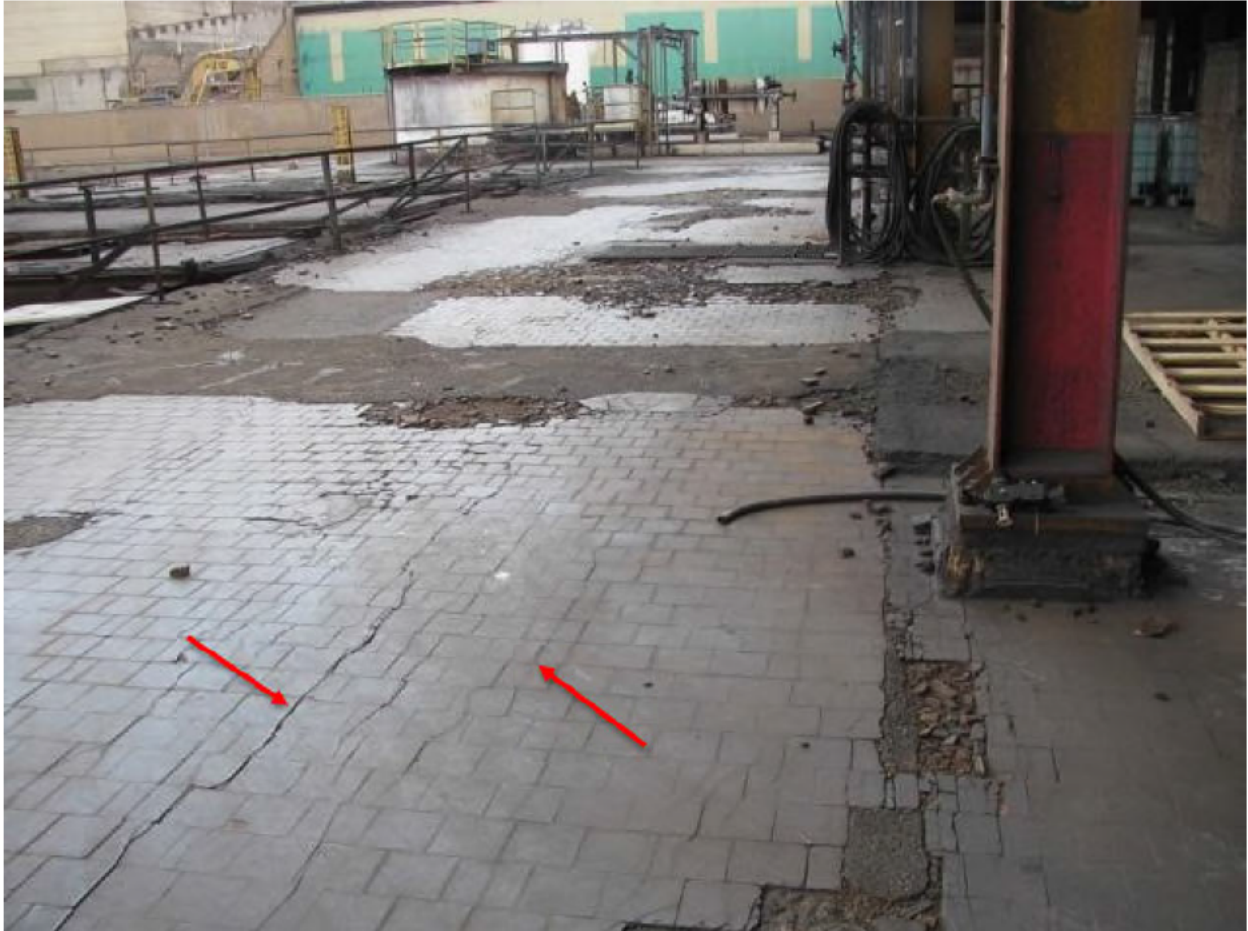
The curtain slab has a brick tile surface with significant cracking, as shown in Figure 26. The cracking appears to be located above the supporting partition wall. The condition of the concrete slab under the brick tile could not be observed.

Figure 26: Unit 4 Cell Building curtain slab brick tile cracking

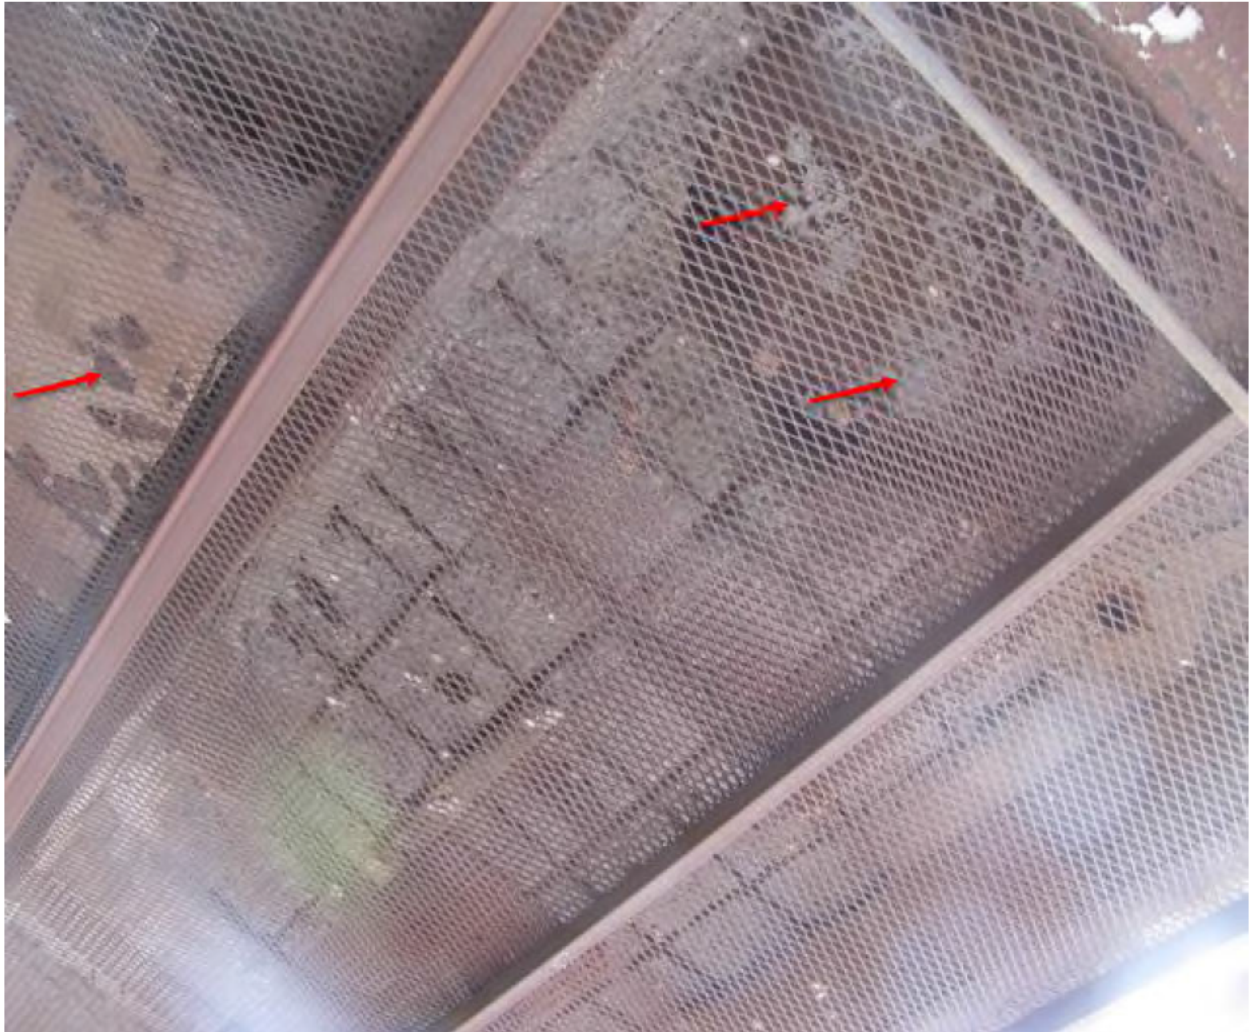
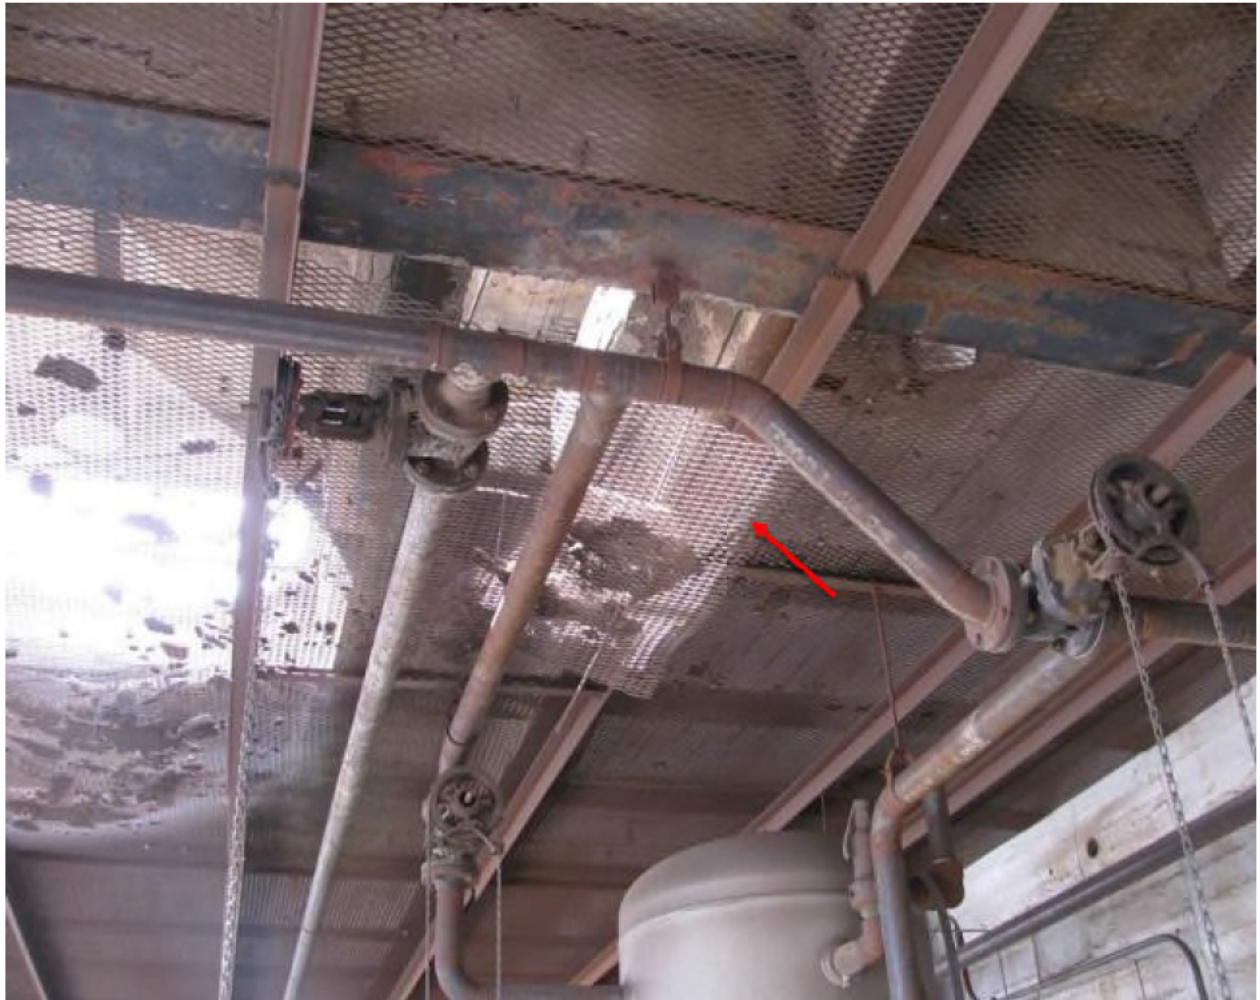
The Unit 4 Chlorinator Building was observed to have actively spalling concrete. Expanded metal grating was retrofit to the underside of the second level steel support beams along the south side of this building, as shown in Figure 27. The Tronox representative indicated that this was placed for catchment of spalling concrete. Areas of grating appear to also be failing, as shown in Figure 28.

Figure 27: Unit 4 Chlorinator Building expanded metal grating retrofit under concrete actively spalling

Figure 28: Unit 4 Chlorinator Building spall protection failure

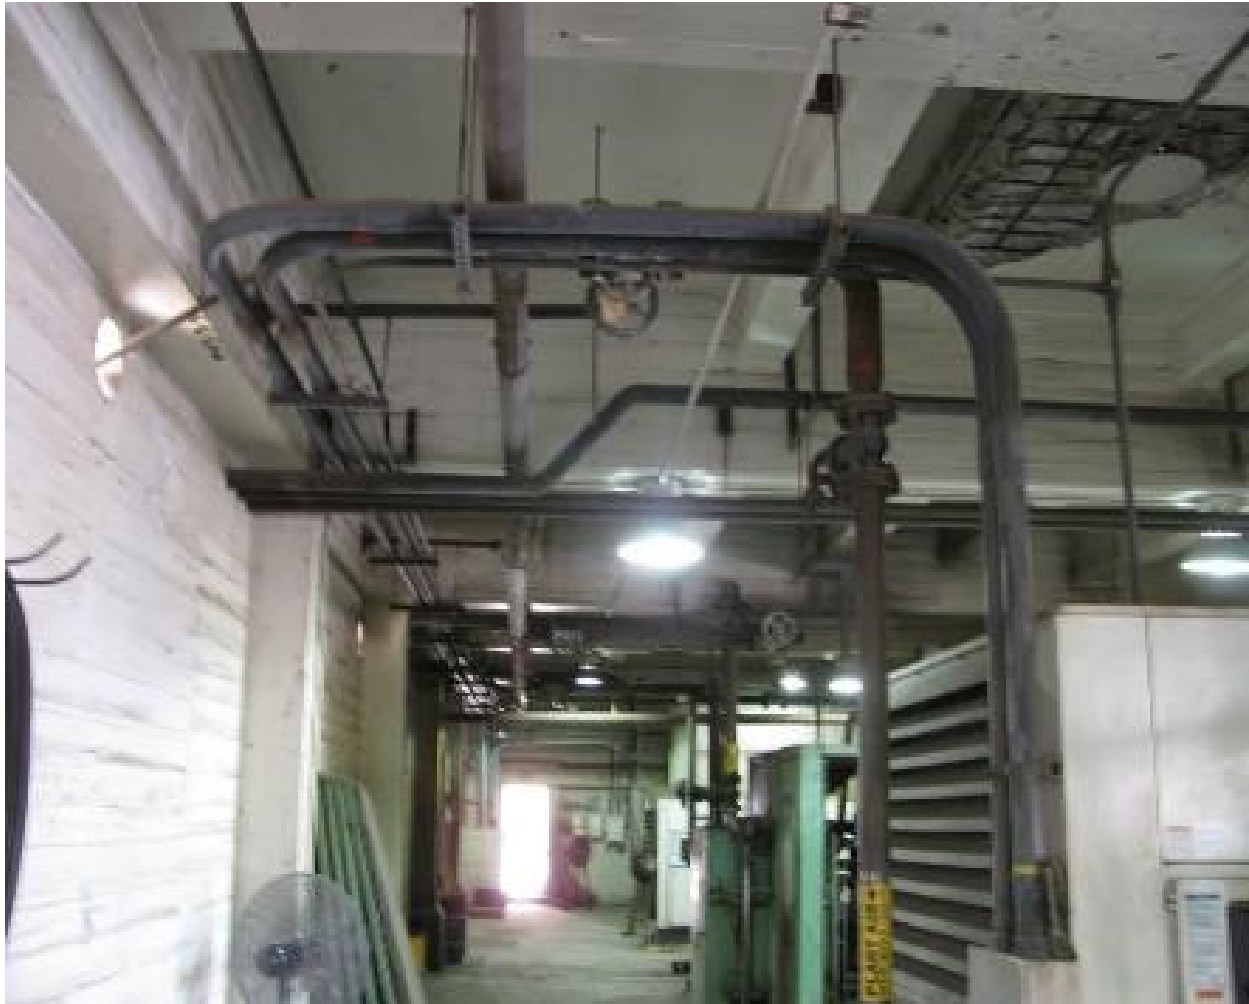
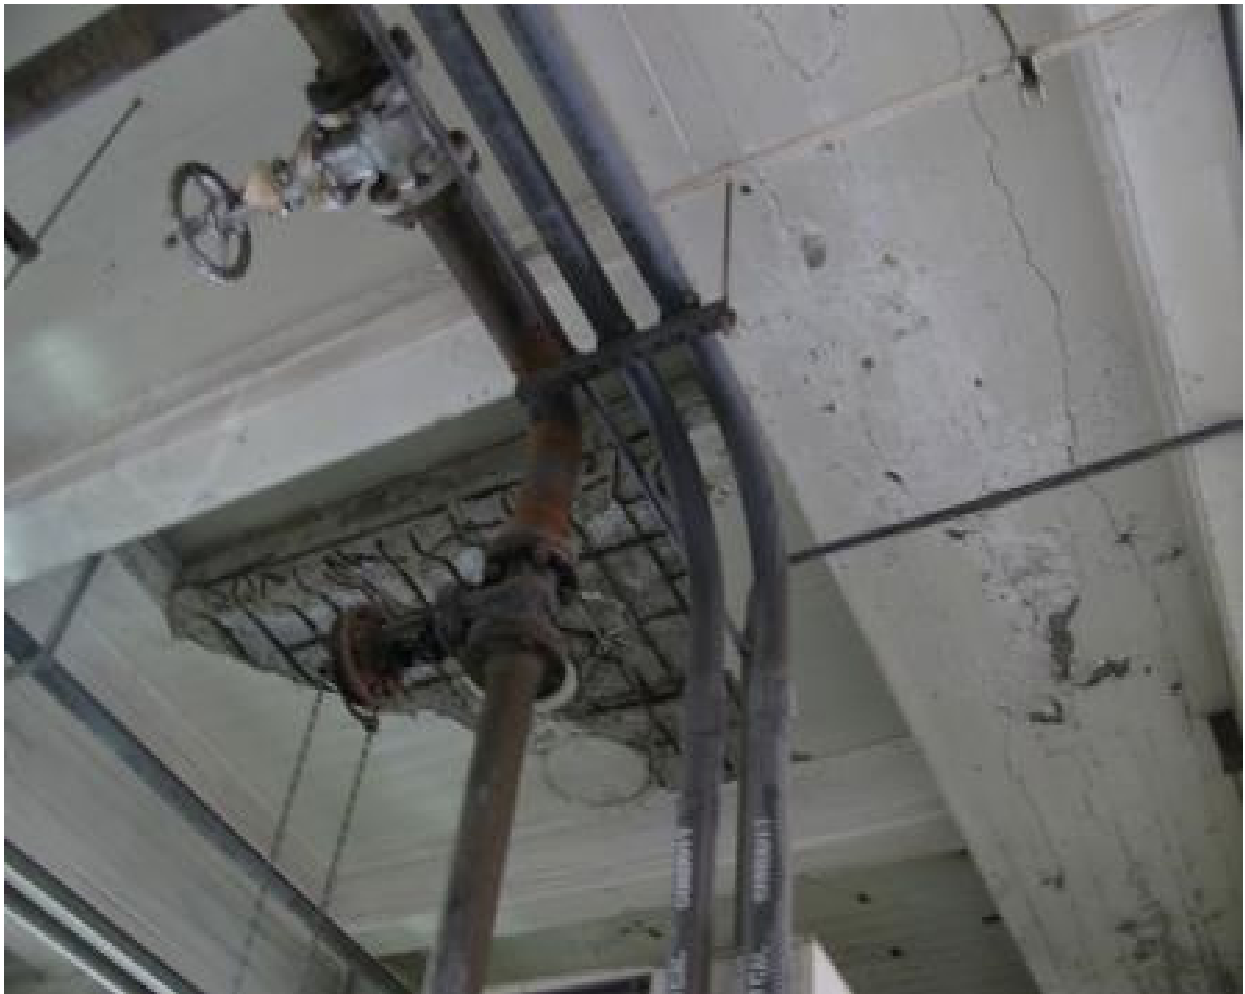
Inside the Unit 4 Chlorinator Building are operational compressors and air dryers. The second floor slab is actively spalling directly above the largest compressor, as shown in Figure 29 and Figure 30.

Figure 29: Unit 4 Chlorinator Building operational Compressor with active concrete spalling above

Figure 30: Unit 4 Chlorinator Building - spalling concrete above compressor

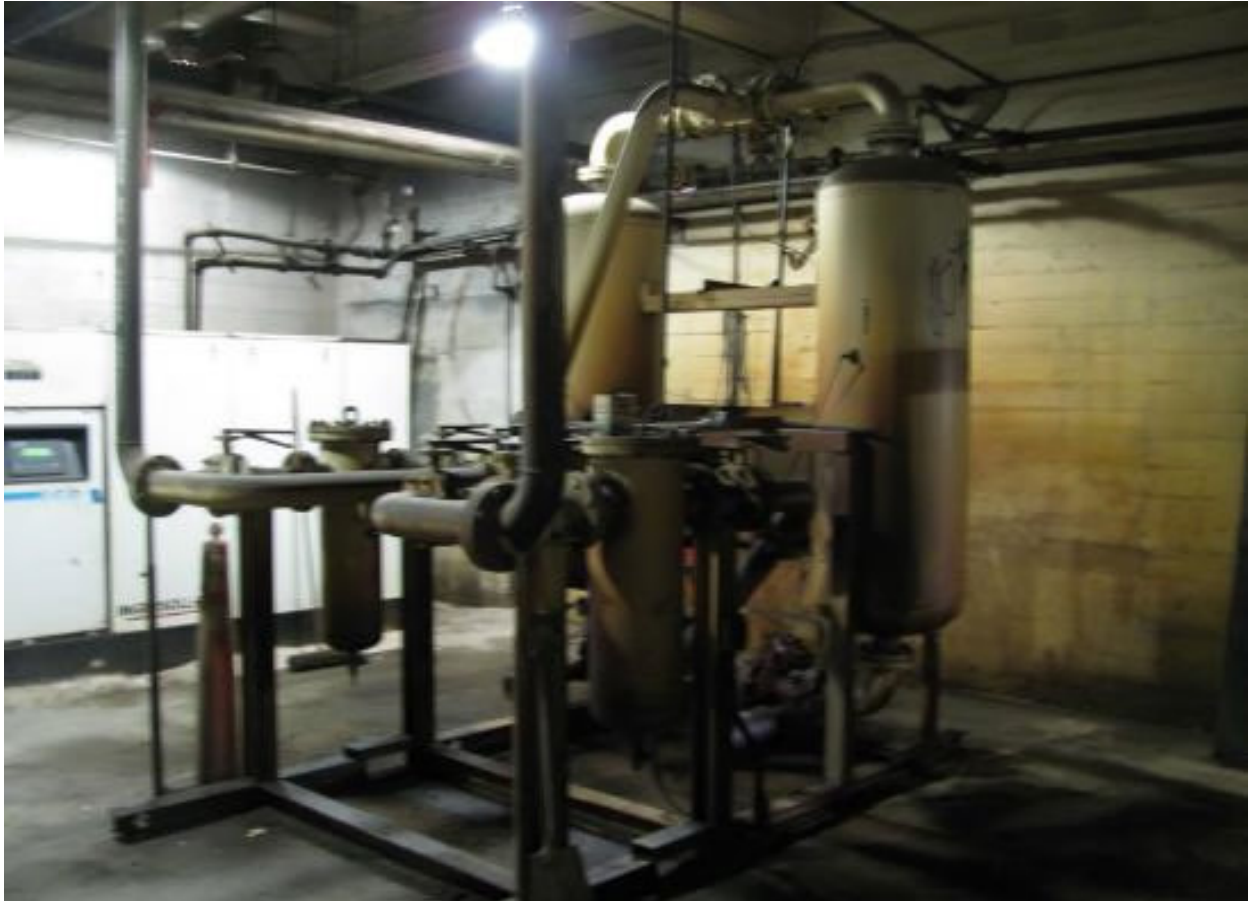
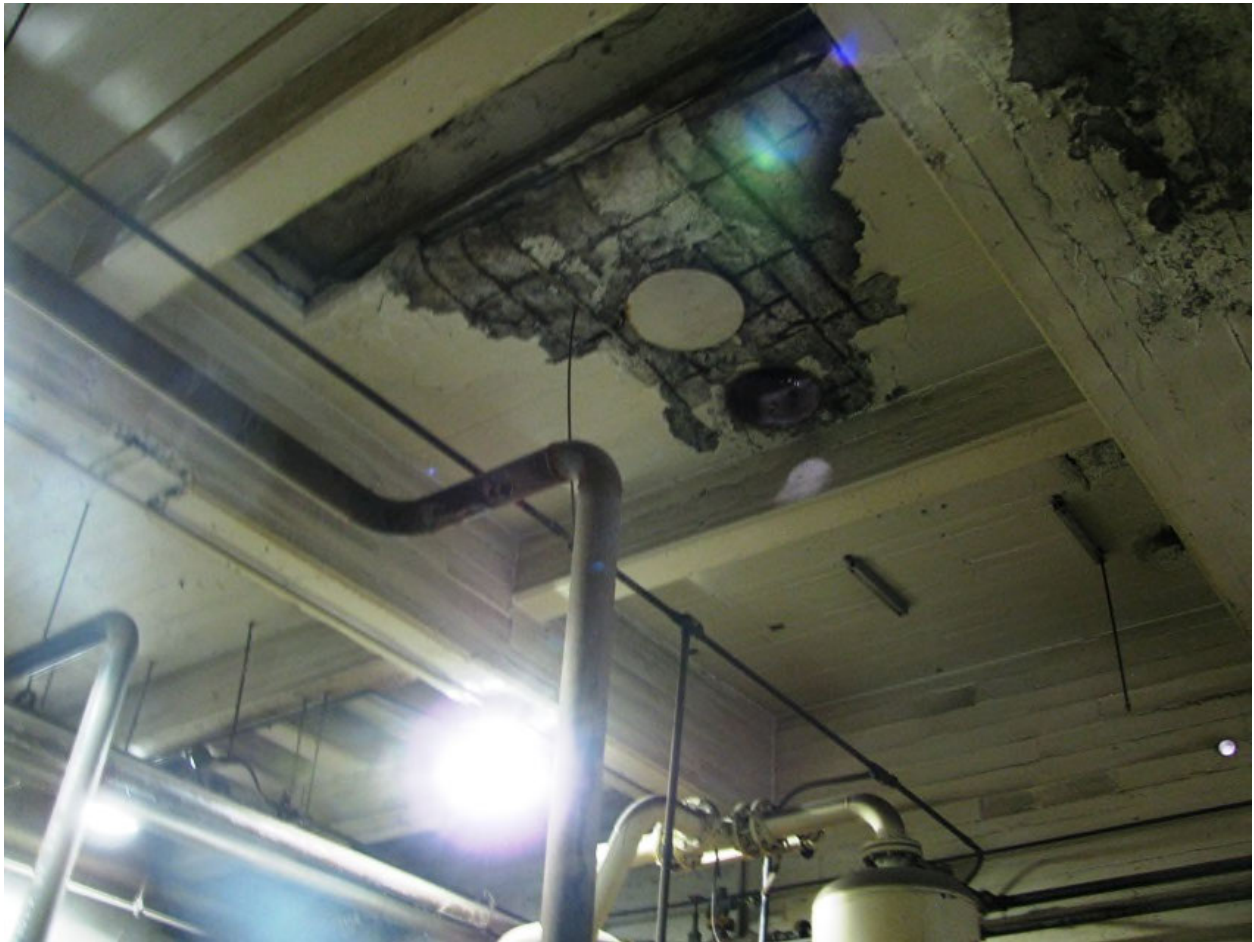
Active spalling was also observed above the air dryer, as shown in Figure 31 and Figure 32.

Figure 31: Unit 4 Chlorinator Building air dryer below spalling concrete

Figure 32: Spalling concrete above air dryer

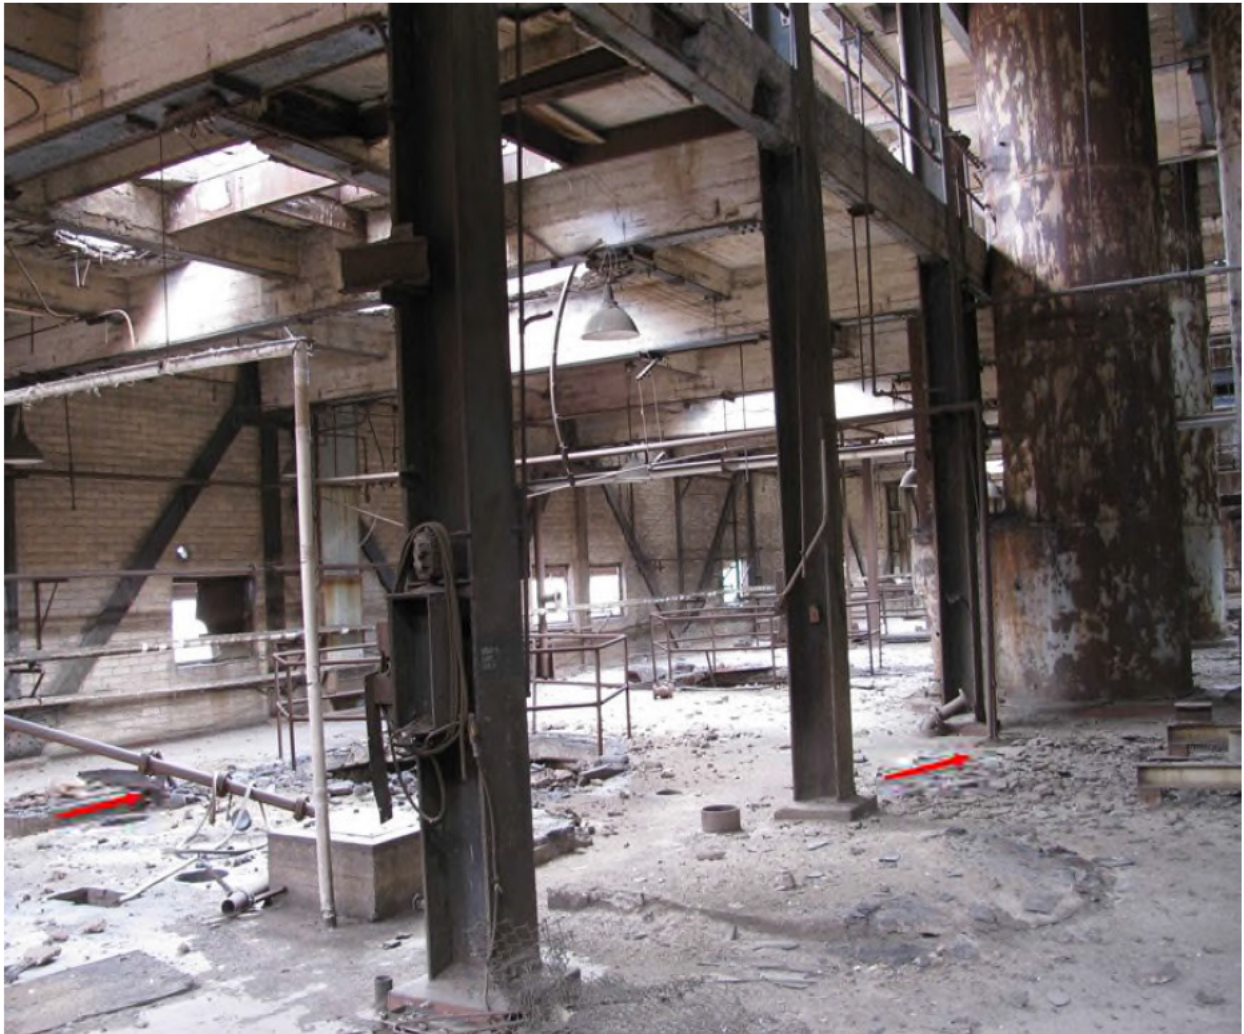
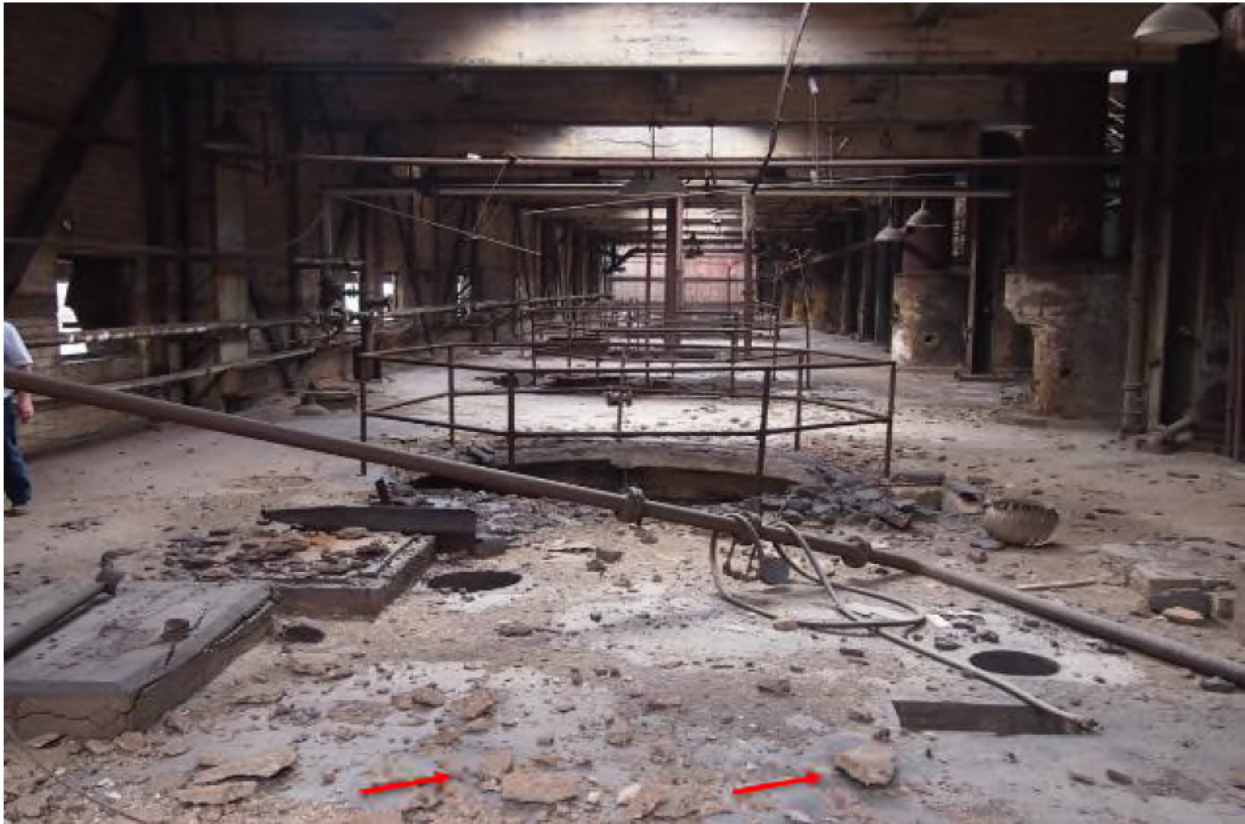
The room east of the compressors does not have a second or third floor above. There are exposed steel beams, an abandoned elevator, and a stairway to the upper floors. The second floor was observed to have active and progressive concrete spalling and other deterioration, as shown in Figure 33 and Figure 34.

Figure 33: Unit 4 Chlorinator Building – second level

Figure 34: Unit 4 Chlorinator Building – second level

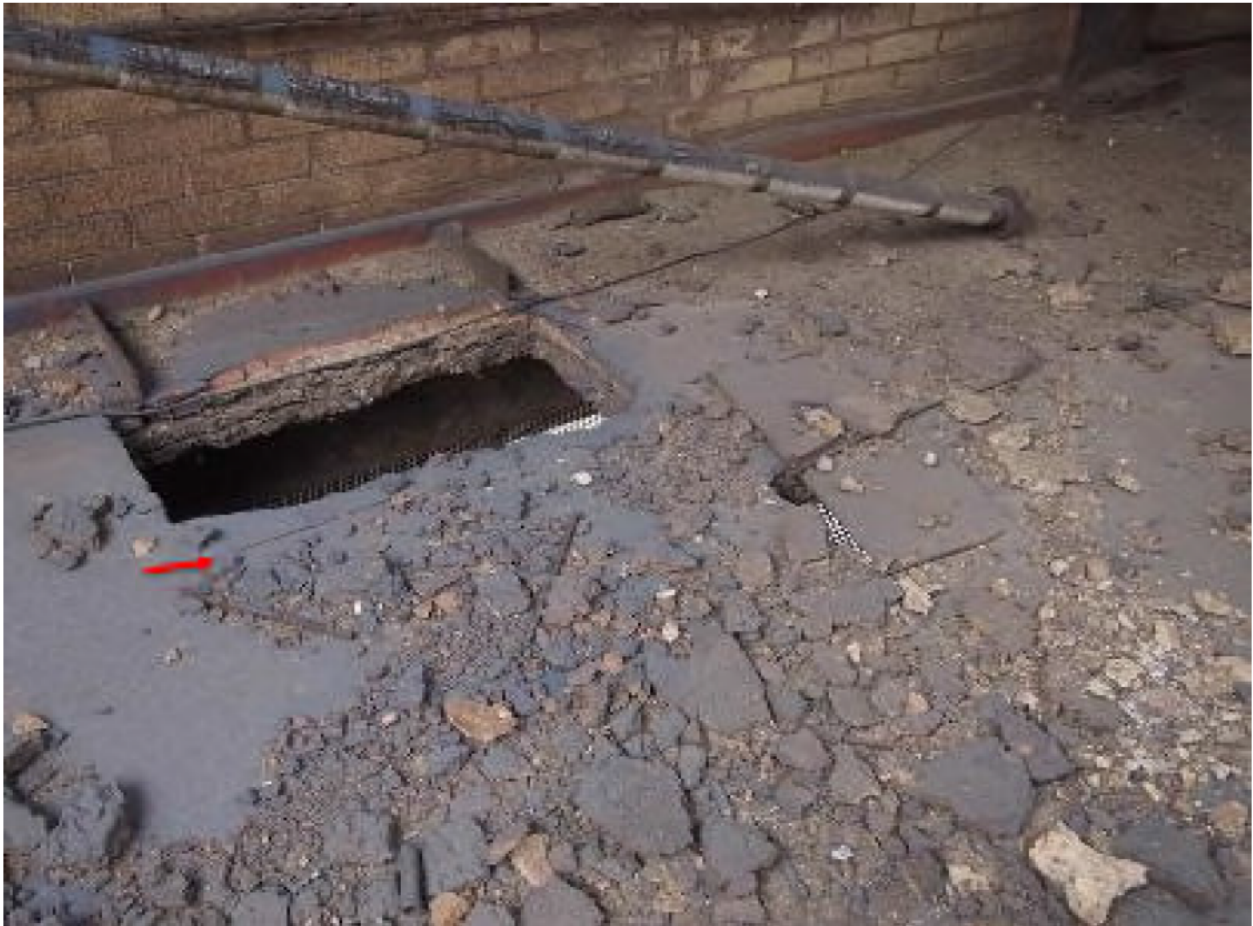
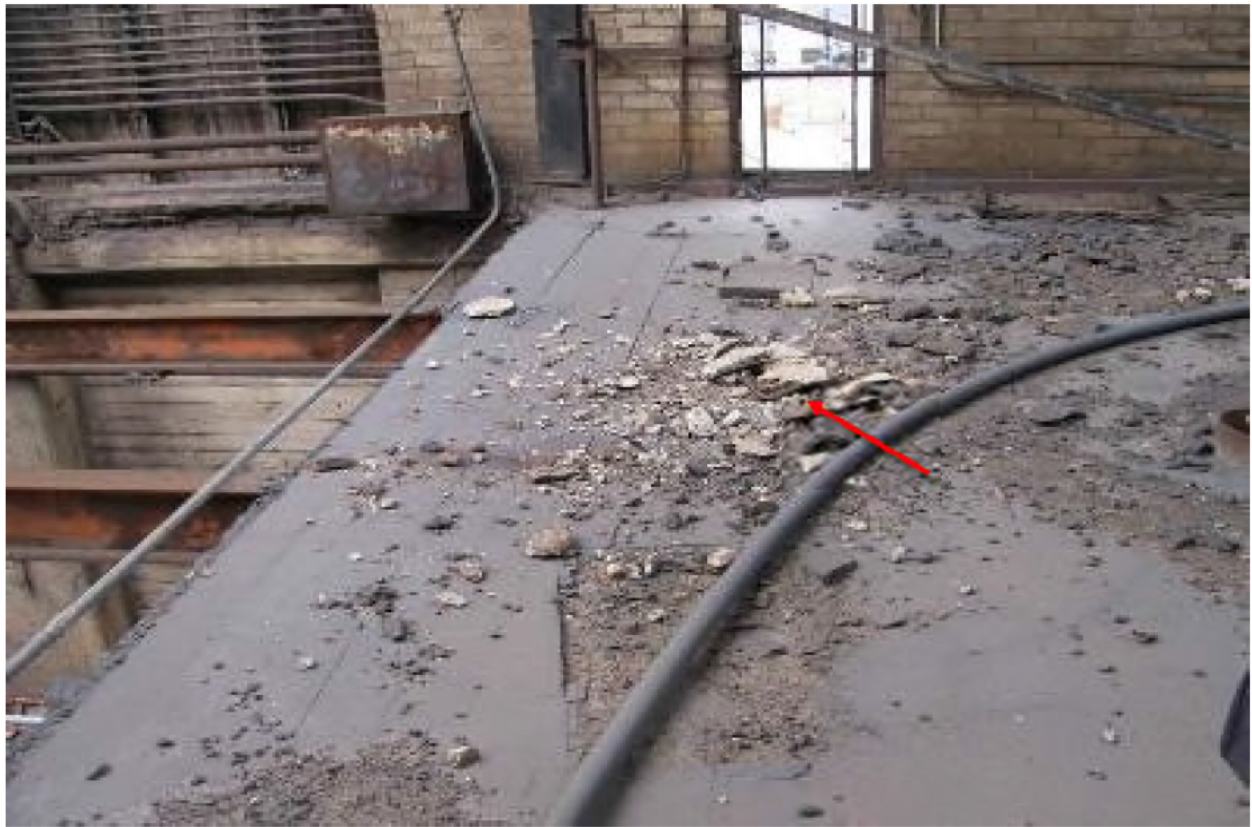
Significant spalled concrete, cracked floor slab, and rough and unmarked holes in the floor were observed on the second floor of the Unit 4 Chlorinator Building. A typical section of the floor slab is shown in Figure 35. One particular pile of spalled concrete was identified by our escort as being “new, from last night’s rain.” This material is shown in Figure 36.

Figure 35: Unit 4 Chlorinator Building – unmarked hole in second level slab

Figure 36: Unit 4 Chlorinator Building, second level “new” spalled concrete

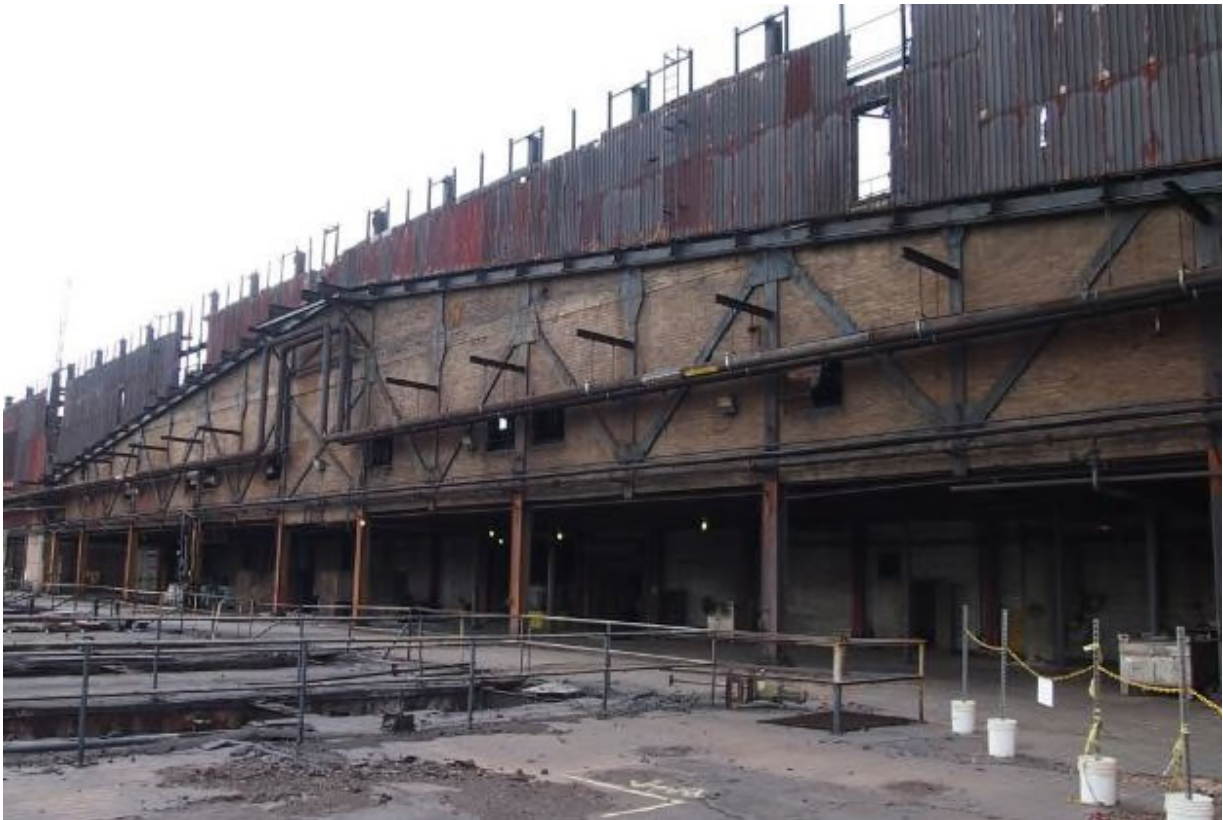
Further observations of the second floor were not made due to safety concerns stemming from the structural condition of the floor and the absence of adequate railings and markings. The third level was also not observed due to these safety concerns. The south wall of the Unit 4 Chlorinator Building has an integrated steel truss that appears to have been part of the roof system formerly over the Cell Floor Area. This truss is infilled with a CMU wall. This CMU wall appeared to have superficial cracking. There is also an integrated pipe rack supported by cantilevers connected to this truss. One of the pipes is known to be compressed air from the compressor units within the Unit 4 Chlorinator Building; another is known to be a water supply pipe; and a third is the recently decommissioned chlorine gas pipe. The pipes are not readily marked but the Tronox representative could identify the service of each pipe. The integrated truss, CMU wall and piperack are shown in Figure 37.

Figure 37: Unit 4 Chlorinator Building - integrated roof truss along south side
