Final Demolition Work Plan

Unit 4 Cell Building

Nevada Environmental Response Trust Site

February 9, 2016

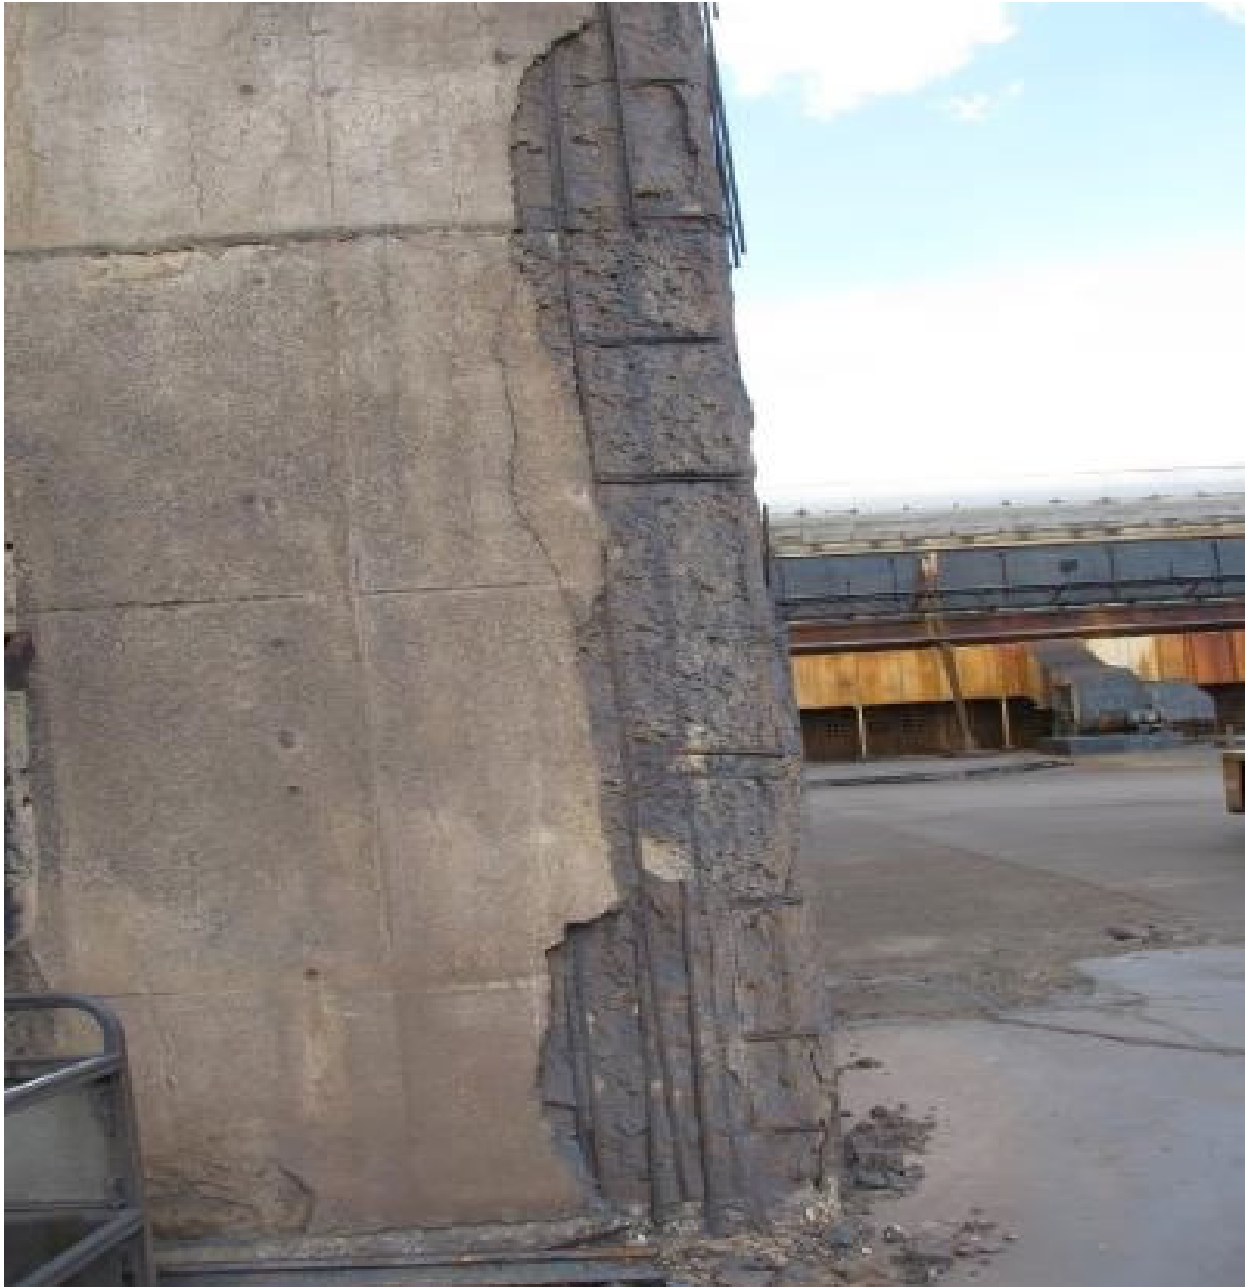
Southeast of the Unit 4 Chlorinator Building is a Wash Down Tower. This tower is constructed of reinforced concrete that is actively spalling; reinforcing steel is also exposed and rusting. There is a heavy brick lining inside the tower but structural evaluation was not possible due to access restrictions. The Wash Down Tower is shown in Figure 5 and 38.

Figure 38: Unit 4 Wash Down Tower – spalling concrete near base

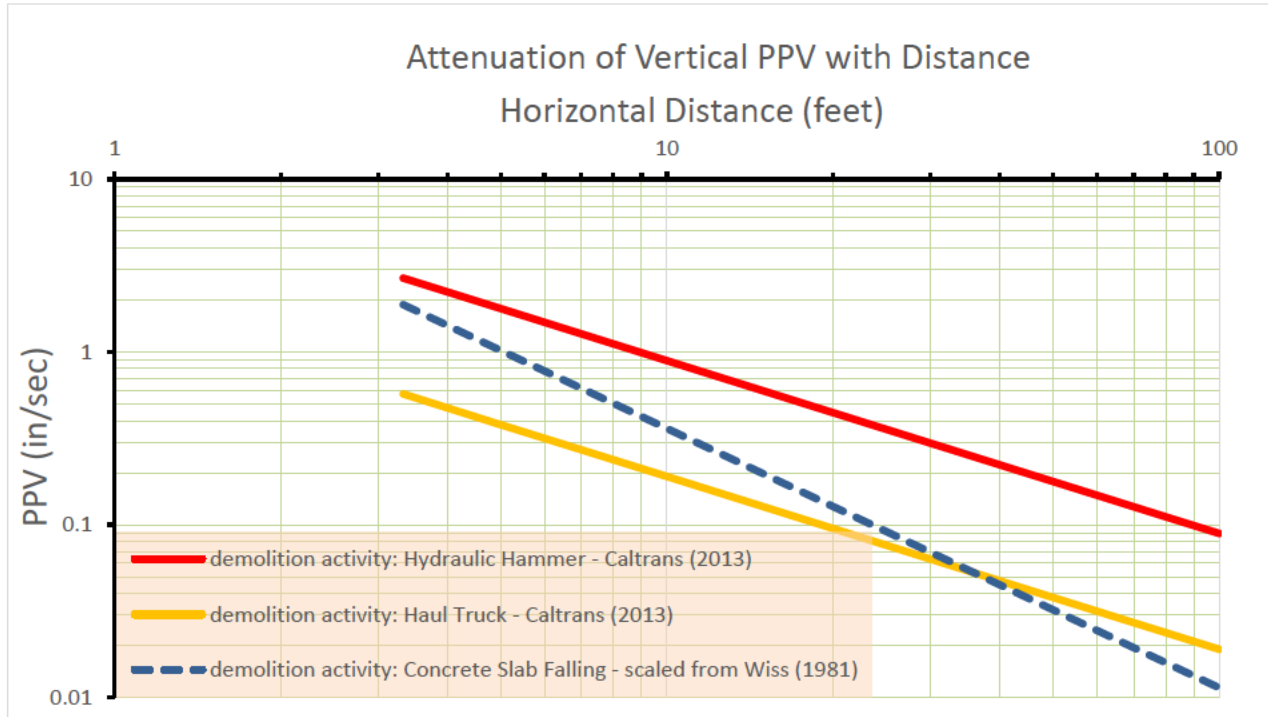
Figure 8. PPV Attenuation with Distance for the considered vibration sources

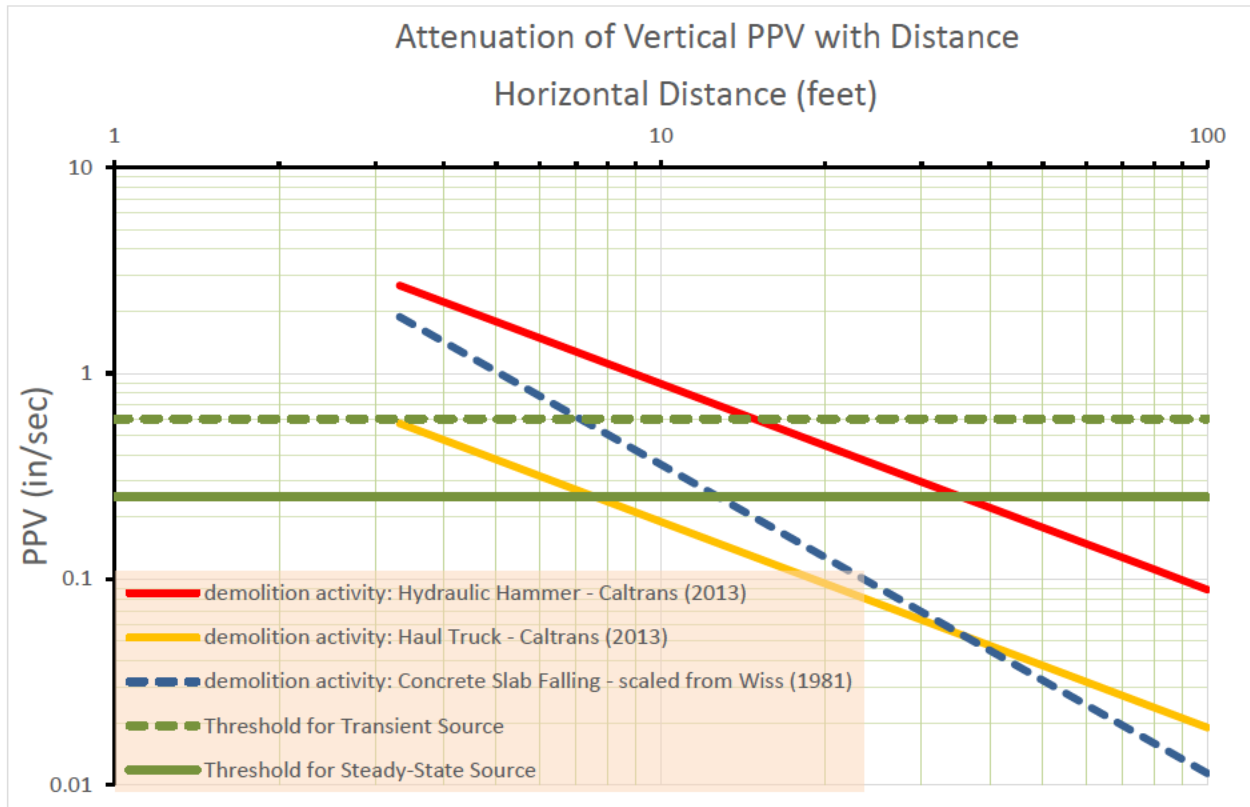
The recommended threshold PPV values are plotted in Figure 9.

Figure 9. PPV attenuation with thresholds for Structural Damage

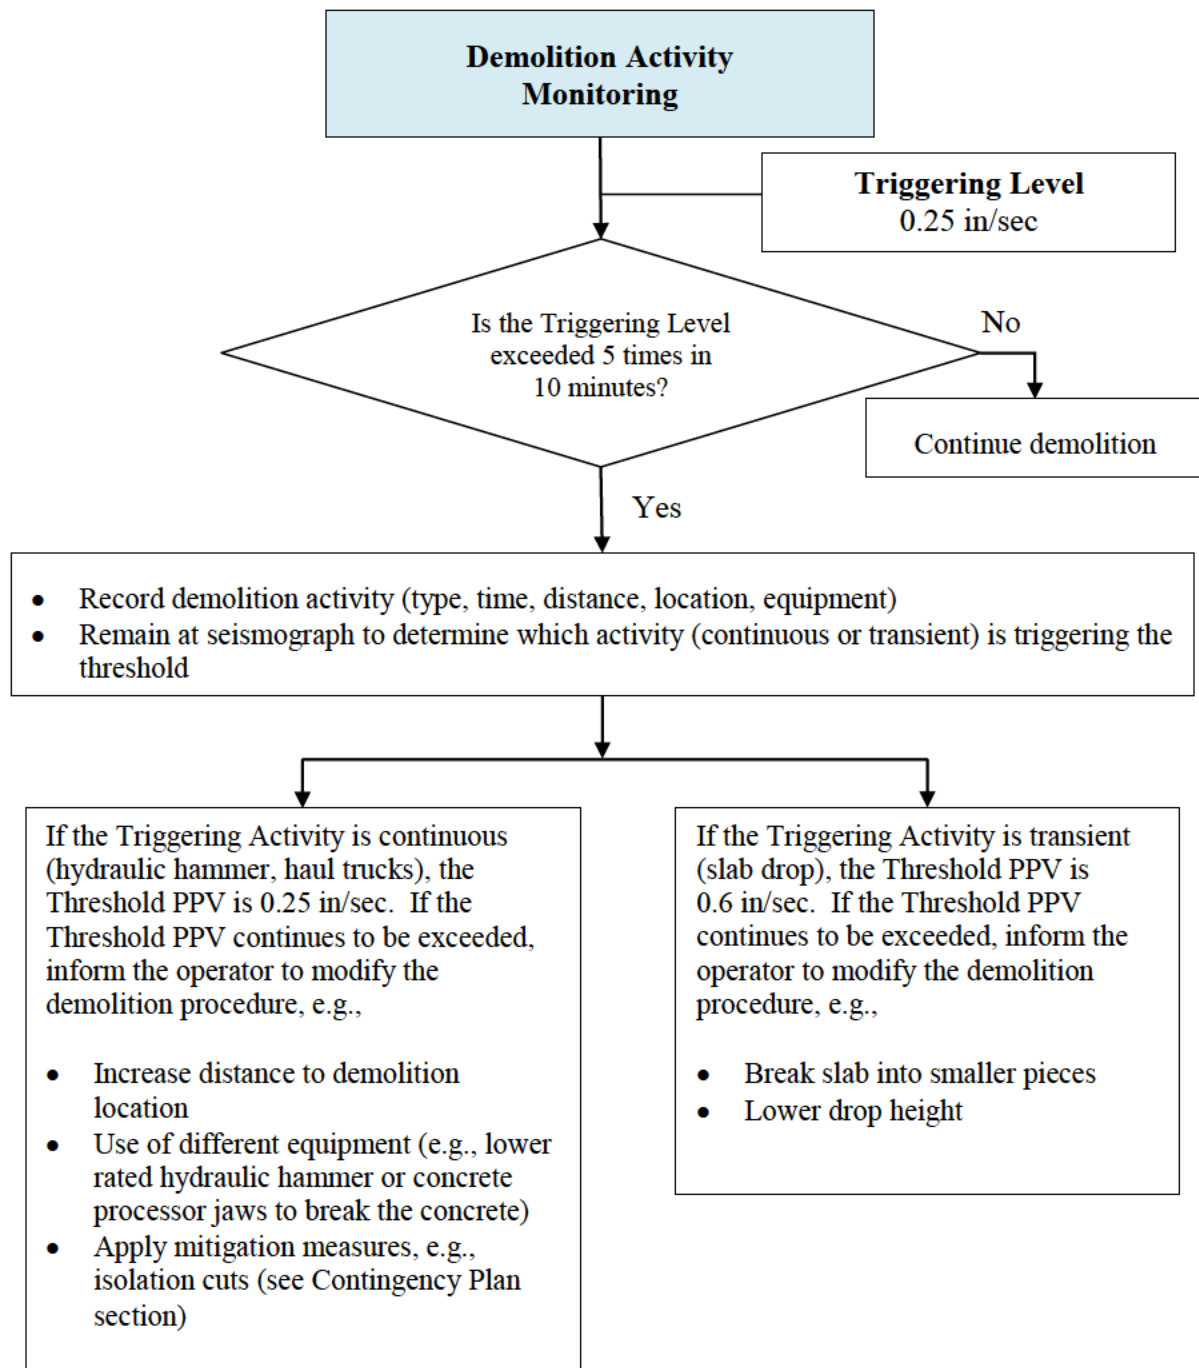
Figure 10. Demolition Monitoring

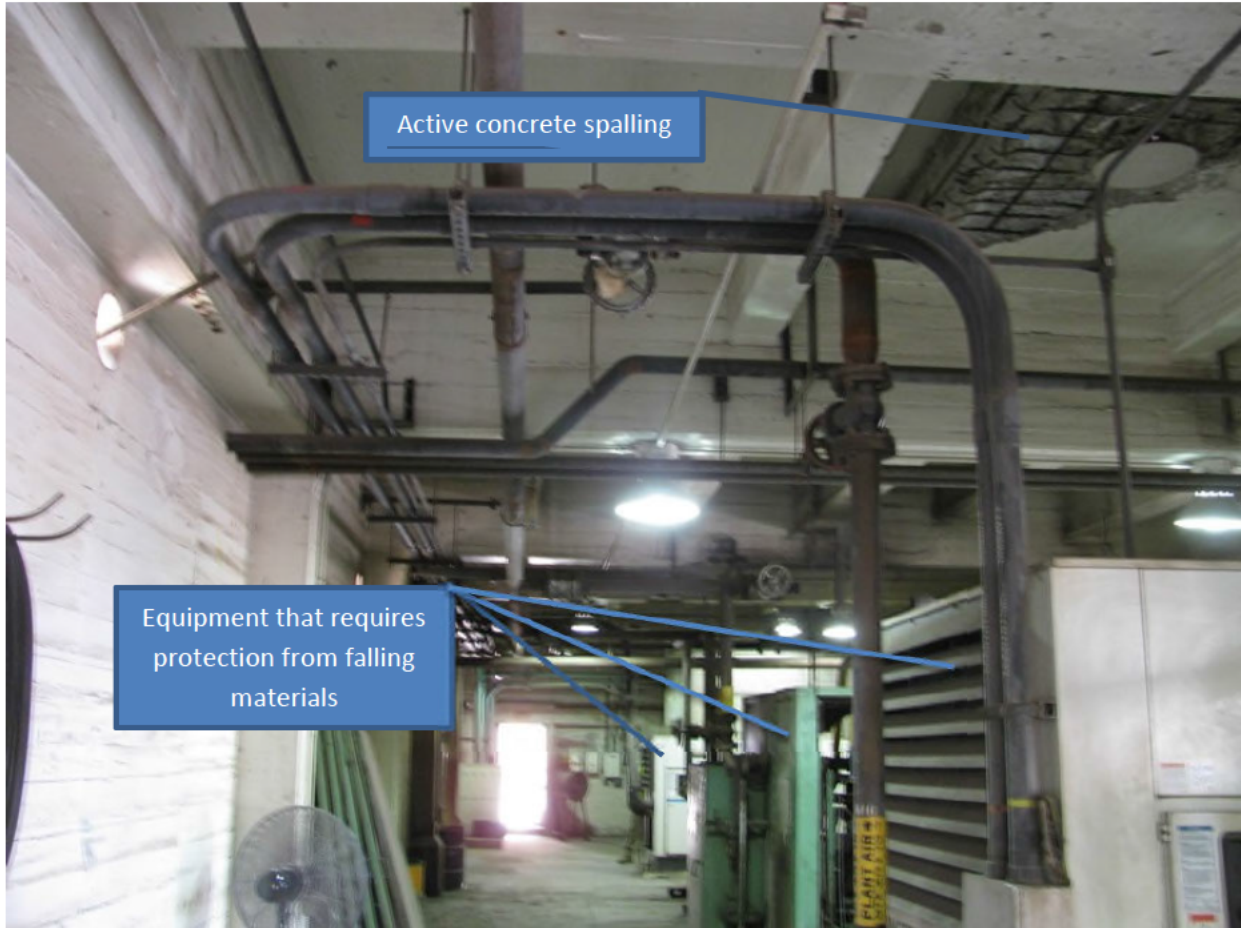
Figure 2: Some of the Tronox Equipment with Spalling Concrete Above

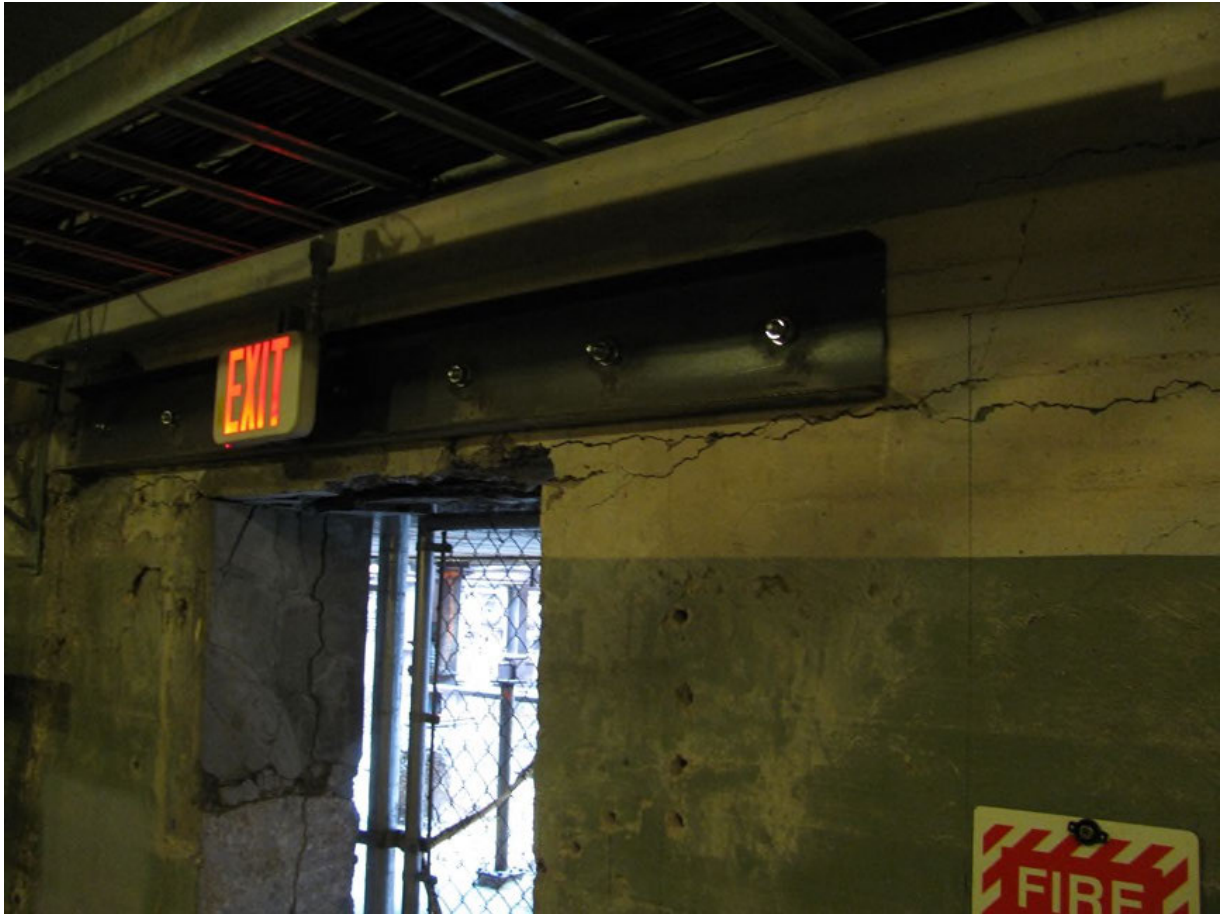
Figure 5: Existing Cracks in Basement of Substation Building at Eastern Doorway

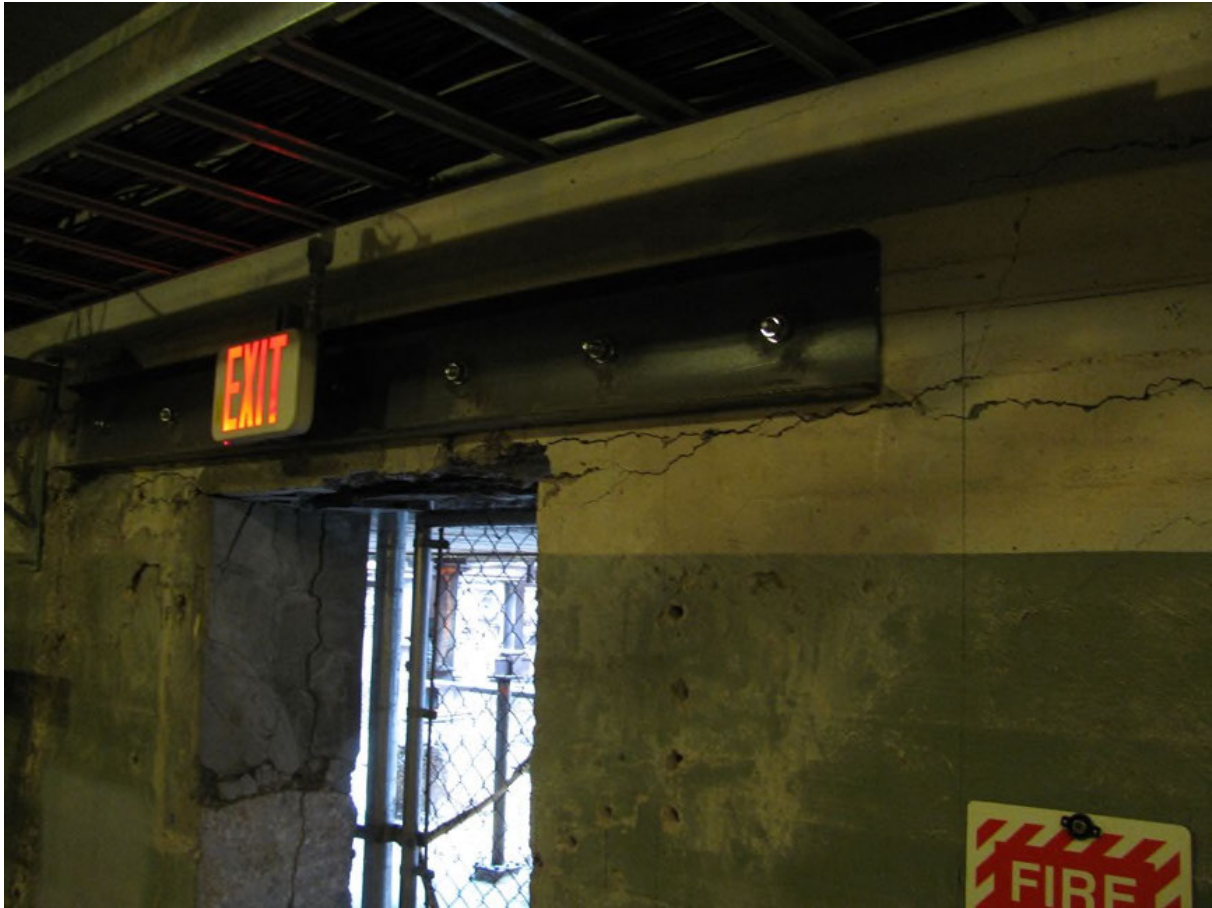
Figure 3: Medium Sized Cracks in Substation Building

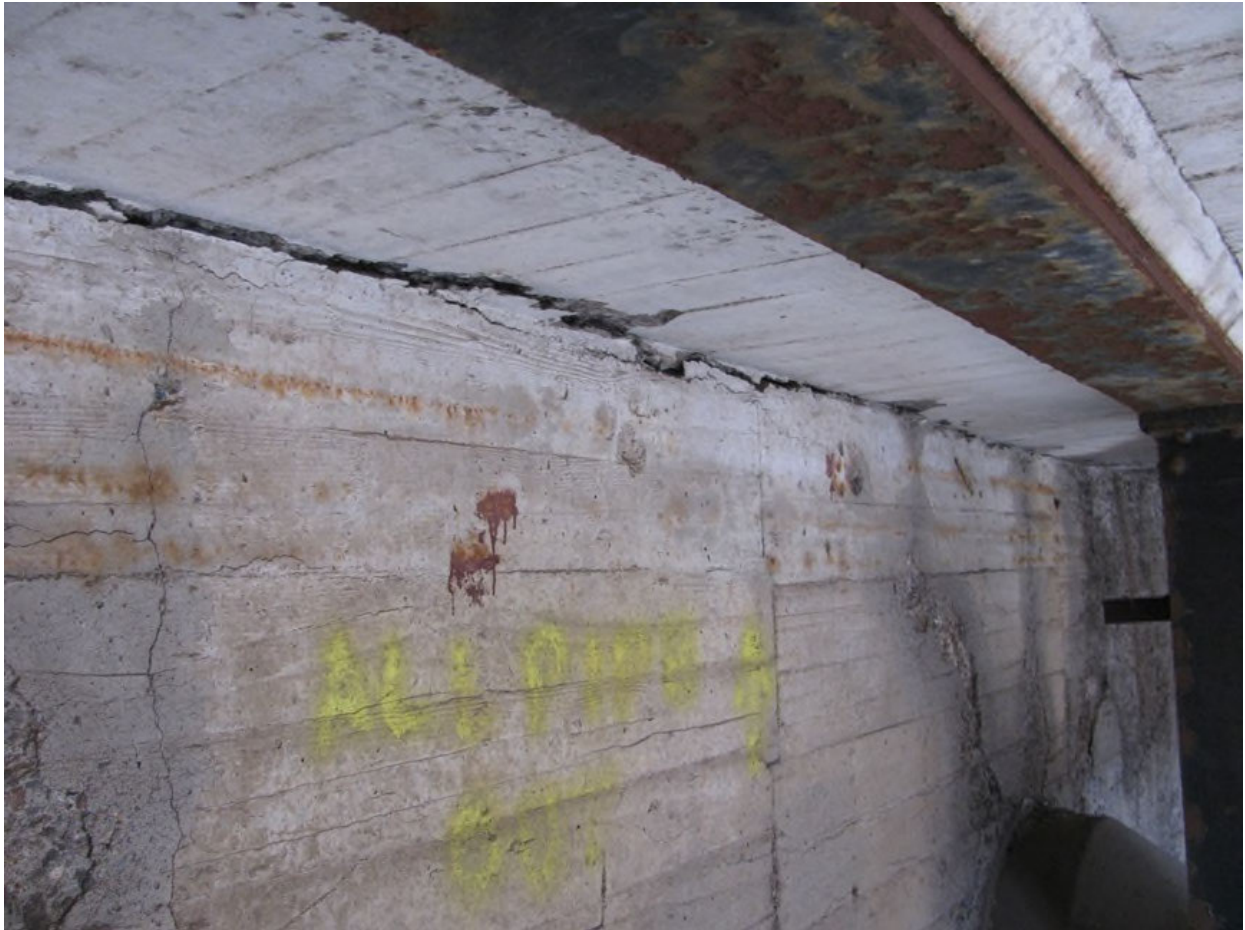
Figure 4: Large Sized Cracks in Substation Building
