ENVIRONMENTAL CONDITIONS ASSESSMENT
KERR-MCGEE CHEMICAL CORPORATION
HENDERSON, NEVADA FACILITY

KLEINFELDER, INC.
6850 S. Paradise Road
Las Vegas, Nevada 89119

KERR-MCGEE CHEMICAL CORPORATION
P.O. Box 55
Henderson, Nevada 89015

April 1993

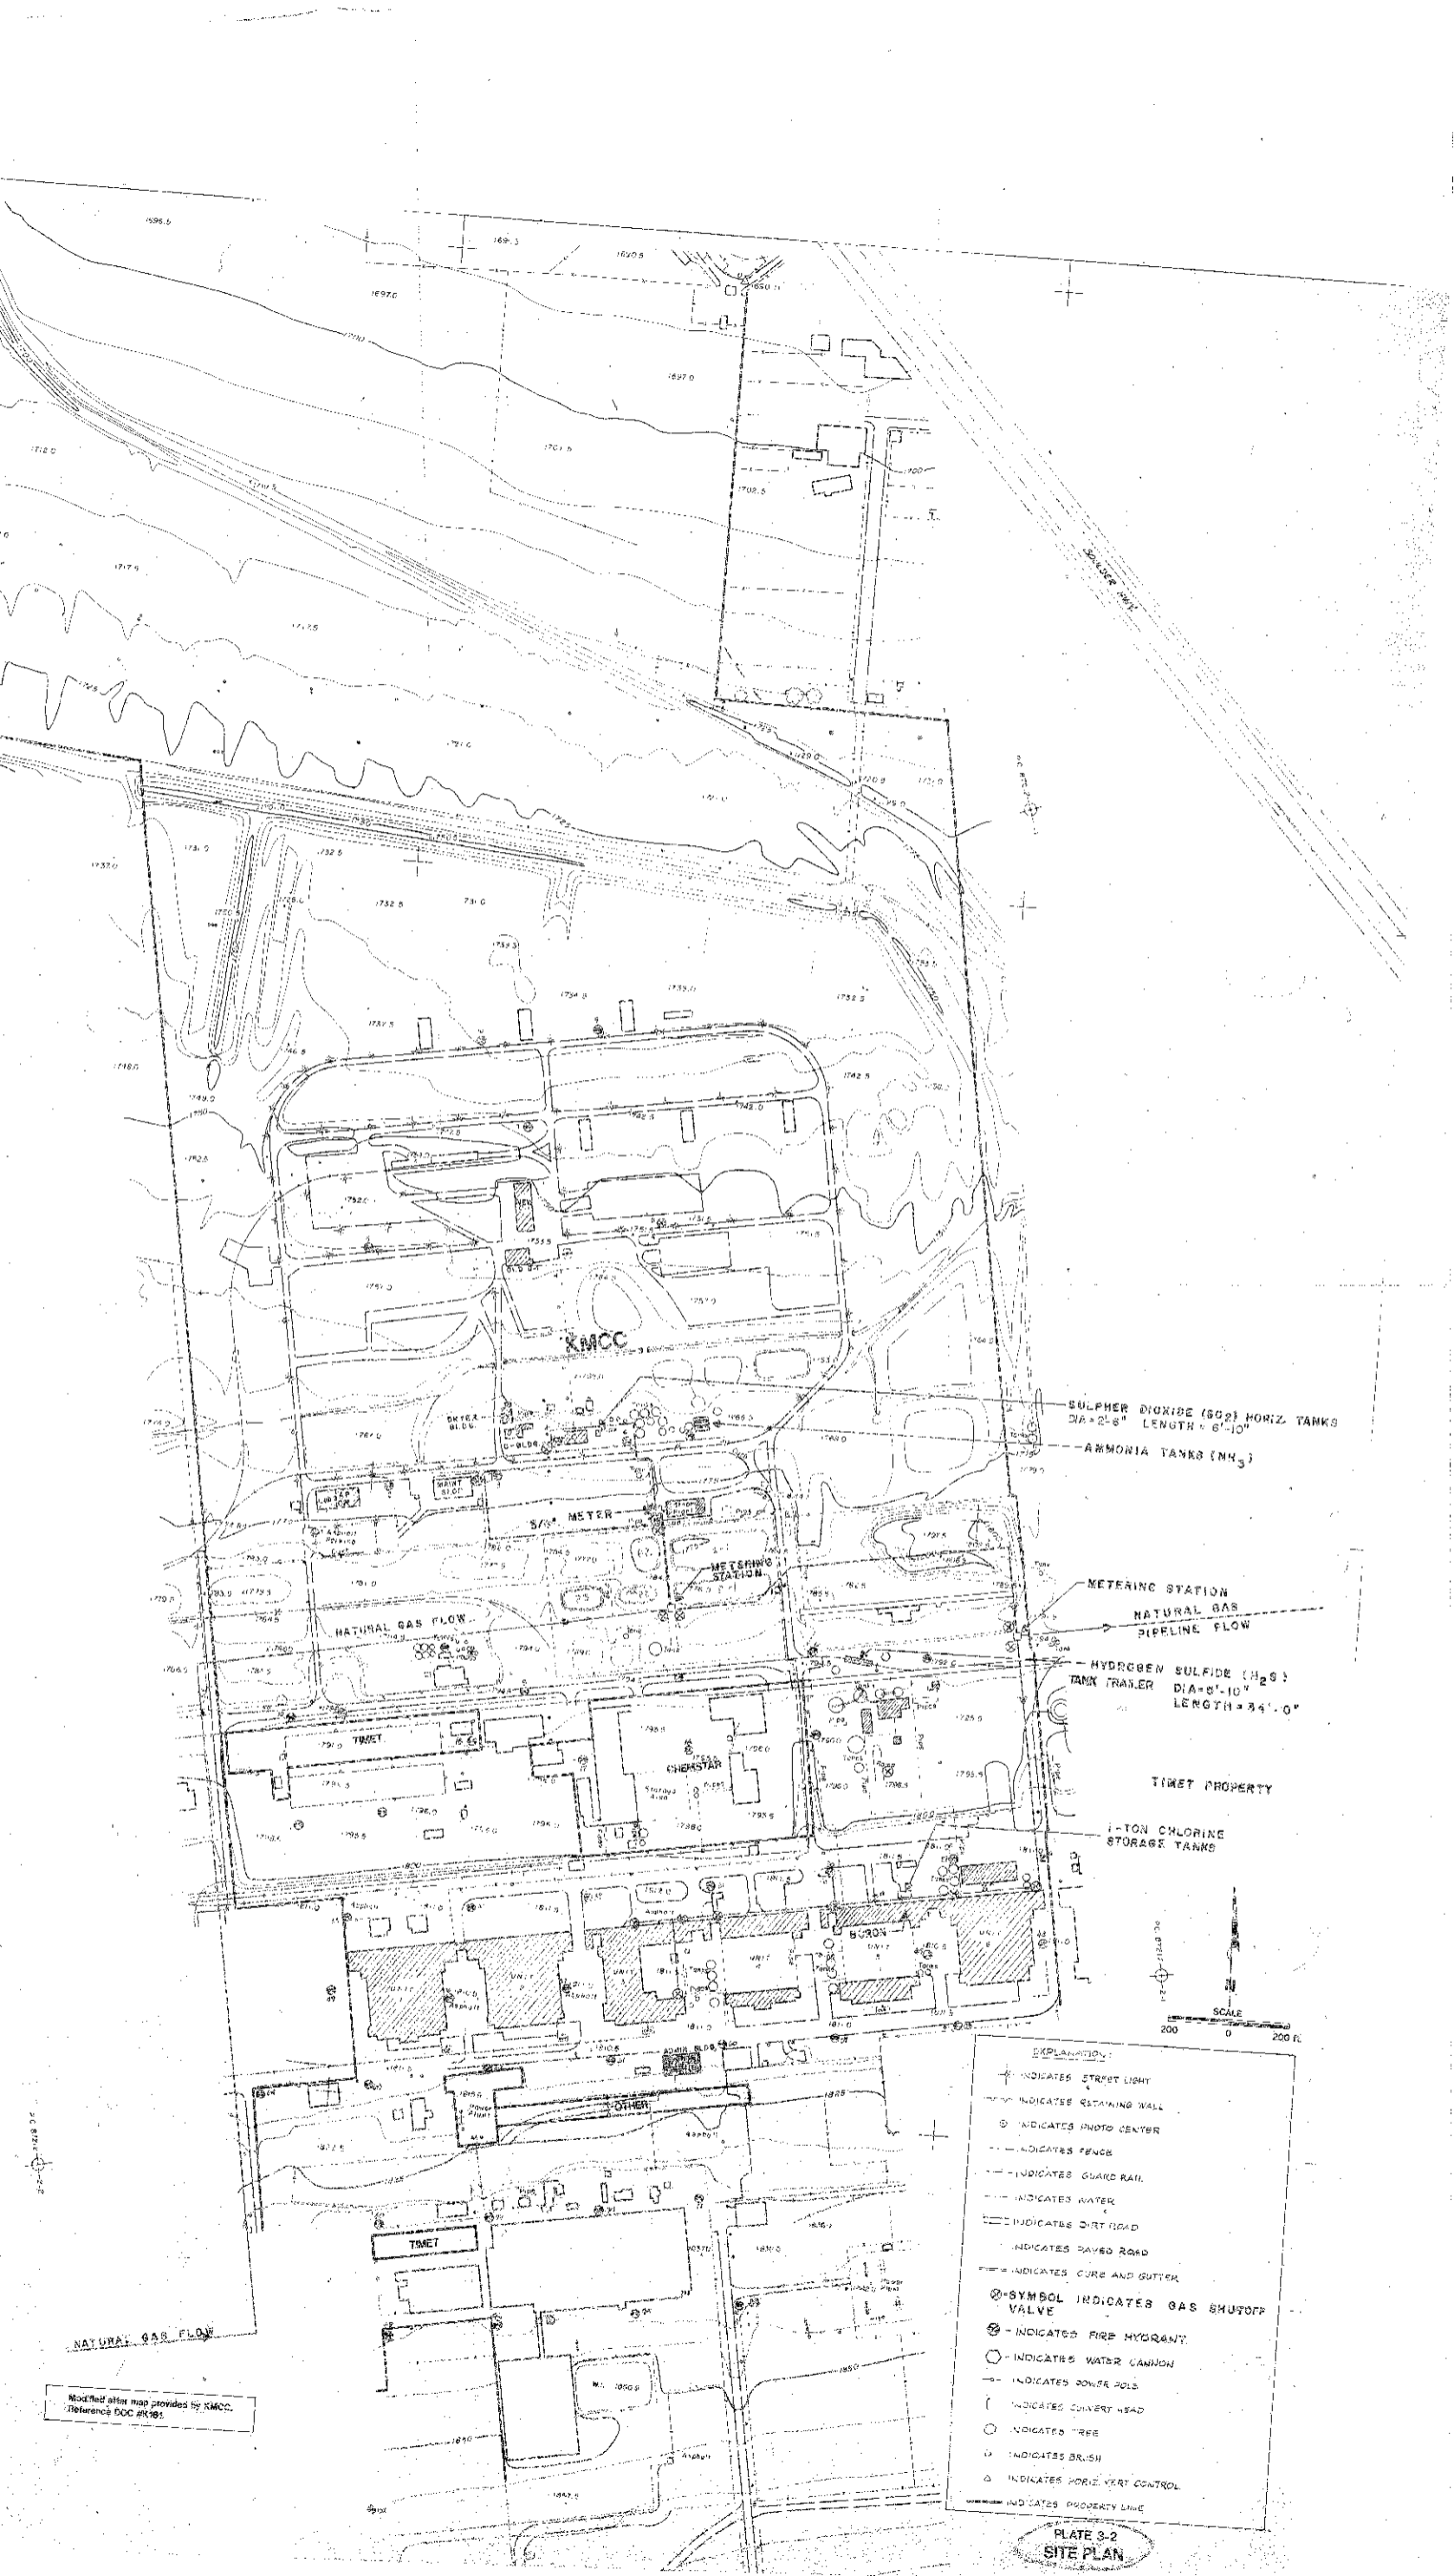
PLATE 3-2
SITE PLAN

SULPHUR DIOXIDE (SO₂) HORIZ. TANKS
DIA = 2'-8" LENGTH = 6'-10"

AMMONIA TANKS (NH₃)
