**Ref:** Damaged HDPE Process Lines  
Tronox Inc.  
560 West Lake Mead Parkway  
Henderson, NV 89015

Earth Resource Group (ERG) is pleased to submit this report documenting the process water release and results of the soil and water sampling conducted at the above-referenced site. The soil and water sampling was performed to determine the potential impact of the subsurface soil resulting from a front loader damaging high-density polyethylene (HDPE) process lines at the facility.

## 2.0 PROCESS LINES RUPTURE EVENT

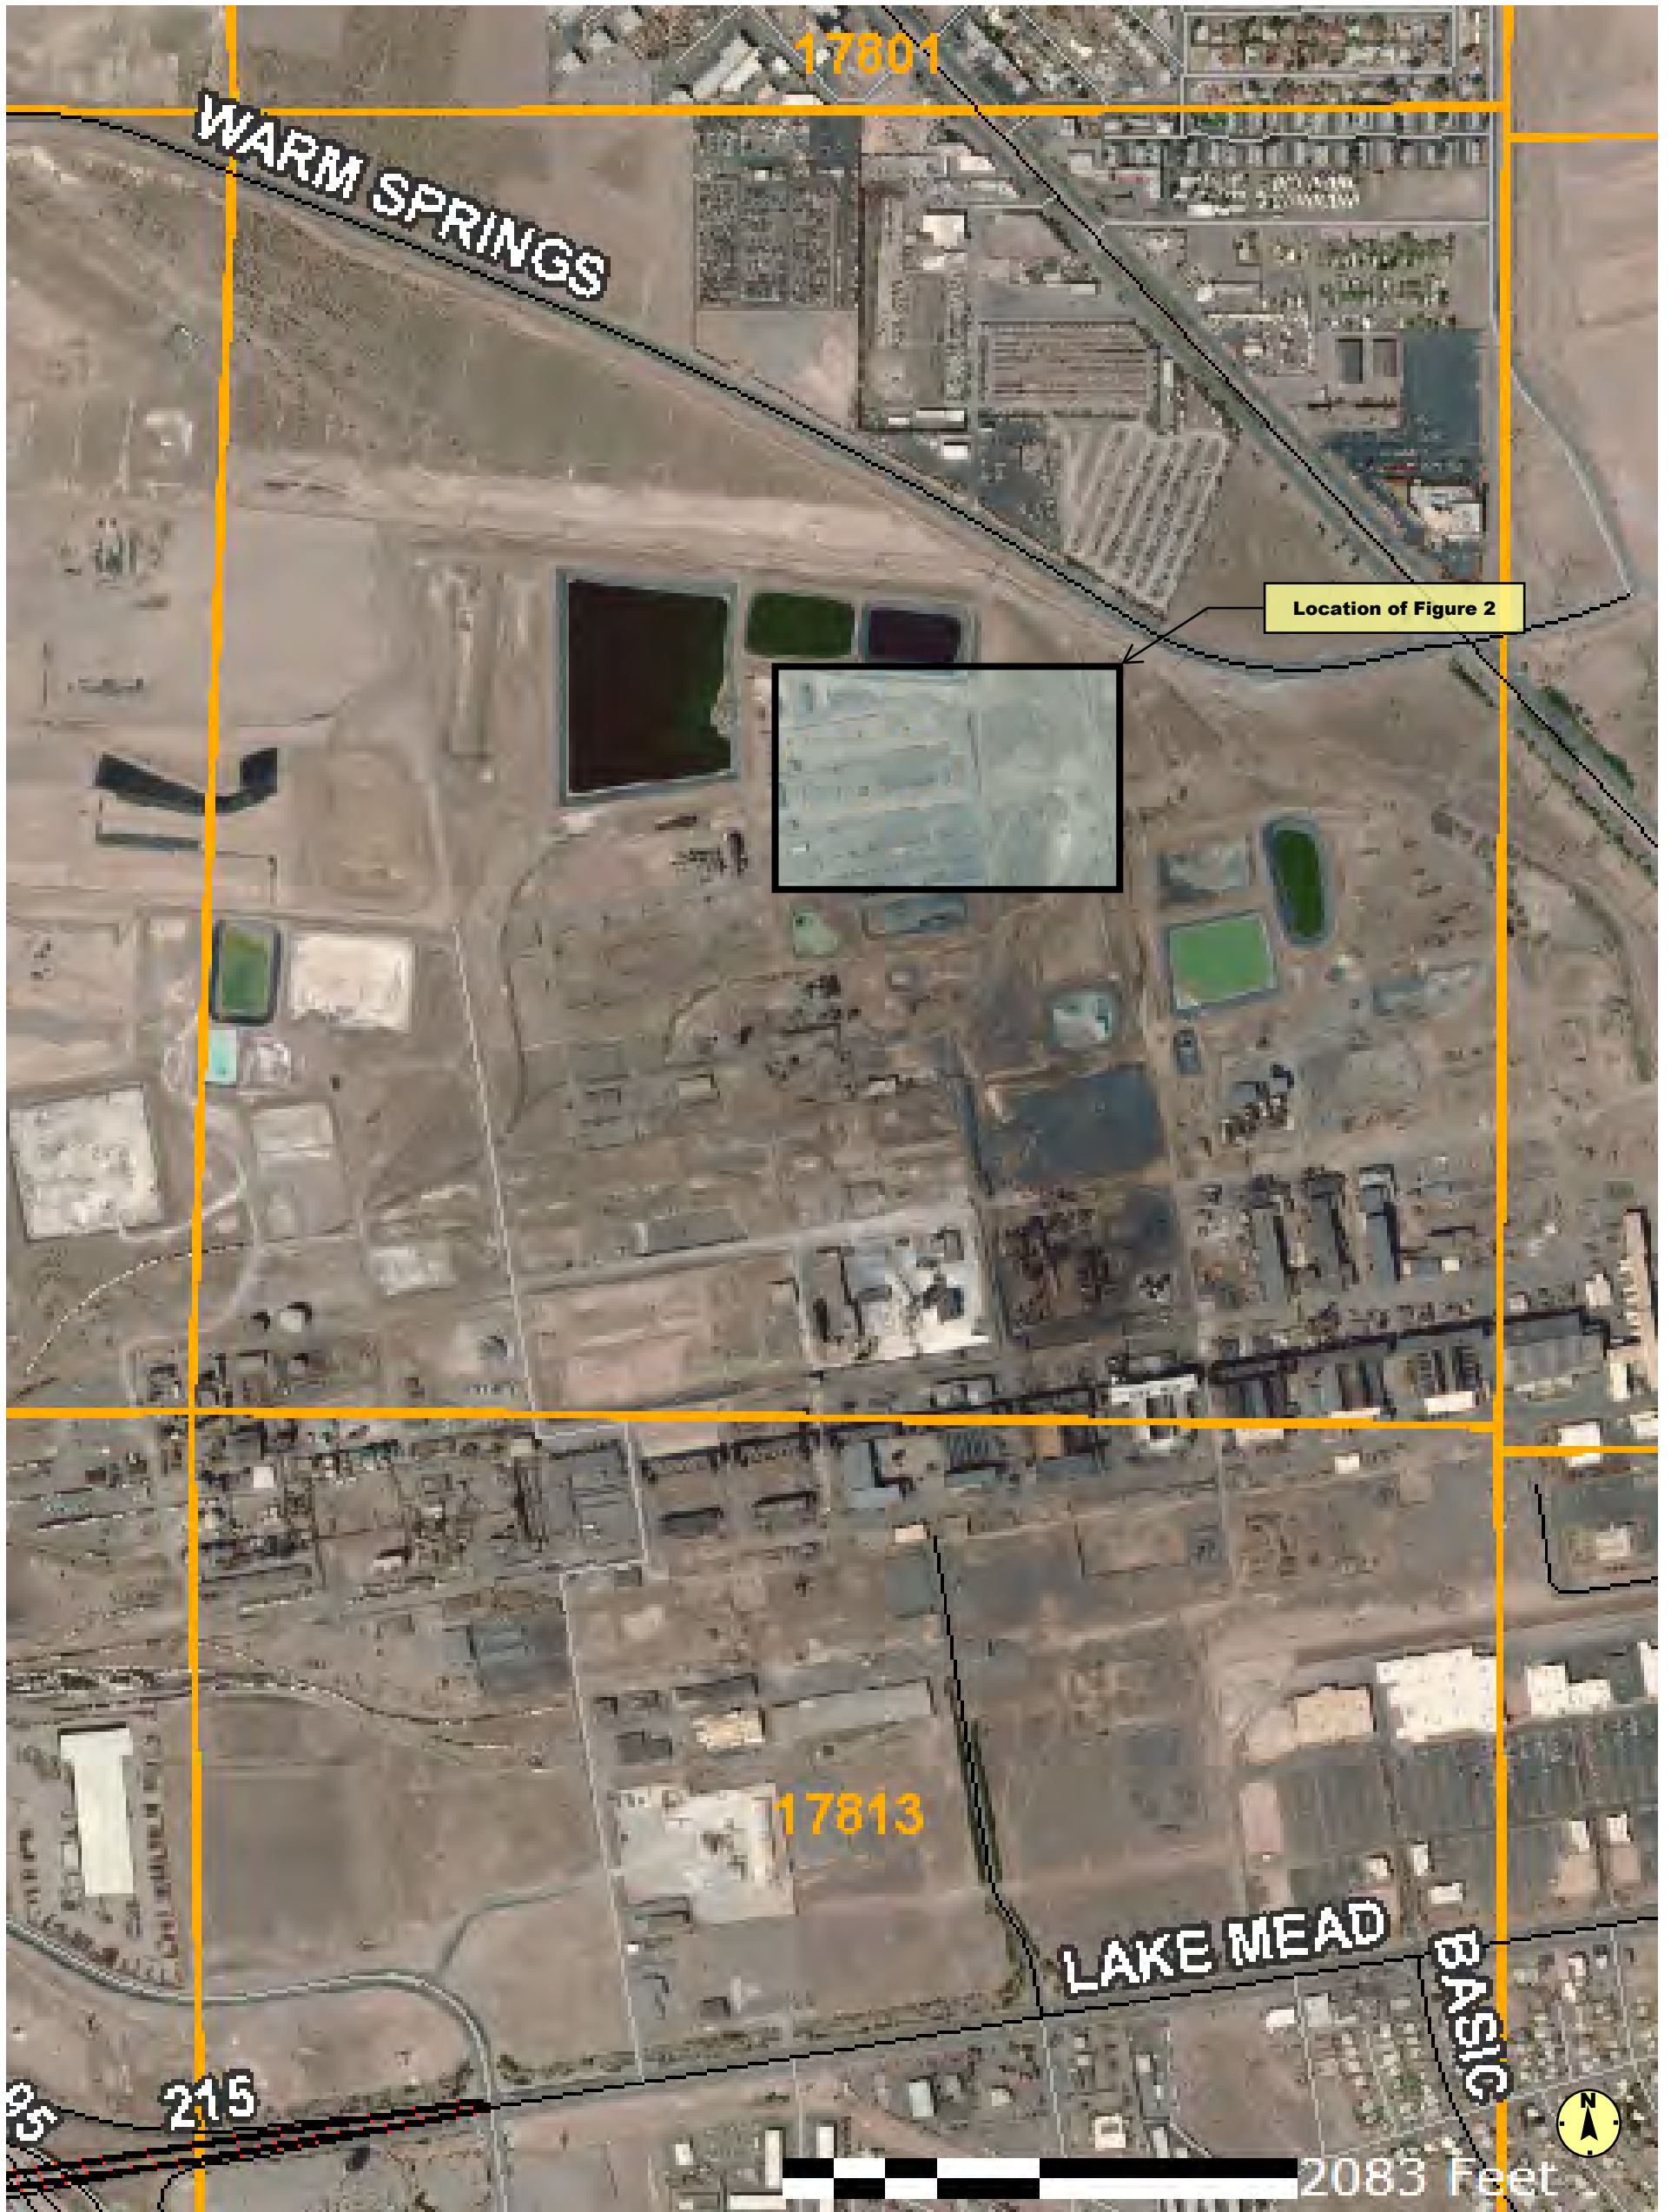
**Figure 1**

## **Overall Tronox Site Map**

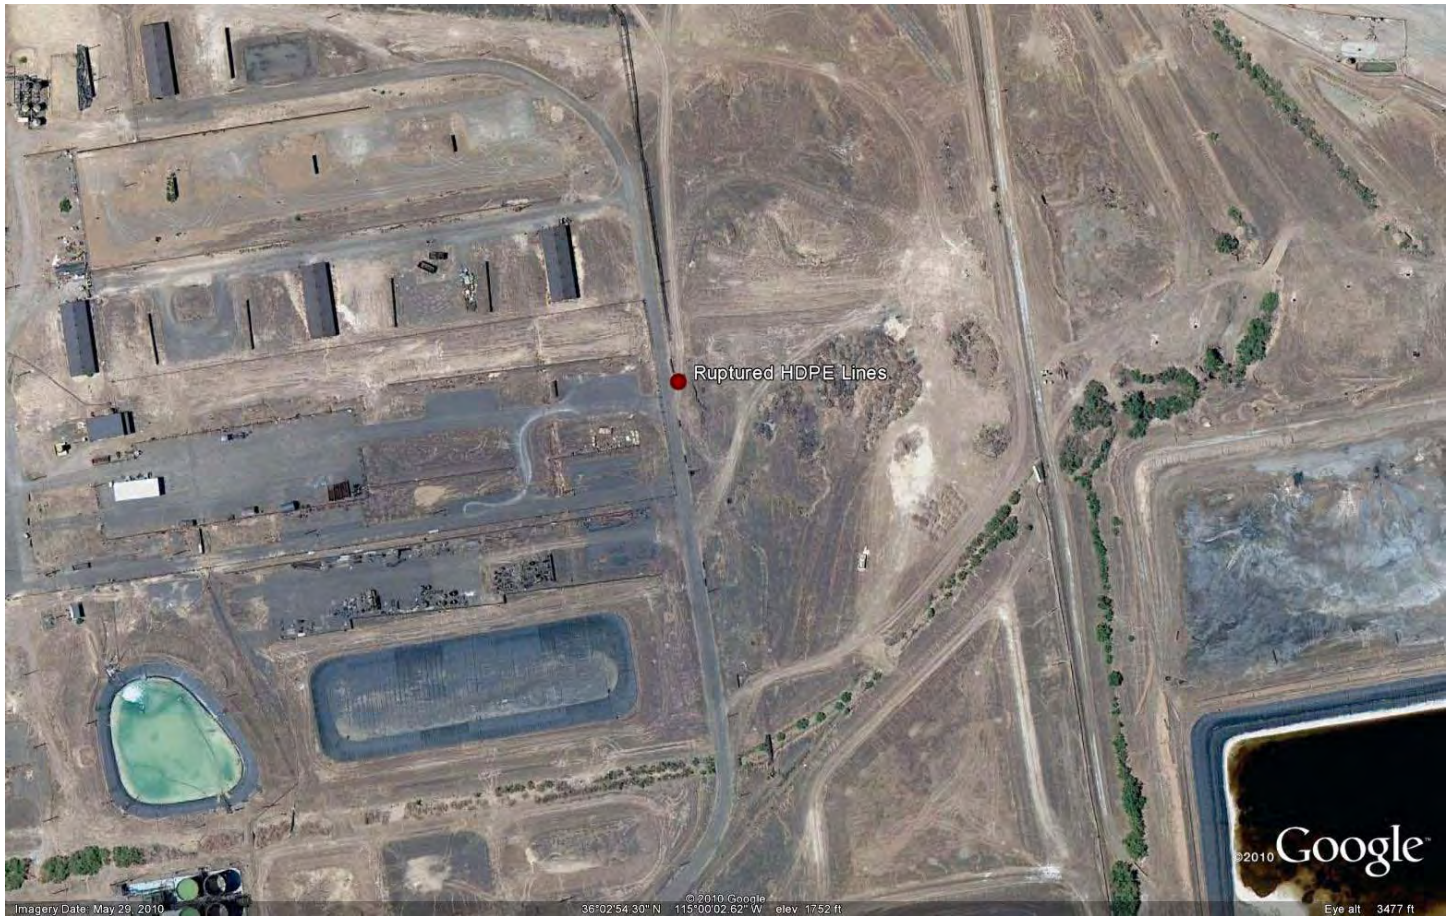
Figure 3 - Aerial View of Ruptured Process Line Location

On Wednesday December 8, 2010 at approximately 4:45 pm a Las Vegas Paving (LVP) front end loader damaged three HDPE process lines at the location described below. The damage occurred during the removal of the protective steel (trench) plates above the underground process lines. The site of the spill is located on the northern part of the Tronox facility with GPS coordinates of N 36 02.923 W 115 00.057 (+/- 10 feet).

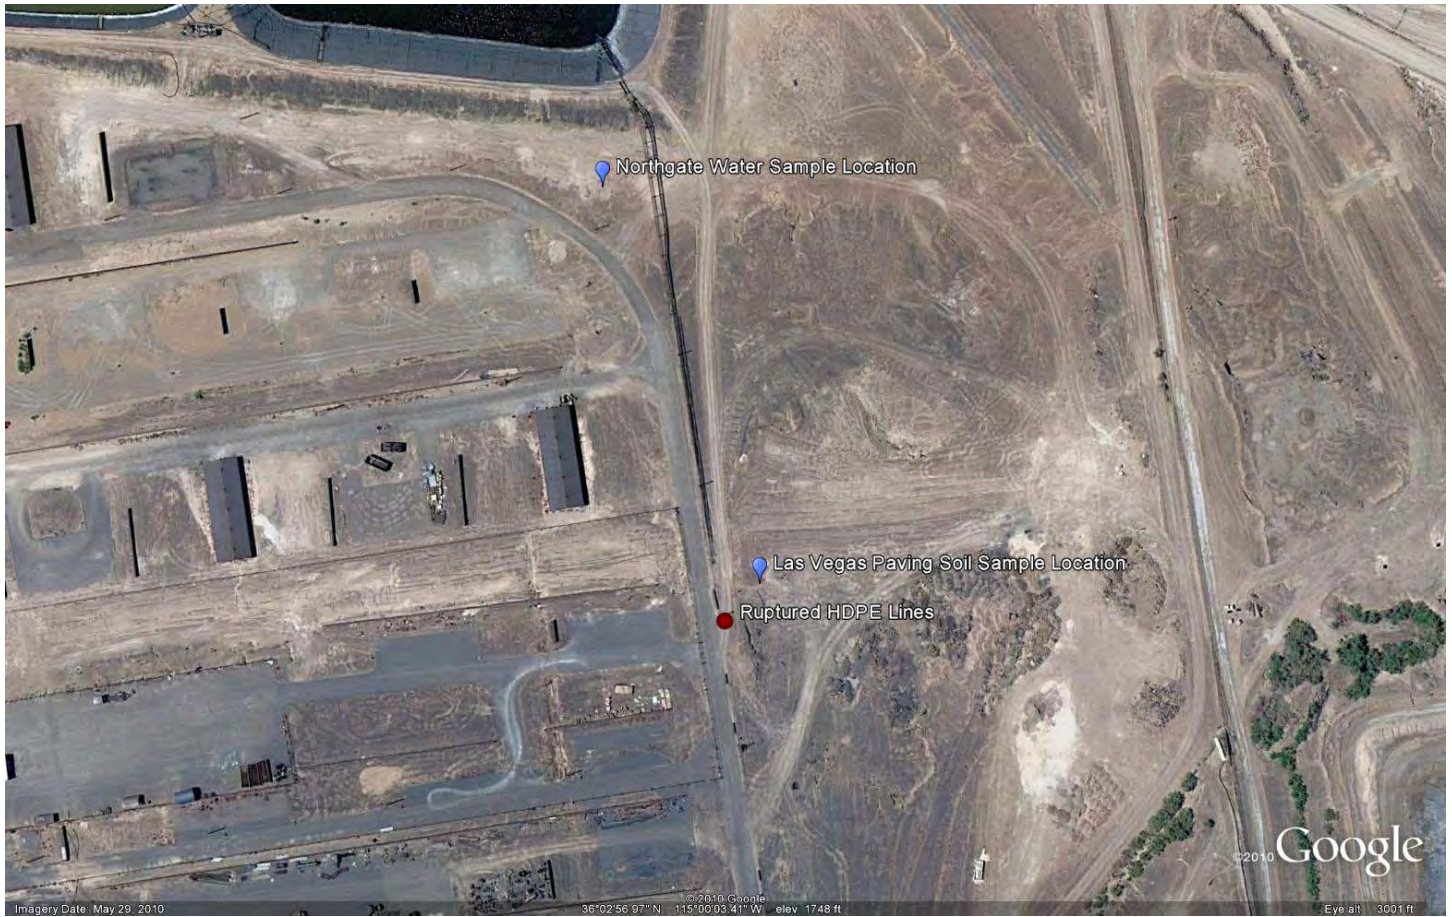
Figure 4 - Aerial View of Soil and Water Sample Locations

**3.1 SOIL AND WATER SAMPLING:** On December 9, 2010 one soil sample was obtained from the area by Dave Breault with LVP, just east of the release/line repair site (See Photo Log Photo 4 and Figure 4). The sample was collected using decontaminated soil scoops and placed in laboratory-supplied glass jars. Recovered samples were sealed, labeled, preserved on ice, and delivered to VERITAS Laboratories Inc. an NDEP-approved laboratory using chain-of-custody protocols. The soil sample was analyzed for total extractable petroleum hydrocarbons (TPH) using EPA method 8015 Modified, Volatile Organic Compounds by 8260B, RCRA 7 Metals by EPA 6010B and for pH using Method SM 4500H+B.

On December 8, 2010 one water sample (collected by Patrick Ferringer with Northgate Environmental and provided to Mike Skromyda with Tronox) was obtained from the area north of the spill and just south of the

ponds (See Figure 2). The sample was collected directly into four 500 ml plastic sterilized bottles. Recovered samples were sealed, labeled, preserved on ice, and delivered to Silver State Analytical Laboratories Inc. an NDEP-approved laboratory using chain-of-custody protocols. The water sample was analyzed for pH using Method SM 4500H+B, RCRA 8 Metals and Total Manganese by EPA Method 200.7 and for Total Dissolved Solids (TDS) by SM2540C.

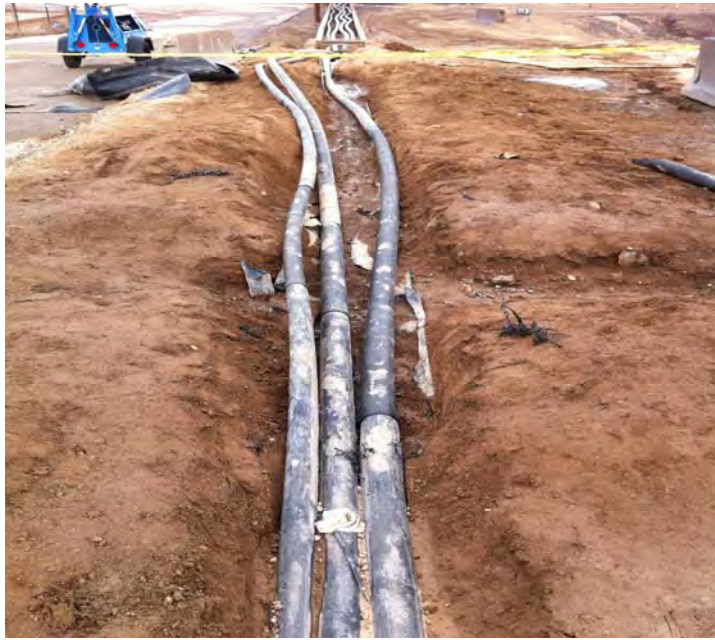
**Photograph 1**

View of repaired process lines looking north.

- LVP made all HDPE fusion repairs in close coordination with Tronox personnel. Tronox's line break and lock out/tag out procedures were implemented and followed.

- The HDPE fusion repairs were completed at 1:15 am on 12/9/10.

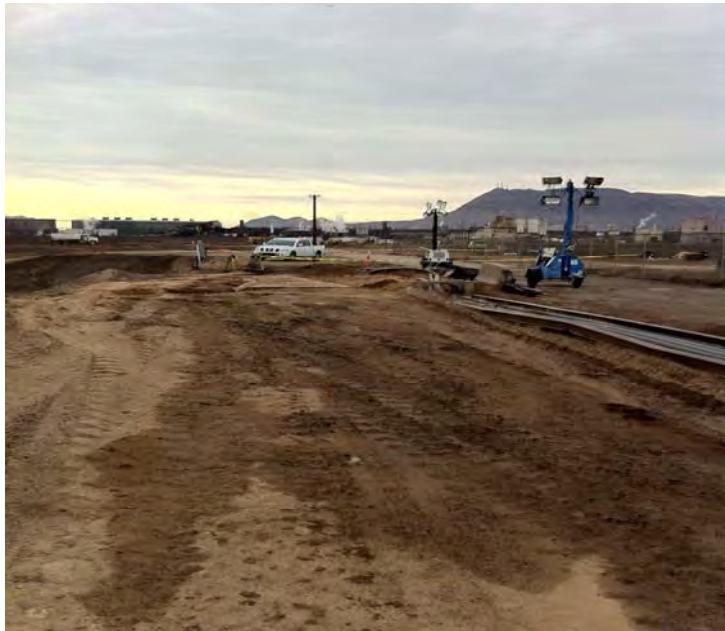
**Photograph 2** View from just north of the damaged process lines looking towards the south.

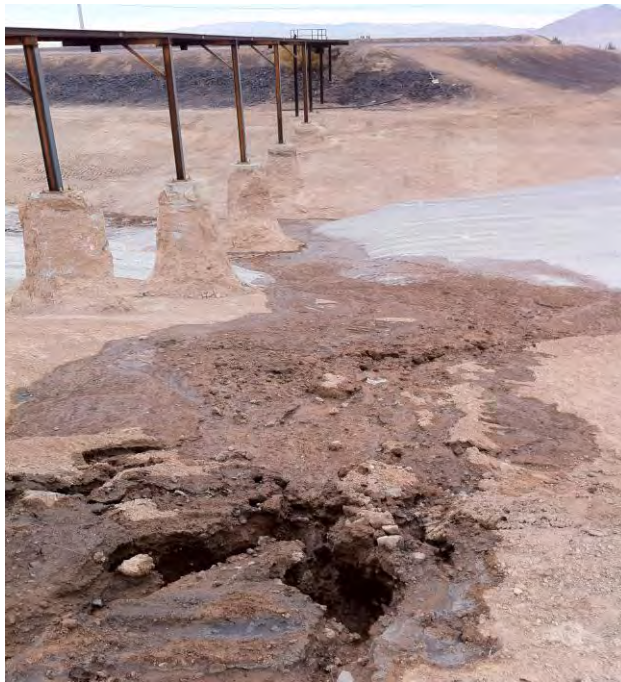
**Photograph 3** View of process water running to north east side of trestle just south of ponds.

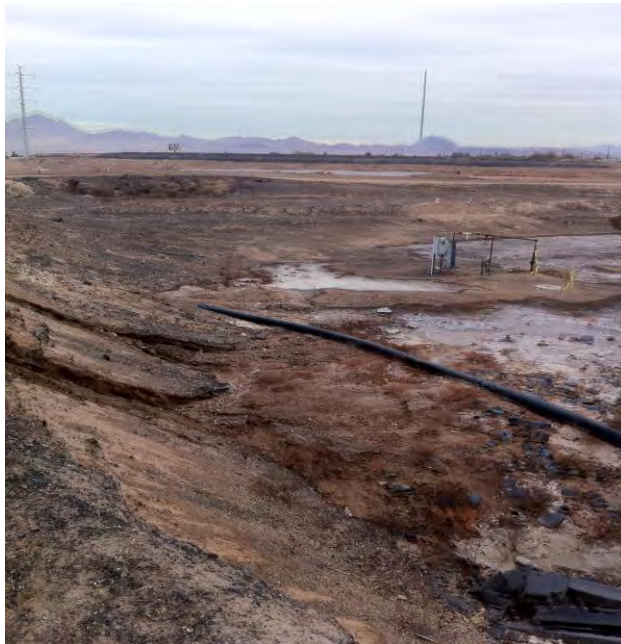
**Photograph 4** View looking north just east of the damaged process lines. Soil sample S-1 was collected approximately 5 feet west of the grey well control box shown in the photo.

**4.1** Soil sample analytical results from sample **S-1** indicate TPH and Volatile Organic Compounds were not detected. The analysis of soil sample **S-1** for RCRA 7 Metals by EPA 6010B indicated Arsenic at 4.8 mg/kg, Barium at 250 mg/kg, Cadmium at 0.97 mg/kg, Chromium at 35 mg/kg, Lead at 75 mg/kg, Selenium and Silver were not detected. Sample S-1 analysis indicated a pH of 11 using Method SM 4500H+B.
