**Regarding:** *Limited Asbestos Survey – RZ-C*  
**Nevada Environmental Response Trust**  
**560 West Lake Mead Parkway**  
**Henderson, Nevada 89015**  
**Project – CON111106**

**Photograph Log  
Bulk Sample Locations**

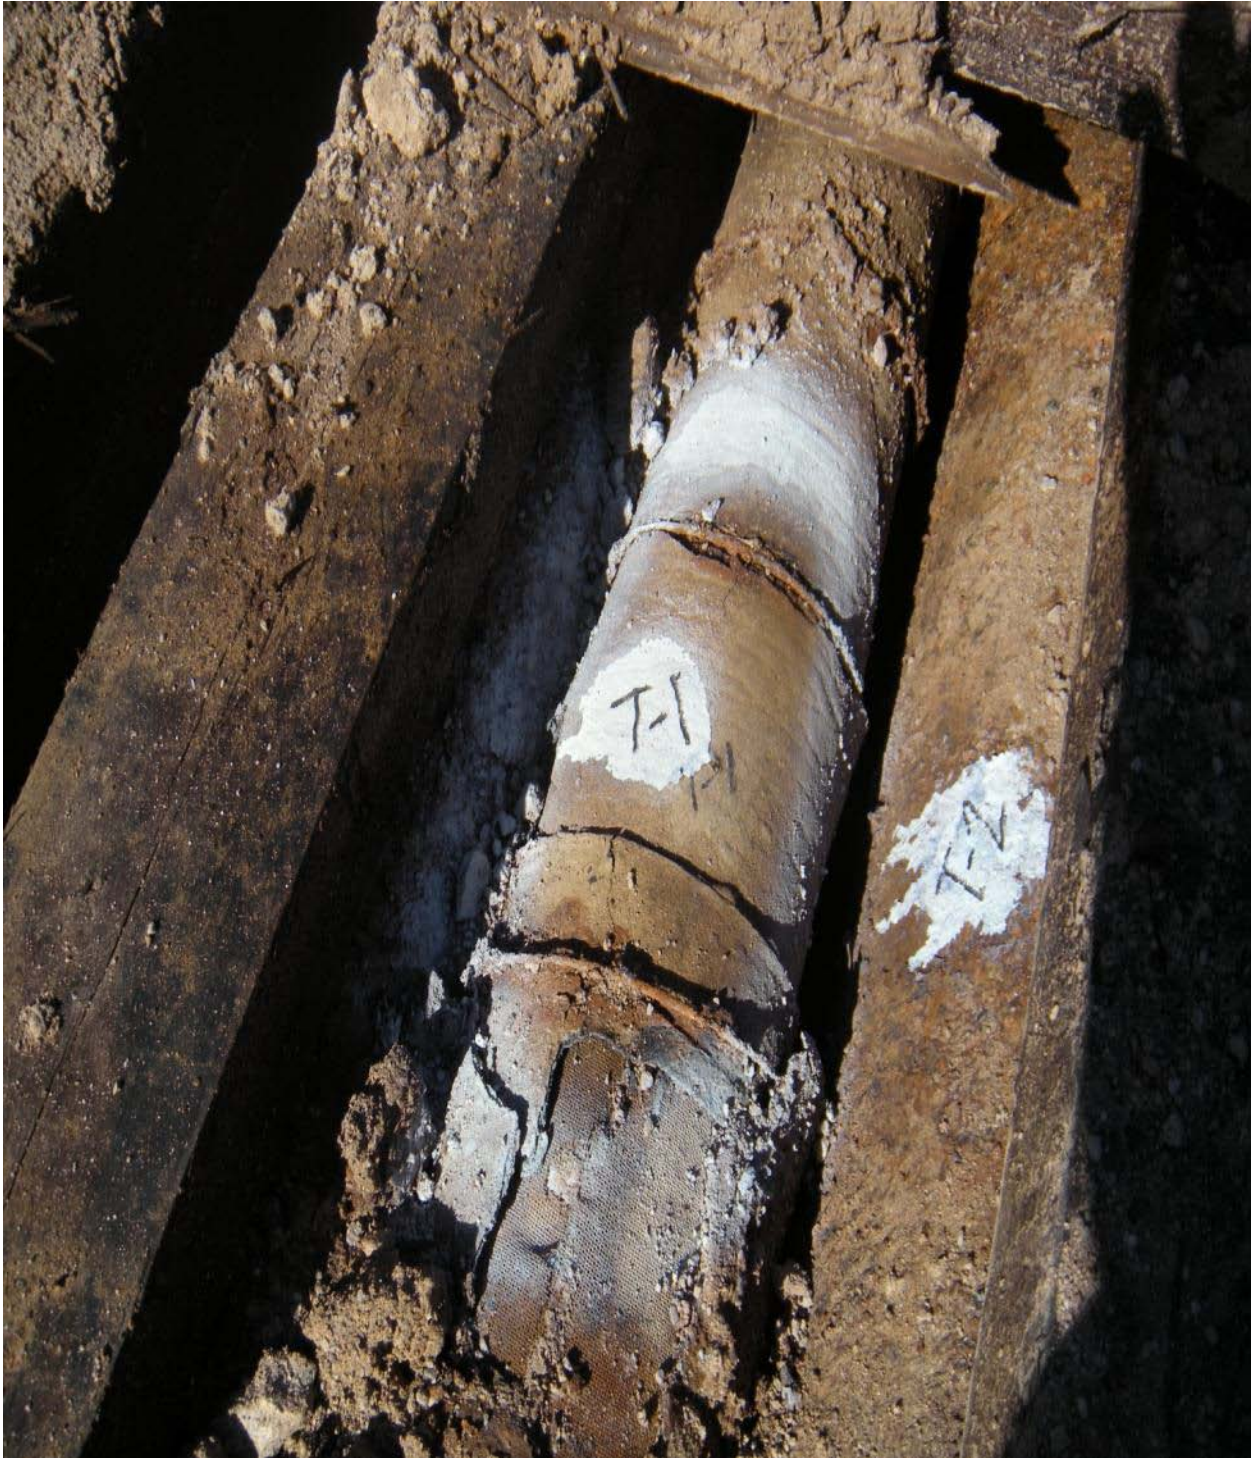
Sample ID	Color	Description	Location	Result	Friable or Non-Friable	Estimated Quantities	Condition
T-1	Brown	pipe wrap, 1" metal piping	RZ-C24	ND	Friable	45 linear feet	Poor

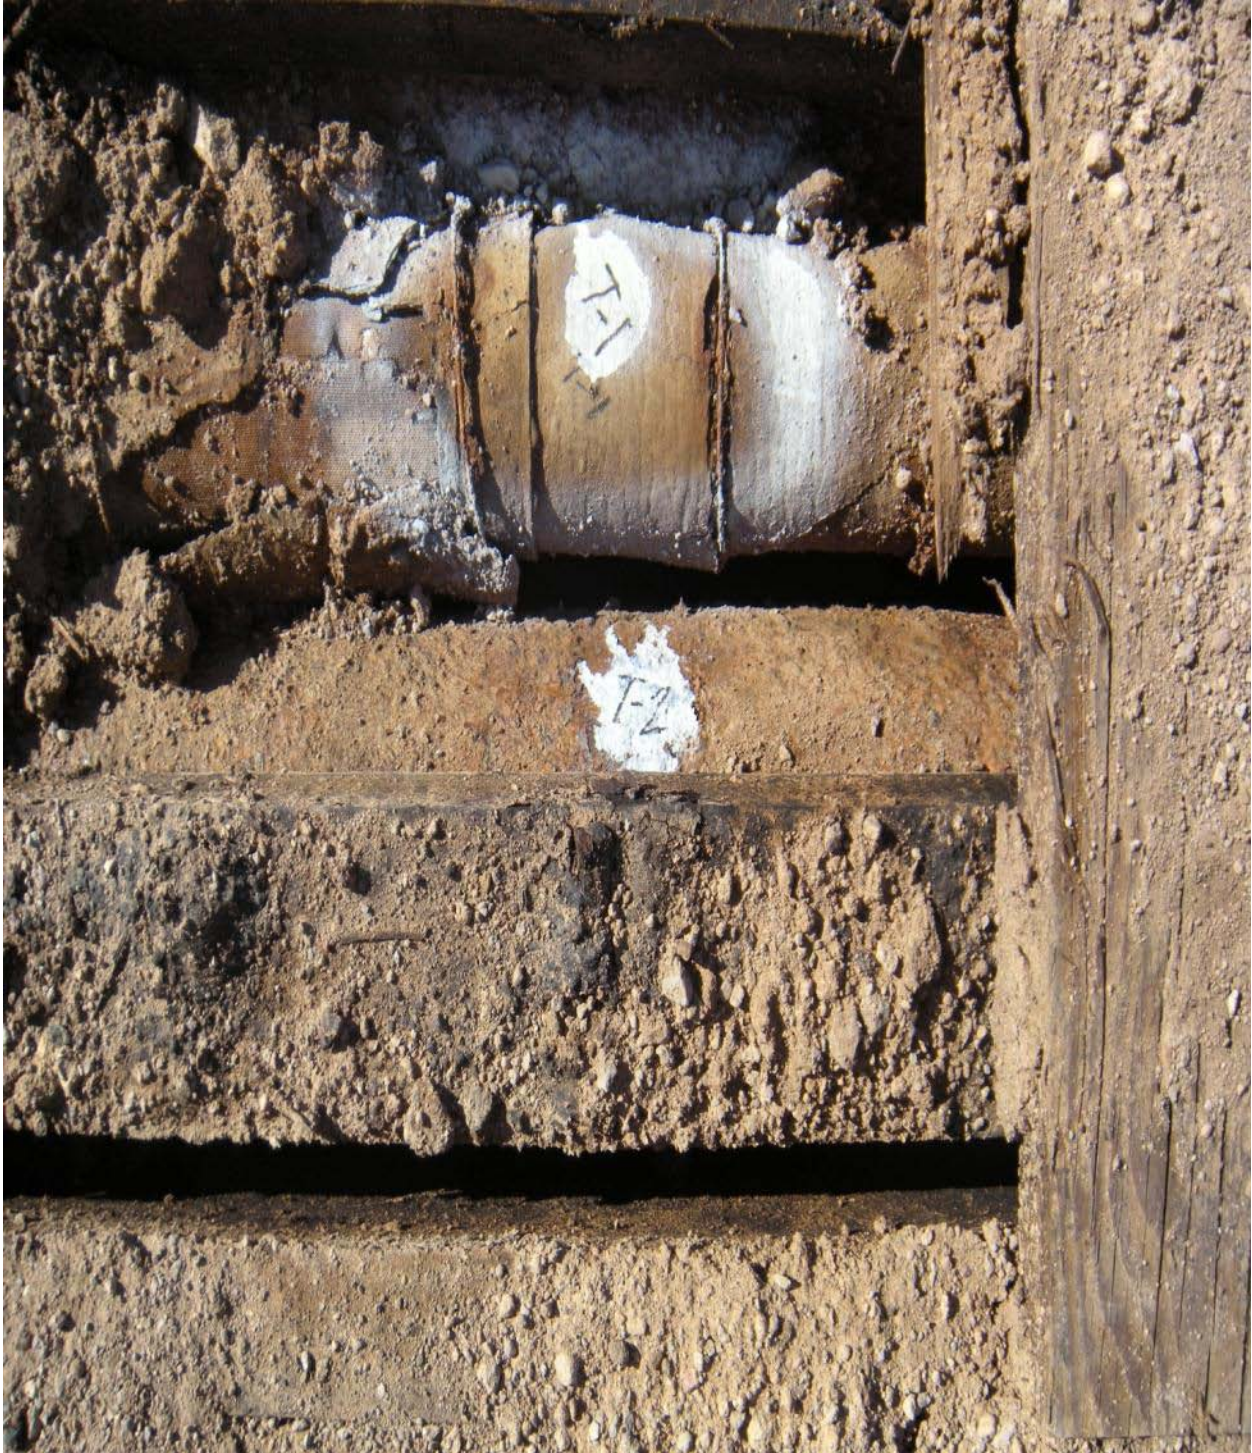
Sample ID	Color	Description	Location	Result	Friable or Non-Friable	Estimated Quantities	Condition
T-2	Brown	pipe wrap, north 4" metal piping	RZ-C24	ND	Friable	90 linear feet	Poor

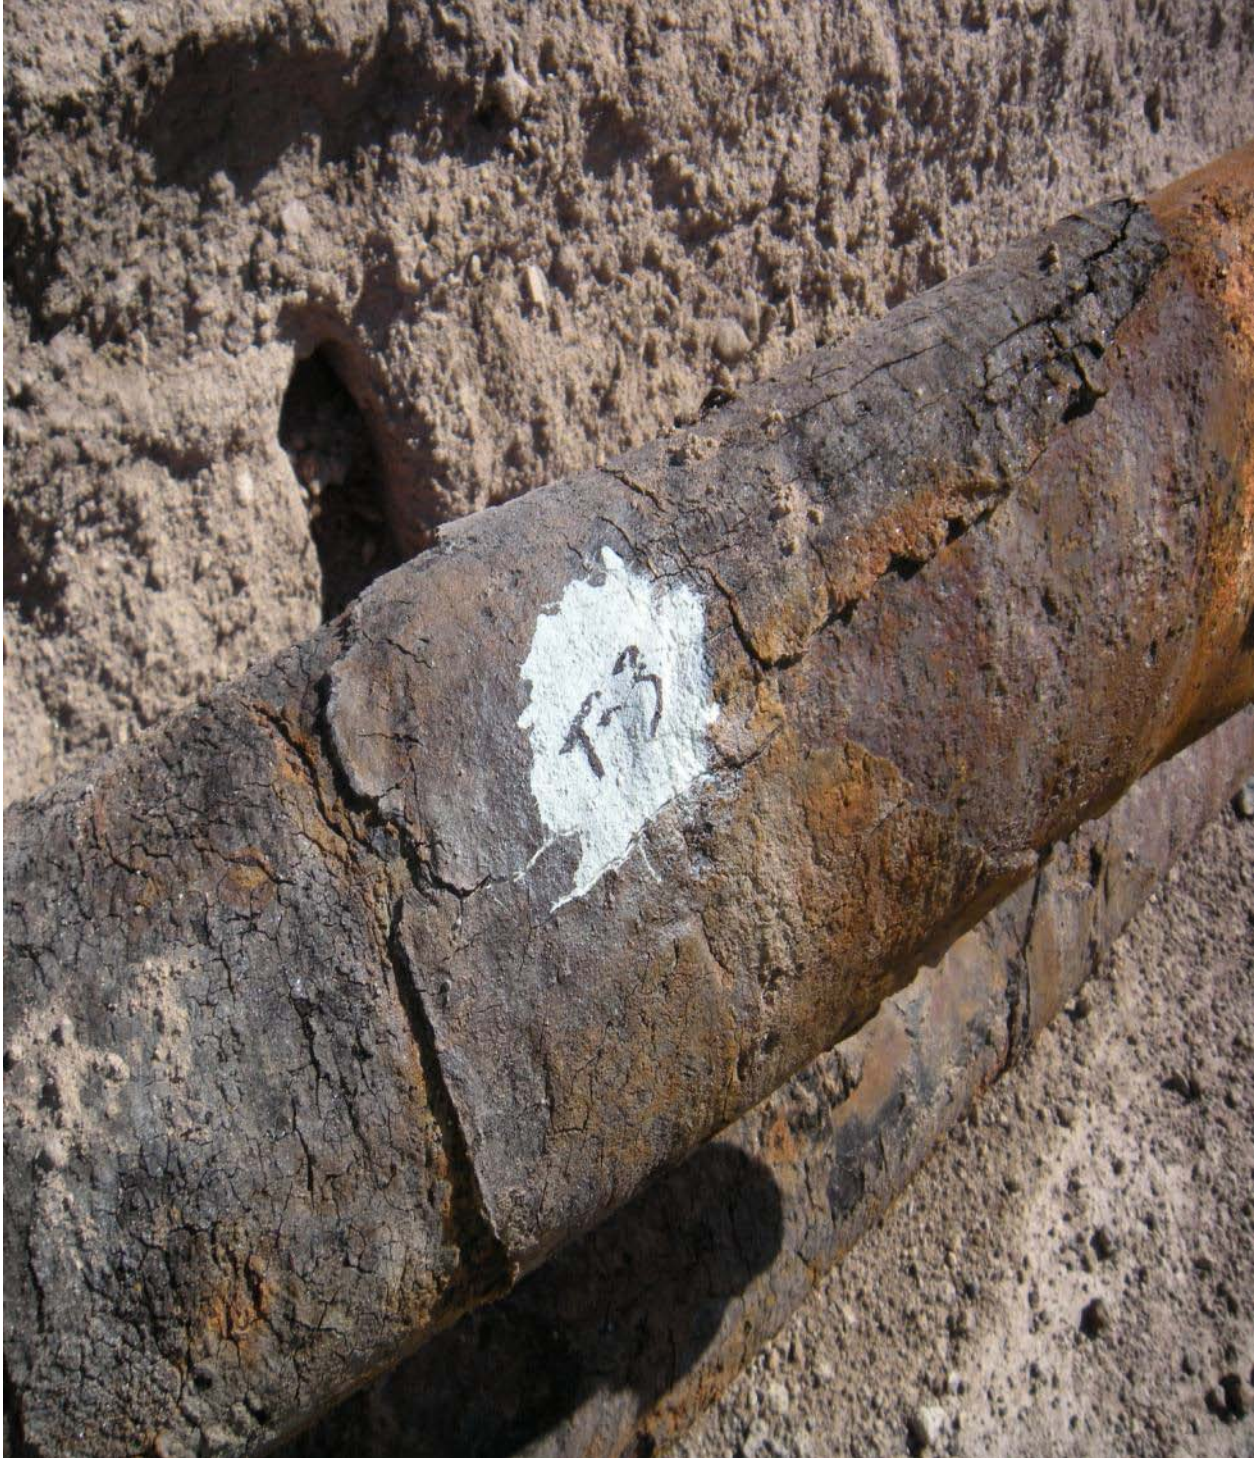
Sample ID	Color	Description	Location	Result	Friable or Non-Friable	Estimated Quantities	Condition
T-3	Brown/Black	pipe wrap, upper 6" metal piping	RZ-C24	ND	Friable	90 linear feet	Poor

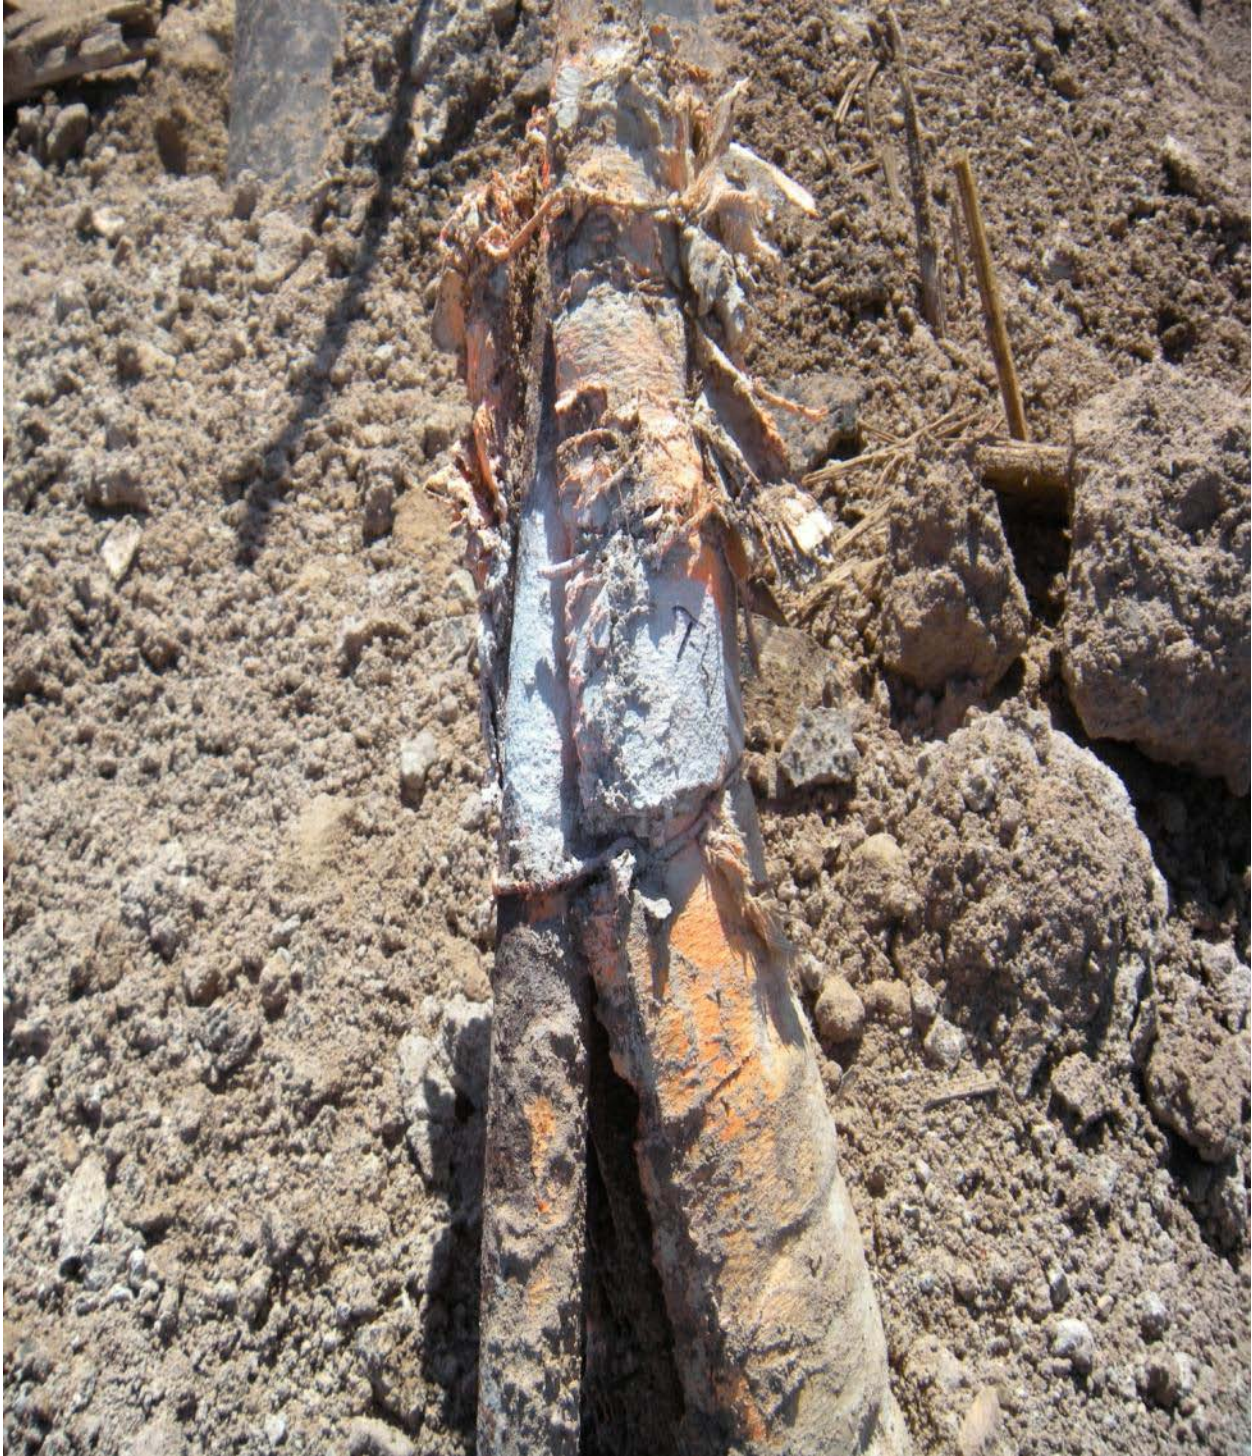
- ◆ Beige pipe wrap, one-inch pipe from RZ-C24 in the northwest corner;
- ◆ Brown/black pipe wrap, eastern two-inch pipe near RZ-C24; and
- ◆ Brown/black pipe wrap, western two-inch pipe near RZ-C24.

Sample ID	Color	Description	Location	Result	Friable or Non-Friable	Estimated Quantities	Condition
T-4	Beige	pipe wrap, 1" metal piping	RZ-C24	35% Chrysotile	Friable	45 linear feet	Poor

A Nevada-licensed asbestos abatement contractor must be used to remove and dispose of RACM prior to disturbance of the materials. Asbestos work activities are categorized according to OSHA 29 CFR 1926.1101(b). Class I asbestos work is defined as activities involving the removal of TSI ACM, surfacing ACM, and PACM. Class II asbestos work means activities involving the removal of ACM which is not thermal system insulation or surfacing material. This includes, but is not limited to, the removal of asbestos-containing wallboard, floor tile and sheeting, roofing and siding shingles, and construction mastics. Class III asbestos work involves repair and maintenance operations, where ACM, including TSI and surfacing ACM and PACM, is likely to be disturbed, and Class IV asbestos work means maintenance and custodial activities during which employees contact but do not disturb ACM or PACM and activities to clean up dust, waste, and debris resulting from Class I, Class II, and Class III activities.

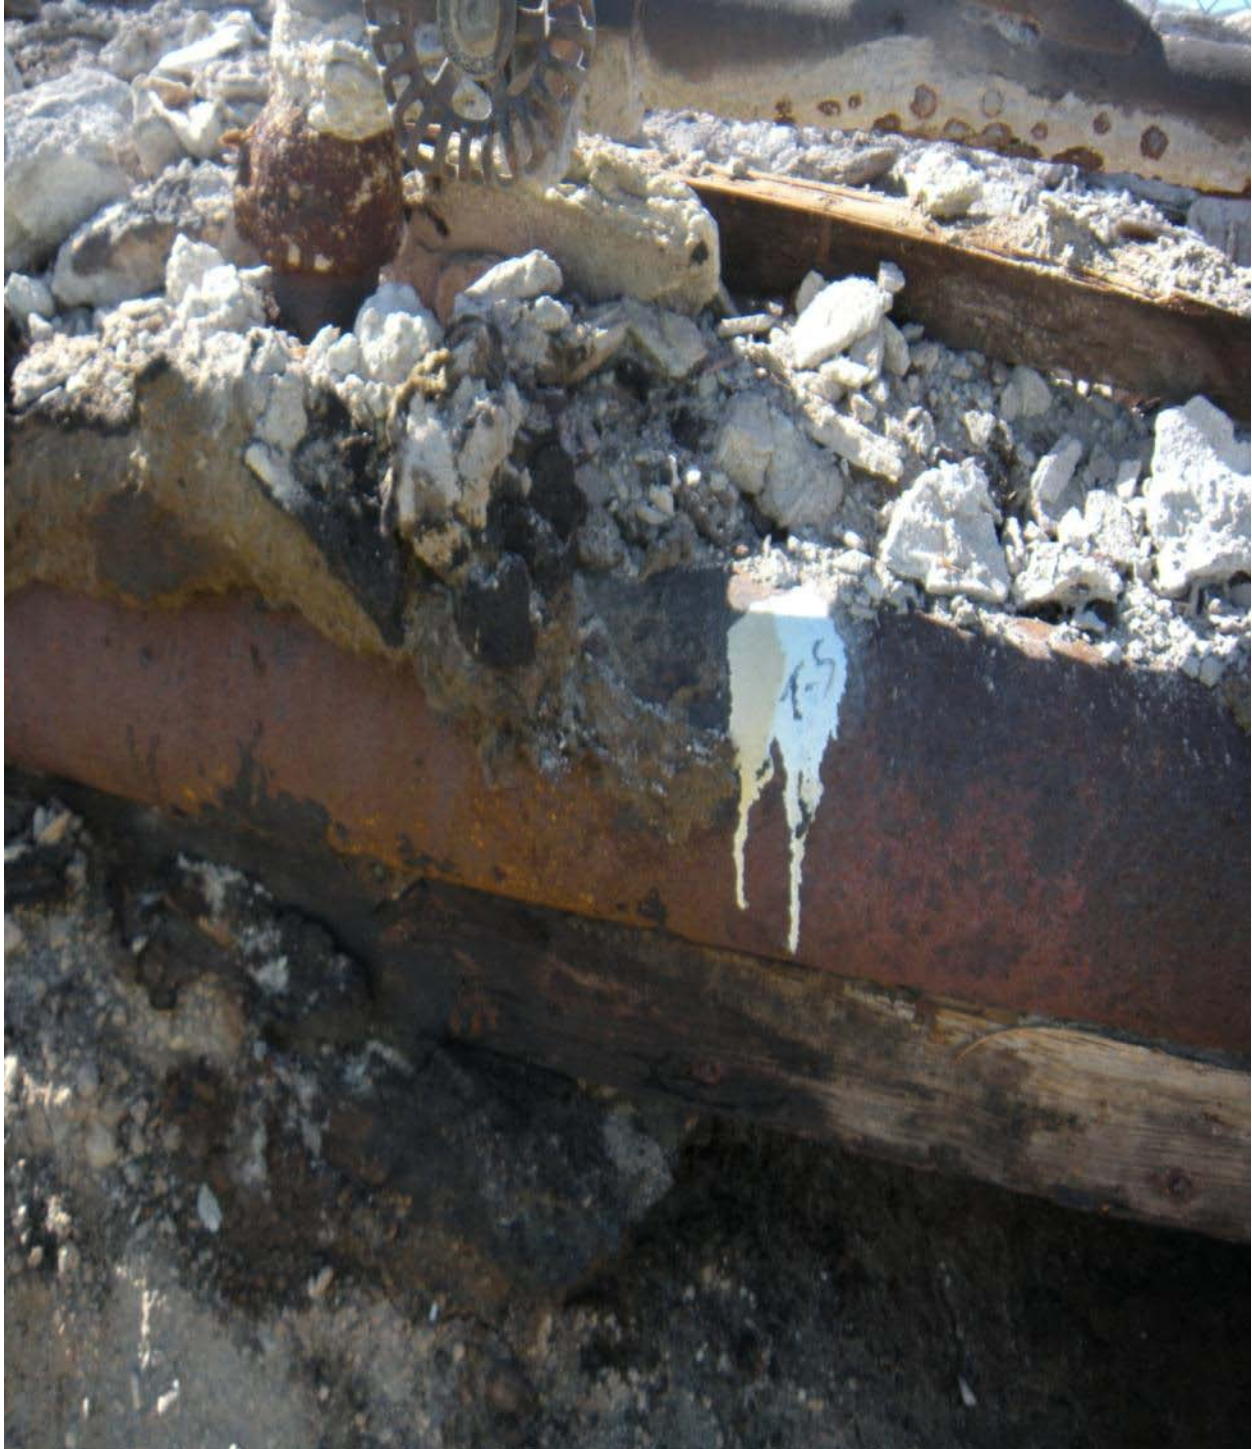
Sample ID	Color	Description	Location	Result	Friable or Non-Friable	Estimated Quantities	Condition
T-5	Brown/Black	pipe wrap, 4" metal piping	RZ-C	ND	Friable	225 linear feet	Poor

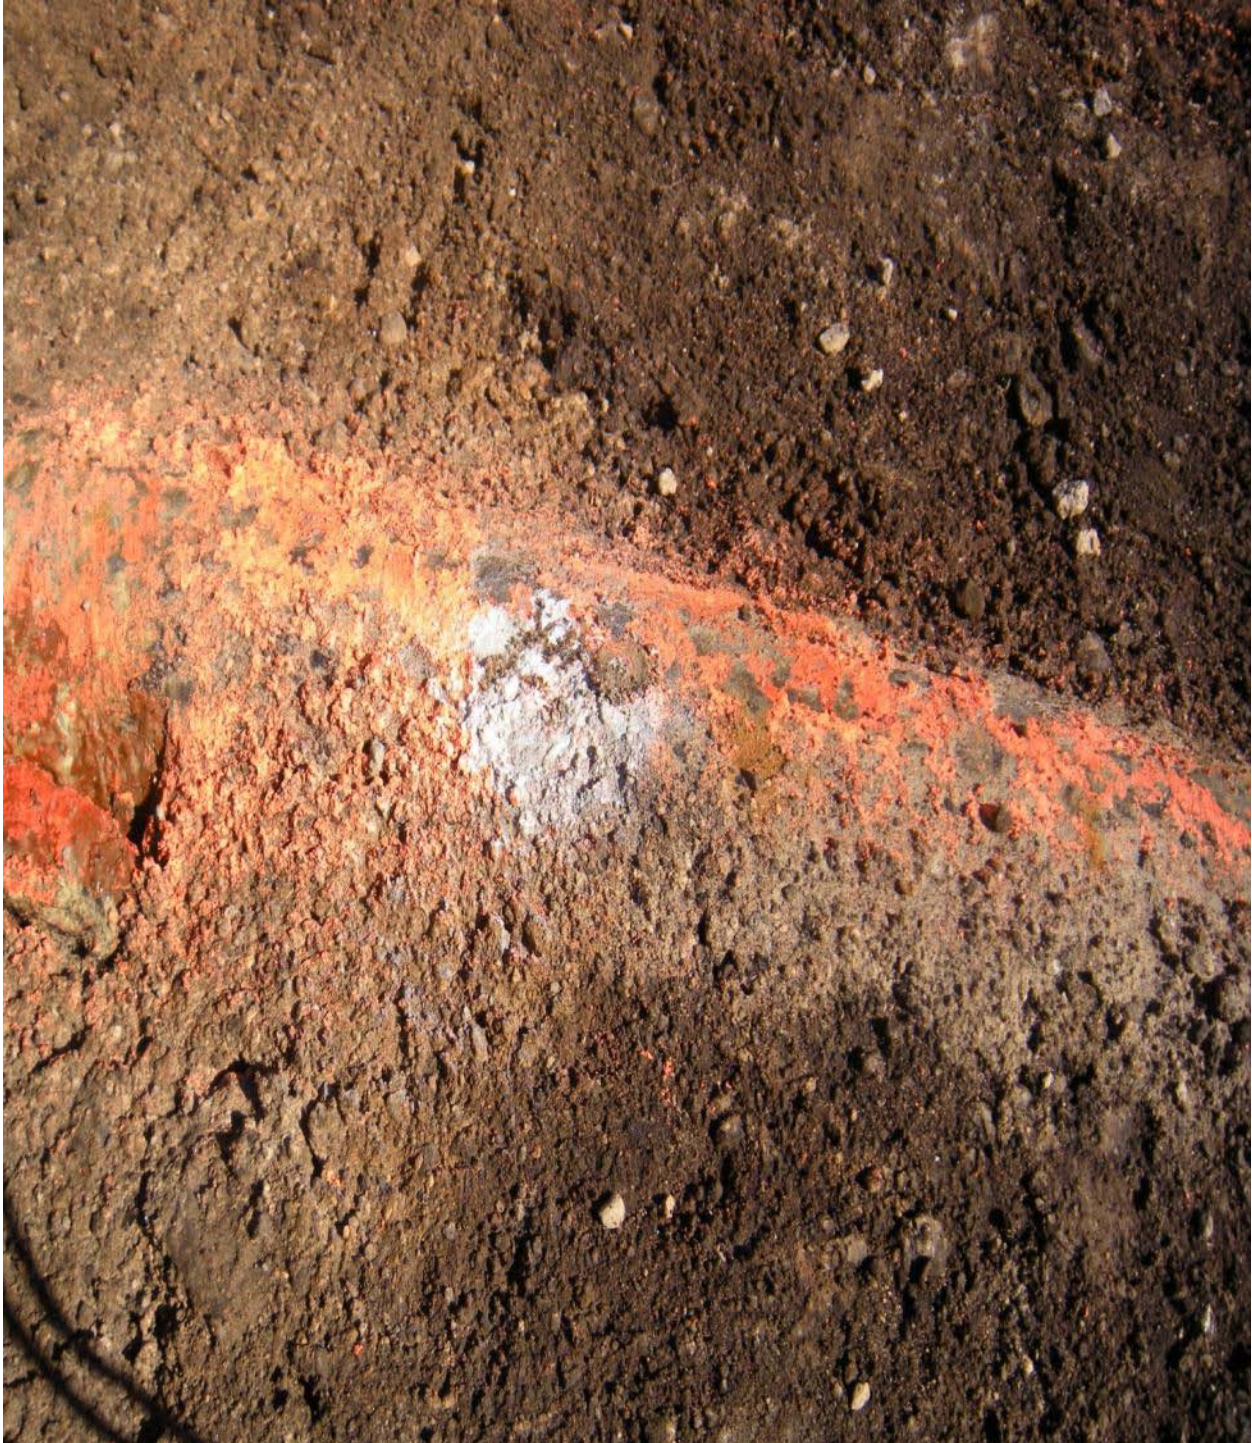
Sample ID	Color	Description	Location	Result	Friable or Non-Friable	Estimated Quantities	Condition
T-6	Brown/Black	pipe wrap, middle of 4" metal piping	RZ-C	ND	Friable	80 linear feet	Poor

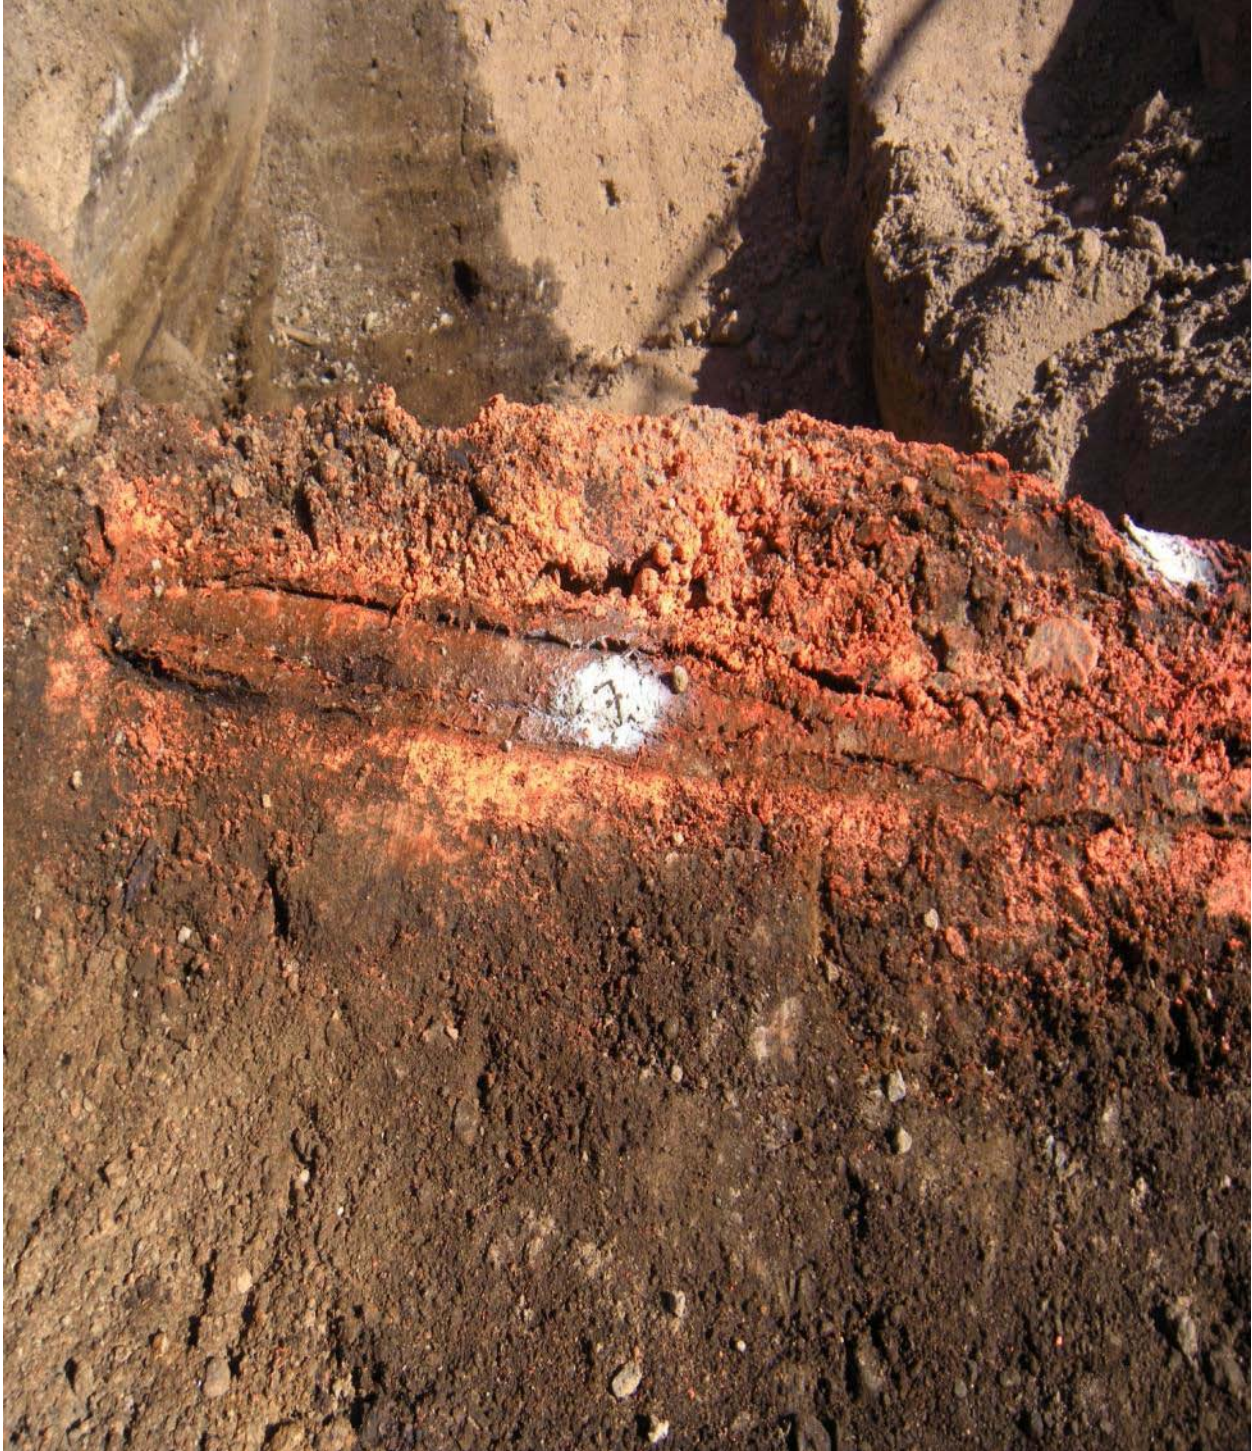
Sample ID	Color	Description	Location	Result	Friable or Non-Friable	Estimated Quantities	Condition
T-7	Brown/Black	pipe wrap, 2" metal piping	RZ-C	3% Amosite	Friable	120 linear feet	Poor

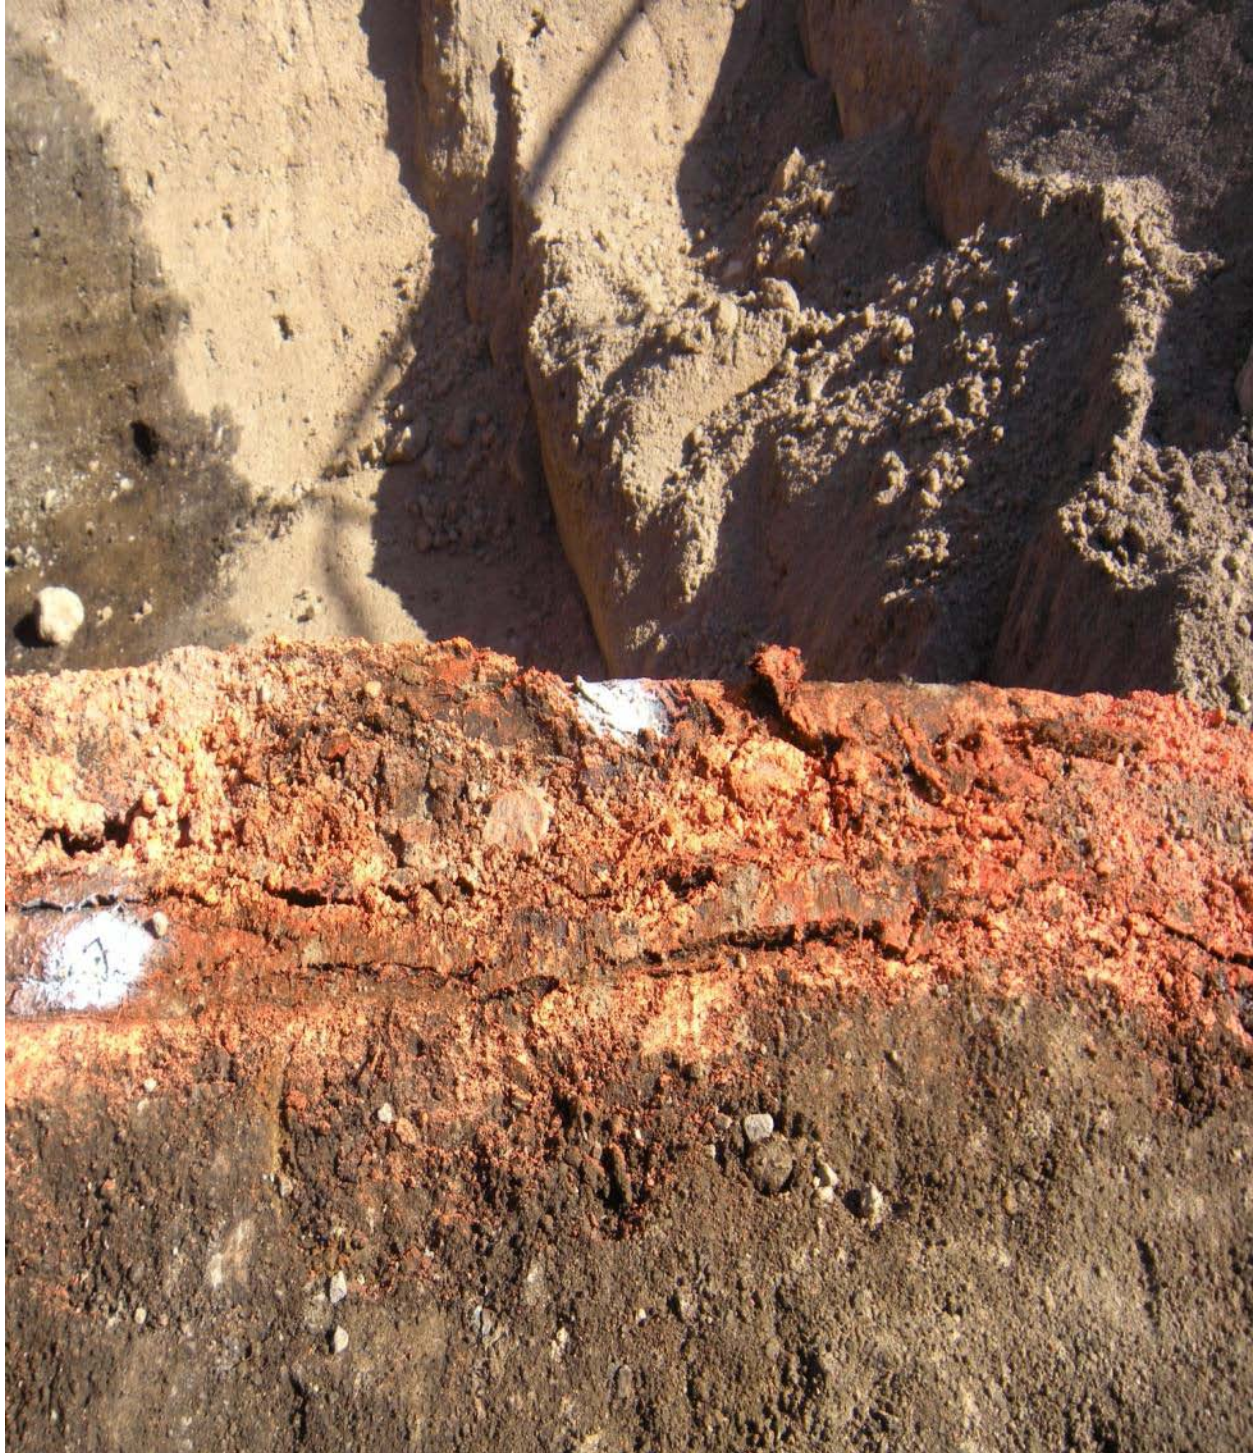
Sample ID	Color	Description	Location	Result	Friable or Non-Friable	Estimated Quantities	Condition
T-8	Brown/Black	pipe wrap, 2" metal piping	RZ-C	3% Chrysotile	Friable	120 linear feet	Poor

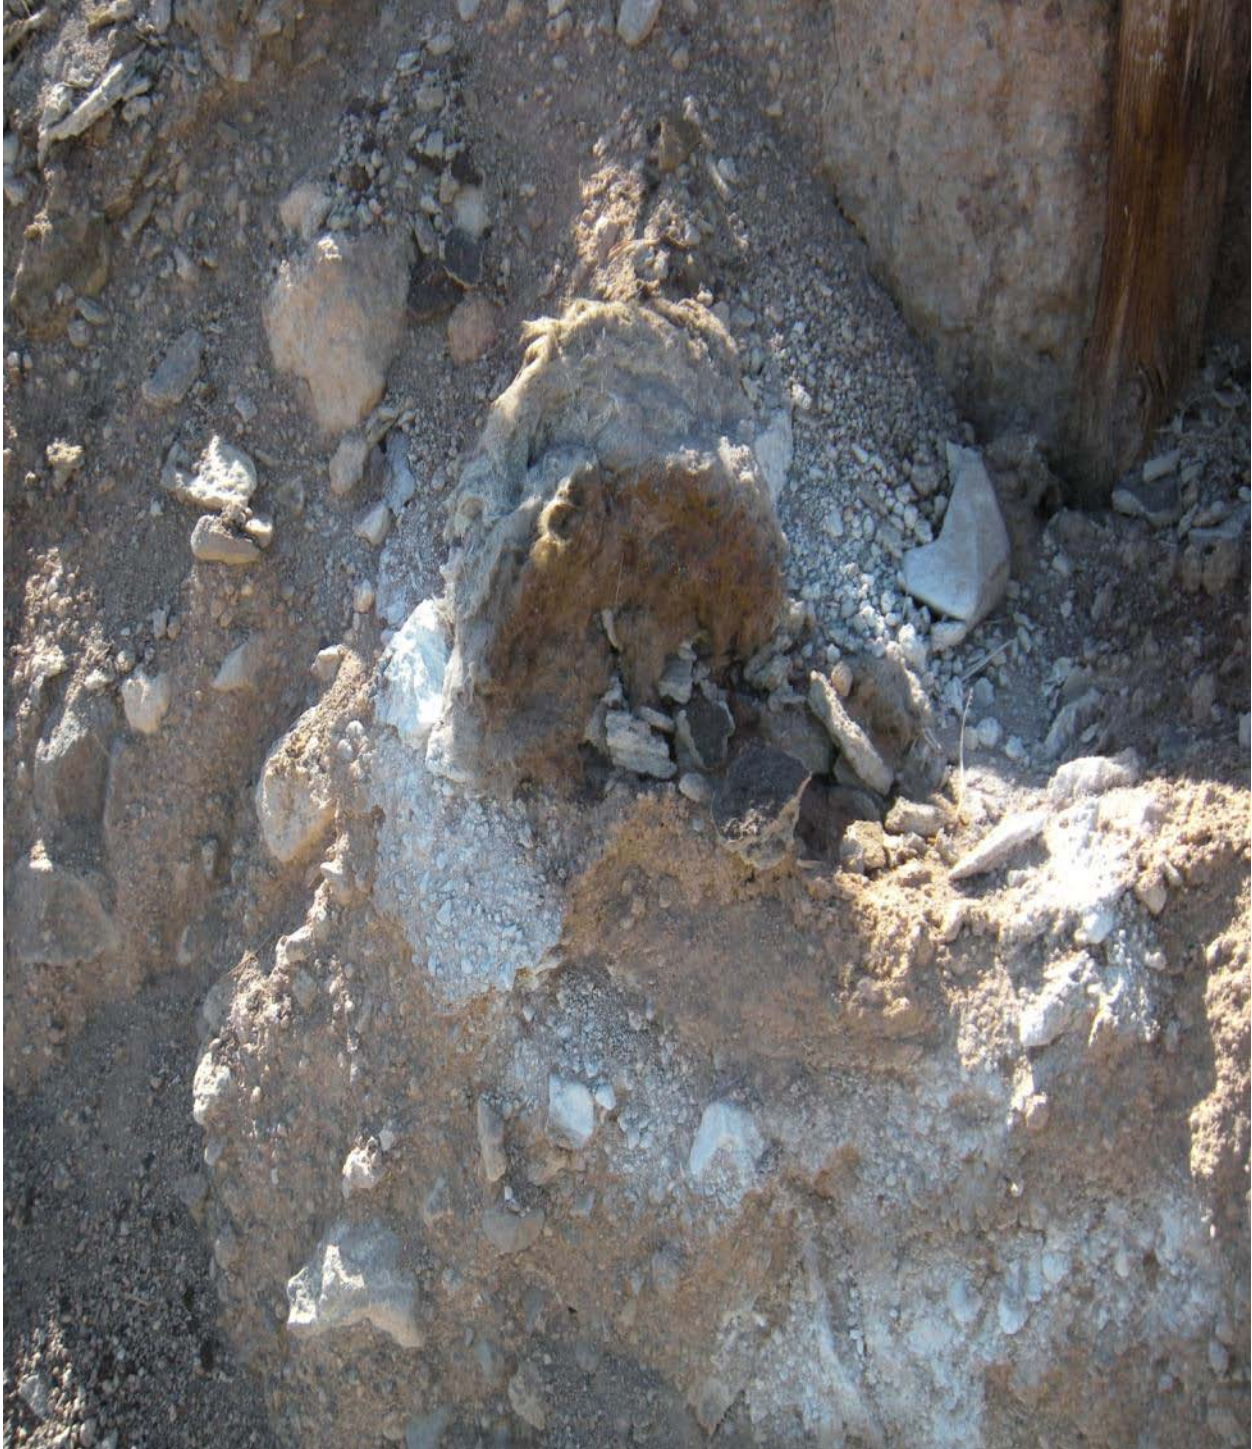
Sample ID	Color	Description	Location	Result	Friable or Non-Friable	Estimated Quantities	Condition
T-9	Grey	Cementitious Material	RZ-C26	ND	Friable	1000 square feet	Poor/Unstable

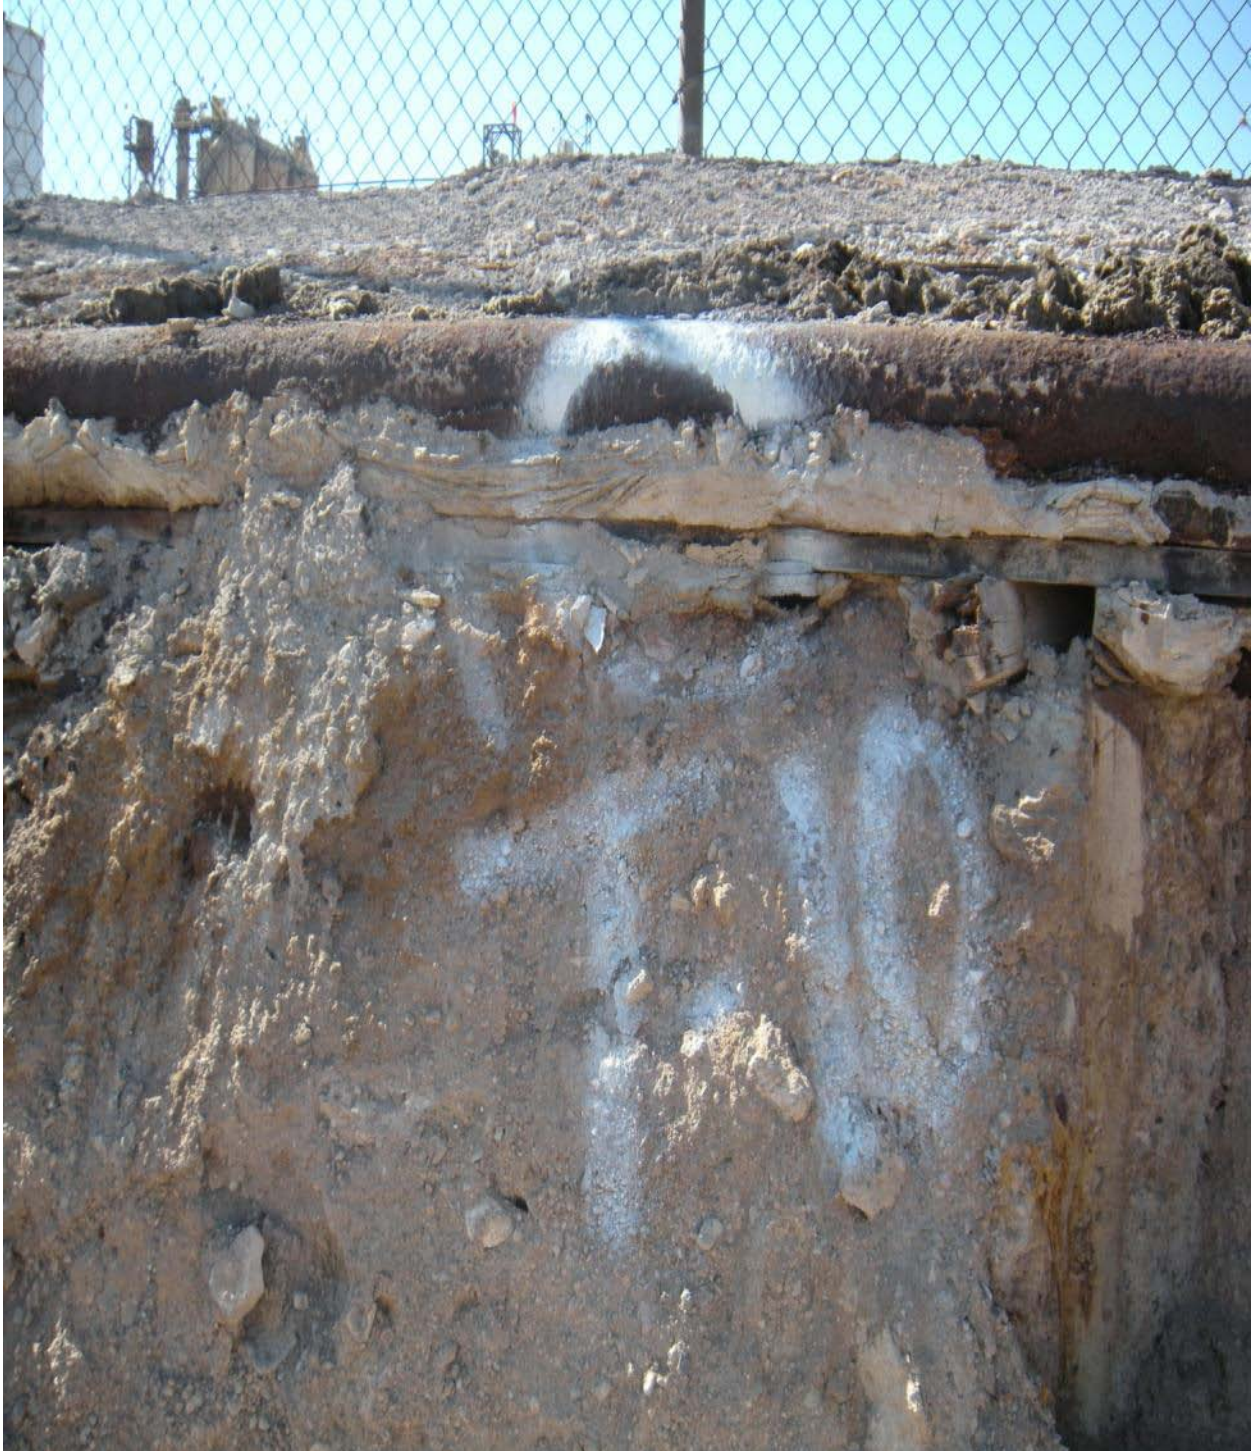
Sample ID	Color	Description	Location	Result	Friable or Non-Friable	Estimated Quantities	Condition
T-10	Grey	Cementitious Material	RZ-C24	ND	Friable	1000 square feet	Poor/Unstable

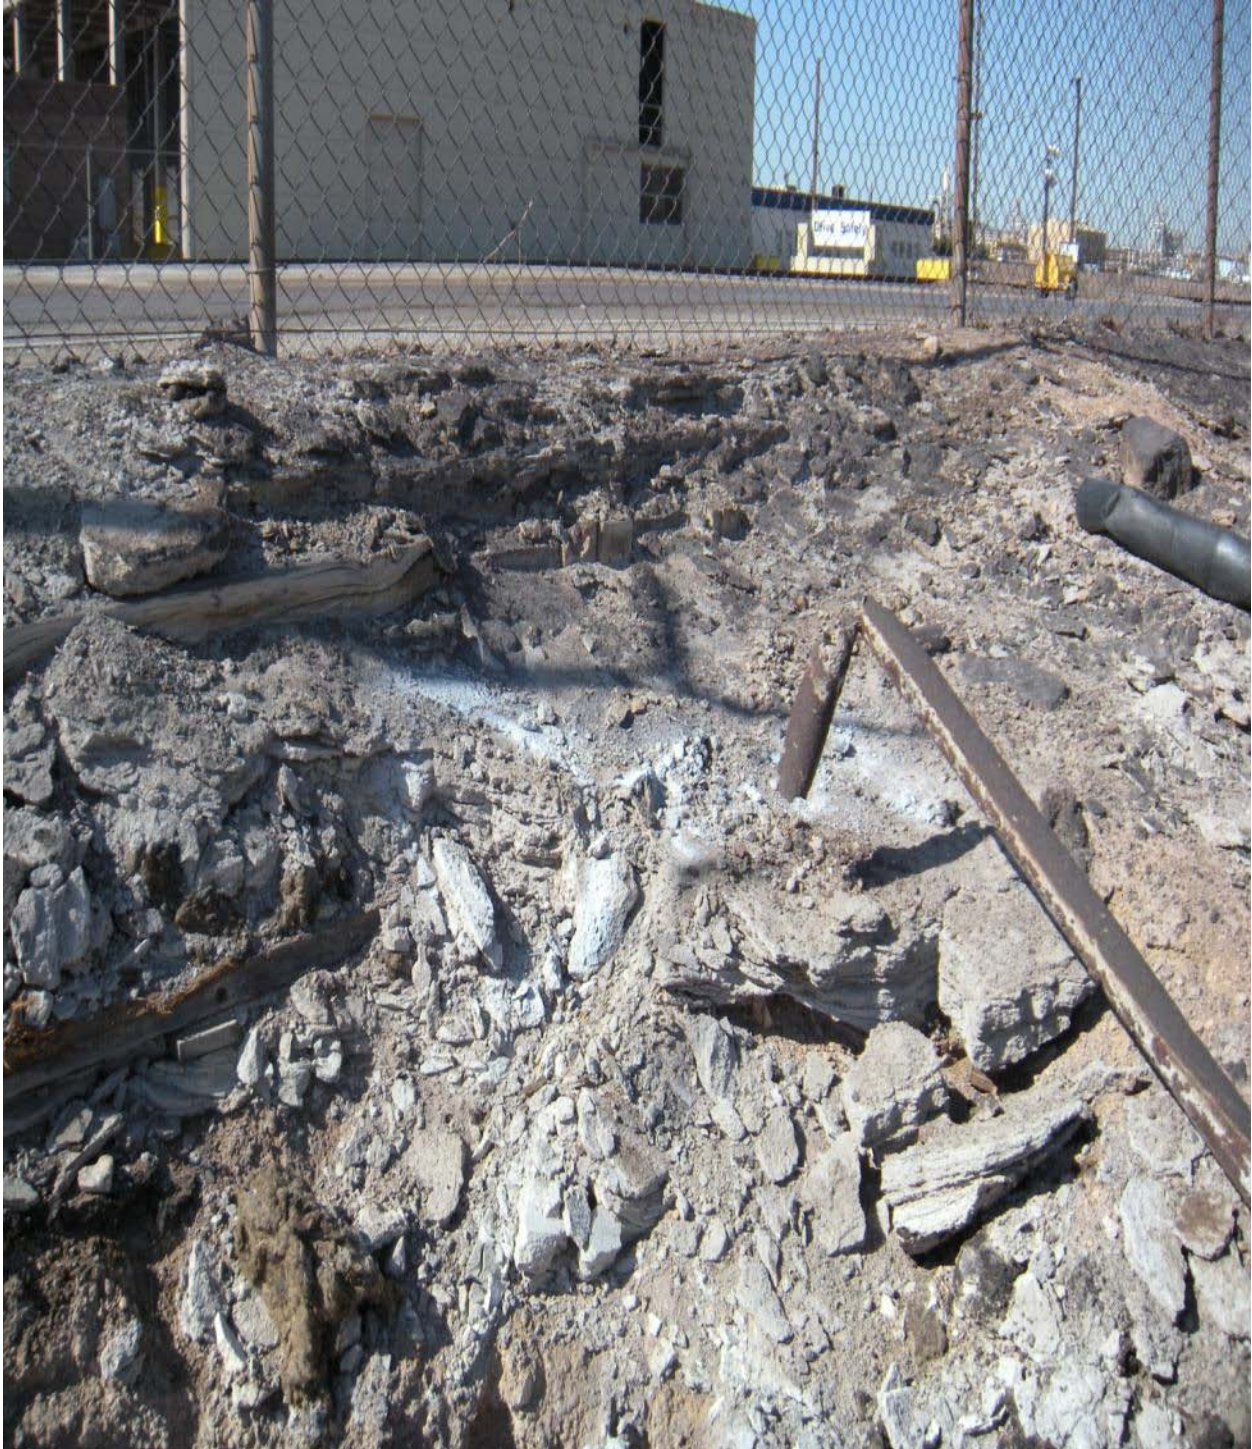
Sample ID	Color	Description	Location	Result	Friable or Non-Friable	Estimated Quantities	Condition
T-11	Grey	Cementitious Material	RZ-C24	ND	Friable	1000 square feet	Poor/Unstable

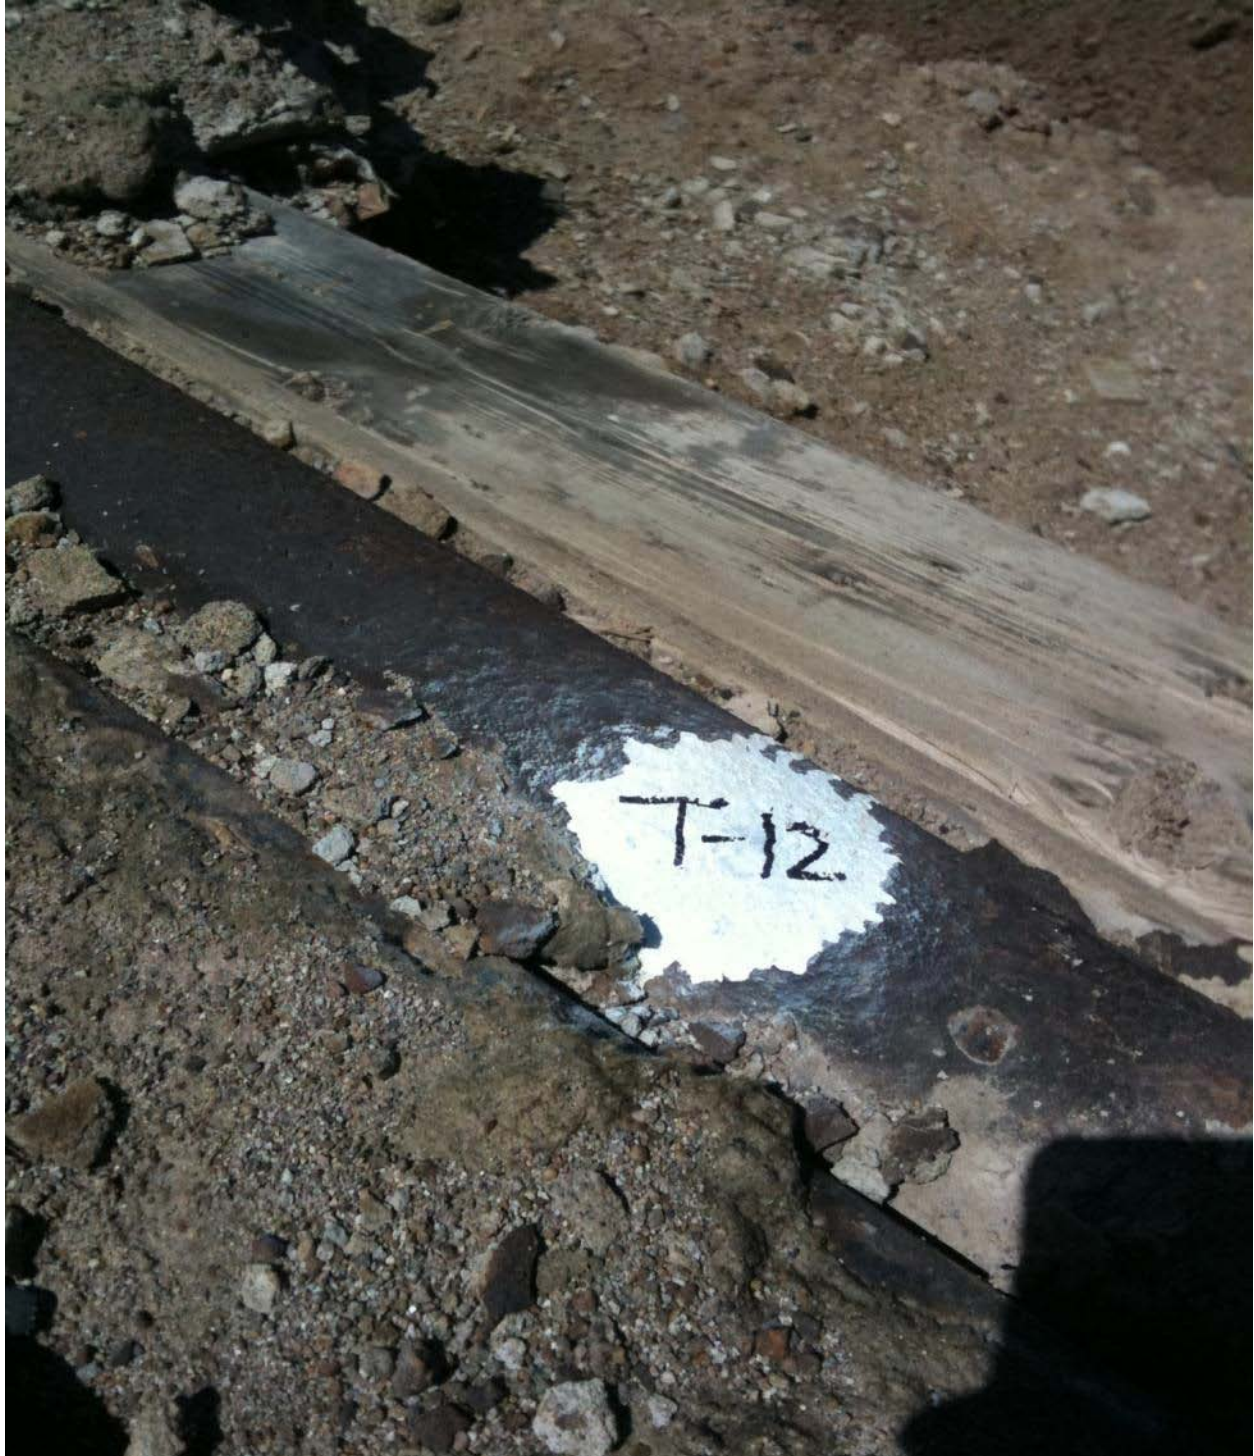
Sample ID	Color	Description	Location	Result	Friable or Non-Friable	Estimated Quantities	Condition
T-12	Brown/Black	pipe wrap, 4" metal piping	RZ-C14	ND	Friable	225 linear feet	Poor
