**Regarding:** *Limited Asbestos Survey – RZ-C*  
**Nevada Environmental Response Trust**  
**560 West Lake Mead Parkway**  
**Henderson, Nevada 89015**  
**Project – CON111106**

**Photograph Log  
Bulk Sample Locations**

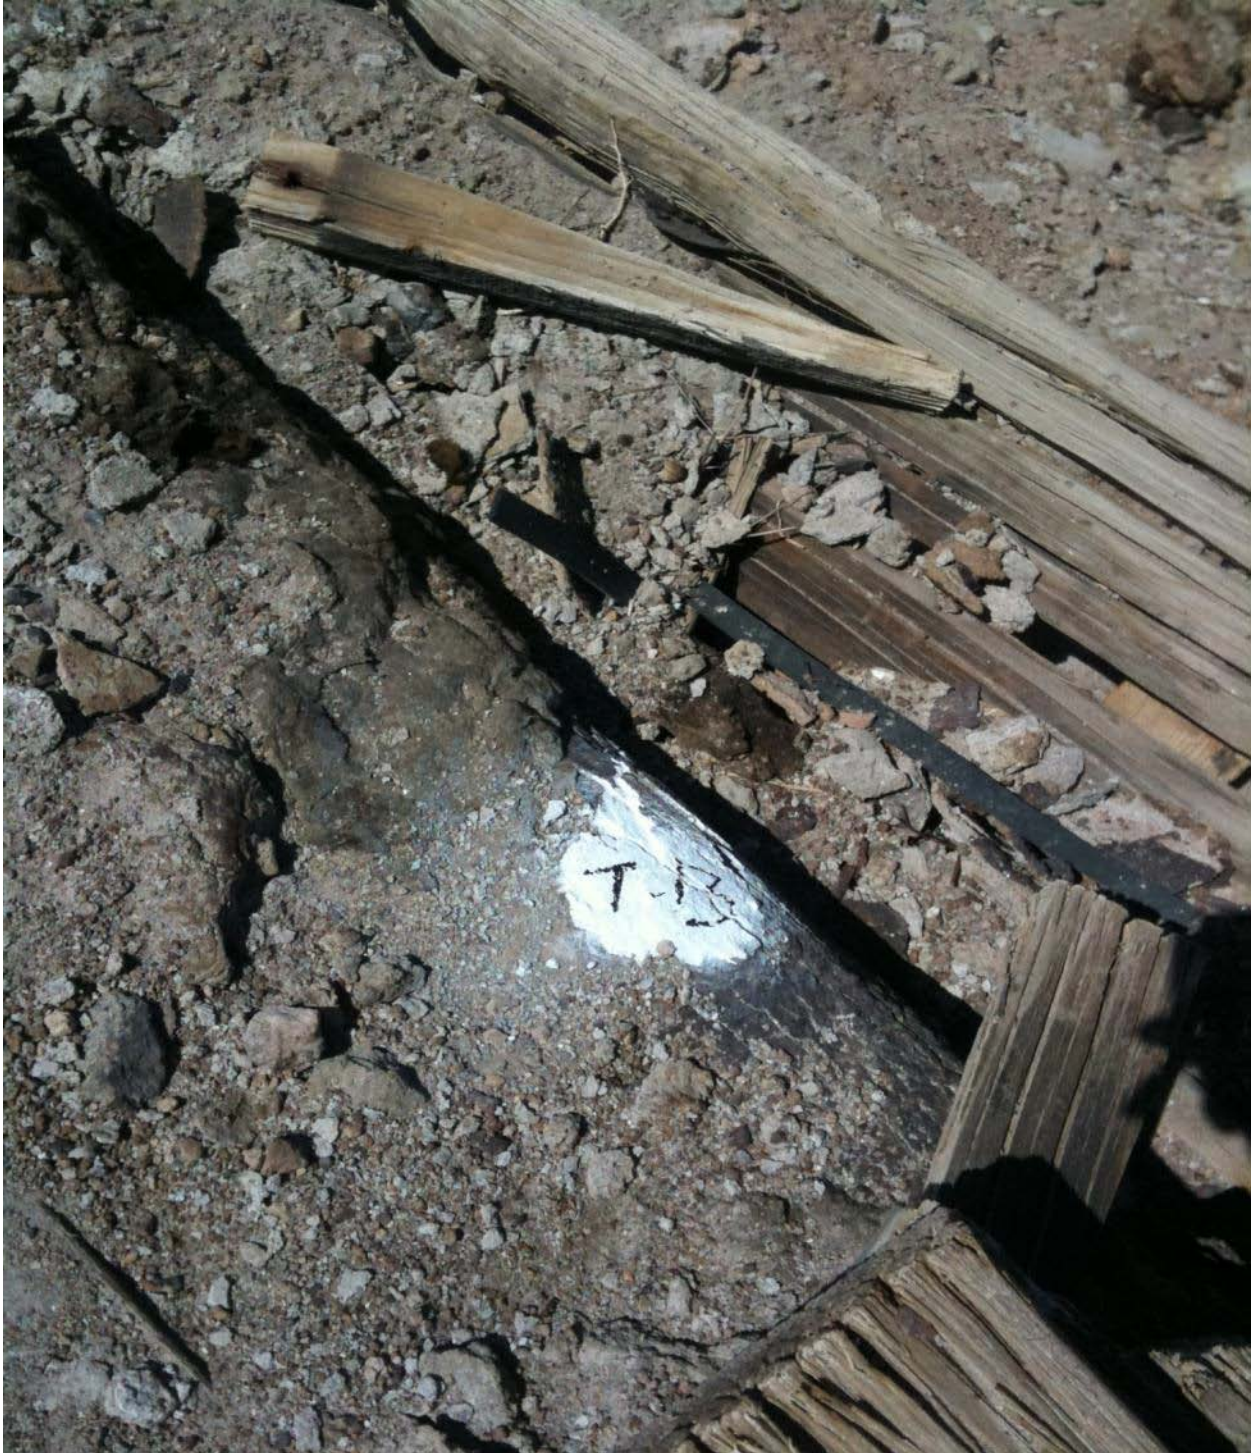
Sample ID	Color	Description	Location	Result	Friable or Non-Friable	Estimated Quantities	Condition
T-13	Brown/Black	pipe wrap, 4" metal piping	RZ-C15, Near Stand Pipe	ND	Friable	225 linear feet	Poor

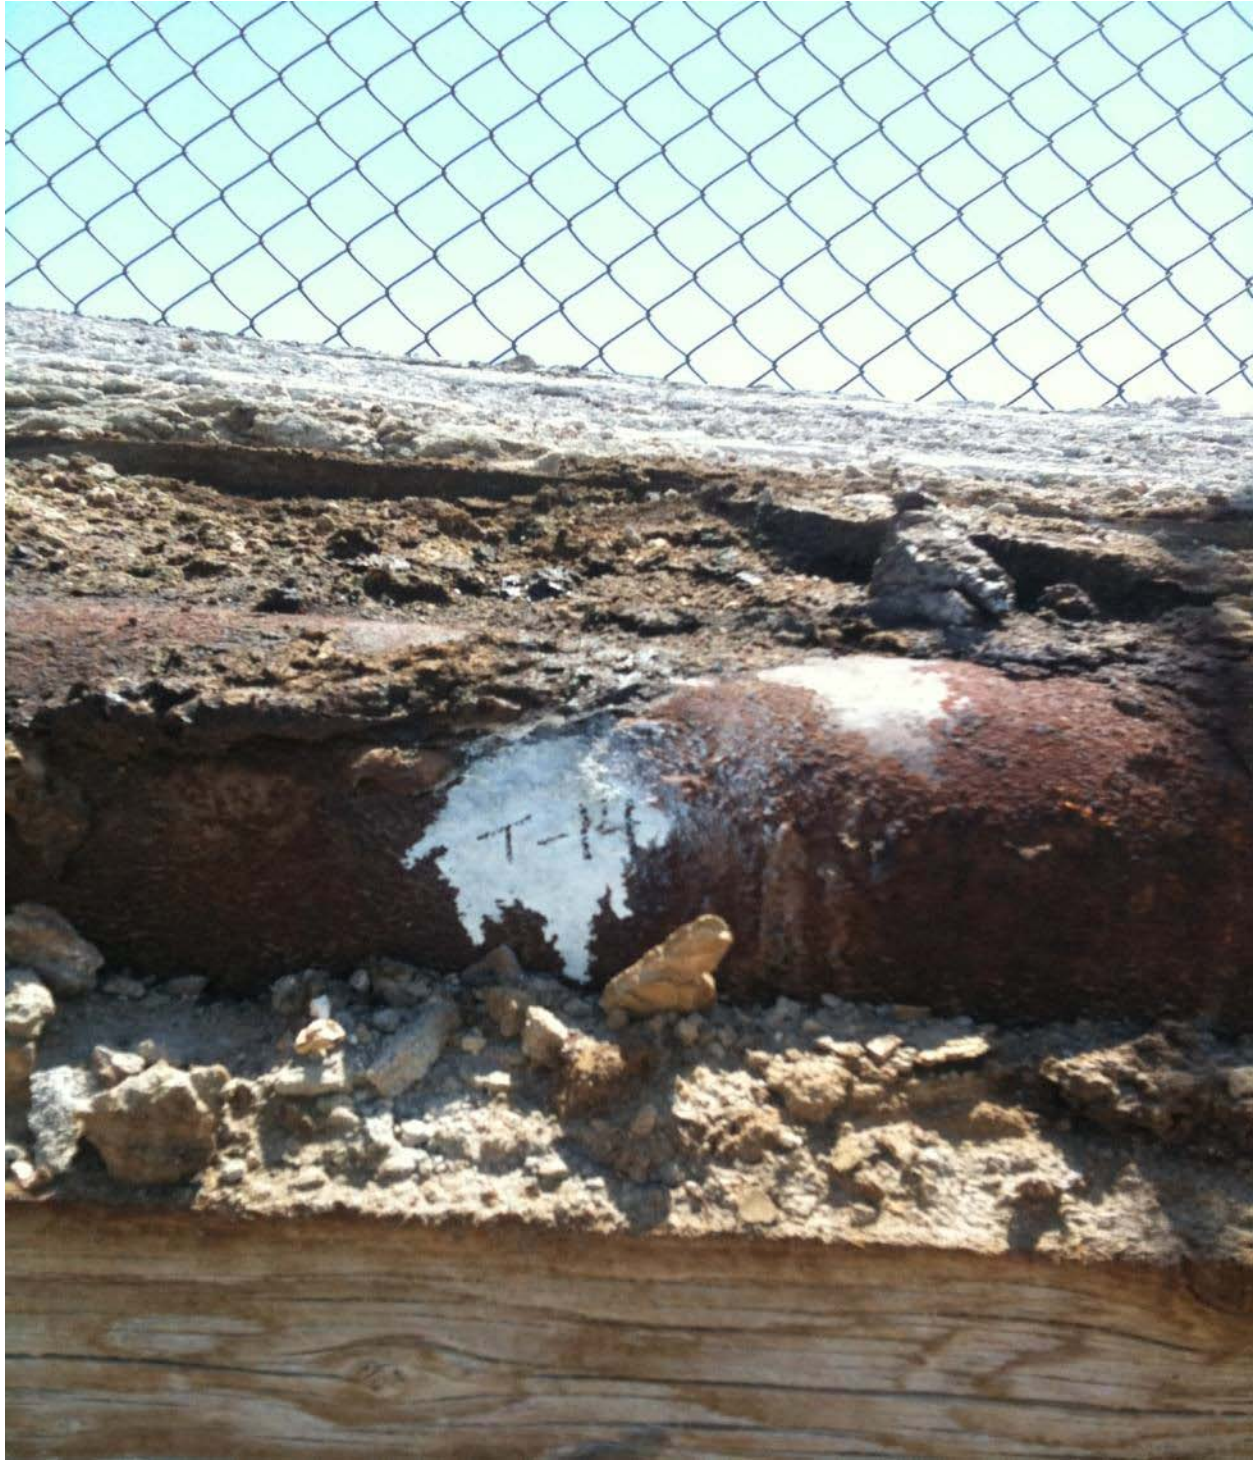
Sample ID	Color	Description	Location	Result	Friable or Non-Friable	Estimated Quantities	Condition
T-14	Brown/Black	pipe wrap, 4" metal piping	RZ-C24, ~60 feet east of fence area	ND	Friable	225 linear feet	Poor

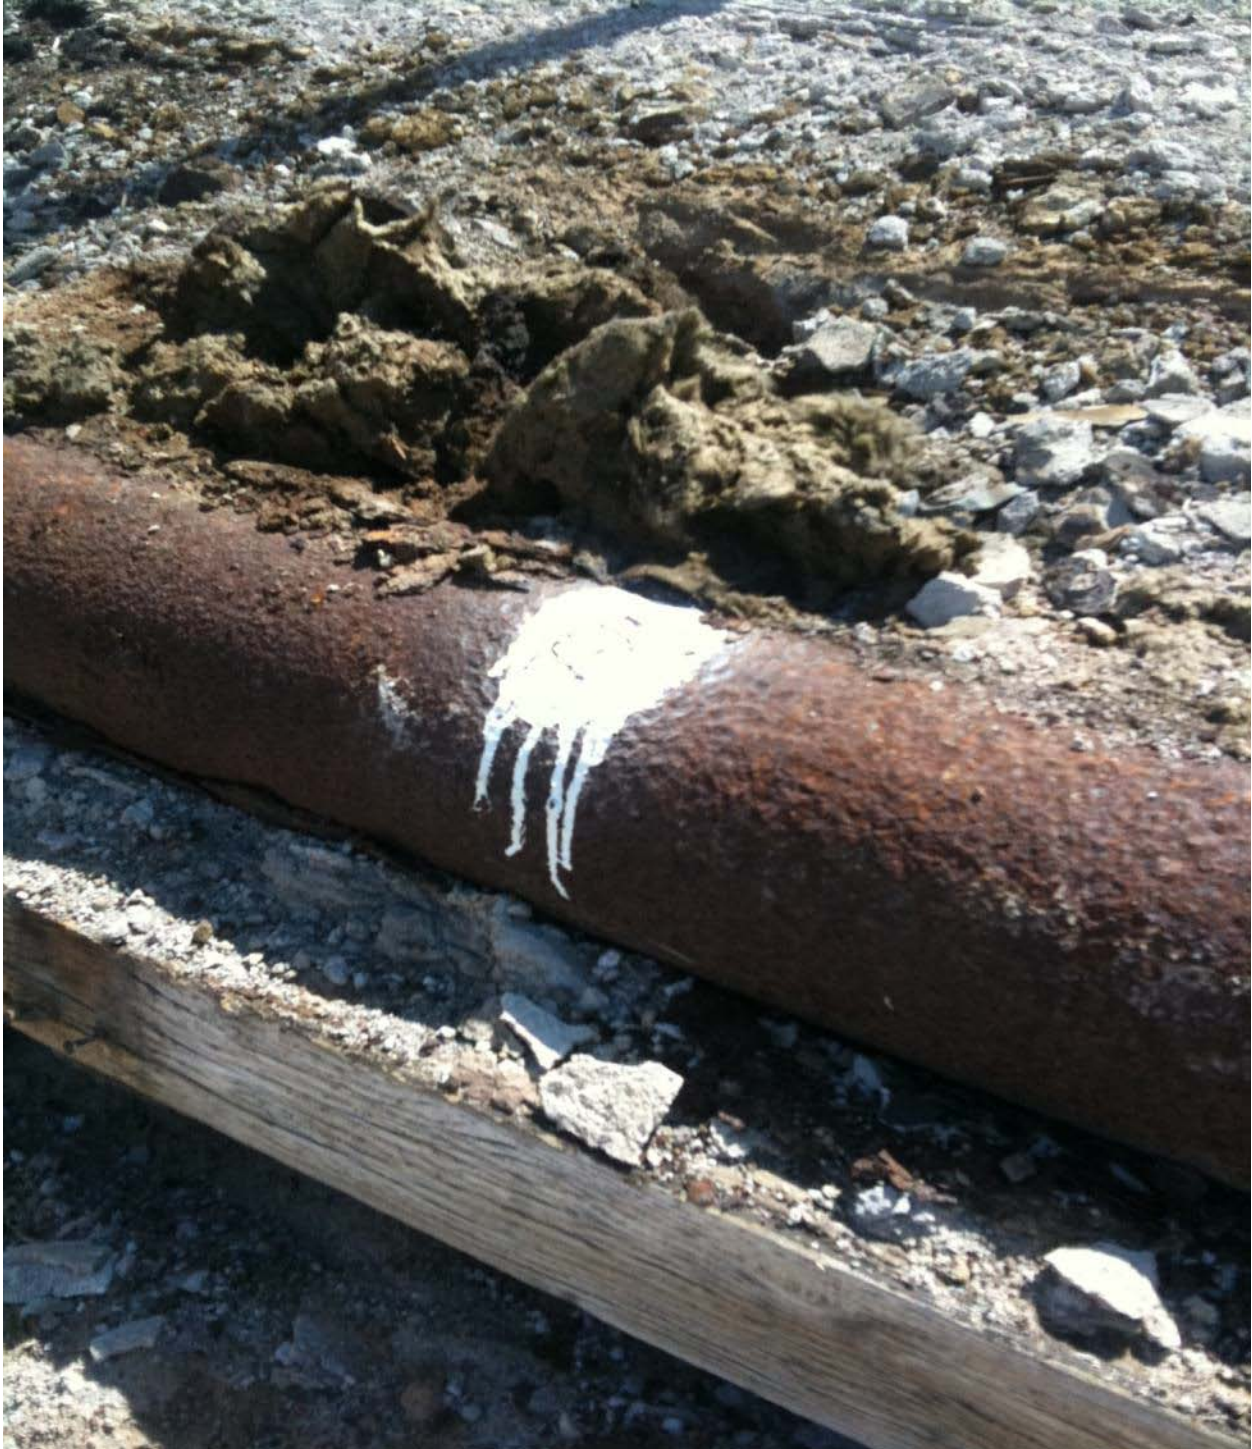
Sample ID	Color	Description	Location	Result	Friable or Non-Friable	Estimated Quantities	Condition
T-15	Brown/Black	pipe wrap, 4" metal piping	RZ-C26, ~100 feet east of fence area	ND	Friable	225 linear feet	Poor

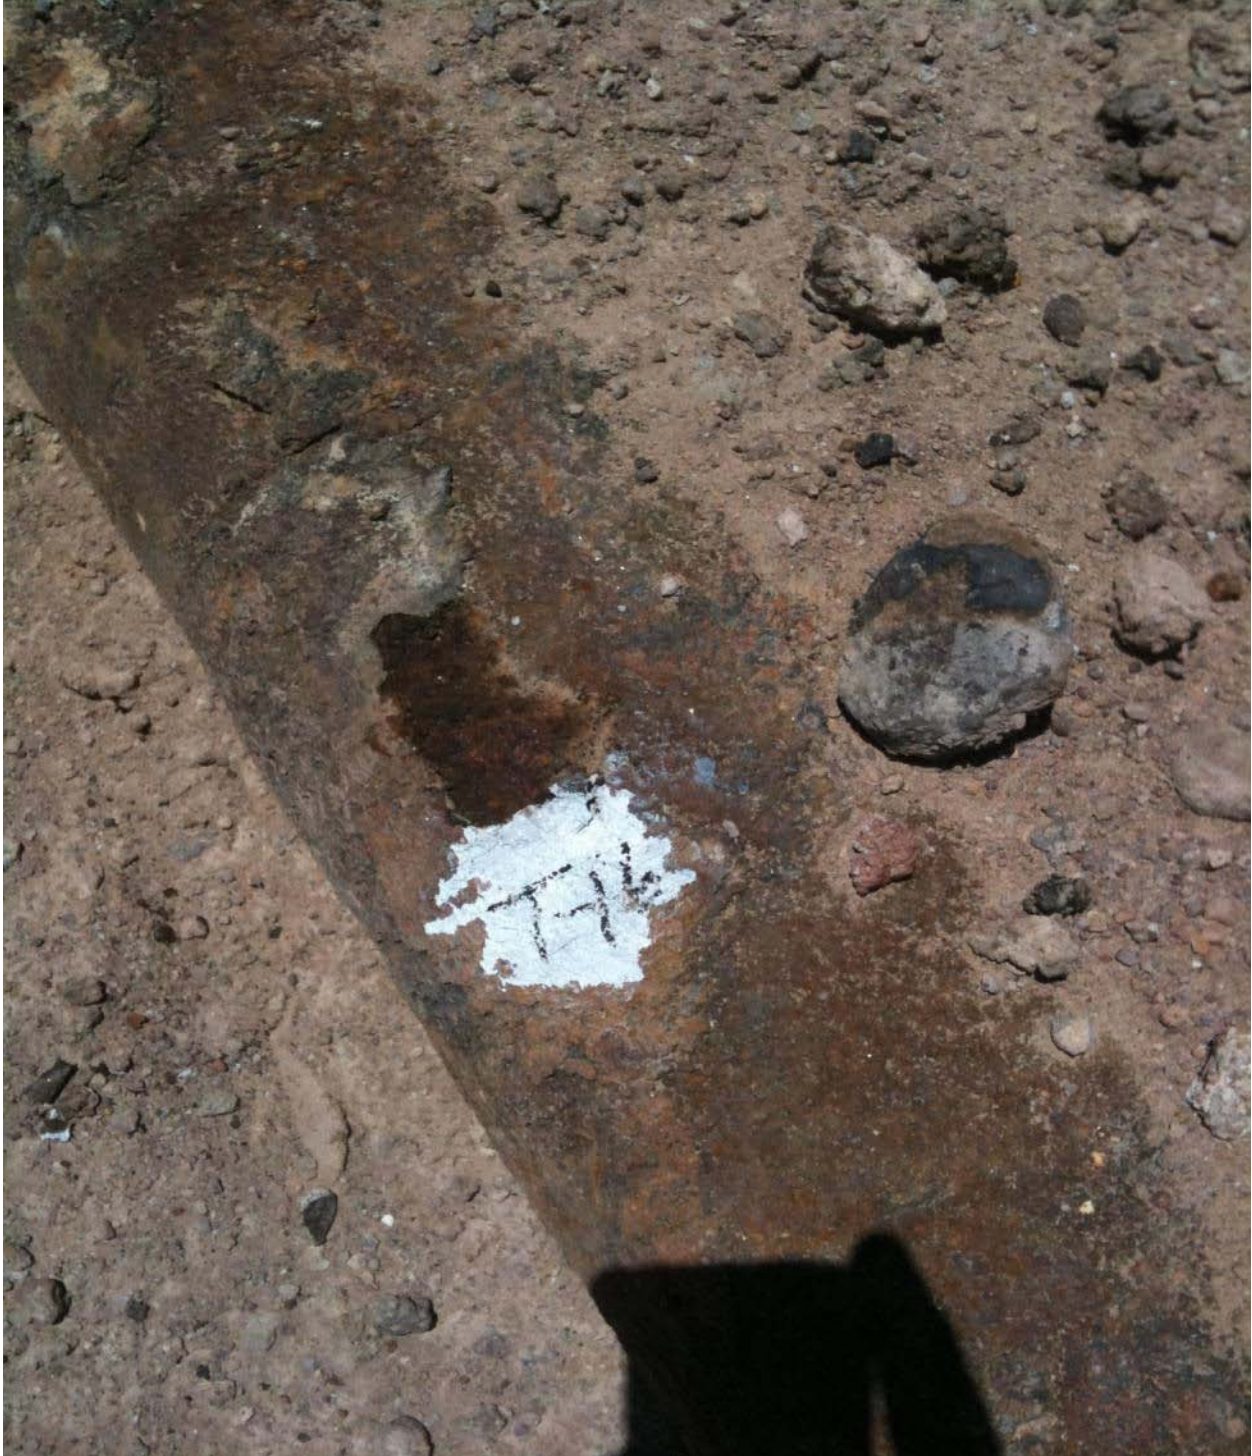
Sample ID	Color	Description	Location	Result	Friable or Non-Friable	Estimated Quantities	Condition
T-16	Brown/Black	pipe wrap, lower 6" metal piping	RZ-C24	ND	Friable	90 linear feet	Poor

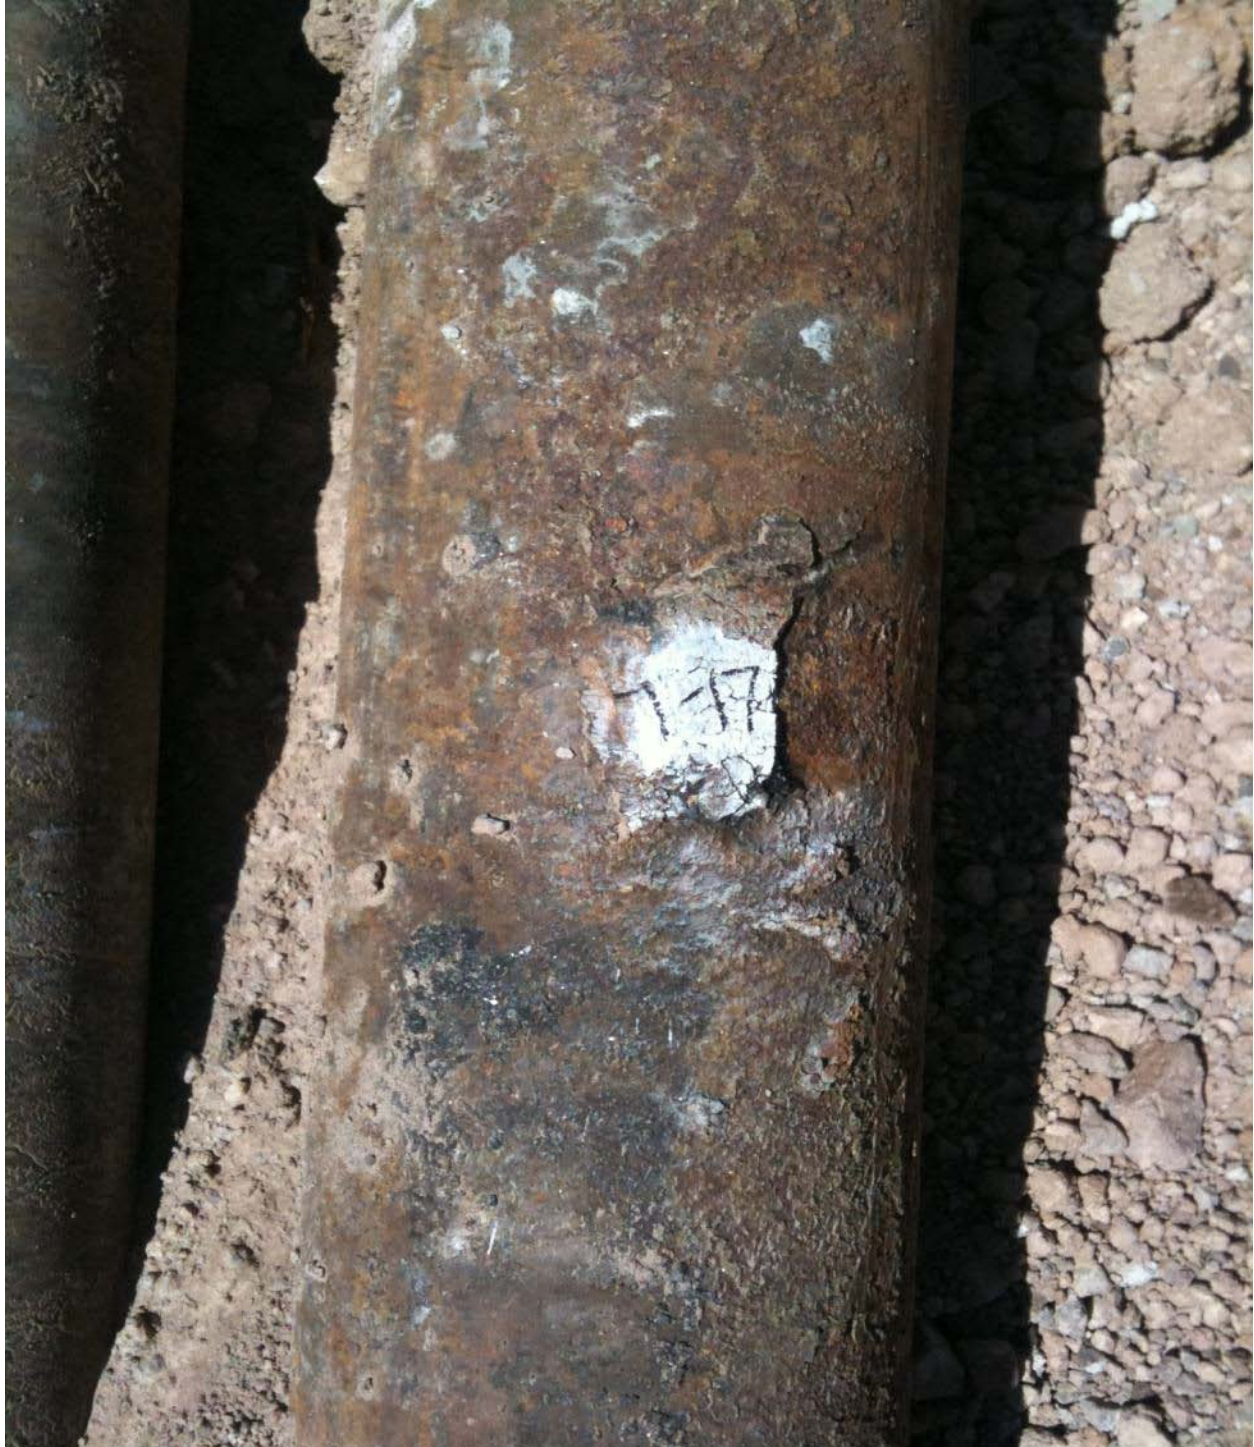
Sample ID	Color	Description	Location	Result	Friable or Non-Friable	Estimated Quantities	Condition
T-17	Brown/Black	pipe wrap, lower 6" metal piping	RZ-C24	ND	Friable	90 linear feet	Poor

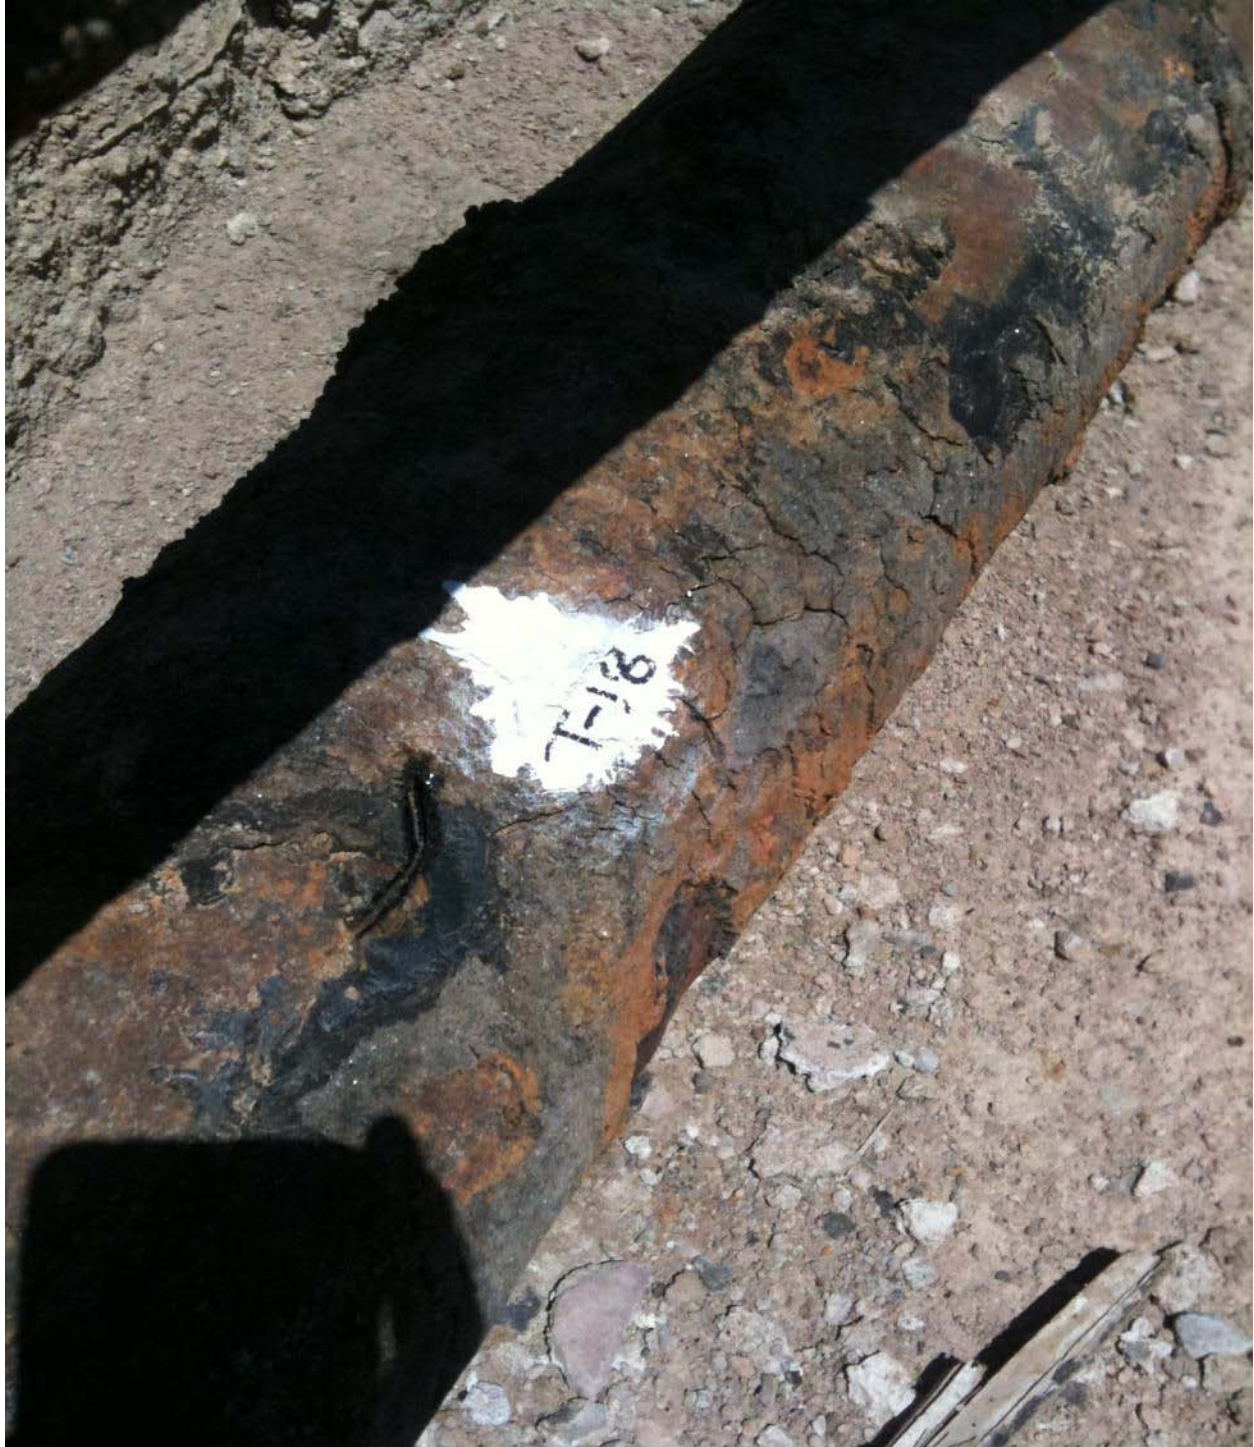
Sample ID	Color	Description	Location	Result	Friable or Non-Friable	Estimated Quantities	Condition
T-18	Brown/Black	pipe wrap, lower 6" metal piping	RZ-C24	ND	Friable	90 linear feet	Poor

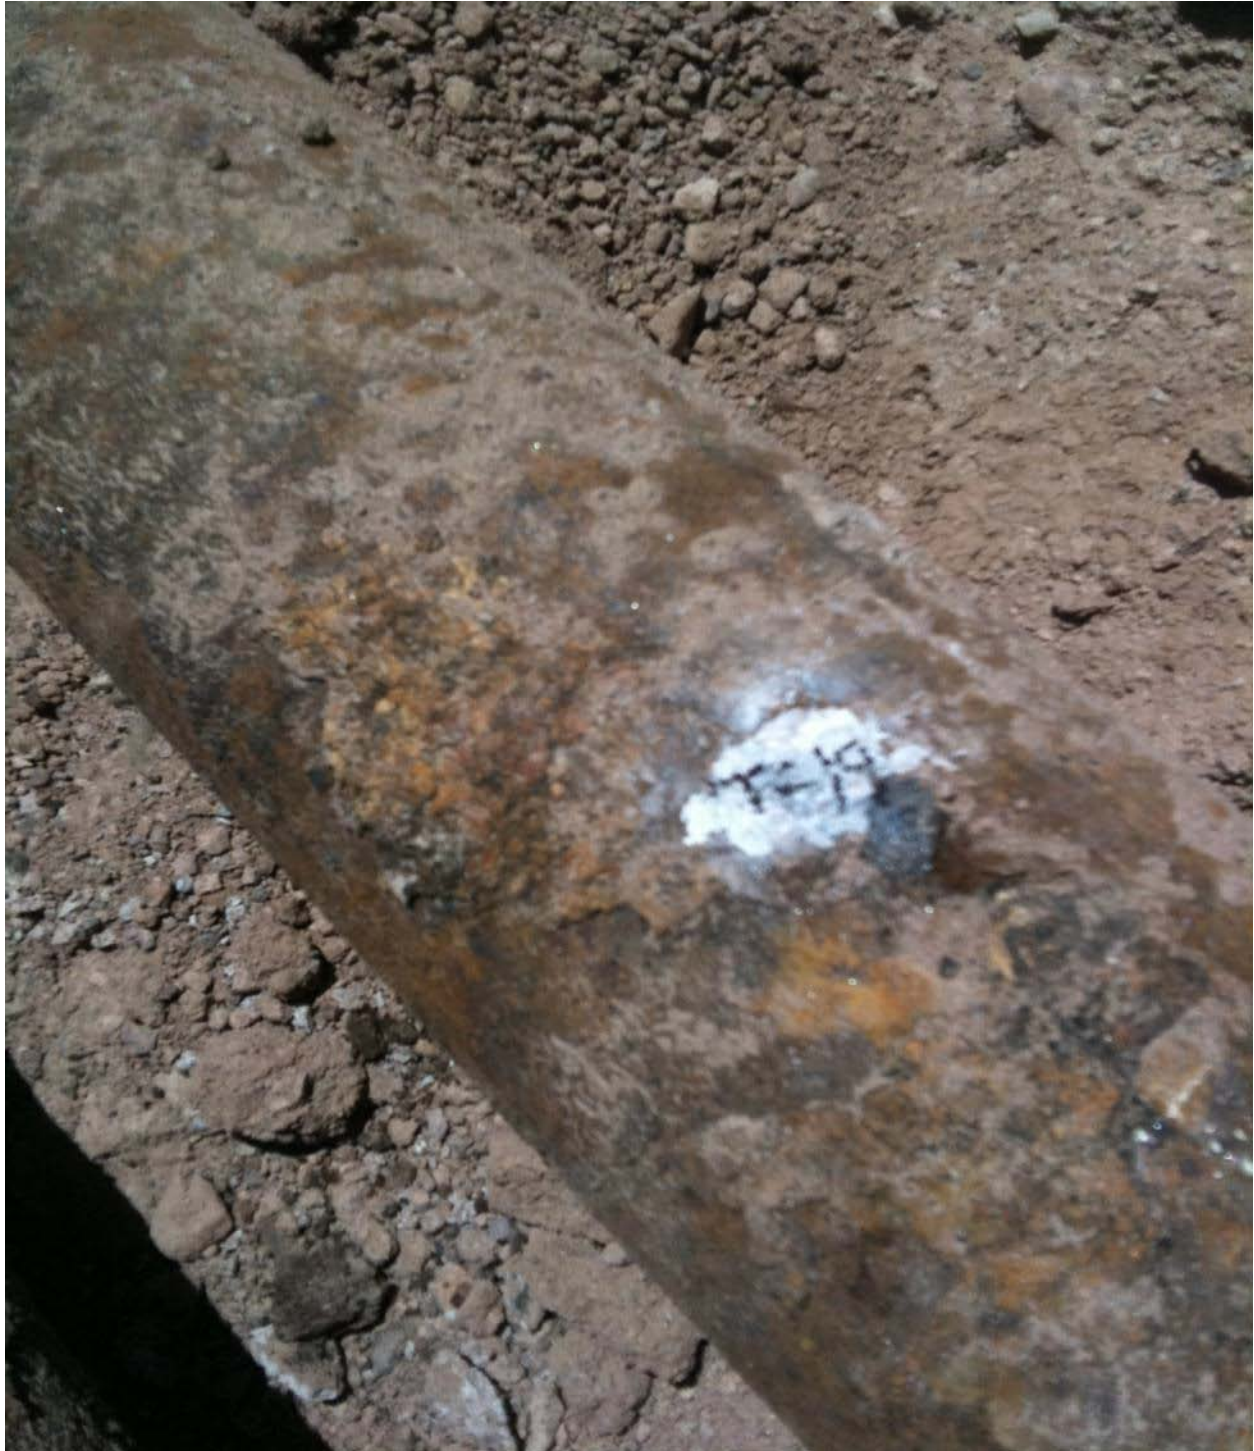
Sample ID	Color	Description	Location	Result	Friable or Non-Friable	Estimated Quantities	Condition
T-19	Brown/Black	pipe wrap, upper 6" metal piping	RZ-C24	ND	Friable	90 linear feet	Poor

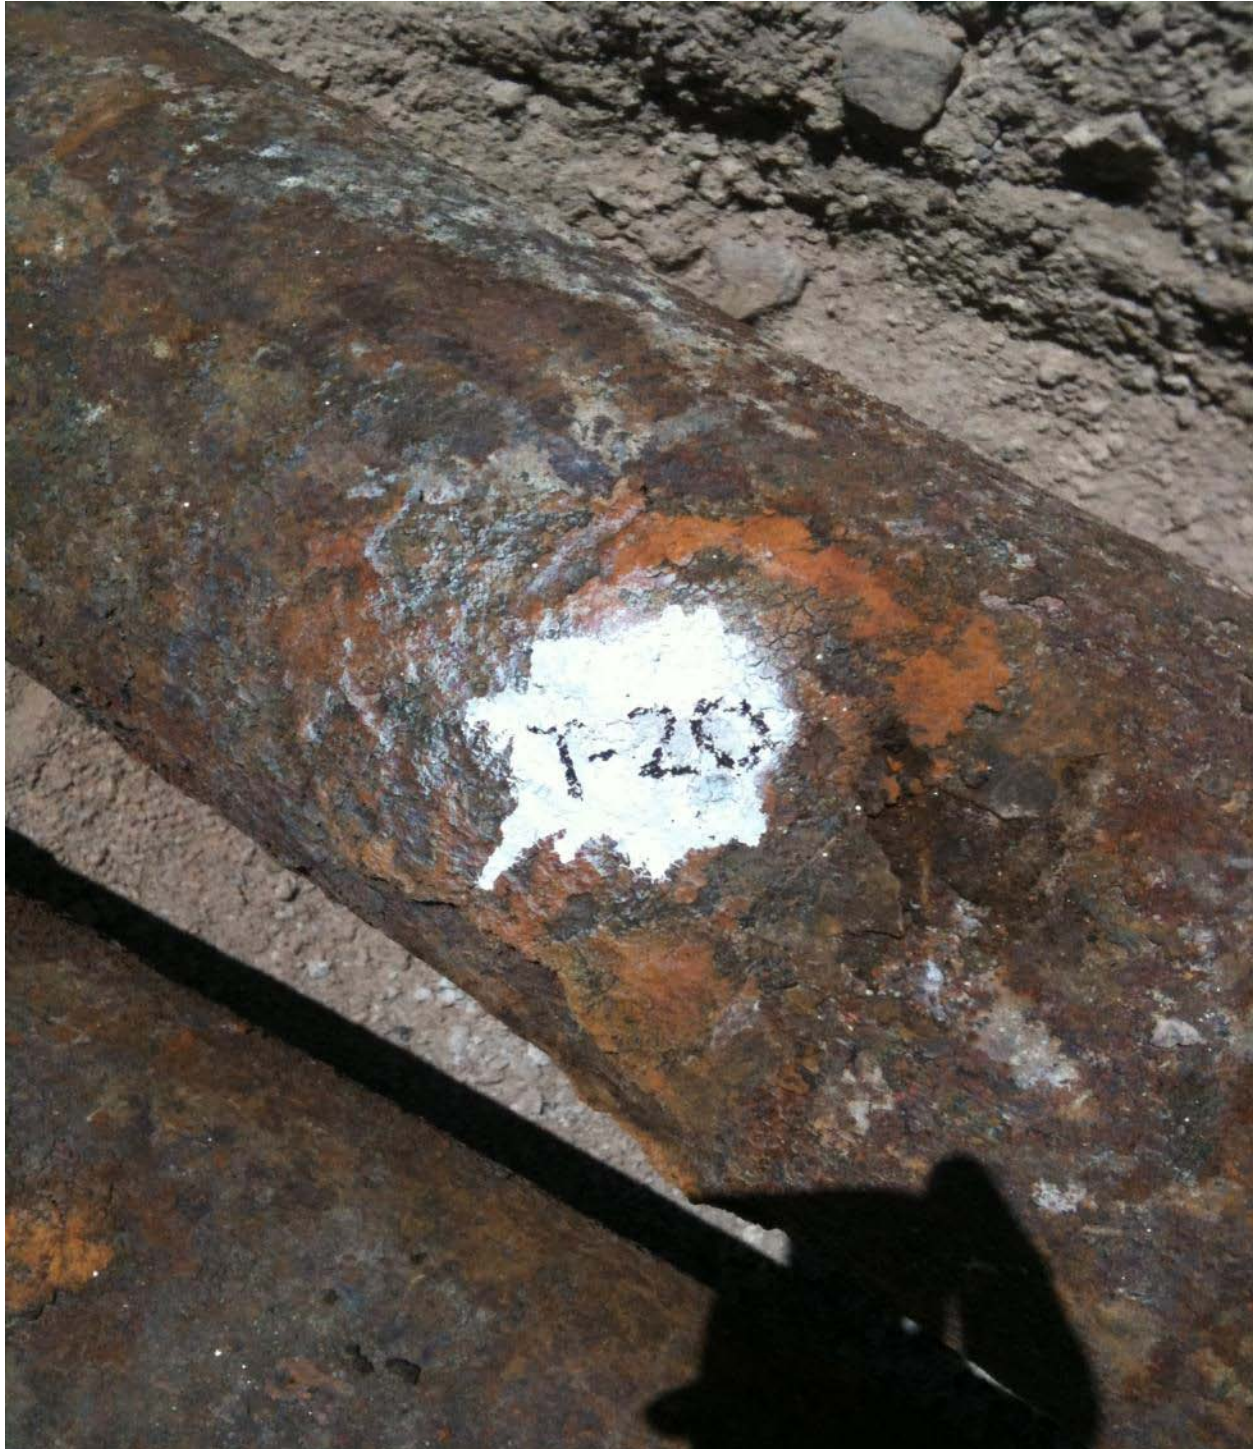
Sample ID	Color	Description	Location	Result	Friable or Non-Friable	Estimated Quantities	Condition
T-20	Brown/Black	pipe wrap, upper 6" metal piping	RZ-C24	ND	Friable	90 linear feet	Poor

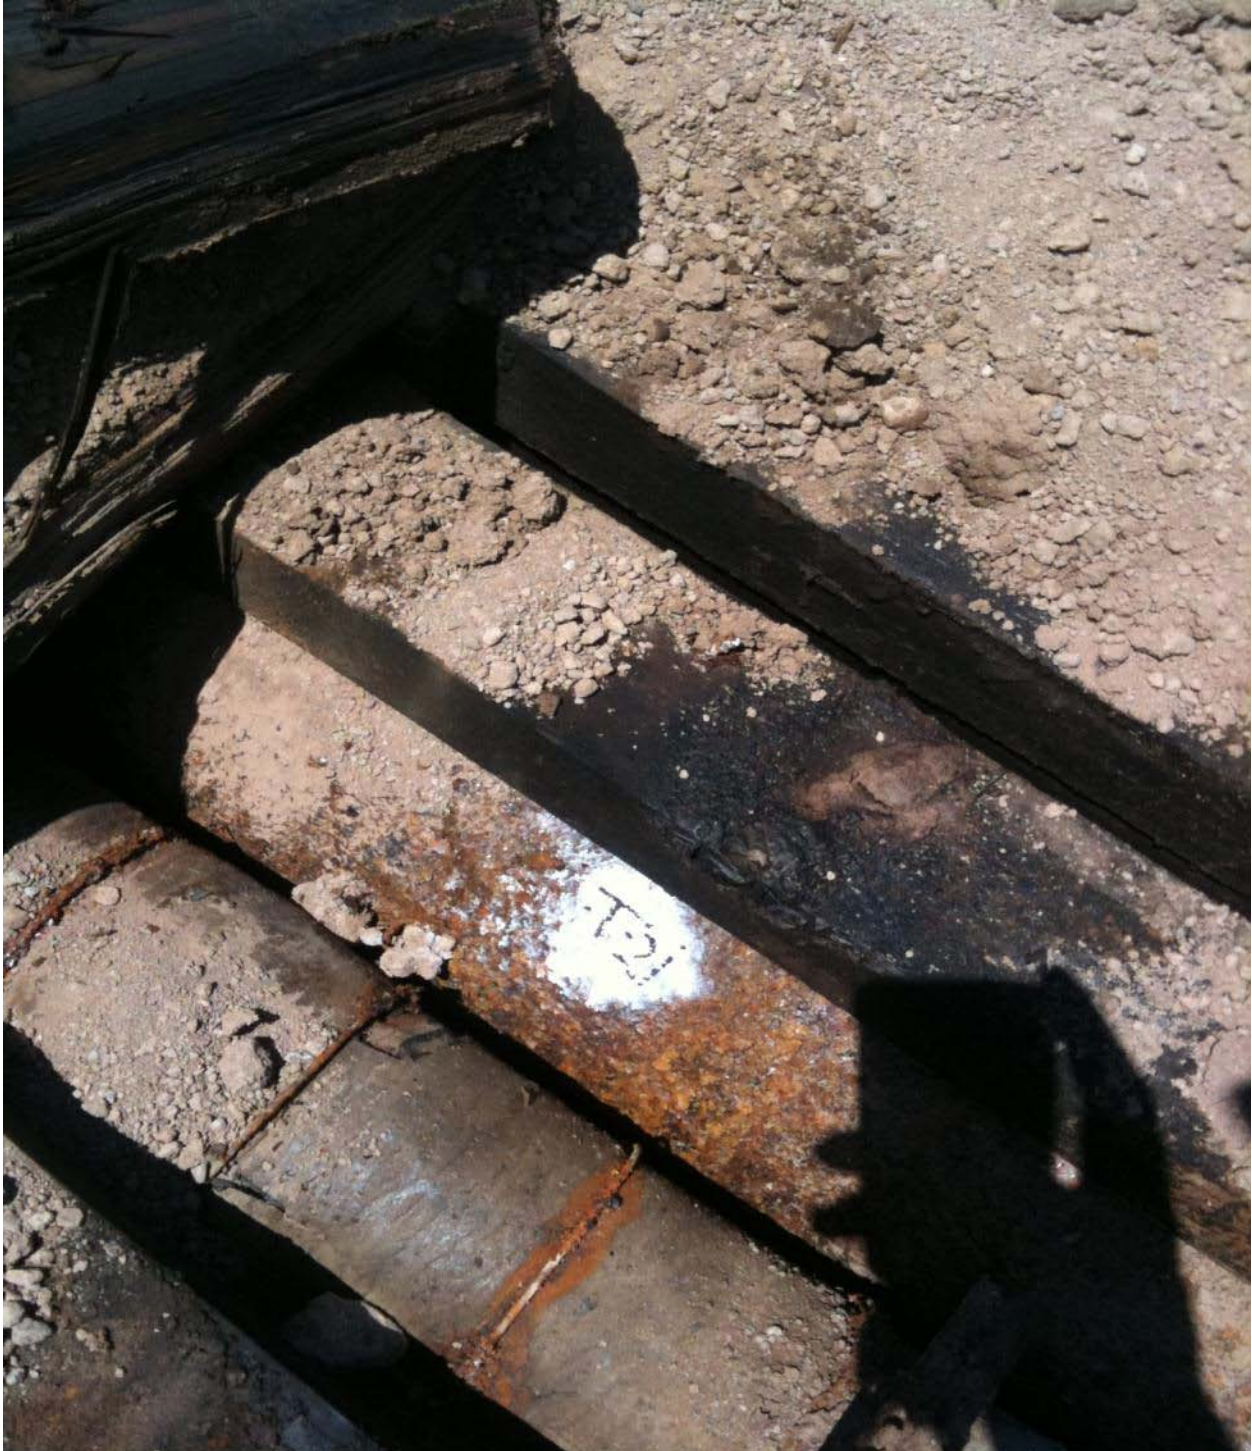
Sample ID	Color	Description	Location	Result	Friable or Non-Friable	Estimated Quantities	Condition
T-21	Brown	pipe wrap, north 4" metal piping	RZ-C24	ND	Friable	90 linear feet	Poor

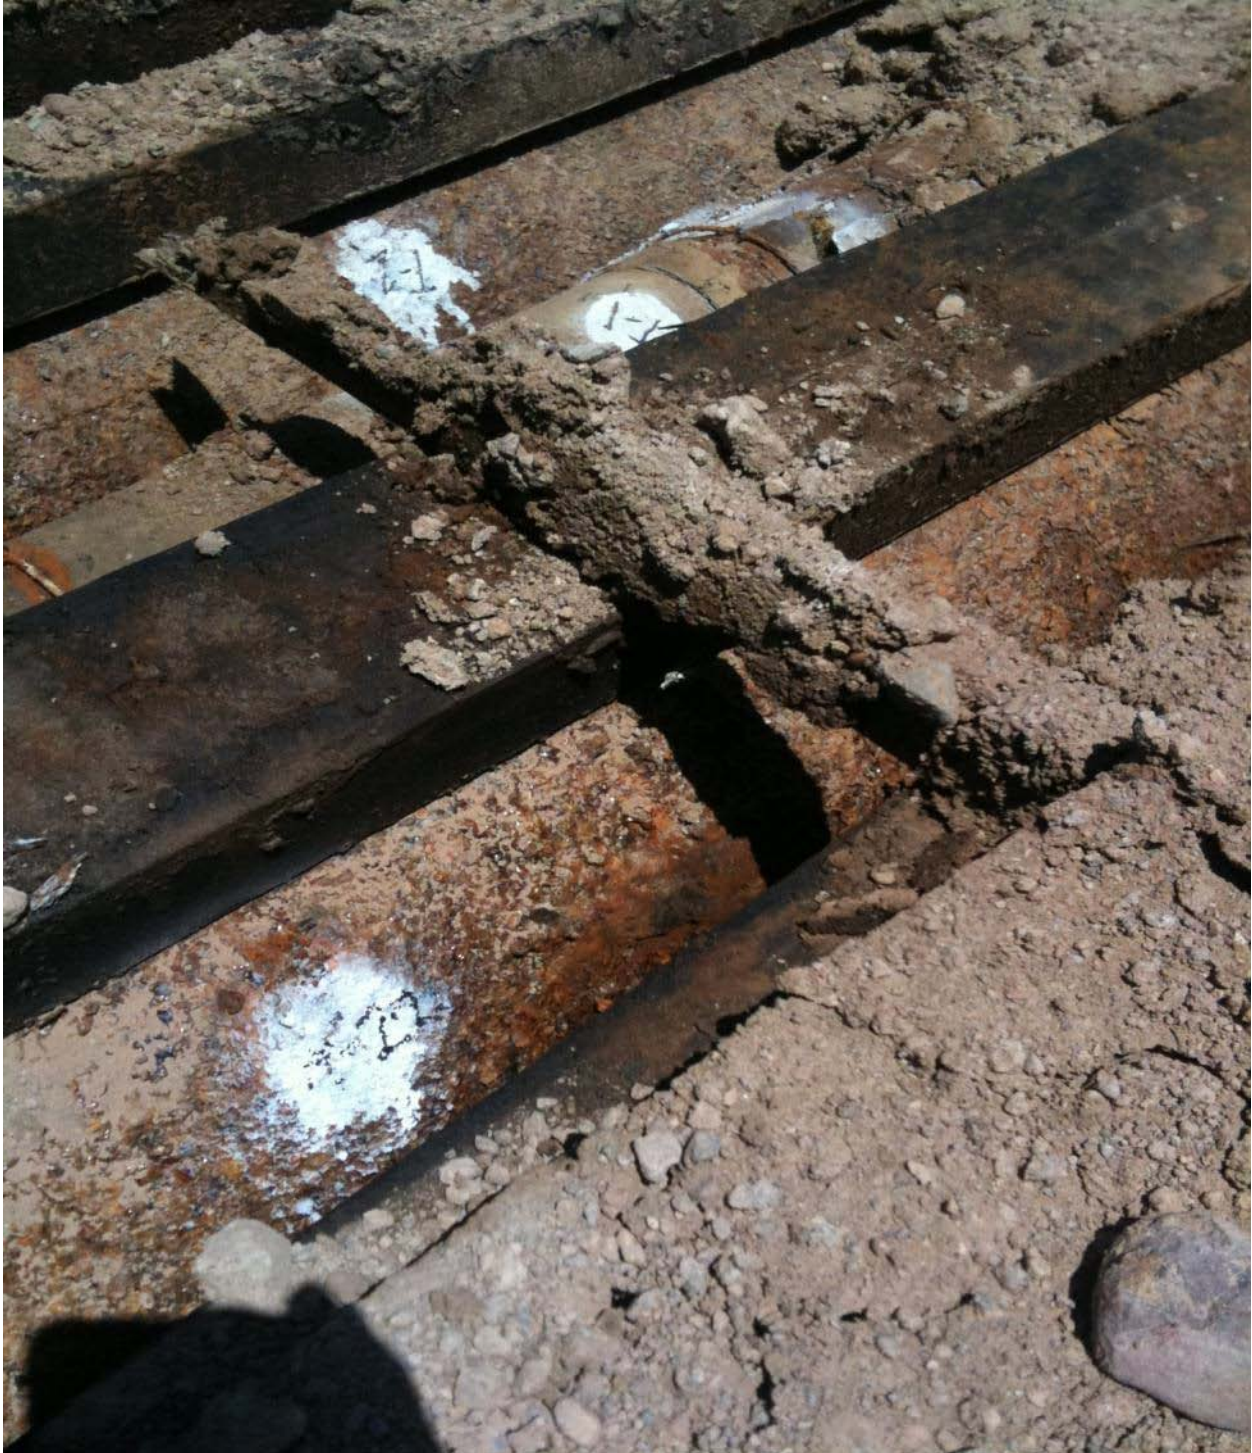
Sample ID	Color	Description	Location	Result	Friable or Non-Friable	Estimated Quantities	Condition
T-22	Brown	pipe wrap, south 4" metal piping	RZ-C24	ND	Friable	90 linear feet	Poor

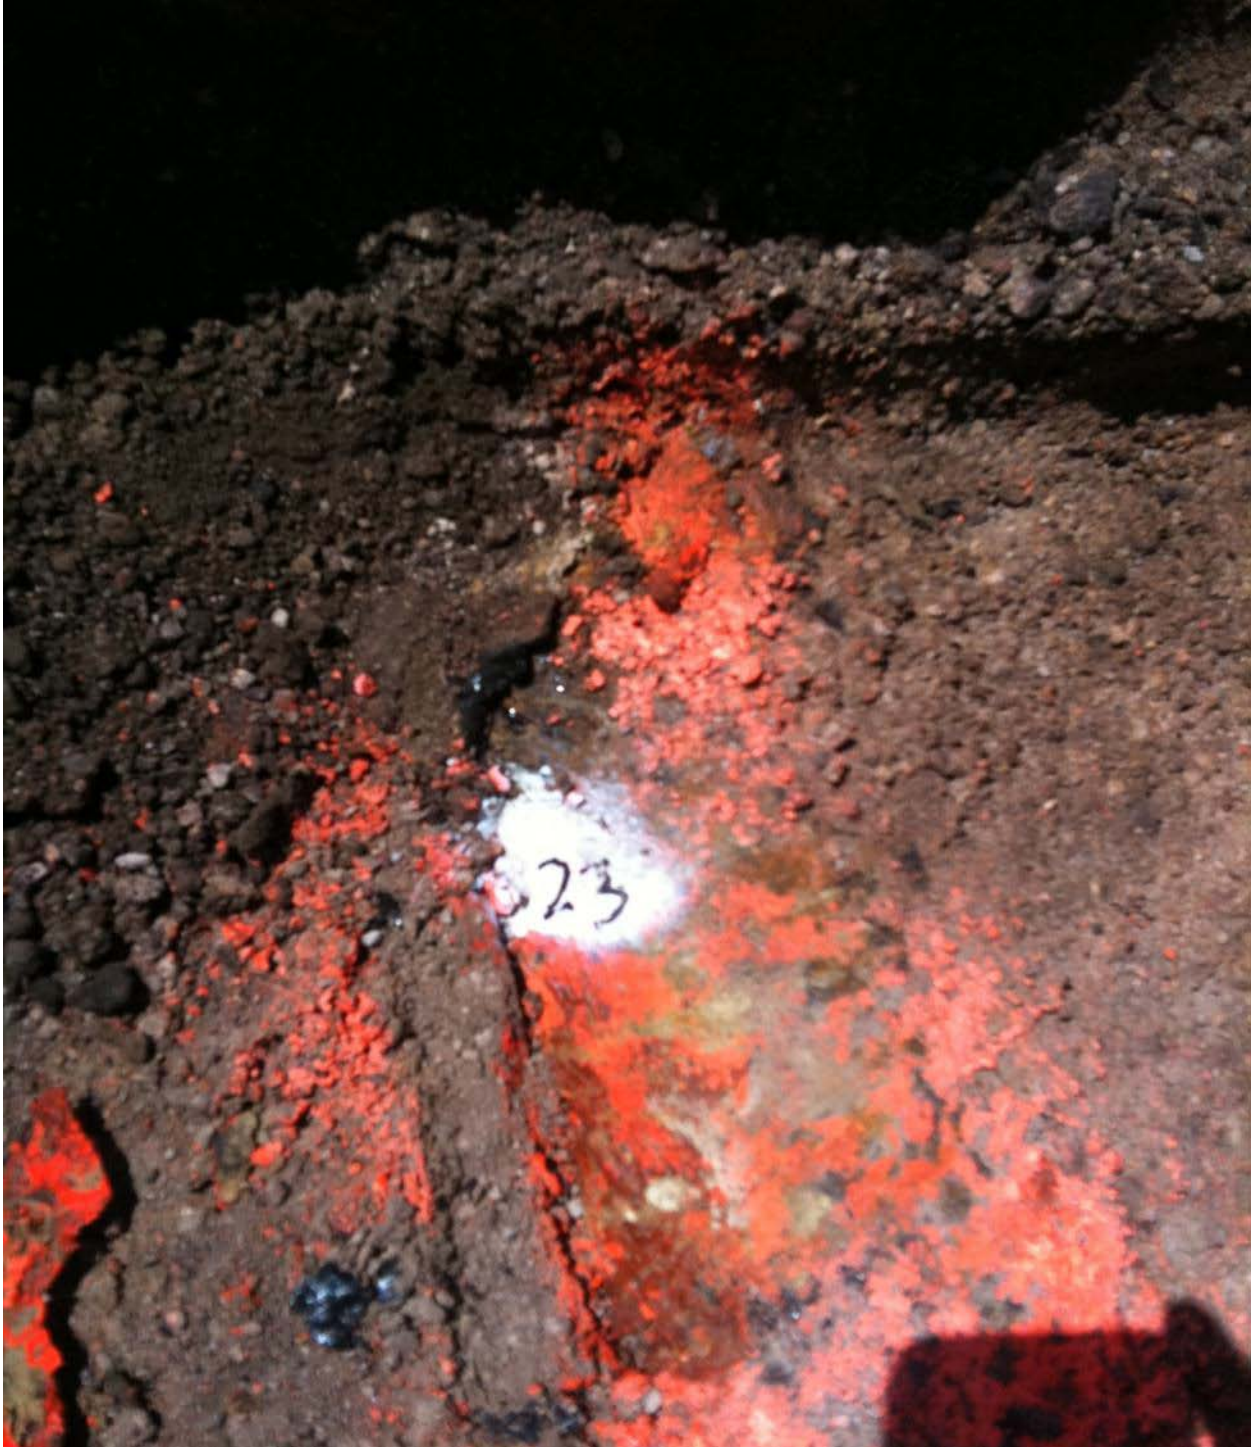
Sample ID	Color	Description	Location	Result	Friable or Non-Friable	Estimated Quantities	Condition
T-23	Brown/Black	pipe wrap, east on 4" metal piping	RZ-C, near tank structure	ND	Friable	80 linear feet	Poor

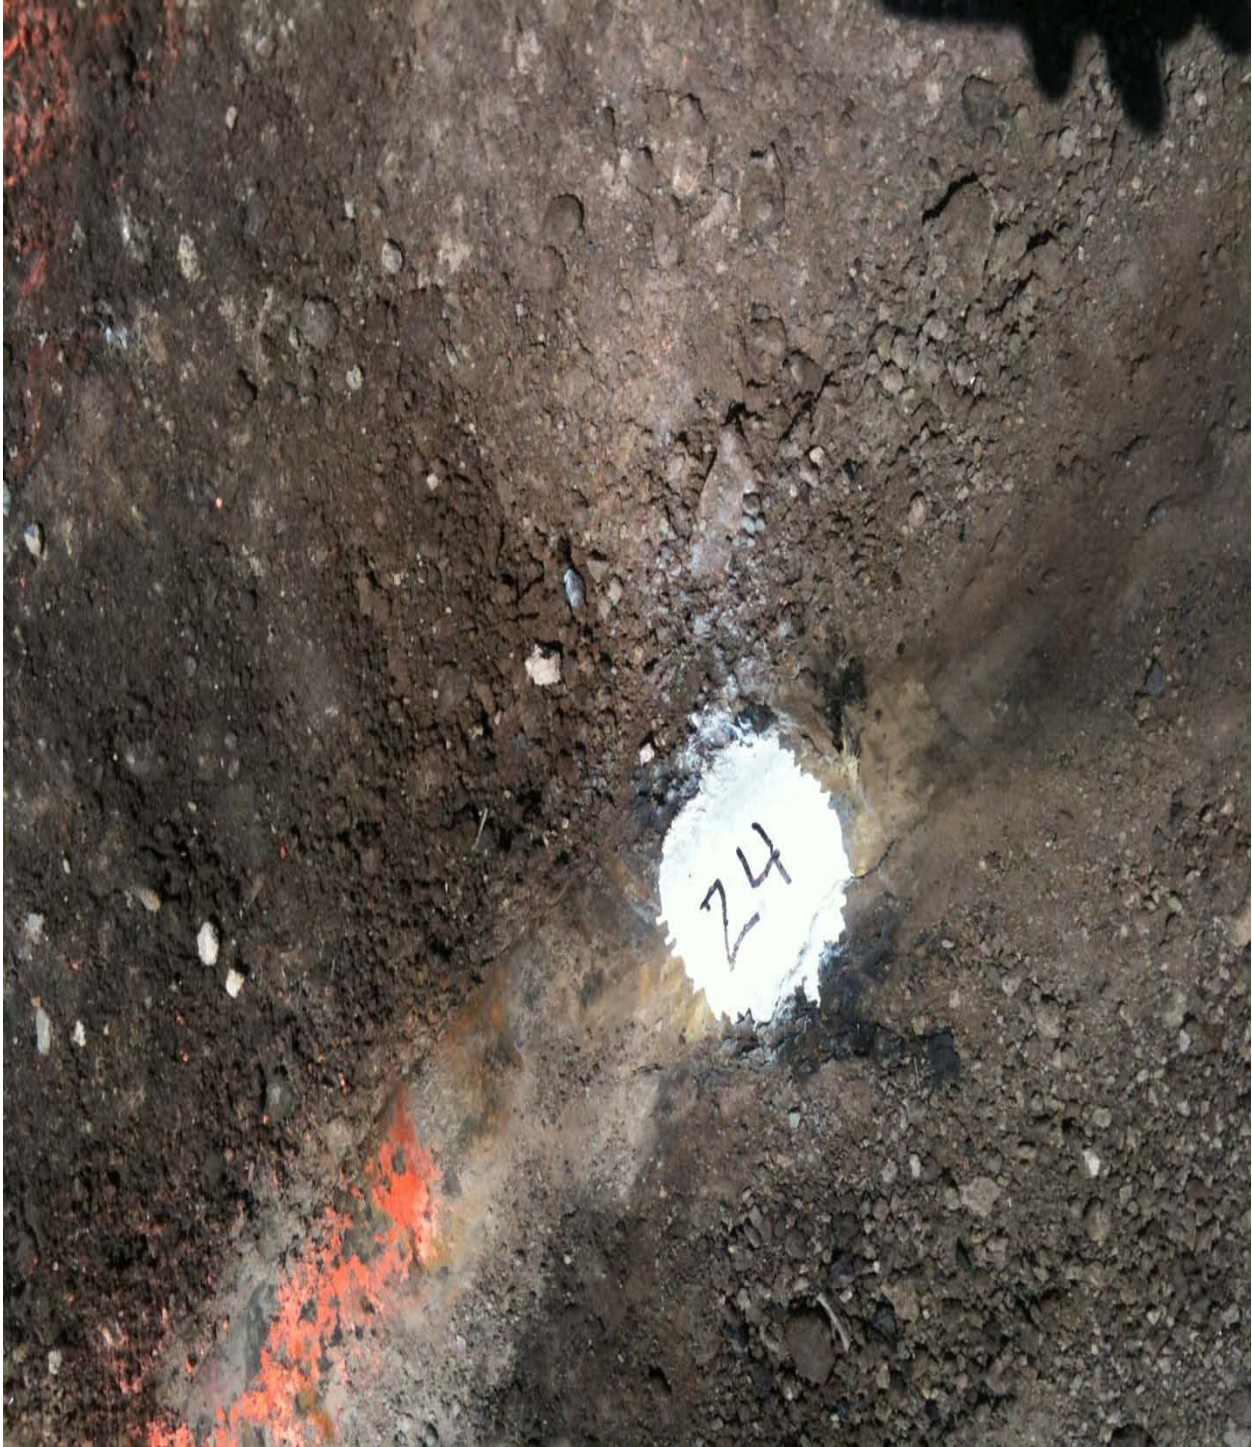
Sample ID	Color	Description	Location	Result	Friable or Non-Friable	Estimated Quantities	Condition
T-24	Brown/Black	pipe wrap, west on 4" metal piping	RZ-C, near tank structure	ND	Friable	80 linear feet	Poor
