Subject: Tronox LLC - Permit # NS2001516  
Spill Report # 130730-03 Addendum.

Tronox LLC (Tronox) operates an inorganic chemical processing facility in Henderson, NV (Henderson facility) and maintains Permit # NEV2001516 for the operation of the synthetically lined (non-discharge) holding ponds at this facility.

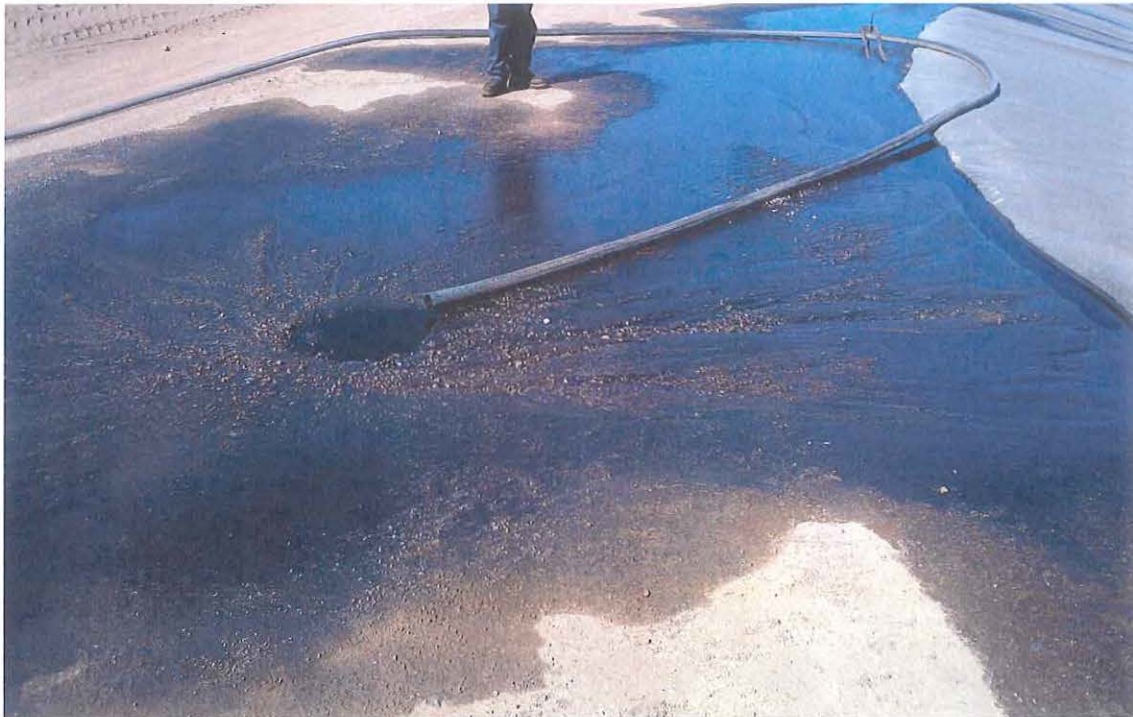
On July 30, 2013 a line carrying process water discharge from the Cathode Wash in Unit 6 to the MN-2 Pond (Outfall 004) came un-mounted from its location along the southern berm of the MN-2 Pond. This resulted in process water spilling down the pond berm and onto adjacent soil. The release was estimated at 2,700 gallons of non-hazardous process water onto the ground (~4,500 ft<sup>2</sup> area). Upon detection, the discharge to this pipe was immediately shut off, the line was secured and samples were taken. To prepare for cleaning the contaminated soils were immediately flagged off and isolated. There was no discharge off factory site.

Fig.1.  
Spill Area on top of the MN-2 Pond Berm ( 7/30/13).

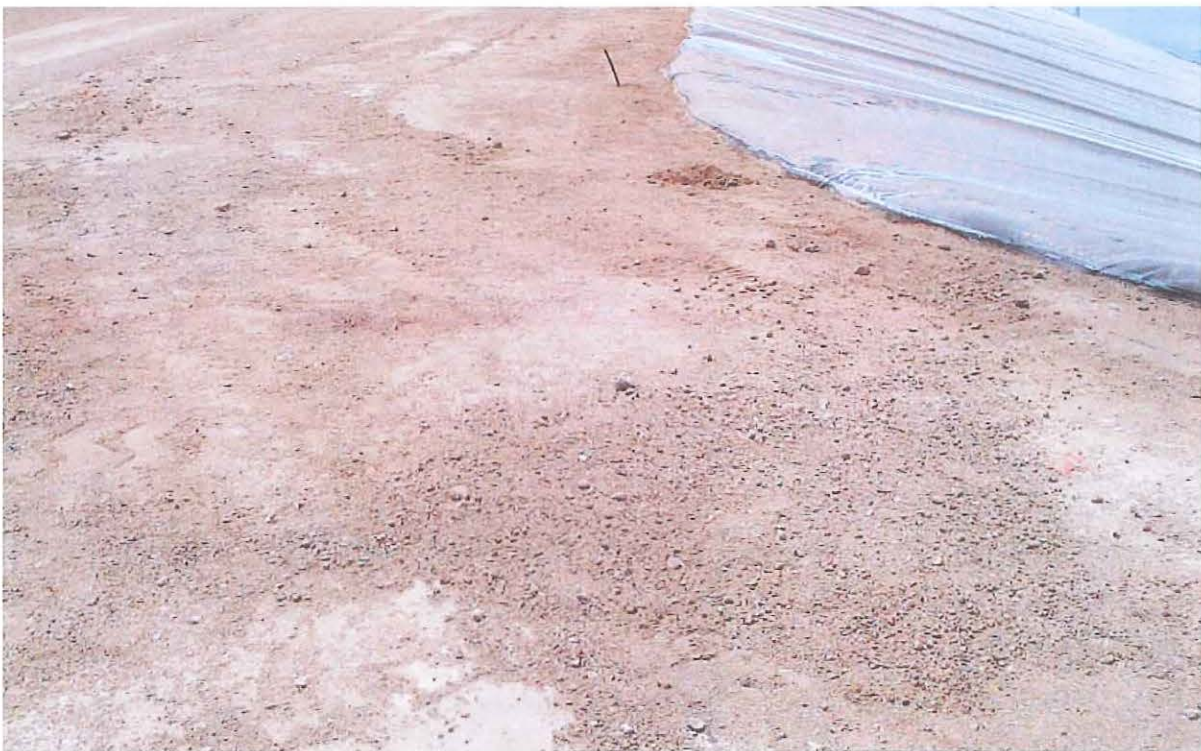
Fig. 2.  
Post clean-up picture (8/2/13) of the top of the MN2 Pond berm where the spill was generated.

As shown in Table I above, the confirmation samples were significantly below the NDEP Site Specific Soil Screening Levels noted in Henderson facility's Site Management Plan. Therefore, Tronox proposes to ship the impacted soil collected during the clean-up to Republic Services Apex Landfill, consider the site clean-up adequate and not remove any additional soil. Photographs of the spill site and post clean-up have been attached.

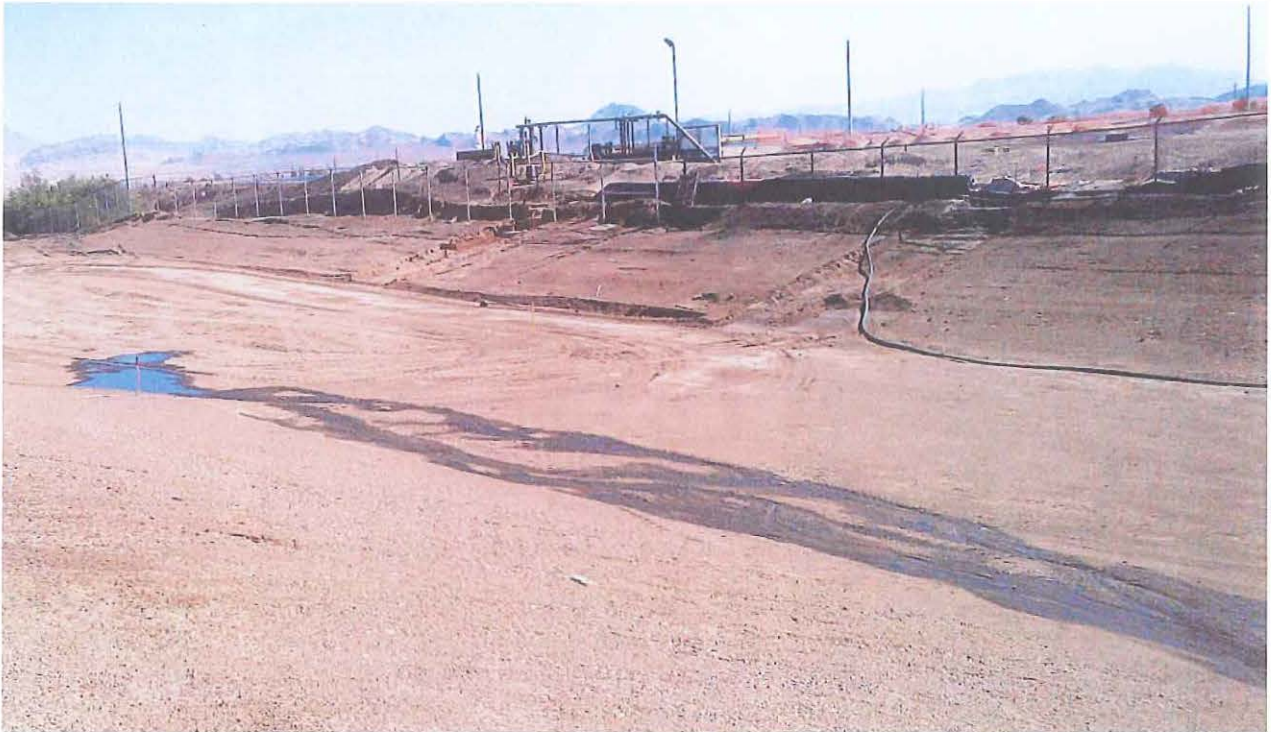
Fig. 3.

Spill flowed north along the bottom of the eastern berm of the MN-2 Pond (7/30/13).

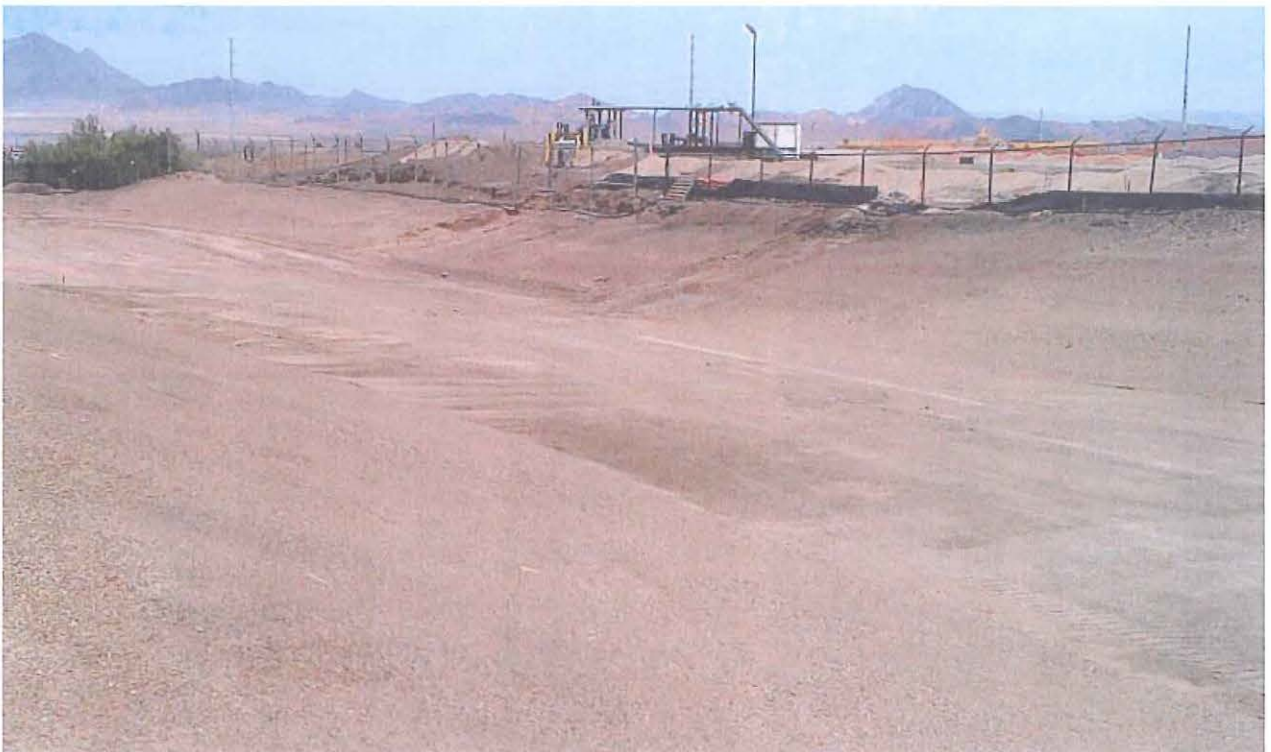
Fig. 4.

Post clean-up picture north along the bottom of the eastern berm of the MN-2 Pond (8/2/13):.
