## MEMORANDUM

To: Shannon Harbour, NDEP  
From: Jim Hutchens, ENVIRON International  
Subject: Proposed Erosion Control Measures – NERT Henderson

Subject: Data Summary for Soil Sampling and Moisture Content Test Results  
NERT/Tronox Site  
Henderson, Nevada  
Project No. 11.1049

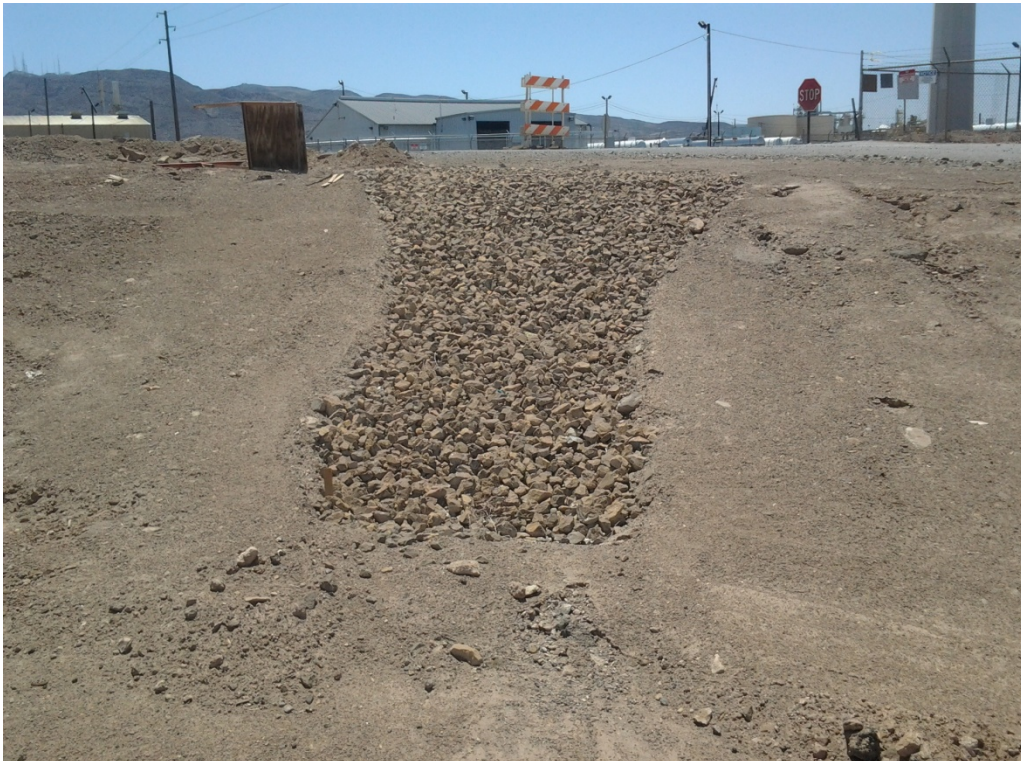
**Photo 1:** Typical Energy Dissipating Channel – Geotextile Fabric Covered with approximately 8” of Stone

Figure 1 identifies the areas which will require repair and additional grading work. The damaged areas will be re-graded to previously designed grades. Directional berms will then be installed to move the water to a designated energy dissipating channel into the respective basin. The flow channel will consist of a geotextile fabric covered by approximately 8 inches of 3" to 6" angular stone. Photographs of the typical flow channels previously constructed on the site are attached.

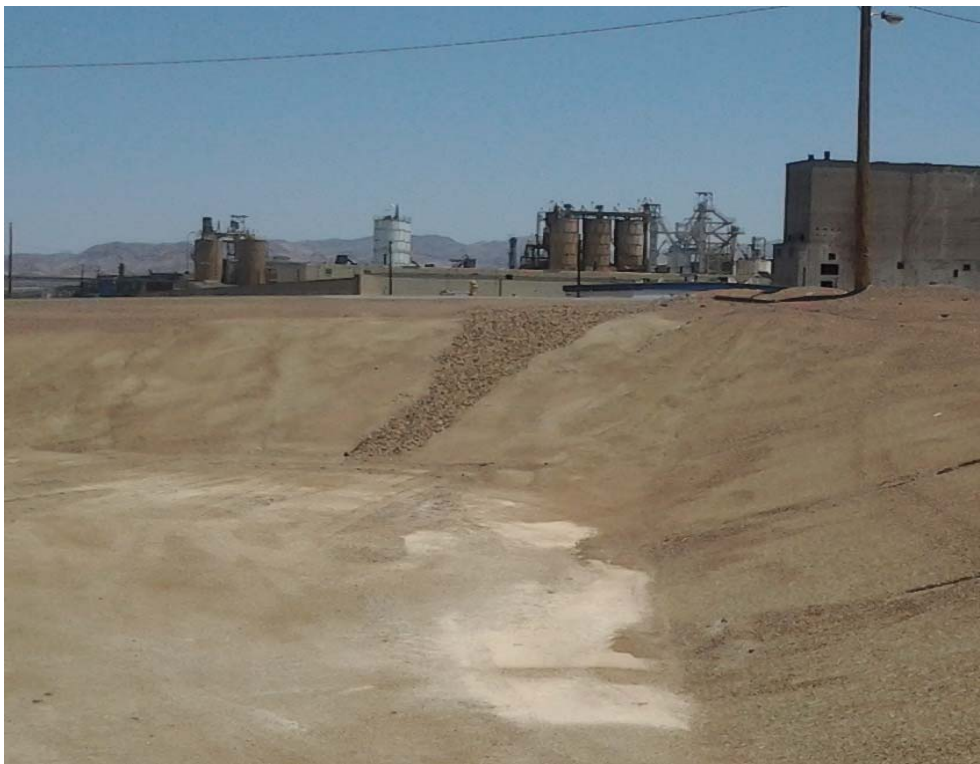
**Photo 2:** Typical Energy Dissipating Channel
