Re: Aquifer Retention Pond GW-11, J-665.

### NEVADA DIVISION OF WATER RESOURCES

### DAM SAFETY INSPECTION OBSERVATIONS

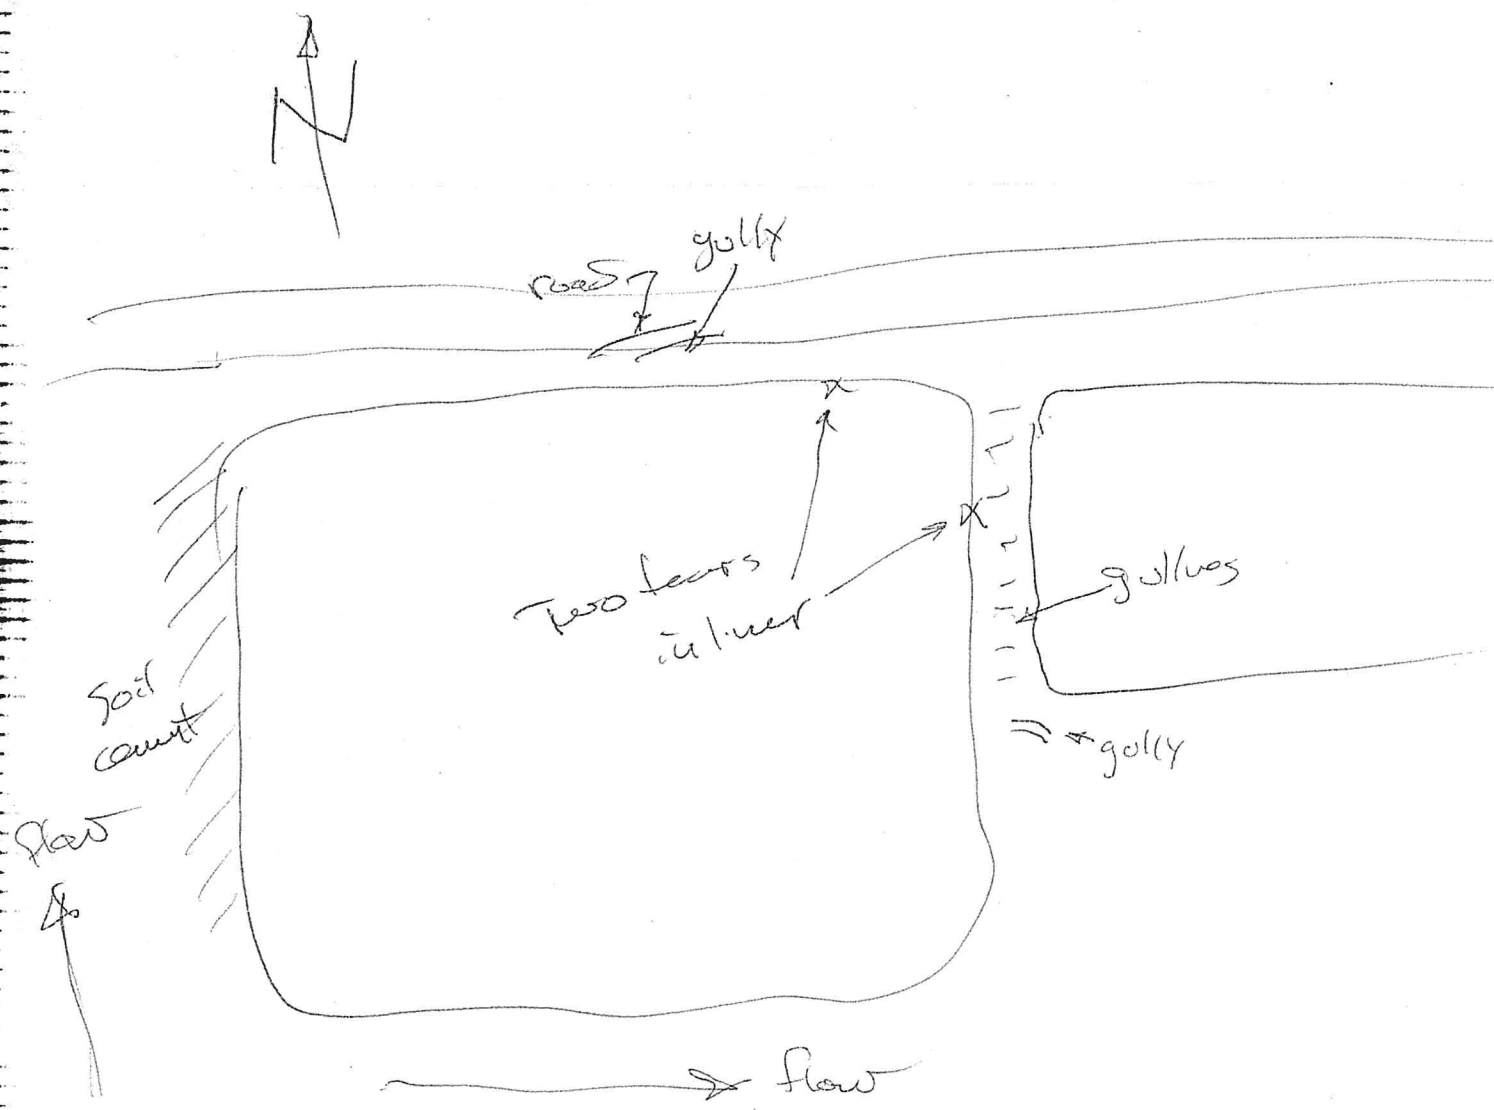
VIII. ILLUSTRATIONS/ADDENDUMS

A. Draw plan and elevation views of the dam showing appurtenances, outlets, spillways, access roads, trouble spots or seeps. Indicate photograph angles.
