Subject: NERT – GWETS Operation Monthly Report – September 2023

At the request of the Nevada Environmental Response Trust (Trust), Envirogen Technologies, Inc. (ETI) is providing this summary of the groundwater extraction and treatment system (GWETS) operation and performance during September 2023.

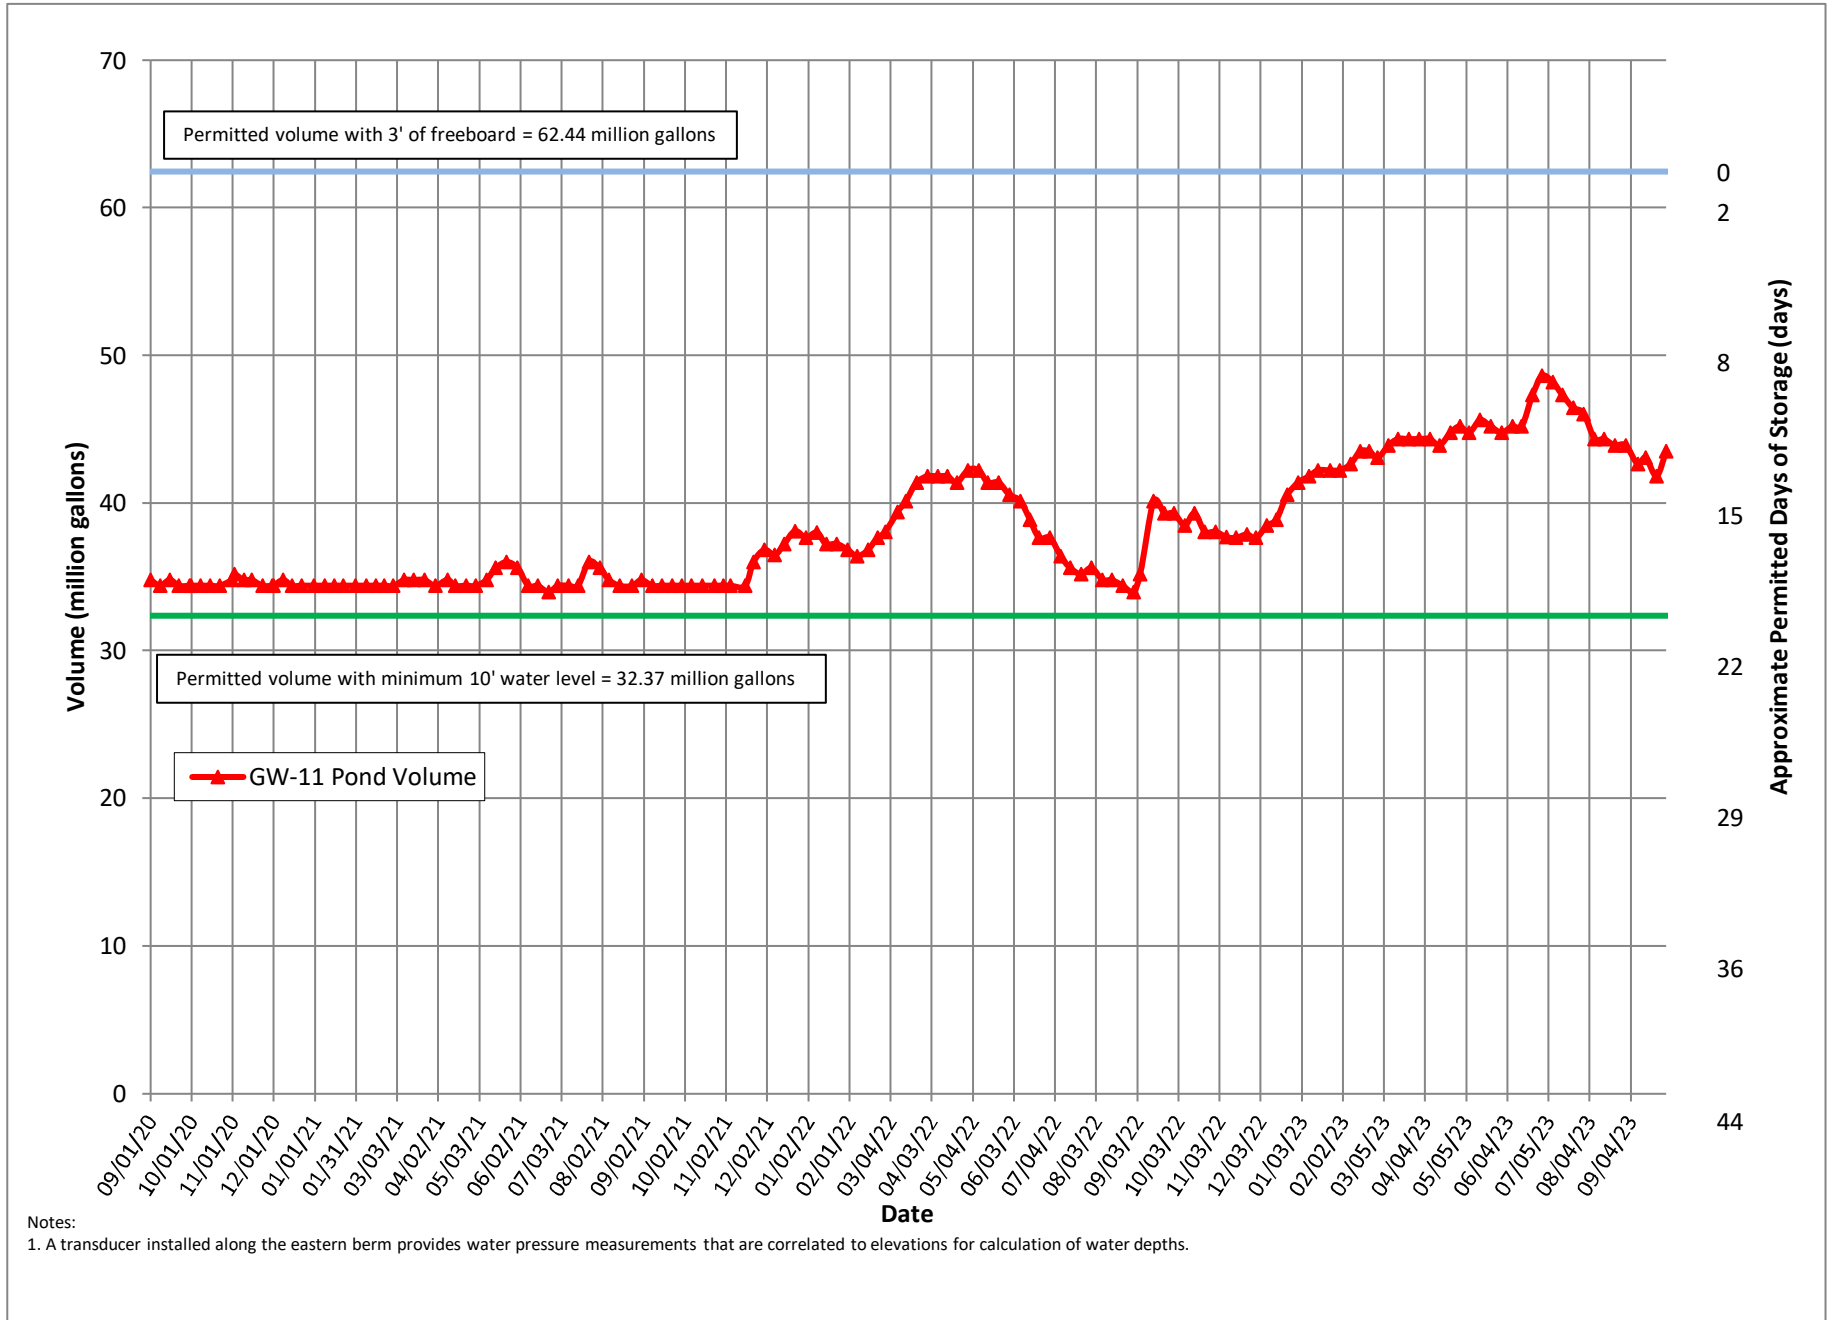
Figure 1 - GW-11 Pond Volume Through 09/30/2023

Notes:
 1. A transducer installed along the eastern berm provides water pressure measurements that are correlated to elevations for calculation of water depths.

Envirogen Technologies, Inc. (ETI) mechanically operated the GWETS and ion exchange (IX) system normally in September 2023. Flow from PC-118, PC-119, PC-120, PC-121, and PC-133 were routed to the IX system, bypassing all flow meters associated with the FBR plant for the month of September. The flow rate to the IX system averaged approximately 258 gallons per minute (gpm). The flow rate to the FBR plant averaged approximately 980 gpm. At the end of the month, the filled GW-11 Pond volume was at 43.5 million gallons (MG), which would allow 13.1 days of available additional storage in the event of a FBR plant shutdown with continued well field pumping. The water volume stored in the GW-11 Pond increased since the end of August 2023; Figure 1 in this report depicts the actual GW-11 pond volumes and additional storage available.
