## COMPLIANCE EVALUATION REPORT

Nevada Division of Environmental Protection  
Bureau of Water Pollution Control

FACILITY PERMIT: Kerr-McGee Chemical LLC – NV0000078

DATE OF INSPECTION: Tuesday, March 1, 2005

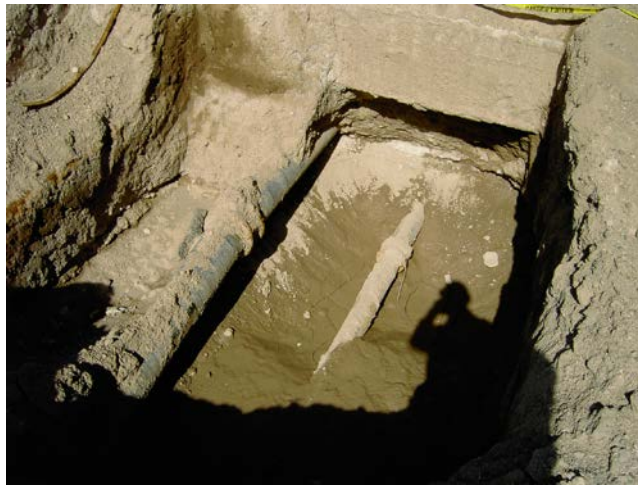
Outfall 001: This outfall collects non-contact, once-through cooling water, process water pipeline leaks and stormwater runoff from the area of Units #1-3, the west ½ of Unit #4 and the Administration Building. A section of water supply pipeline that was recently excavated to make repairs was pointed out near this outfall. The supply pipeline dates to the 1940's. Outfall 001 discharges through the Beta and Alpha ditches. An ultrasonic device measures flow. An ISCO unit collects composite samples. During this inspection, the weather was sunny and no stormwater was being discharged.

Fig. 1 – Supply Pipeline Excavation and Repair

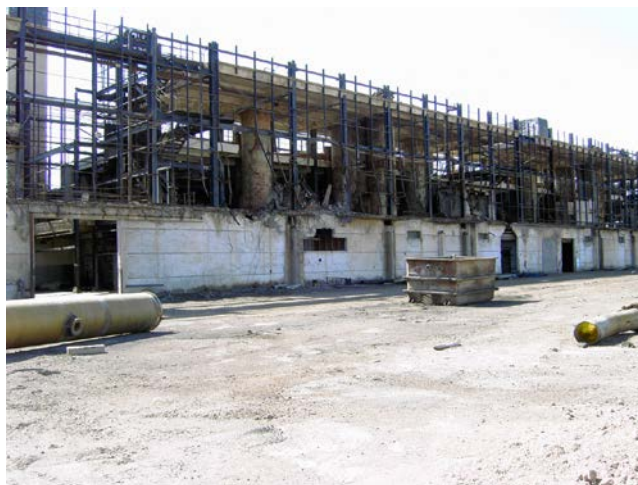
Fig. 2 – Decommissioned Process Unit

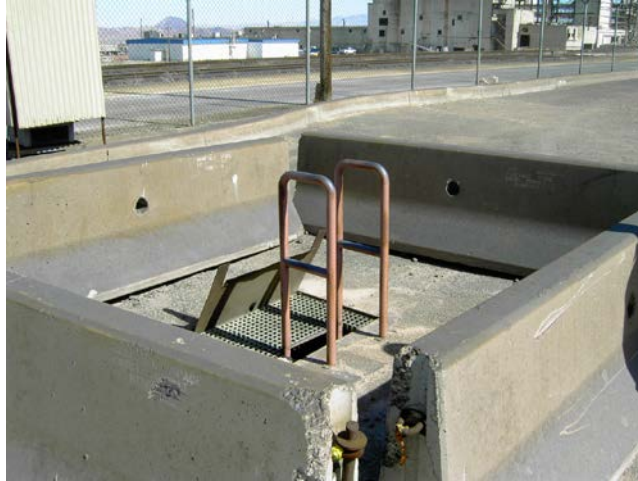
Fig. 3 – Outfall 001 Manhole

1. Kerr-McGee needs to post Outfalls 001 and 002 on its property with “No Dumping Allowed” or similar advisory language.
2. NDEP recommends that Kerr-McGee or the BMI property manager post the outfalls in Figures 6-7 at the wash with language to advise the general public that the discharged water is non-potable.
3. The DMR data indicates an increase in the perchlorate level over the background concentration observed in the raw water supply and incident precipitation. Please prepare a mass balance for calendar year 2004, which estimates the lbs/yr of perchlorate discharged from Outfalls 001 and 002 for both stormwater and non-stormwater events.

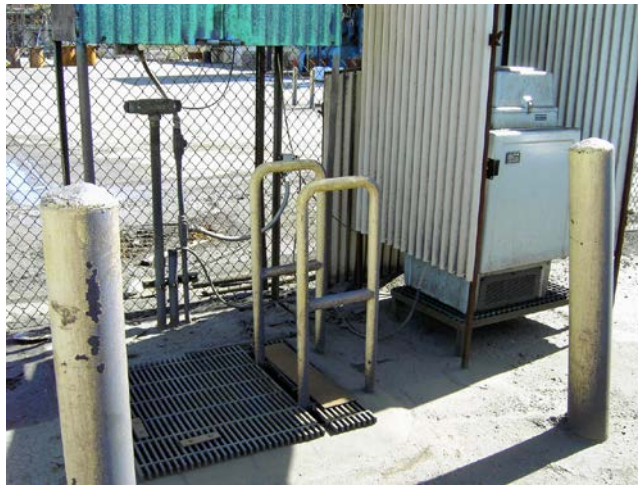
Outfall 002: This outfall collects non-contact, once-through cooling water, process water pipeline leaks and stormwater runoff from the east ½ of Unit #4 and Units #5-6. Outfall 002 is located at the property line bordering Kerr-McGee and TIMET. Curbing and physical barriers separate the two facilities to avoid commingling flow. Outfall 002 discharges to the Beta ditch. An ultrasonic device measures flow. An ISCO unit collects composite samples.

Fig. 4 – Outfall 002 Manhole

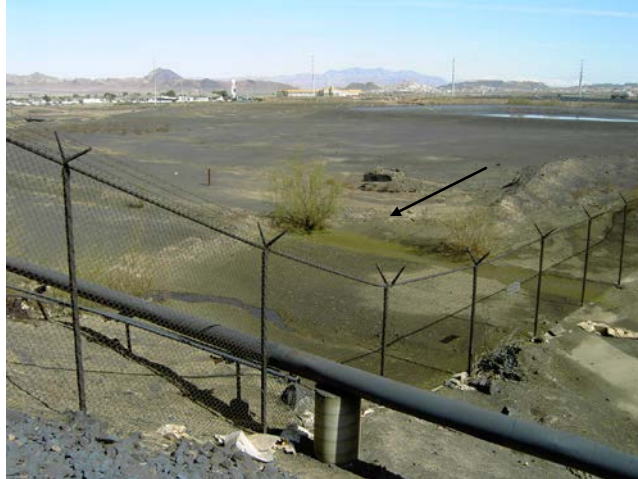
Outfall 003: Outfall 003 is an earthen ditch designed to carry runoff from major storm events falling on the manganese dioxide tails storage area. Normally, incident precipitation infiltrates onto the manganese dioxide tails storage area. The tailings piles are bermed to contain most storm events. This outfall did not discharge runoff last year off the property according to the DMR reports. Stormwater samples must be obtained manually (discrete). Outfall 003 discharges to the Beta ditch.

Fig. 5 – Outfall 003 (earthen ditch)

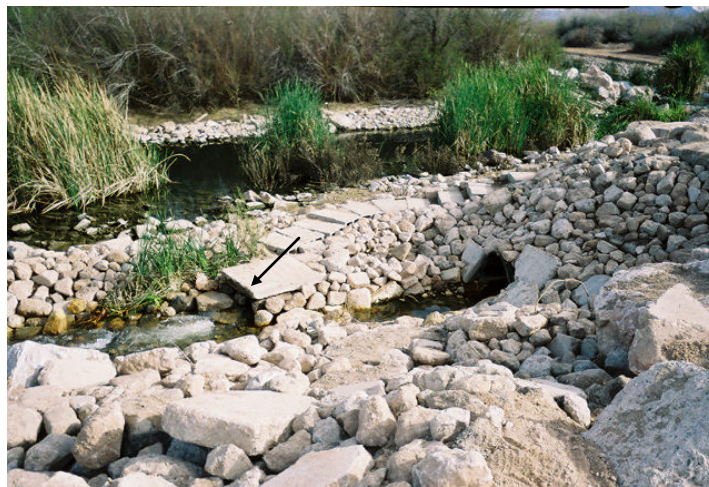
Las Vegas Wash: After touring the Kerr-McGee BMI facility, we drove out to inspect the outfalls at the wash in Henderson. The first outfall (Fig. 6) discharges treated effluent from the perchlorate bioreactor facility at BMI. The second outfall (Fig. 7) carries flow from the Pittman Bypass Pipeline. This pipeline discharges non-contact, once-through cooling water, stormwater runoff, and pipeline leakage from the Pioneer Americas, TIMET and Kerr-McGee facilities at BMI.

Fig. 6 – Treated Perchlorate Effluent (Las Vegas Wash)

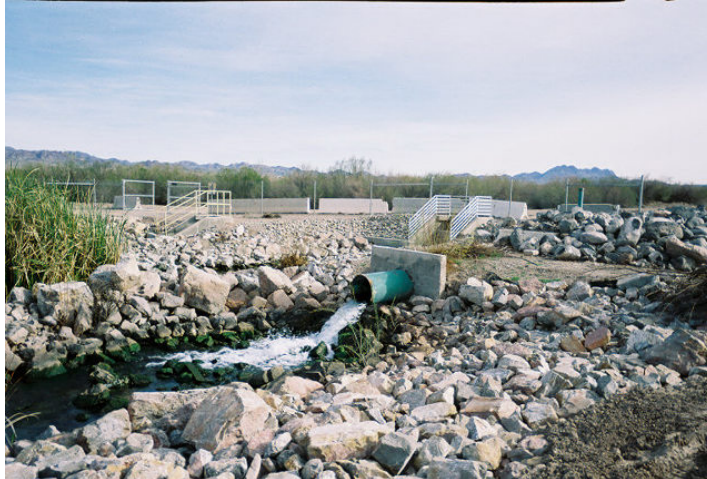
Fig. 7 – Pittman Bypass Pipeline (Las Vegas Wash)
