PLATE NUMBER:
1-6
SHEET NUMBER:
1

AREAS I, II, III, AND IV SOIL PERCHLORATE RESULTS EXCEEDING BCLS
Tronox Facility
Henderson, Nevada

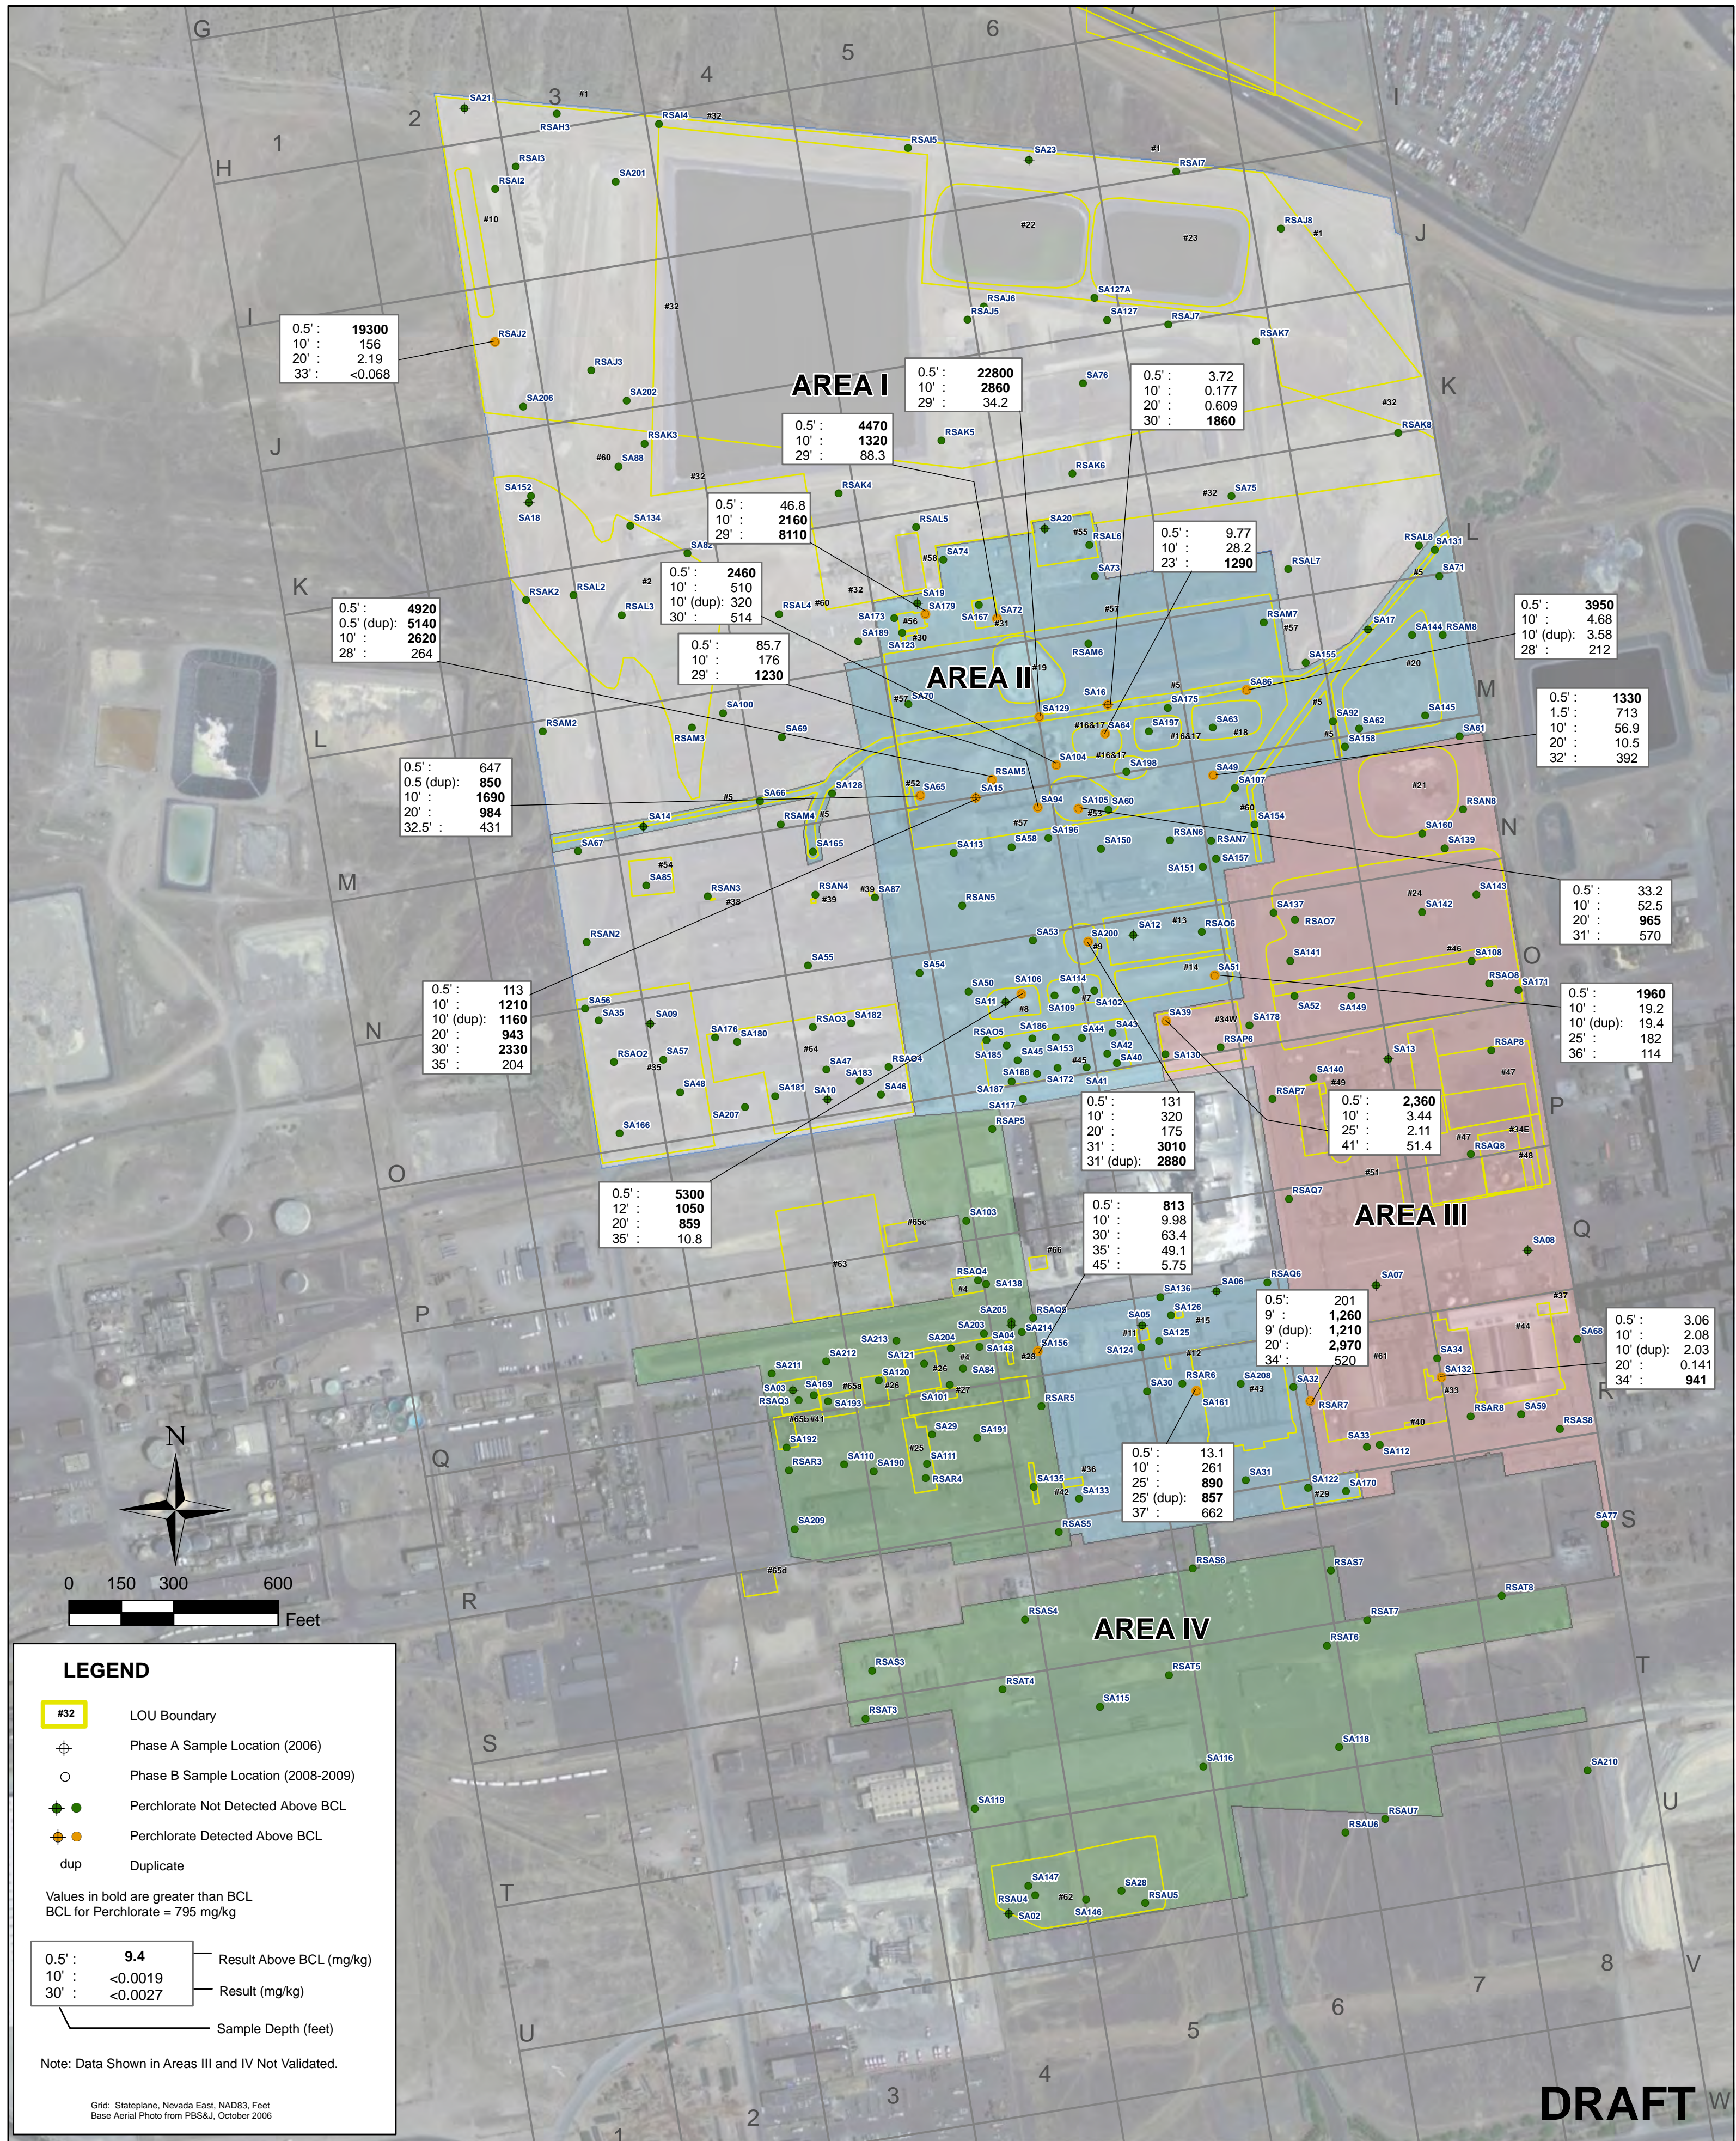
Note: Data Shown in Areas III and IV Not Validated.
