Subject: KMCC Phase II Written Response to Letter of Understanding

RESPONSE TO LETTER OF UNDERSTANDING

HENDERSON SITE

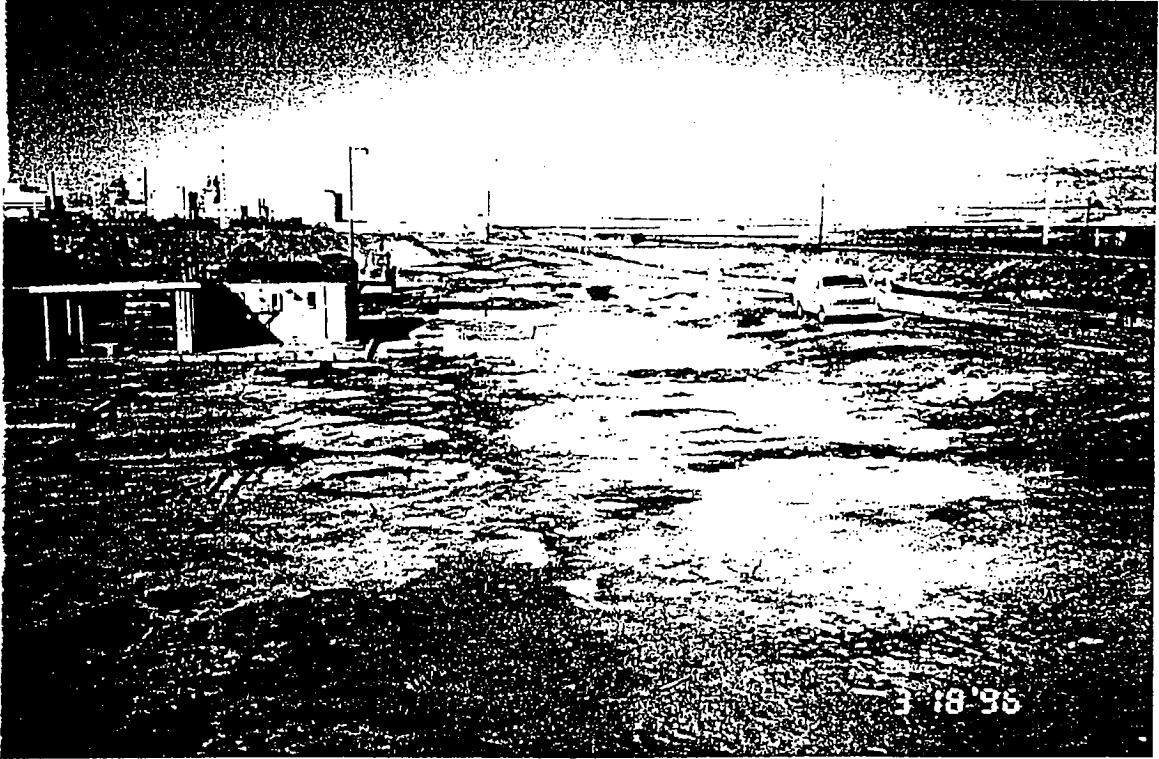
Photograph #1 View to the west showing project area prior to excavation activities.
