RE: Final Report of Findings “Column Tests to Evaluate *In-situ* Soil Flushing of Perchlorate”, Tronox, LLC, Henderson, Nevada

Report of Findings
**COLUMN TESTS TO EVALUATE
IN-SITU SOIL FLUSHING OF PERCHLORATE**

Tronox, LLC
Henderson, Nevada

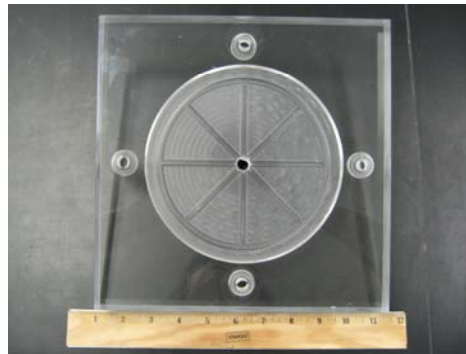
Figure 1. Endplate for Columns.

Four identical columns were built for use in the percolation and flushing tests. The design was based on that described in ASTM D 4874 – 95 (Standard Testing Method for Leaching Solid Material in a Column Apparatus). The columns were constructed from 6 in. diameter, 6 ft. long clear Schedule 40 PVC pipe. End plates were fabricated by Precision Plastics (Elk Grove, CA) from 10 in x 10 in x 1 ¼ in. thick clear acrylic (Figure 1). The bottom diffusion plates were 6 inch diameter, 1/16 inch thick sintered stainless steel with a nominal pore size of 75 microns (mm). The top diffusion plates were 6 inch diameter, 1/2 inch thick sintered glass with a nominal pore size of 70-100 mm. Glass frits were used on the top because they were available in thicker sizes than the stainless steel and thus were expected to be more effective. O-rings were Viton® (Figure 2). The endplates were bolted to the pipe via a collar welded ¾ inches from each end of the pipe as shown in Figure 3. Water was delivered to the columns via Tygon® tubing.

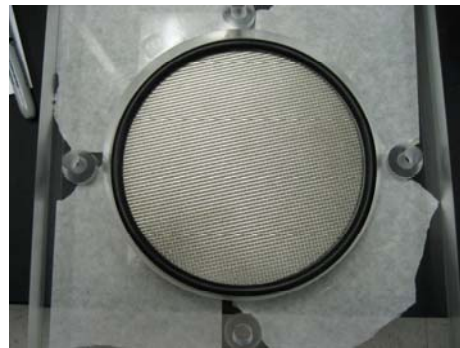
Figure 2. Bottom endplate with stainless steel disk and o-ring.

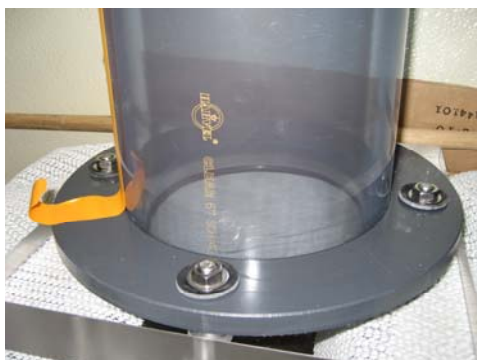
Figure 3. Column bolted to bottom endplate.

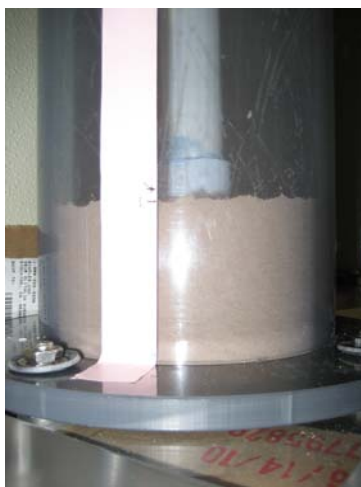
Figure 4. Addition of the first lift to a column.

Each of four columns was filled with one of the screened, homogenized soils (see Section 2.1). Columns were filled in lifts (20 per column), which were tamped before adding the next lift (Figure 4). Most lifts consisted of 3.00 kg soil compacted to a depth of 3.5 inches, which generated an approximate density of 1.85 g/cm^3 . The exceptions were the first lift of column SA-179, which consisted of 3.83 kg soil, compacted to 4.625 inches, and the final lift of each column which consisted of 1.30 to 2.36 kg soil compacted appropriately. After filling, a glass frit was placed on top the soil column, then the o-ring and endplate were secured. The exact amount of soil used in each column, the average bulk density, and other parameters are shown in Table 1. Note that SA-179—the soil used for the percolation test—was filled to a height of 70.375 in order to allow for an approximately 1 inch head of water on the surface. The other columns were filled to a height of 71.5 inches.

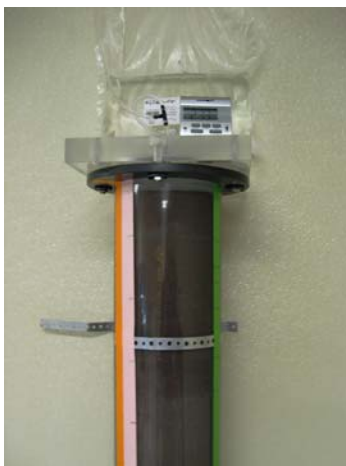
Figure 5. Addition of Water via Gravity Feed into Percolation Column.
Note: wetting front below silver band.

Soil SA-179 was selected by NGEM for use in the percolation study. The column was prepared as described in Section 2.2. Stabilized Lake Mead water (2.8 L, the equivalent of 6 inches of water or 1.5 times the annual rainfall for the site) was placed in a Tedlar® bag and gravity fed into the top of the column (Figure 5). All of the water had entered the column within 2 days. The location of the wetting front was recorded over time for four days. No effluent was obtained from the column after six days.

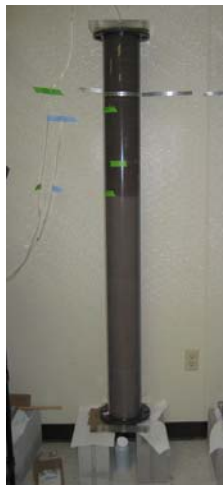
Figure 6. Soil Flush Column near Beginning of Test.

Note: Wetting Front.

Columns were constructed as described in Section 2.2. Water from the four carboys was combined into a single container, then pumped to the top of each column at a flow rate of approximately 2.0 mL/min using a peristaltic pump until about 2 pore volumes of water were added (see Table 1 for exact flow rates and number of pore volumes put through). The wetting front was monitored for each column. Once breakthrough occurred, effluent was collected (in covered plastic containers) until the next day, then approximately every 24 hours thereafter. The final sample was collected for at least two days until the rate of leachate collection was very slow (dripping was no longer evident and less than about 100 mL was collected in a 24 hour period). Effluent samples were analyzed for the parameters in Table 2, which are listed in order of priority. This priority order was followed for samples for which an insufficient volume of water was available to perform all analyses (the first and final effluent samples). Figure 6 shows a column at the beginning of the test.

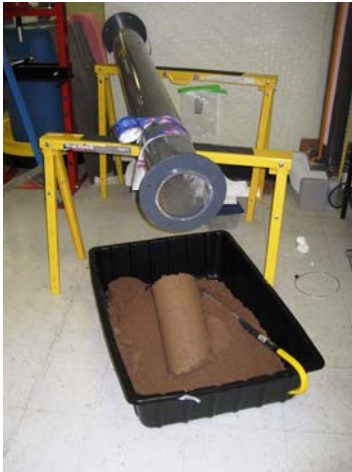
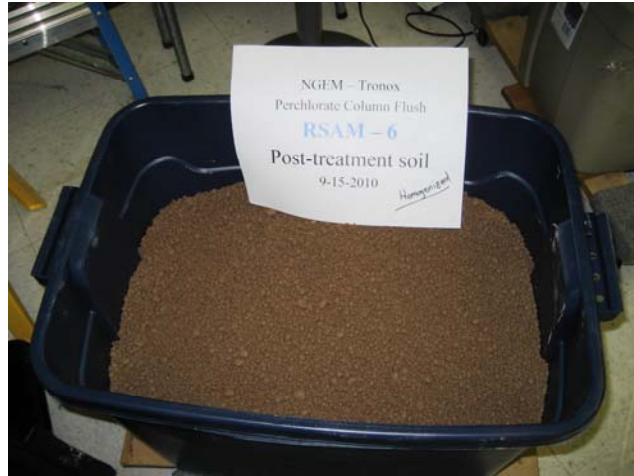
Figure 7. Removal of Soil from Columns.

Left: Removal of RSAM-5 soil. *Right:* Homogenized post-treatment RSAM-6 soil.

After the final effluent sample was collected, the soil from each column was removed, thoroughly homogenized, then analyzed for perchlorate, Cr(VI), pesticides, metals, and moisture content. Each sample was homogenized by placing it in a cement mixer and mixing for a total of 8 minutes (RSAM-5) or 10 minutes (RSAM-6 and SA-189). The mixer was stopped every 2 minutes to break up any clumps and to scrape soil from the sides of the mixer. The mixer was washed thoroughly between samples. Figure 7 shows removal of the soil, and homogenized RSAM-6 soil.

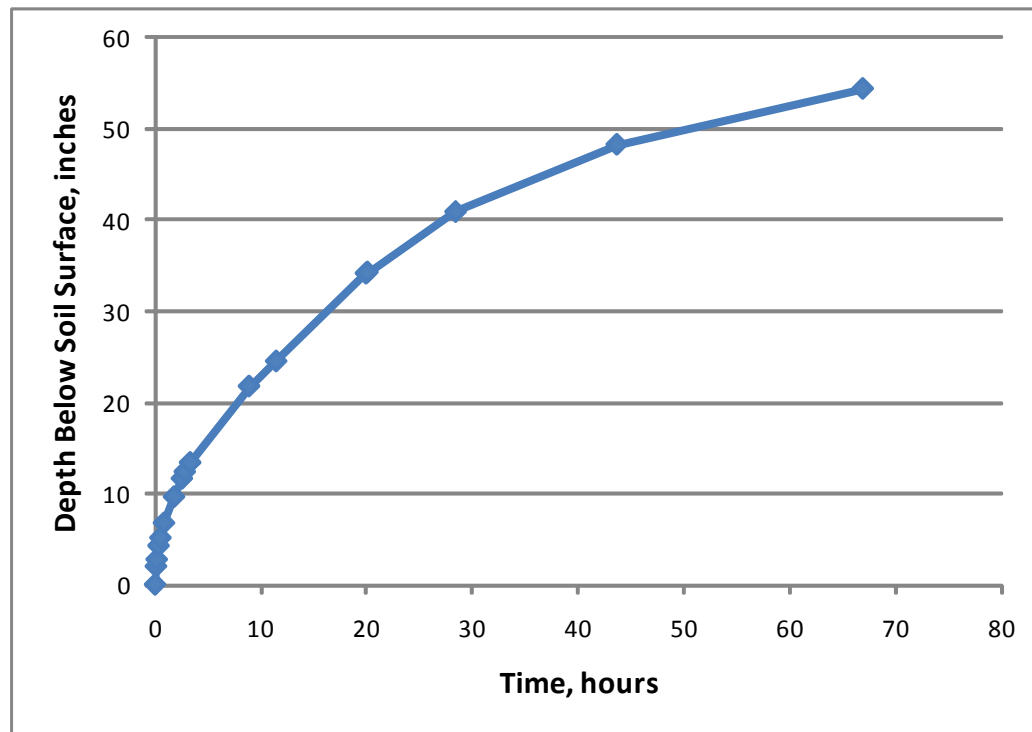
Figure 8. Movement of Wetting Front. Percolation Column Test.

Movement of the wetting front versus time for the percolation test is shown in Figure 8. Water moved down the column quickly for about the first 2 hours, then began to slow. The front was clearly evident early on, but became more difficult to discern over time. By 67 hours it was faint and by 93 hours, it is uncertain whether the front reached the bottom of the column or was simply too faint to detect. Although all of the water drained into the column within 2 days, no effluent was detected, even after 6 days. This is expected since the amount of water put through (2.8L) is only 0.25 pore volumes.

Time	Depth Below Soil Surface
hours	inches
0.00	0
0.09	2
0.16	2.8
0.33	4.3
0.51	5.1
0.85	6.8
1.8	9.6
2.5	11.6
2.8	12.4
3.3	13.4
8.9	21.8
11	24.5
20	34.1
20	34.3
28	40.9
44	48.3
67	54.4
93	70?*

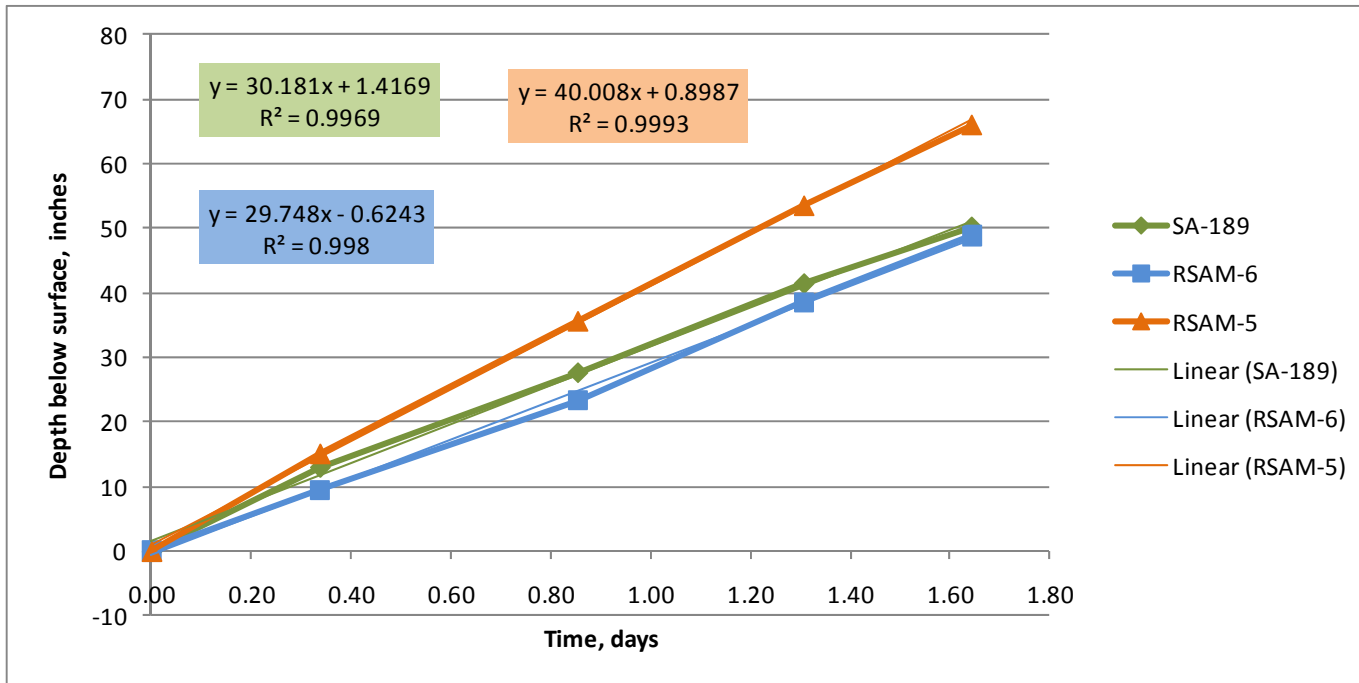
Figure 9. Movement of Wetting Front. Soil Flushing Tests.

Movement of the wetting front versus time for the soil flushing columns is shown in Figure 9. Movement of all three fronts was nearly linear, moving at approximately 30 inches per day for SA-189 and RSAM-6 and at 40 inches per day for RSAM-5. It is expected that these rates would continue as long as water is applied to the top of the soil

columns. Once application of water ceases, the downward movement of the water would slow as in the percolation test.

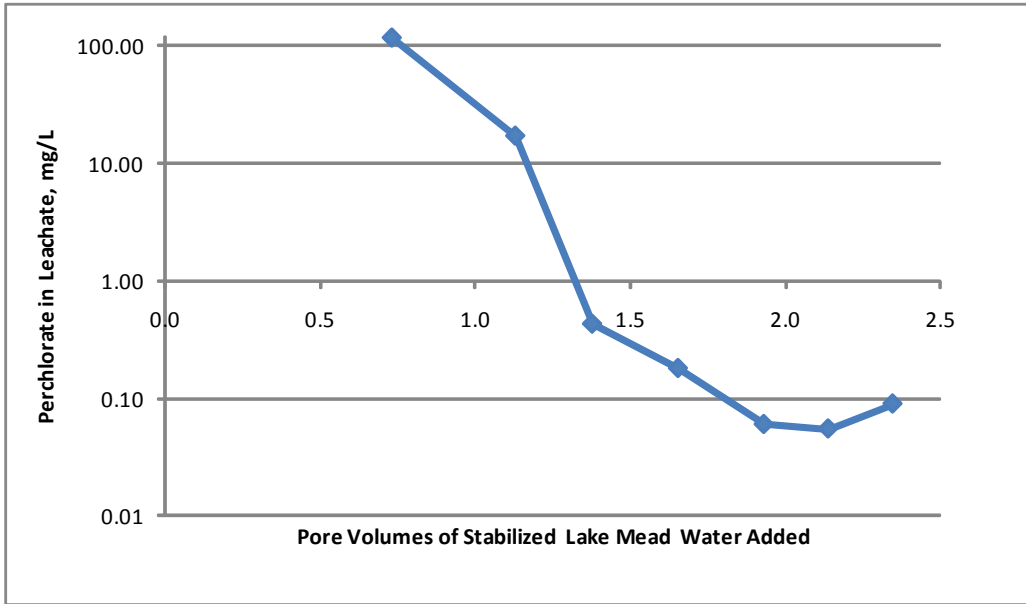
Figure 10. Perchlorate in Leachate. SA-189.

The concentrations of perchlorate in the leachate samples and the accumulated mass removed are shown in Figure 10. The concentration of perchlorate decreased over time, though some perchlorate (0.0892 mg/L) was still present in the final sample, after application of 2.35 pore volumes of Lake Mead water. Most of the perchlorate was detected in the first two leachate samples. These samples together constituted 0.33 pore volumes of water and contained 0.123 g perchlorate, which was 32% of the perchlorate initially present in the column (see Section 3.3.1.2 for further discussion of soil and perchlorate mass balance). The remaining leachate samples, which together constituted 1.29 pore volumes of water, contained only 0.003 g perchlorate. Thus, the total mass of perchlorate collected was only 33% of the initial mass present.

The slight increase in perchlorate concentration between the S6 and the S7 samples may be due to resuming flow during collection of S7. S6 was collected about 4 hours after flow to the column was initially stopped (after 2 pore volumes were put through). After draining for 5 days, flow was resumed for 18 hours (0.2 pore volumes was added), then the column allowed to drain again. The small increase in perchlorate suggests that starting and stopping flow during soil flushing could potentially enhance removal, although it should be noted that the additional mass removed is very low compared to the mass of perchlorate in the S1 and S2 samples.

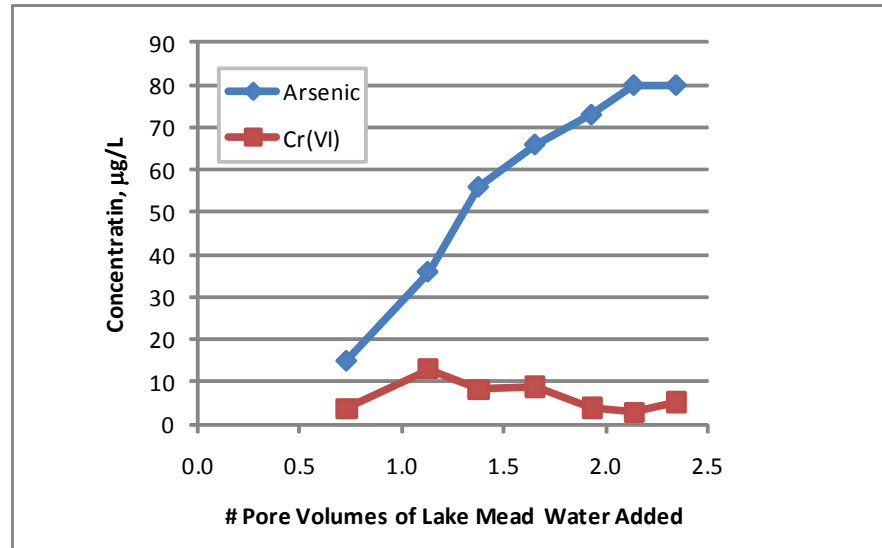
Figure 11. Arsenic and Cr(VI) in Leachate. SA-189.

The concentrations of arsenic and Cr(VI) in leachate samples are shown in Figure 11. Arsenic increased slowly from 15 µg/L in the S1 sample to 80 µg/L by the final leachate sample. Cr(VI) initially increased, then decreased, with the maximum concentration [8.3 µg/L Cr(VI)] occurring in the S3 and S4 samples.

Sample ID	# Pore Volumes Added	Leachate Concentration	
		Arsenic	Cr(VI)
		mg/L	µg/L
S1	0.73	15	3.8
S2	1.13	36	13 [^]
S3	1.38	56	8.3 [^]
S4	1.65	66	8.8 [^]
S5	1.93	73	3.9
S6	2.14	80	2.9
S7	2.35	80	5.3

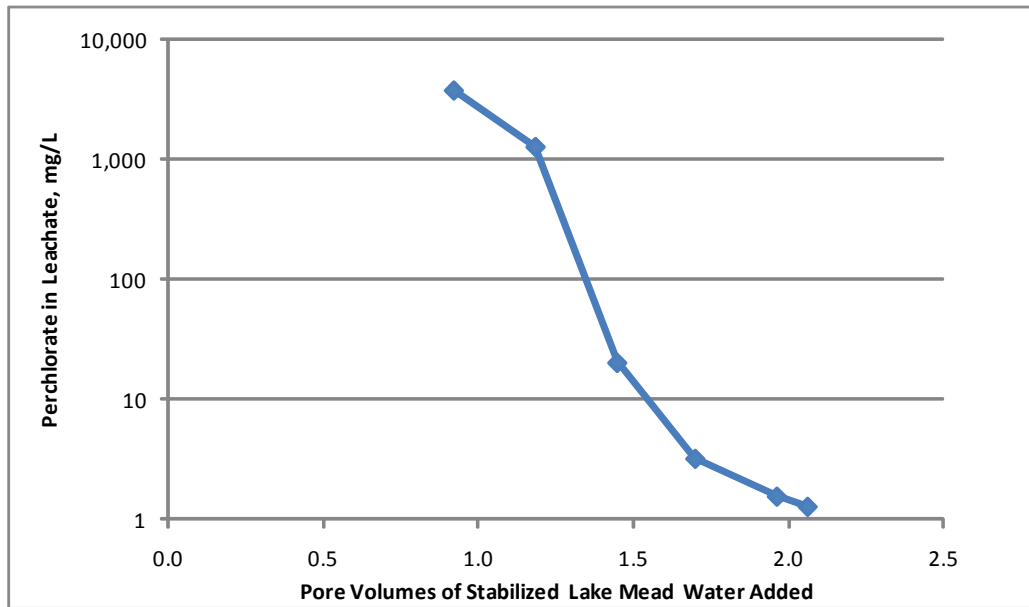
Figure 12. Perchlorate in Leachate. RSAM-6.

Sample ID	# pore volumes		Perchlorate in Effluent		Perchlorate Removed		
	Added	Collected	mg/L	g	sample	cummulative	
					% of total*	g	%
S1	0.92	0.06	3,780	2.66	29.8	2.7	30
S2	1.18	0.25	1,280	2.82	31.6	5.5	61
S3	1.45	0.51	20.4	0.0595	0.7	5.5	62
S4	1.70	0.72	3.24	0.00789	0.1	5.5	62
S5	1.96	0.96	1.57	0.00429	0.05	5.5	62
S6	2.06	1.15	1.29	0.00292	0.03	5.5	62

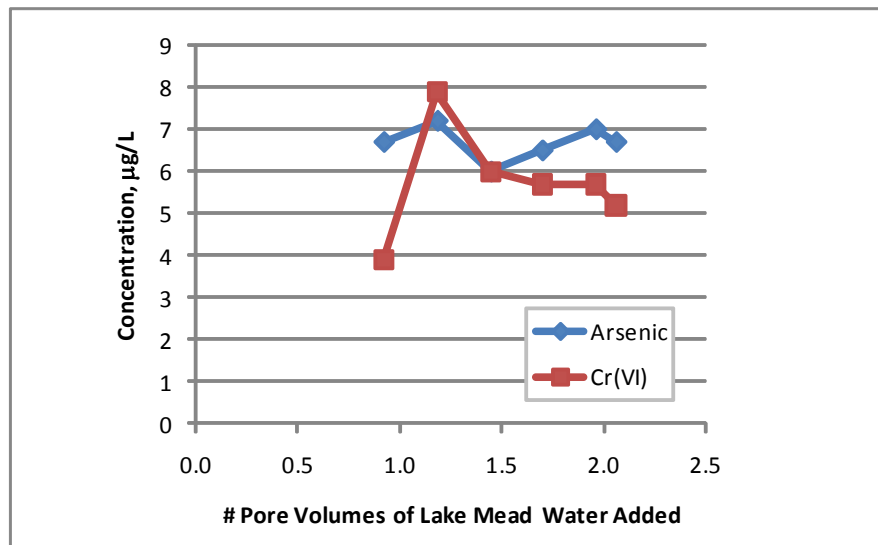
Figure 13. Arsenic and Cr(VI) in Leachate. RSAM-6.

Sample ID	# Pore Volumes Added	Leachate Concentration	
		Arsenic	Cr(VI)
		mg/L	µg/L
S1	0.92	6.7	3.9
S2	1.18	7.2	7.9
S3	1.45	6.0	6.0
S4	1.70	6.5	5.7
S5	1.96	7.0	5.7 [^]
S6	2.06	6.7	5.2

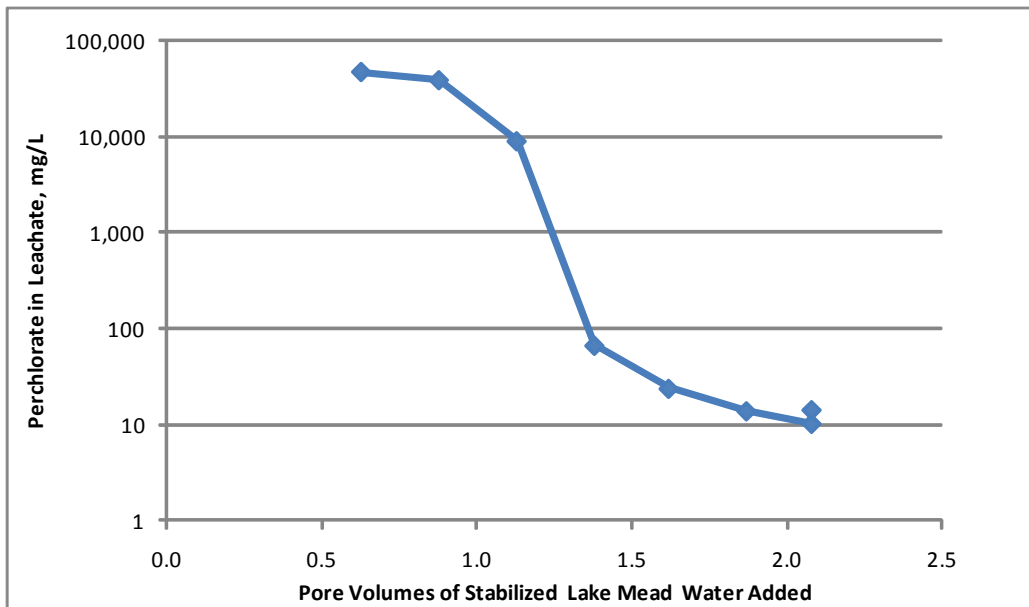
Figure 14. Perchlorate in Leachate. RSAM-5.

Sample ID	# pore volumes		Perchlorate in Effluent		Perchlorate Removed		
	Added	Collected	mg/L	g	sample	cummulative	
					% of total*	g	%
S1	0.63	0.15	46,900	79.7	41.6	80	42
S2	0.88	0.38	38,500	104	54.0	183	96
S3	1.13	0.62	8,920	24.7	13	208	108
S4	1.38	0.86	66.8	0.189	0.10	208	109
S5	1.62	1.08	23.8	0.0620	0.032	208	109
S6	1.87	1.32	13.9	0.0379	0.020	208	109
S7	2.08	1.54	10.3	0.0265	0.014	208	109
S8	2.08	1.62	14.3	0.0132	0.007	208	109

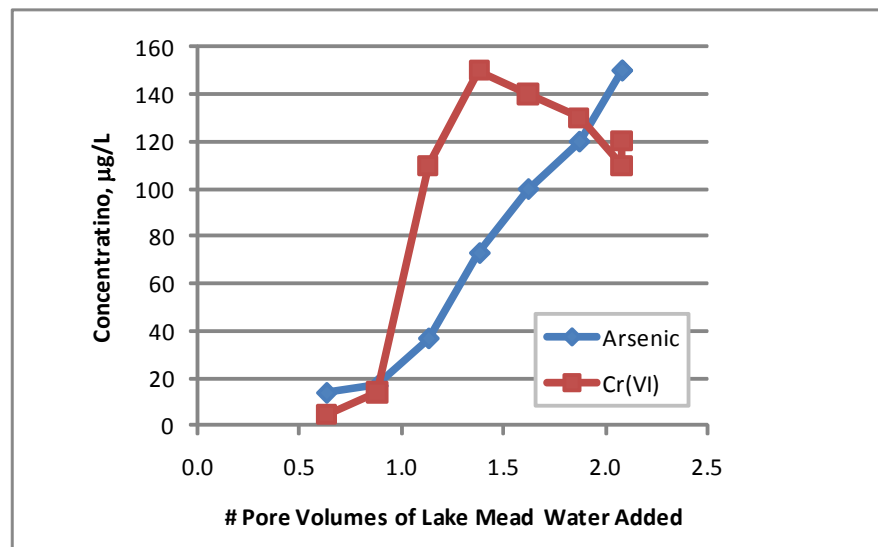
Figure 15. Arsenic and Cr(VI) in Leachate. RSAM-5.

probably due to some uncertainty in the initial concentration. The concentrations of arsenic and Cr(VI) in leachate samples are shown in Figure 15.

Sample ID	# Pore Volumes Added	Leachate Concentration	
		Arsenic	Cr(VI)
		mg/L	µg/L
S1	0.63	14	4.5 J
S2	0.88	17	14
S3	1.13	37	110
S4	1.38	73	150
S5	1.62	100	140
S6	1.87	120	130^
S7	2.08	150	110^
S8	2.08	150	120
