Prepared by
Ramboll Environ
Emeryville, California

SITE MANAGEMENT PLAN, REVISION 2

Nevada Environmental Response Trust Site

Henderson, Nevada

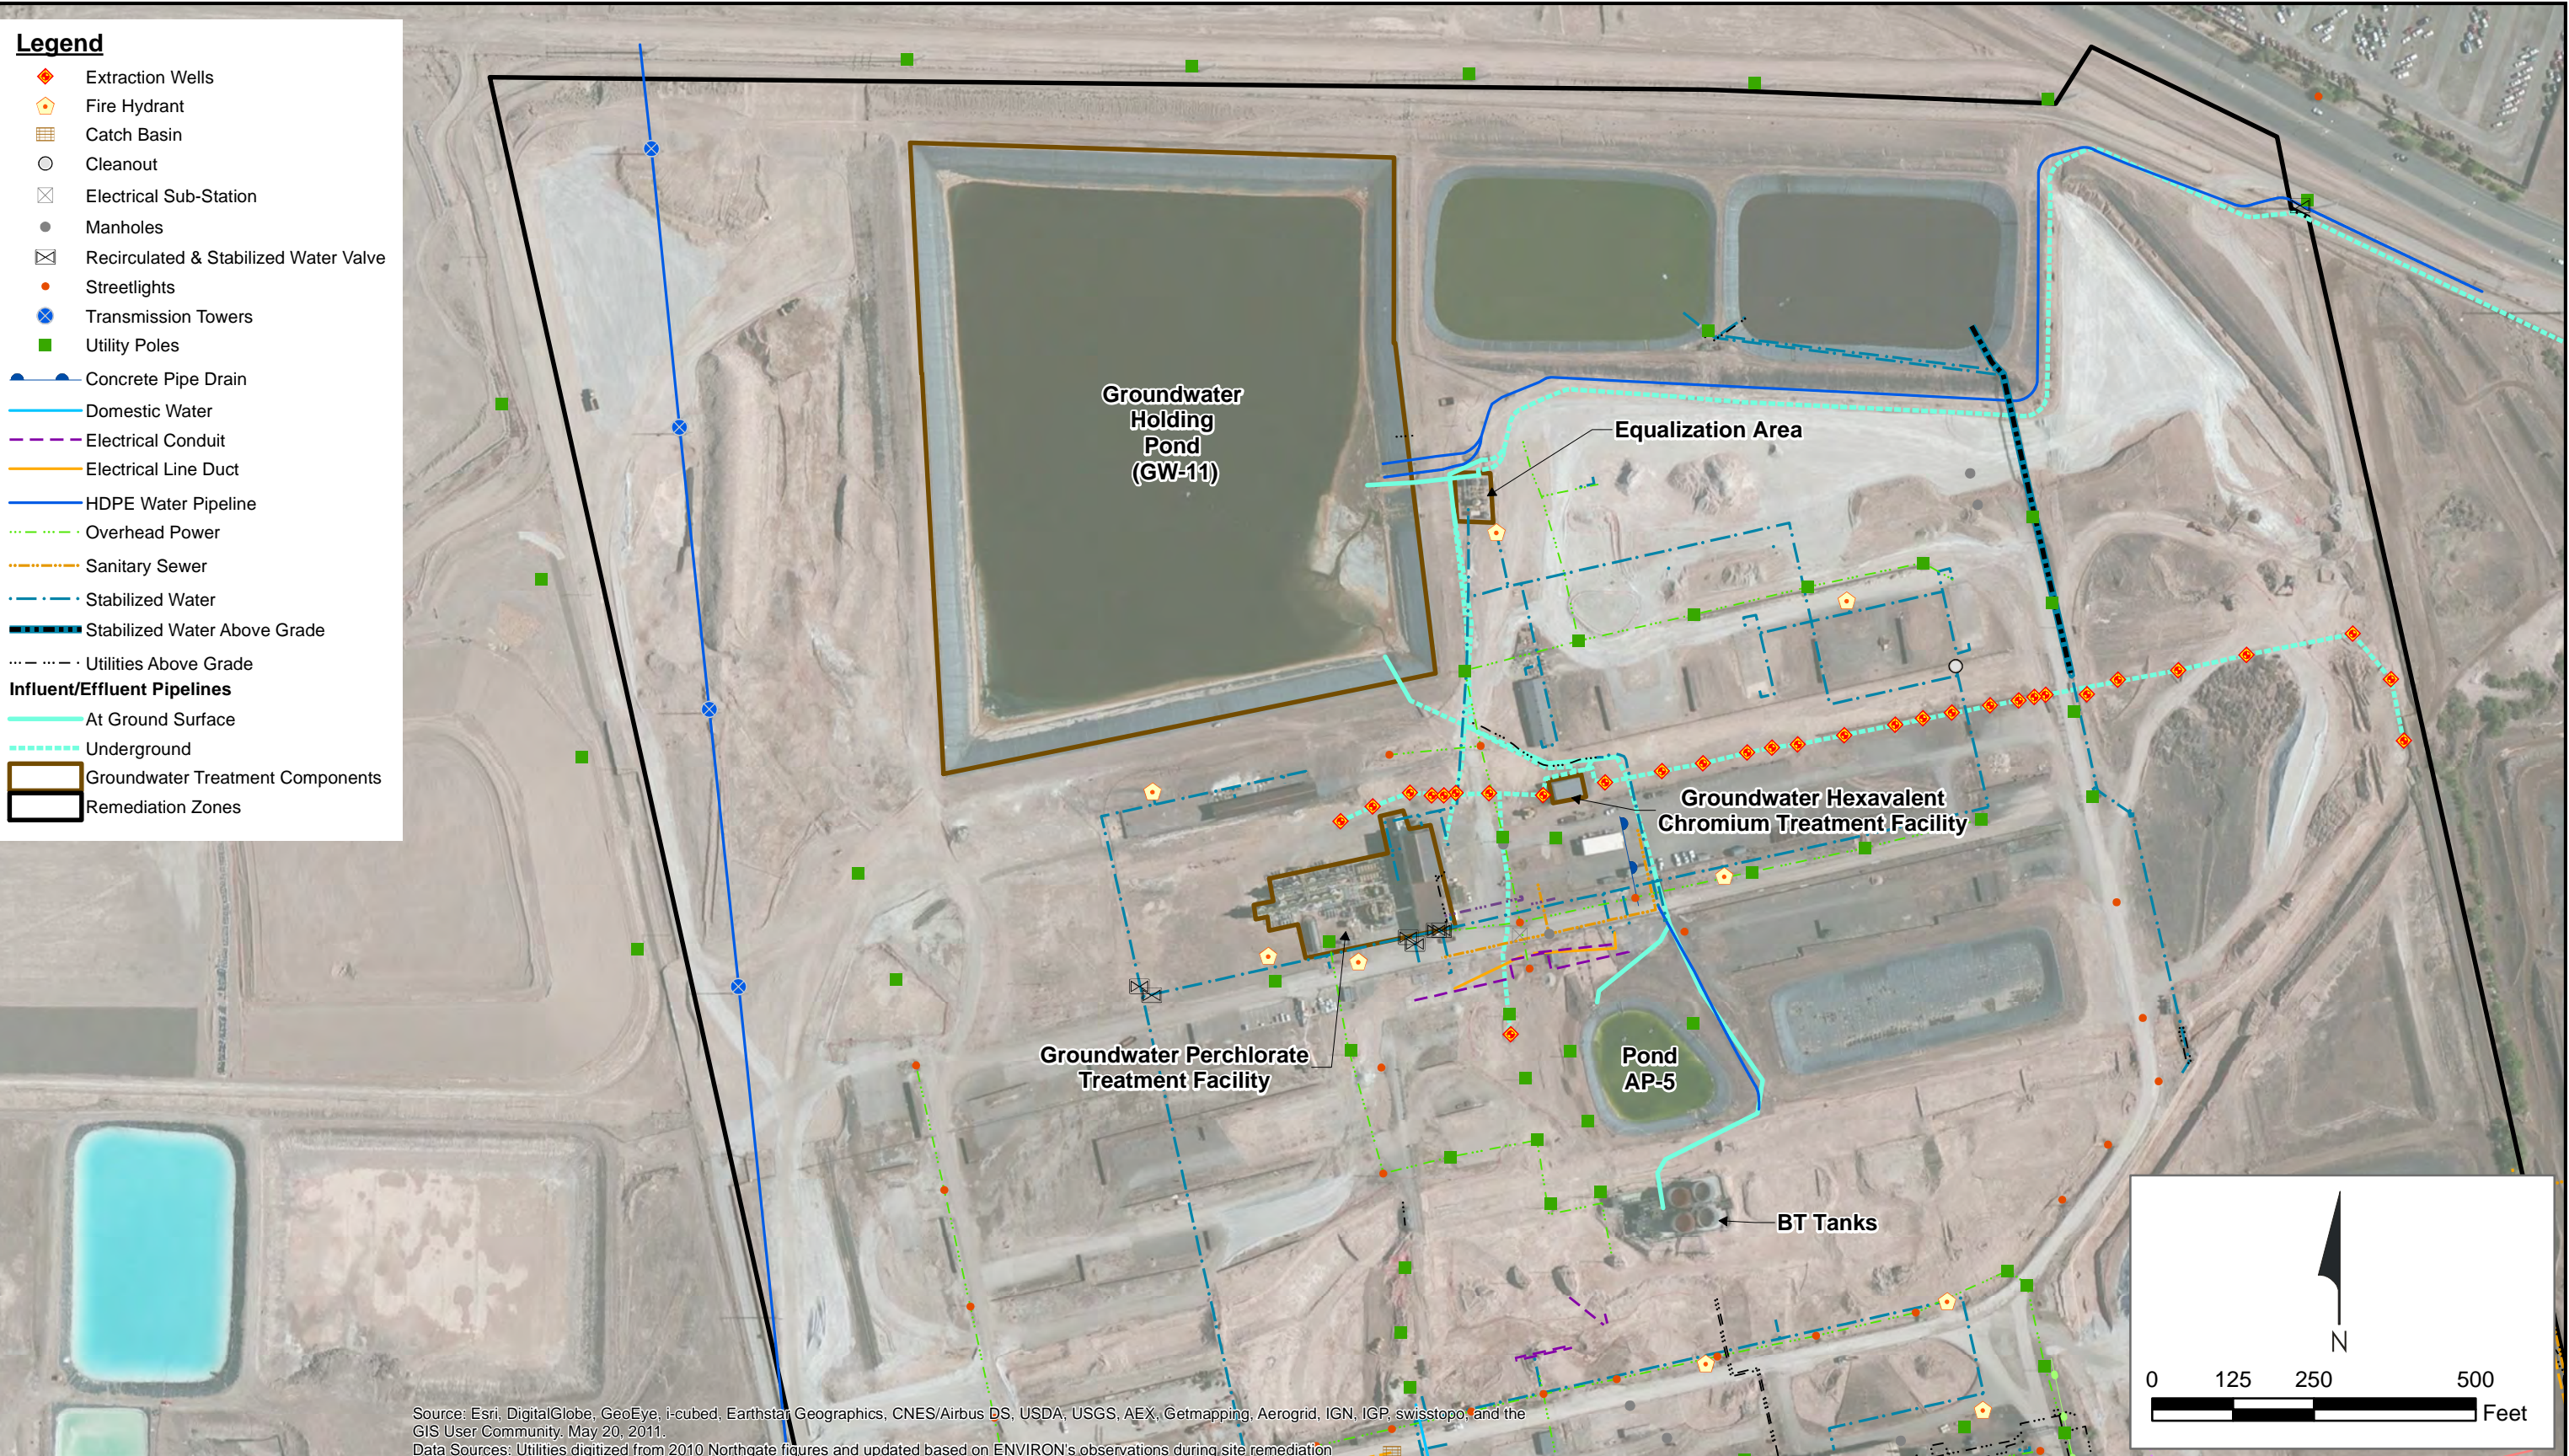
Source: Esri, DigitalGlobe, GeoEye, i-cubed, Earthstar Geographics, CNES/Airbus DS, USDA, USGS, AEX, Getmapping, Aerogrid, IGN, IGP, swisstopo, and the GIS User Community, May 20, 2011.
 Data Sources: Utilities digitized from 2010 Northgate figures and updated based on ENVIRON's observations during site remediation

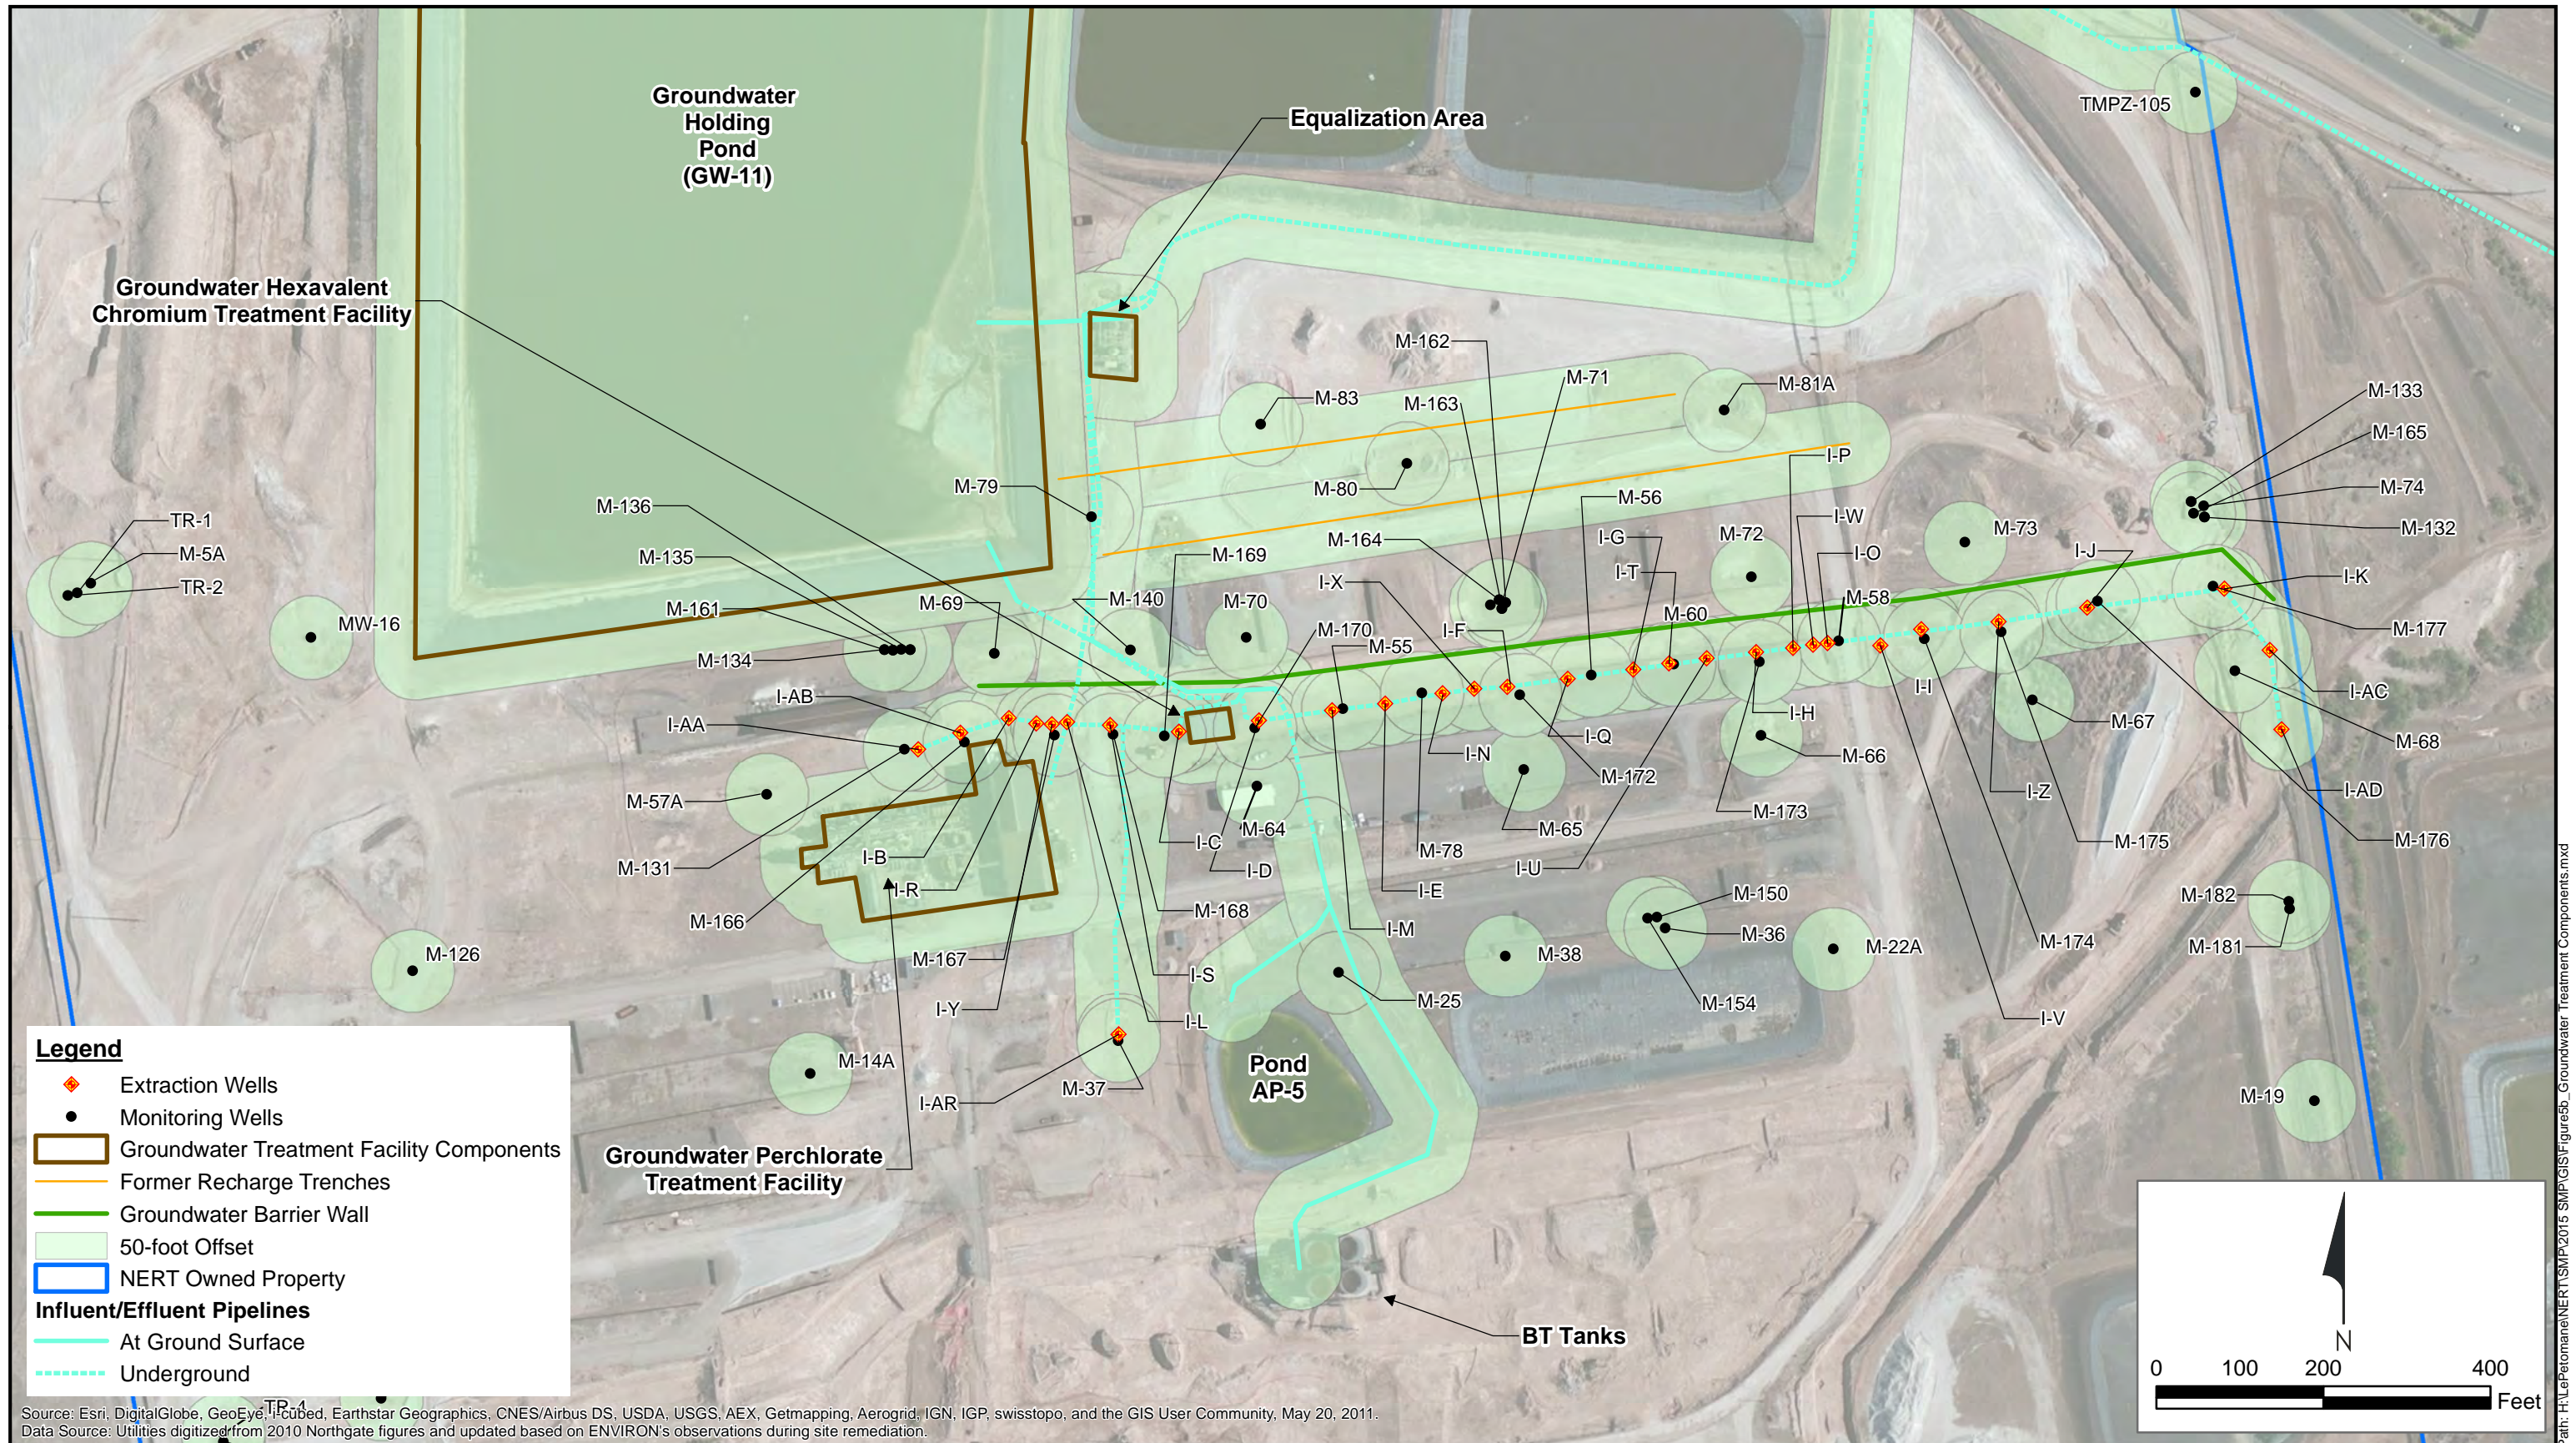
Figure
5b

On-Site Groundwater Monitoring, Extraction, and Treatment Systems - Inset from Figure 5a
 Nevada Environmental Response Trust Site, Henderson, Nevada

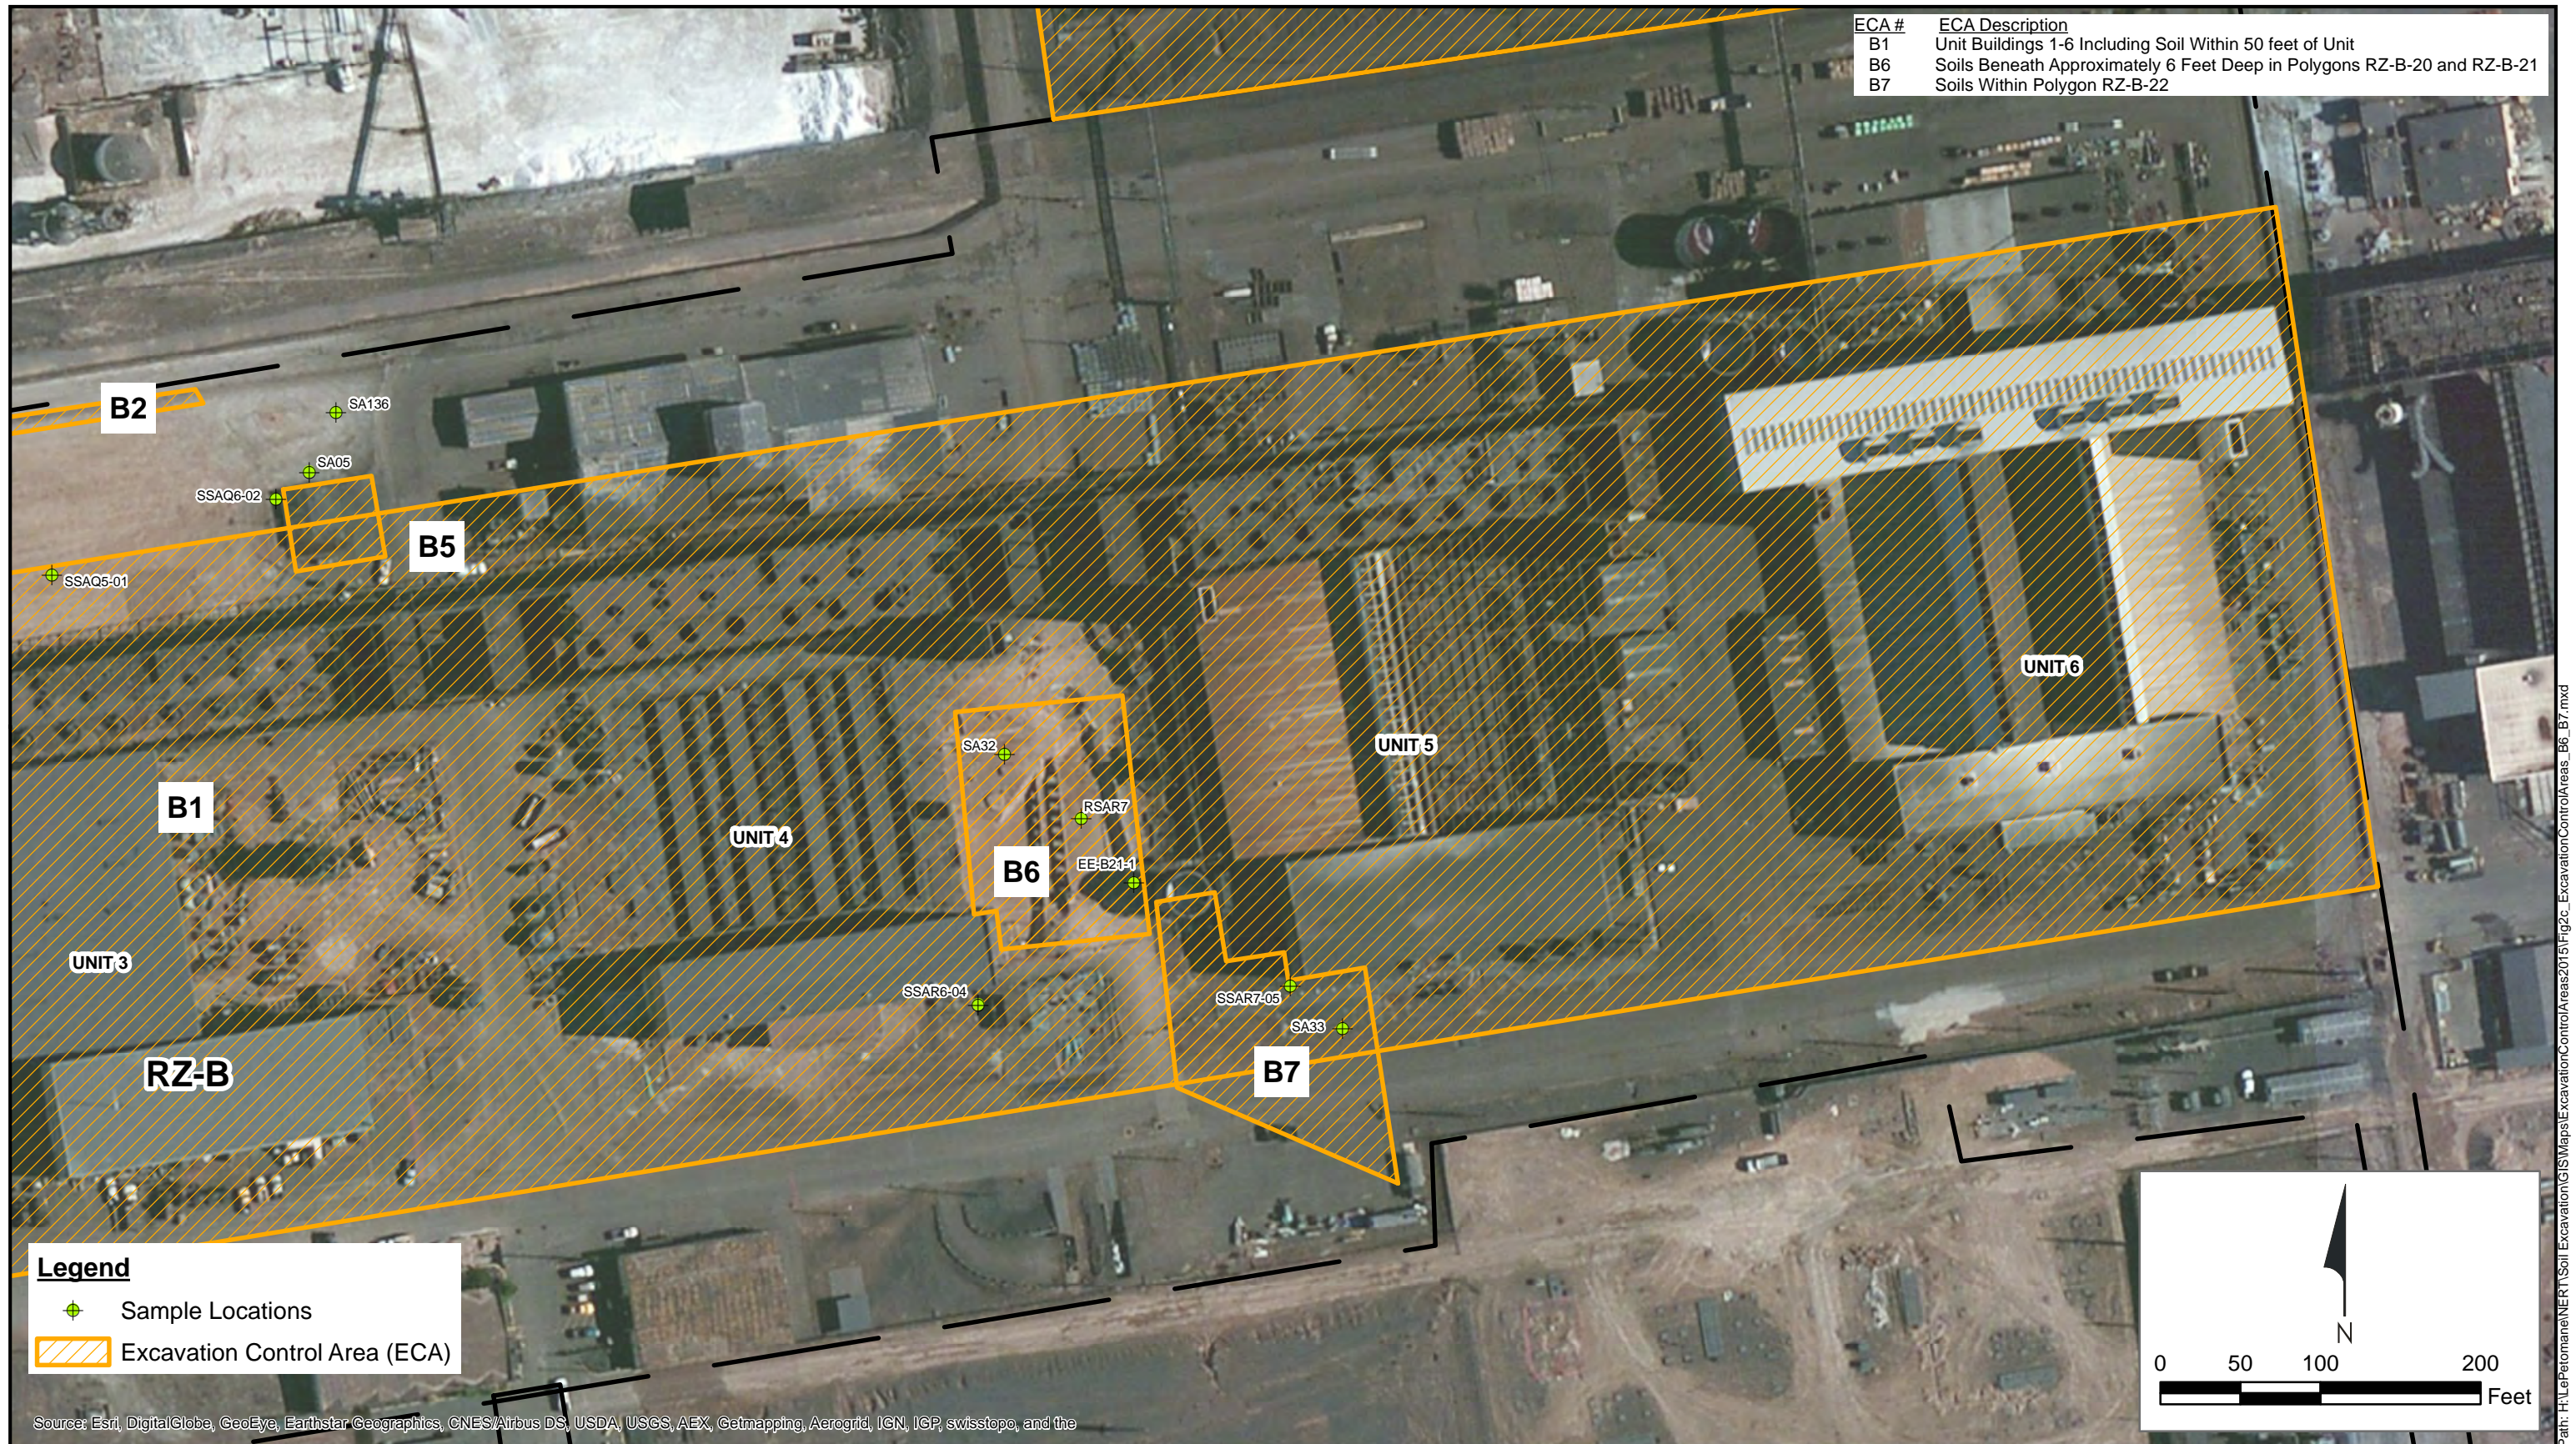
ECA #	ECA Description
B1	Unit Buildings 1-6 Including Soil Within 50 feet of Unit
B6	Soils Beneath Approximately 6 Feet Deep in Polygons RZ-B-20 and RZ-B-21
B7	Soils Within Polygon RZ-B-22

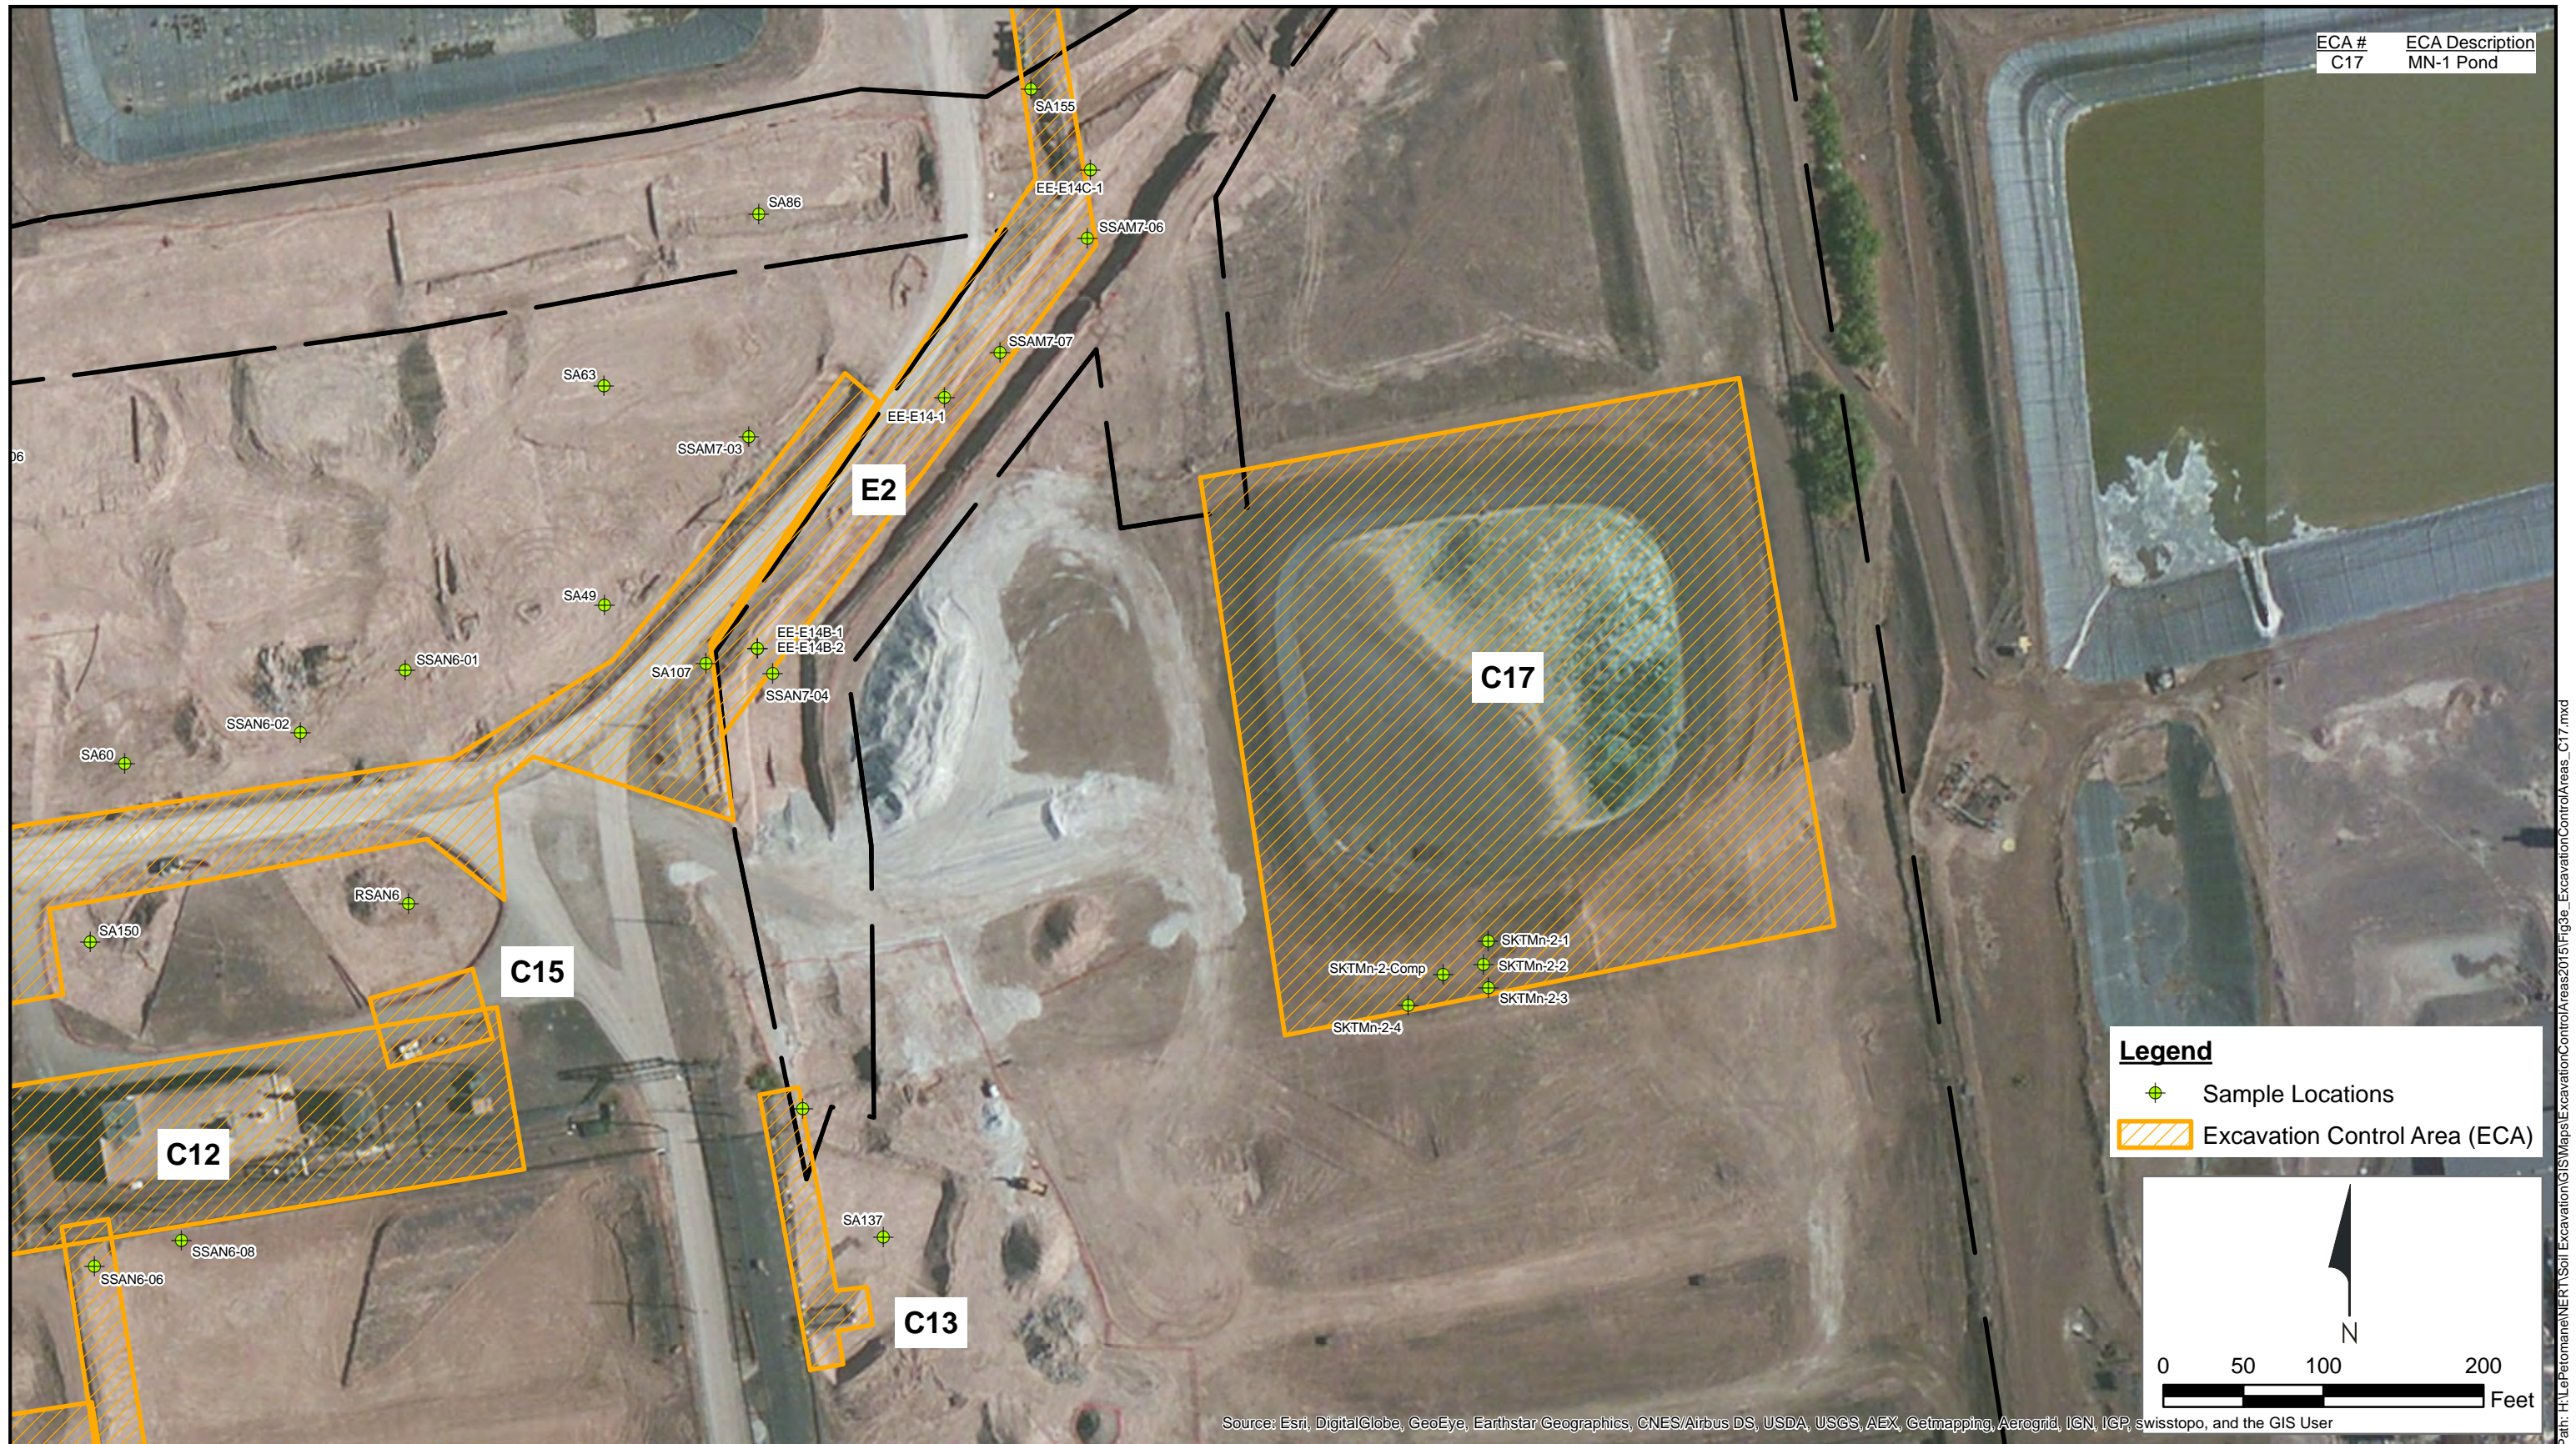
ECA #	ECA Description
C17	MN-1 Pond

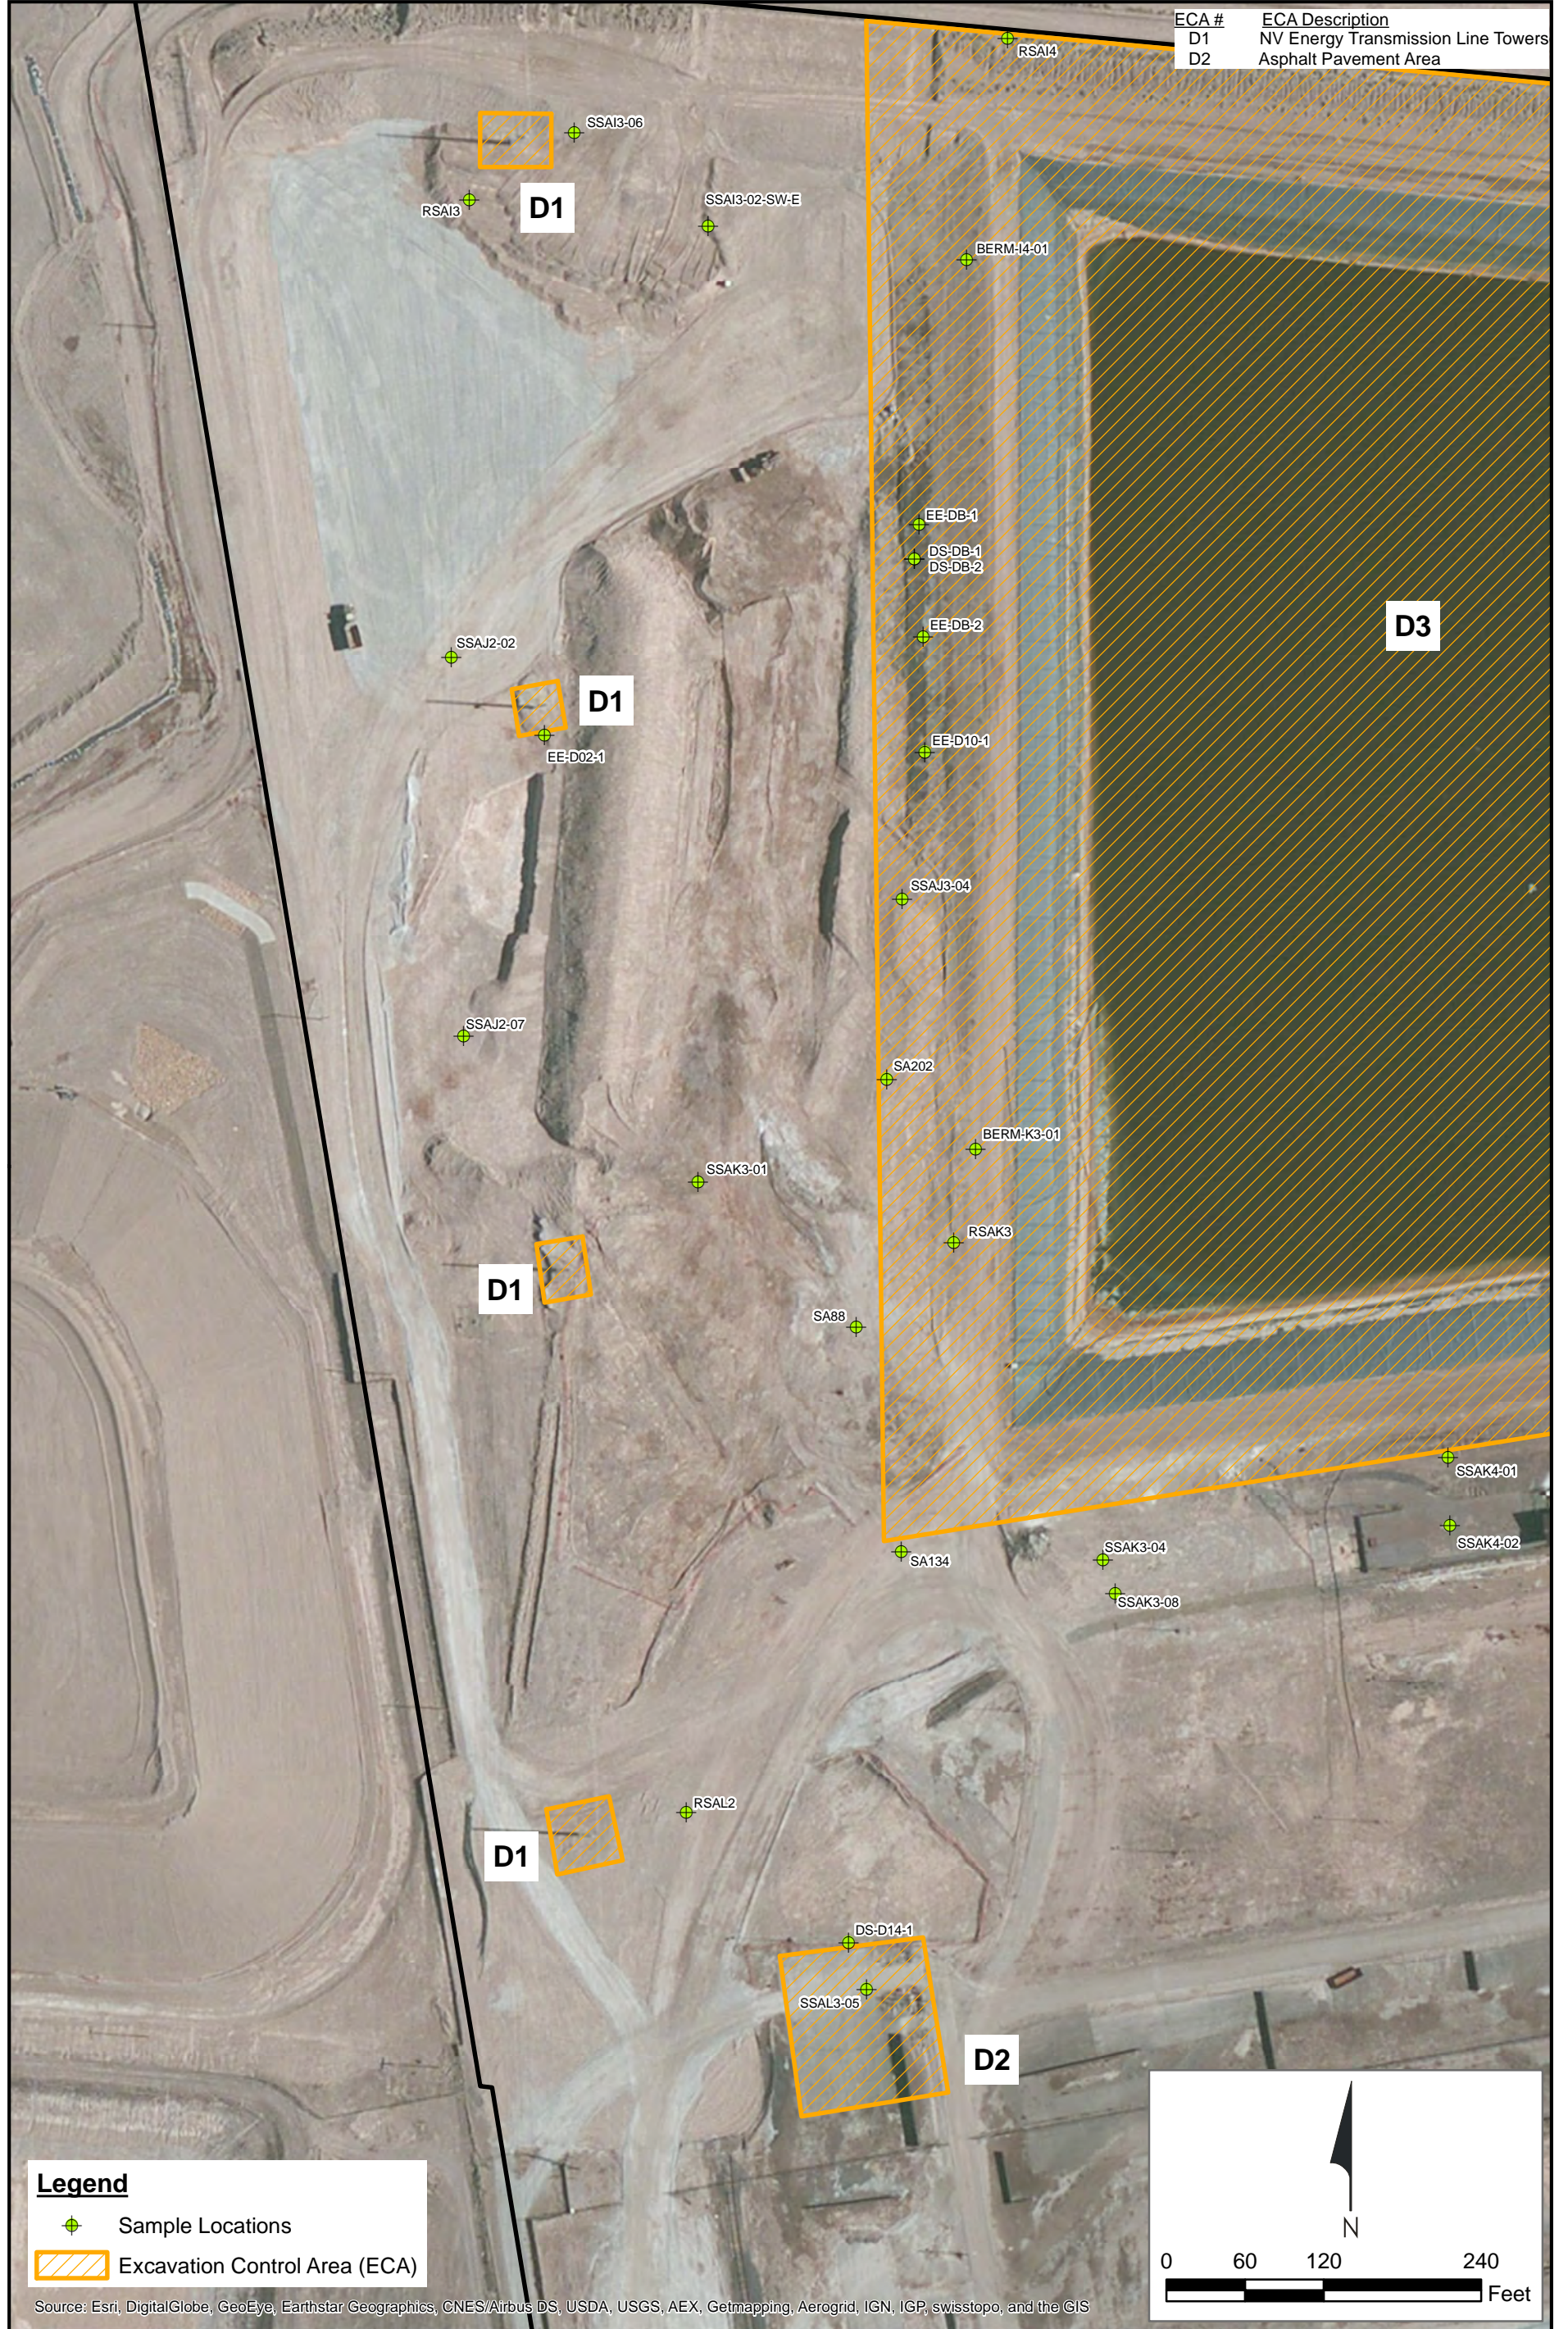
Figure
4b

Excavation Control Areas D1 and D2
 Nevada Environmental Response Trust Site, Henderson, Nevada

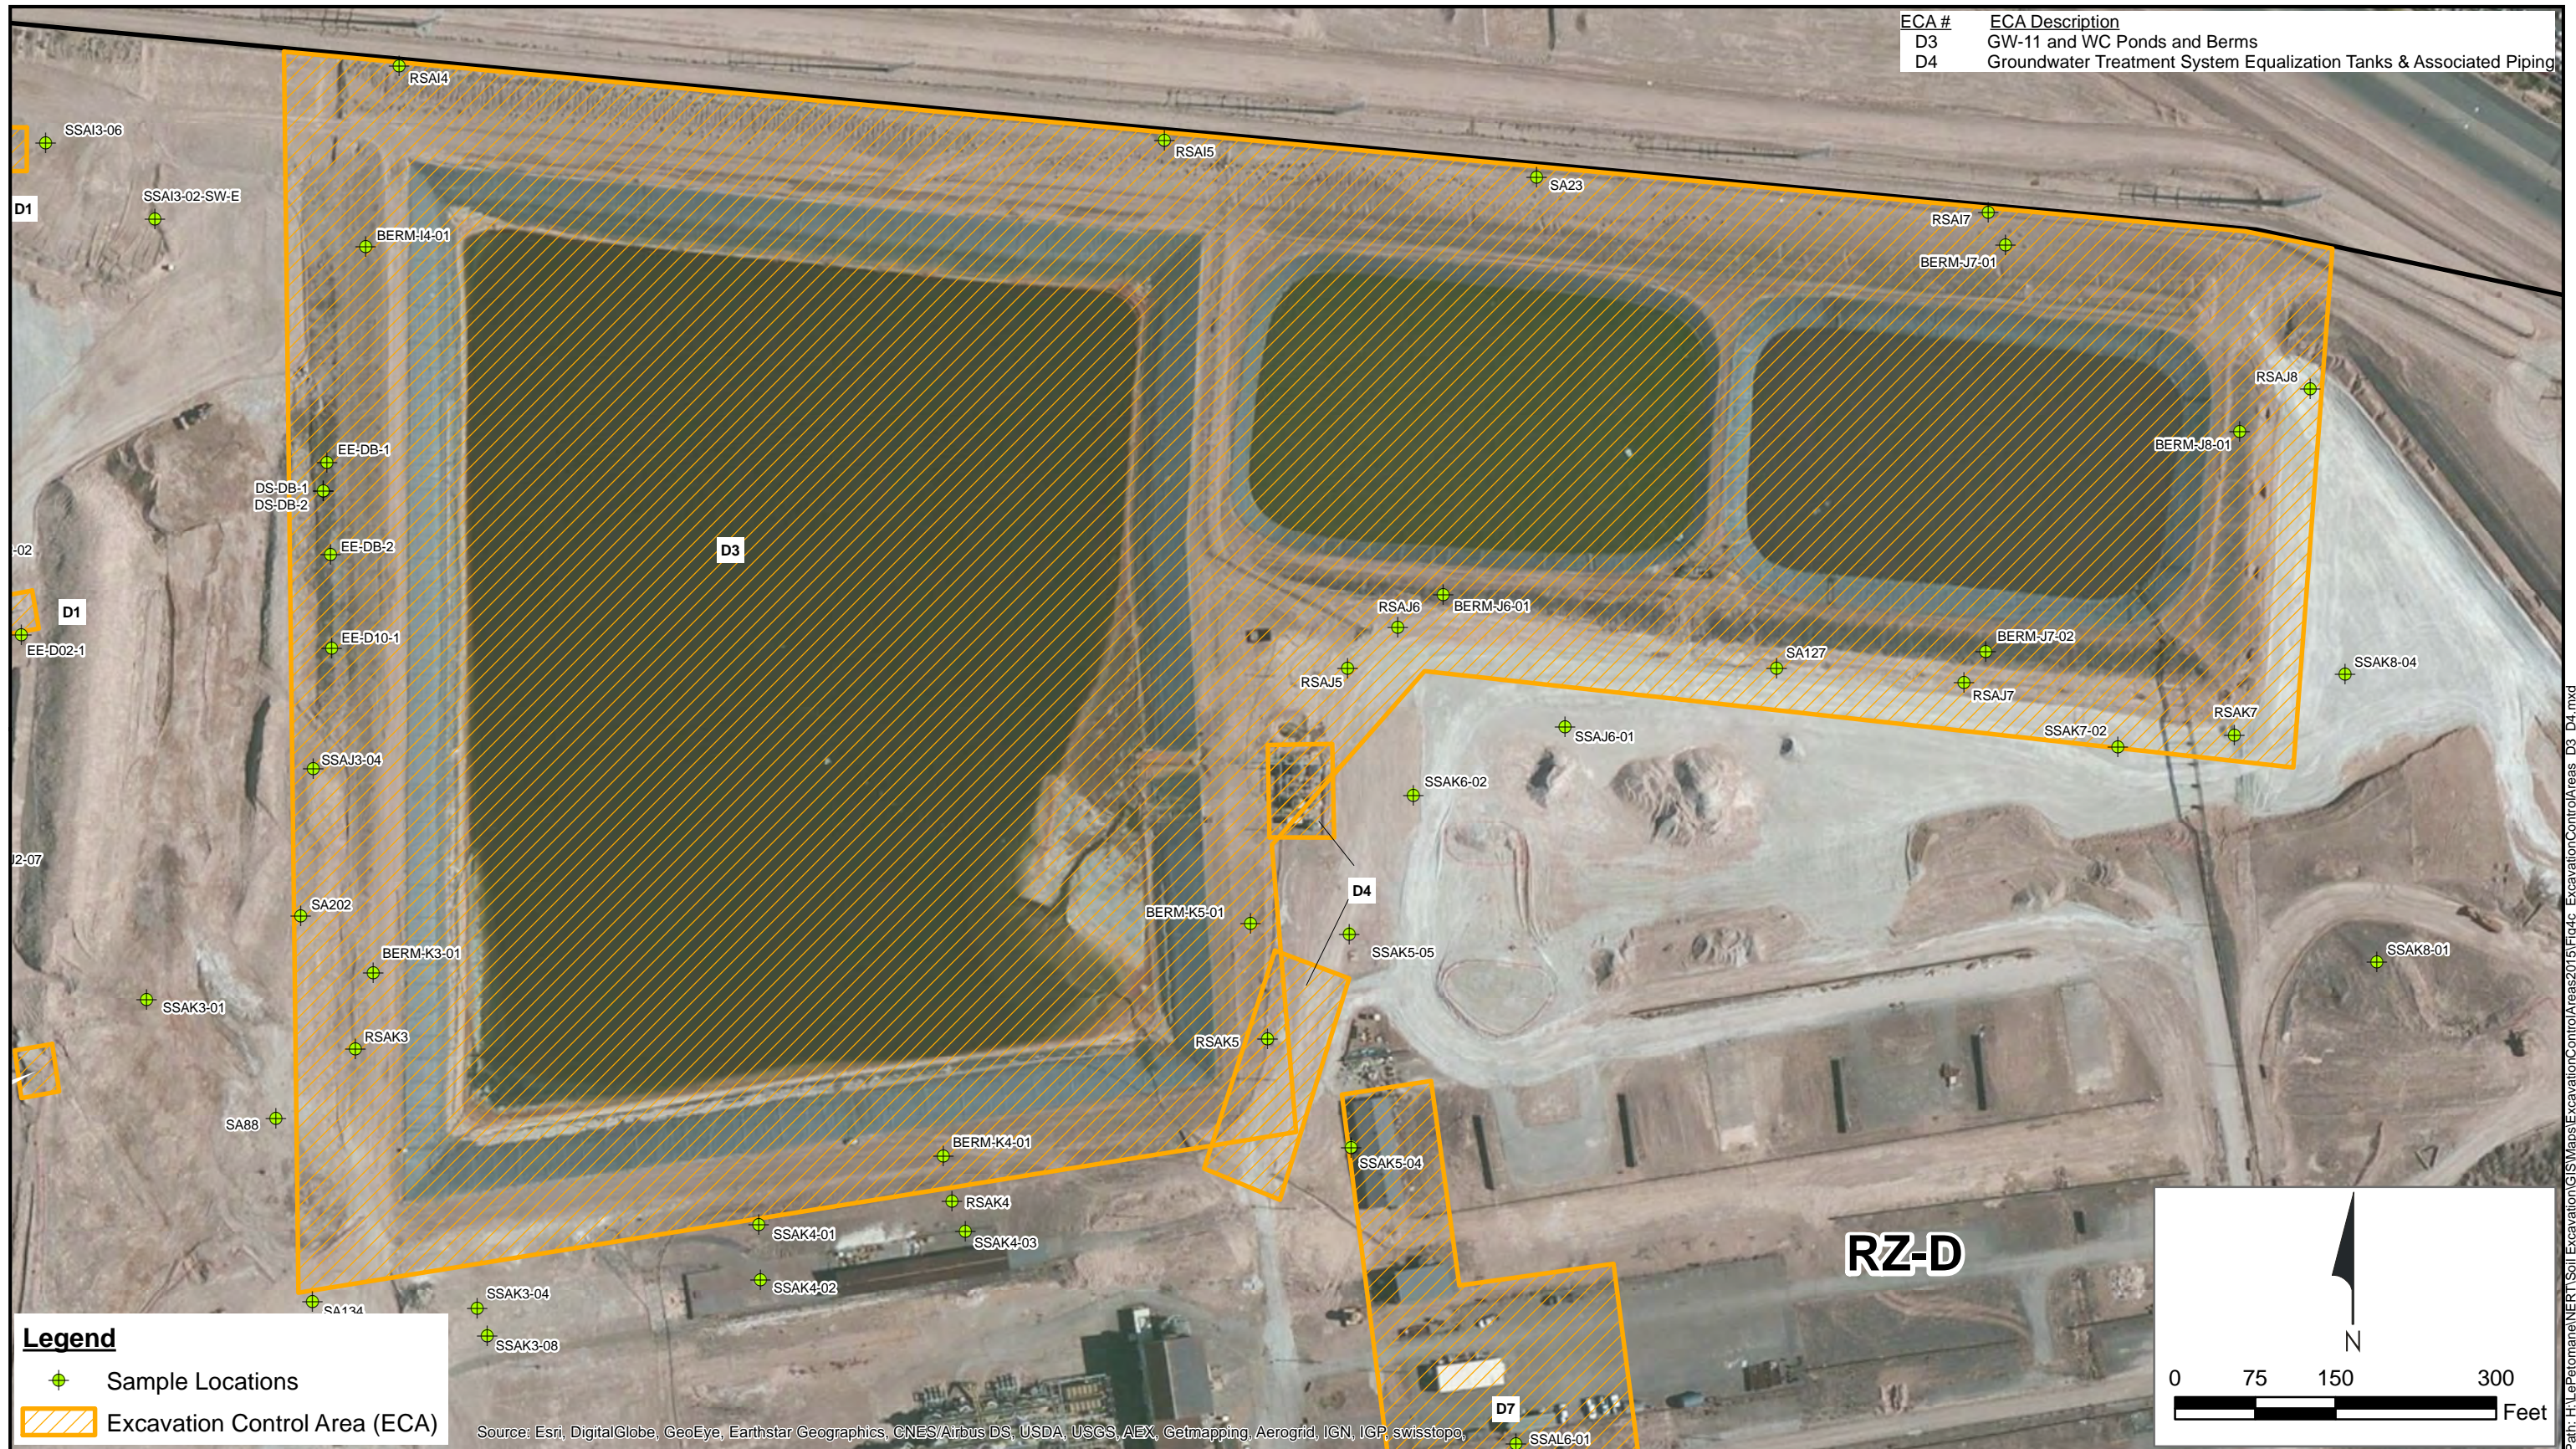
ECA #	ECA Description
D3	GW-11 and WC Ponds and Berms
D4	Groundwater Treatment System Equalization Tanks & Associated Piping
