Prepared by
Ramboll Environ
Emeryville, California

SITE MANAGEMENT PLAN, REVISION 2

Nevada Environmental Response Trust Site

Henderson, Nevada

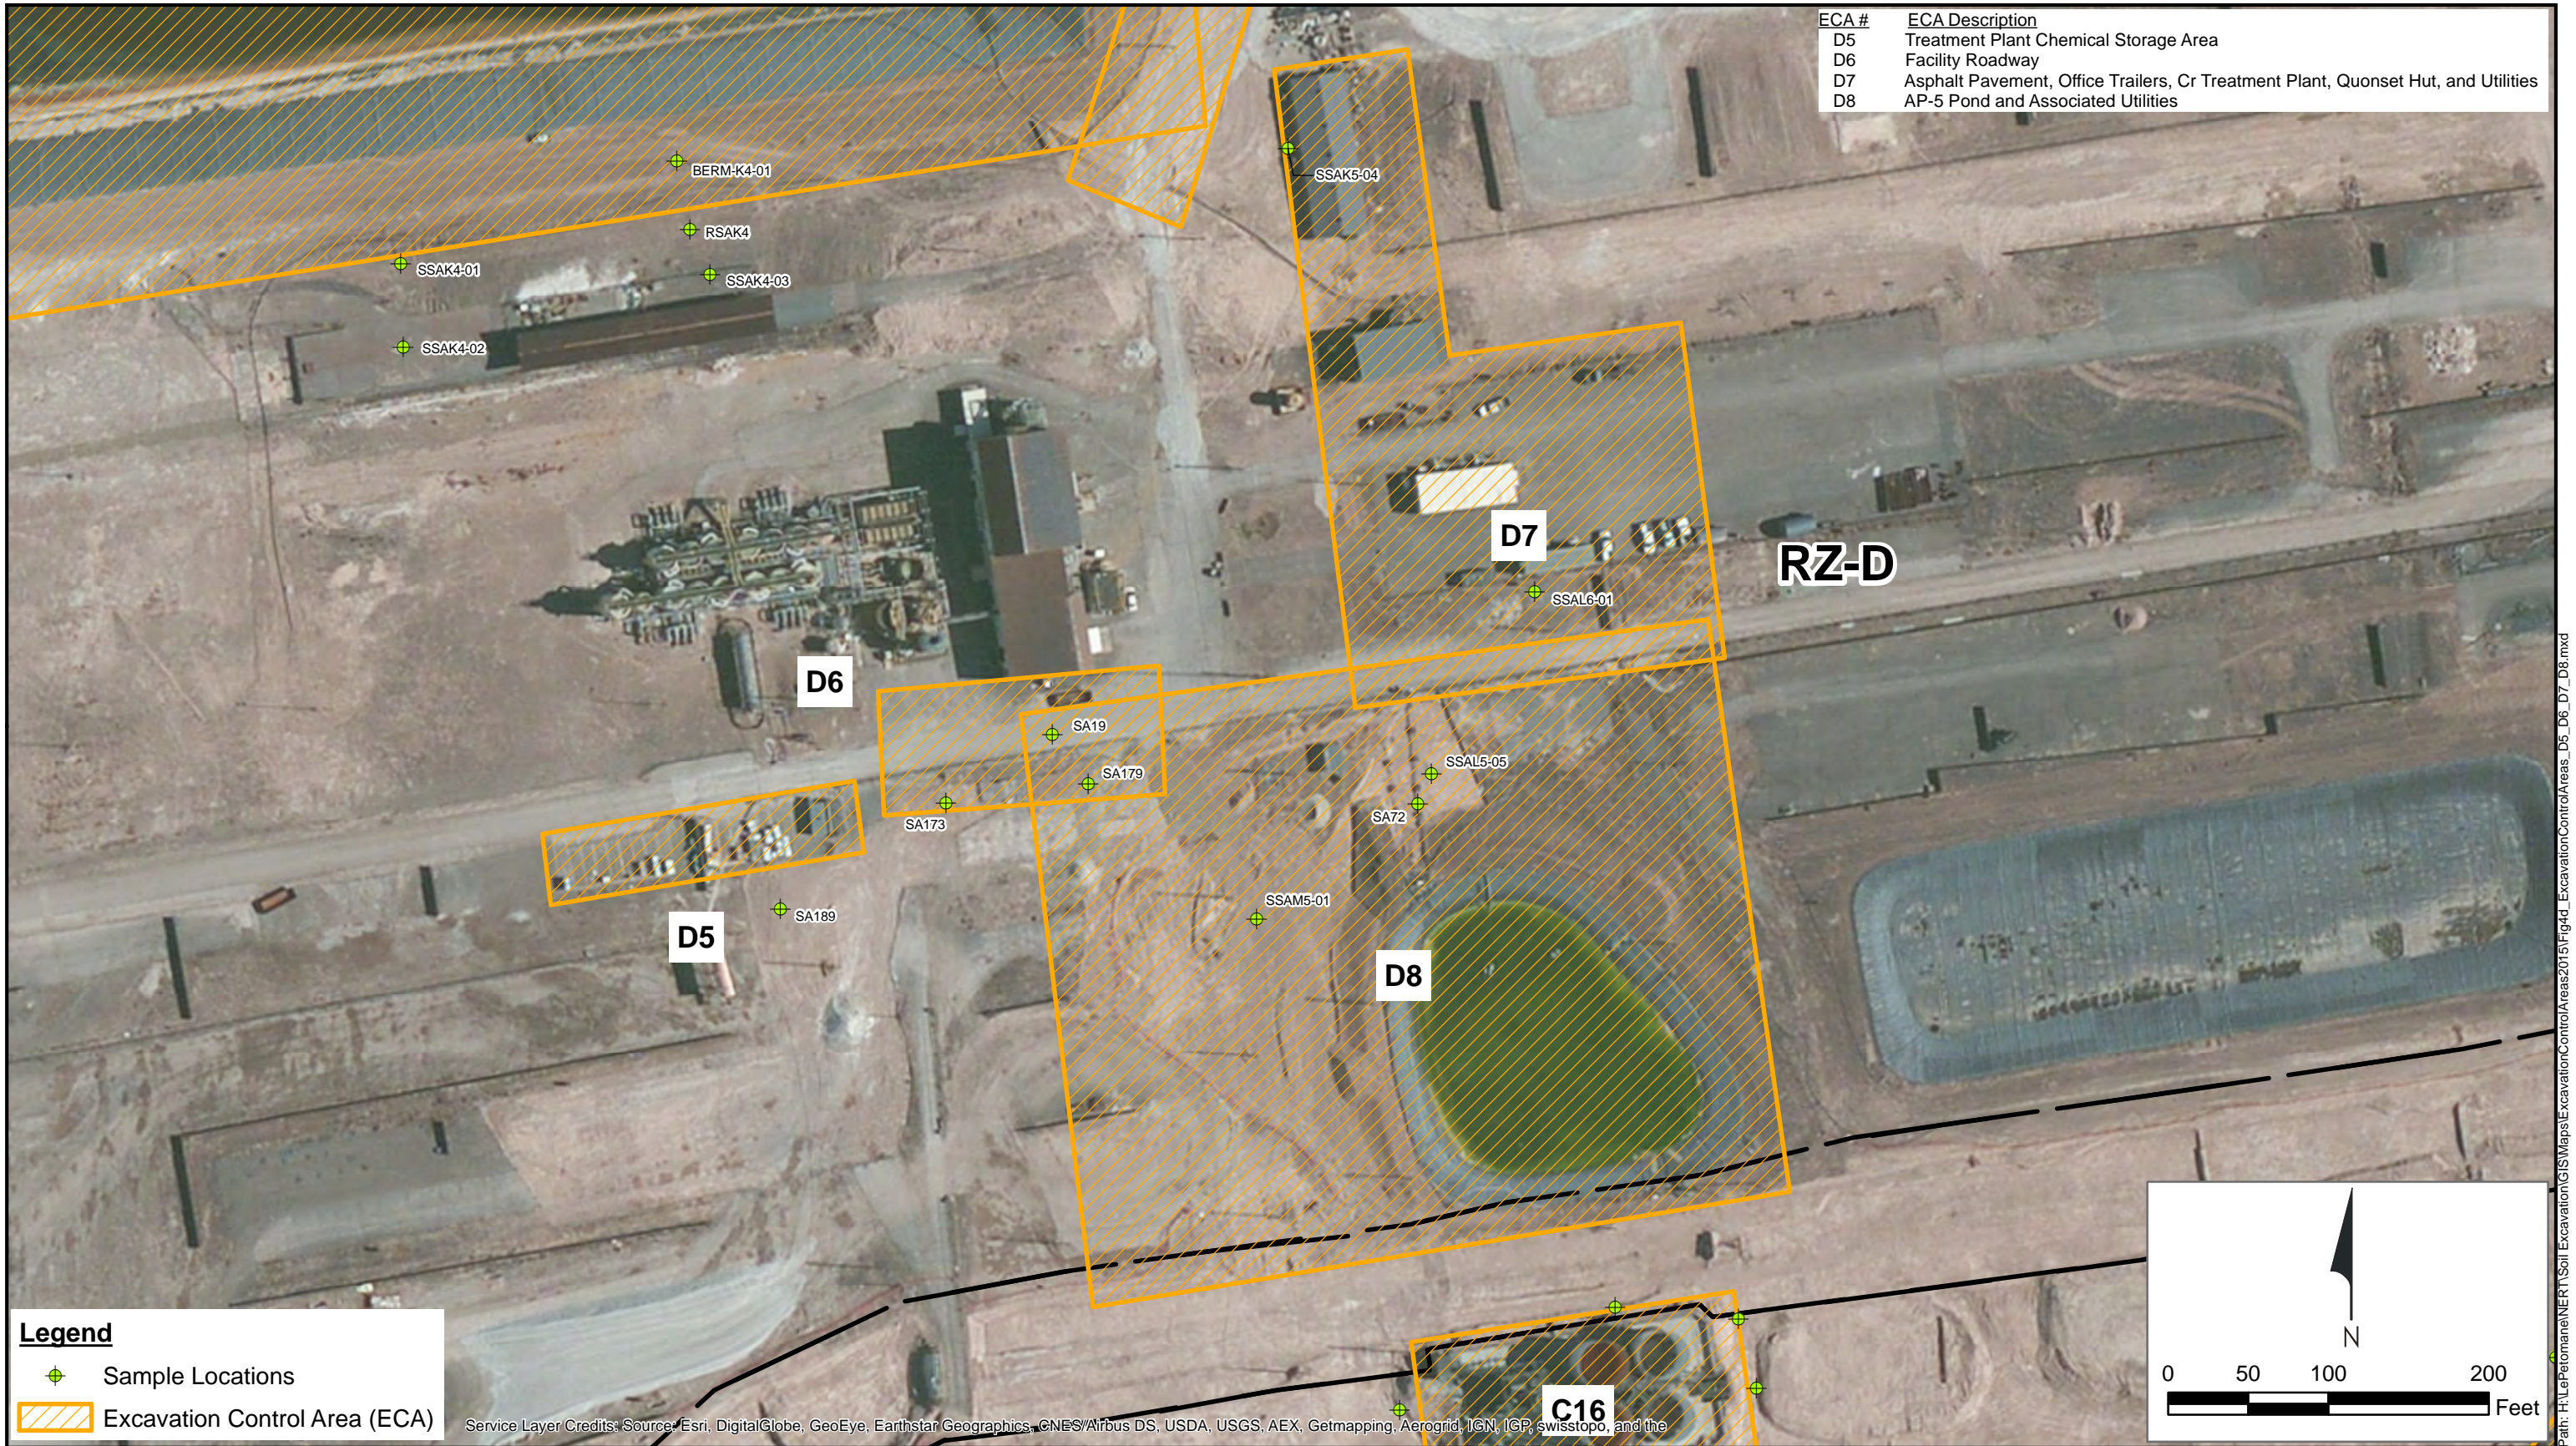
Figure
4d

ECA #	ECA Description
D5	Treatment Plant Chemical Storage Area
D6	Facility Roadway
D7	Asphalt Pavement, Office Trailers, Cr Treatment Plant, Quonset Hut, and Utilities
D8	AP-5 Pond and Associated Utilities

Excavation Control Areas D5, D6, D7, and D8
 Nevada Environmental Response Trust Site, Henderson, Nevada

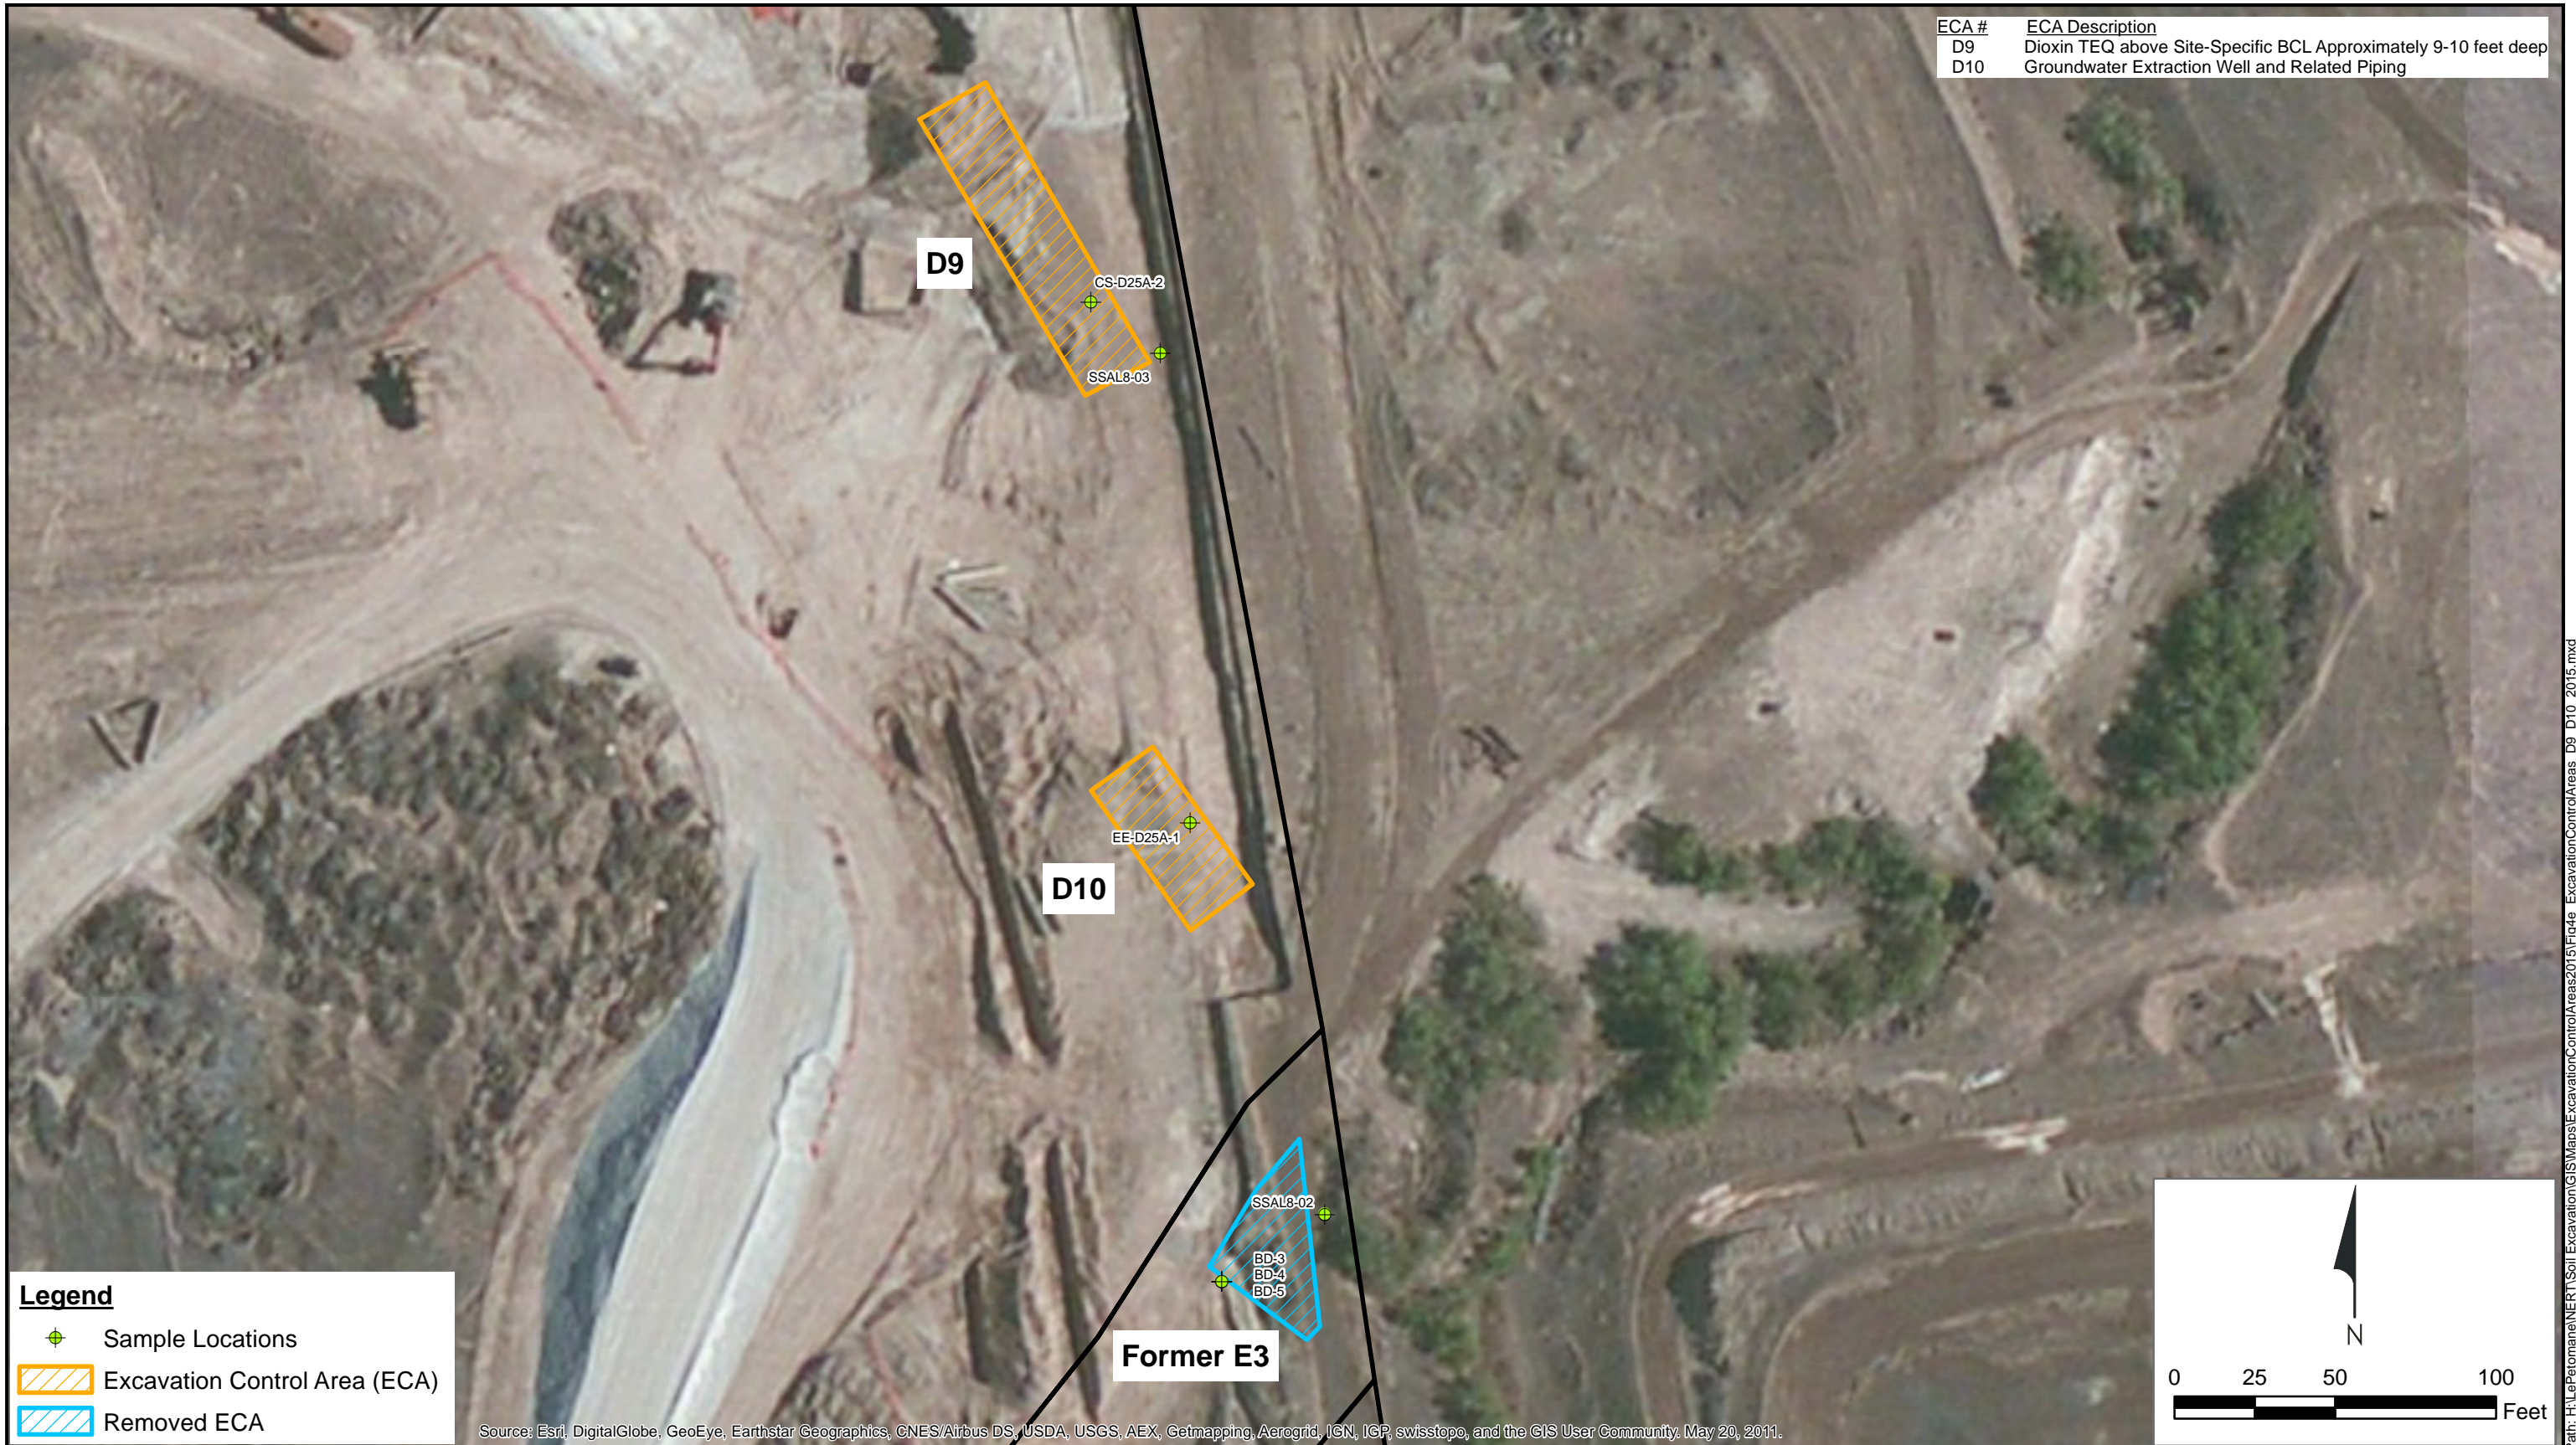
Figure
4e

ECA #	ECA Description
D9	Dioxin TEQ above Site-Specific BCL Approximately 9-10 feet deep
D10	Groundwater Extraction Well and Related Piping

Excavation Control Areas D9 and D10
 Nevada Environmental Response Trust Site, Henderson, Nevada

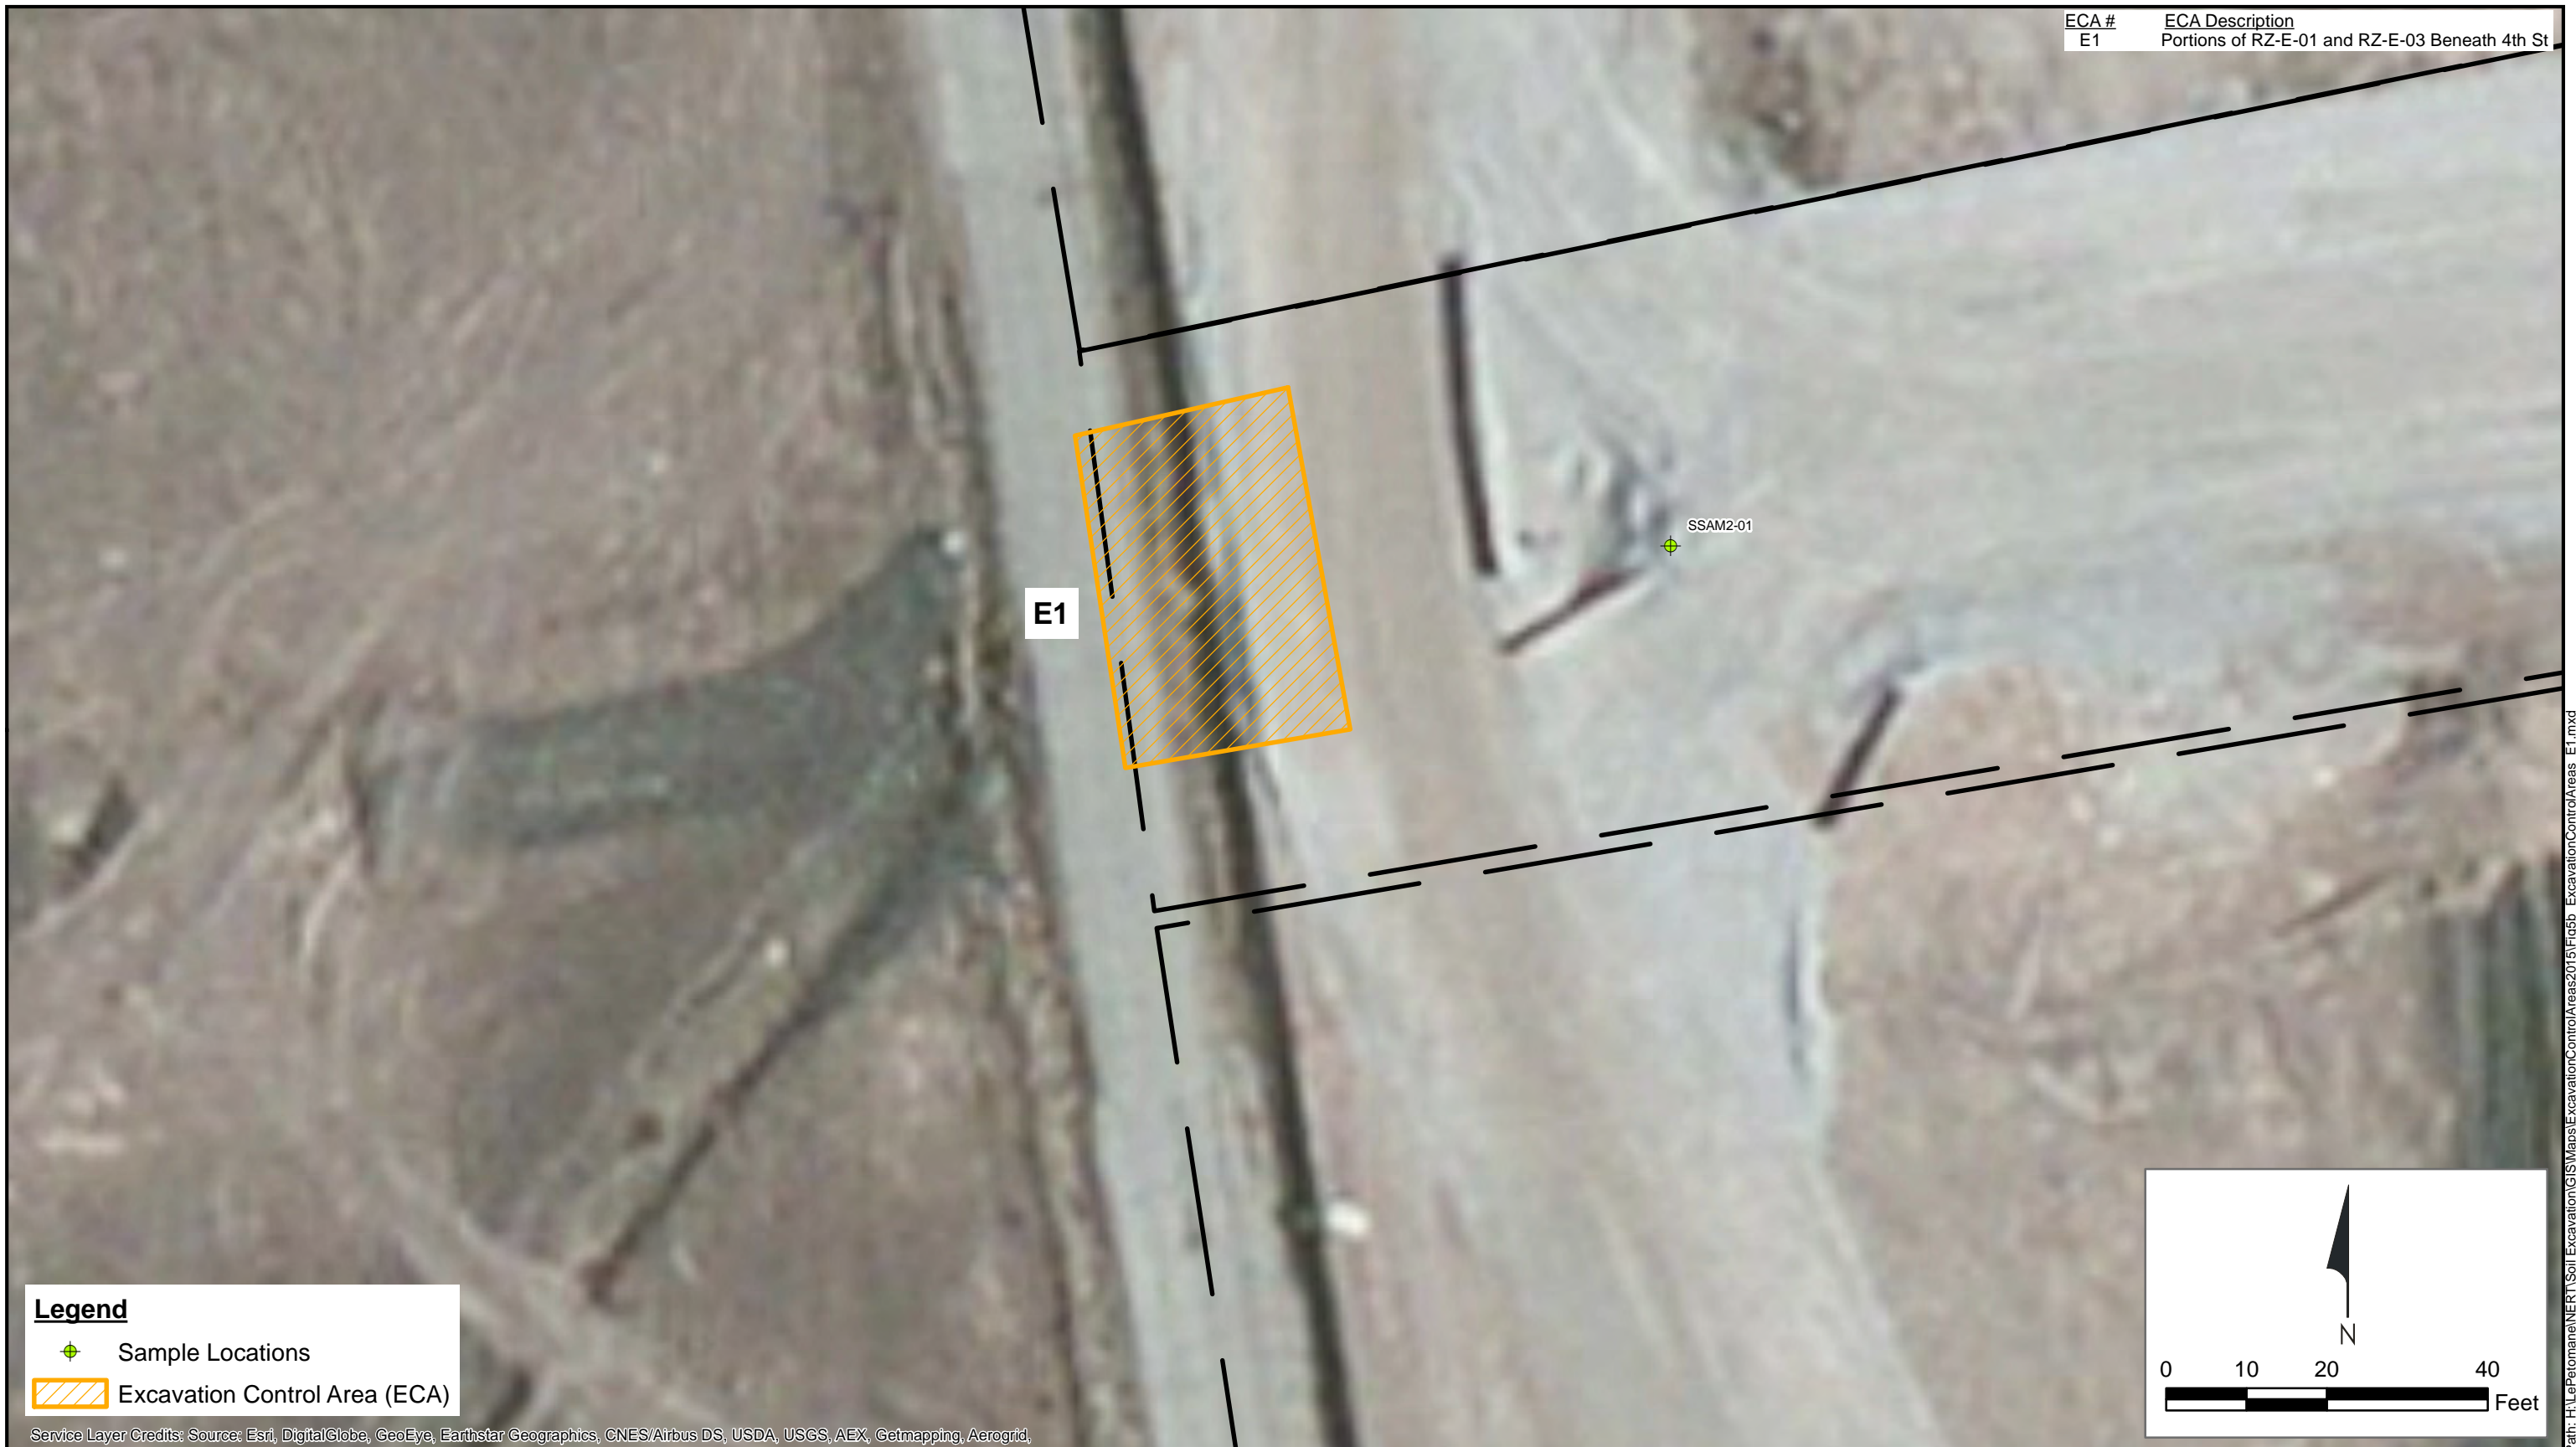
ECA #	ECA Description
E1	Portions of RZ-E-01 and RZ-E-03 Beneath 4th St

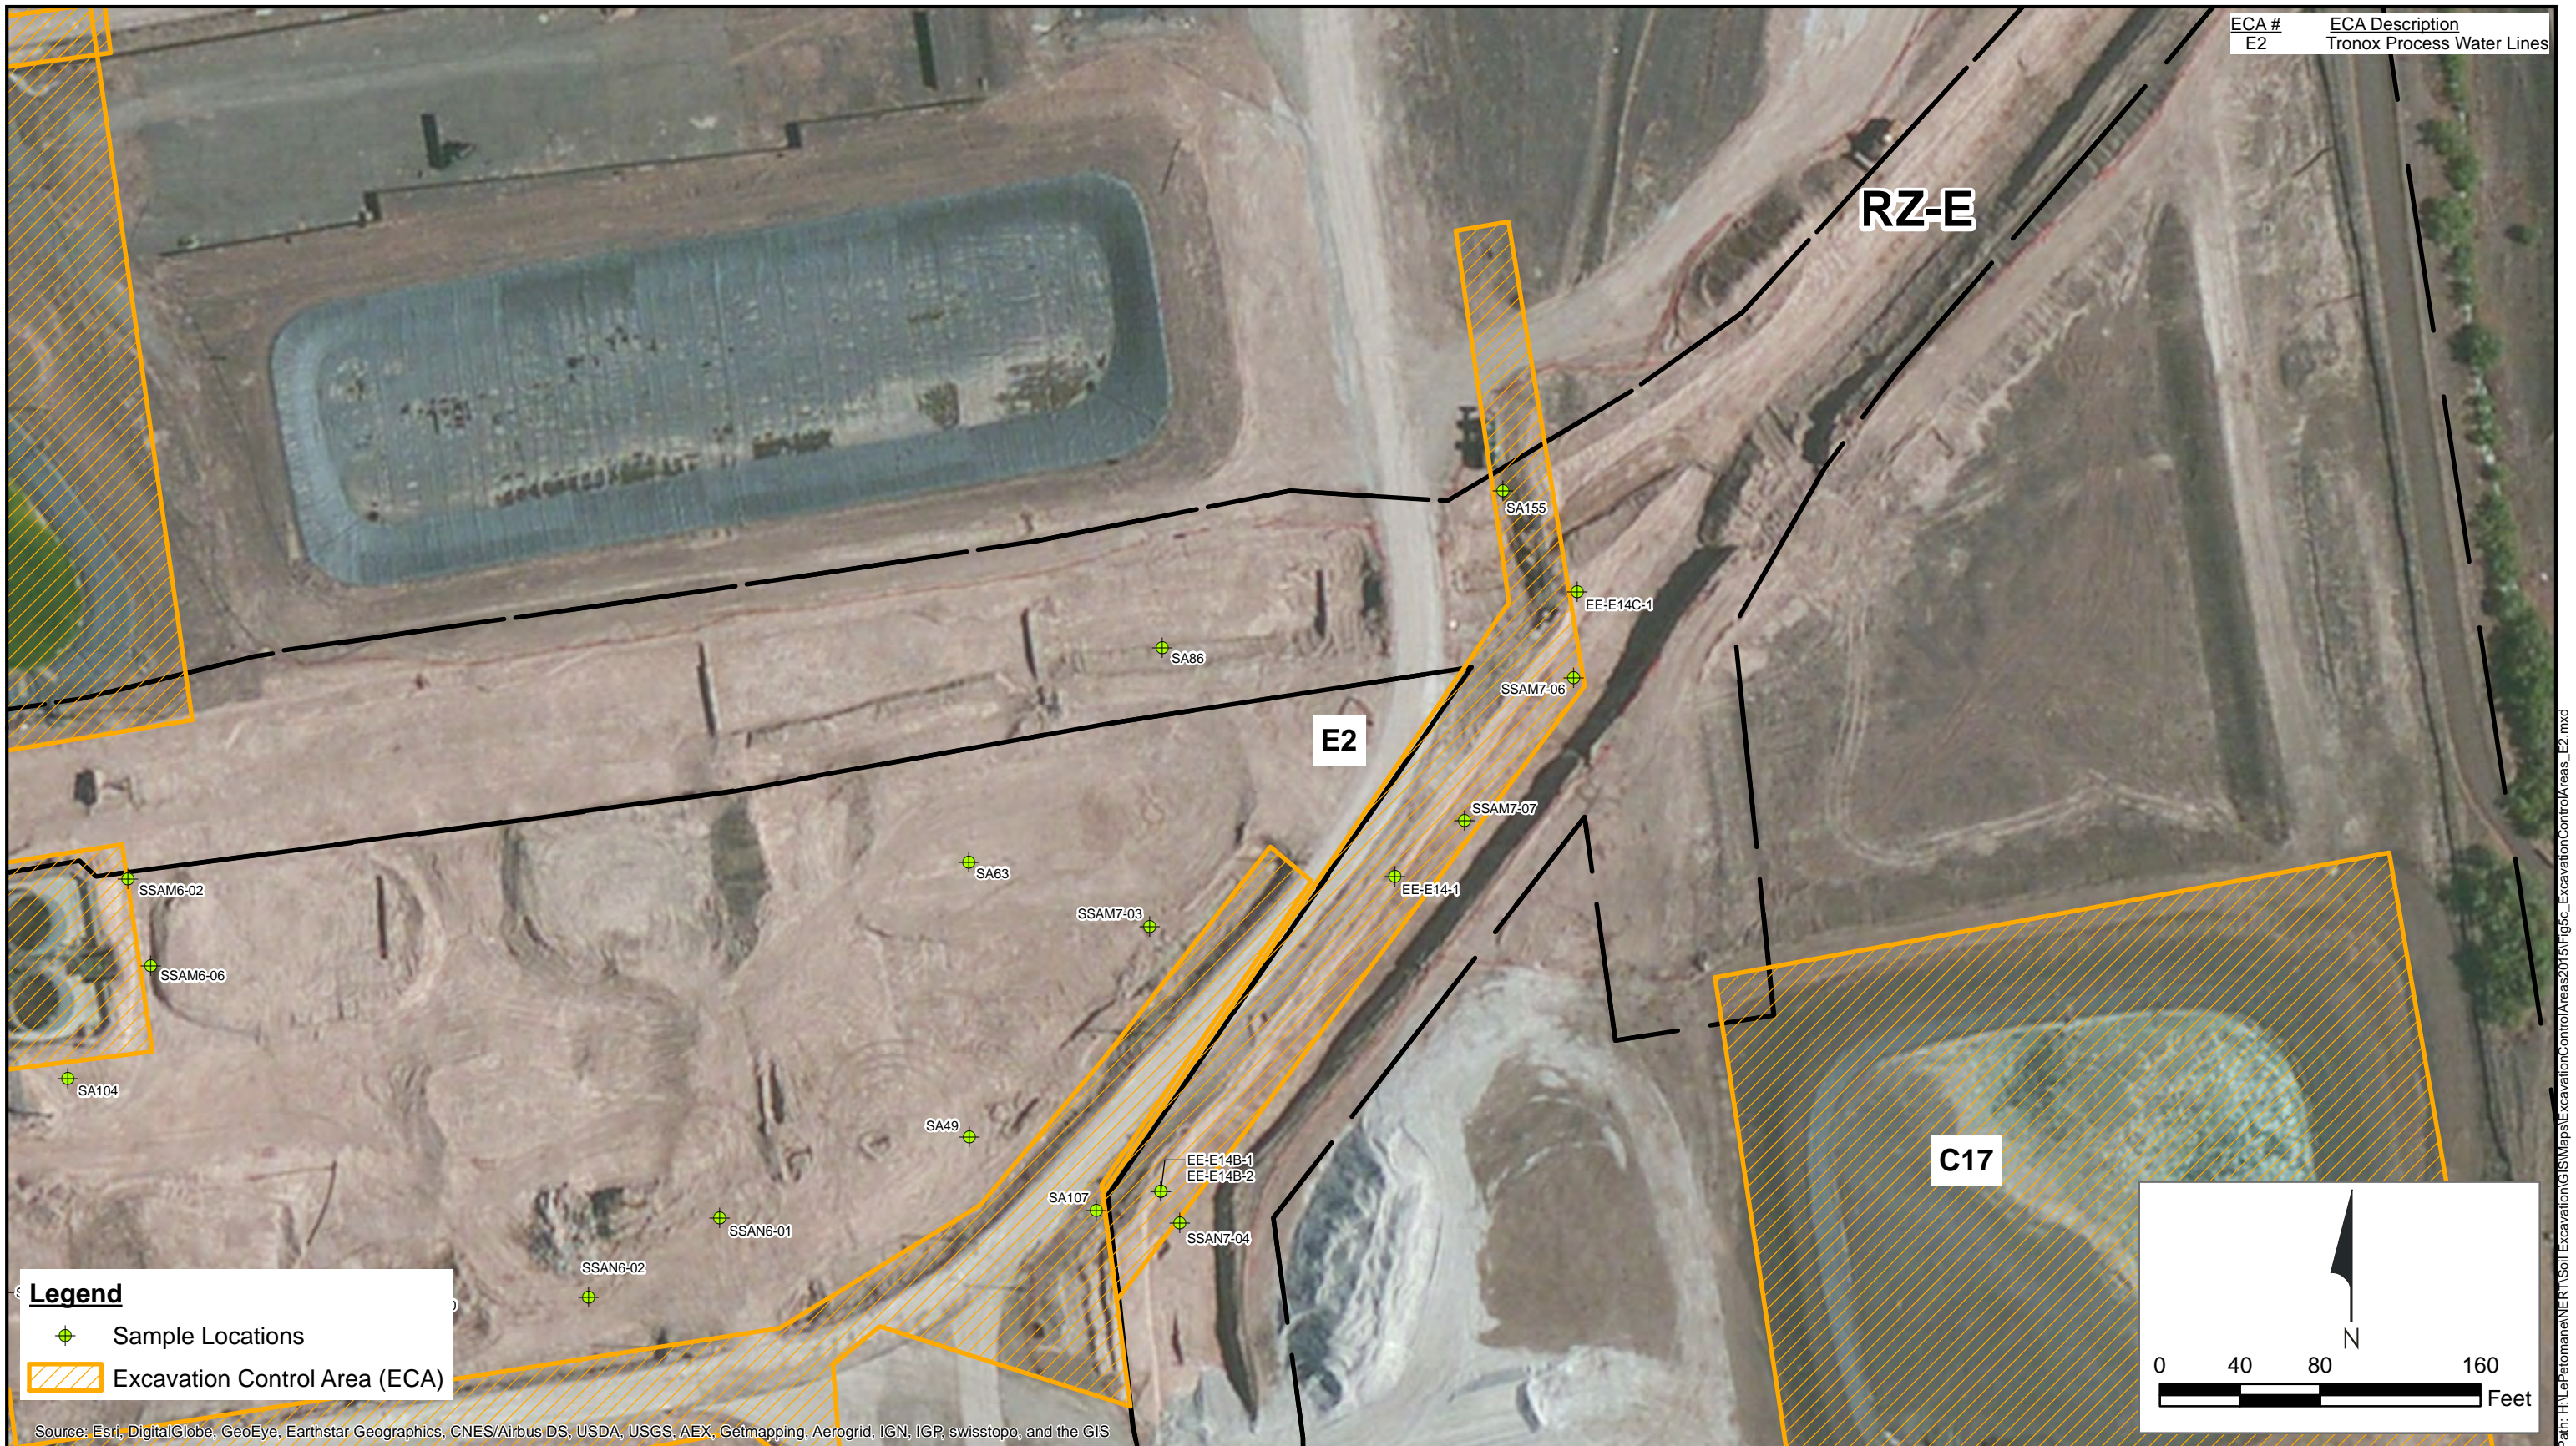
Figure
5c

Excavation Control Area E2
 Nevada Environmental Response Trust Site, Henderson, Nevada
