# TECHNICAL MEMORANDUM

To:	Nevada Environmental Response Trust
Cc:	Dan Pastor, Tetra Tech, Inc.
From:	April Hussey
Date:	April 20, 2018
Subject:	Operation and Maintenance Summary – March 2018 Weir Dewatering Treatment Plant Nevada Environmental Response Trust; Henderson, Nevada

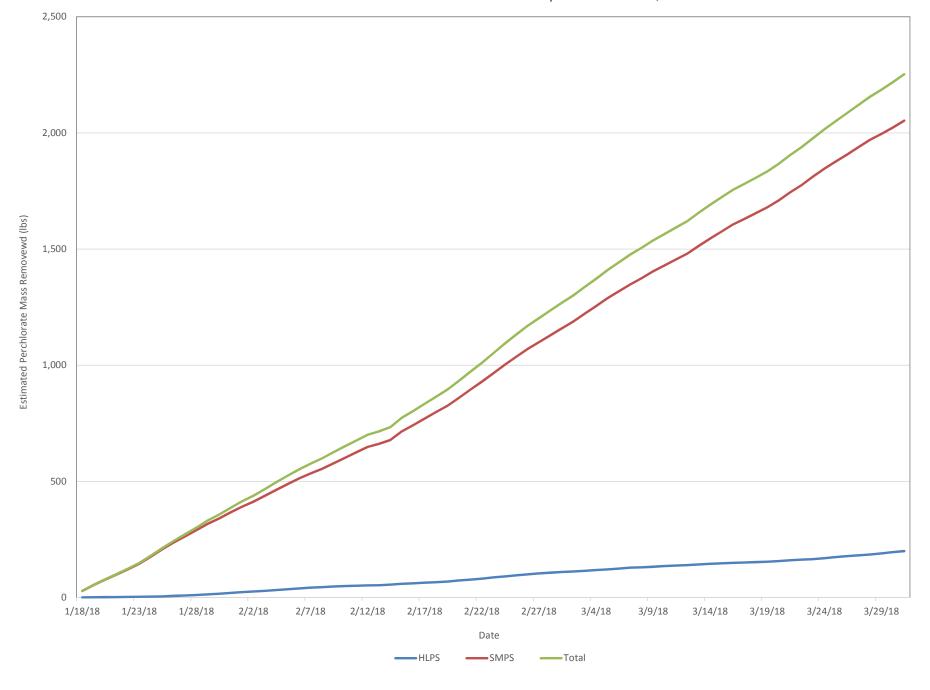
Figure 1
Estimated Perchlorate Mass Removed January 18 - March 31, 2018

Perchlorate removal estimates have been tabulated since the startup period ended January 17, 2018. The estimated total perchlorate mass removed from January 18, 2018 through March 31, 2018 is:

HLPS: 200 poundsSMPS: 2,053 poundsTotal: 2,253 pounds

A graph showing the estimated removal of perchlorate from January 18 through March 31 is presented in Figure 1.
