Project Number  
**1940106391-001**

# **SITE MANAGEMENT PLAN, REVISION 9**

## **NEVADA ENVIRONMENTAL RESPONSE TRUST SITE**

### **HENDERSON, NEVADA**

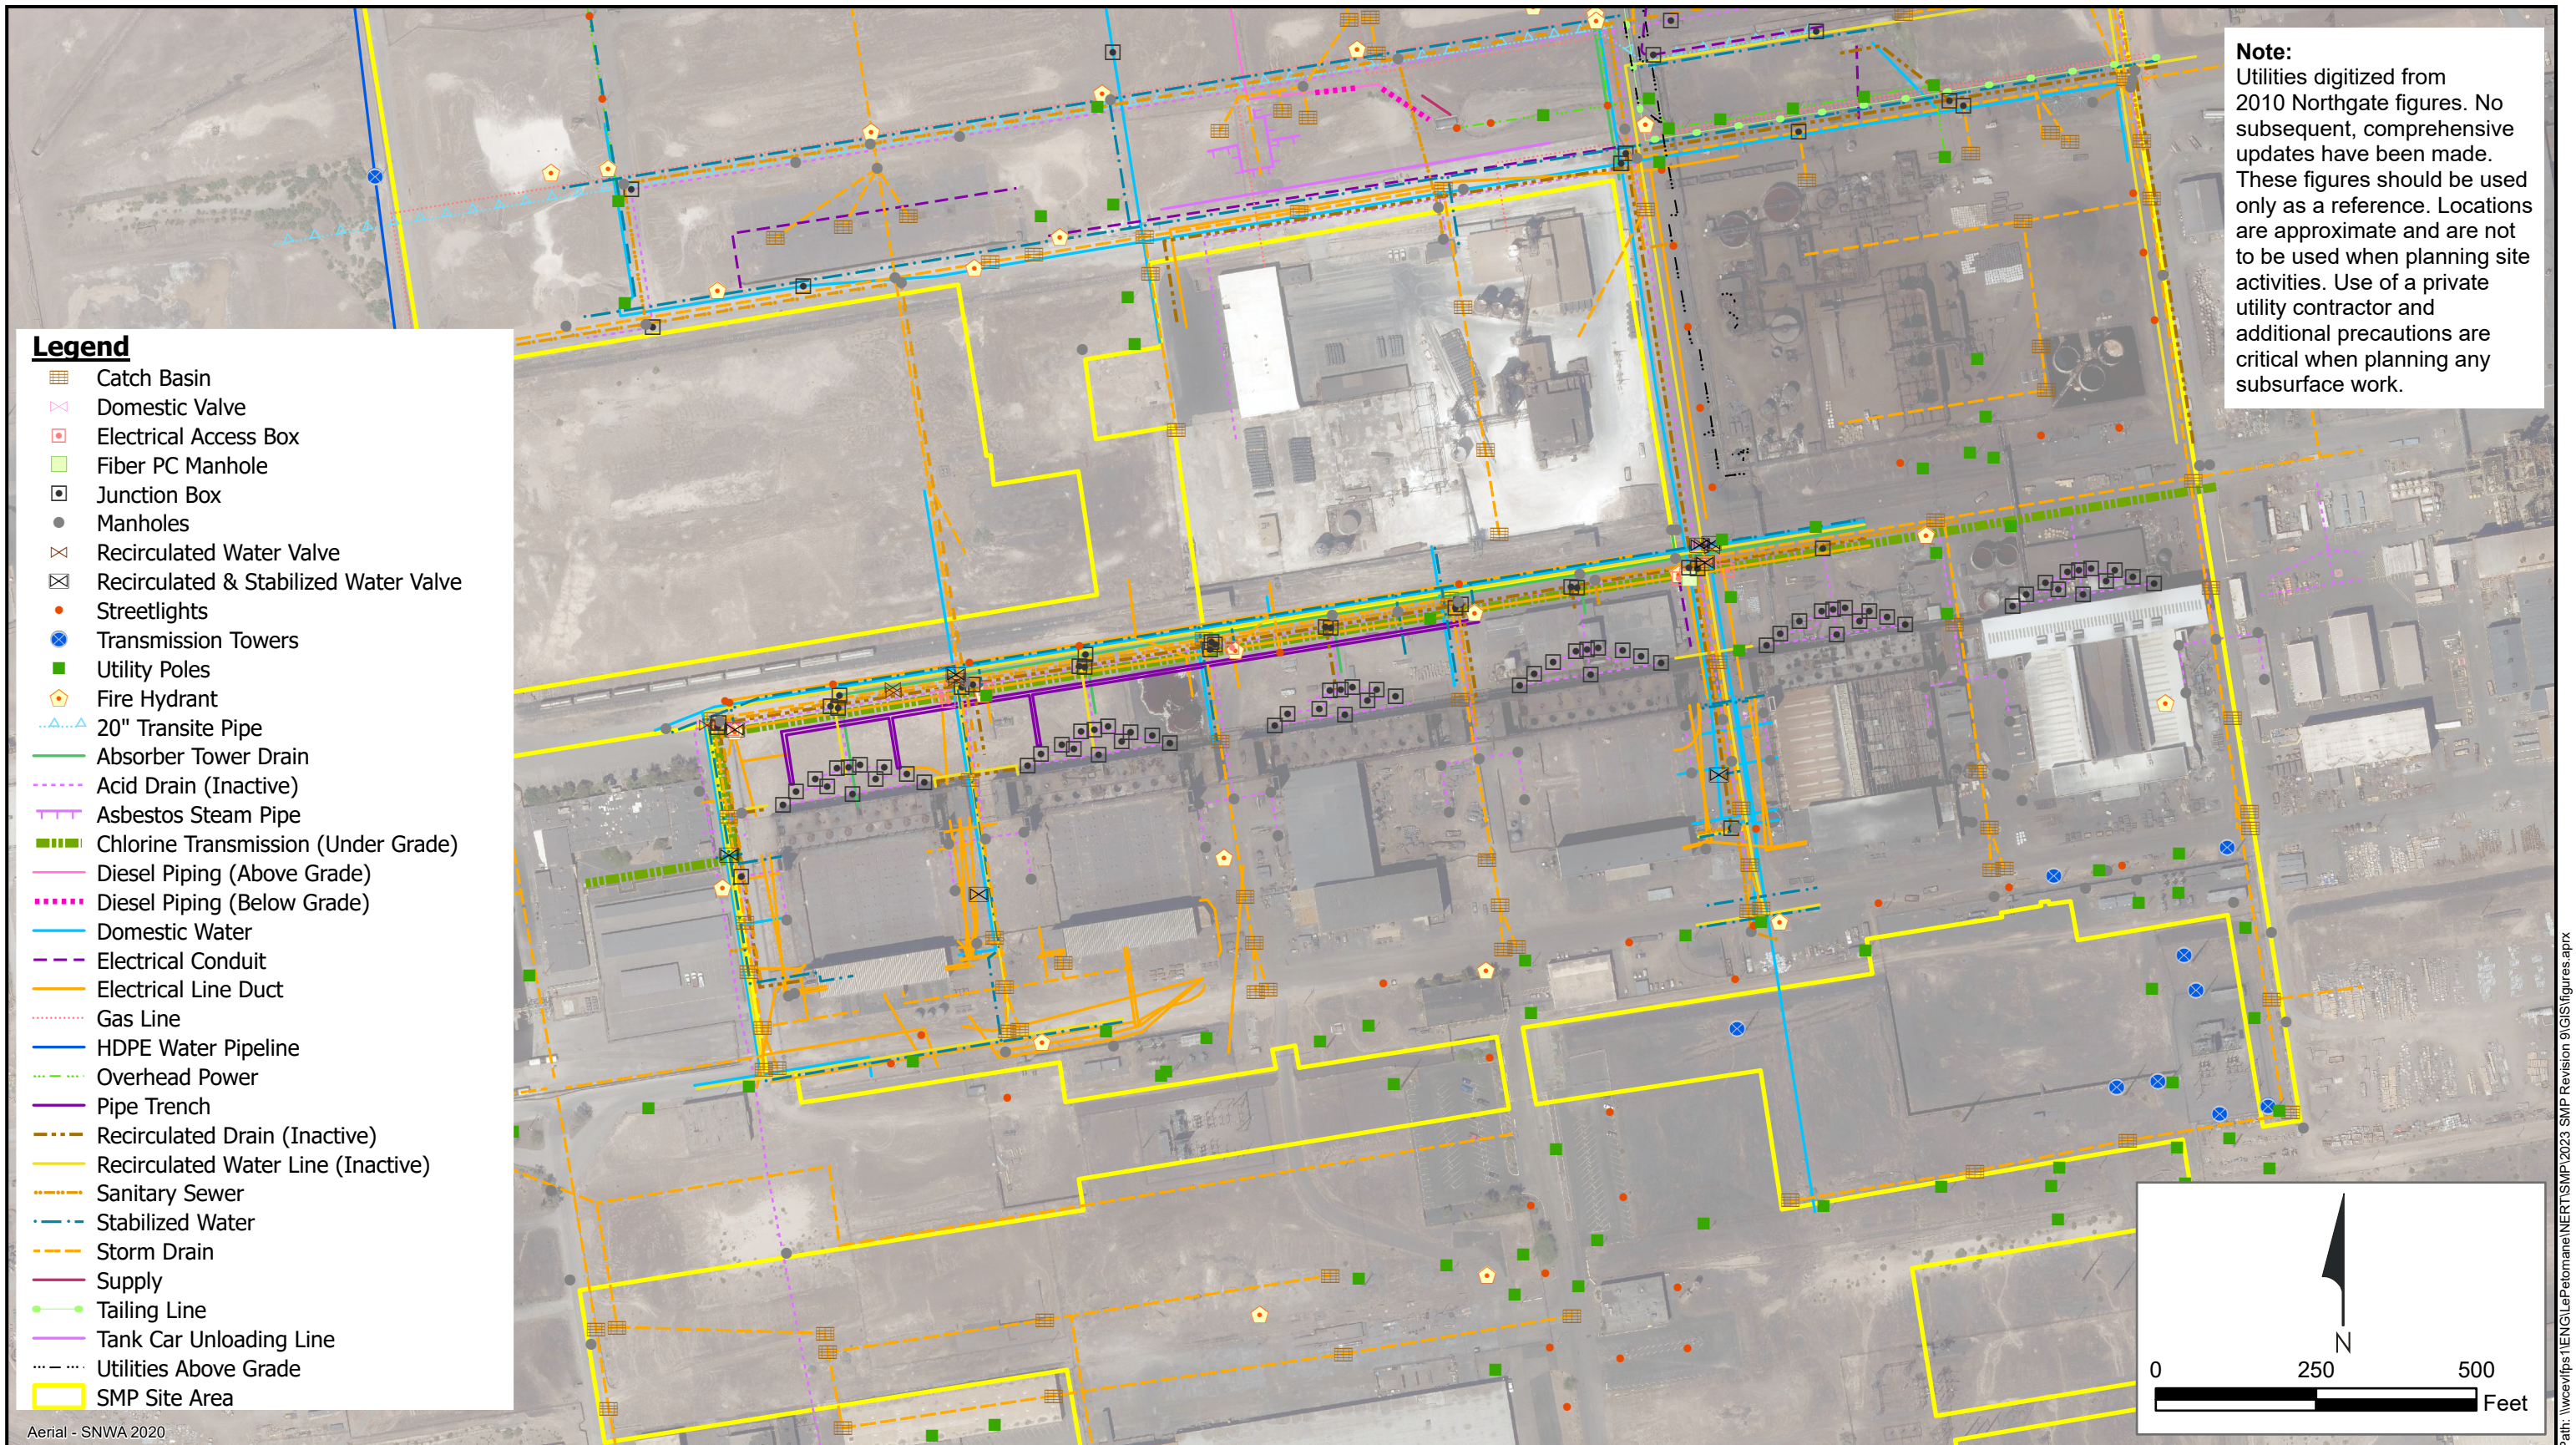
Figure  
**3a**

**Note:**  
 Utilities digitized from 2010 Northgate figures. No subsequent, comprehensive updates have been made. These figures should be used only as a reference. Locations are approximate and are not to be used when planning site activities. Use of a private utility contractor and additional precautions are critical when planning any subsurface work.

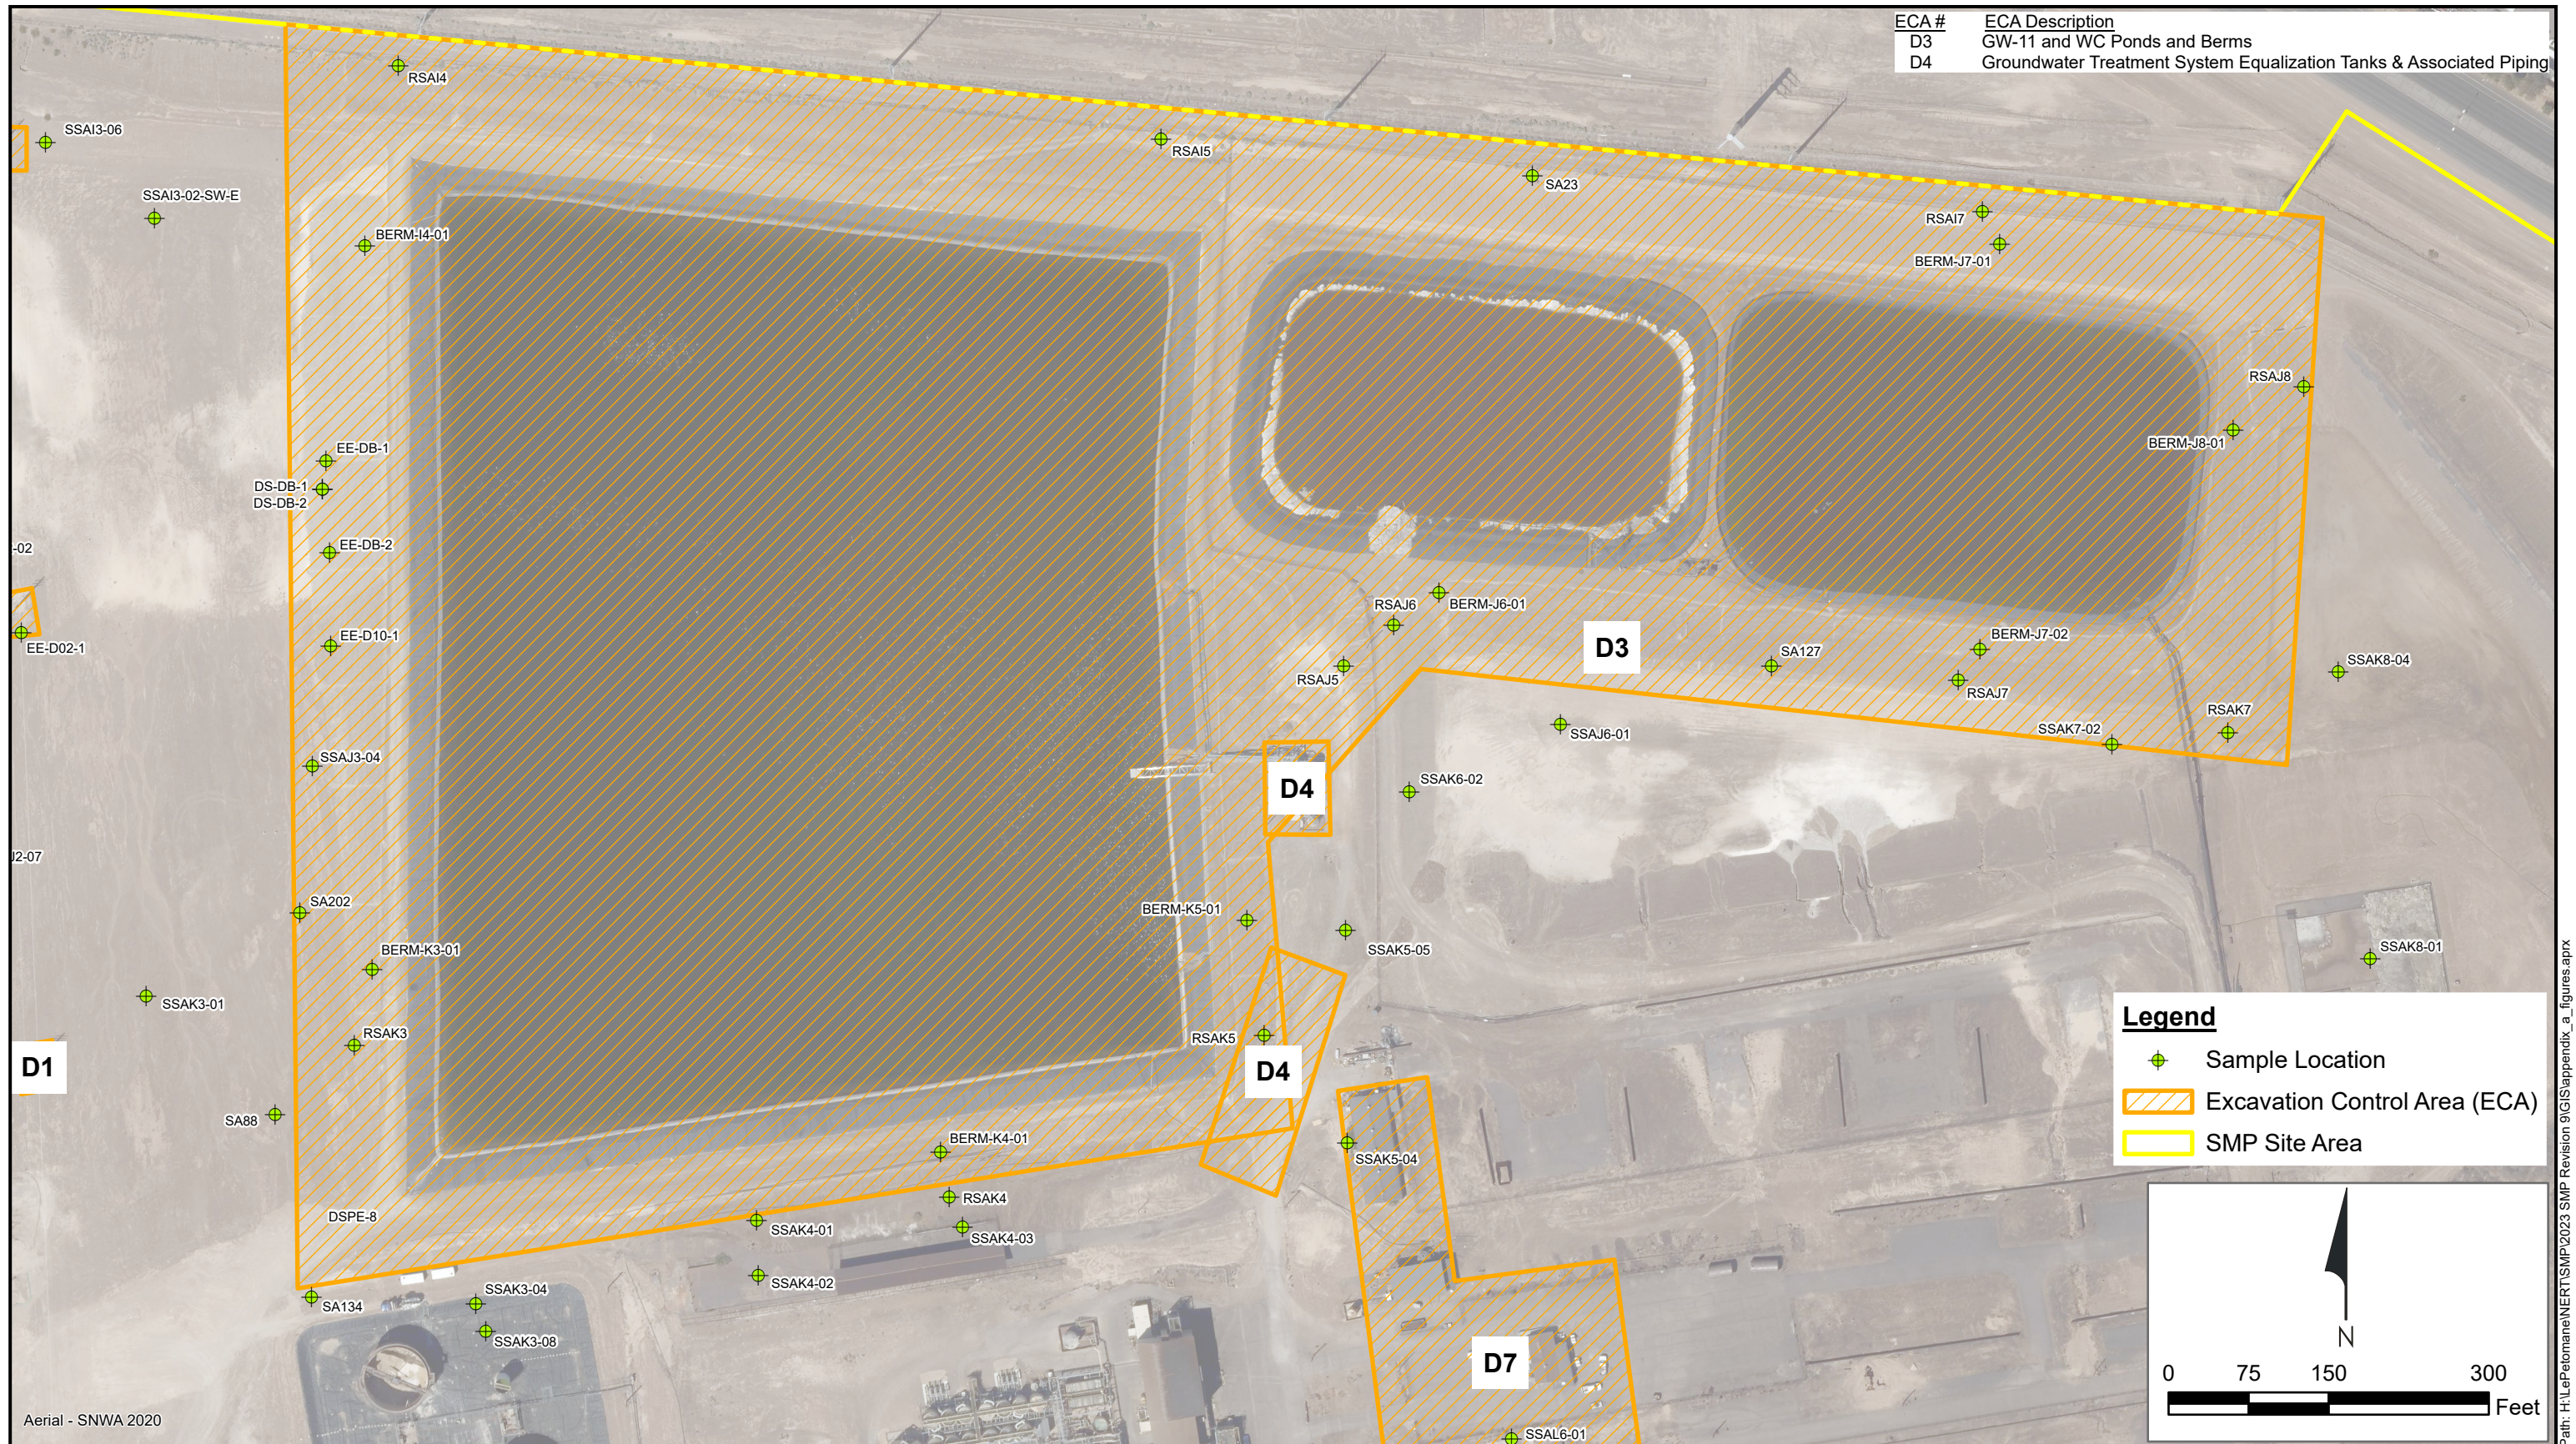
Figure  
**4b**

**Excavation Control Areas D3 and D4**  
Nevada Environmental Response Trust Site, Henderson, Nevada

In 2015, discoloration was observed in the road cut along the emergency egress route north of the GW-11 and WC Ponds. Therefore, the northern boundary of ECA #D3 has been extended to the Site boundary to include the berm to the north, as shown on Figure 4.

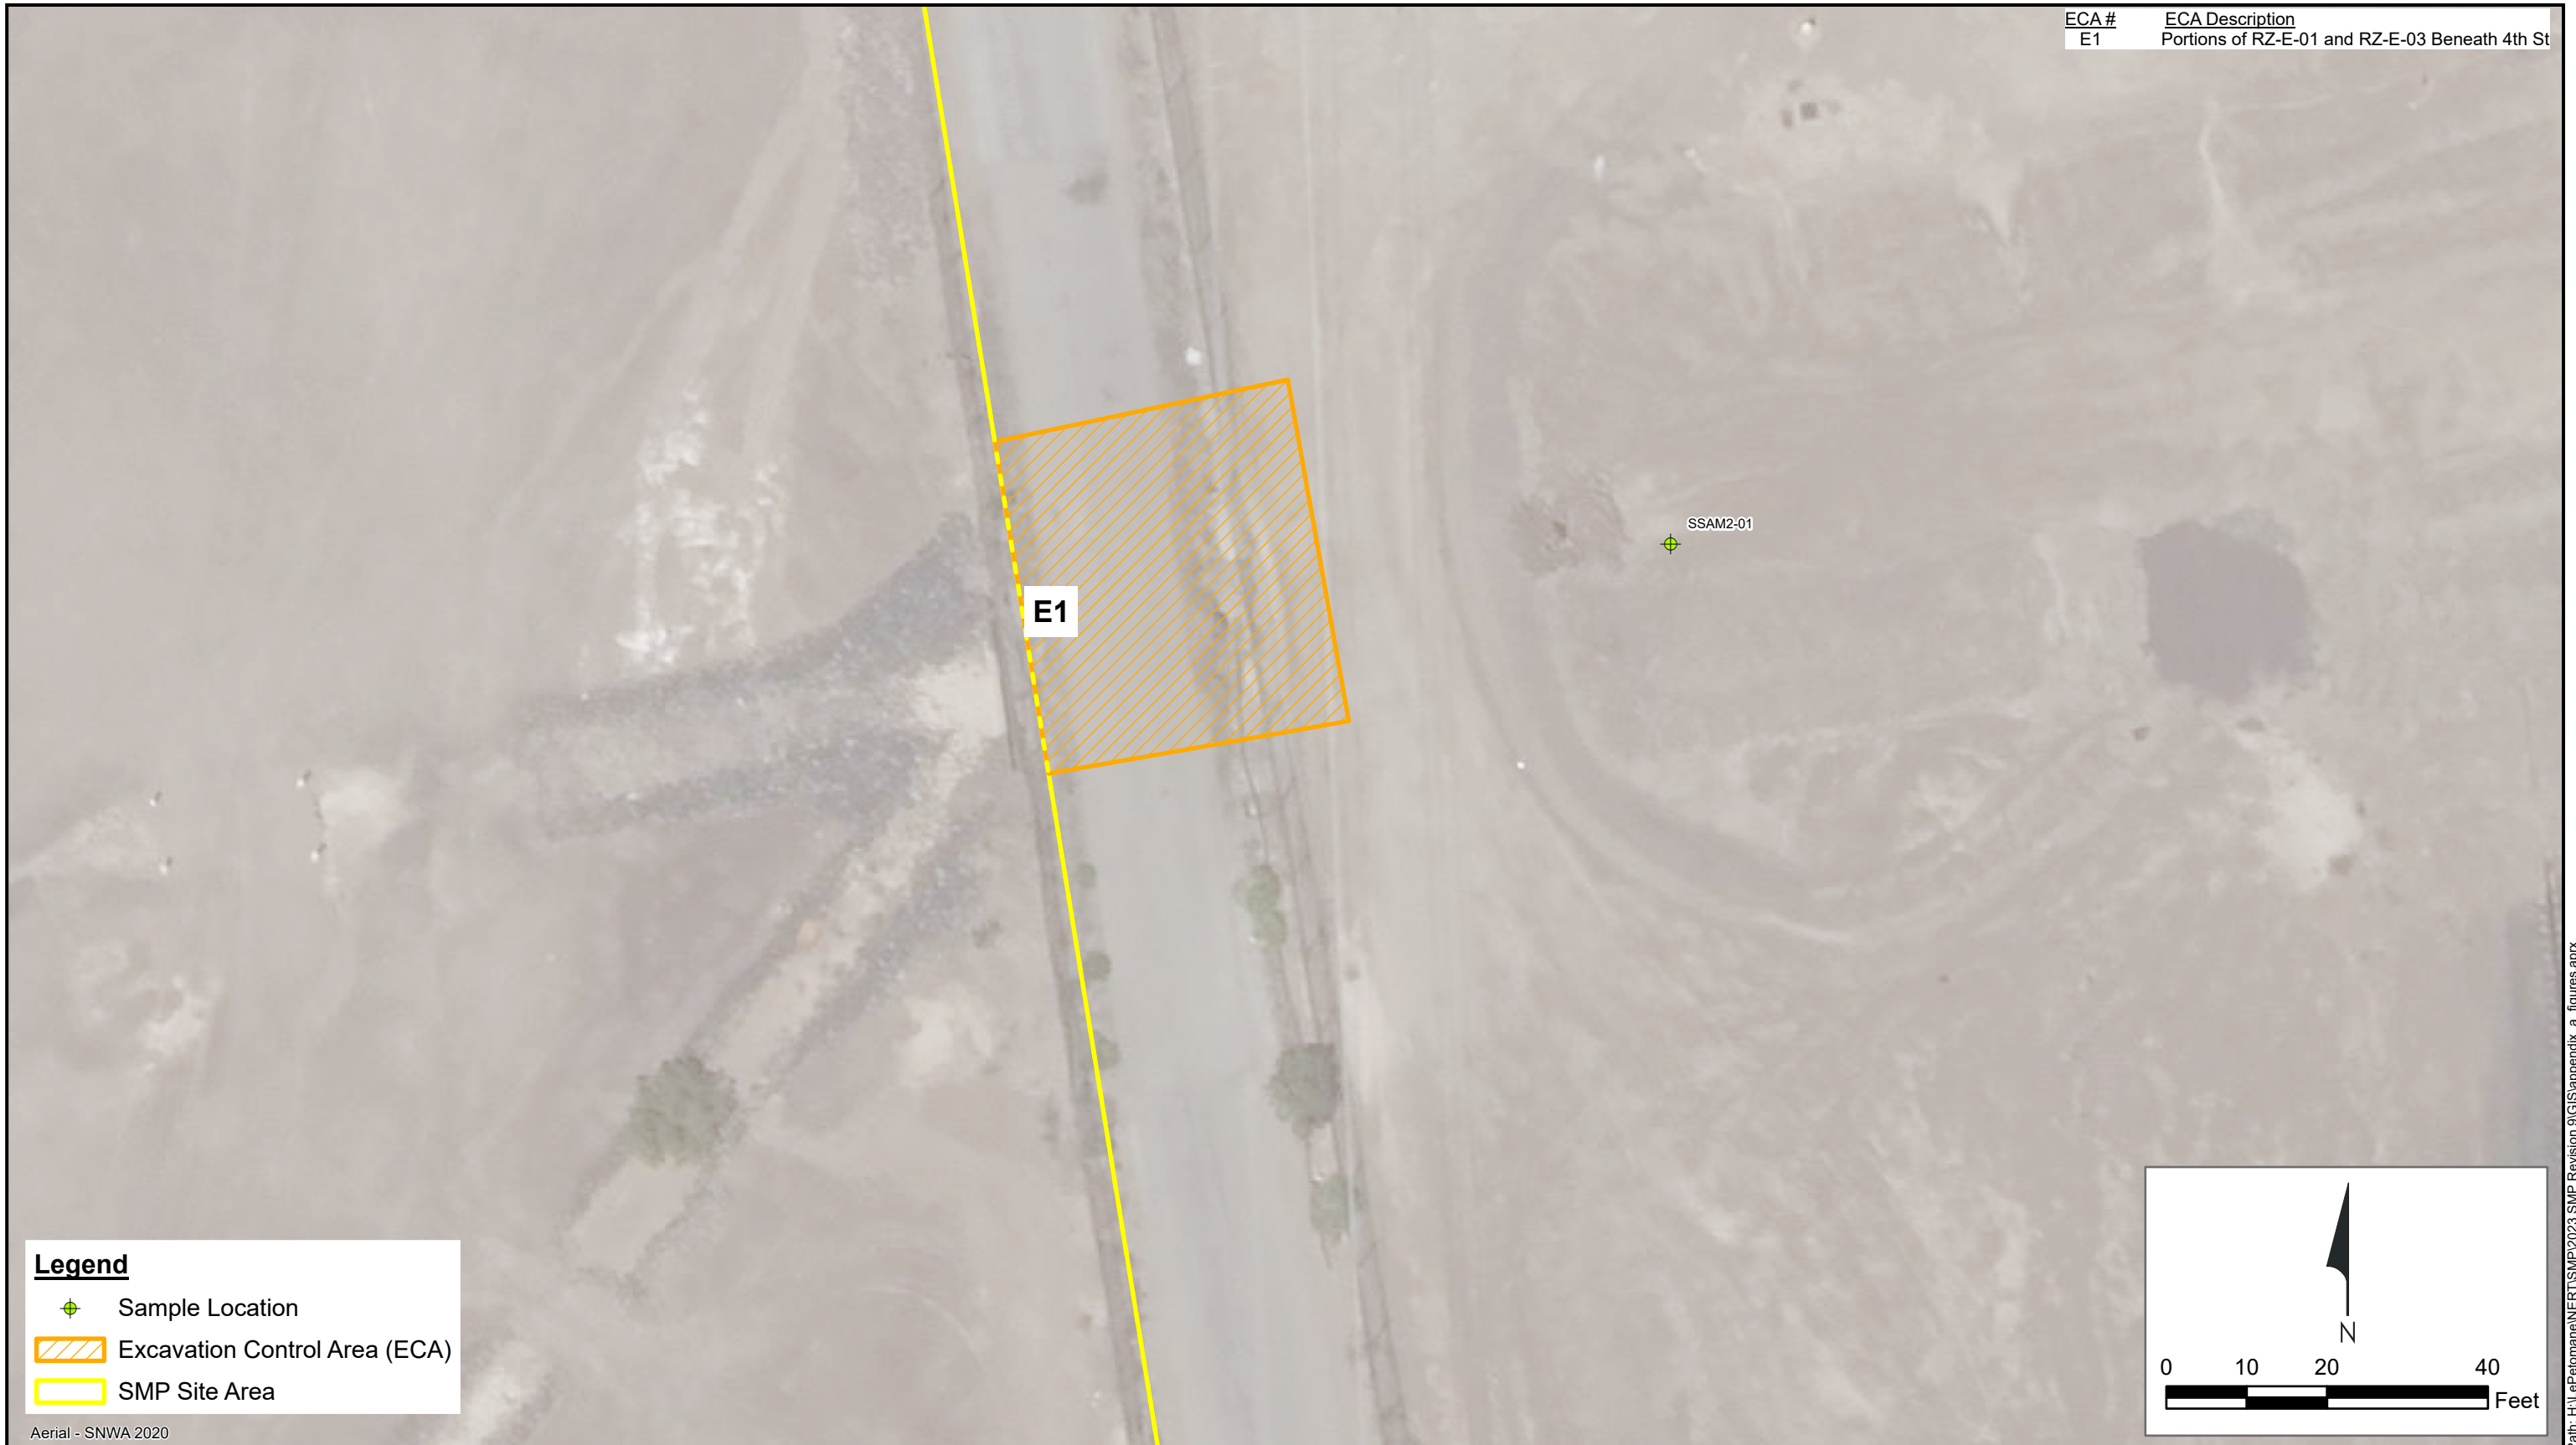
ECA #	ECA Description
E1	Portions of RZ-E-01 and RZ-E-03 Beneath 4th St

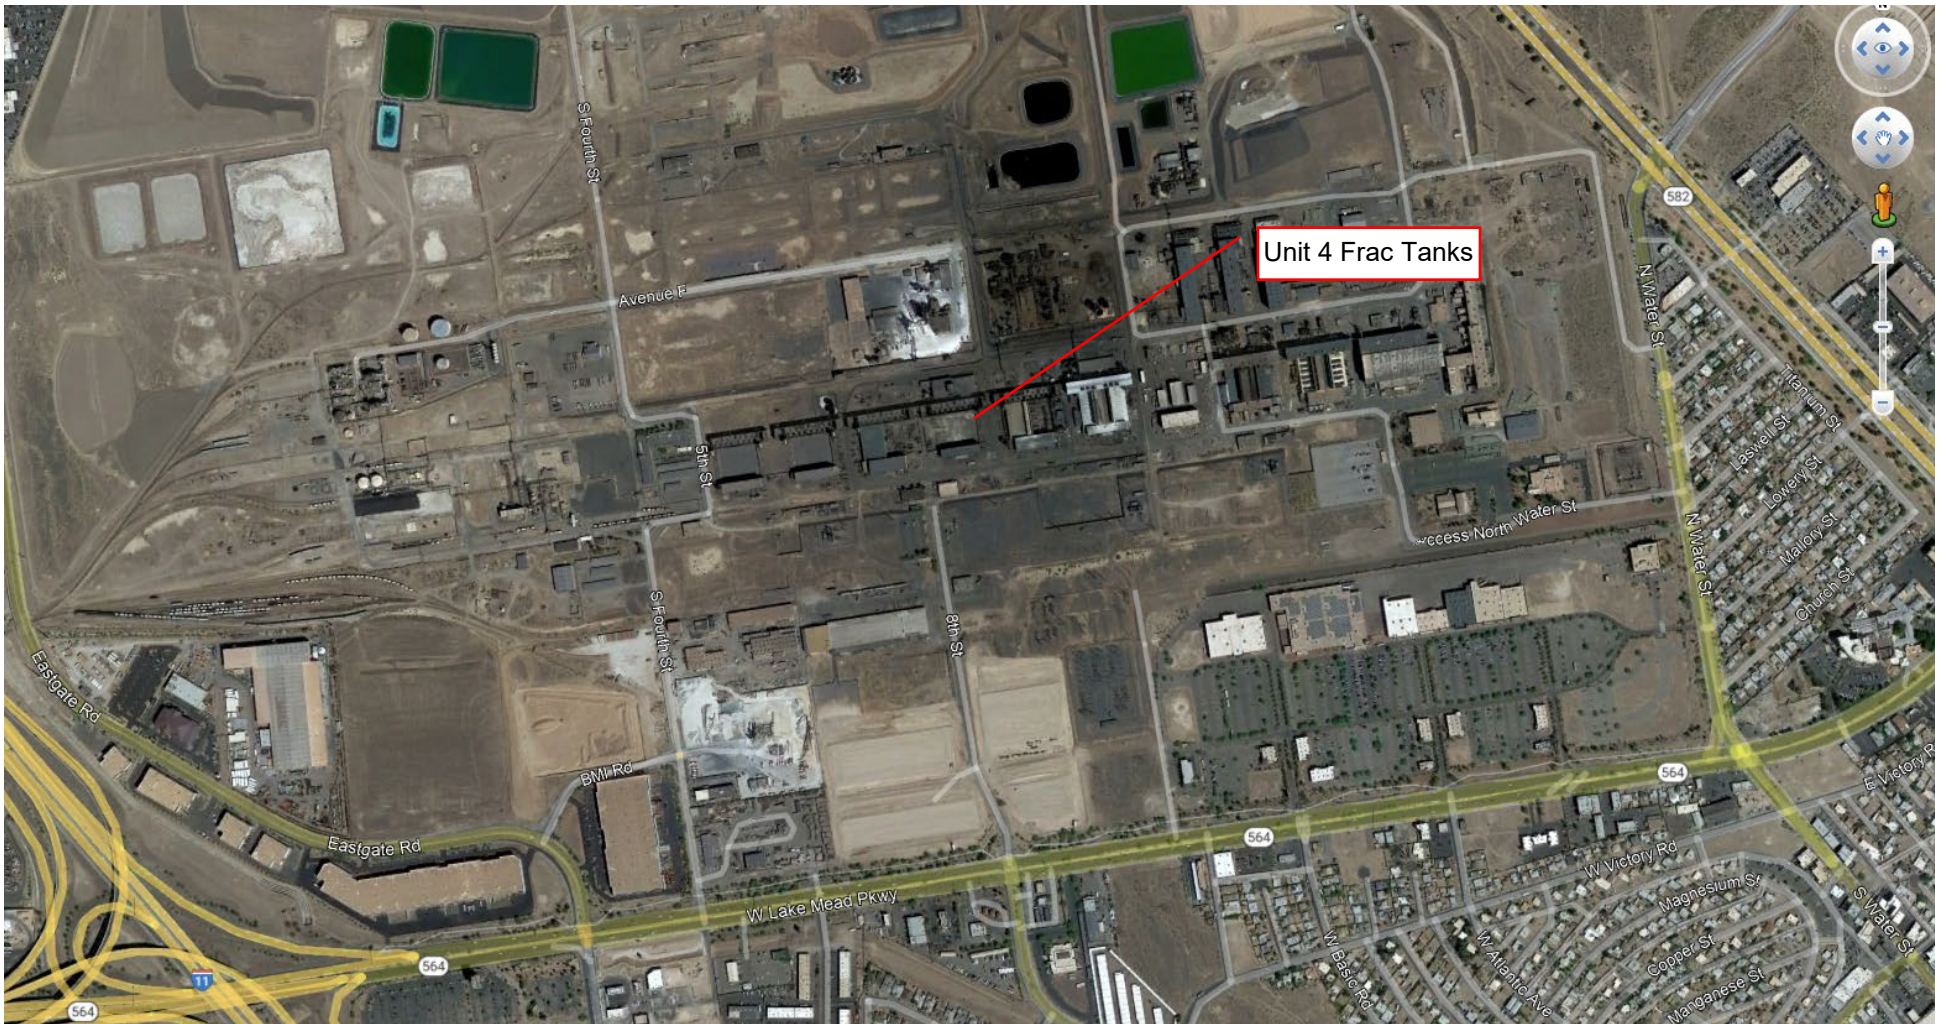
Groundwater waste will be generated at the Unit 4 source area; Figure B-1 shows the location of Unit 4. The waste is accumulated in two frac tanks on a secondary containment pad adjacent to the area where the groundwater is extracted (Figure B-2). The Unit 4 source area is within the EMD leasehold and can be accessed (1) through the main EMD gate on W. Lake Mead Parkway or (2) via the Trust's main entrance on S. 4<sup>th</sup> Street, then via a gate on the north side of the EMD leasehold. Approximately twice a week, water is pumped from the frac tanks and transported by tanker truck to the Groundwater Extraction and Treatment System (GWETS), the site's exempt WWTU, shown in Figure B-1. The wastewater is only transported on-site.

**Figure B-2 – Aerial Photograph Showing Area of Waste Generation and Accumulation**

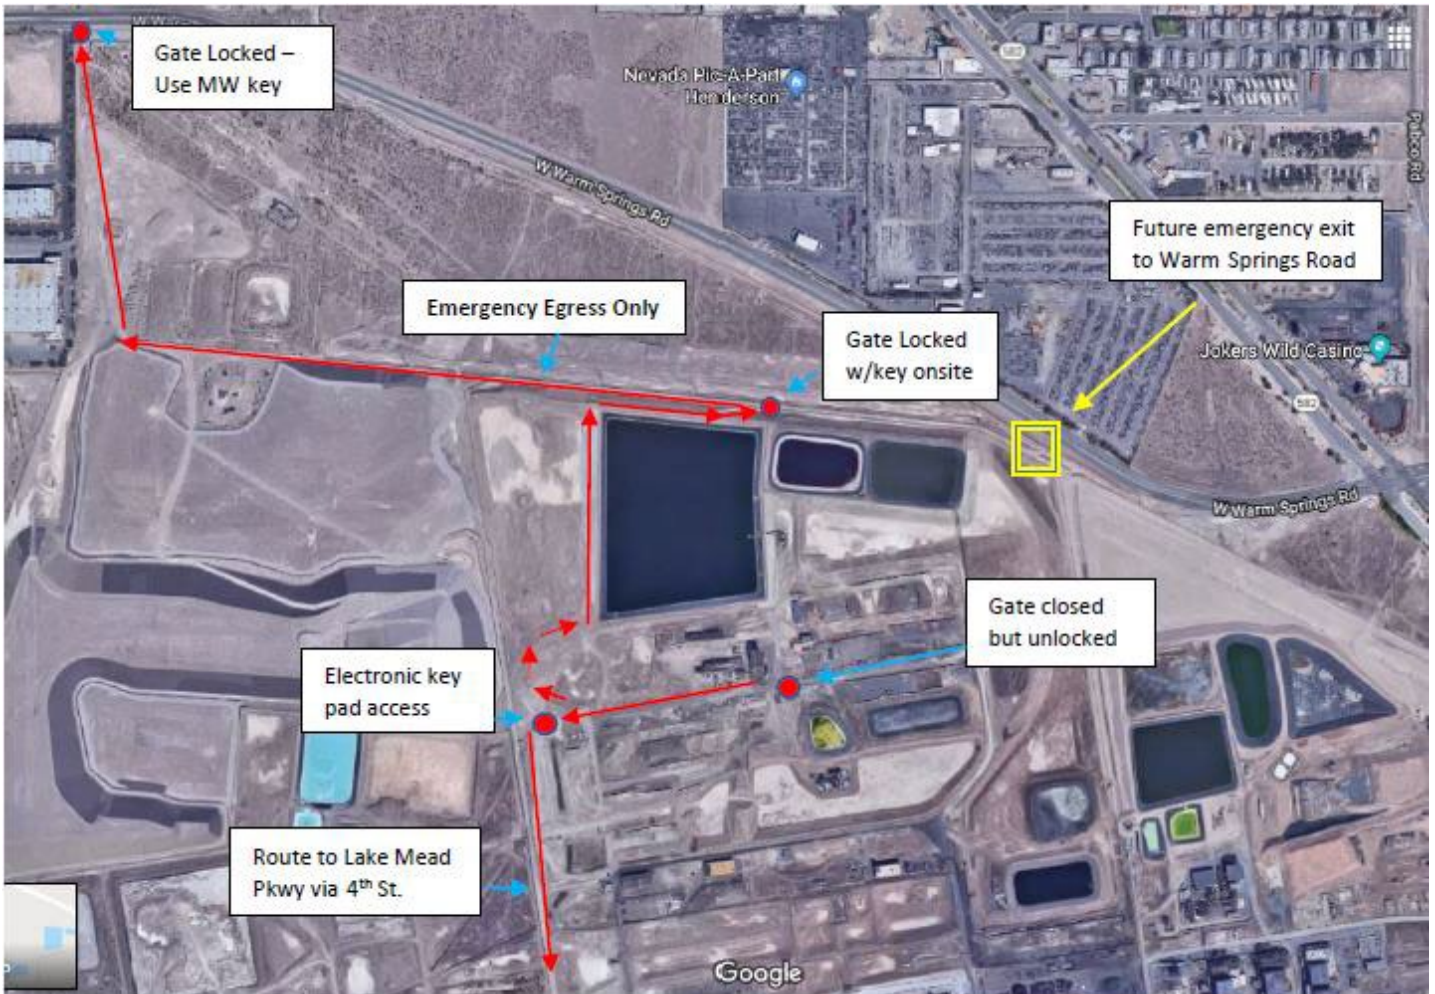
The NERT site can be accessed through multiple gates, as shown in Figure B-3. The main gate is a keypad entry gate that can be accessed by turning north onto S. 4<sup>th</sup> Street from W. Lake Mead Parkway. The properties surrounding the Site are heavy industrial or vacant land, as shown on the figures below. Properties adjacent to the southeast and southwest of the Site and south of W. Lake Mead Parkway are commercial, residential, and light industrial (Figure B-4).

**Figure B-3 – Aerial Photograph Showing Access Points**

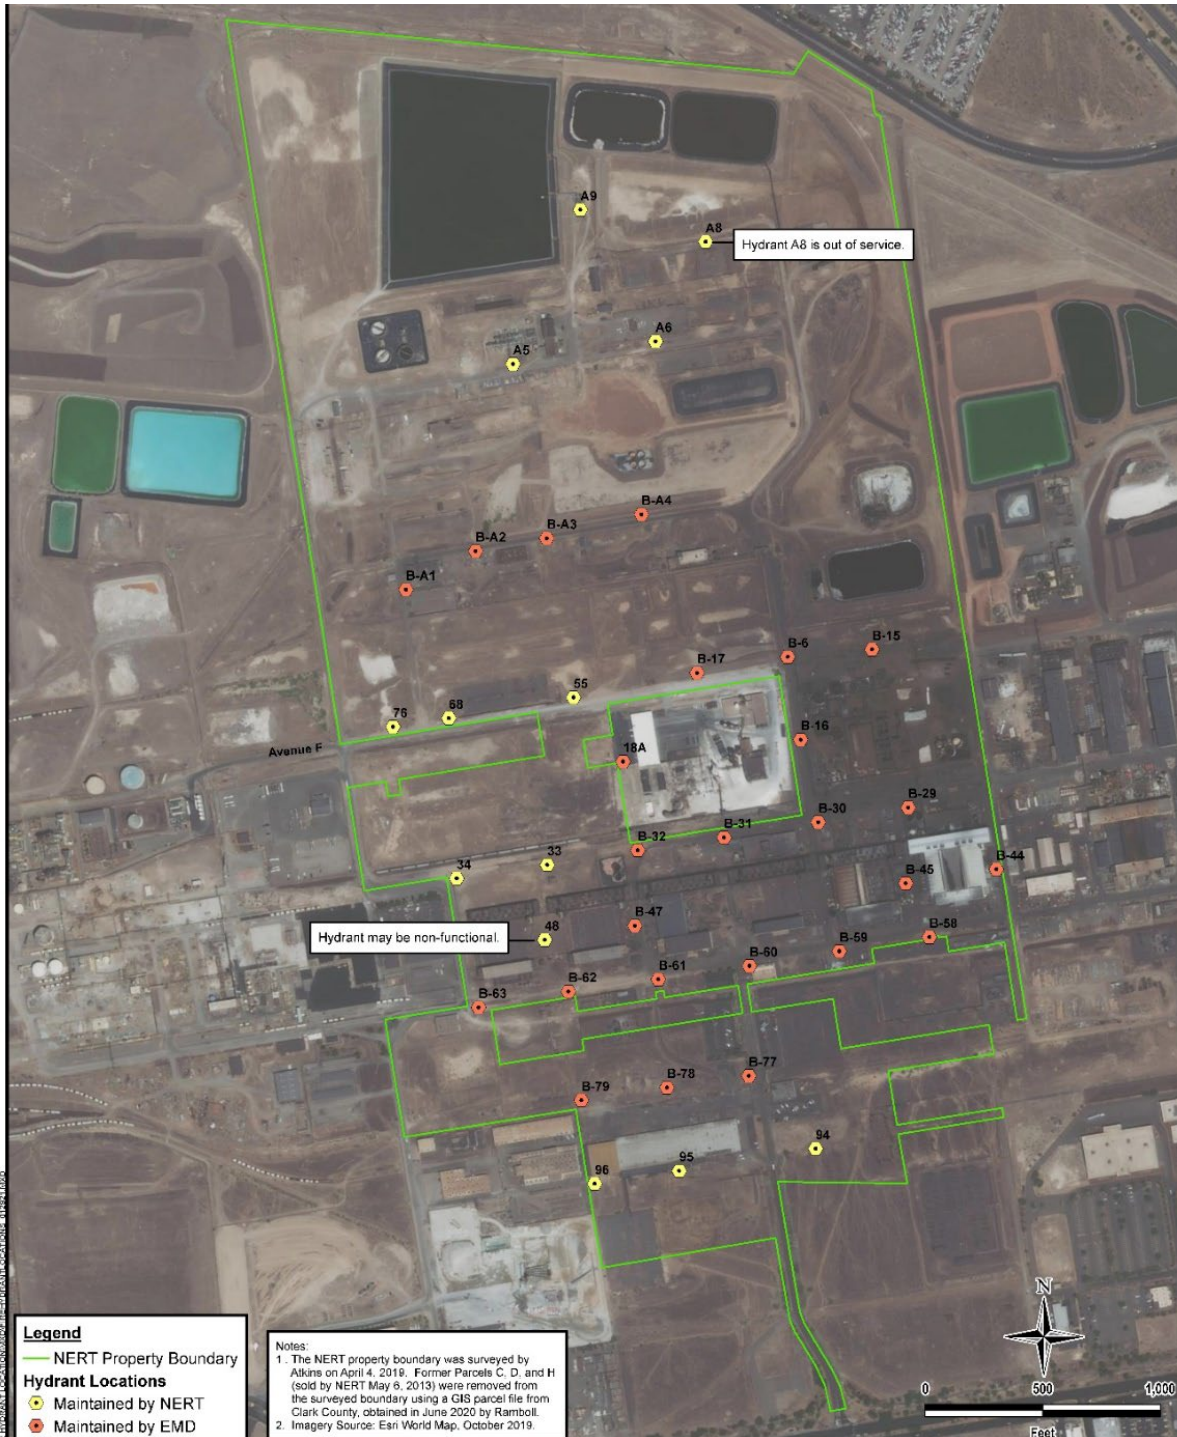
The fire hydrants located within the NERT Property Boundary are within the Clark County jurisdiction and are shown on Figure B-5. Clark County has adopted portions of the International Fire Code (IFC), 2018 Edition and 2018 Southern Nevada Consensus Fire (SNCF) Code Amendments into the Fire Code of Clark County. Based on SNFC C105.1, the minimum number of fire hydrants required to meet the fire flow shall be based on a maximum flow of 1,000 gallons per minute (gpm) per hydrant. All hydrants utilized in providing the fire flow shall be within 750 feet of the structure being protected as measured along the street or approved fire apparatus access road. Maximum flow is 1,500 gpm in unincorporated Clark County.

**Figure B-5 – Fire Hydrant Map**
