Client: <i>Tronox LLC</i>	WELL ID: M-117
Project Number: <i>04020-023-151</i>	
Site Location: <i>Henderson, NV</i>	Date Installed: <i>03/12/06</i>
Well Coords: <i>26715198.289 N, 828917.057 E ; NAD 83 Nevada East</i>	Inspector:
Method: <i>Sonic Drilling</i>	Contractor: <i>Prosonic Corporation</i>

MONITORING WELL CONSTRUCTION DETAIL

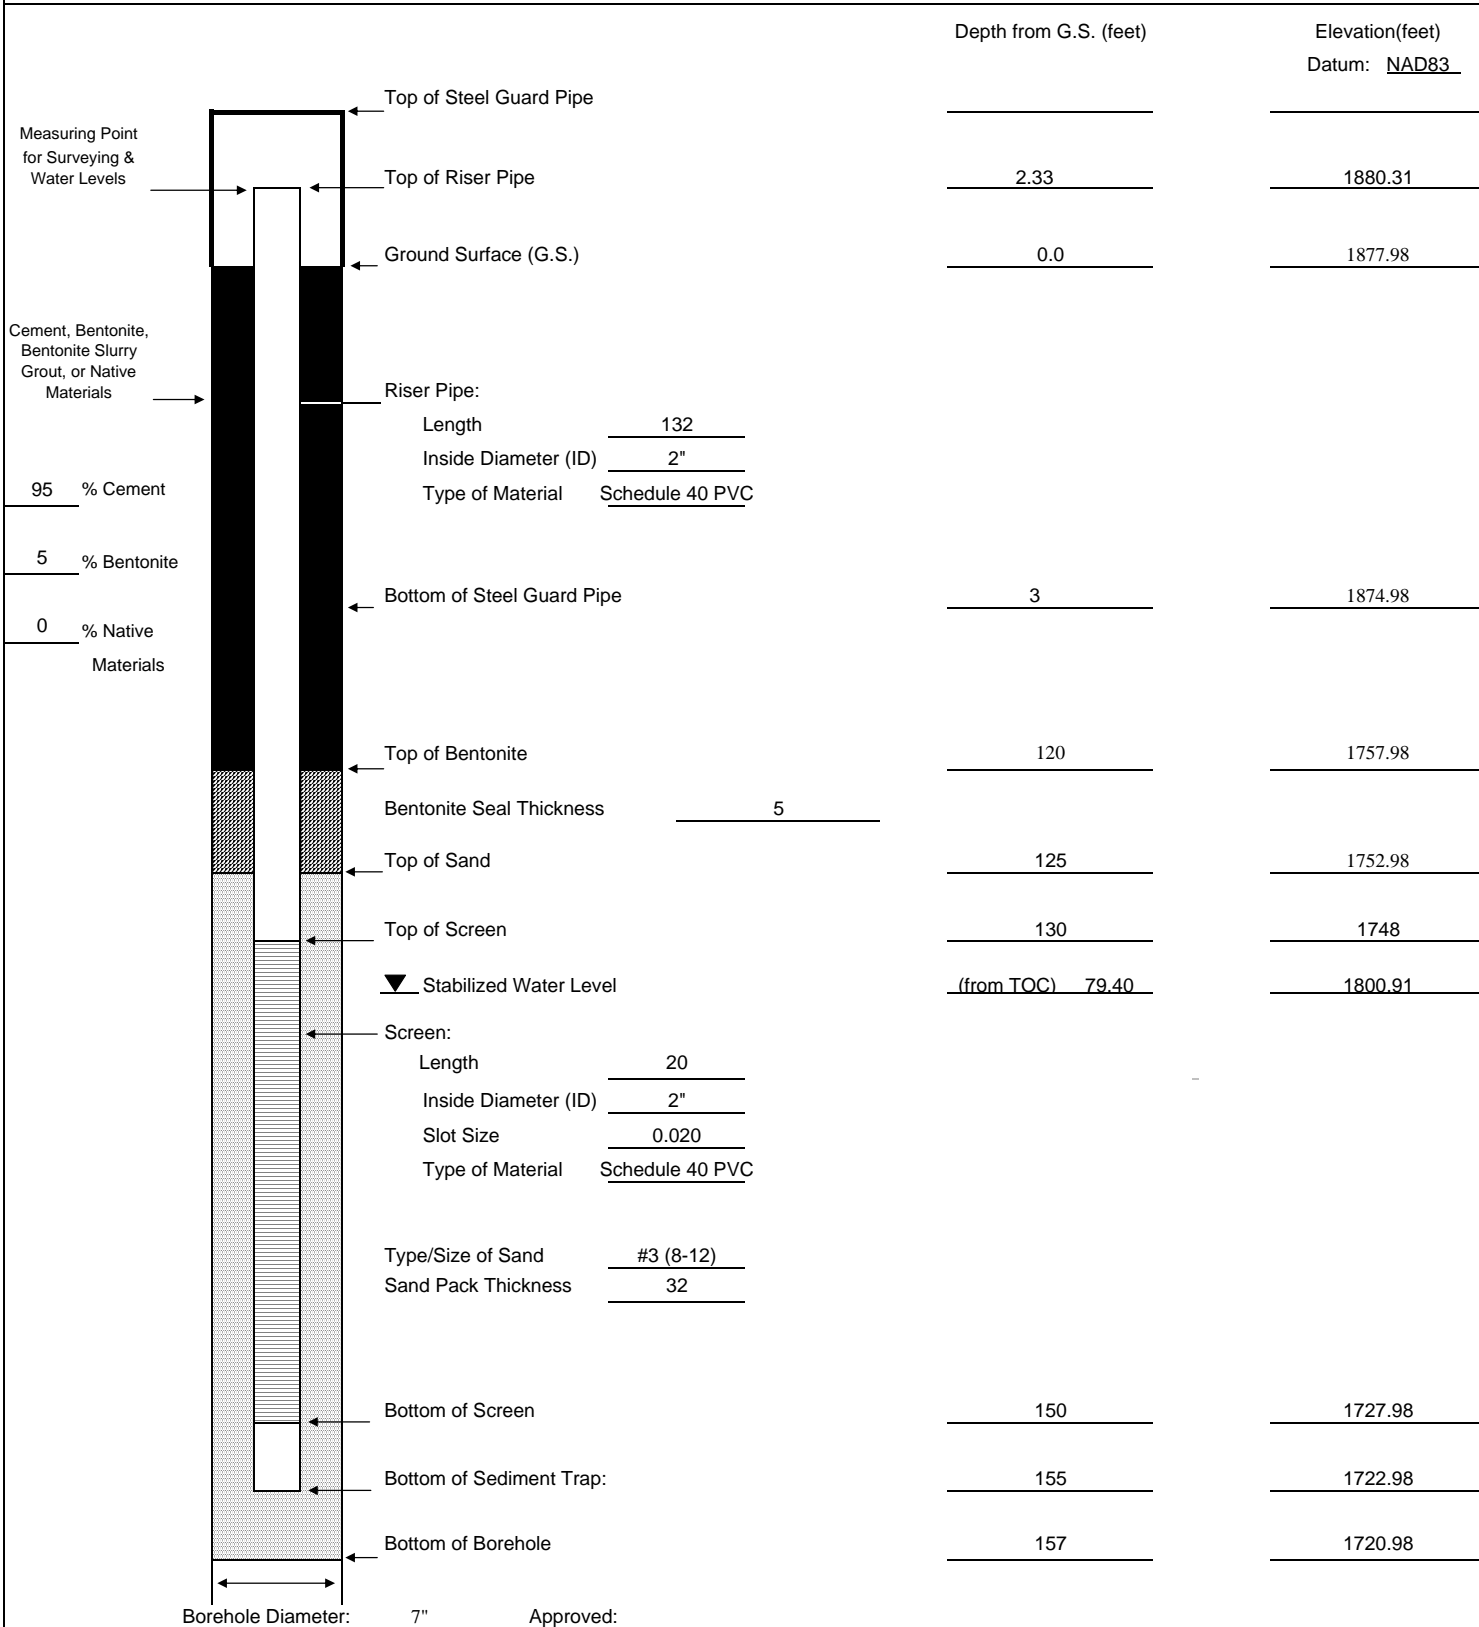
Describe Measuring Point: Top of PVC Riser Pipe at 1880.31 feet SWB 3/13/2006
 Signature _____ Date _____

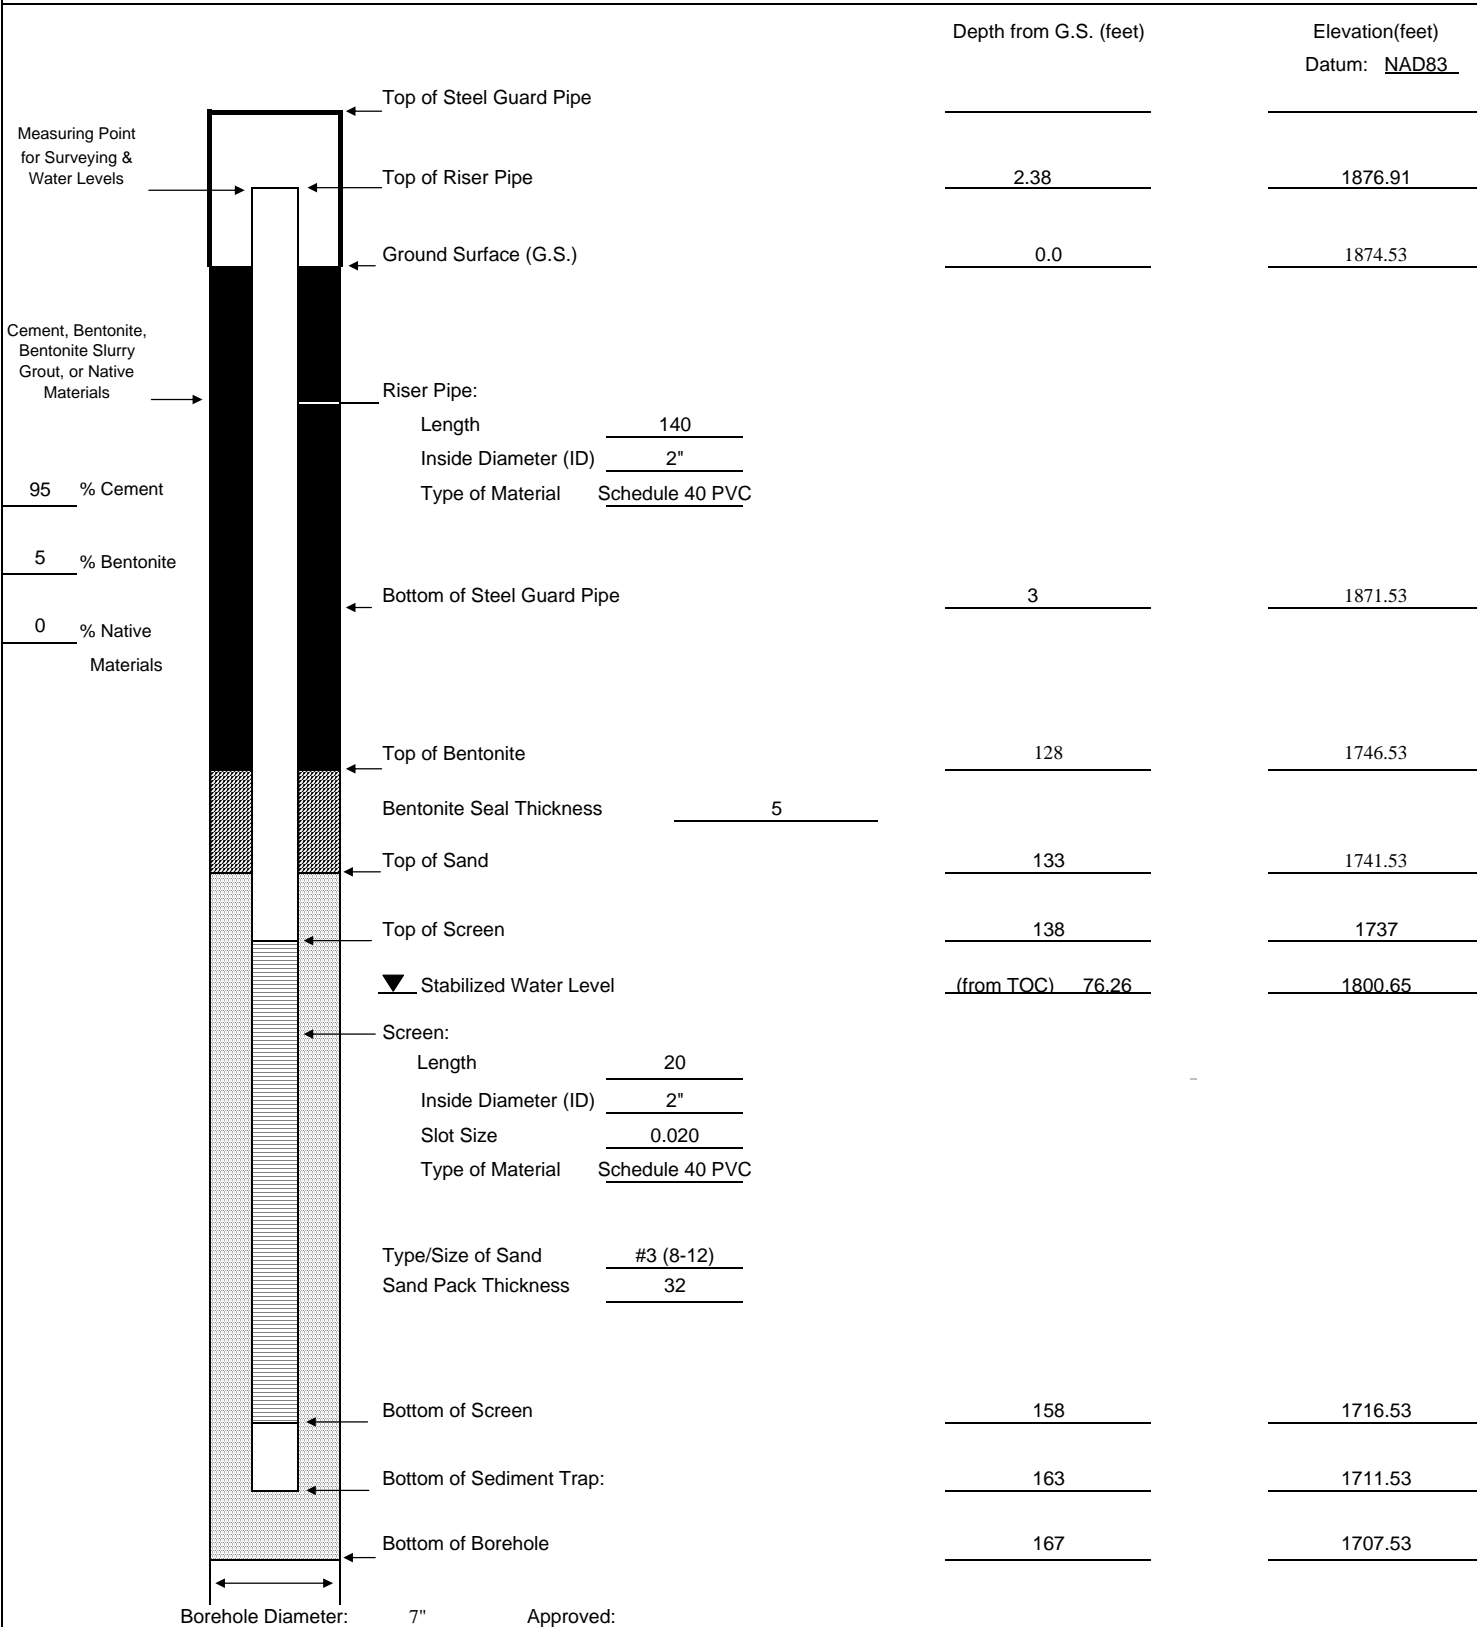
MONITORING WELL CONSTRUCTION DETAIL

Client: <i>Tronox LLC</i>	WELL ID: M-118
Project Number: <i>04020-023-151</i>	
Site Location: <i>Henderson, NV</i>	Date Installed: <i>03/9/06</i>
Well Coords: <i>26715068.012 N, 828036.397 E ; NAD 83 Nevada East</i>	Inspector:
Method: <i>Sonic Drilling</i>	Contractor: <i>Prosonic Corporation</i>

Describe Measuring Point: Top of PVC Riser Pipe at 1876.91 feet SWB 3/10/2006

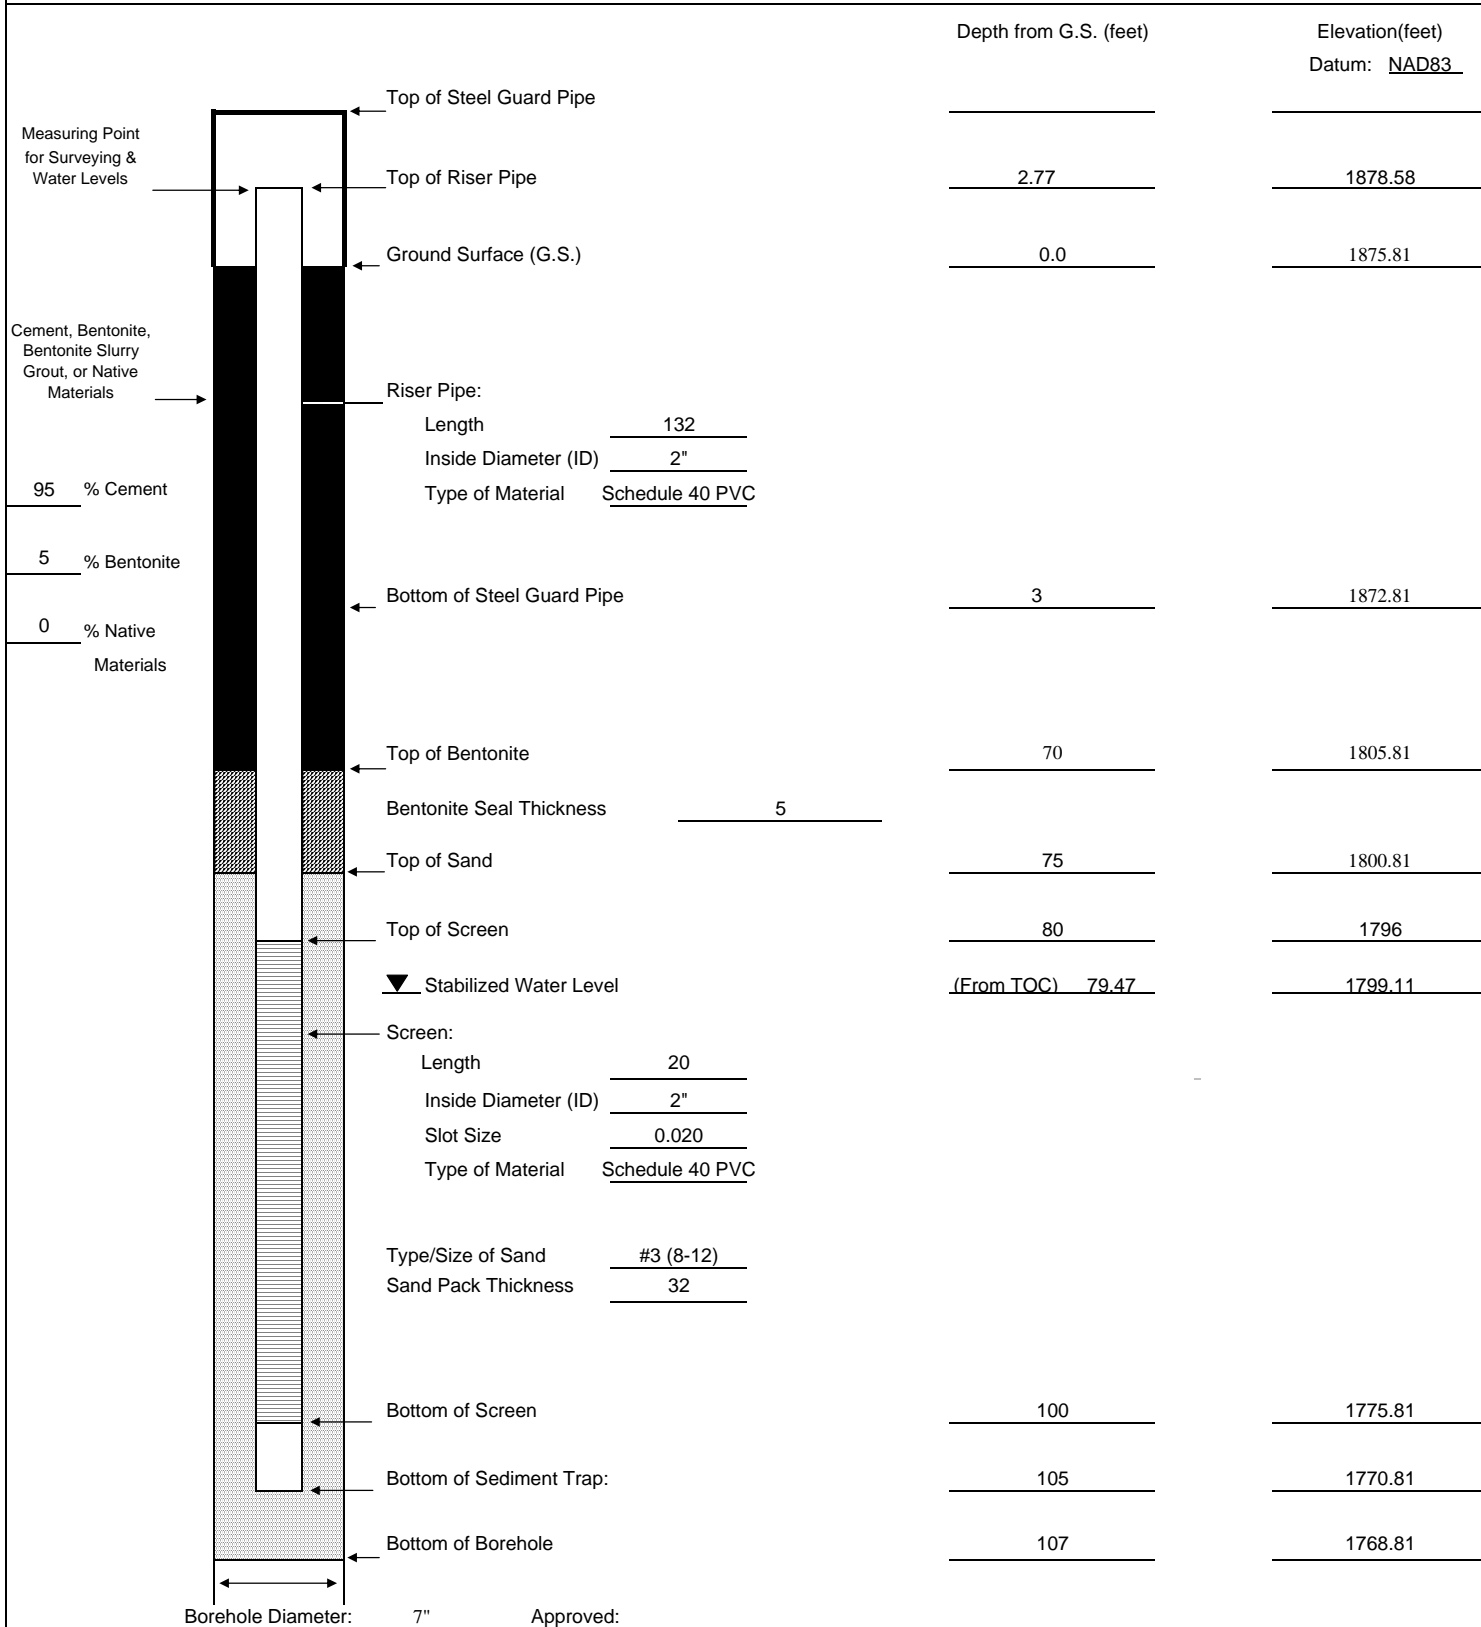
MONITORING WELL CONSTRUCTION DETAIL

Client: <i>Tronox LLC</i>	WELL ID: M-120
Project Number: <i>04020-023-151</i>	
Site Location: <i>Henderson, NV</i>	Date Installed: <i>03/8/06</i>
Well Coords: <i>26715162.900 N, 828387.792 E; NAD 83 Nevada East</i>	Inspector:
Method: <i>Sonic Drilling</i>	Contractor: <i>Prosonic Corporation</i>

Describe Measuring Point: Top of PVC Riser Pipe at 1878.58 feet Approved: SWB Date: 3/8/2006
 Signature _____

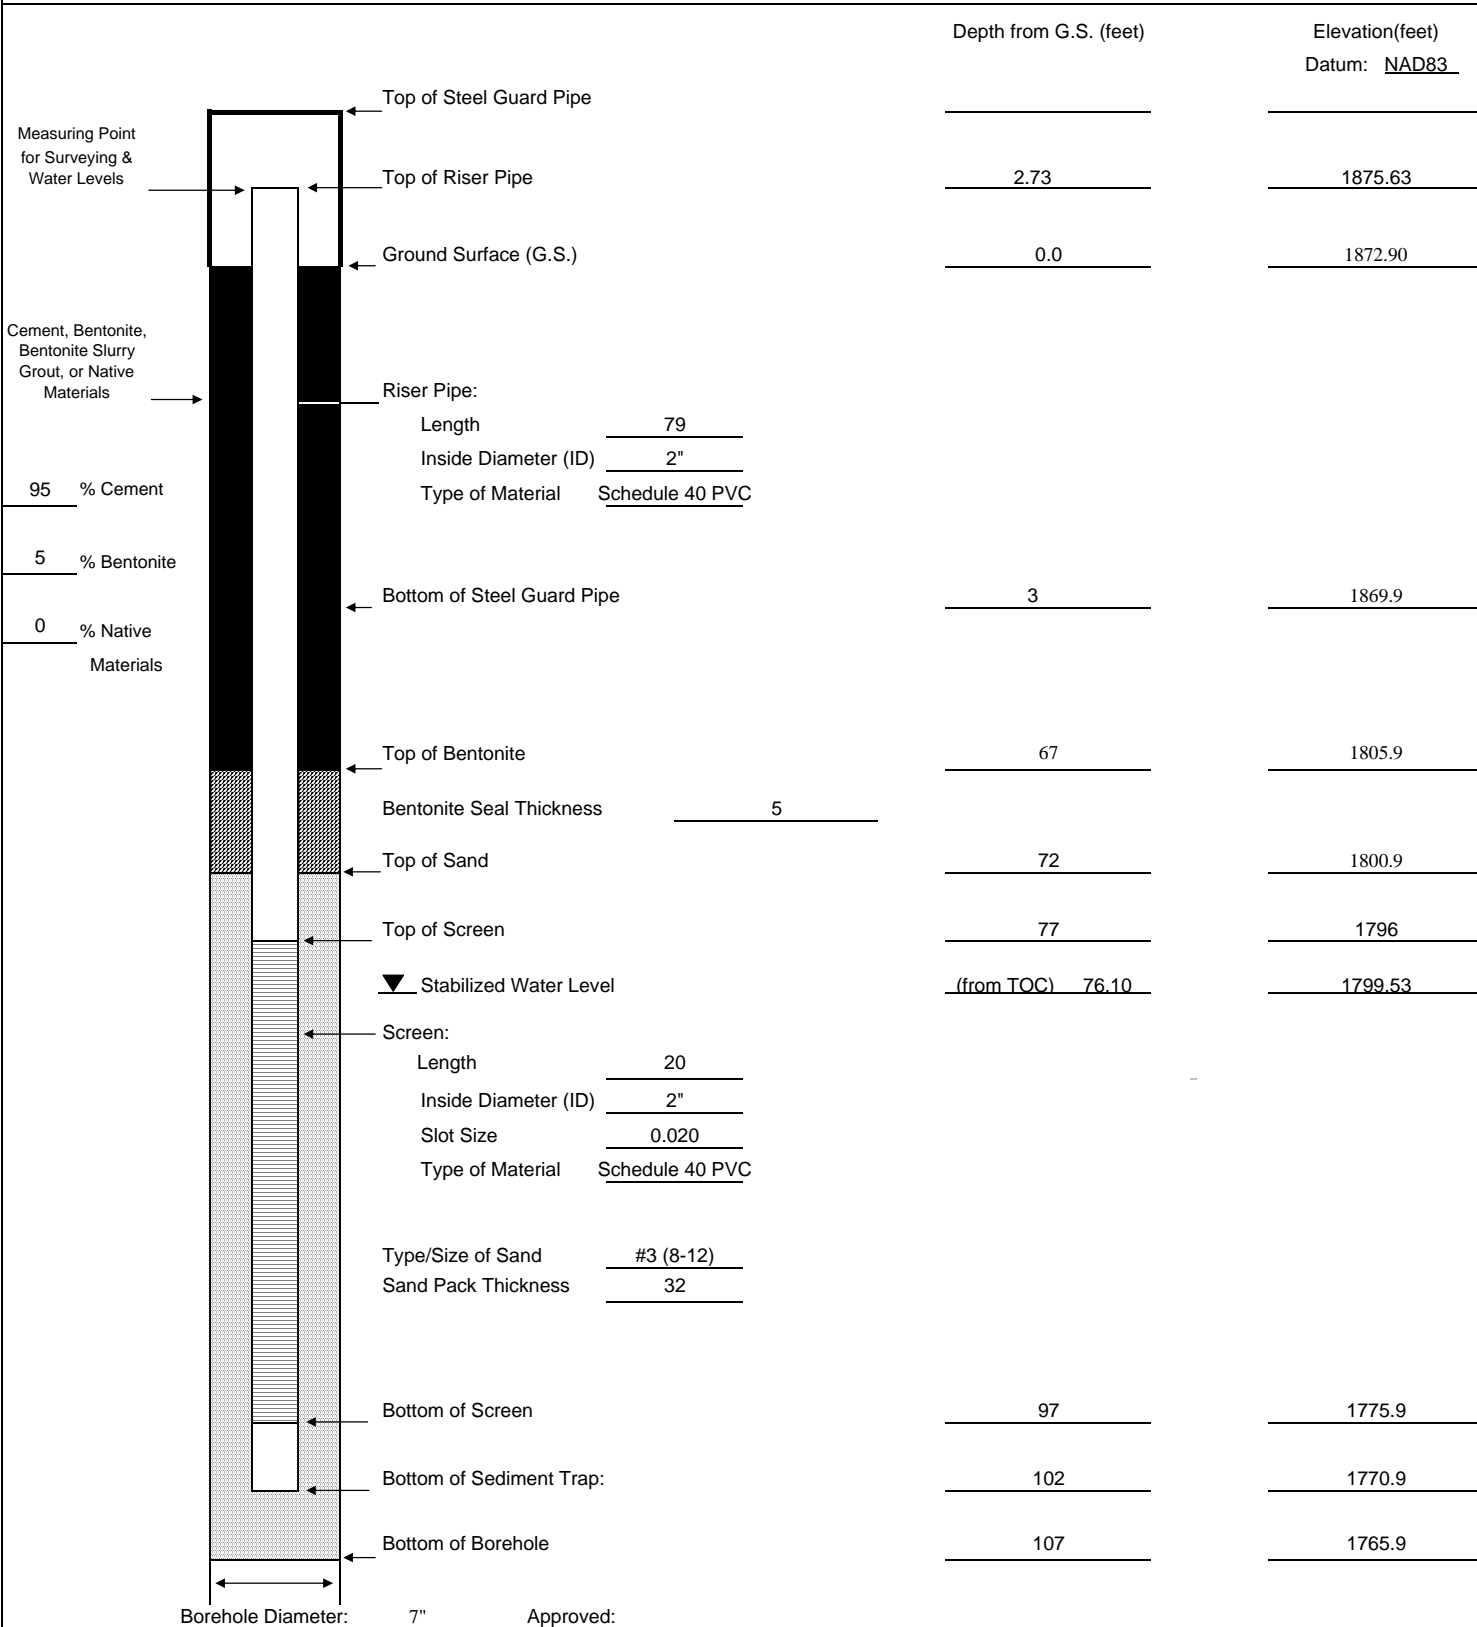
MONITORING WELL CONSTRUCTION DETAIL

Client: <i>Tronox LLC</i>	WELL ID: M-121
Project Number: <i>04020-023-151</i>	
Site Location: <i>Henderson, NV</i>	Date Installed: <i>03/10/06</i>
Well Coords: <i>26715011.237 N, 827694.571 E ; NAD 83 Nevada East</i>	Inspector:
Method: <i>Sonic Drilling</i>	Contractor: <i>Prosonic Corporation</i>

Describe Measuring Point: Top of PVC Riser Pipe at 1875.63 feet SWB 3/11/2006
