Appendix C

Monitoring Well Construction Diagrams

Client: <i>Tronox LLC</i>	WELL ID: M-117
Project Number: <i>04020-023-151</i>	
Site Location: <i>Henderson, NV</i>	Date Installed: <i>03/12/06</i>
Well Coords: <i>26715198.289 N, 828917.057 E ; NAD 83 Nevada East</i>	Inspector:
Method: <i>Sonic Drilling</i>	Contractor: <i>Prosonic Corporation</i>

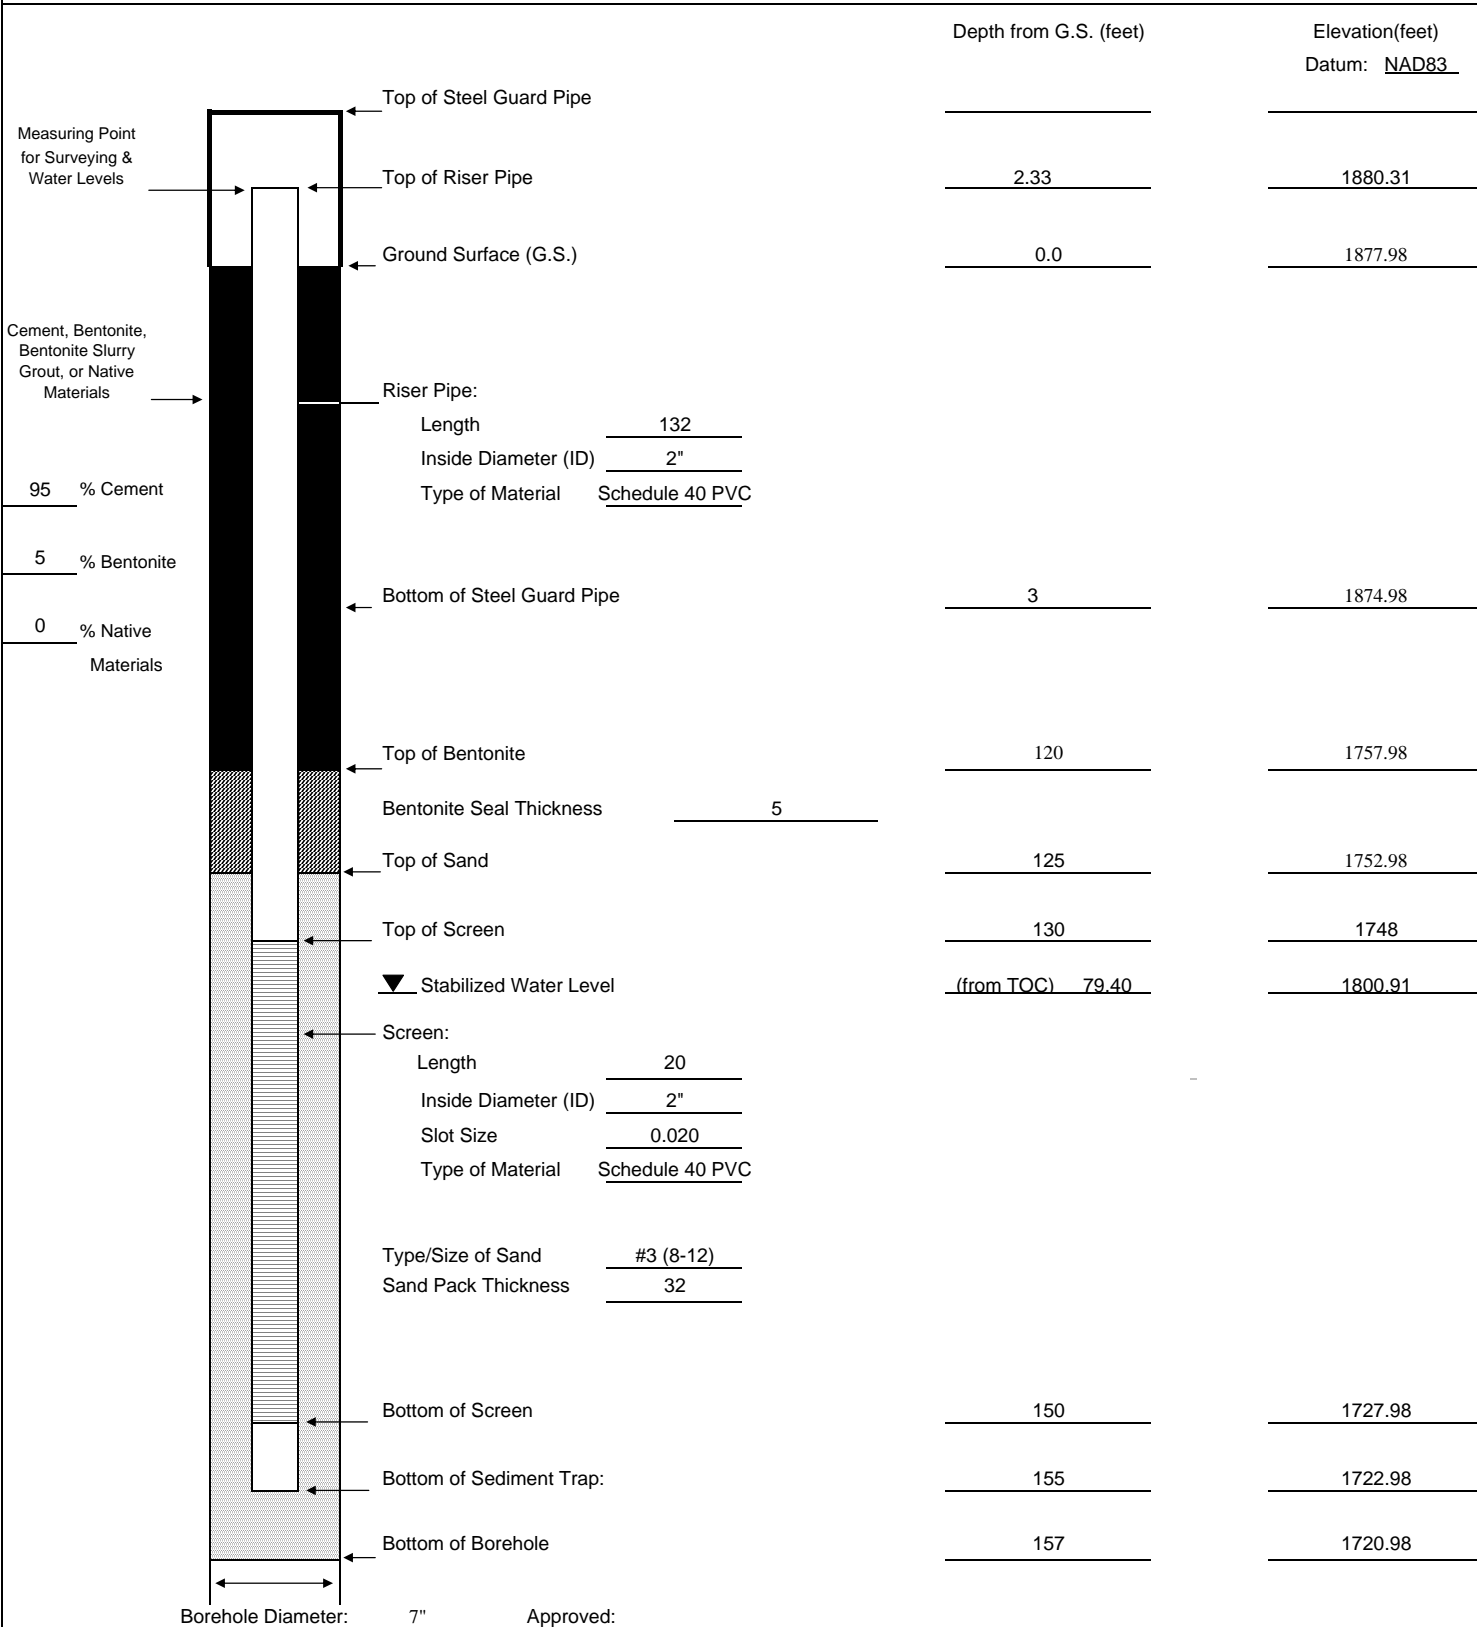
MONITORING WELL CONSTRUCTION DETAIL

Describe Measuring Point: Top of PVC Riser Pipe at 1880.31 feet

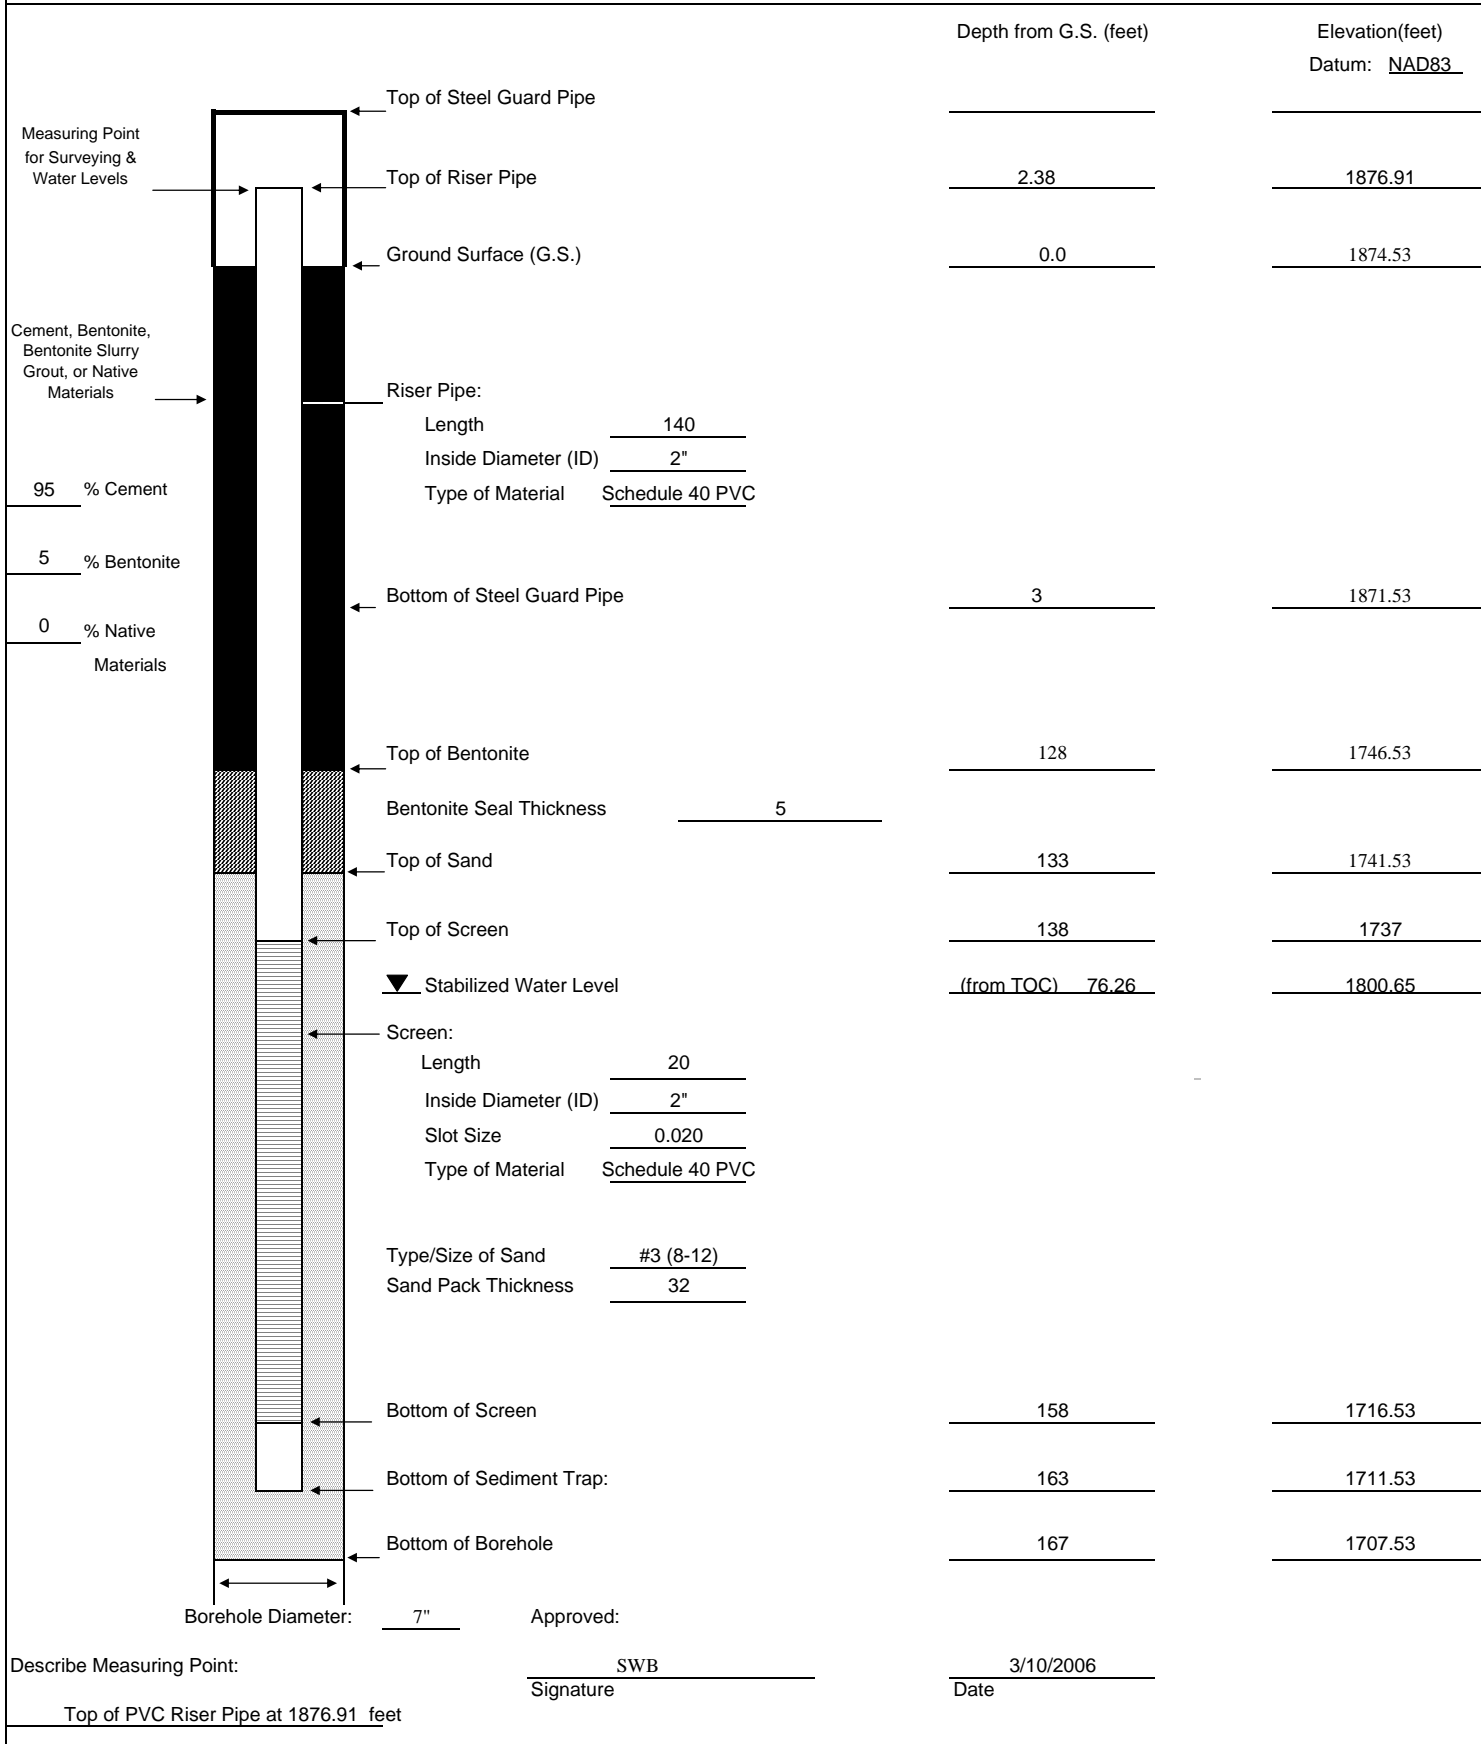
MONITORING WELL CONSTRUCTION DETAIL

Client: <i>Tronox LLC</i>	WELL ID: M-118
Project Number: <i>04020-023-151</i>	
Site Location: <i>Henderson, NV</i>	Date Installed: <i>03/9/06</i>
Well Coords: <i>26715068.012 N, 828036.397 E ; NAD 83 Nevada East</i>	Inspector:
Method: <i>Sonic Drilling</i>	Contractor: <i>Prosonic Corporation</i>

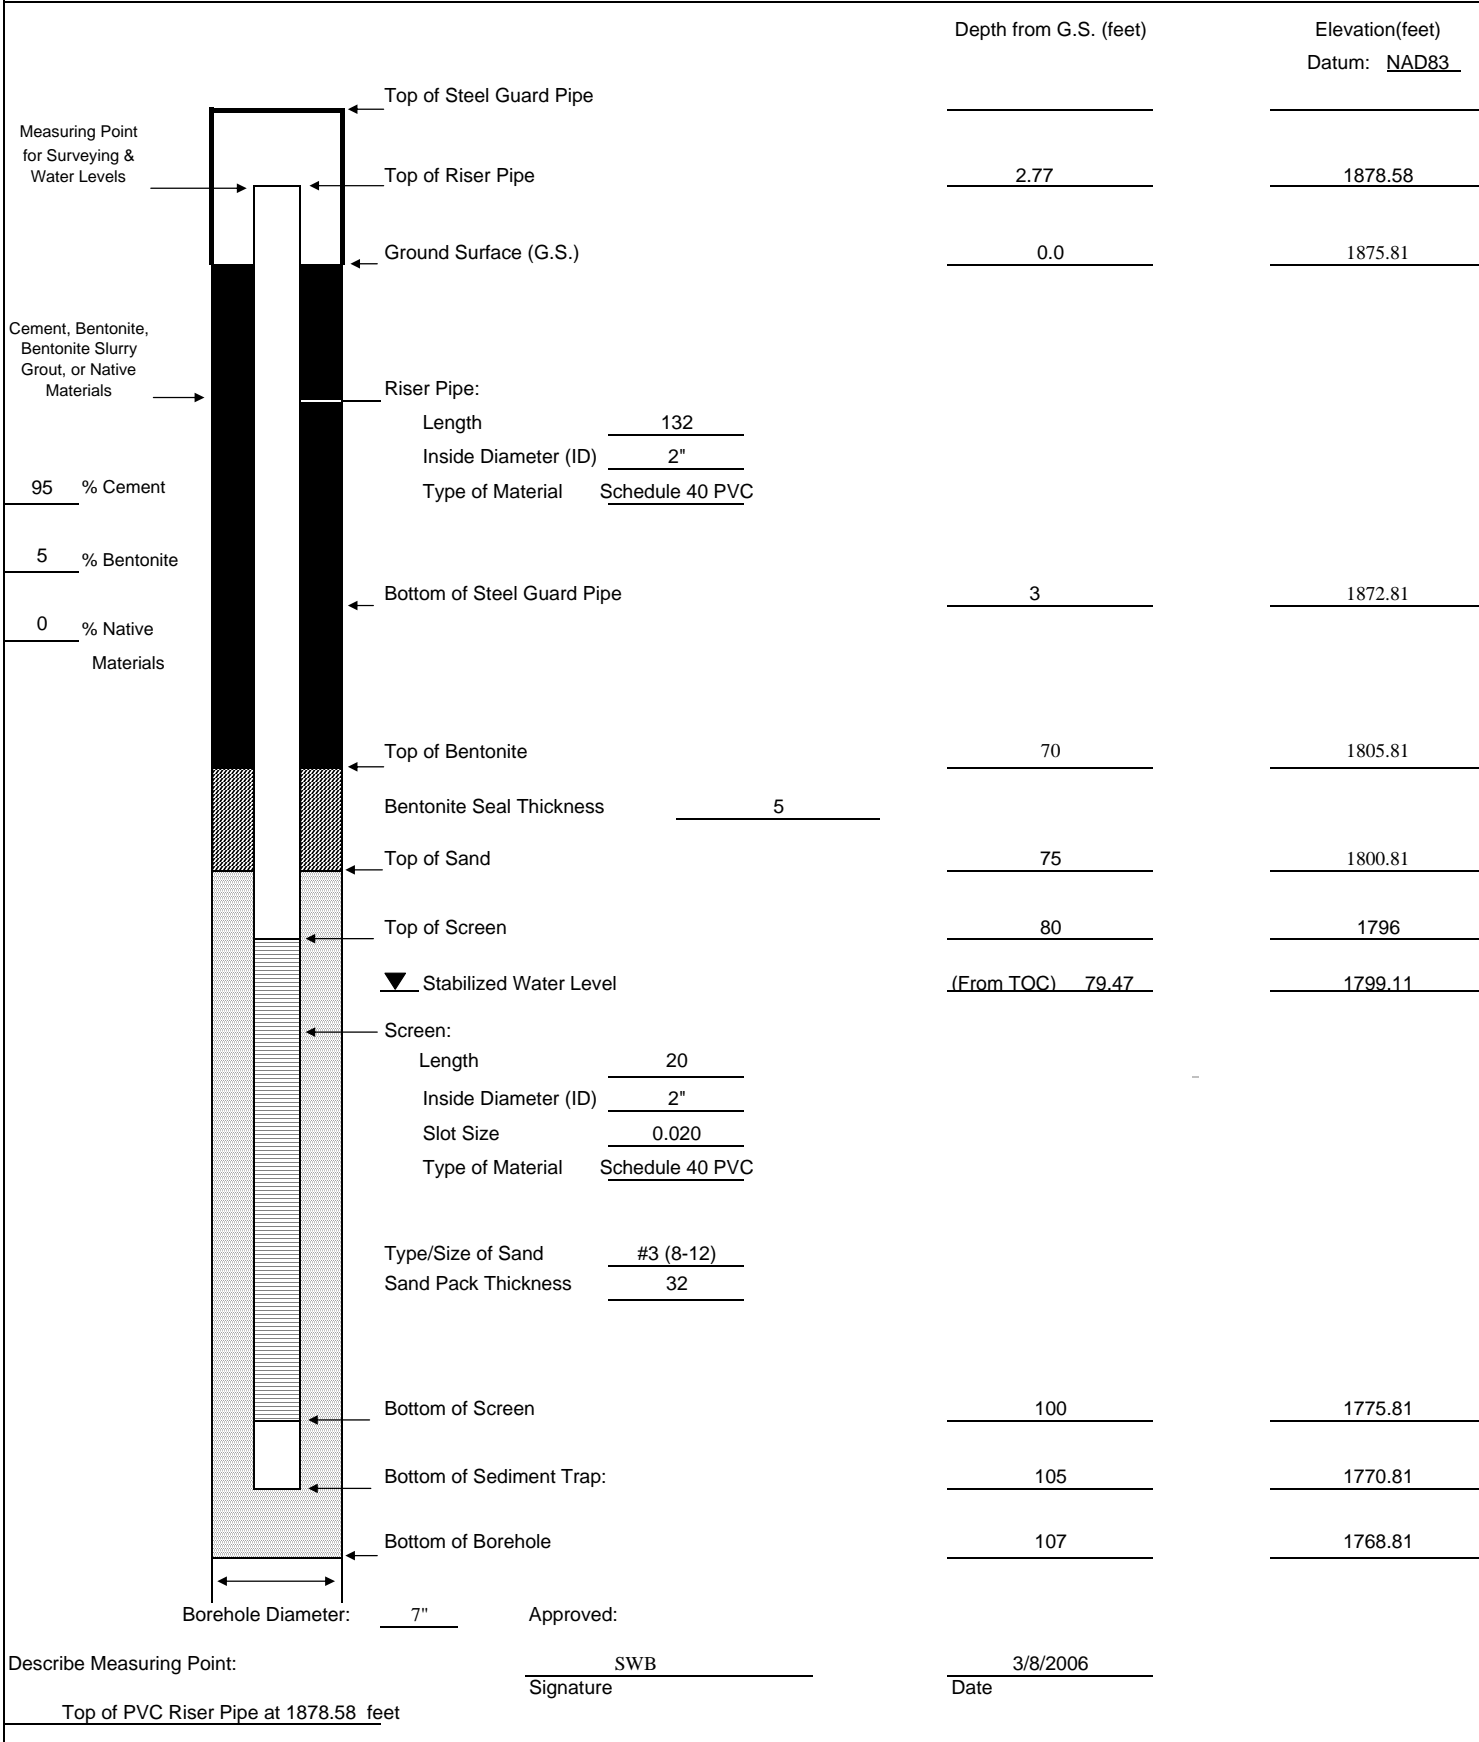
MONITORING WELL CONSTRUCTION DETAIL

Client: <i>Tronox LLC</i>	WELL ID: M-120
Project Number: <i>04020-023-151</i>	
Site Location: <i>Henderson, NV</i>	Date Installed: <i>03/8/06</i>
Well Coords: <i>26715162.900 N, 828387.792 E; NAD 83 Nevada East</i>	Inspector:
Method: <i>Sonic Drilling</i>	Contractor: <i>Prosonic Corporation</i>

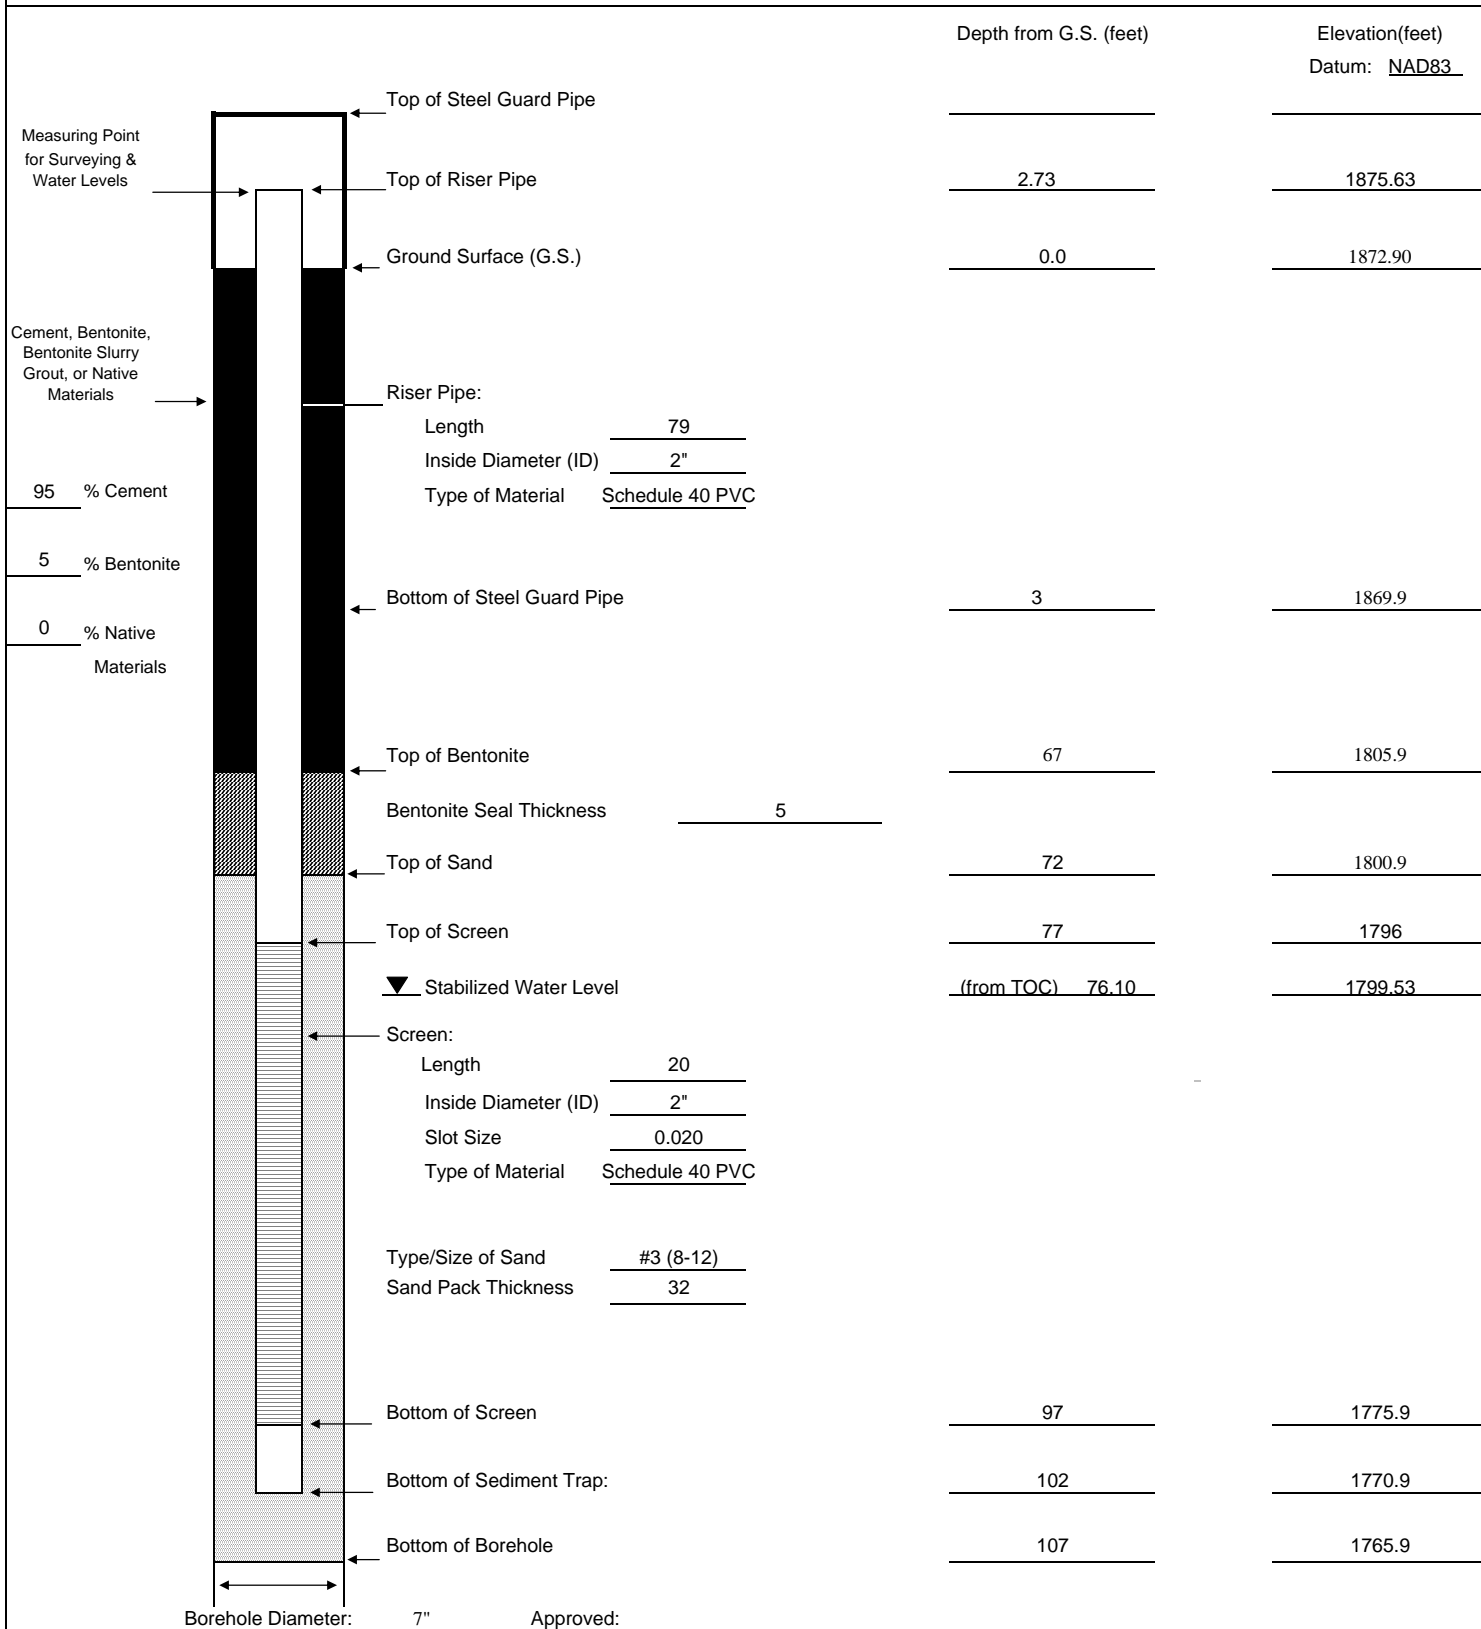
MONITORING WELL CONSTRUCTION DETAIL

Client: <i>Tronox LLC</i>	WELL ID: M-121
Project Number: <i>04020-023-151</i>	
Site Location: <i>Henderson, NV</i>	Date Installed: <i>03/10/06</i>
Well Coords: <i>26715011.237 N, 827694.571 E ; NAD 83 Nevada East</i>	Inspector:
Method: <i>Sonic Drilling</i>	Contractor: <i>Prosonic Corporation</i>

Describe Measuring Point: Top of PVC Riser Pipe at 1875.63 feet SWB _____ 3/11/2006
