Location: Nevada Facility, Henderson, NV	Position: NORTHGATE	Ground level:	Test No.: PSS-2
Project ID:	Client: NORTHGATE	Date: 10-4-10	Scale: 1 : 61
Project: TRONOX REMEDIATION		Page: 1/1	Fig.:
		File: CA04O1002C.cpd

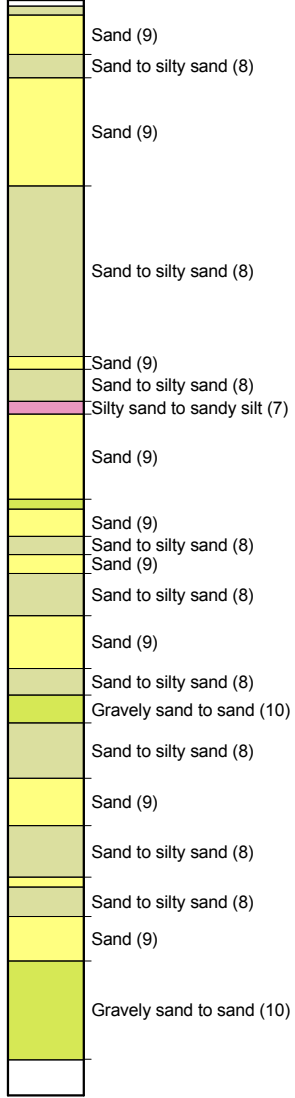
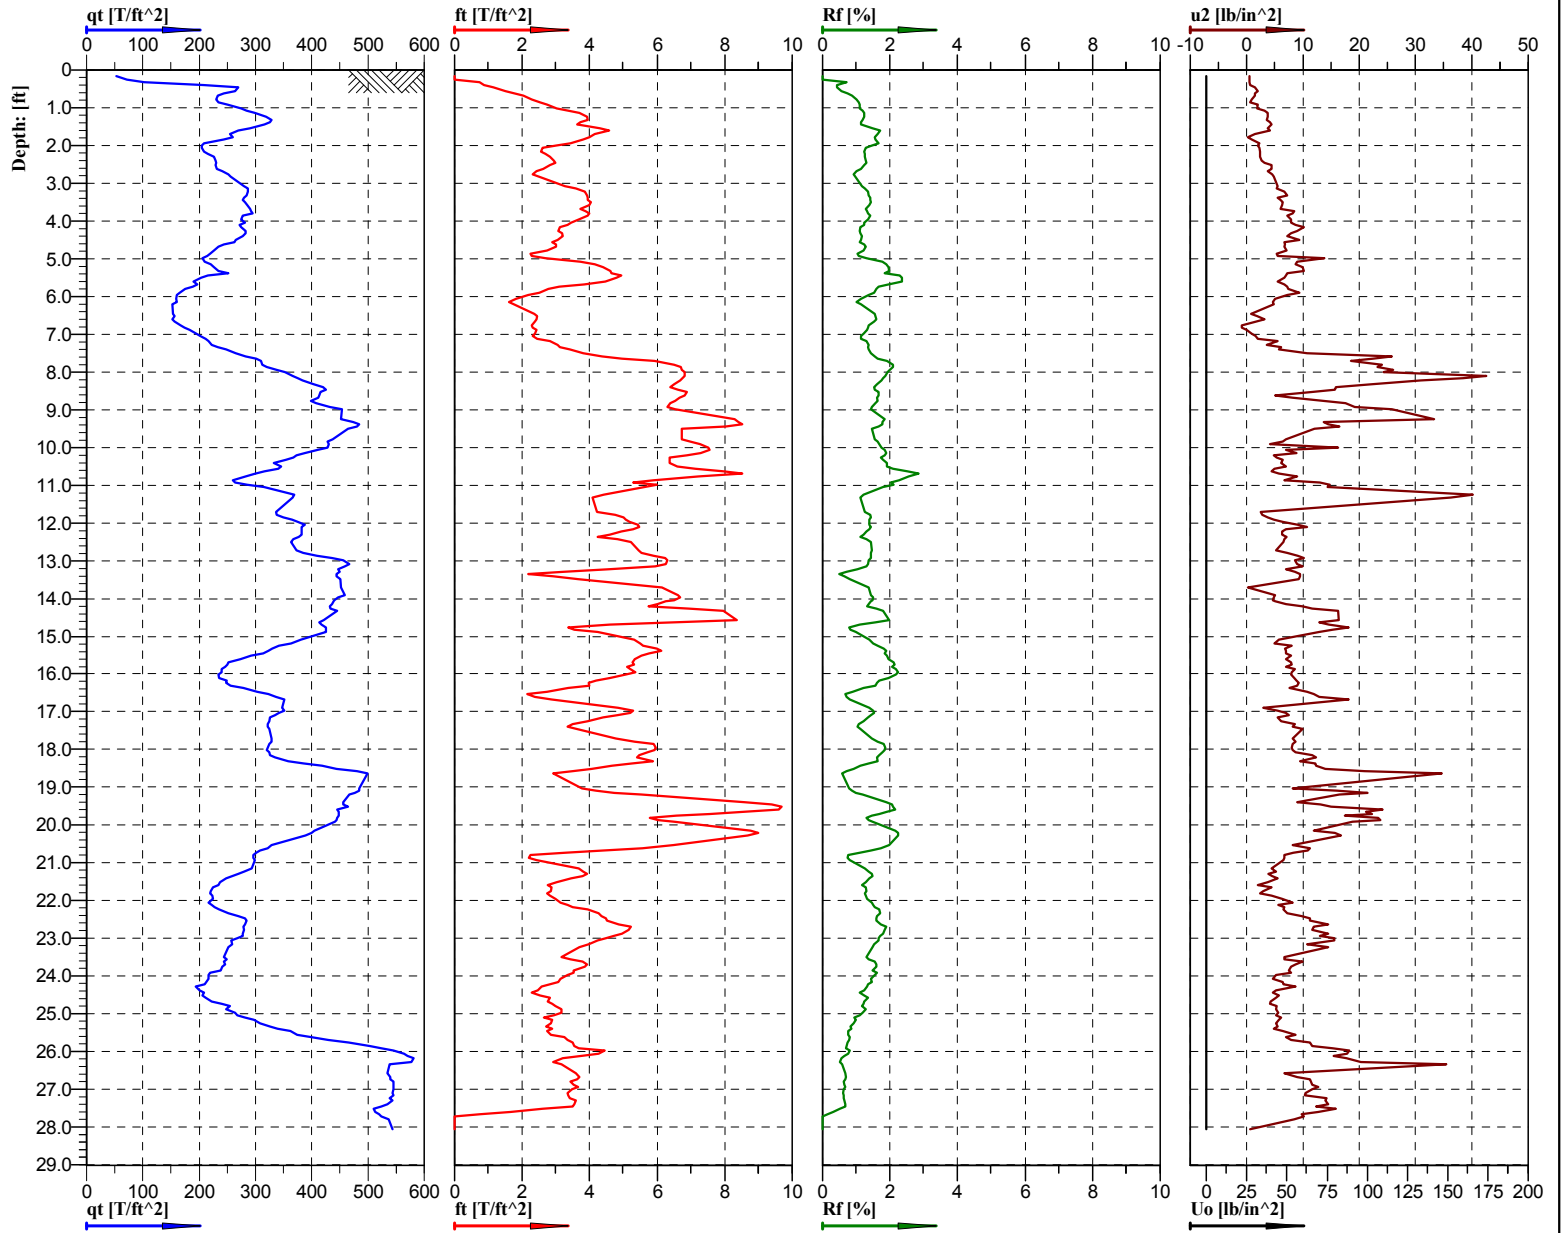
**Classification by Robertson 1986**
