Site Management Plan

Nevada Environmental Response Trust Site
Henderson, Nevada

Prepared by:
ENVIRON International Corporation
Emeryville, California

Date:
September 2013

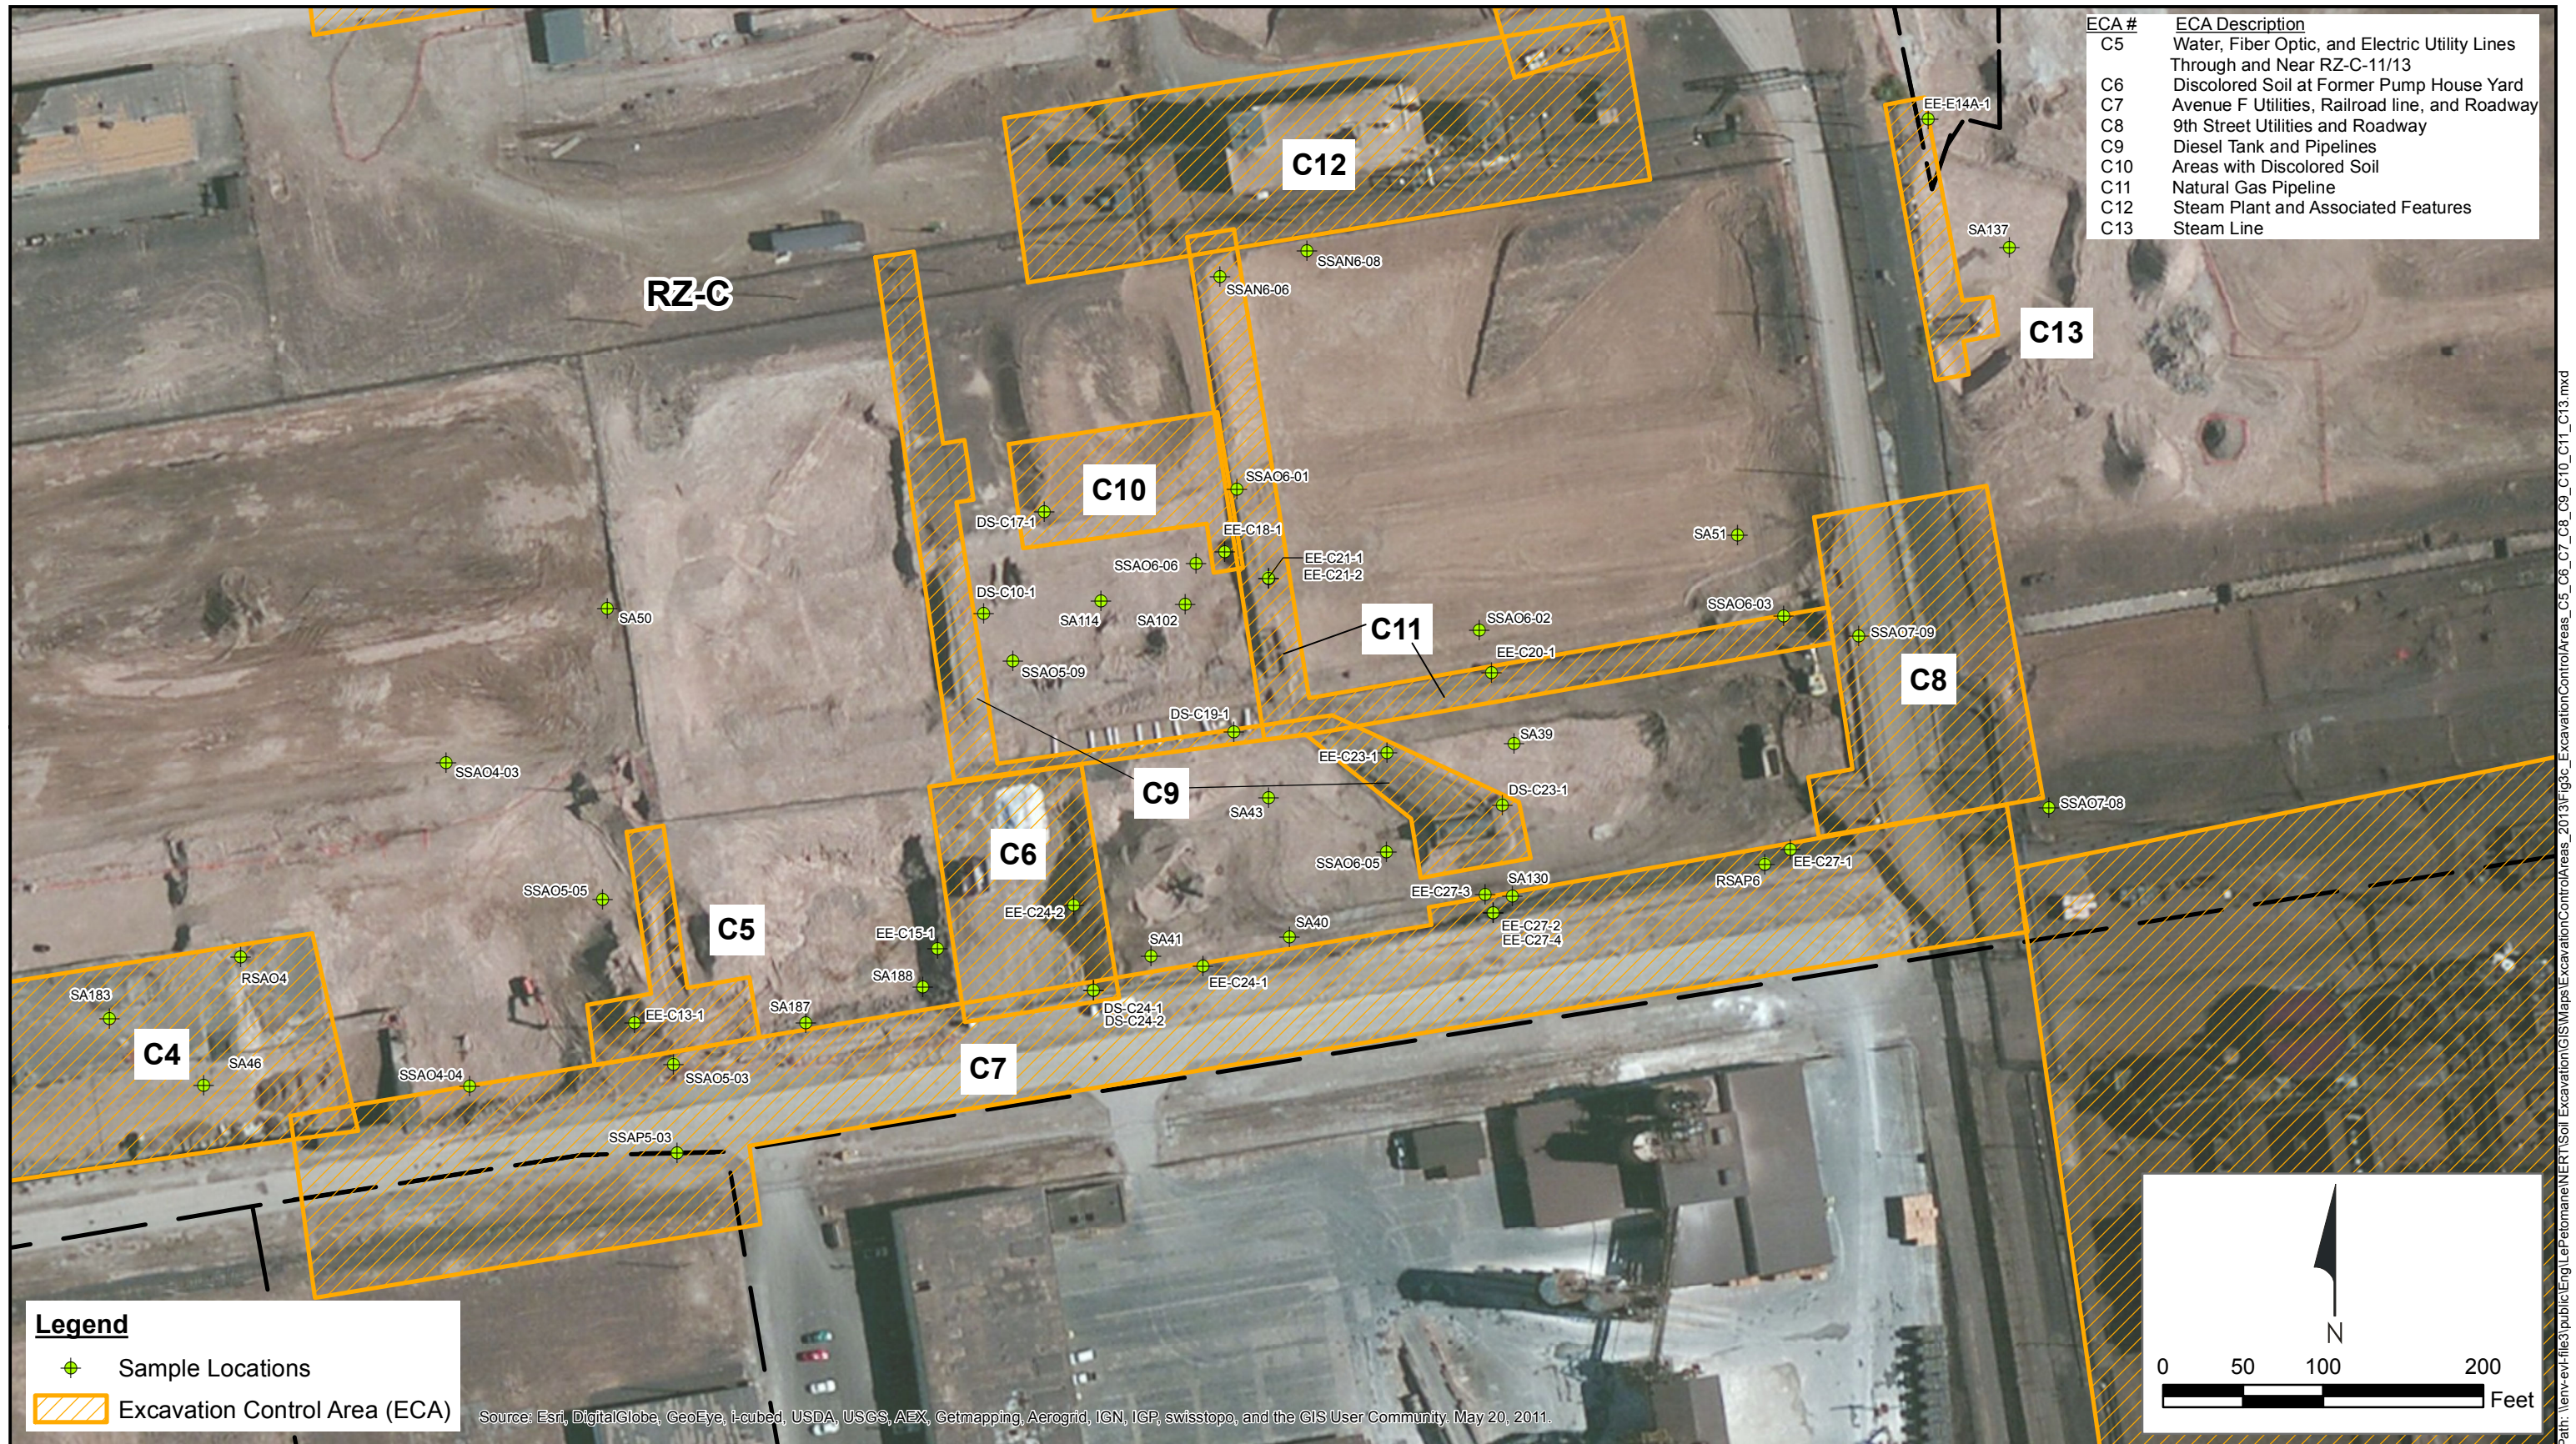
Figure
3c

Excavation Control Areas C5, C6, C7, C8, C9, C10, C11, C12, and C13 Nevada Environmental Response Trust Site, Henderson, Nevada

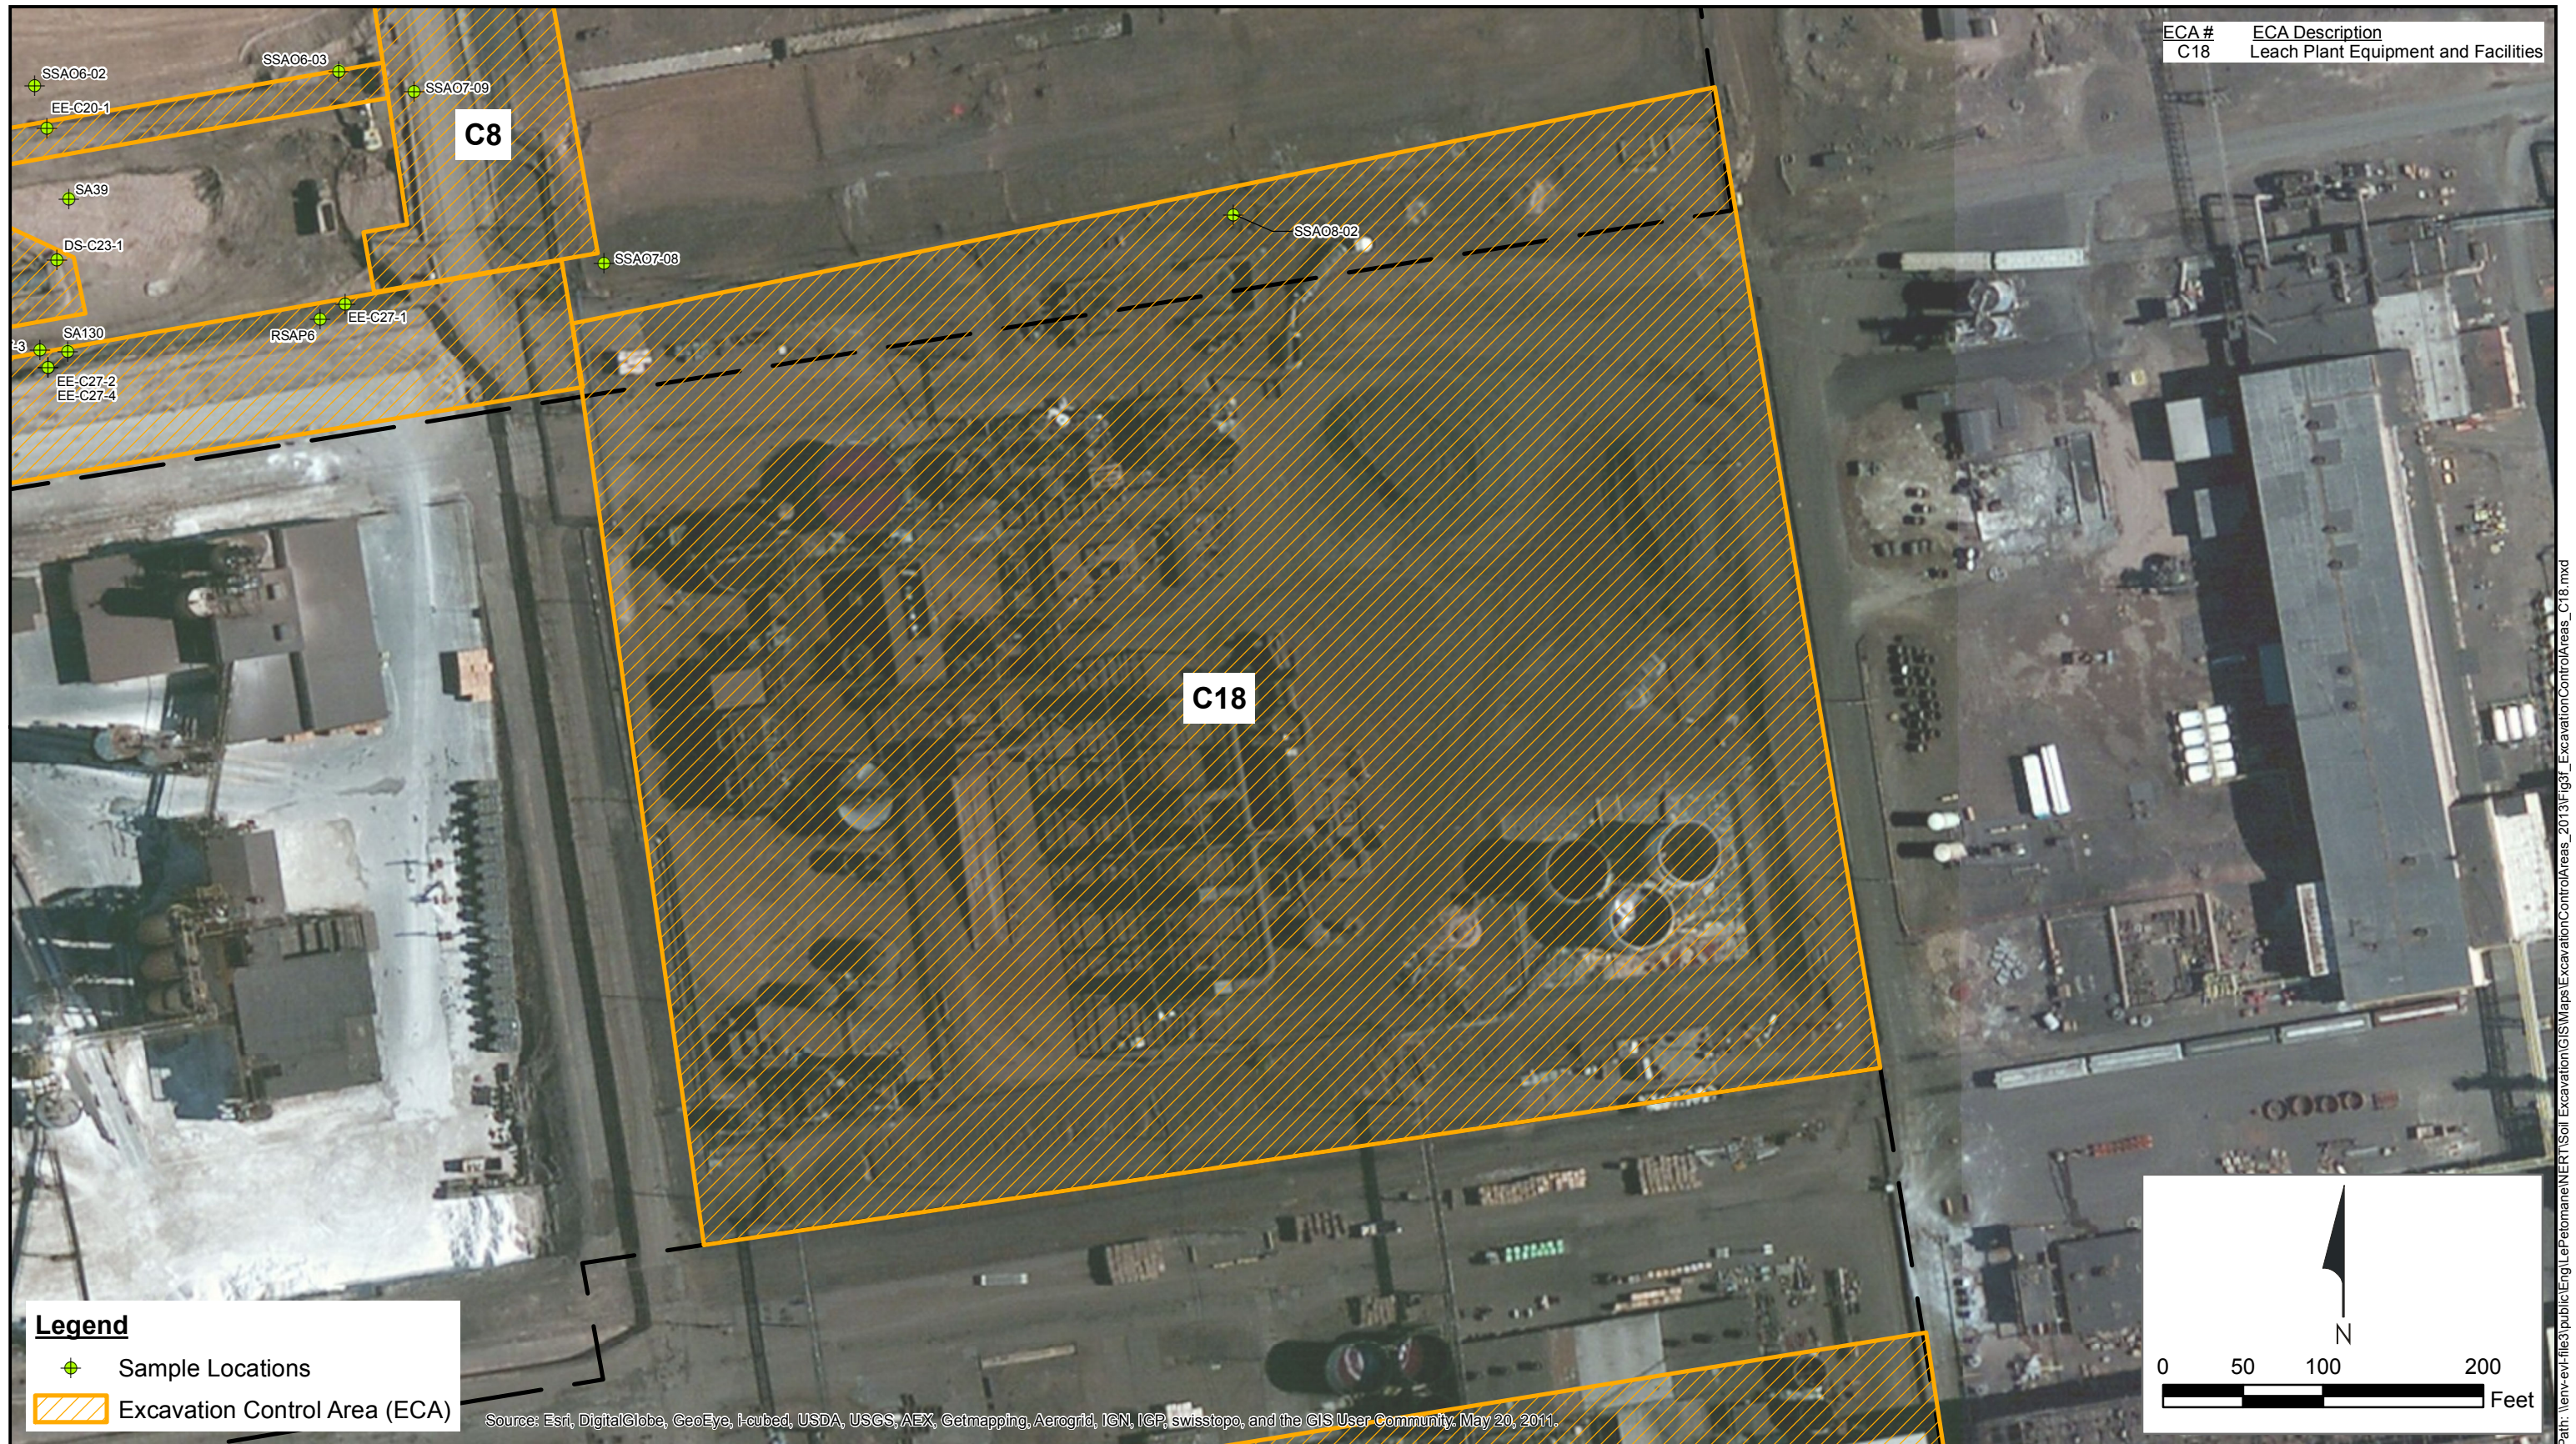
ECA #	ECA Description
C18	Leach Plant Equipment and Facilities

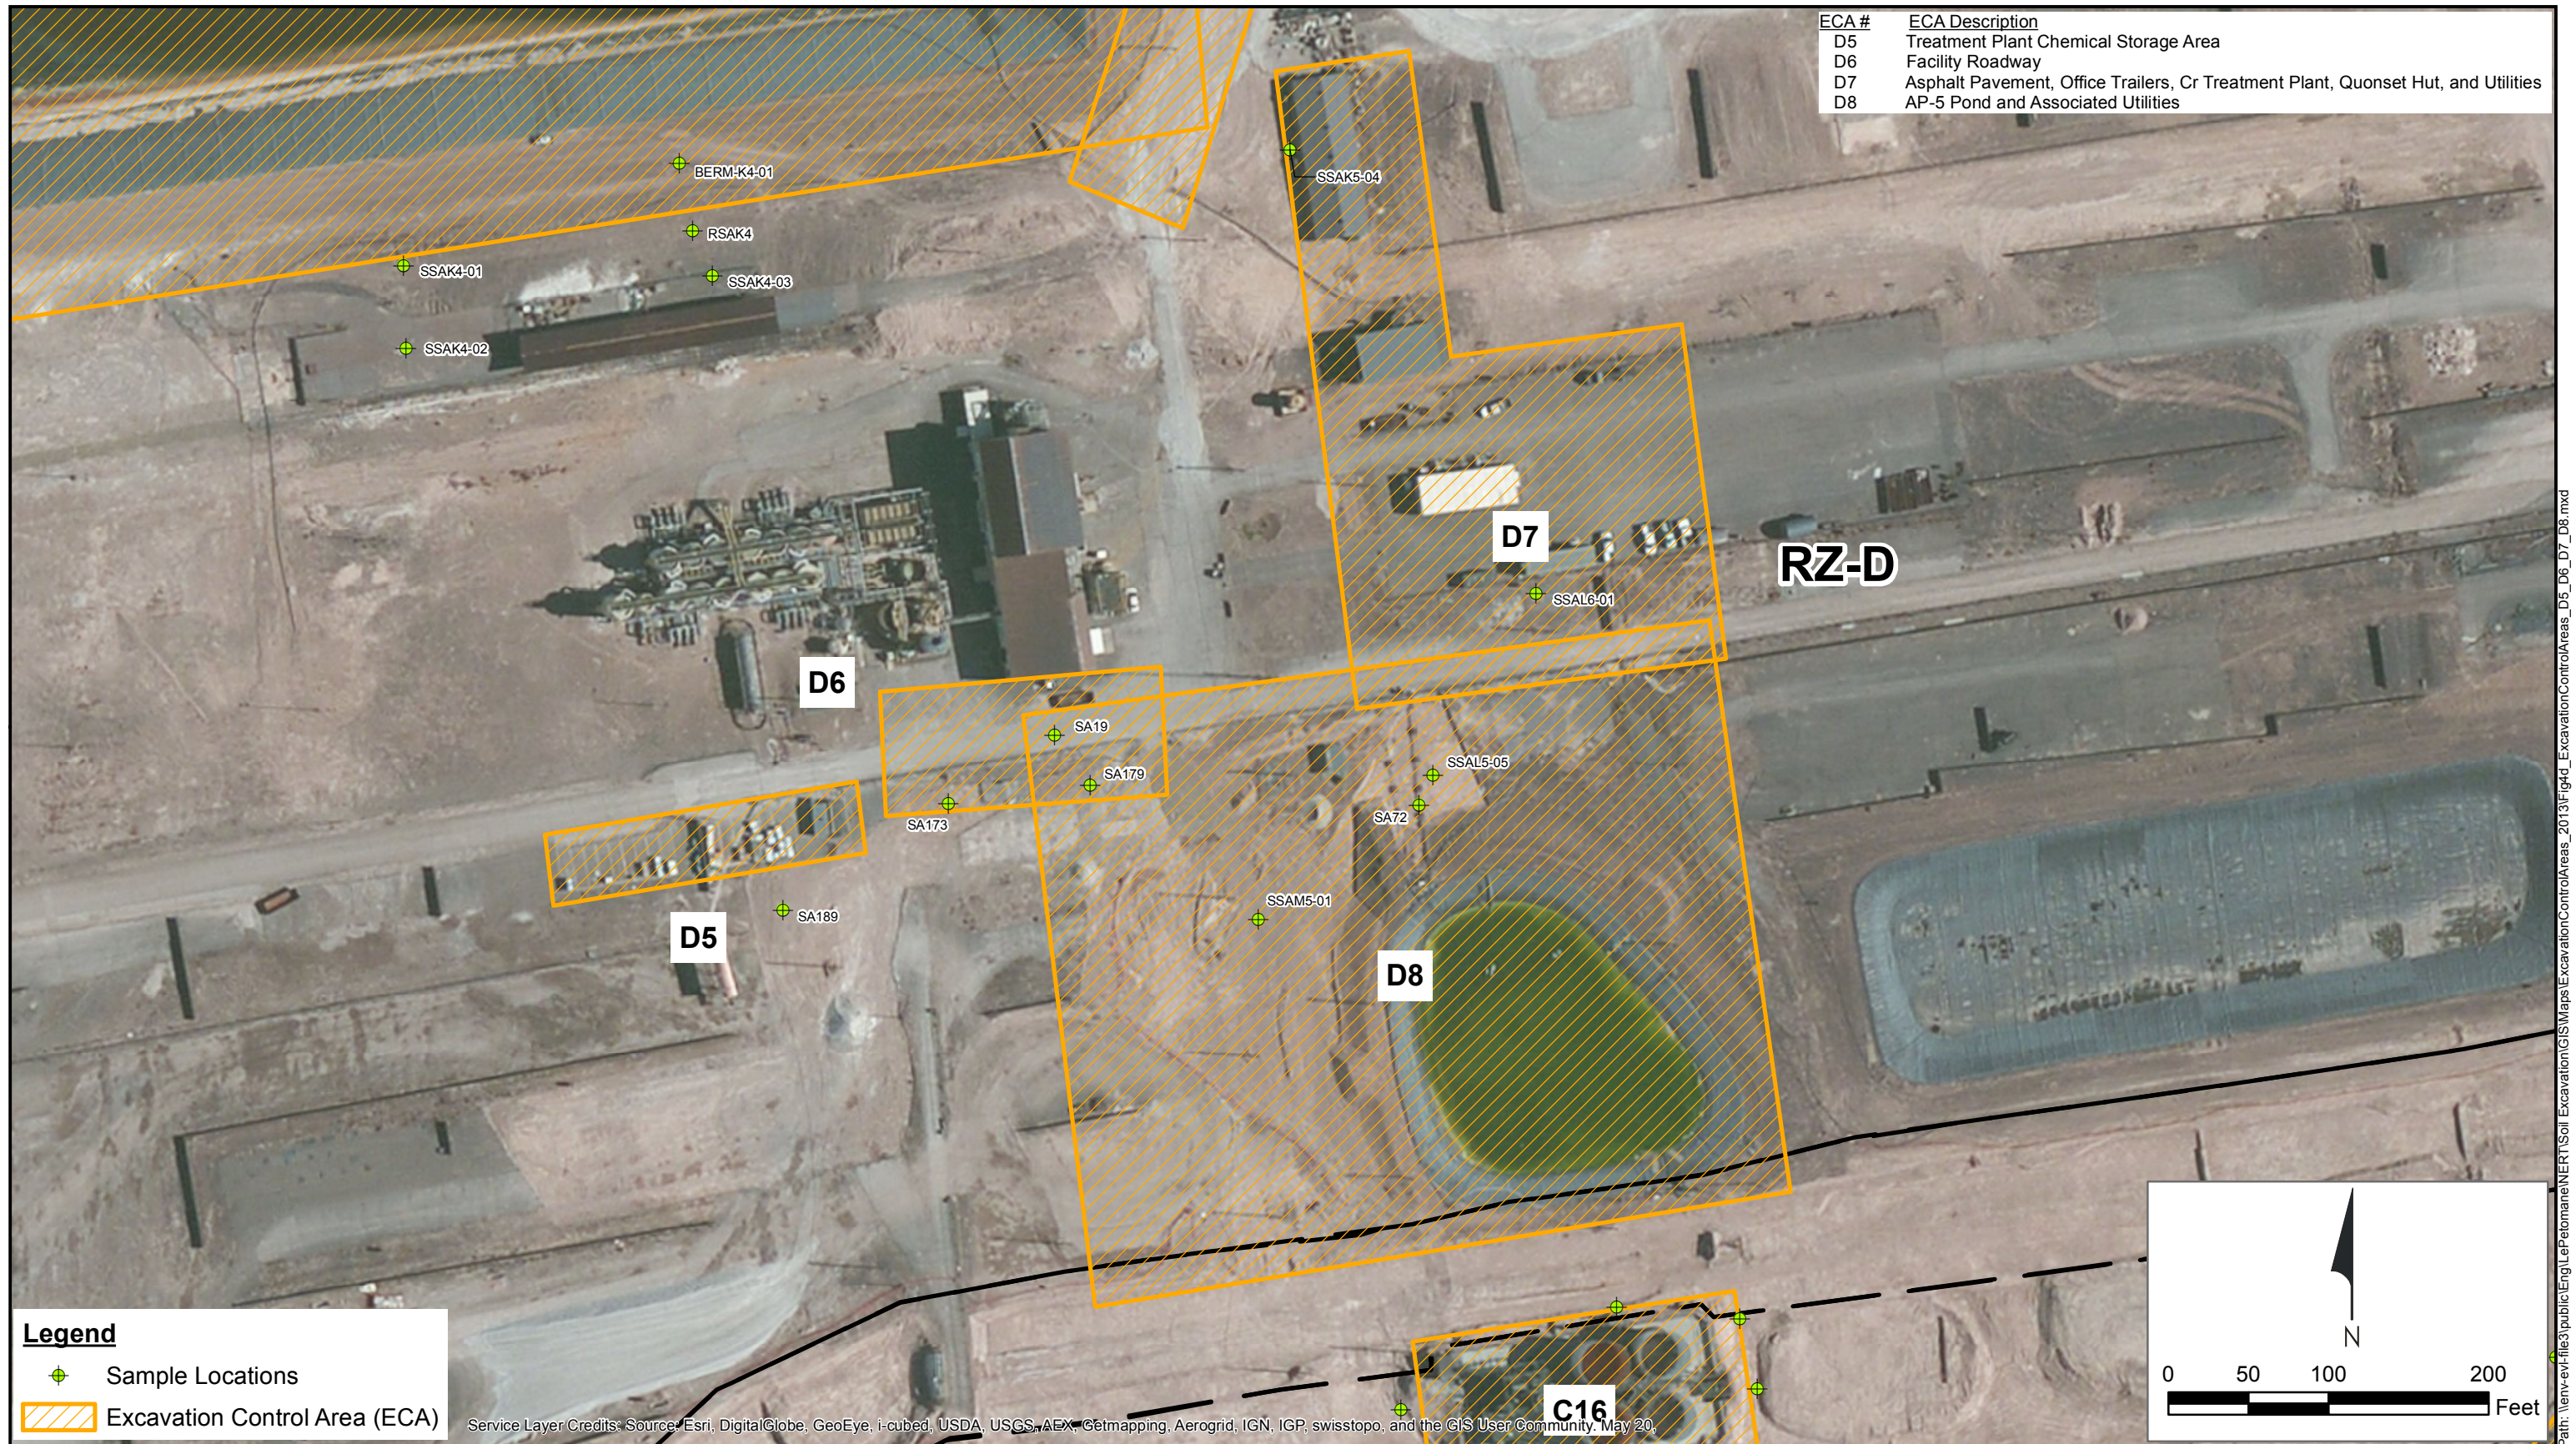
ECA #	ECA Description
D5	Treatment Plant Chemical Storage Area
D6	Facility Roadway
D7	Asphalt Pavement, Office Trailers, Cr Treatment Plant, Quonset Hut, and Utilities
D8	AP-5 Pond and Associated Utilities

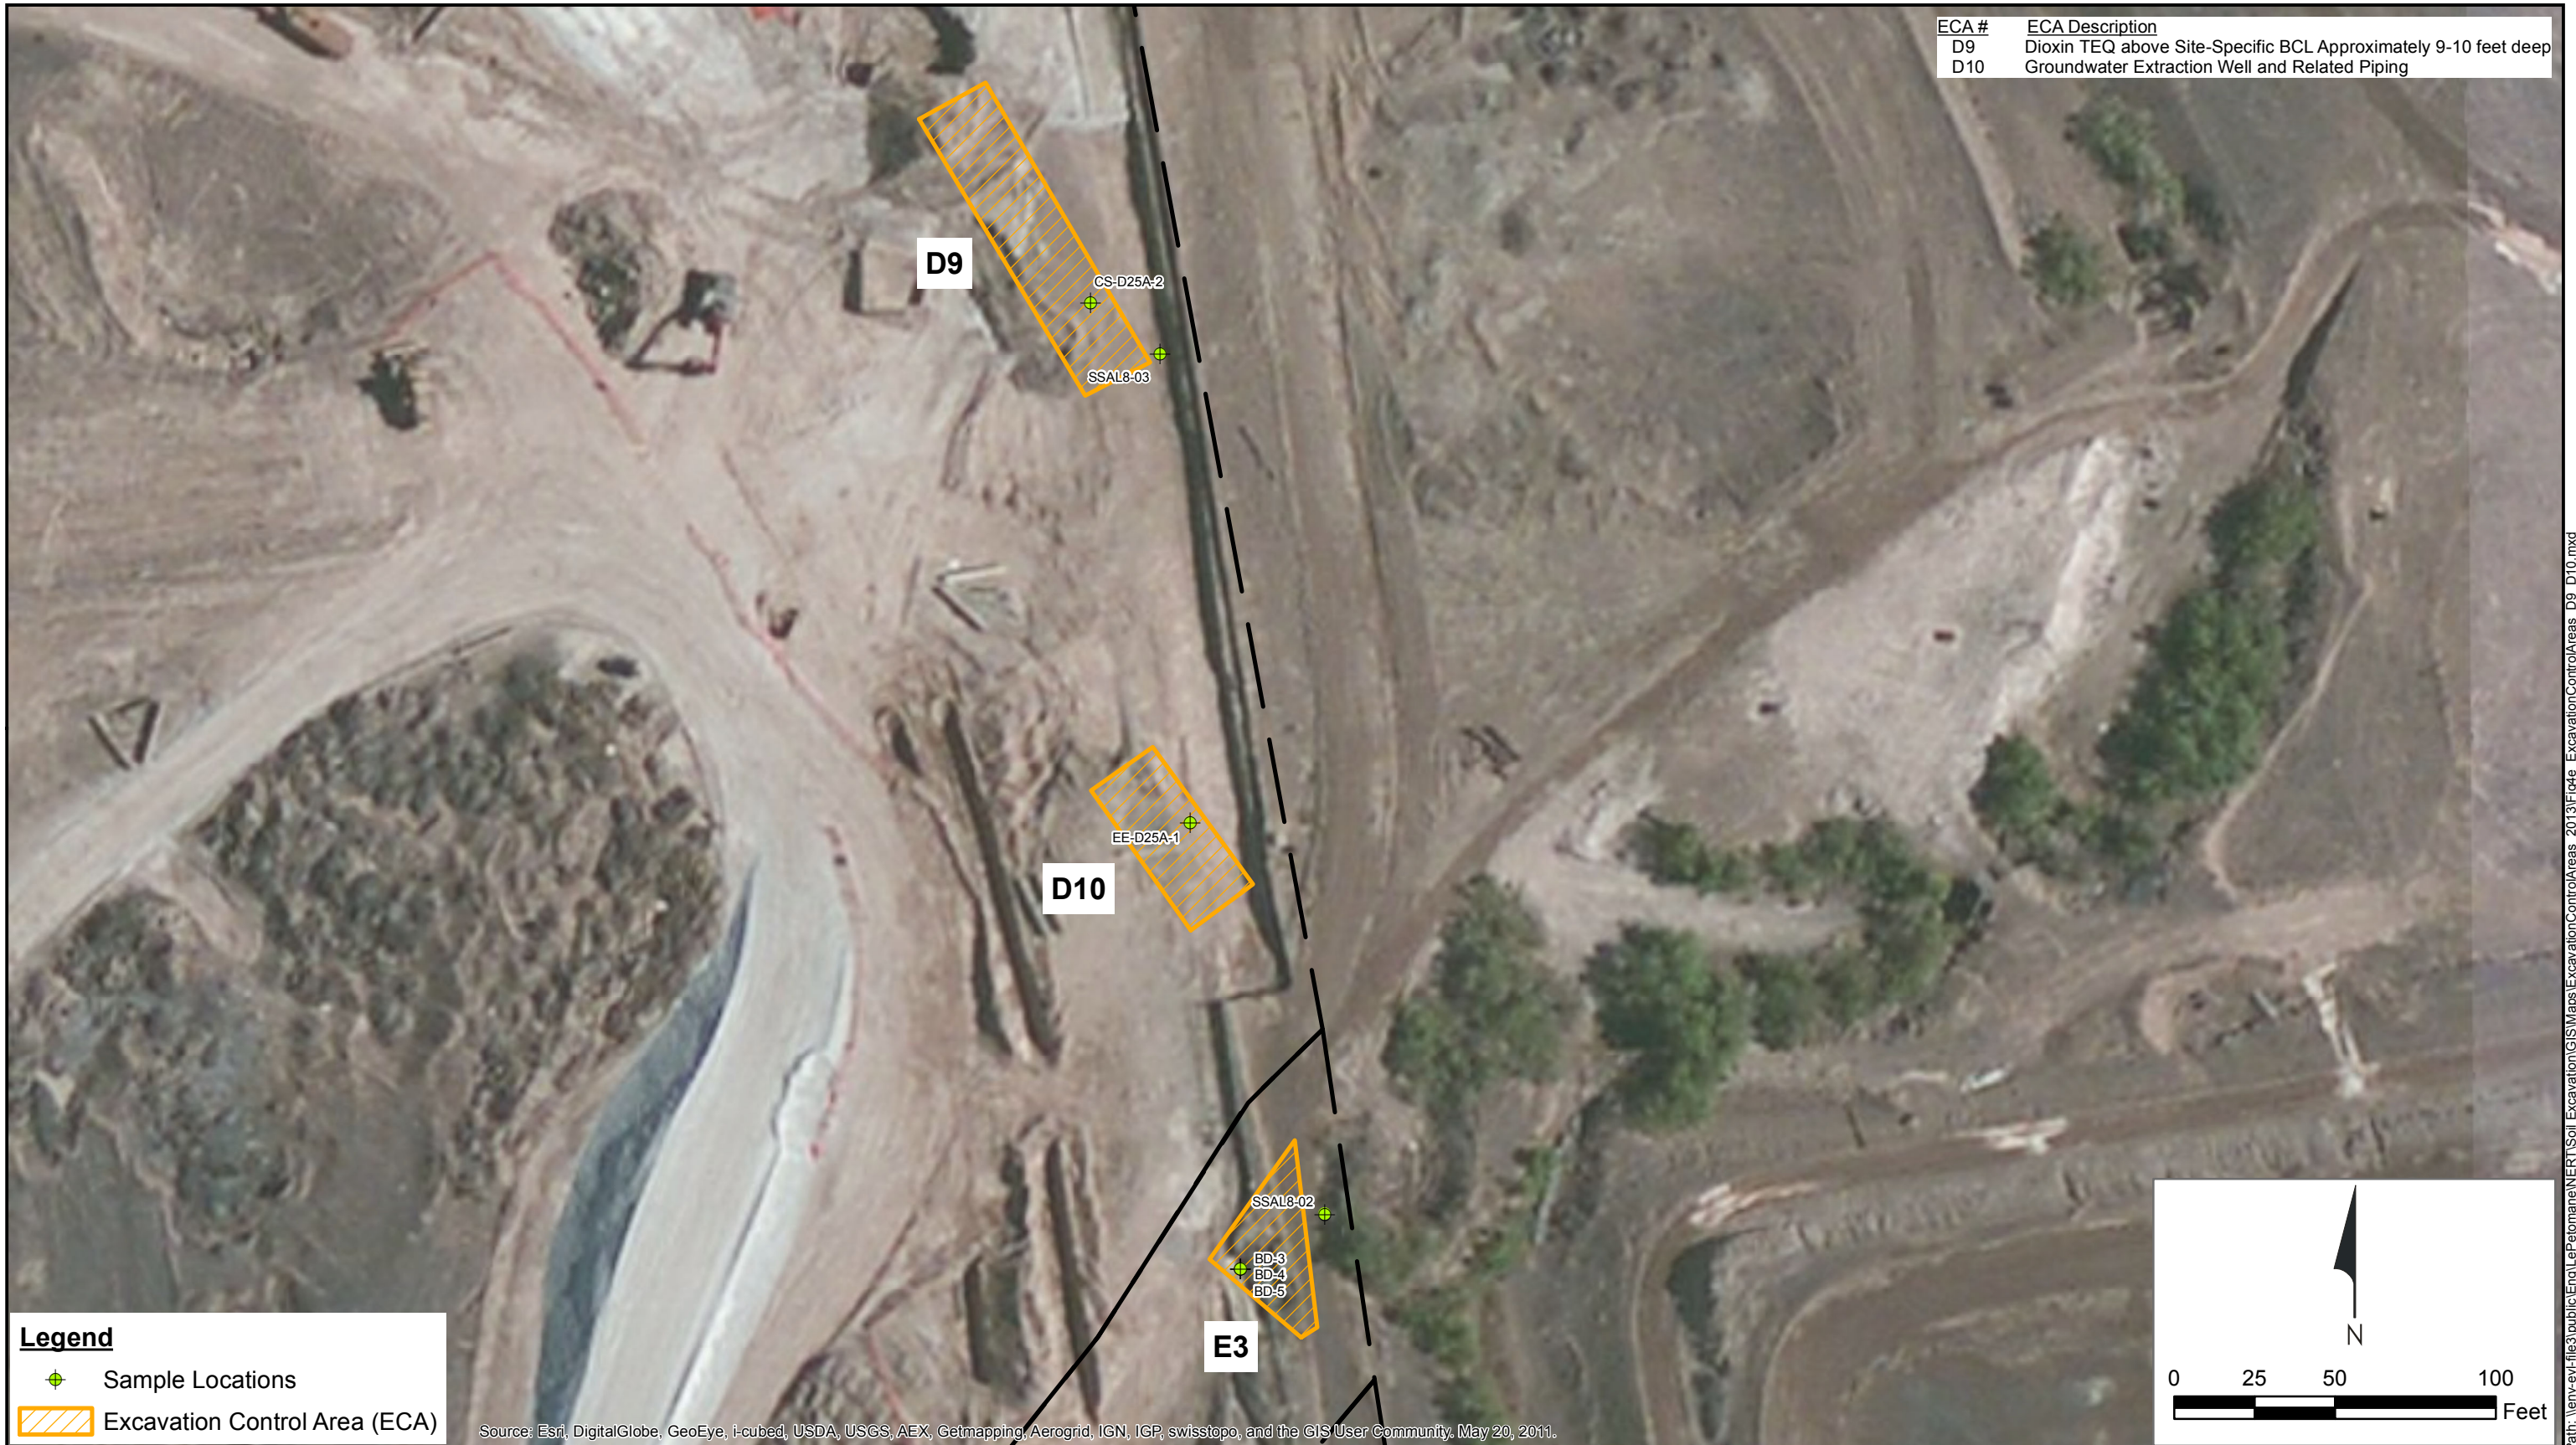
ECA #	ECA Description
D9	Dioxin TEQ above Site-Specific BCL Approximately 9-10 feet deep
D10	Groundwater Extraction Well and Related Piping

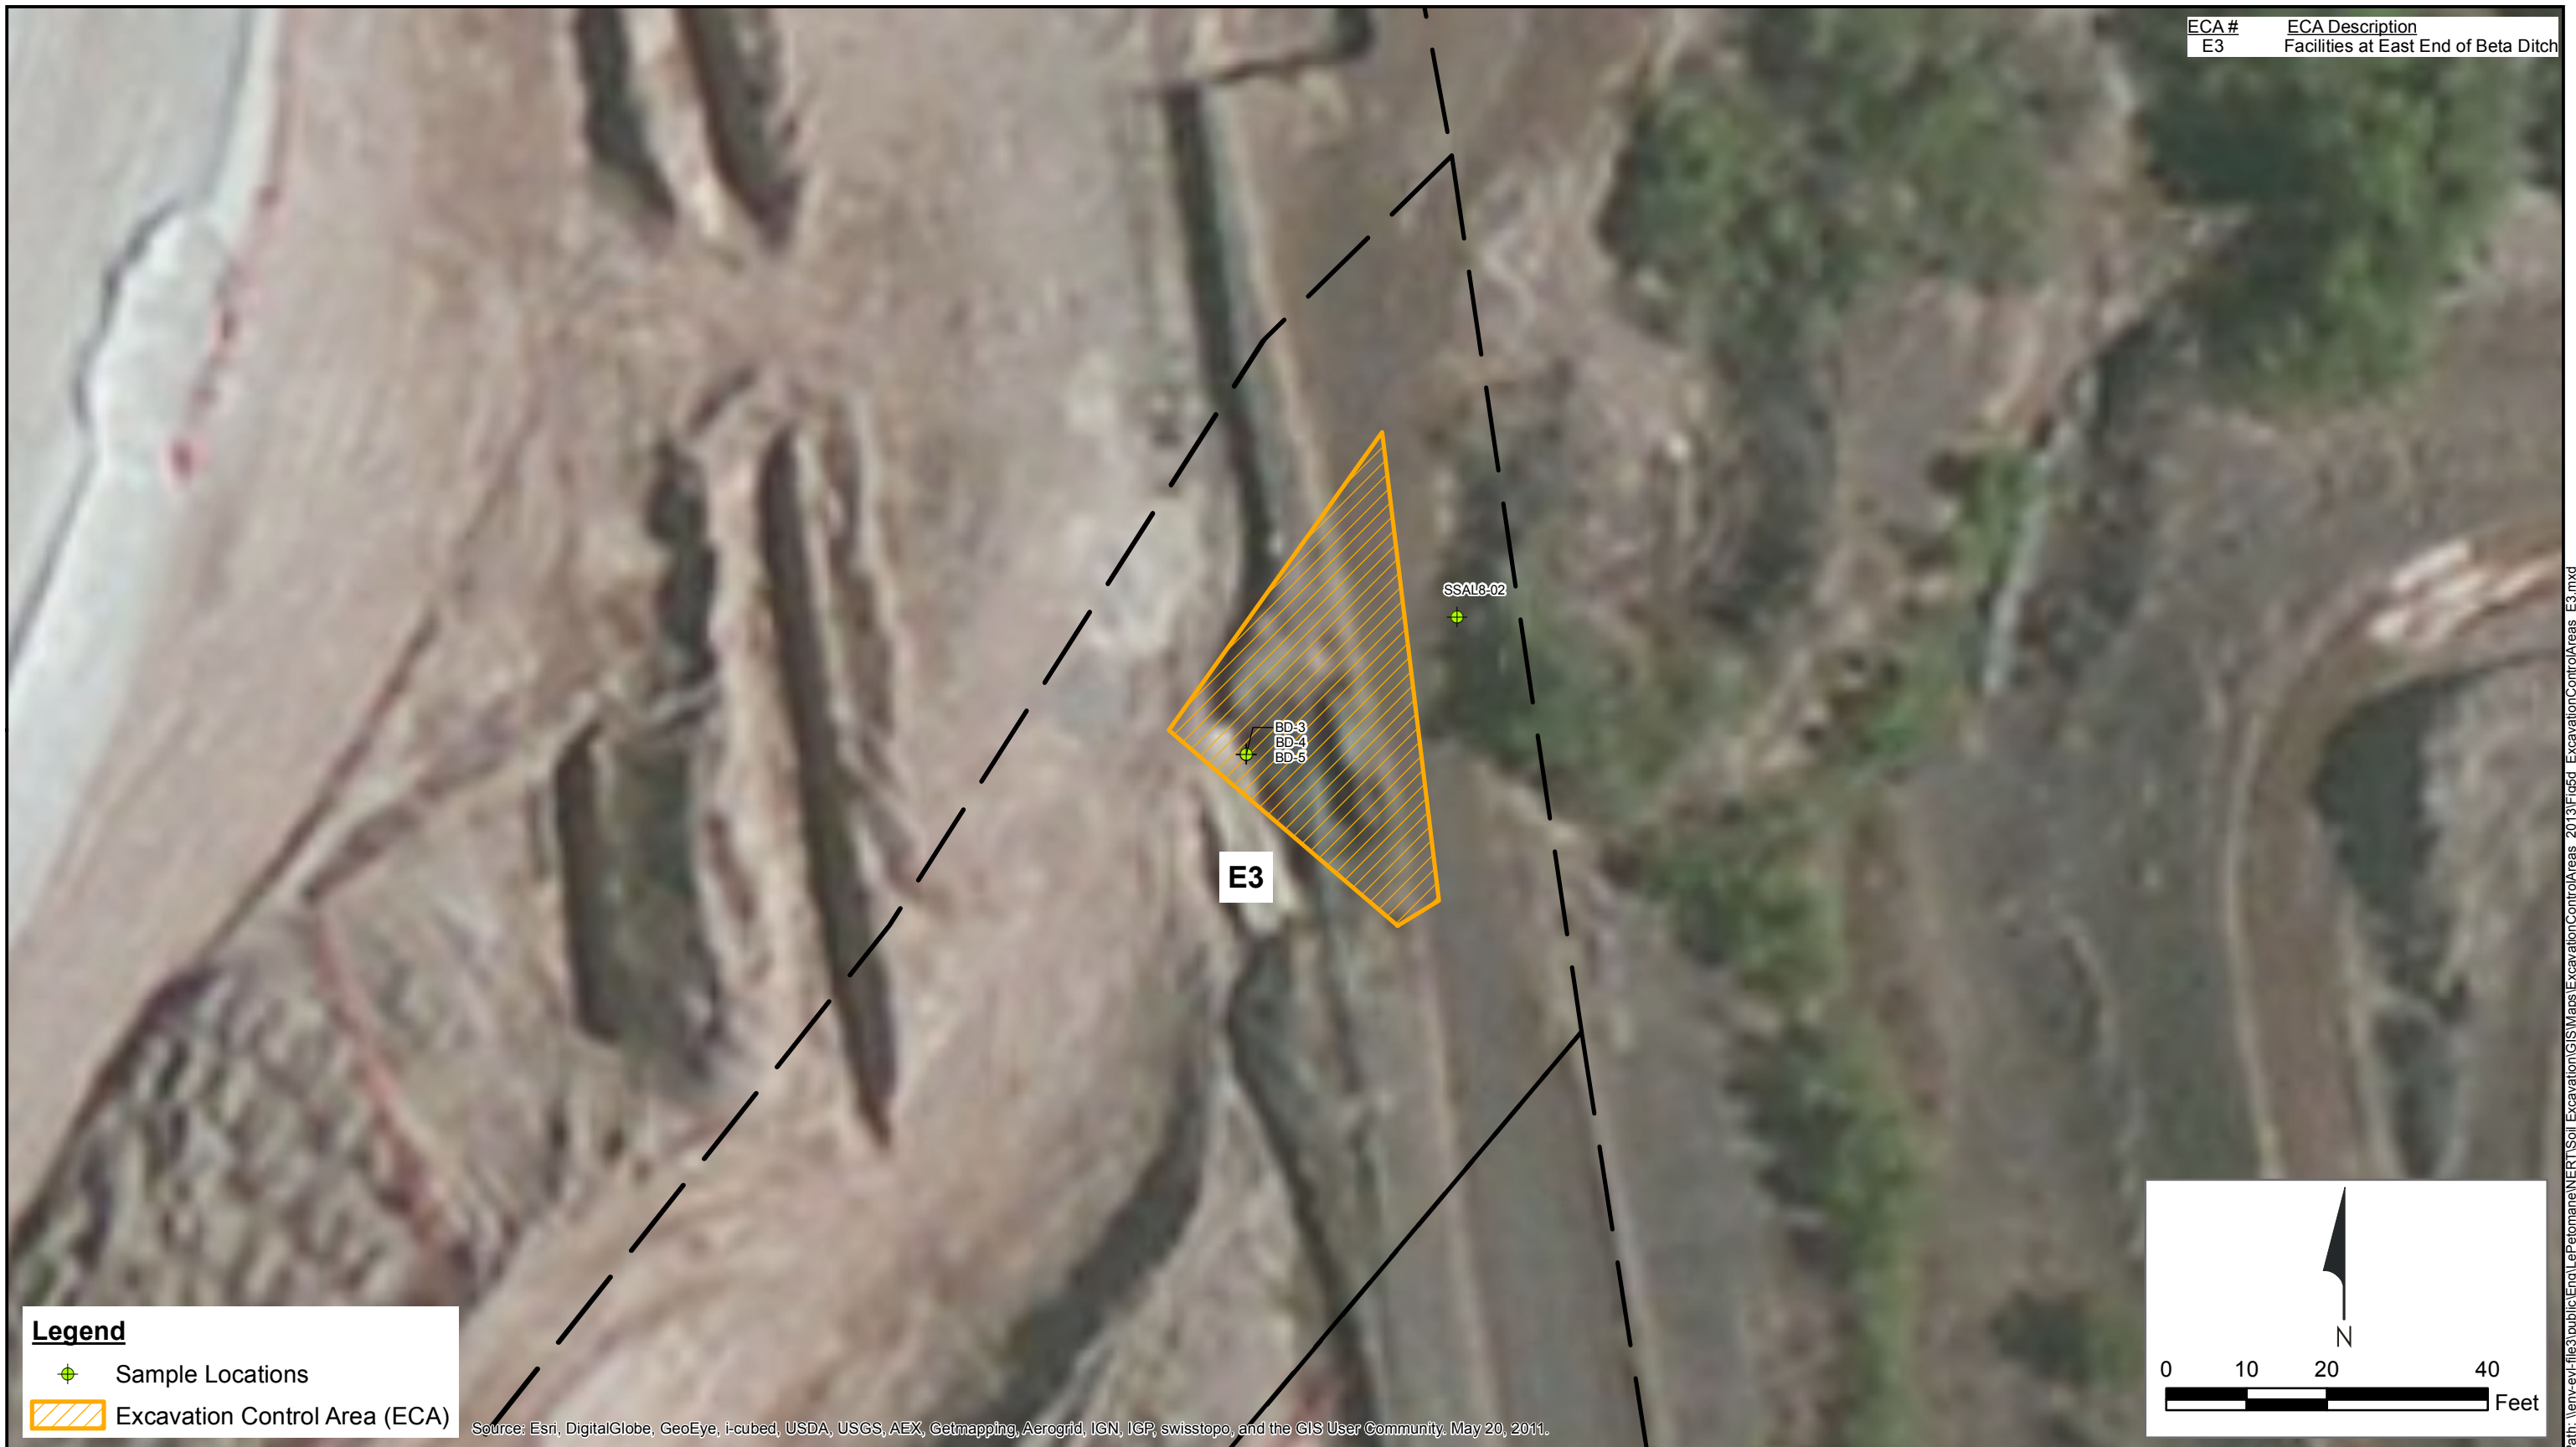
Figure
5d

ECA #	ECA Description
E3	Facilities at East End of Beta Ditch

Excavation Control Area E3
 Nevada Environmental Response Trust Site, Henderson, Nevada
