TECHNICAL MEMORANDUM

То:	Nevada Environmental Response Trust
Cc:	Dan Pastor, Tetra Tech, Inc.
From:	April Hussey
Date:	March 23, 2018
Subject:	Operation and Maintenance Summary – February 2018 Weir Dewatering Treatment Plant Nevada Environmental Response Trust; Henderson, Nevada

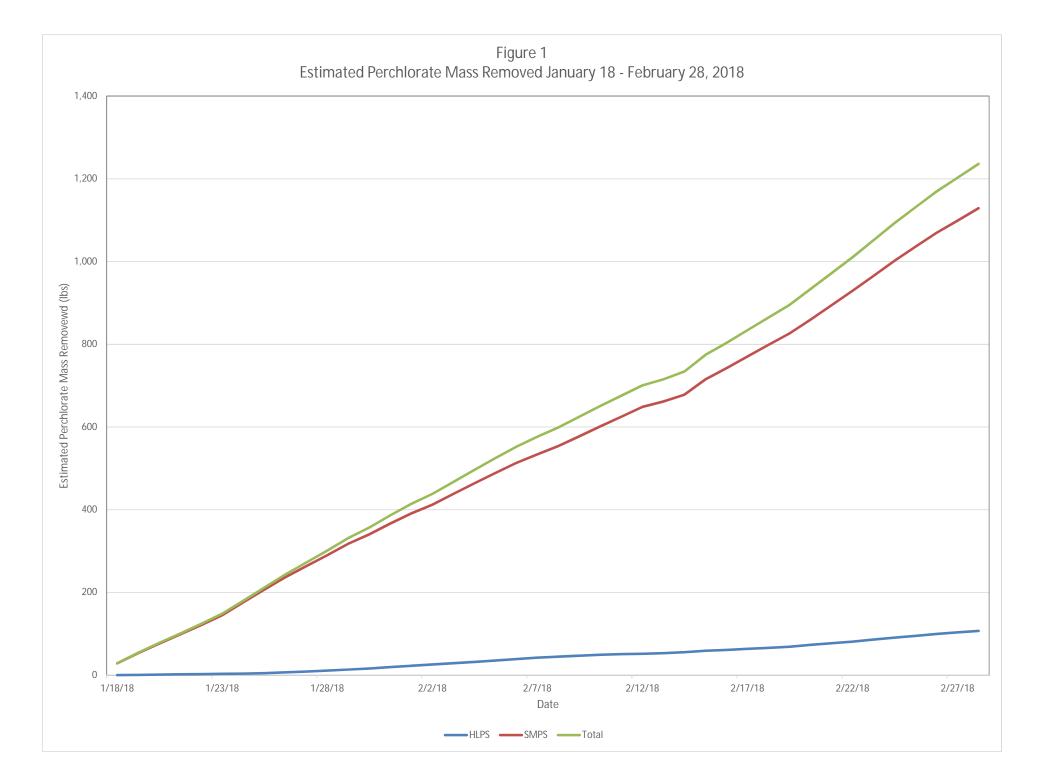
A graph showing the estimated removal of perchlorate from January 18 through February 28 is presented in Figure 1.
