STATE OF NEVADA
Department of Conservation & Natural Resources
DIVISION OF ENVIRONMENTAL PROTECTION

Re: **Tronox LLC (TRX)**
NDEP Facility ID #H-000539
Nevada Division of Environmental Protection (NDEP) Response to:
*Revised Excavation Plan for Phase B Soil Remediation of RZ-D, Addendum to the
Removal Action Work Plan, Tronox LLC, Henderson, Nevada*
Dated: August 31, 2010

Attachment A

Attachment C

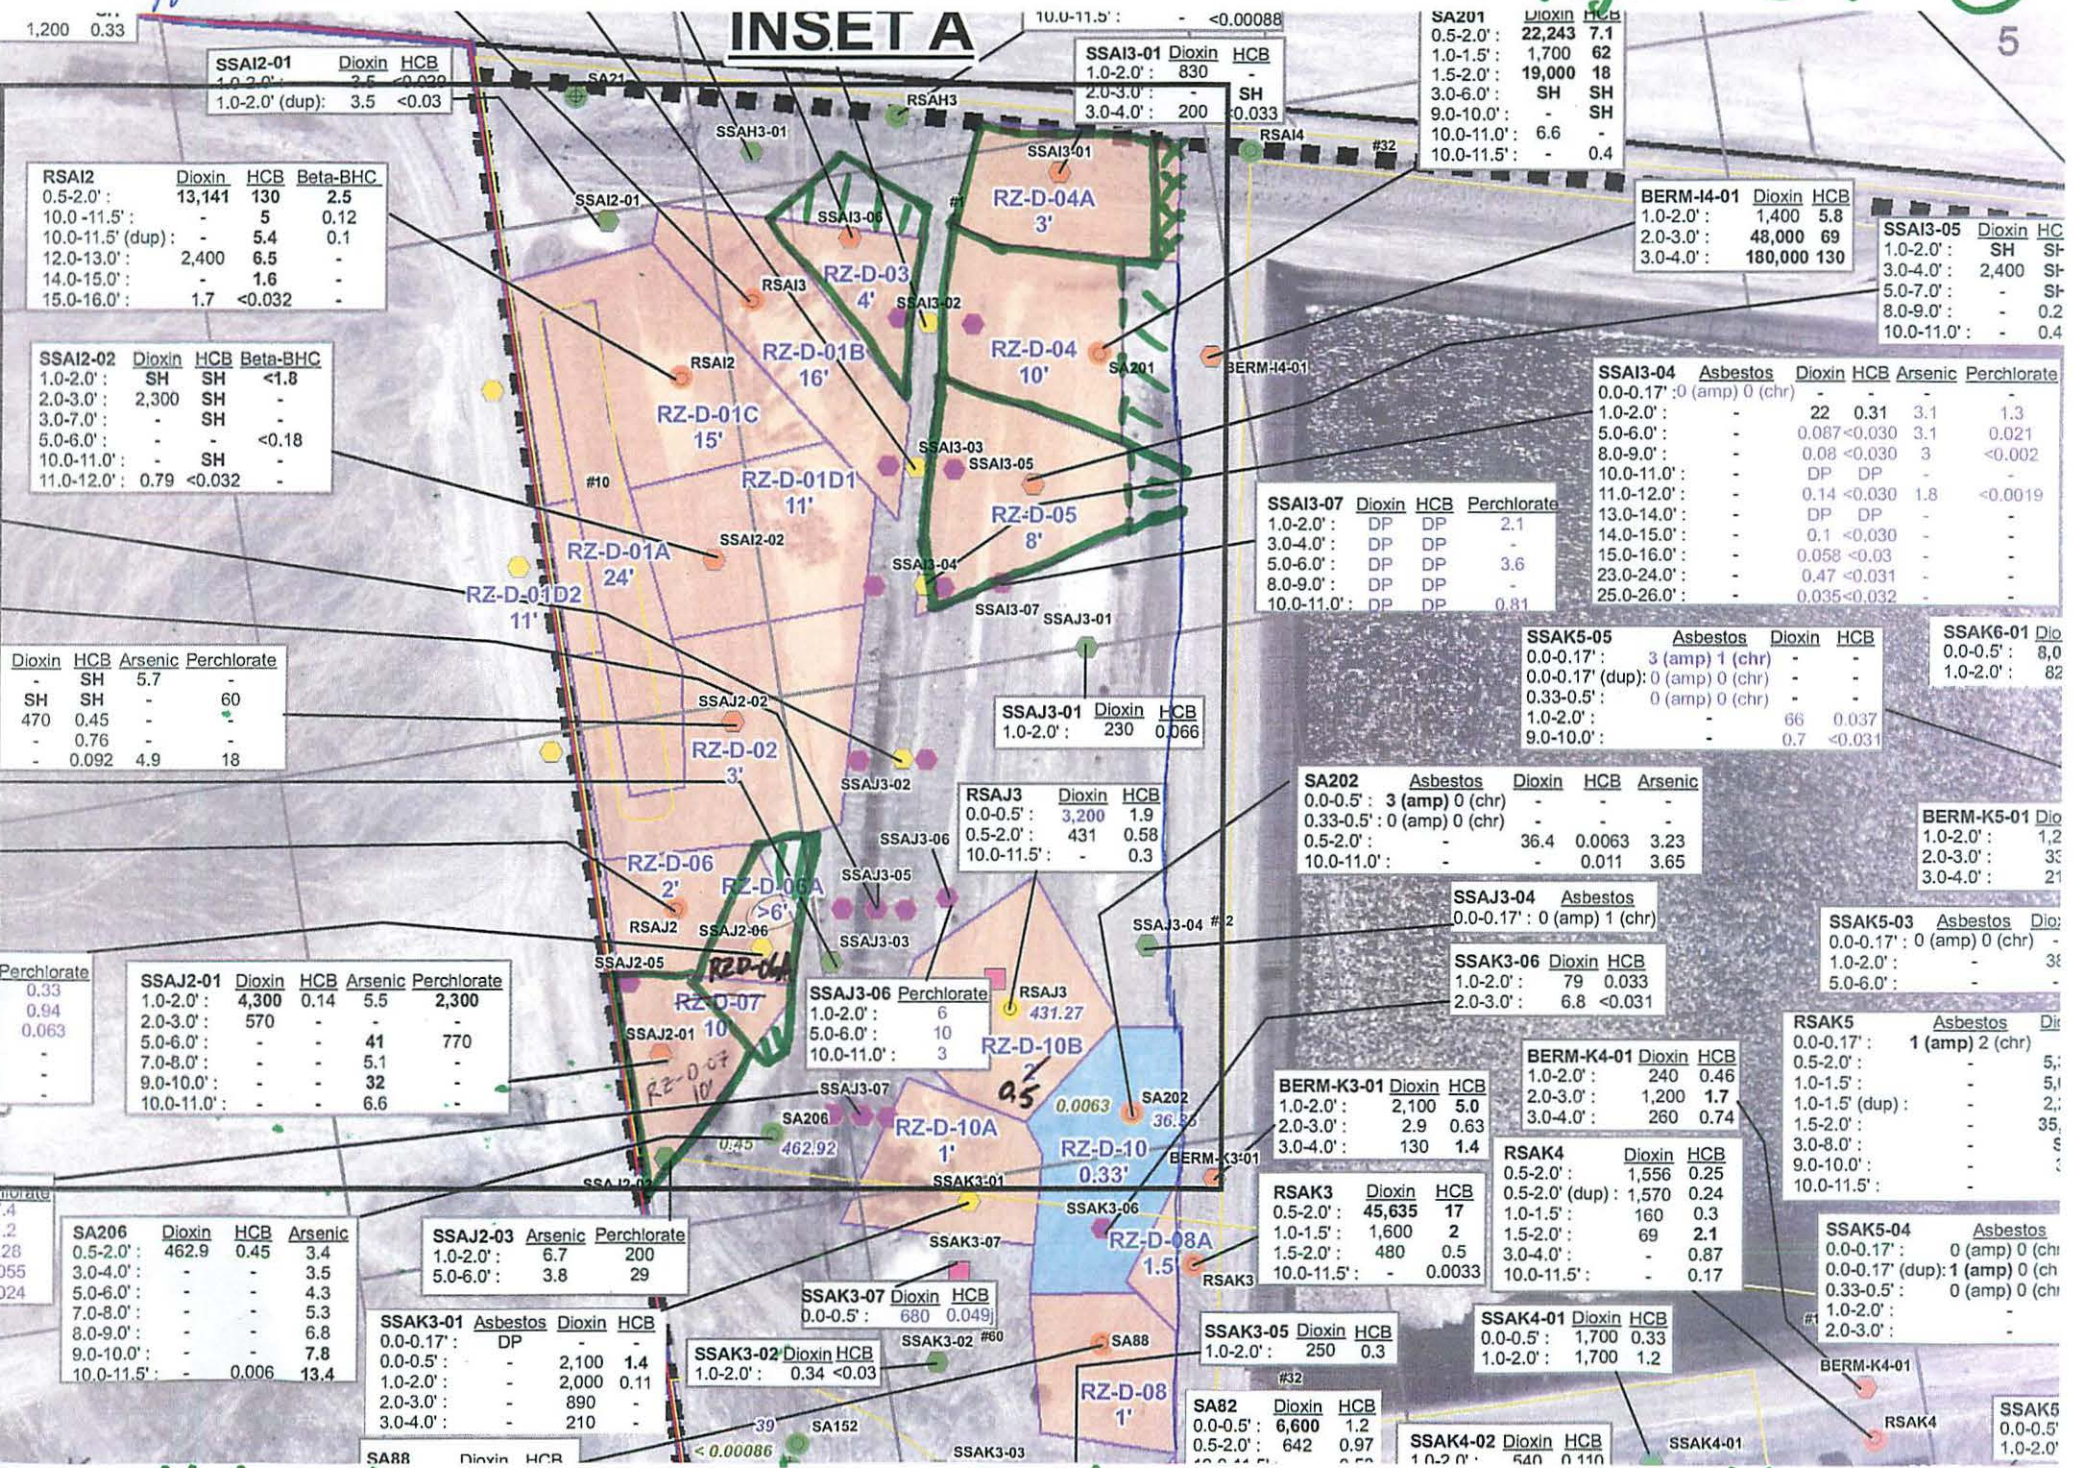
Figure C-1

The following Figures are excerpts from Figure 1: RZ-D Excavation Areas and Nature and Extent of Contamination (dated September 24, 2010). NDEP has provided approximate revisions to excavation limits to illustrate the comments made in the Attachment B Table as well as based on comment 3 of Attachment A.

NDEP acknowledges the temporary setback of 50 feet around the berms of the Active Ponds. NDEP has noted the approximate location of the toe of slope for these berms as a reference for some of the comments in the Attachment B Table.

Excavation Area	Contaminated Sampling Location	Adjacent Sampling Locations	Depth fbgs	Exceptions
RZ-D-01A	Hazardous Waste Landfill (HWL)	Limits of the HWL	24	
RZ-D-01B	RSAI3	SSAI2-01 SSAH3-01 RSAI2	16	Western cutline: western property boundary **HWL located within this area
	SSAI3-03-SW-W	SSAI3-03		
RZ-D-01C	RSAI2	SSAI2-01 RSAI3 SSAI2-02	15	Western cutline: western property boundary
RZ-D-01D1	SSAI2-02	SSAJ2-02 RSAI2	11	Eastern cutline: boundary of Trade Effluent Pond berm Western cutline: western property boundary **HWL located within this area
RZ-D-01D2			11	Eastern cutline: HWL boundary Western cutline: western property boundary
RZ-D-02	SSAJ2-02	SSAI2-02 RSAJ2	3	Eastern cutline: boundary of Trade Effluent Pond berm Western cutline: western property boundary
RZ-D-03 (C-1)	SSAI3-06	RSAI3 SSH3-01 RSAH3	4	
	SSAI3-02-SW-W	SSAI3-02		
RZ-D-04 (C-1)	SA201	SSAI3-01 SSAI3-05	10	Eastern cutline: toe of GW-11 pond berm (or approved setback)

SSAI3-02-SW-E	SSAI3-02		
RZ-D-04A (C-1)	SSAI3-01	RSAH3 SA201 RSAI4	3	Northern cutline: Parcel C boundary

Excavation Area	Contaminated Sampling Location	Adjacent Sampling Locations	Depth fbgs	Exceptions
RZ-D-05 (C-1)	SSAI3-05	SA201 SSAJ3-01	8	Eastern cutline: toe of GW-11 pond berm (or approved setback)
	SSAI3-03-SW-E	SSAI3-03		
	SSAI3-04-SW-E	SSAI3-04		
RZ-D-06	RSAJ2	SSAJ2-02 HWL SSAJ2-01 SSAJ2-06	2	Western cutline: western property boundary
RZ-D-06A (C-1)	SSAJ2-06	RSAJ2 SSAJ2-01 SSAJ3-07 SSAJ3-03 SSAJ2-02	≥6	
RZ-D-07 (C-1)	SSAJ2-01	RSAJ2 SA206 SSAJ2-06	10	Western cutline: western property boundary
RZ-D-08	SA88	SSAK3-05 SSAK3-02 SSAK3-06 RSAK3	1	Eastern cutline: toe of GW-11 pond berm
RZ-D-08A	RSAK3	SSAK3-06 SA88	1.5	Eastern cutline: toe of GW-11 pond berm
RZ-D-10	SA202	RSAJ3 RSAJ3-04 SA88 SSAK3-01	0.33	Eastern cutline: toe of GW-11 pond berm
RZ-D-10A	SSAK3-01	SA202 RSAJ3 SA206 SSAK3-07 SSAK3-06	1	
RZ-D-10B	RSAJ3	SSAJ3-05 SSAJ3-03 SSAJ3-07 SSAK3-01 SA202 SSAJ3-04	0.5

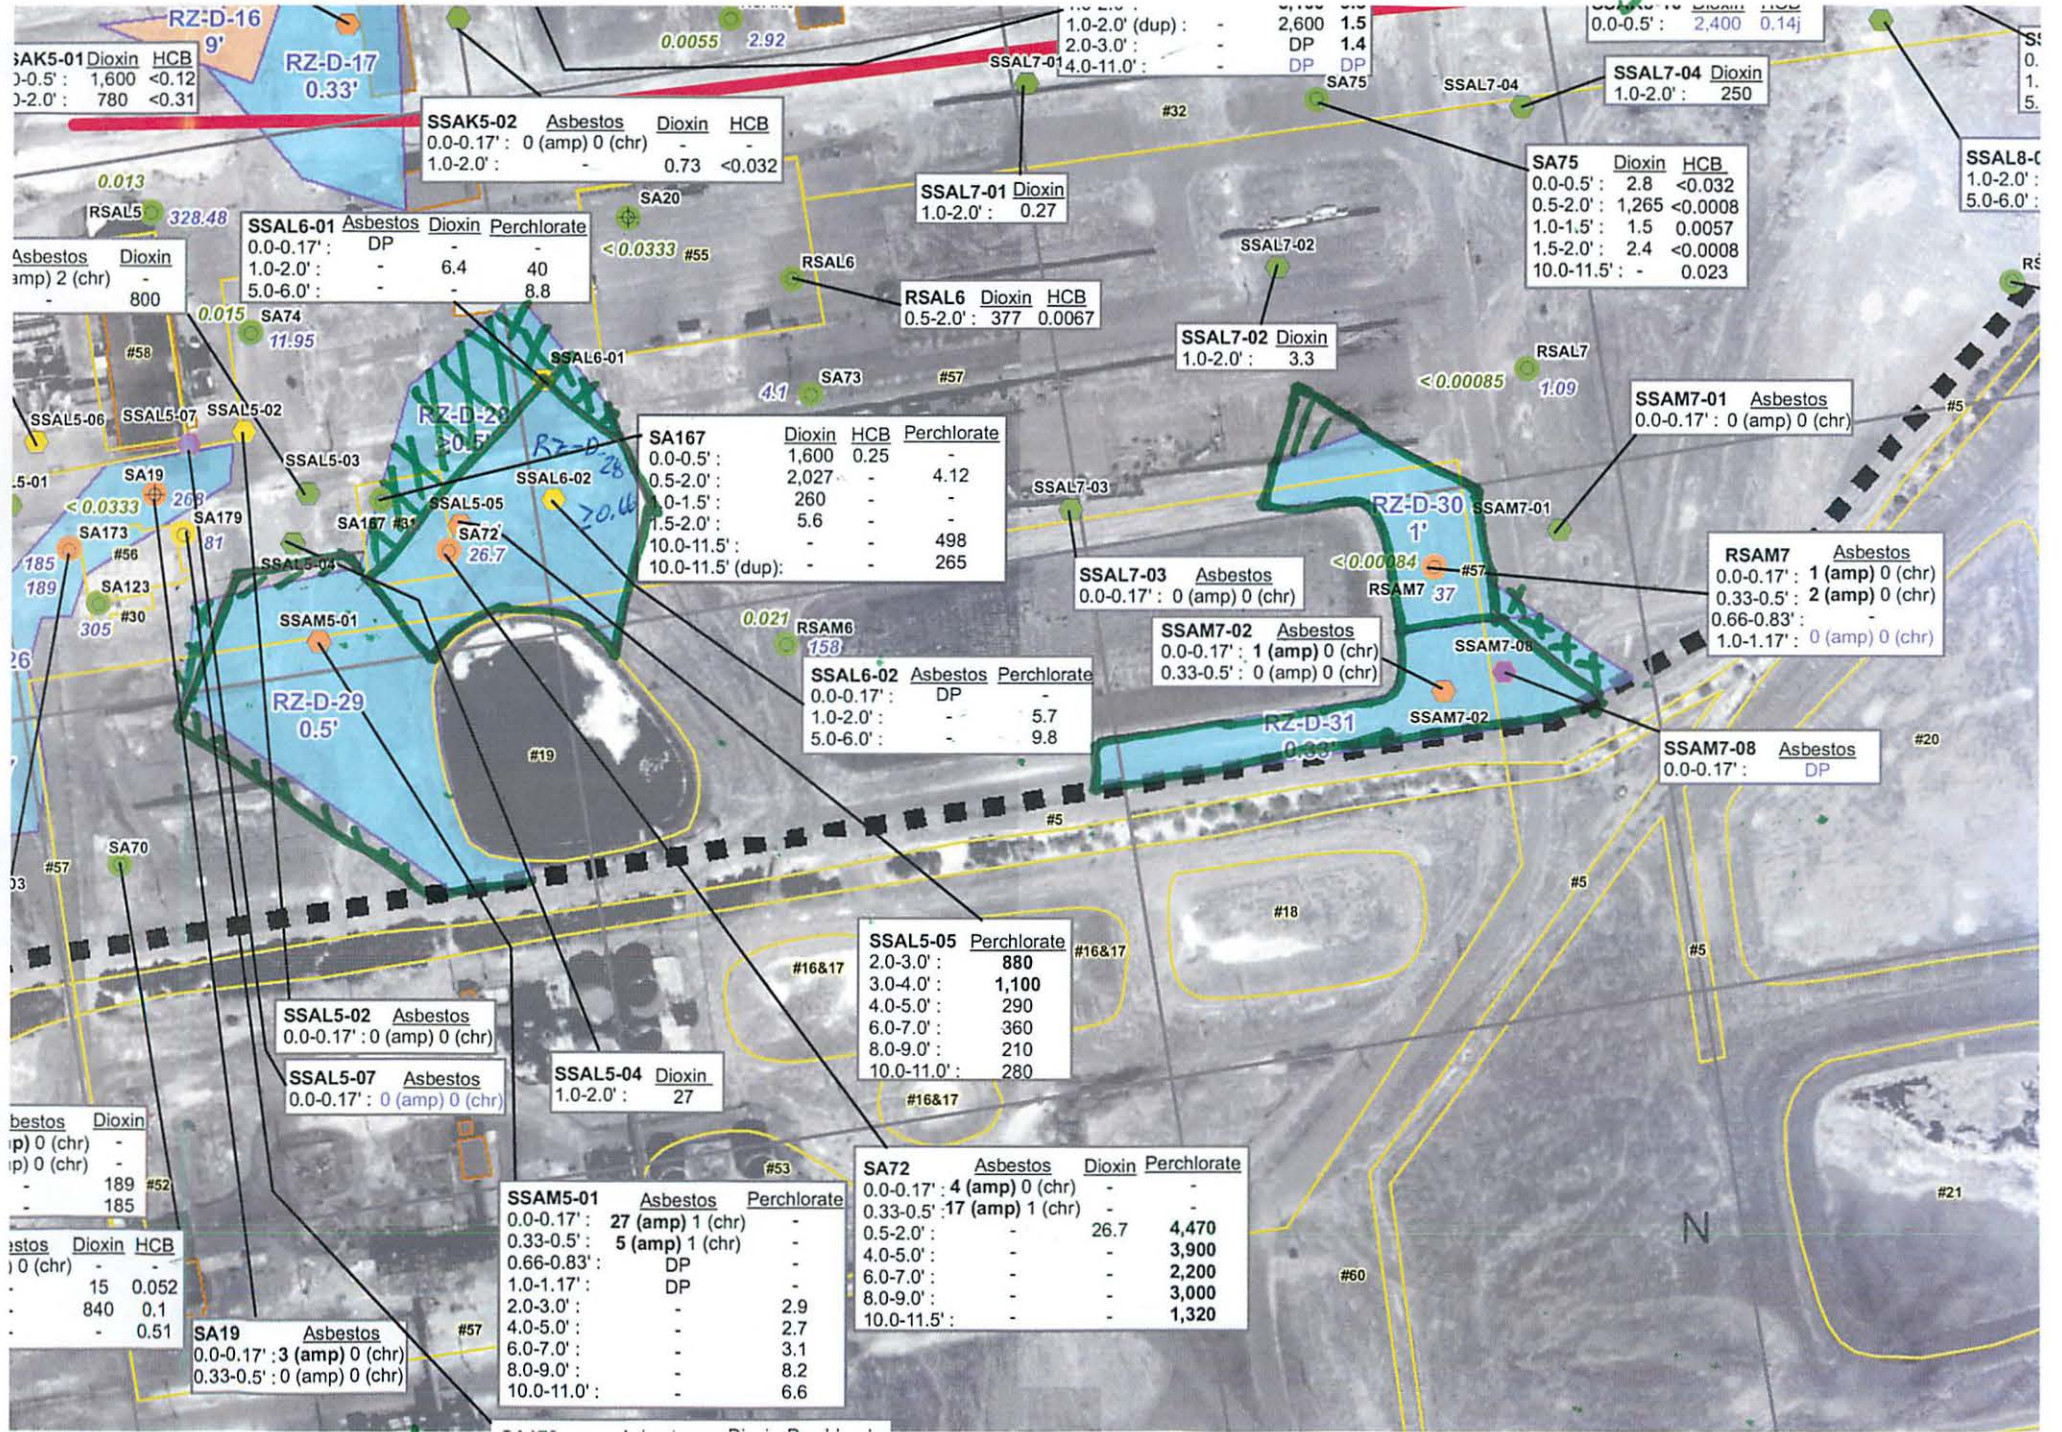
XXX reduced excavation area

/// additional excavation area

- e. RZ-D-28 / RZ-D-28A, TRX states that they have “elected to keep RZ-D-28 as one area”. Additionally, TRX states that this one area will be excavated to 10 fbgs. However, based on discussions on September 27, 2010 between NDEP and TRX and the September 27, 2010 Errata, NDEP understands that TRX will continue to investigate alternate remediation options for the perchlorate contaminated soils; therefore, TRX will excavate the asbestos contaminated soil and will recommend an alternative remedial method for the perchlorate-only contaminated soils. Please see Attachment B table and Figure C-4 for additional information.

RZ-D-29 (C-4)	SSAM5-01	SSAL5-03 SA167 SA72 SA70 SA123 SA179	≥0.66	Eastern cutline: toe of AP-5 pond berm

Excavation Area Name	Contaminated Sampling Location	Adjacent Sampling Locations	Depth fbg	Exceptions
RZ-D-30 (C-4)	RSAM7	SSAM7-02 SSAL7-03 RSAL7 SSAM7-01	1	Southern cutline: RZ-E cutline NDEP currently does not approve exclusion of the roadway from excavation.
RZ-D-31 (C-4)	SSAM7-02	RSAM6 RSAM7 SSAM7-01	0.33	Southern cutline: RZ-E cutline NDEP currently does not approve exclusion of the roadway from excavation.
