STATE OF NEVADA
Department of Conservation & Natural Resources
DIVISION OF ENVIRONMENTAL PROTECTION

Re: **Tronox LLC (TRX)**
NDEP Facility ID #H-000539
Nevada Division of Environmental Protection (NDEP) Response to:
*Revised Excavation Plan for Phase B Soil Remediation of RZ-D, Addendum to the
Removal Action Work Plan, Tronox LLC, Henderson, Nevada*
Dated: August 31, 2010

*Errata to Addendum to the Excavation Plan for RZ-D, Concerning Set-Backs for GW-11
and WC Pond Embankments and Changes to the Proposed Excavation Areas, Tronox
Facility, Henderson, Nevada, dated August 31, 2010*
Dated: September 27, 2010

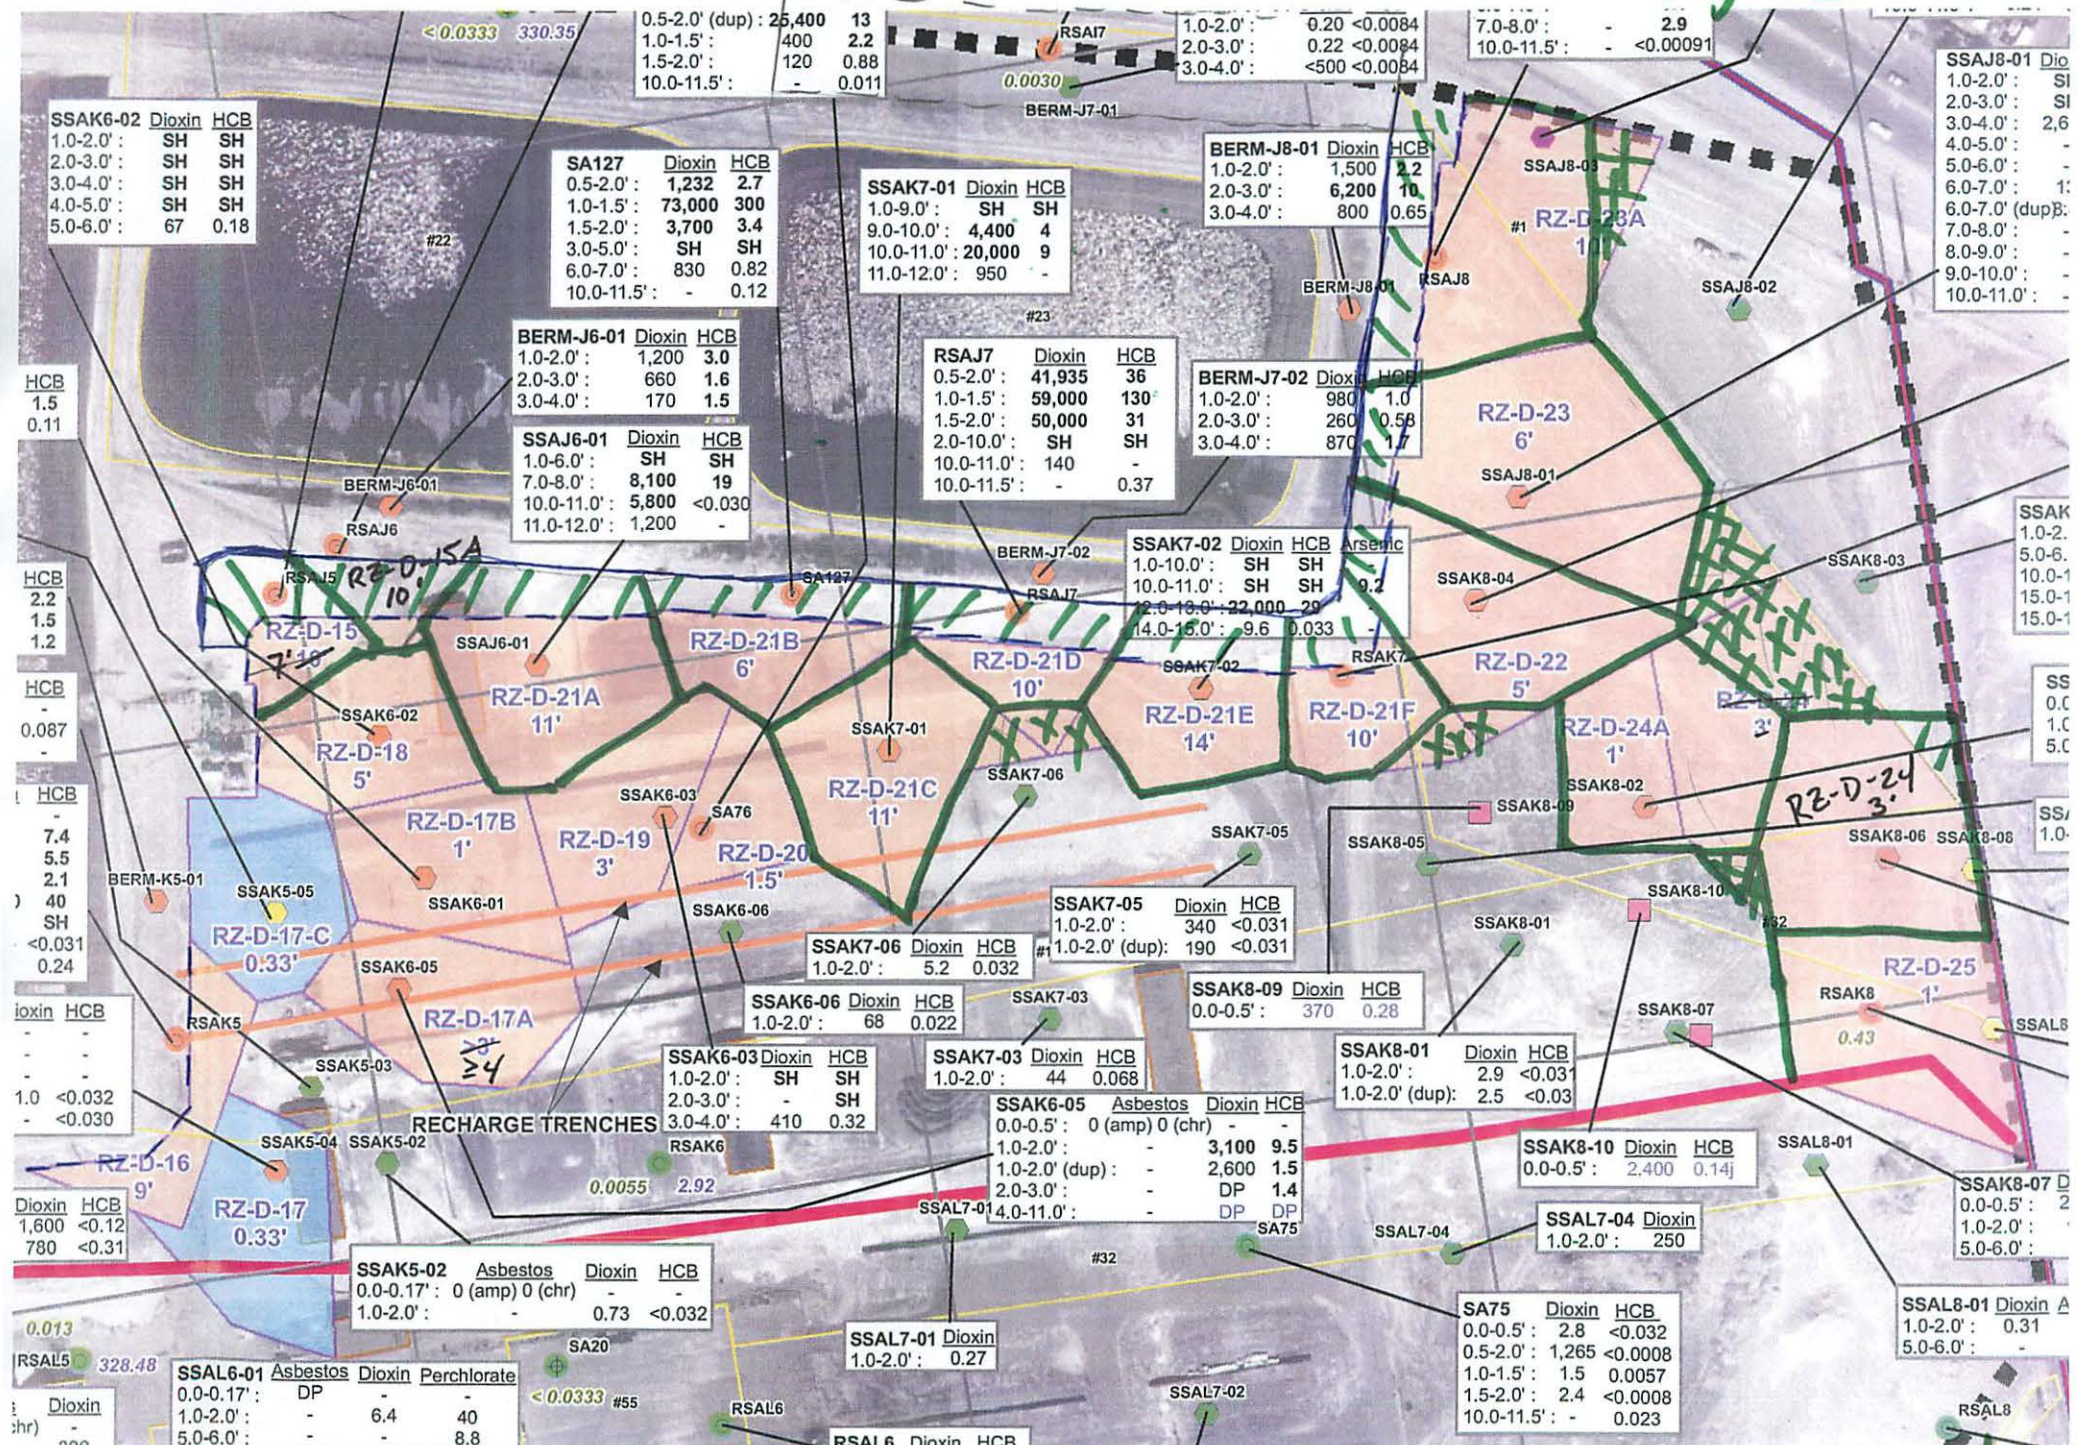
Figure C-3

The following Figures are excerpts from Figure 1: RZ-D Excavation Areas and Nature and Extent of Contamination (dated September 24, 2010). NDEP has provided approximate revisions to excavation limits to illustrate the comments made in the Attachment B Table as well as based on comment 3 of Attachment A.

NDEP acknowledges the temporary setback of 50 feet around the berms of the Active Ponds. NDEP has noted the approximate location of the toe of slope for these berms as a reference for some of the comments in the Attachment B Table.

Excavation Area	Contaminated Sampling Location	Adjacent Sampling Locations	Depth fbgs	Exceptions
RZ-D-15A (C-3)	RSAJ6	RSAJ5 SSAJ6-01 SSAK6-02	10	Northern cutline: toe of WC-West pond berm (or approved setback)
RZ-D-16	RSAK5	SSAK5-05 SSAK5-04 RSAL5	9	Western cutline: toe of GW-11 pond berm (or approved setback)
RZ-D-17	SSAK5-04	RSAK5 SSAK5-03 SSAK5-02 SA74 RSAL5	0.33	
RZ-D-17A	SSAK6-05	SSAK5-05 SSAK6-01 SSAK6-06 RSAK6 SSAK5-02 SSAK5-03	≥4	Final depth of excavation has not been determined. Additional sampling is required.
RZ-D-17B	SSAK6-01	SSAK5-05 SSAK6-02 SSAJ6-01 SSAK6-03 SSAK5-05	1	
RZ-D-17C	SSAK5-05	SSAK6-02 SSAK6-01 SSAK6-05 SSAK5-03 RSAK5	0.33	
RZ-D-18	SSAK6-02	RSAJ5 RSAJ6 SSAJ6-01 SSAK6-01 SSAK5-05	5	Western cutline: toe of GW-11 pond berm (or approved setback)
RZ-D-19	SSAK6-03	SSAJ6-01 SA127 SA76 SSAK6-06 SSAK6-01	3	
RZ-D-20	SA76	SSAK6-03 SA127 SSAK7-01 SSAK6-06	1.5

Excavation Area	Contaminated Sampling Location	Adjacent Sampling Locations	Depth fbgs	Exceptions
RZ-D-21A (C-3)	SSAJ6-01	SSAK6-02 SSAK6-01 SSAK6-03 SA127	11	Northern cutline: toe of WC-West pond berm (or approved setback)
RZ-D-21B (C-3)	SA127	SSAJ6-01 SSAK6-03 SA76 SSAK7-01 RSAJ7	6	Northern cutline: toe of WC-West and WC-East pond berms(or approved setback)
RZ-D-21C (C-3)	SSAK7-01	SA127 SA76 SSAK6-06 SSAK7-06 RSAJ7	11	
RZ-D-21D (C-3)	RSAJ7	SA127 SSAK7-01 SSAK7-06 SSAK7-02	10	Northern cutline: toe of WC-East pond berm (or approved setback)
RZ-D-21E (C-3)	SSAK7-02	RSAJ7 SSAK7-06 SSAK7-05 RSAK7	14	Northern cutline: toe of WC-East pond berm (or approved setback)
RZ-D-21F (C-3)	RSK7	SSAK7-02 SSAK7-05 SSAK8-05 SSAK8-09 SSAK8-04	10	Northwestern cutline: toe of WC-East pond berm (or approved setback)
RZ-D-22 (C-3)	SSAK8-04	RSK7 SSAK8-09 SSAK8-02 SSAJ8-01	5	Western cutline: toe of WC-East pond berm (or approved setback)

RZ-D-23 (C-3)	SSAJ8-01	SSAK8-04 RSAJ8 SSAJ8-02 SSAK8-03	6	Western cutline: toe of WC-East pond berm (or approved setback)
RZ-D-23A (C-3)	RSAJ8	SSAJ8-01 SSAJ8-02	10	Western cutline: toe of WC-East pond berm (or approved setback) Northern cutline: property boundary with Parcel C

Excavation Area	Contaminated Sampling Location	Adjacent Sampling Locations	Depth fbgs	Exceptions
RZ-D-24 (C-3)	SSAK8-06	SSAK8-03 RSAK8 SSAK8-10 SSAK8-02	3	Eastern cutline: eastern property boundary
RZ-D-24A (C-3)	SSAK8-02	SSAK8-04 SSAK8-03 SSAK8-06 SSAK8-10 SSAK8-09	1	
RZ-D-25	RSAK8	SSAK8-10 SSAK8-06 SSAL8-01	1	Eastern cutline: eastern property
RZ-D-26 (C-2)	SA173	SA189 SA123 SSAL5-01	0.33	Northern cutline: Groundwater treatment system area
	SA19	SA179 SSAL5-07		
RZ-D-26A (C-2)	SA189	SSAL4-03 SSAL4-02 SSAL5-01 SA173 SA123 SSAM4-01	0.5	No surface sample for dioxins/furans TEQ was collected per the NDEP-approved surface sampling protocol established by TRX. Therefore, the depth of this polygon is based on the 0.5-2 fbgs sample as it is less than the modified dioxins/furans TEQ BCL.
RZ-D-27 (C-2)	SSAM4-01	SSAL4-03 SA189 SA70 SSAM4-03 SSAM4-04	0.66	Southern cutline: RZ-E cutline
RZ-D-28 (C-4)	SA72	SA167 SA20 SA73 RSAM6	≥0.66	**remediation alternatives will be investigated for perchlorate contamination Southern cutline: toe of AP-5 pond berm
